REPORT ON ULTRASONIC EXAMINATION
STEAM GENERATOR CLAD CRACKING
NO. 1 UNIT
SALEM NUCLEAR GENERATING STATION
DOCKET NO. 50-272

REPORT OF ULTRASONIC EXAMINATION
STEAM GENERATOR CLADDING CRACKING
NO. 1 UNIT
SALEM NUCLEAR GENERATING STATION

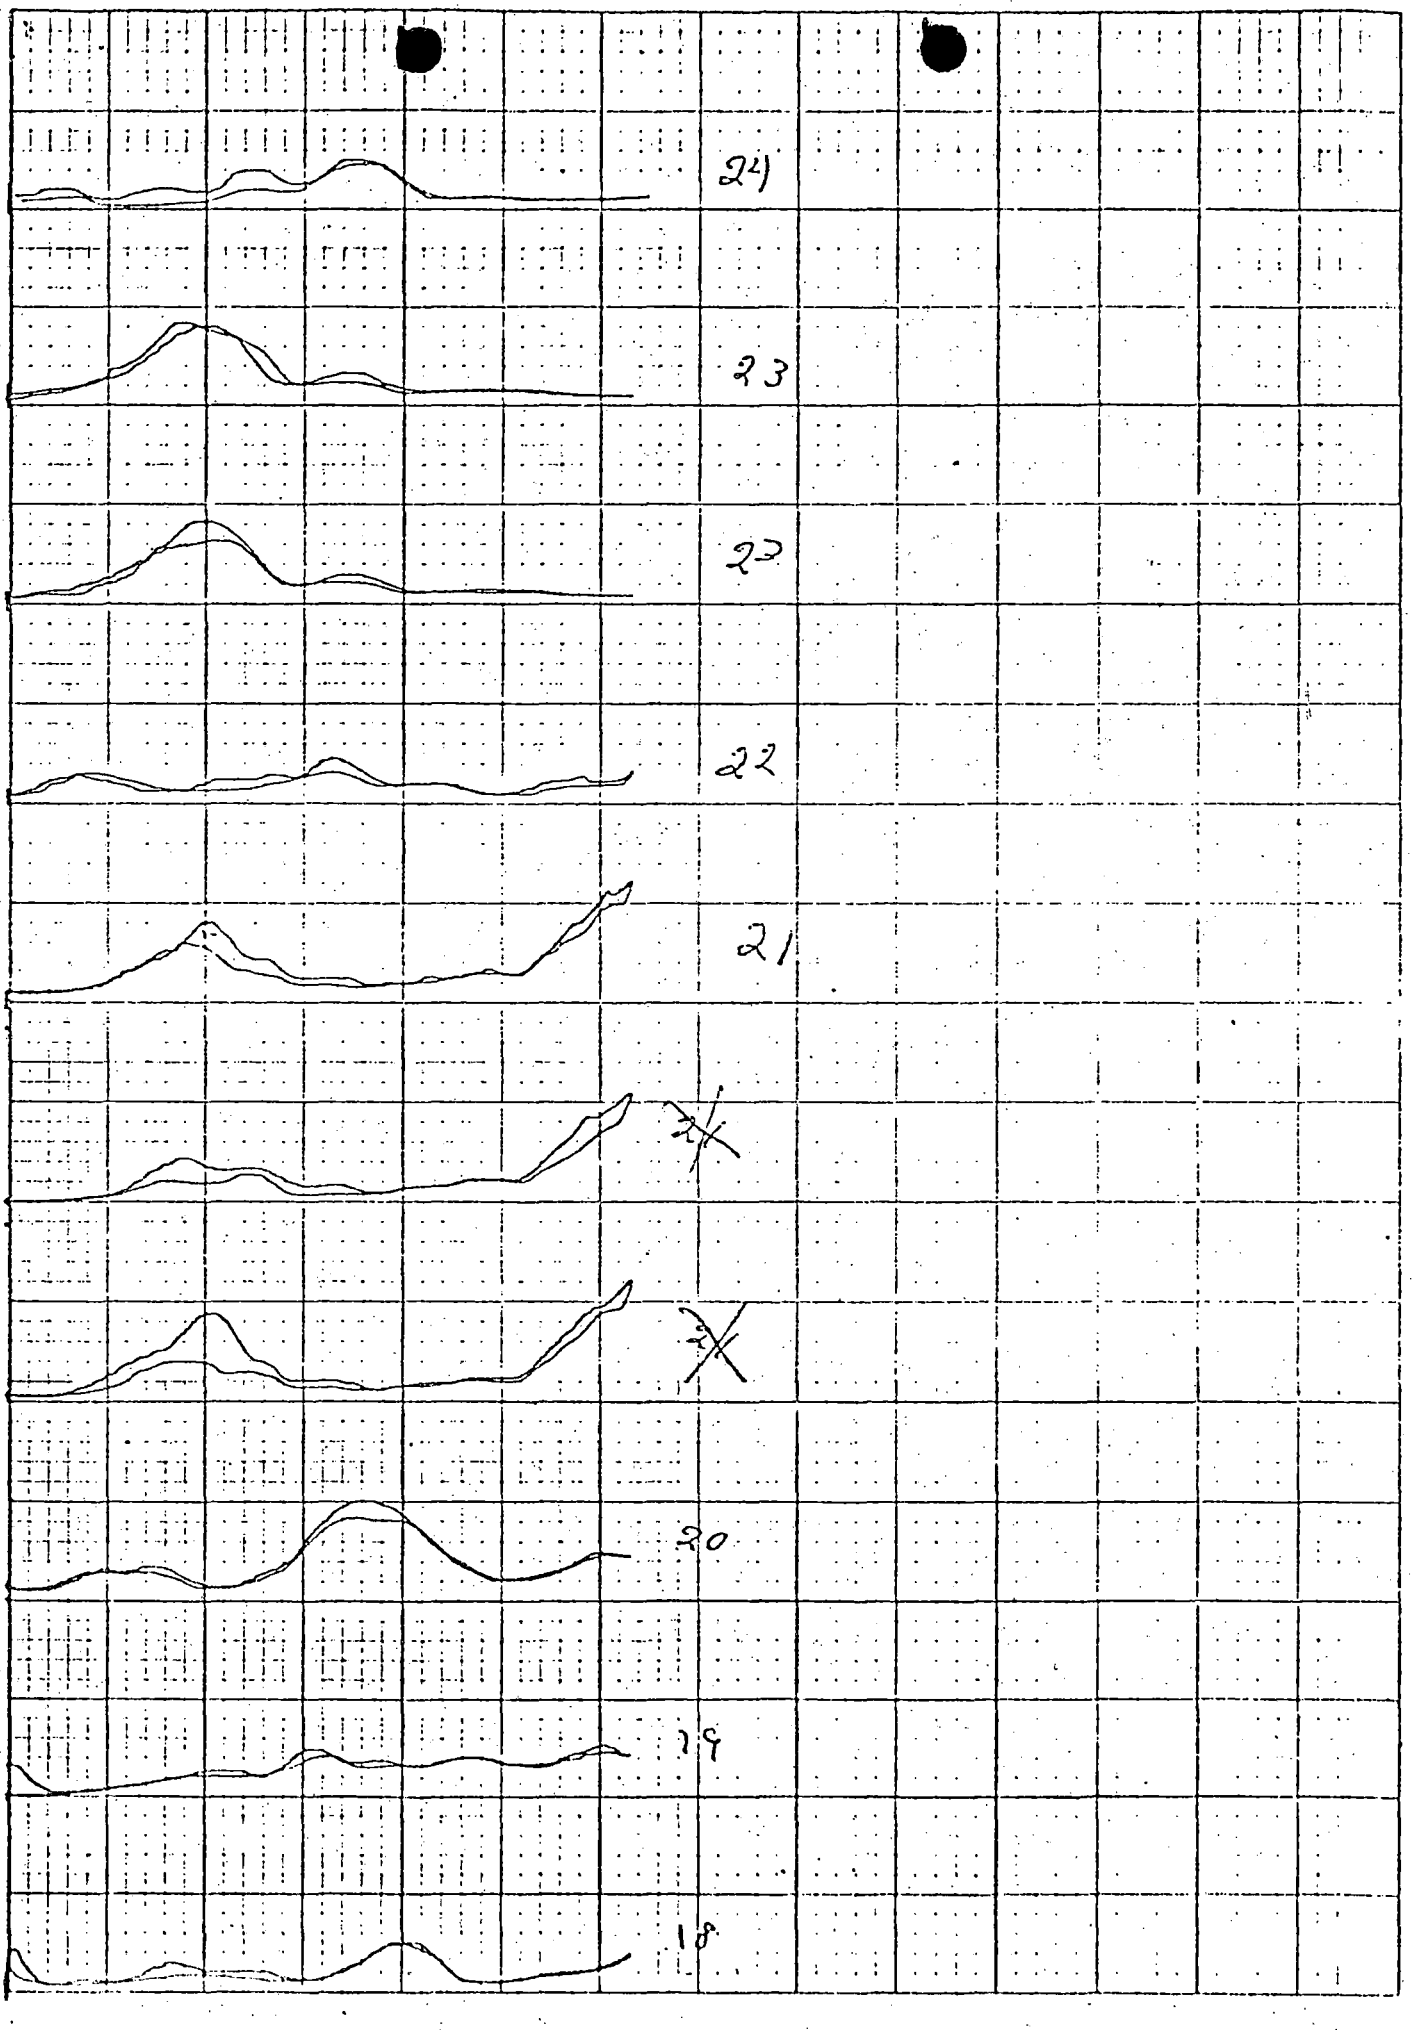
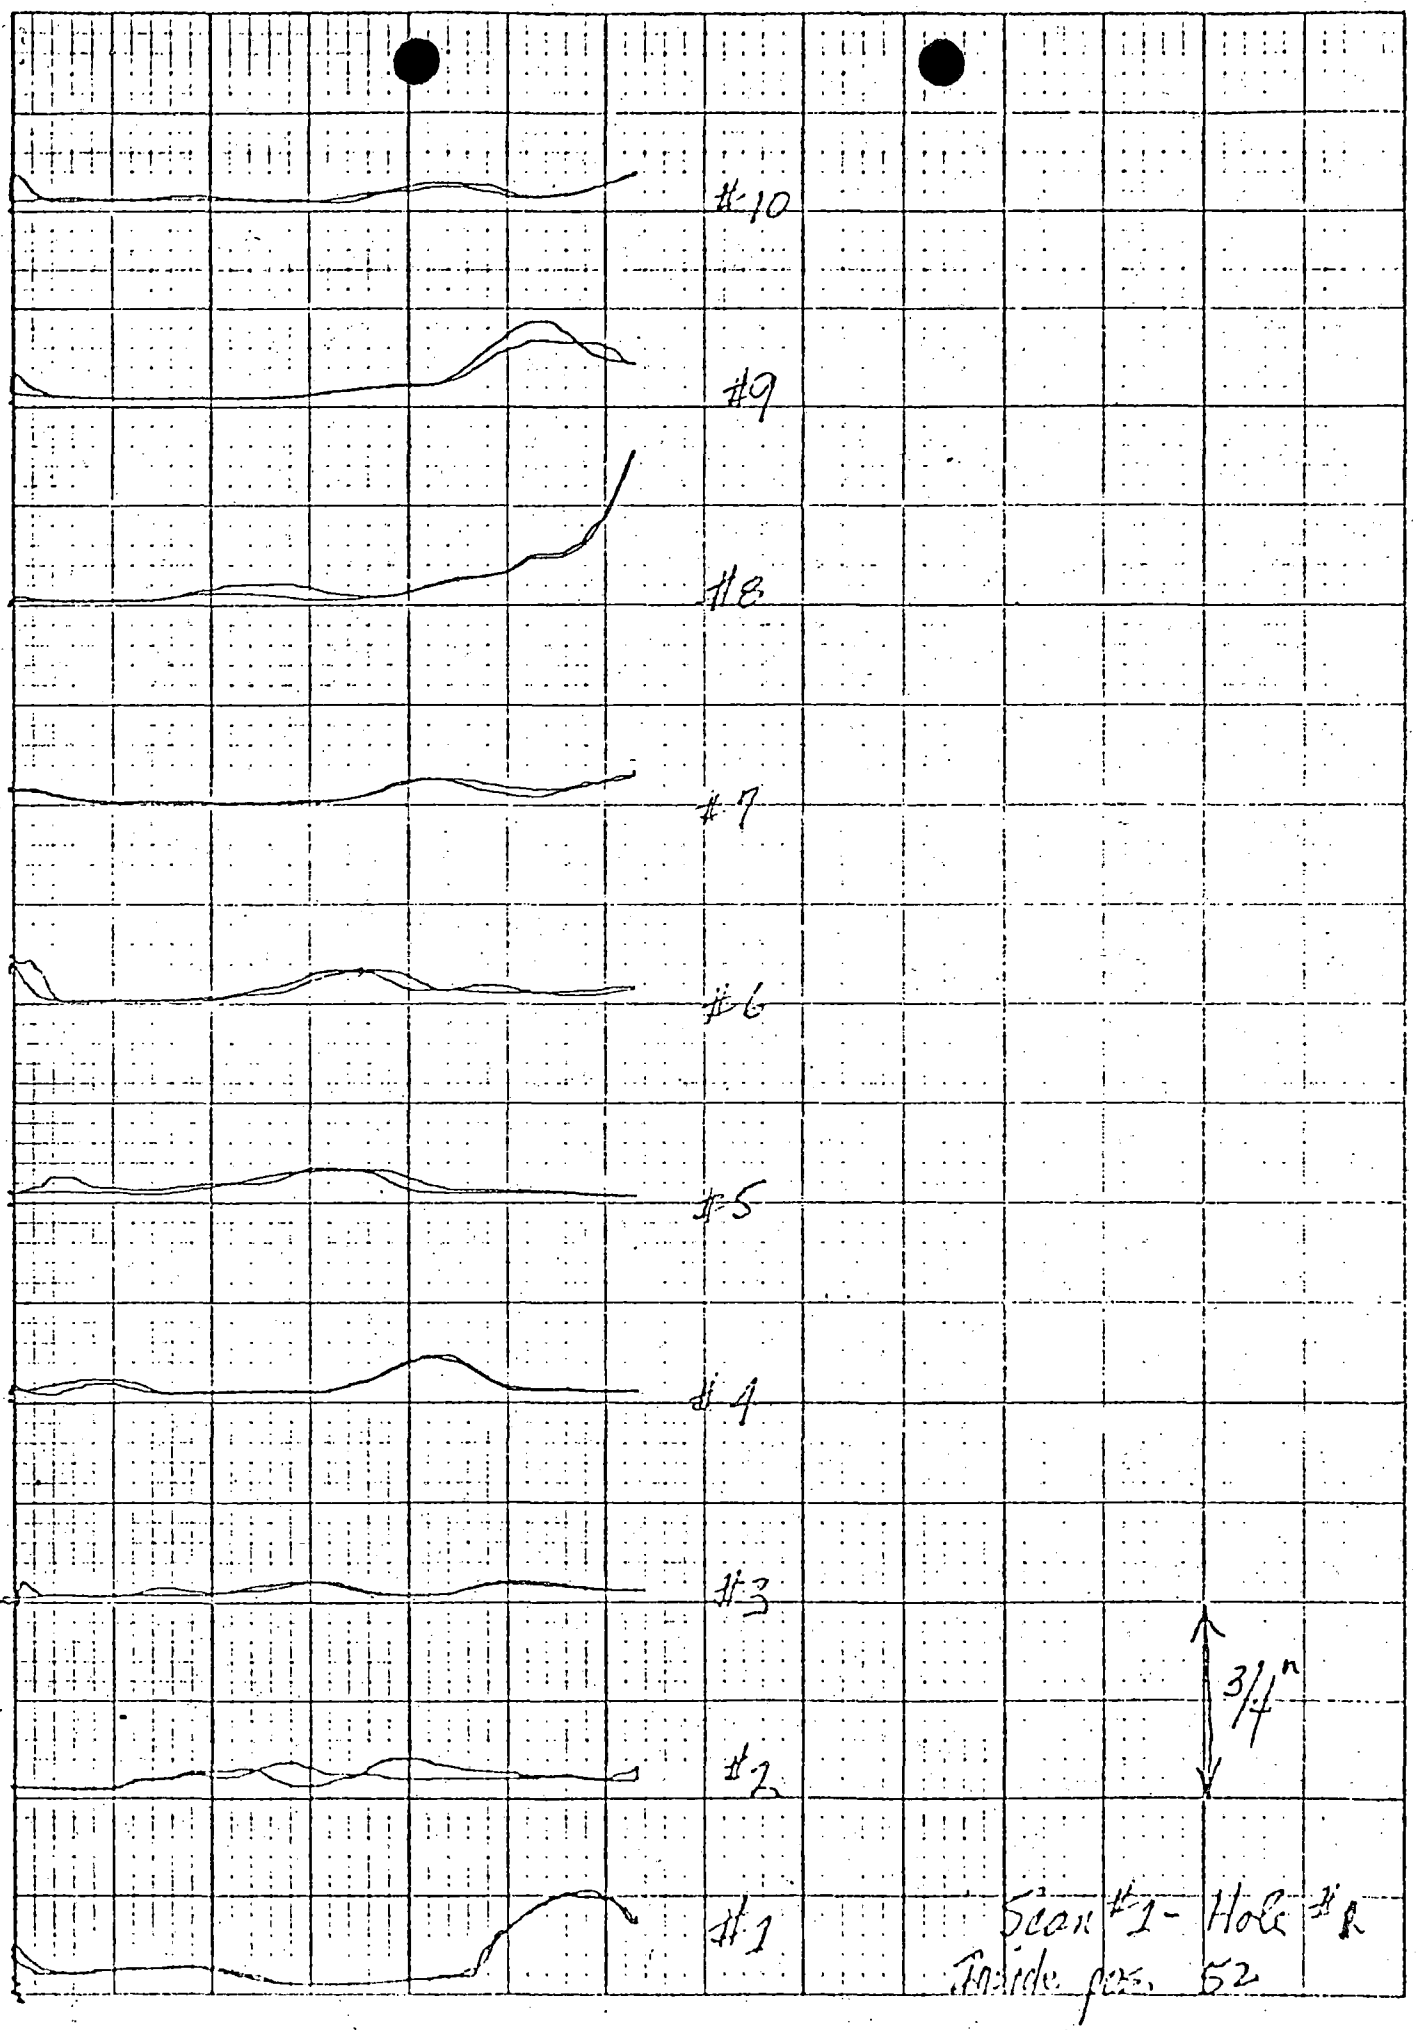
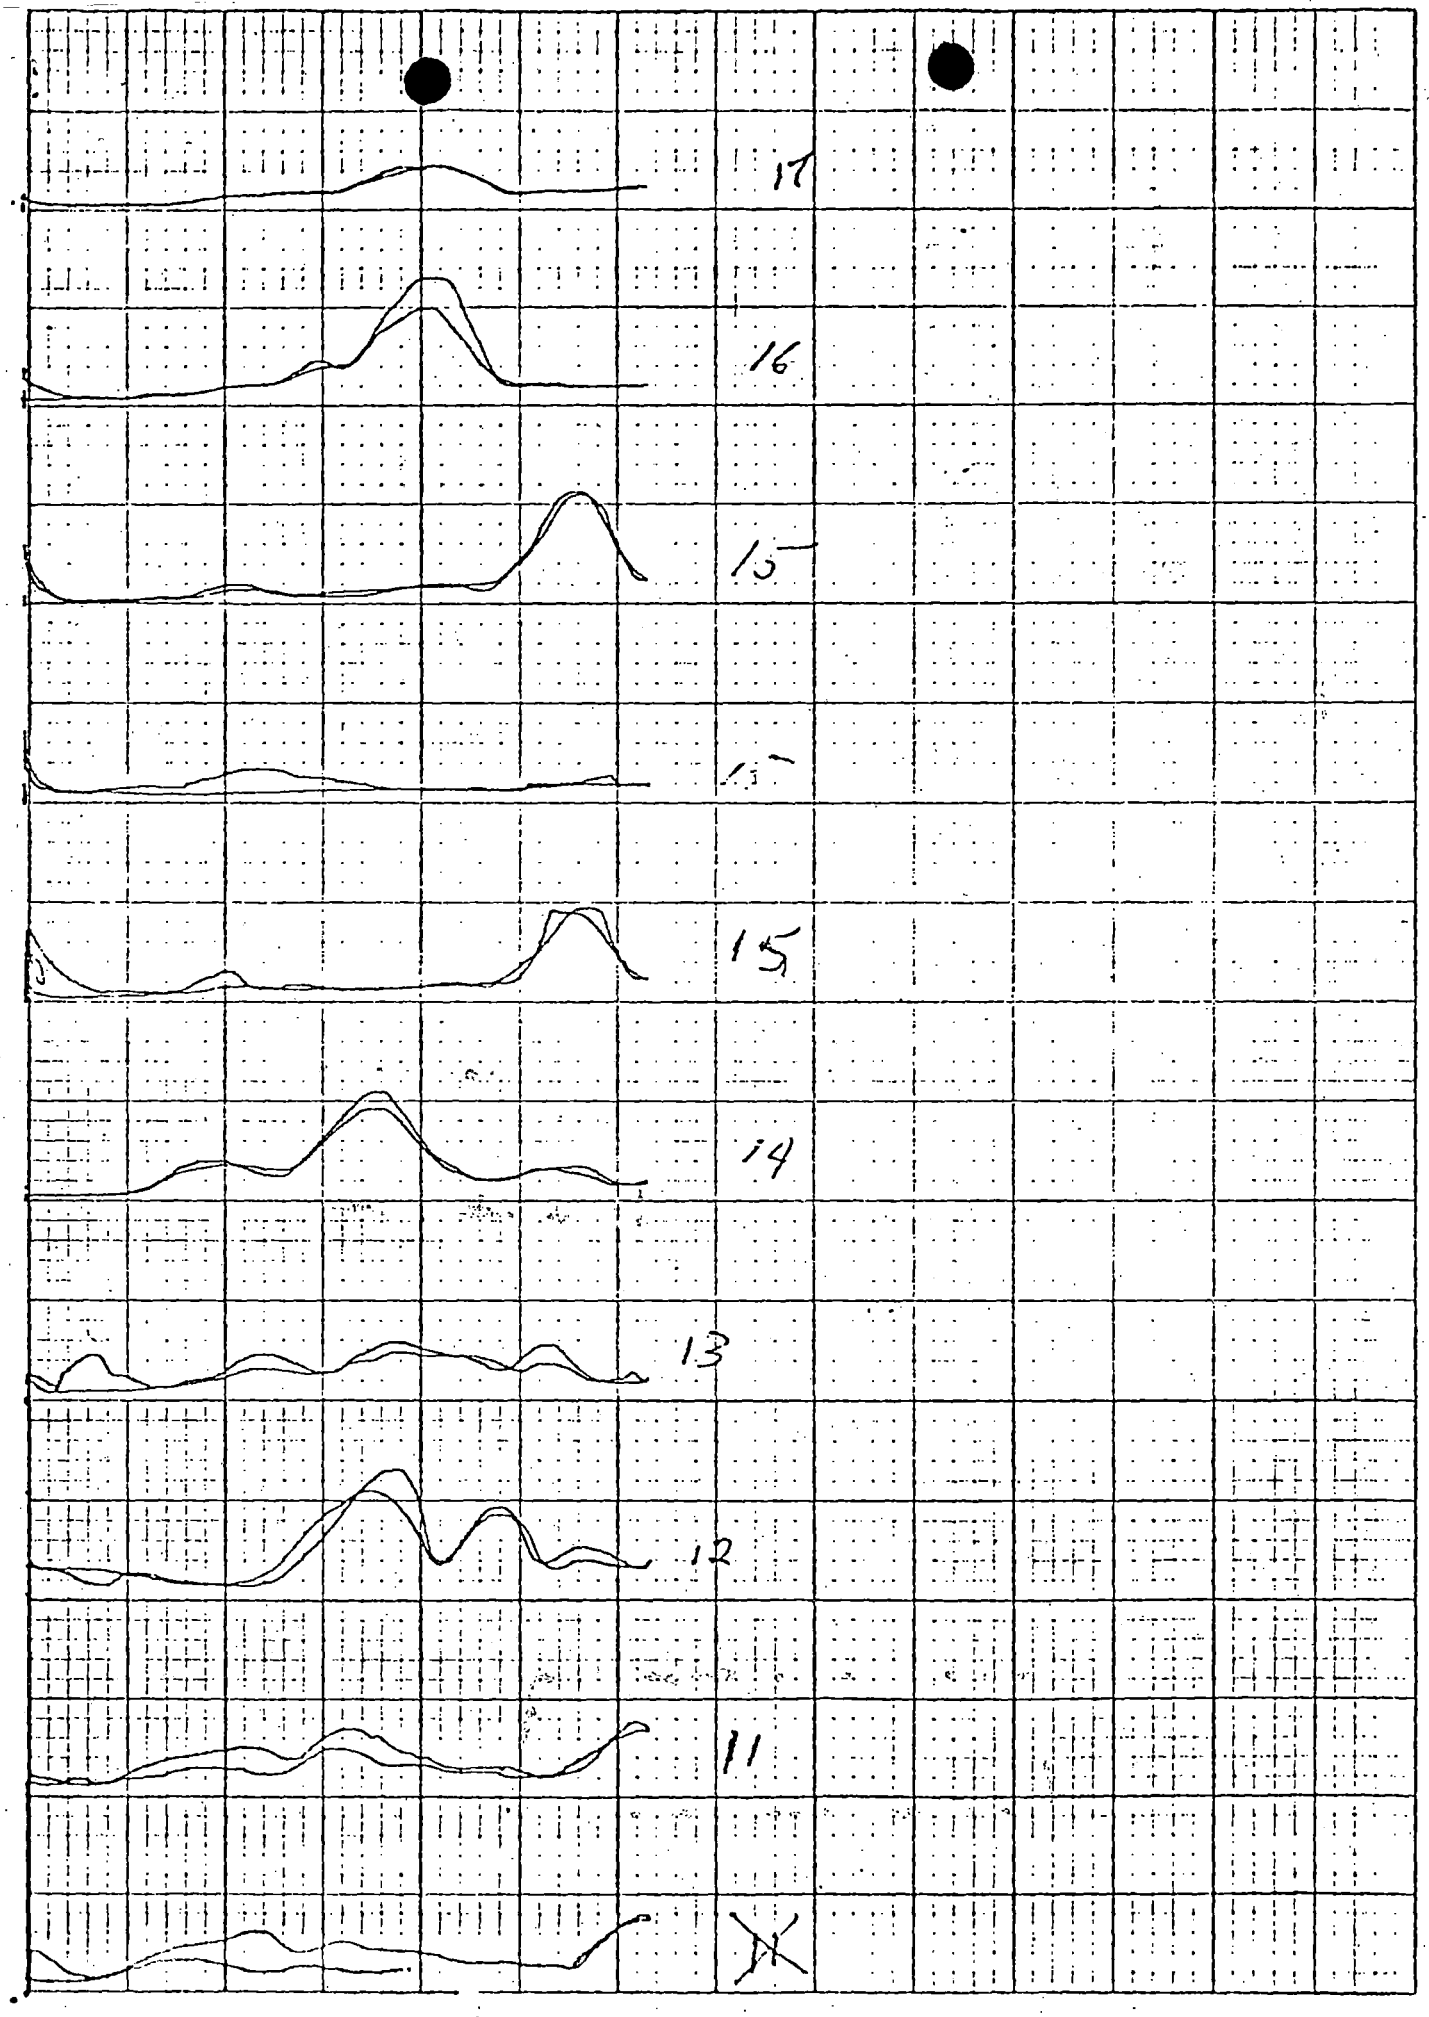
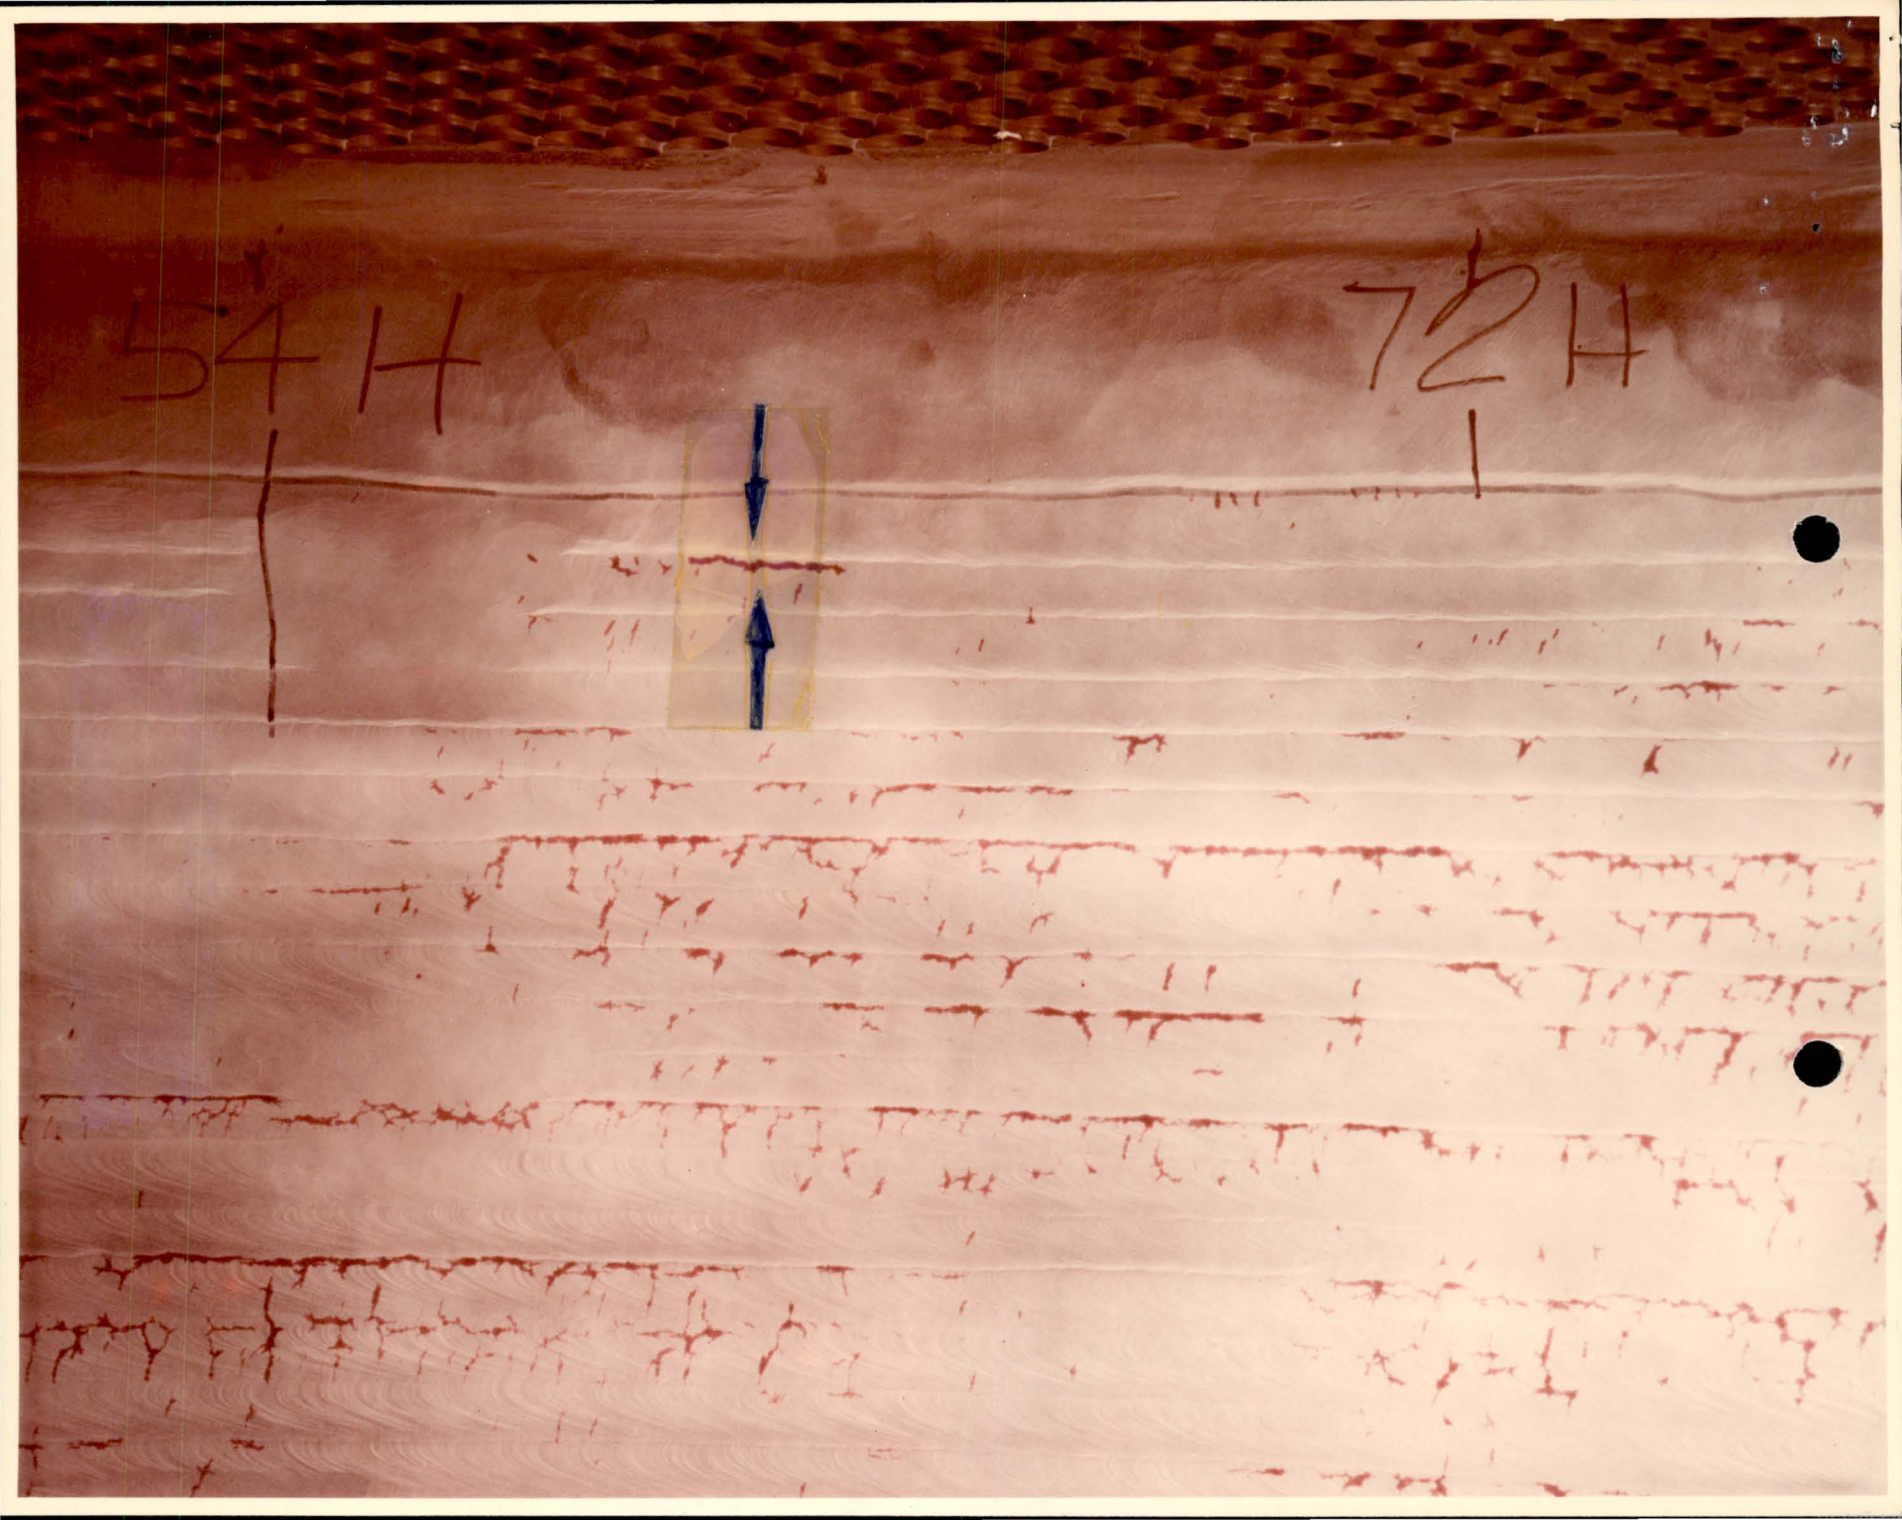
Dual traces were made of each scan on the X-Y recorder. Several reflections of approximately 20 to 25% of screen height were recorded indicating that the cracking 5" from the tube sheet was detectable but not significantly deeper than 1/8". All scanning was done from the cyclindrical portion of the channel head O.D. with the 48° 1-1/8" diameter, 1 MH_z shear wave search unit focused upwards towards the channel head-to-tube sheet weld. No surface preparation was required other than wire brushing to remove loose rust and dirt. USP grade glycerine was used as the couplant as in the on-site calibration and Danbury demonstration.

The data shows that the 4" long cladding crack determined previously by dye penetrant inspection was detectable by ultrasonic examination from the O.D. of the channel head. More importantly, the depth of the crack was indicated to be no greater than 1/8" below the cladding surface and therefore still within the boundary of the stainless steel cladding.

The ultrasonic inspection will serve as the base line preservice surveillance examination for the cracked cladding. Public Service will continue to monitor the above cracking on a schedule consistent with the first three re-fueling outages.

The inspection will consist of monitoring the same area (defined by the existing locator points) discussed in the preceding discussion with the same U.T. procedure.
