Rancho Seco ISFSI License Renewal Application, Revision 2 (non-proprietary version)

Rancho Seco ISFSI License Renewal Application

Revision 2

April 2019

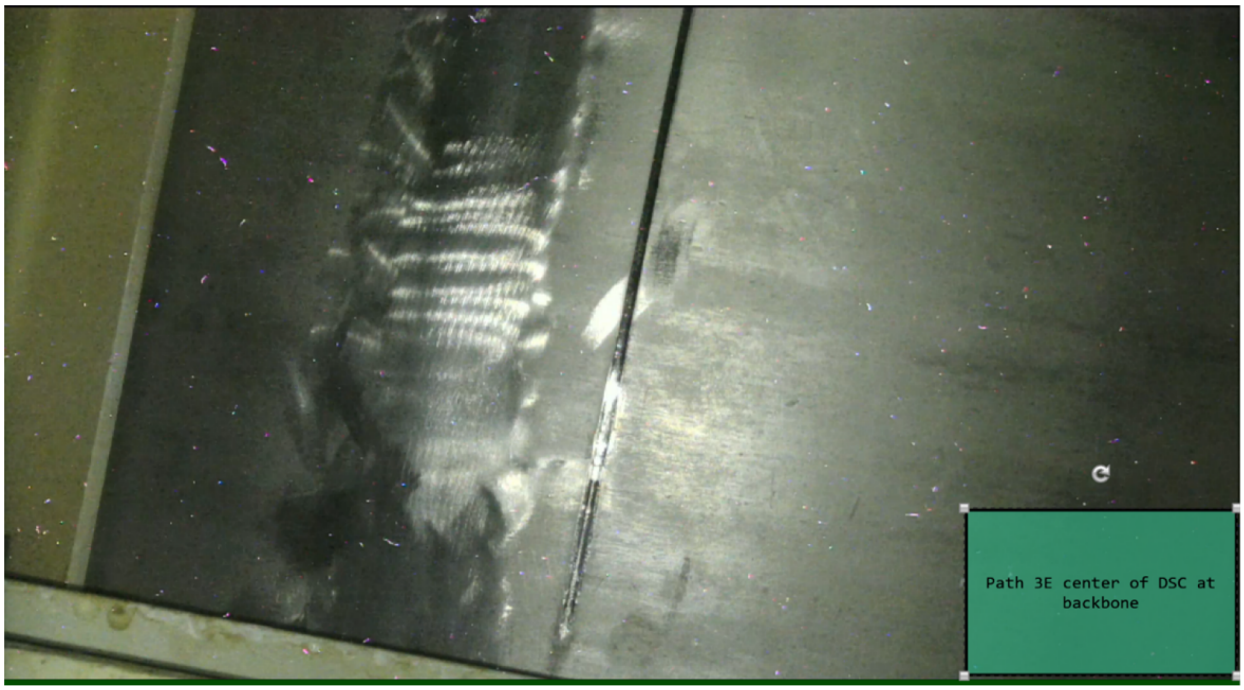
Figure 3-5
DSC Bottom Scrape at Northern Terminus

As noted in DQ No. 01-0052, DSC P01 had received a scrape along the bottom due to contact with the TC during its insertion test performance in 2001. As shown, this scrape is clearly evident.

This picture shows a zoomed-in view of the scrape. There is no visible rust in the scrape observed. There are no sharp raised metal surfaces along the edges observed.

The scrape terminus is about 7 feet north of the interior face of the front wall. The middle crossbeam is at the lower portion of the picture. East rail flange is along the left portion of the picture.

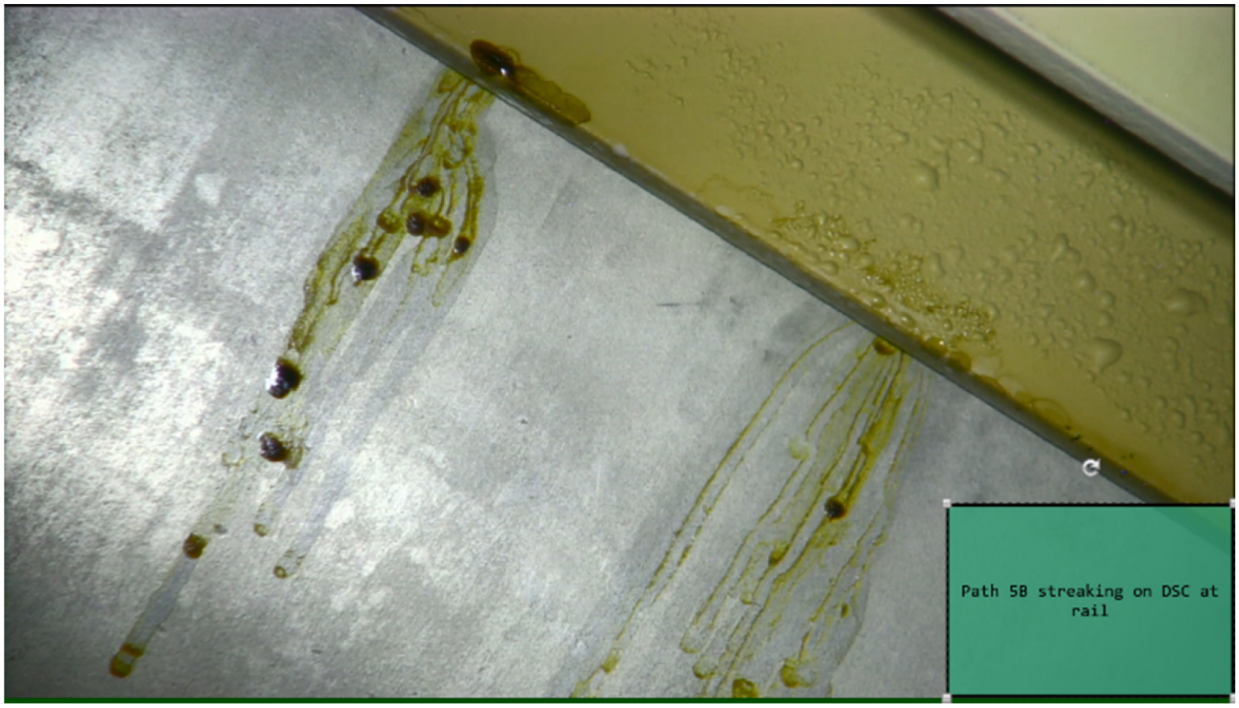
Figure 3-6
DSC Bottom and Support Rail, East Side, between Support #2 and Support #3

Note discoloration streaks can be seen on the DSC that appear to be rail lubricant carried by rainwater intrusion. The streaks appear to be dry with no indication of active water intrusion. Paint blisters were also observed on the Support Rail

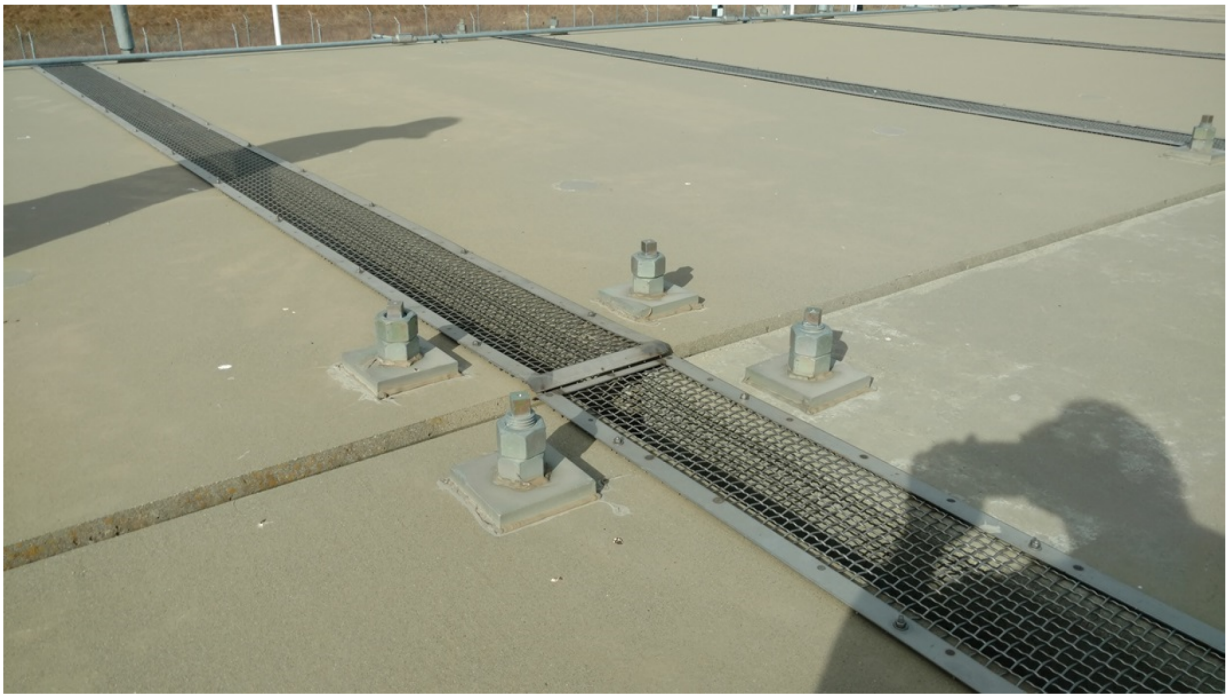
Figure 3-8
HSM-20 Roof

The HSM roof surface has the original finish with no indications of map cracking, scale, or abrasion. The four grout patches that fill the lift embeds are sound and free of deleterious cracks.

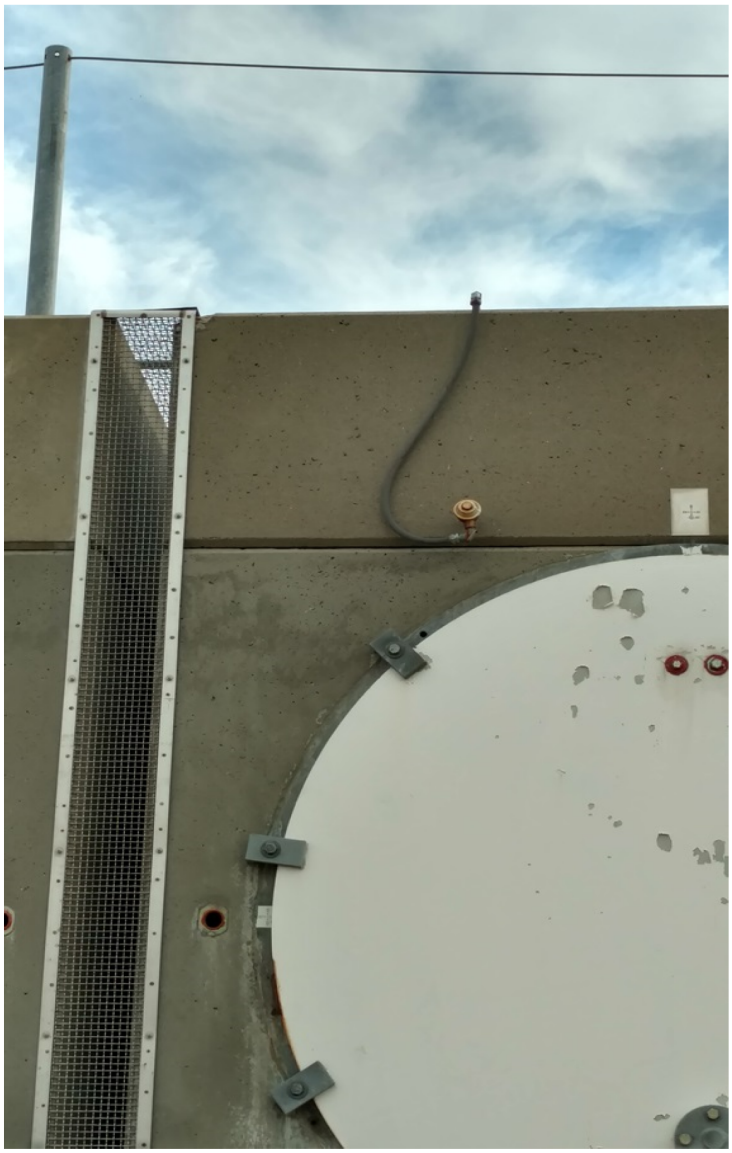
Figure 3-12
HSM-16 Spall at Roof Left Corner

HSM-16 had a spall at the upper left corner. The spall likely occurred during transport and assembly of the HSMs. The spall did not appear to be associated with active deterioration.
