GULF STATES UTILITIES COMPANY

River Bend Station - Unit 1
Docket No. 50-458

LICENSEE EVENT REPORT (LER)

TITLE (4): DESIGN DISCREPANCY IN THE WIRING DIAGRAM FOR TWO HYDROGEN MIXING SYSTEM VALVES

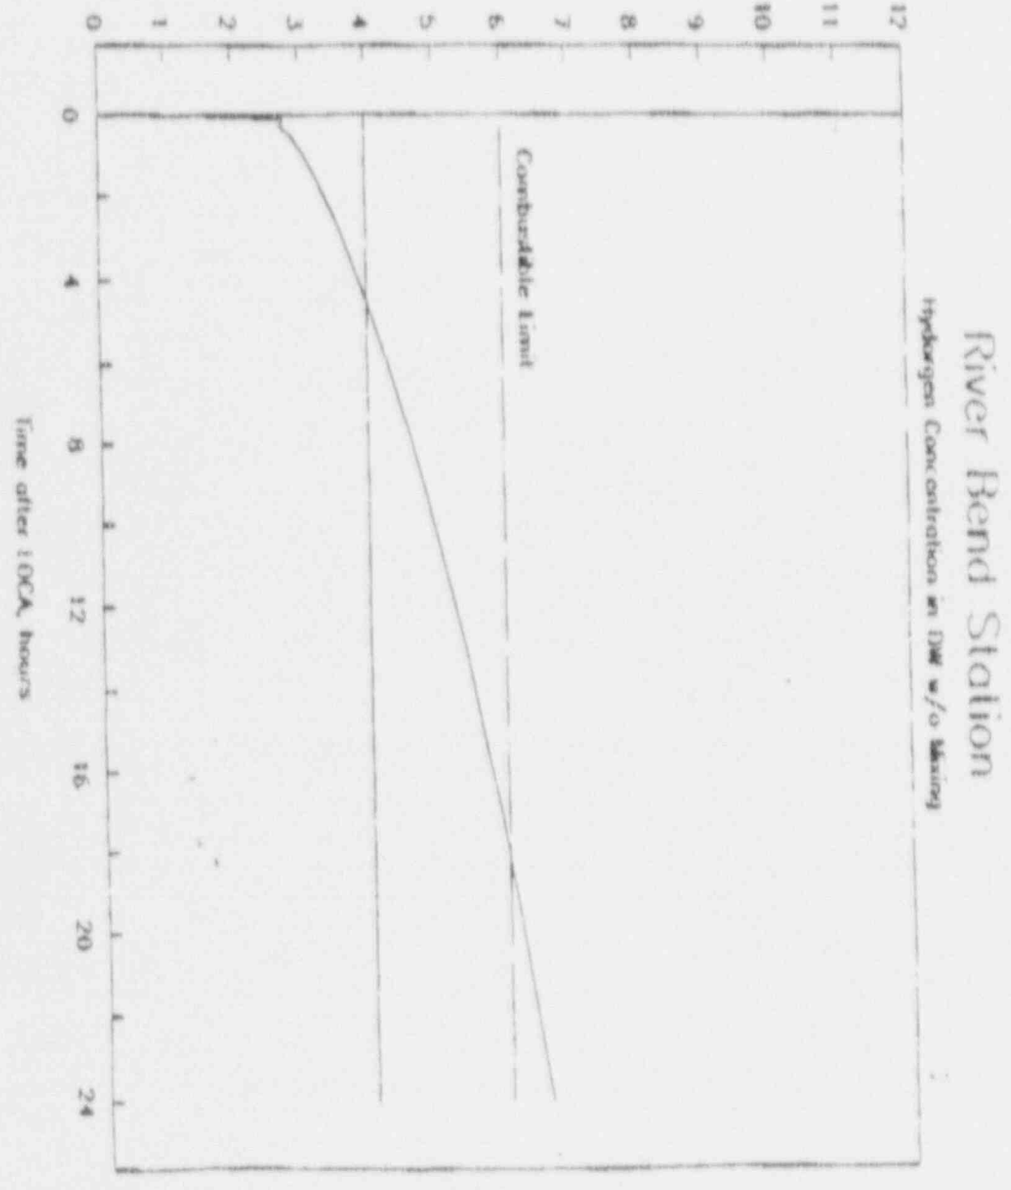
"FIGURE 1"

Based on this regulatory guidance, the hydrogen production at River Bend following a LOCA was calculated in Reference 3. Figure 1 is a plot of the resulting drywell hydrogen concentration (percent) versus time after the LOCA. For this calculation, hydrogen mixing (*BB*) was assumed to be inoperable.

As stated in the USAR (Ref. 1), 4% drywell hydrogen is the design basis for hydrogen mixing. This level is reached at about 4.5 hours after the LOCA. Hydrogen mixing (*BB*) would be necessary at or before this time to meet the design basis.

Reg. Guide 1.7 discusses hydrogen burning between 4% and 6%, and states that "... a limit of 6 volume percent would not result in effects that would be adverse to containment systems." If 6% is considered limiting, then hydrogen mixing (*BB*) operation would be needed within about 17 hours of the LOCA.
