LILCO, June 21, 1984

In the Matter of	)	
	)	
LONG ISLAND LIGHTING COMPANY	)	Docket No. 50-322 (OL)
	)	
(Shoreham Nuclear Power Station, Unit 1)	)	
	)

LILCO'S RESPONSE TO SUFFOLK COUNTY'S FILING CONCERNING LITIGATION OF EMERGENCY DIESEL GENERATOR CONTENTIONS

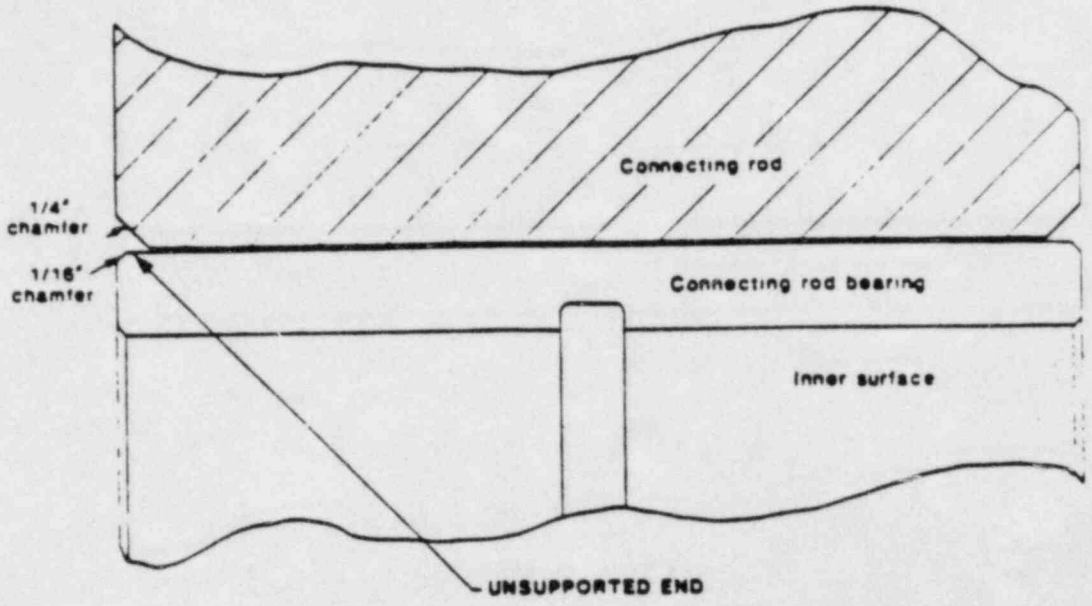
Figure 3a. Bearing: Connecting rod and bearing configuration original 11-inch journals

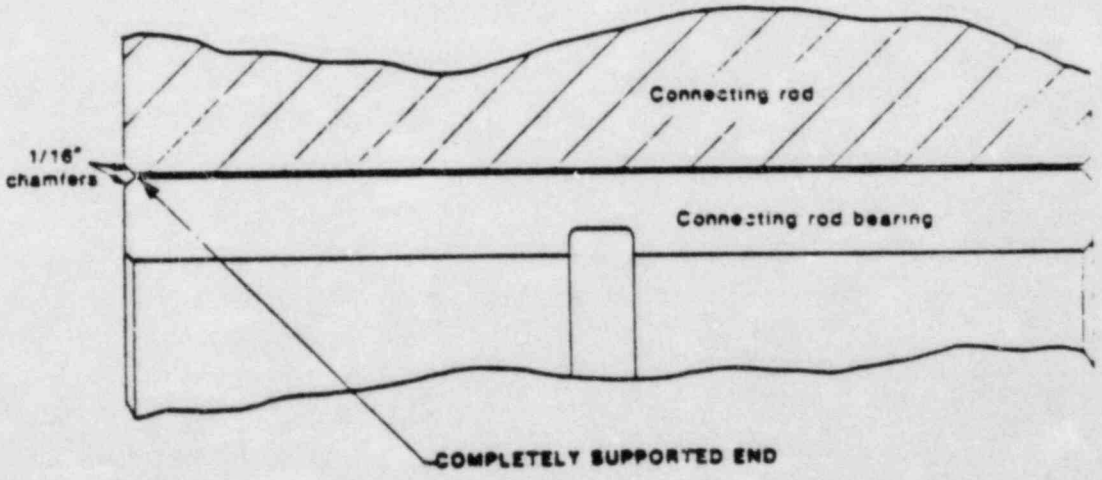
Figure 3b. Bearing: Connecting rod and bearing with replacement 12-inch journals.

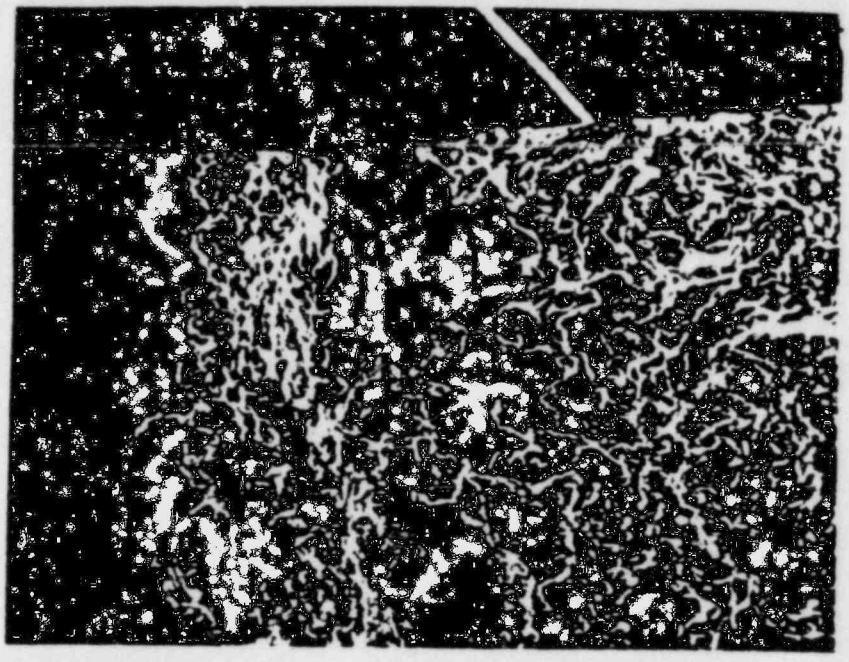
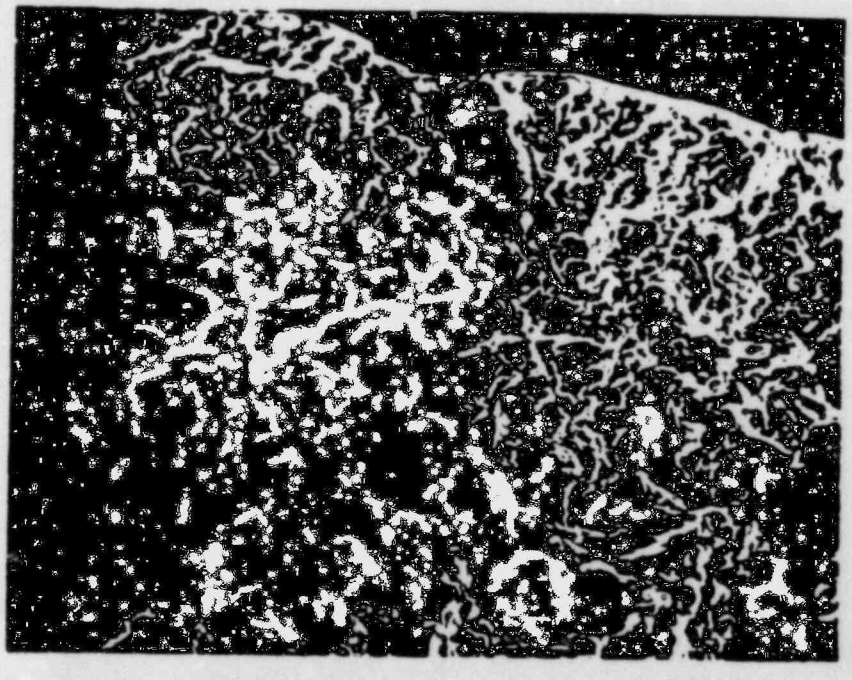
Figure 4. Scanning electron microscope fractographs of DG103, No. 4. Voids are approximately 0.020-inch to 0.030-inch.
