Final Precursor Analysis

Davis-Besse	Cracking of Control Rod Drive Mechanism Nozzles and Reactor Pressure Vessel Head Degradation, Potential Clogging of the Emergency Sump, and Potential Degradation of High Pressure Injection Pumps	
Event Date: February 2002	**LERs:** 346/02-002, 346/02-005, and ~~/////////~~346/03-002	**ΔCDP =** 6×10^{-3}

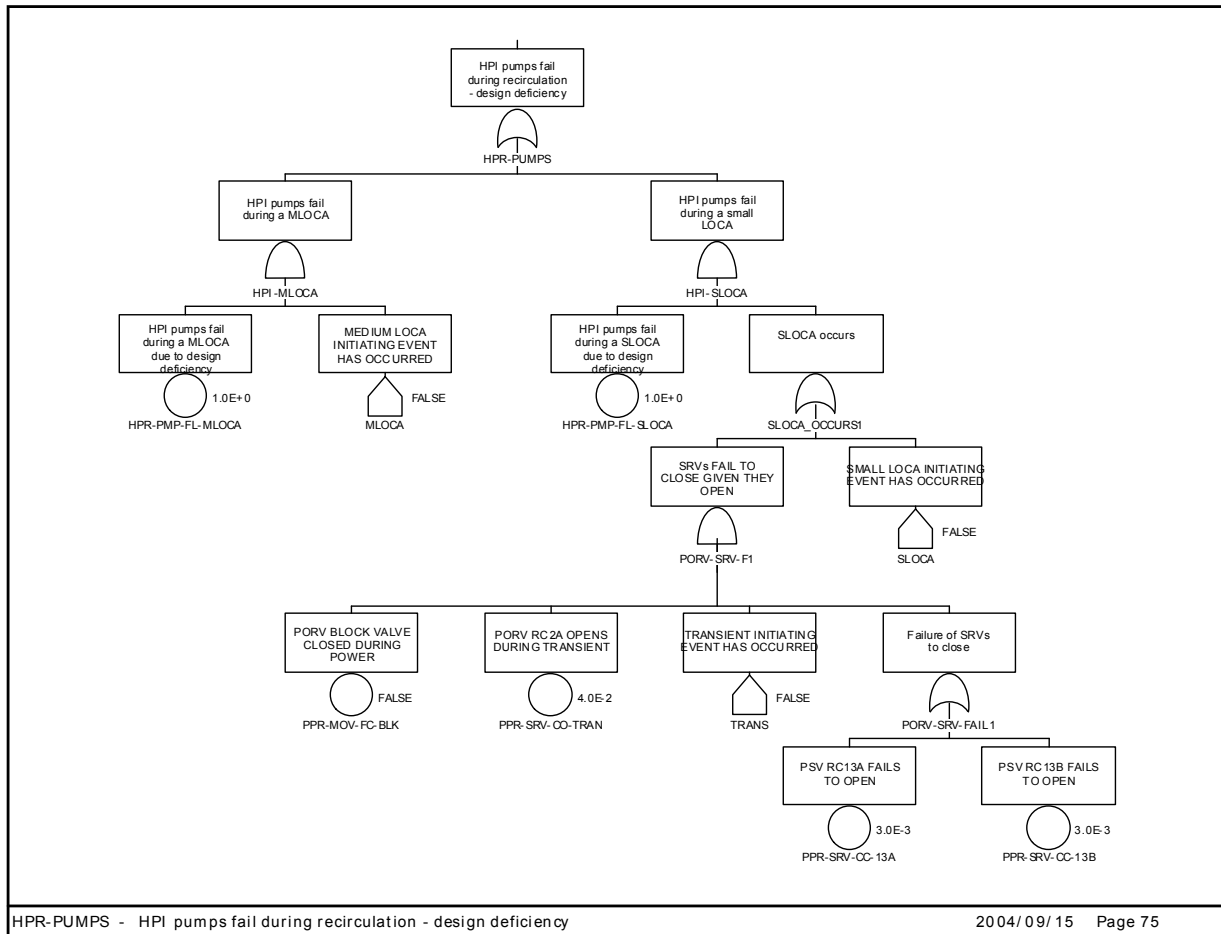
Figure 1. Large LOCA Event Tree

The dominant core damage sequence for this condition is a large LOCA sequence (Sequence 2). The events and important component failures in this sequence (shown in Figure 1) include:

- failure of High Pressure Recirculation.

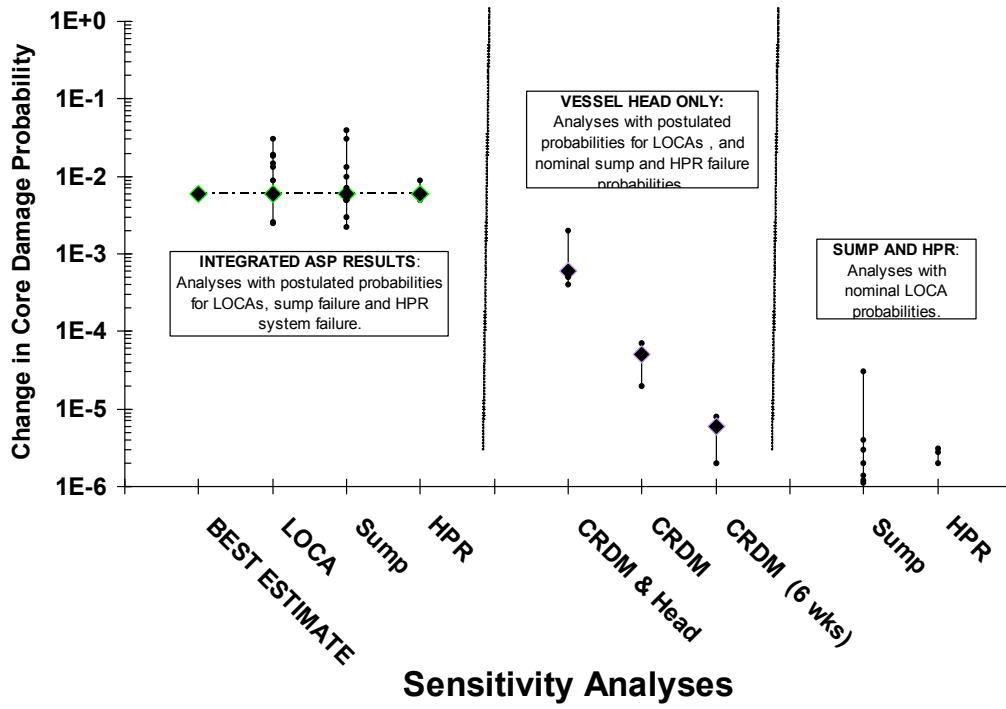
FIGURE 5: SUMMARY OF ASP ANALYSIS RESULTS

Since the analytic approaches to calculating initiating event and sump failure probabilities do not produce parameter uncertainty distributions that can readily be used for standard PRA uncertainty analysis, an extensive set of sensitivity analyses was performed. The sensitivity analysis shows that the area that contributes the largest amount of uncertainty to the analysis is the modeling of the sump, which contains both modeling and parametric uncertainties. The second largest effect is from the parametric uncertainties associated with LOCA probabilities. Finally, the third largest uncertainties come from the modeling uncertainties associated with the performance of the HPR function. Based on the range of reasonable risk estimates from these sensitivity analyses, each of these areas contribute a larger quantitative range than would be expected from a standard, parametric PRA uncertainty analysis. Table 5 summarizes the results of the sensitivity analysis and Attachment C describes the sensitivity cases and results in more detail. Figure 5 shows the results of the sensitivity analysis.
