Re: Indian Point Unit No. 2
Docket No. 50-247
NL-01-005

Subject: Reply to a Notice of Violation – NRC Inspection Report 05000247/2000-010

ATTACHMENT B TO NL 01-005
REPLY TO A NOTICE OF VIOLATION
INSPECTION REPORT NO. 05000247/2000-010

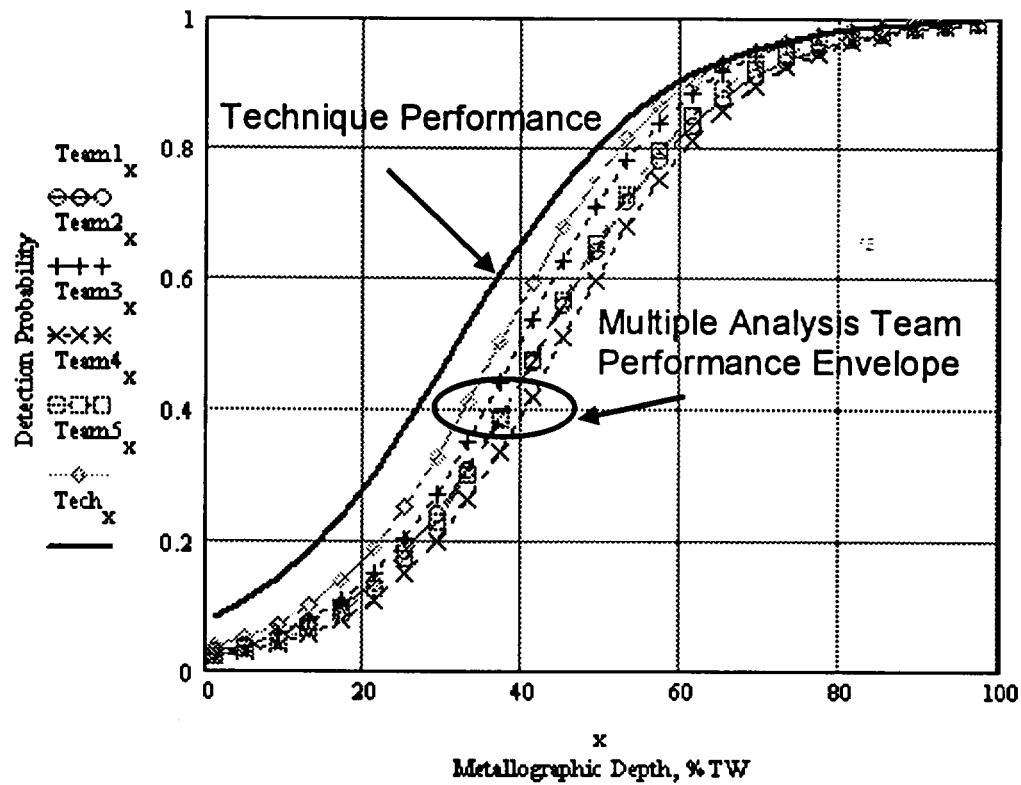
Exhibit 10
Probability of Detection Curve Illustrating Basic Technique and Human Factor
Imperfections in the Detection Process

57. This exhibit shows that relatively deep cracks can inadvertently remain in service due to basic technique limitations or human factor effects.
