SUBJECT: TELECON - GERMANE TO SAFETY - SCRAM DISCHARGE VOLUME DRAIN VALVE
COUPLING FAILURE

SUBJECT: SCRAM DISCHARGE VOLUME DRAIN VALVE COUPLING FAILURE

MFN 017-85

SUBJECT: TELECON-GERMANE TO SAFETY - SCRAM DISCHARGE VOLUME DRAIN
VALVE COUPLING FAILURE-SUPPLEMENTAL INFORMATION

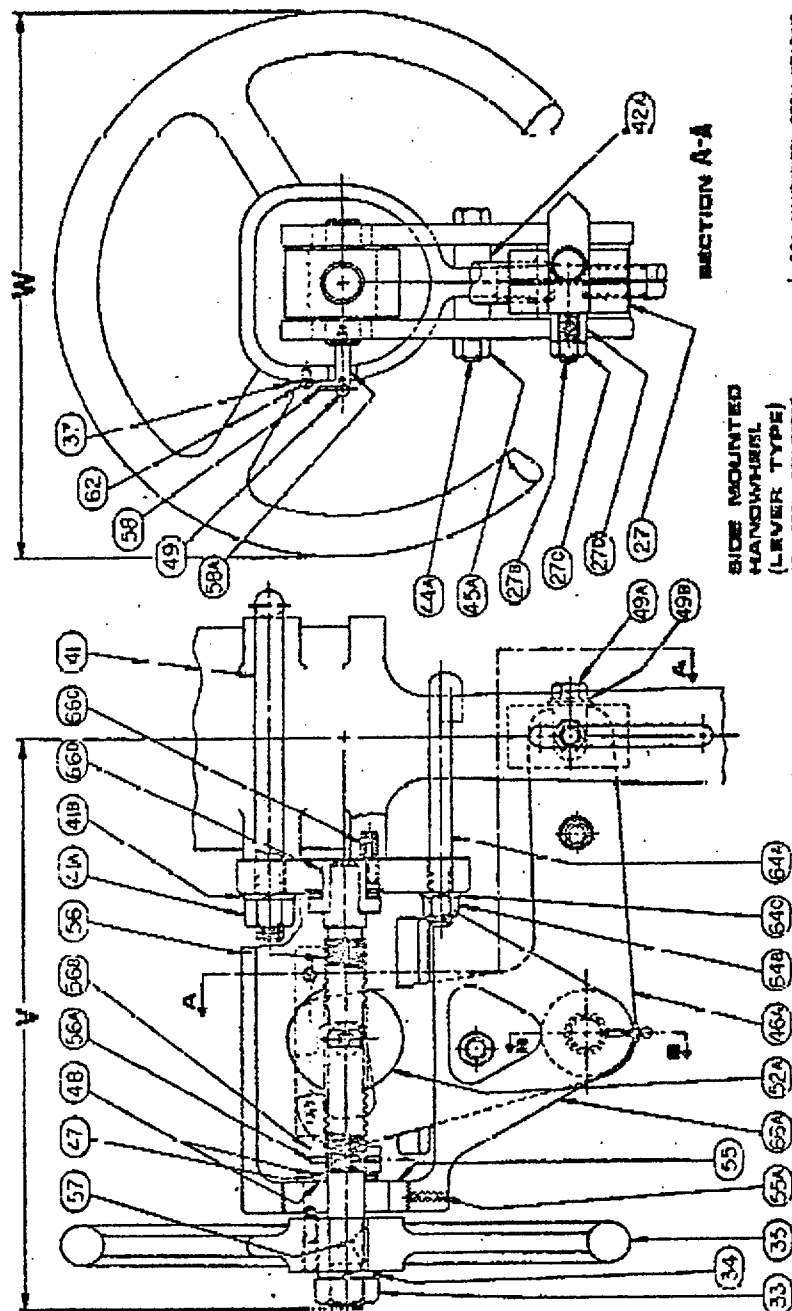
SIDE MOUNTED
HANDWHEEL
(LEVER TYPE)

The coupling failure occurred during a five-second delay test at Wyle Laboratory. The cause of failure was determined to be inadvertent engagement of the valve hand wheel during valve setup for test purposes. On valve actuation during the test, coupling loads exceeded design loads. The stem connector deformed allowing disengagement between the stem connector and valve stem.

this is the
fork that
can cause a
problem if
left unadjusted
