**CORRECTIVE ACTION
DOCUMENT
CLOSURE PACKAGE**

TRACKING NO: WBPER950246 R0

A1 Description of Condition: After the completion of the WBN Unit 1 ice loading and weighing, it was discovered that approx 170 ice basket sheet metal screws heads and 32 whole screws were found in the temporary waste ice melt tank.

**WESTINGHOUSE ASSESSMENT OF BROKEN
ICE BASKET SCREWS**

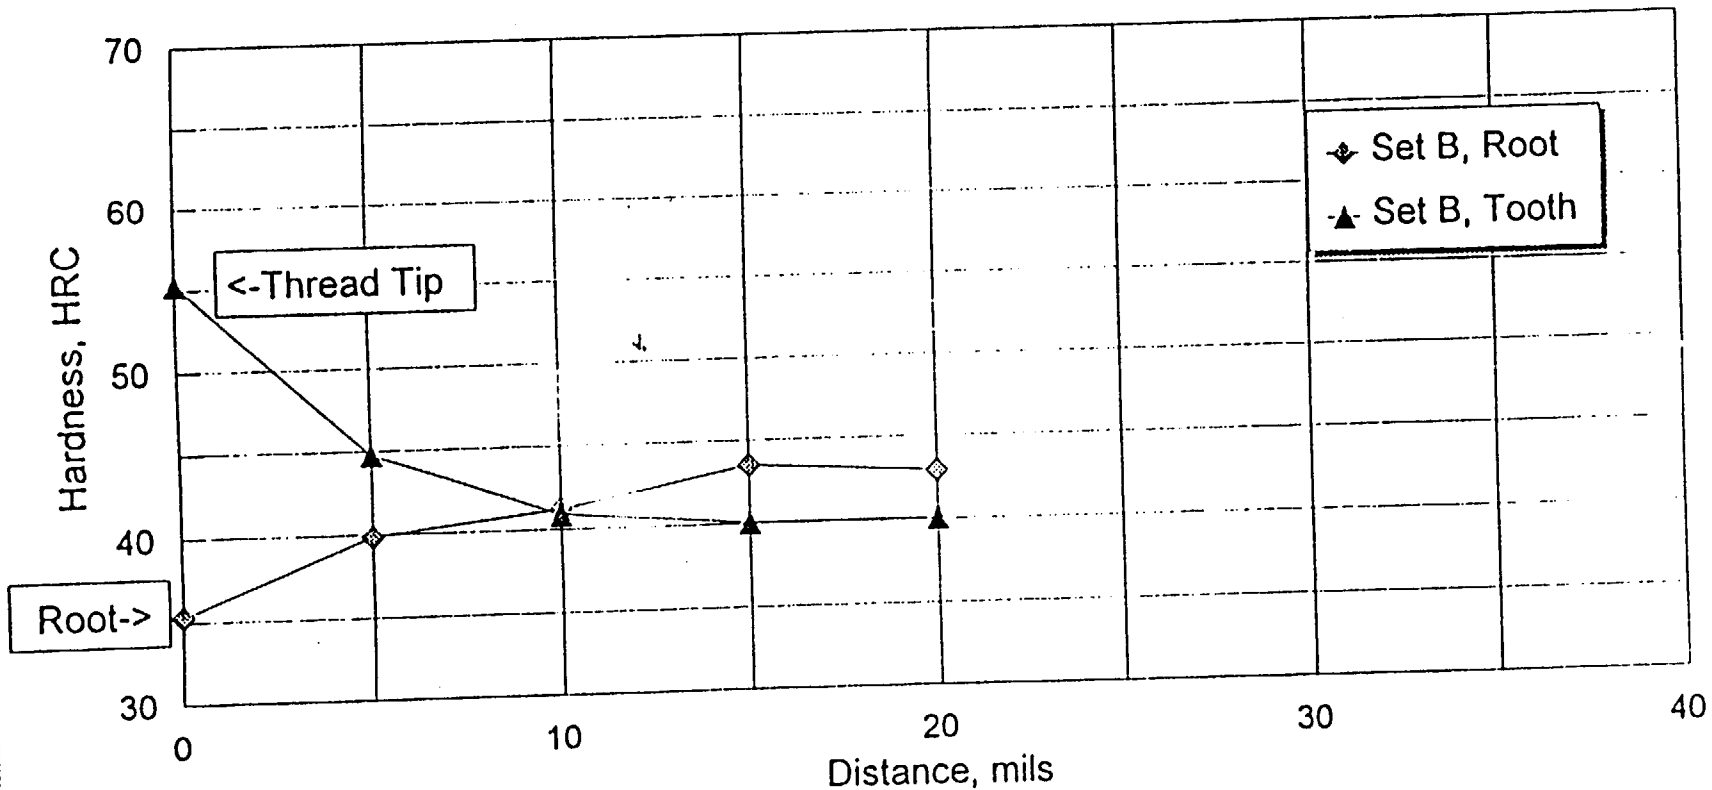
Figure 13 - Ice Condenser Basket Screws, Watts Bar Nuclear Plant, Unit No. 1. Customer Identification No. 95-07. Laboratory Report No. 95-1021.

New Screw (Set B) Hardness Traverses

Hardness vs. Distance Into Screw

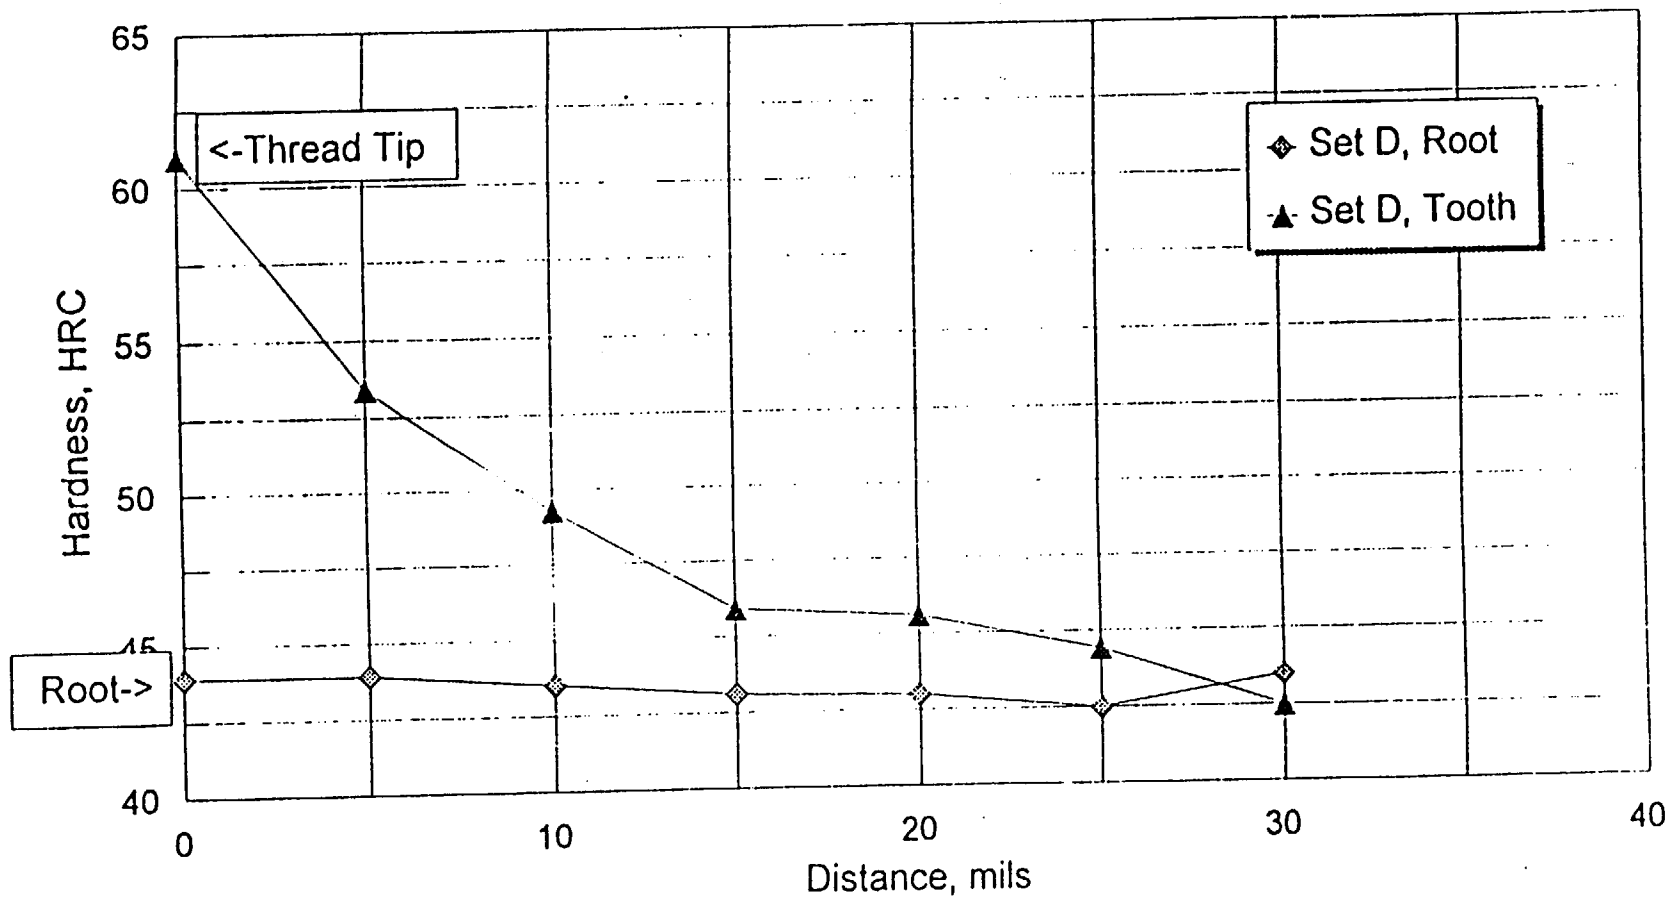
Figure 14 - Ice Condenser Basket Screws, Watts Bar Nuclear Plant, Unit No. 1. Customer Identification No. 95-07. Laboratory Report No. 95-1021.

Uncracked Screw (Set D) Hardness Traverses

Hardness vs. Distance Into Screw

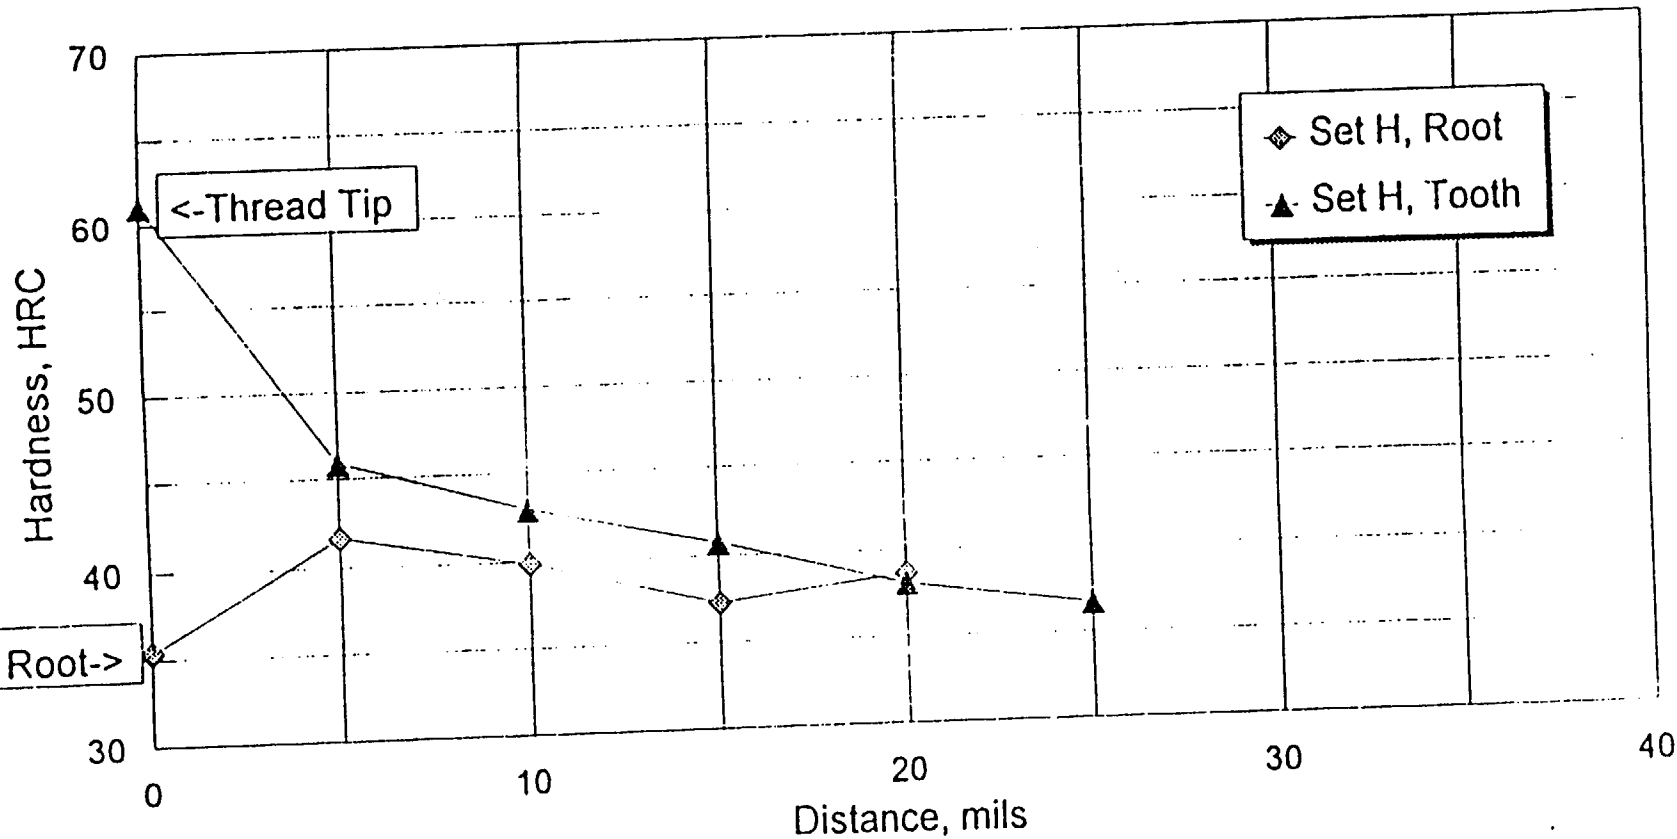
Figure 15 - Ice Condenser Basket Screws, Watts Bar Nuclear Plant, Unit No. 1. Customer Identification No. 95-07.
Laboratory Report No. 95-1021.

Cracked Screw (Set H) Hardness Traverses

Hardness vs. Distance Into Screw
