## **CENTER FOR NUCLEAR WASTE REGULATORY ANALYSES**

### **TRIP REPORT**

**SUBJECT:** Trip Report for Busted Butte Rock Sampling and Observations of PTn on West Flank of Yucca Mountain (20.01402.861)

**DATE/PLACE:** May 22–23, 2000  
Yucca Mountain, Nevada

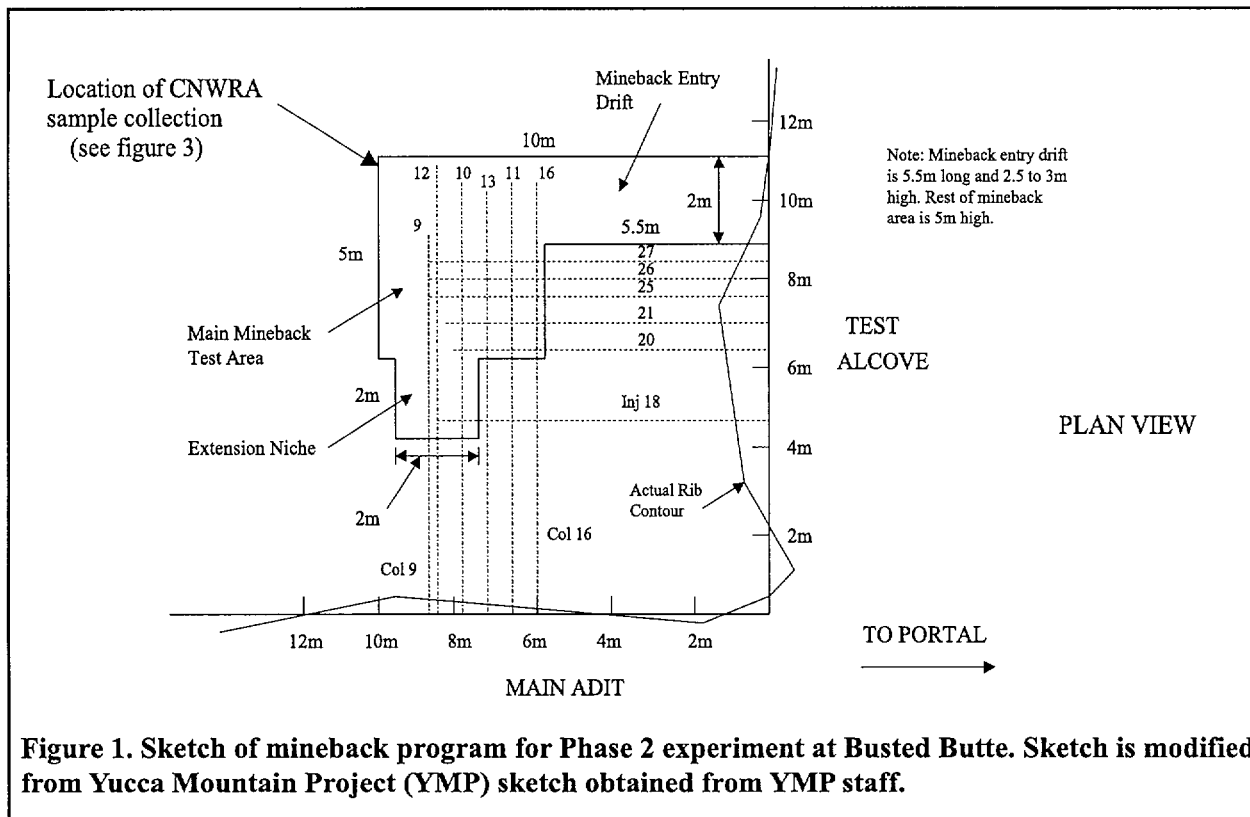
During the week of May 21–25, 2001, Los Alamos National Laboratory (LANL) and YM project (YMP) staff were analyzing the 4<sup>th</sup> mineback face and obtaining samples from the injection/collection area (figure 1). Each face is scraped by a front-end loader to a depth of about 30–40 cm. The tuff is extremely friable when dry. A soil coring device was used to collect samples (figure 2). Project scientists also used an ultraviolet light to observe the pattern of fluorescent tracers migrating through the rock below injection boreholes. The walls of the mineback area were wetted with a high-pH solution to bring the fluorescent tracers to the surface of the wall; ventilation in the Busted Butte facility rapidly dries out the rock. LANL staff assumes that the 20–30 cm core sampling depth is significantly beyond the drying front of the scraped faces.

**Figure 1. Sketch of mineback program for Phase 2 experiment at Busted Butte. Sketch is modified from Yucca Mountain Project (YMP) sketch obtained from YMP staff.**

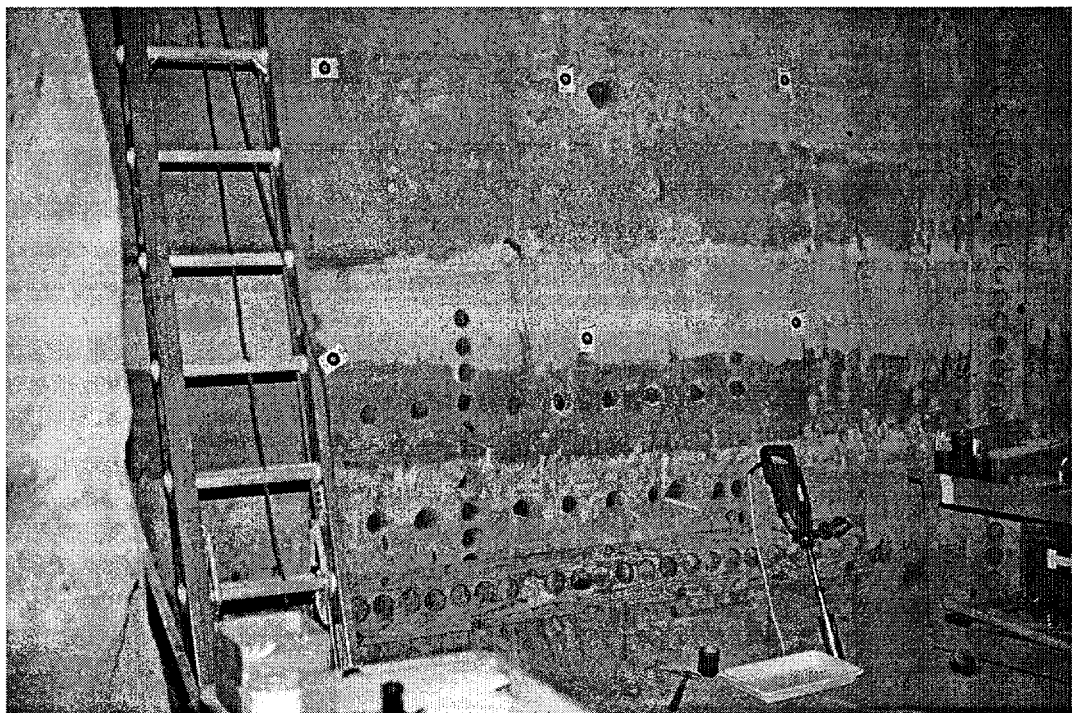
**Figure 2. Photograph of 4th face of mineback in Phase 2 test and power core sampler at the Busted Butte facility. Horizontal banding in the lower portion of the photograph is due to wetness variations caused by the recent removal of wood template used for core sampling.**
