VIRGINIA ELECTRIC AND POWER COMPANY
SURRY POWER STATION UNITS 1 AND 2
NRC SPECIAL INSPECTION REPORT NOS. 50-280/01-06 AND 50-281/01-06
TRANSMITTAL OF TECHNICAL REPORTS

REPORT NUMBER 87360-FA

FAILURE ANALYSIS
FOR (1) ONE
POWER ASSEMBLY, FORK ROD
EMD P/N 8470863

FAILURE ANALYSIS
FOR (10) TEN
POWER ASSEMBLY, FORK ROD
EMD P/N 8470863
& (10) TEN
POWER ASSEMBLY, BLADE ROD
EMD P/N 8470864

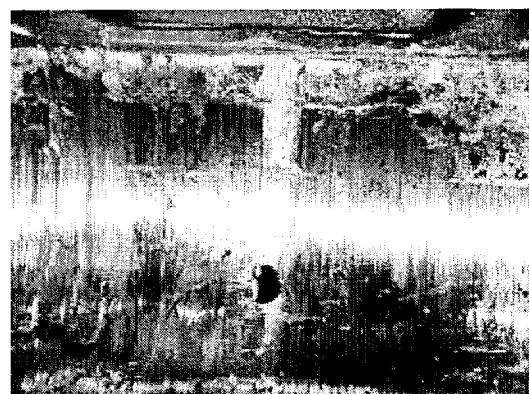
90342-10 Bearing detail

The connecting rod from specimen 90342-10 indicated some distress to the bearing surface. Surry personnel questioned the condition of the rod. This rod plus several others picked at random were inspected, with the results provided below:

The damage identified in specimen 90342-10 is consistent with failures resulting from lack of lubrication. The failed insert bearing and distressed piston pin appear to be directly related to lube oil starvation. The connecting rod from this cylinder is also condemned as a result of the damage to the carrier insert bearing.

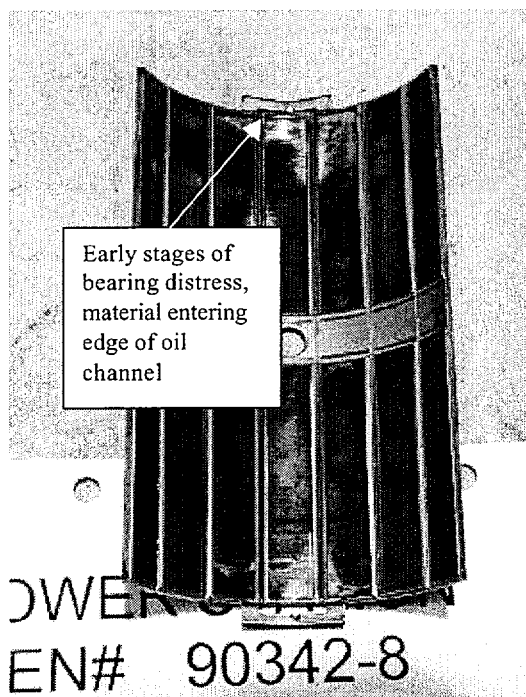
90342-7	Bearing – some polishing, all oil channels open, Pin – Sat, Thrust Washer & Piston Carrier exhibit some circular grooves
90342-8	Bearing – some polishing, some material displacement beginning to enter an oil channel, Pin – Sat, Thrust Washer – wear step and circular grooves, Piston Carrier – some circular grooves
90342-9	All components – Sat
90342-10	Bearing – Catastrophic damage, all oil channels blocked, Pin – Catastrophic, Thrust Washer – wear step, debris scratches, Piston Carrier – Sat w/some debris scratches
90342-11	Bearing – some polishing, all oil channels open, Pin – Sat, Thrust Washer – some debris scratches, Piston Carrier – Sat
90342-12	Bearing – some distress, beginning of material displacement, all oil channels open, Pin/Thrust Washer/Piston Carrier – all Sat
90342-13	Bearing – polishing, 1 oil groove beginning to be blocked, some material displacement, Pin – Sat, Thrust Washer – wear step, Piston Carrier – Sat

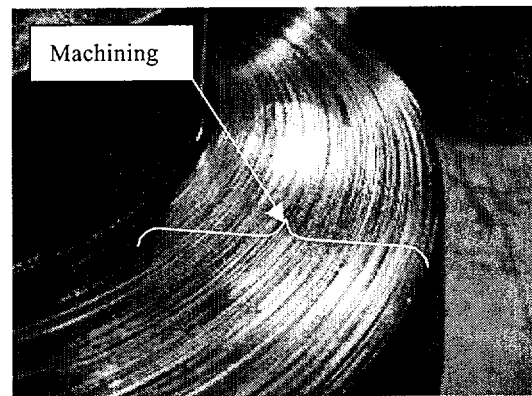
90342-15 Carrier

90342-14	Bearing/Pin/Piston Carrier – Sat, Thrust Washer has a wear step
90342-15	Bearing – some polishing, all oil channels open, Pin – Sat, Thrust Washer & Piston Carrier exhibit a significant number of circular grooves across the mating surfaces
90342-16	Bearing – some polishing, 1 oil groove beginning to be blocked, Pin – Sat, Thrust Washer – wear step, Piston Carrier – Sat
90342-17	Bearing – polishing present, all oil channels open, Pin – Sat, Thrust Washer & Piston Carrier have 1 heavy groove apparently from a debris scratch
90342-18	Bearing/Pin/Piston Carrier – Sat, Thrust Washer has a wear step
90342-19	Bearing – distressed, heavy polishing, 1 oil channel 50% blocked, 1 oil channel 25% blocked, Pin – Sat, Thrust Washer – wear step, Piston Carrier – Sat
90342-20	Bearing – polishing, 1 oil channel beginning to exhibit blocking from displaced material, Pin – Sat, Thrust Washer – wear step, Piston Carrier – Sat
