Client Name: Dominion Virginia Power
Project No.: H0829
Archive: D01-1740
Client Confidential

Ricardo Inc.

Ricardo has undertaken an examination of components, reports and laboratory data from Surry Station following the failure of the wrist pin bearings on two EMD 645 engines. The engines were found to have severely or partially degraded wrist pin bearings. Ricardo were engaged to review the failure mode and determine if it were possible to predict when the EDG3 engine entered a degraded condition such that it could not operate for a period of 24 hours supplying emergency power.

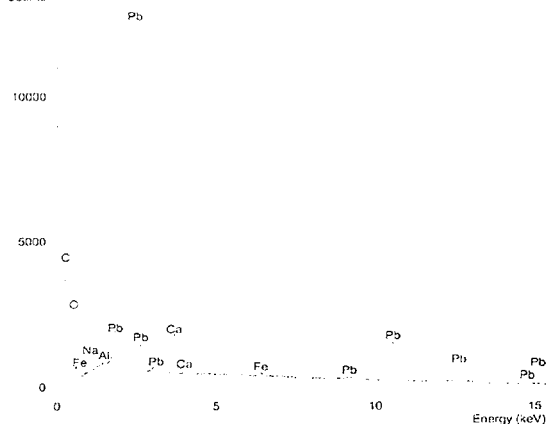
Figure 13 – Spectrum 4

A "good" bearing from EDG1 was visually examined and found to be discolored in a regular pattern beginning at the outermost parts of the bearing moving in towards the oil feed hole, see highlighted section of figure 11. The bearing was then analyzed using the SEM and the results showed a pattern of lead "islands" surrounded by silver see figure 12 and figures 13 and 14 for elemental analysis. This was again in line with findings of the un-

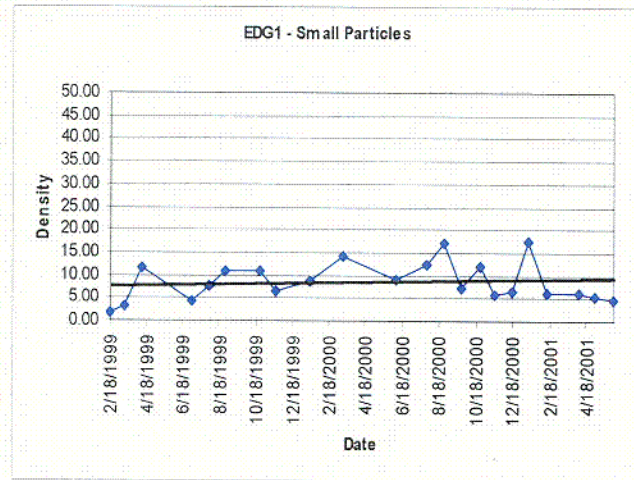
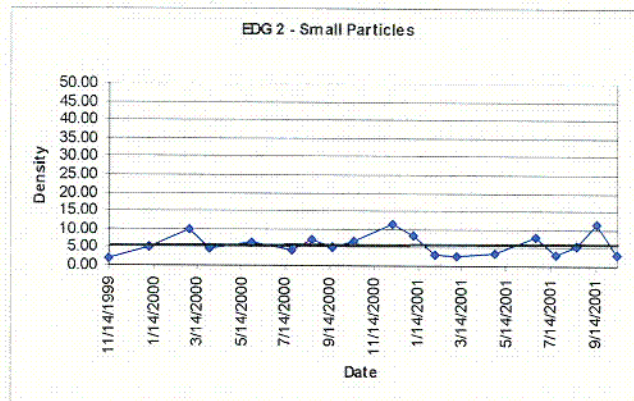
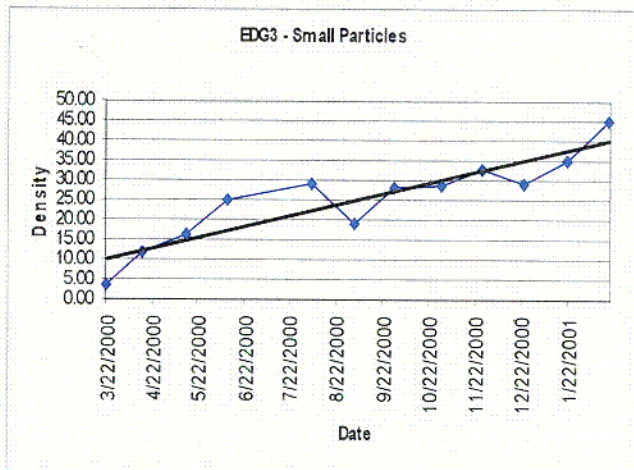
Figure 17 – DR Ferrographic Analysis of Small Particles

The DR ferrography results were inconclusive in determining a point in time or operating hour when bearing failure commenced.
