Subject: Beaver Valley Power Station, Unit No. 1
Docket No. 50-334, License No. DPR-66
Bulletin 2000-01 Circumferential Cracking of Reactor
Pressure Vessel Head Penetration Nozzles

**Evaluation Report for 1R14 Visual Inspection of
Beaver Valley Unit 1 CRDM Penetrations**

Summary Report for Beaver Valley Unit 1 RVH CRDM Penetration Visual Inspection

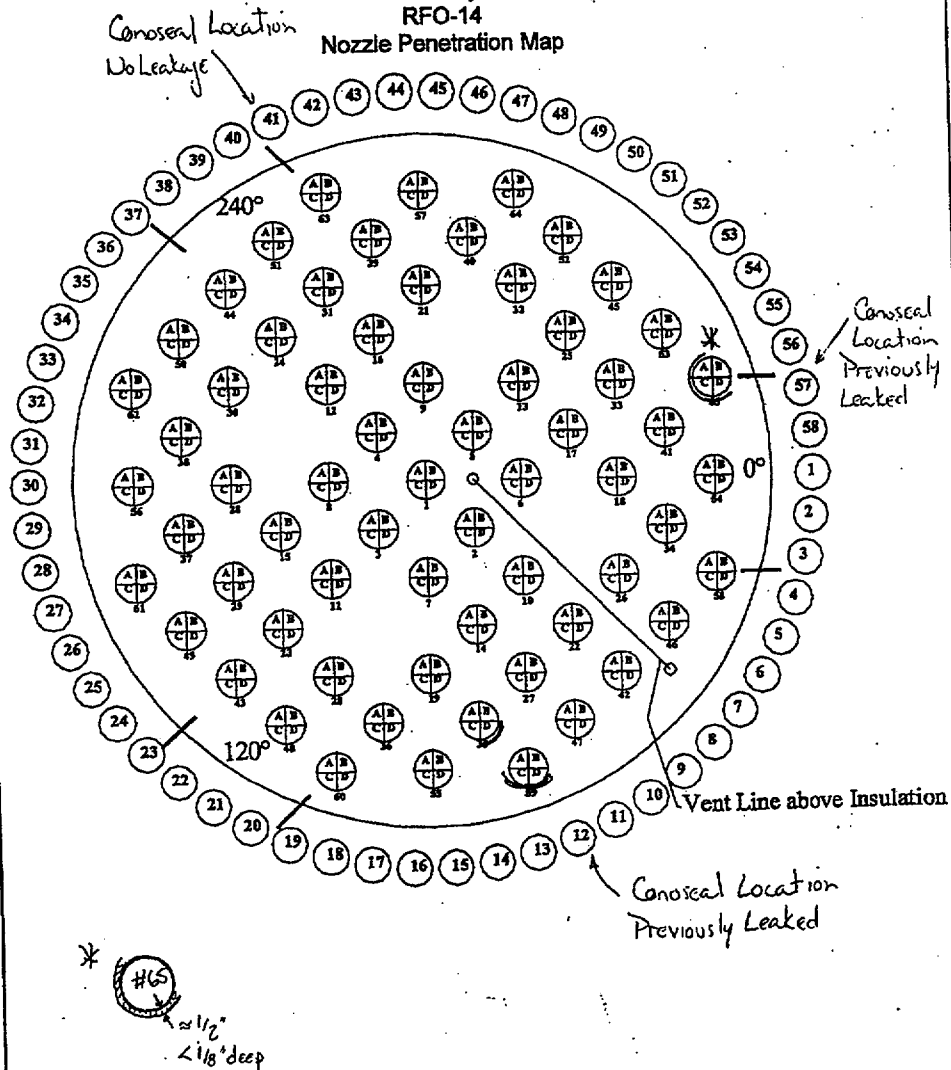
Attachment A
Beaver Valley Unit 1
RFO-14
Nozzle Penetration Map

Documented leakage has occurred at the conoseals located near RPV stud location #57 and stud location #12. In both cases, the nozzles nearest to these studs (nozzles #65 and #59 respectively) showed evidence of a significant boric acid event. Refer to the attached map for stud and nozzle location data.

The second conoseal leak occurred near the reactor vessel stud location #57. As a result, the #65 nozzle was affected by a flow of boric acid. Refer to the attached map for stud and nozzle location data. In this case, the boric acid seems to flow directly down the nozzle on the uphill side. As the acid flowed around the nozzle, at operating temperatures, the carbon steel of the head was affected. Erosion to a depth of less than .125 inches for about 1/2 inch around the base of the
