Subject: **Docket Nos. 50-361 and 50-362**  
**Voluntary Report**  
**Licensee Event Report No. 2002-001**  
**San Onofre Nuclear Generating Station, Units 2 and 3**

LER No. 2002-001

<b>FACILITY NAME (1)</b> San Onofre Nuclear Generation Station (SONGS) Unit 2				<b>DOCKET NUMBER (2)</b> 05000-361	
				<b>PAGE (3)</b> 1 of 7	
<b>TITLE (4)</b> Aging Phenomenon Affects Certain Potter and Brumfield Relays					
<b>EVENT DATE (5)</b>			<b>LER NUMBER (6)</b>		<b>REPORT DATE (7)</b>
MONTH	DAY	YEAR	YEAR	SEQUENTIAL NUMBER	REVISION NUMBER
09	11	2001	2002	001	00
			01	29	2002
			<b>OTHER FACILITIES INVOLVED (8)</b>		
			<b>FACILITY NAME</b> SONGS Unit 3		<b>DOCKET NUMBER</b> 05000-362
			<b>FACILITY NAME</b>		<b>DOCKET NUMBER</b>
<b>OPERATING MODE (9)</b> 1		<b>THIS REPORT IS SUBMITTED PURSUANT TO THE REQUIREMENTS OF 10 CFR §: (Check all that apply) (11)</b>			
<b>POWER LEVEL (10)</b> 100

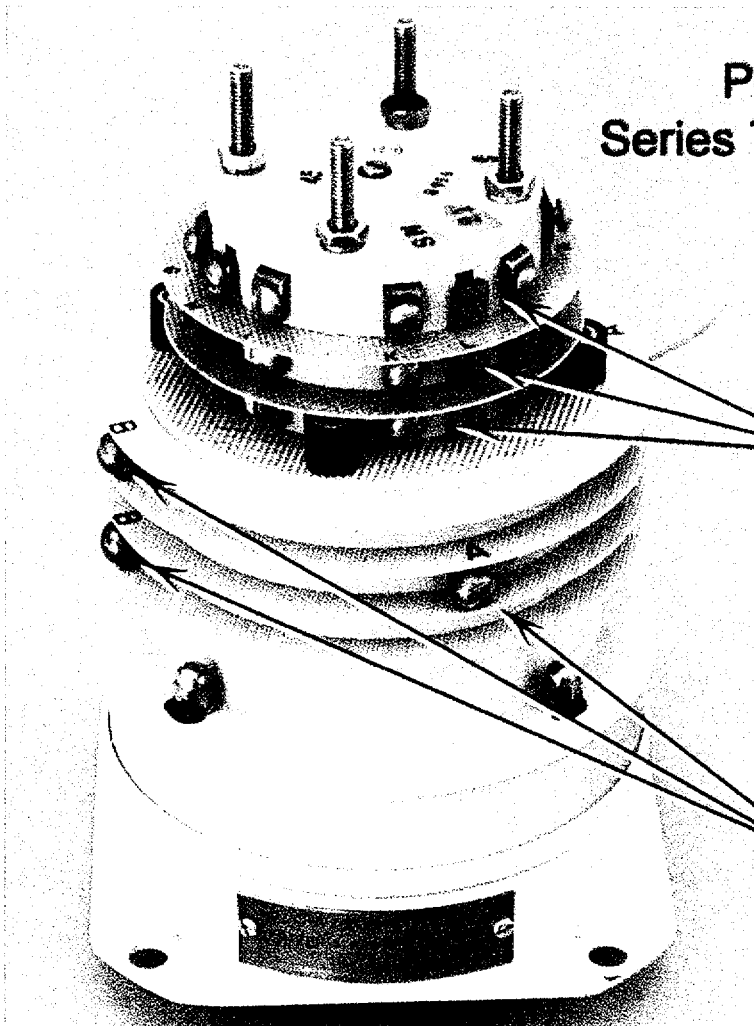
**Figure 1**

Series 7032 relays are non-latching MDR relays (Figure 1). These relays have two positions: "energized" and "de-energized." When energized, two coils, connected in series and located inside the relay, rotate the relay rotor shaft and operate the relay contacts by a shaft extension. When de-energized, the rotor shaft is returned to its normal position by two connected springs (Figure 2). Relay shaft rotation is limited to a 30-degree arc by the stator faces and a stop ring. At SONGS, the Series 7032 relays are normally energized so that only spring force is used to rotate the relay on a loss of power.

**Potter and Brumfield  
Series 7032 Motor Driven Relay**
