EA No. 00-179-1

SUBJECT: NRC SPECIAL INSPECTION 50-247/2000010- STEAM GENERATOR TUBE
FAILURE

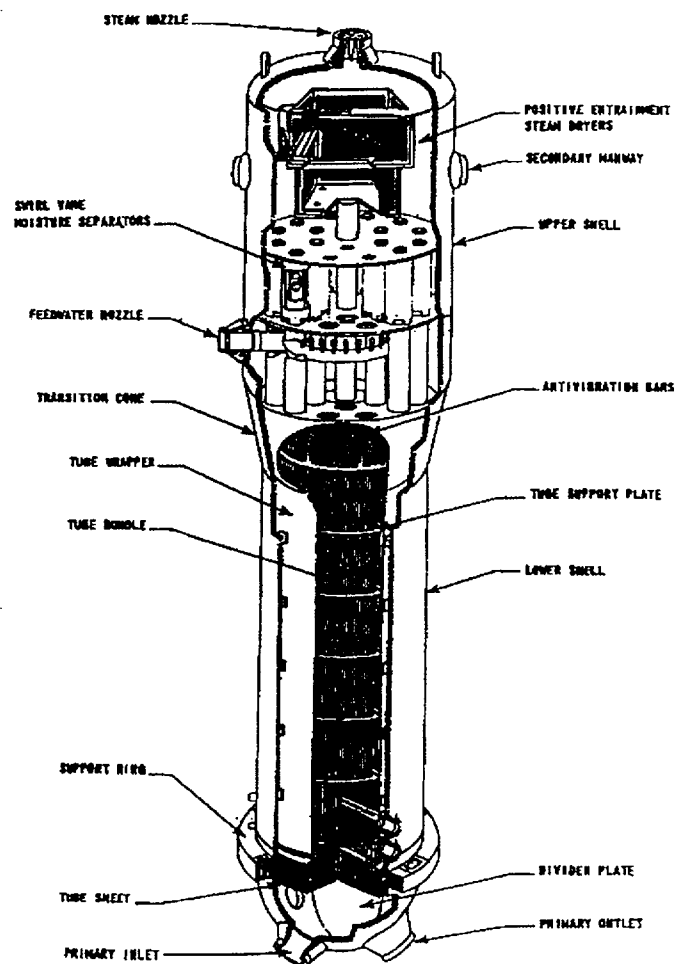
REFERENCED FIGURES
Figure 1 - Westinghouse Model 44 Steam Generator

Indian Point 2 is a four loop pressurized water reactor, meaning that there are four SGs, one per loop, that transfer heat from the reactor coolant to the secondary water. This heat causes the secondary water boil and the associated steam is used to run the turbine with turns the electrical generator. Figure 1 shows a Westinghouse Model 44 SG, like those installed at Indian Point 2.

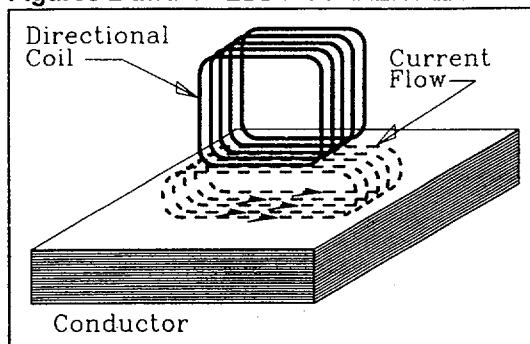
**Figure 2** Directional pancake probe**Figure 3** Plus Point probe

Single coil probes as shown in Figure 2 will induce the eddy current in only one direction, which is a compressed mirror image of the current in the coils. If the defect is not in the direction which interrupts the eddy-current flow (parallel to the defect direction rather than perpendicular to the current flow), then that particular coil will not detect the defect. Specially designed eddy-current probes can classify defects as axial cracks, circumferential cracks or both.

The Plus Point probe consists of two coils wound at 90 degrees to each other, as shown in Figure 3. The coils are mounted on a shoe that rotates as it passes through the tube to allow a complete examination. The turns of the two coils are interleaved so that both are effectively the same distance from the surface of the conductor. The coils are connected in a bridge circuit, as shown in Figure 4, and voltage the difference between the two signals is amplified. The two coils allow the scanning for both axial and circumferential defects. The mid range Plus Point probe used during the 1997 examination is multifrequency probe, operating at 10, 300, and 400 KHz.
