Subject: 2001 Annual Site Inspection and Monitoring Compliance Report for UMTRCA
Title I Disposal Sites

2001 Annual Site Inspection and Monitoring Report for Uranium Mill Tailings Radiation Control Act Title I Disposal Sites

January 2002

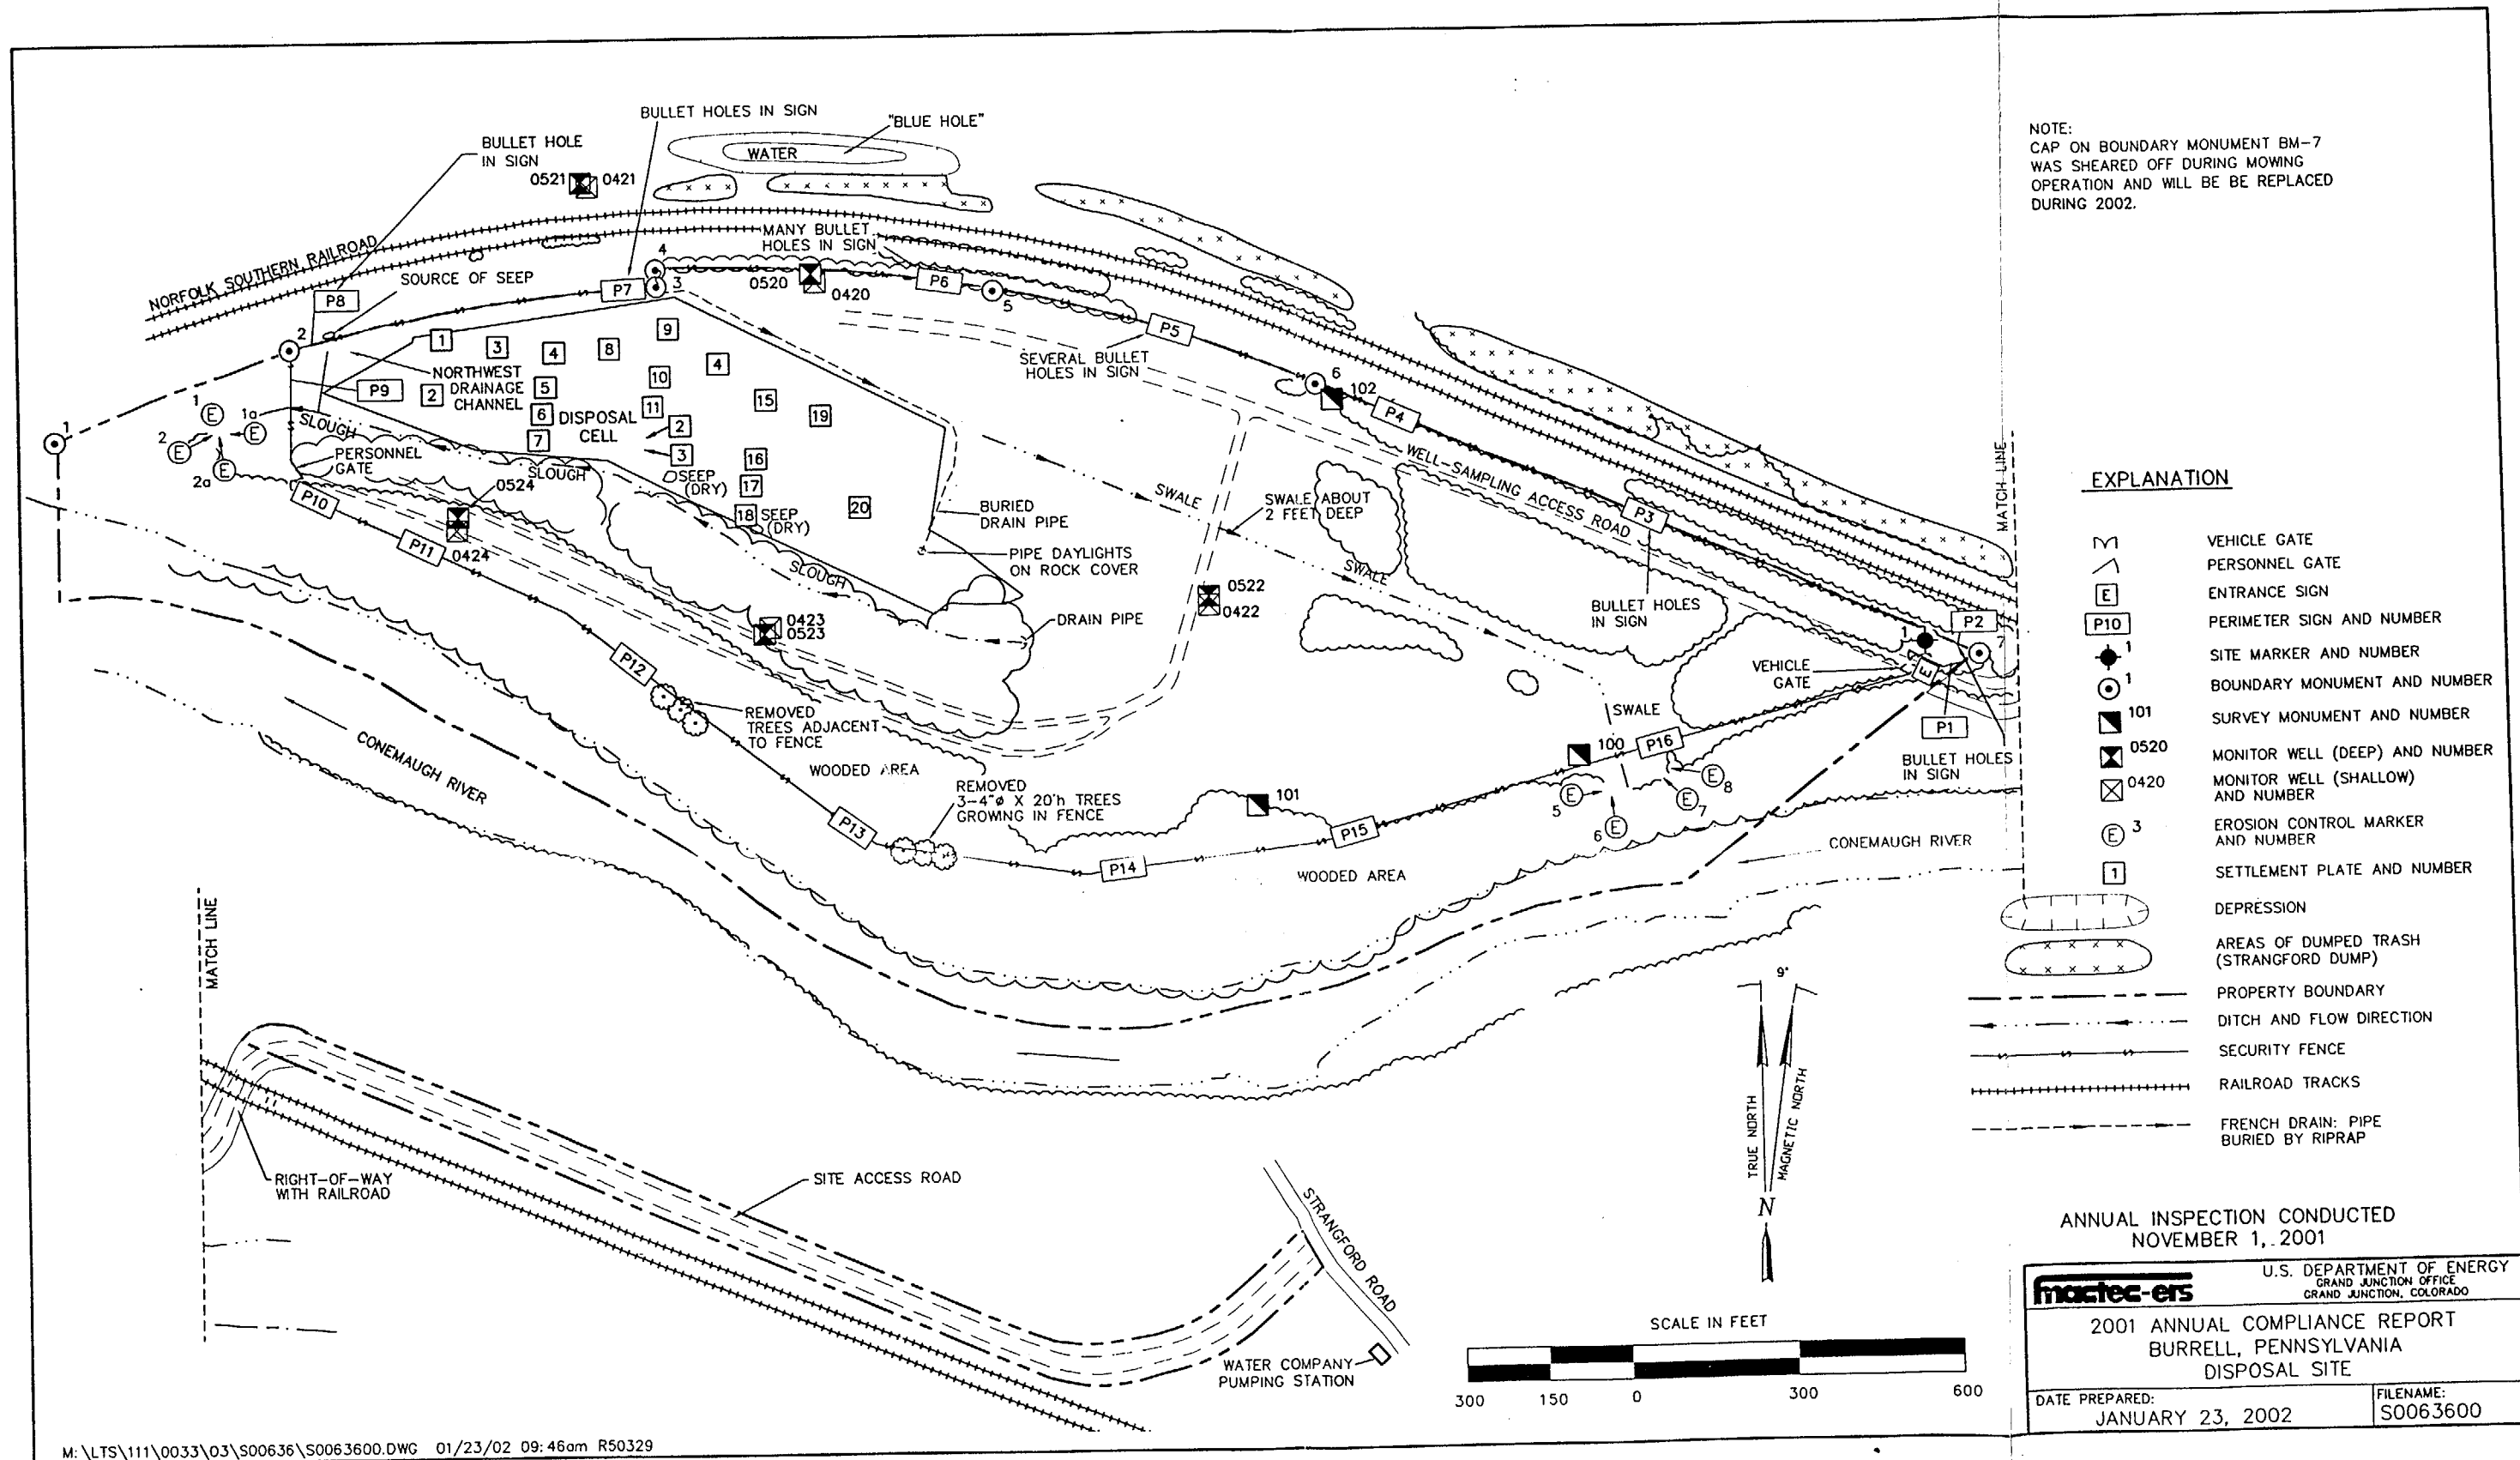
Figure 2-1. 2001 Compliance Drawing for the Burrell, Pennsylvania, Disposal Site

2A The security fence is chain-link with three strands of barbed wire on top. The fence is rusty at many places but remains secure. There are two gates in the fence—a vehicle gate at the east end of the site and a personnel gate at the west end. With one exception, the fence and gates are in good condition. A large (14-inch diameter) hardwood tree had fallen onto the security fence along the southern site boundary; the tree was too large for inspectors to remove. A local subcontractor removed the tree and repaired the fence in December 2001 to restore site access control.

The entrance sign and 17 perimeter signs are hung on the security fence. Many of the perimeter signs along the northern property boundary have been damaged by bullet holes but are legible. No signs needed replacement this year.

2C The site has three survey monuments (SM-100 through SM-102) and seven boundary monuments (BM-1 through BM-7). With one exception, the markers and monuments are undisturbed and in excellent condition, although dense vegetation makes them hard to find. The cap on boundary monument BM-7 was sheared off, apparently when a subcontractor mowed vegetation along the fence lines. The monument will be repaired in 2002.

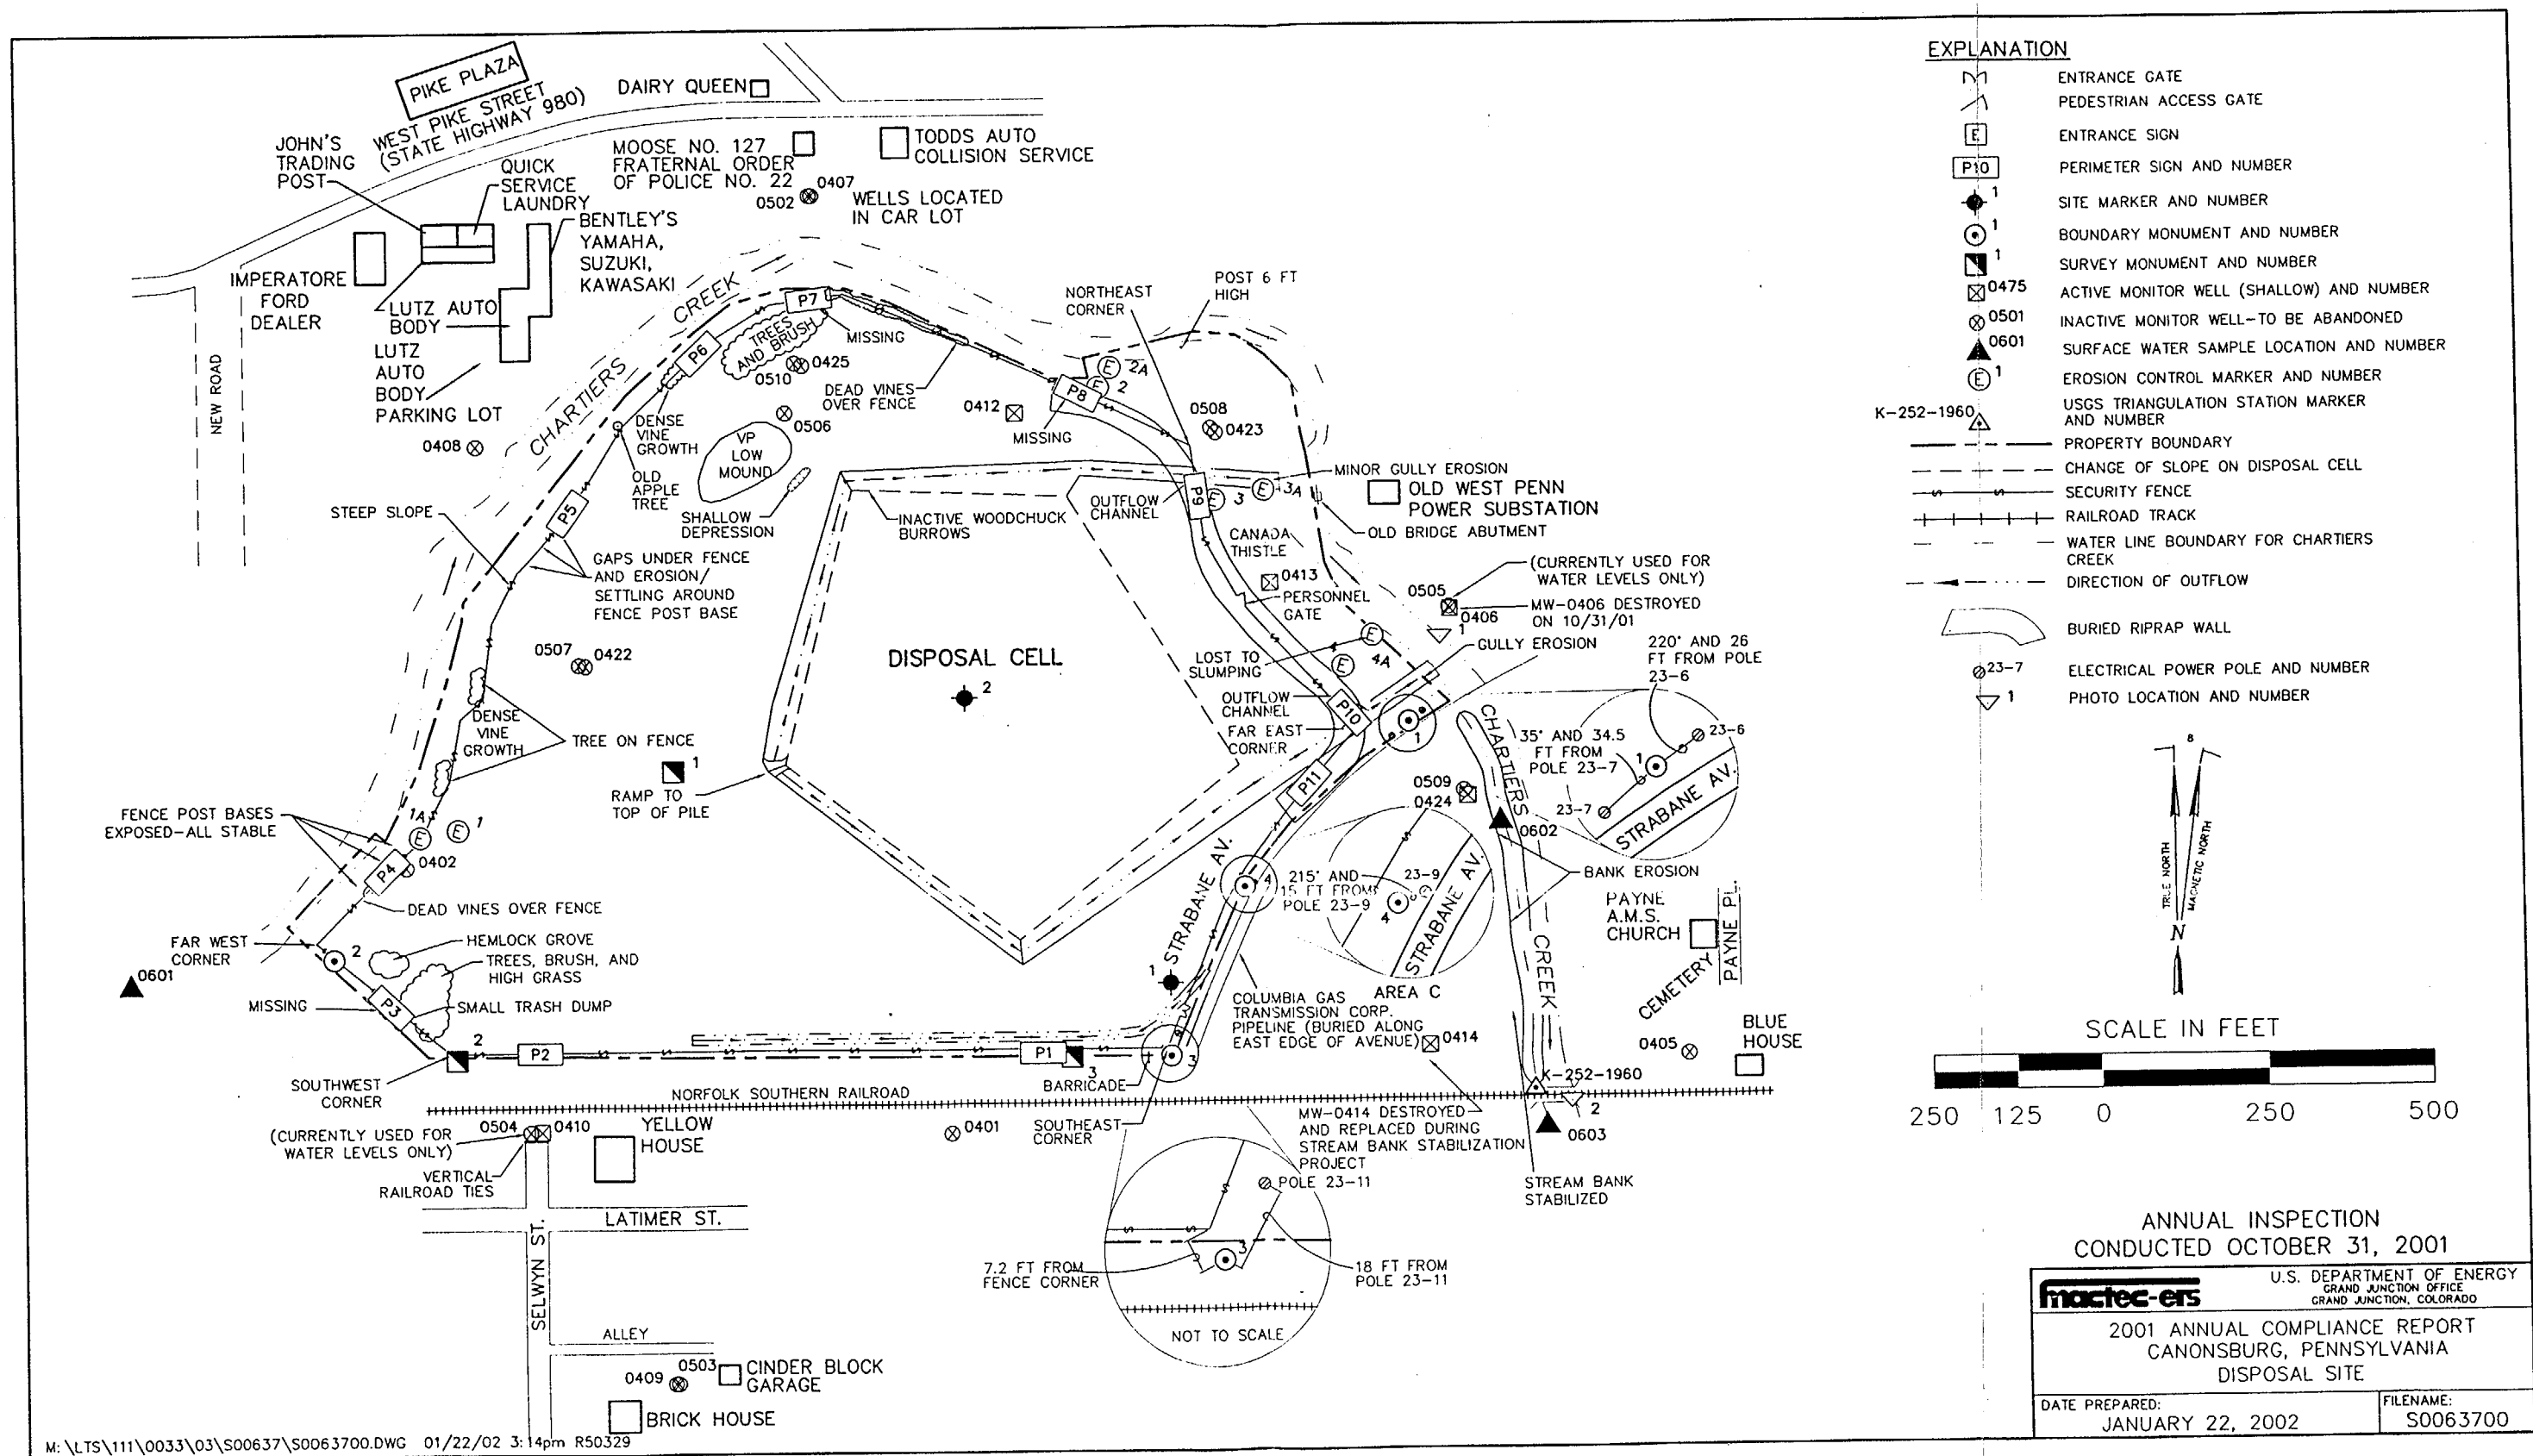
Figure 3-1. 2001 Compliance Drawing for the Canonsburg, Pennsylvania, Disposal Site

Disposal Cell—The disposal cell is a grass-covered knoll in excellent condition. The grass is mowed and mulched annually, most recently in July 2001. There is no evidence of slumping, settling, erosion, or other modifying process.

Diversion Channels and Perimeter Ditches—Diversion channels around the disposal cell and the perimeter ditch along the south and east sides of the site are armored with riprap and are in excellent condition.

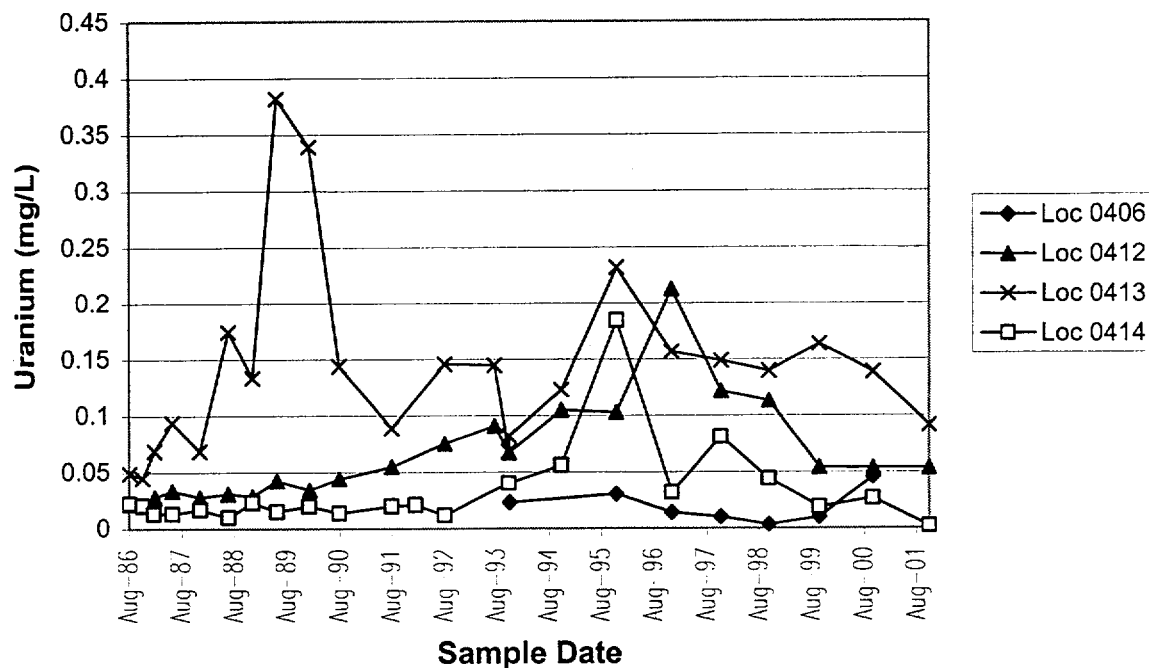
Figure 3-2. Time-Concentration Plot of Uranium in Ground Water at the Canonsburg, Pennsylvania, Disposal Site

In 2001, uranium concentration exceeded the standard at two of the three sampled downgradient wells: 0412 and 0413. All results are consistent with previous results. Although long-term trends in the data are conjectural, short-term trends, since about 1995, may be developing. DOE is cautious on this point because of the wide variations in the historical results (Figure 3-2).

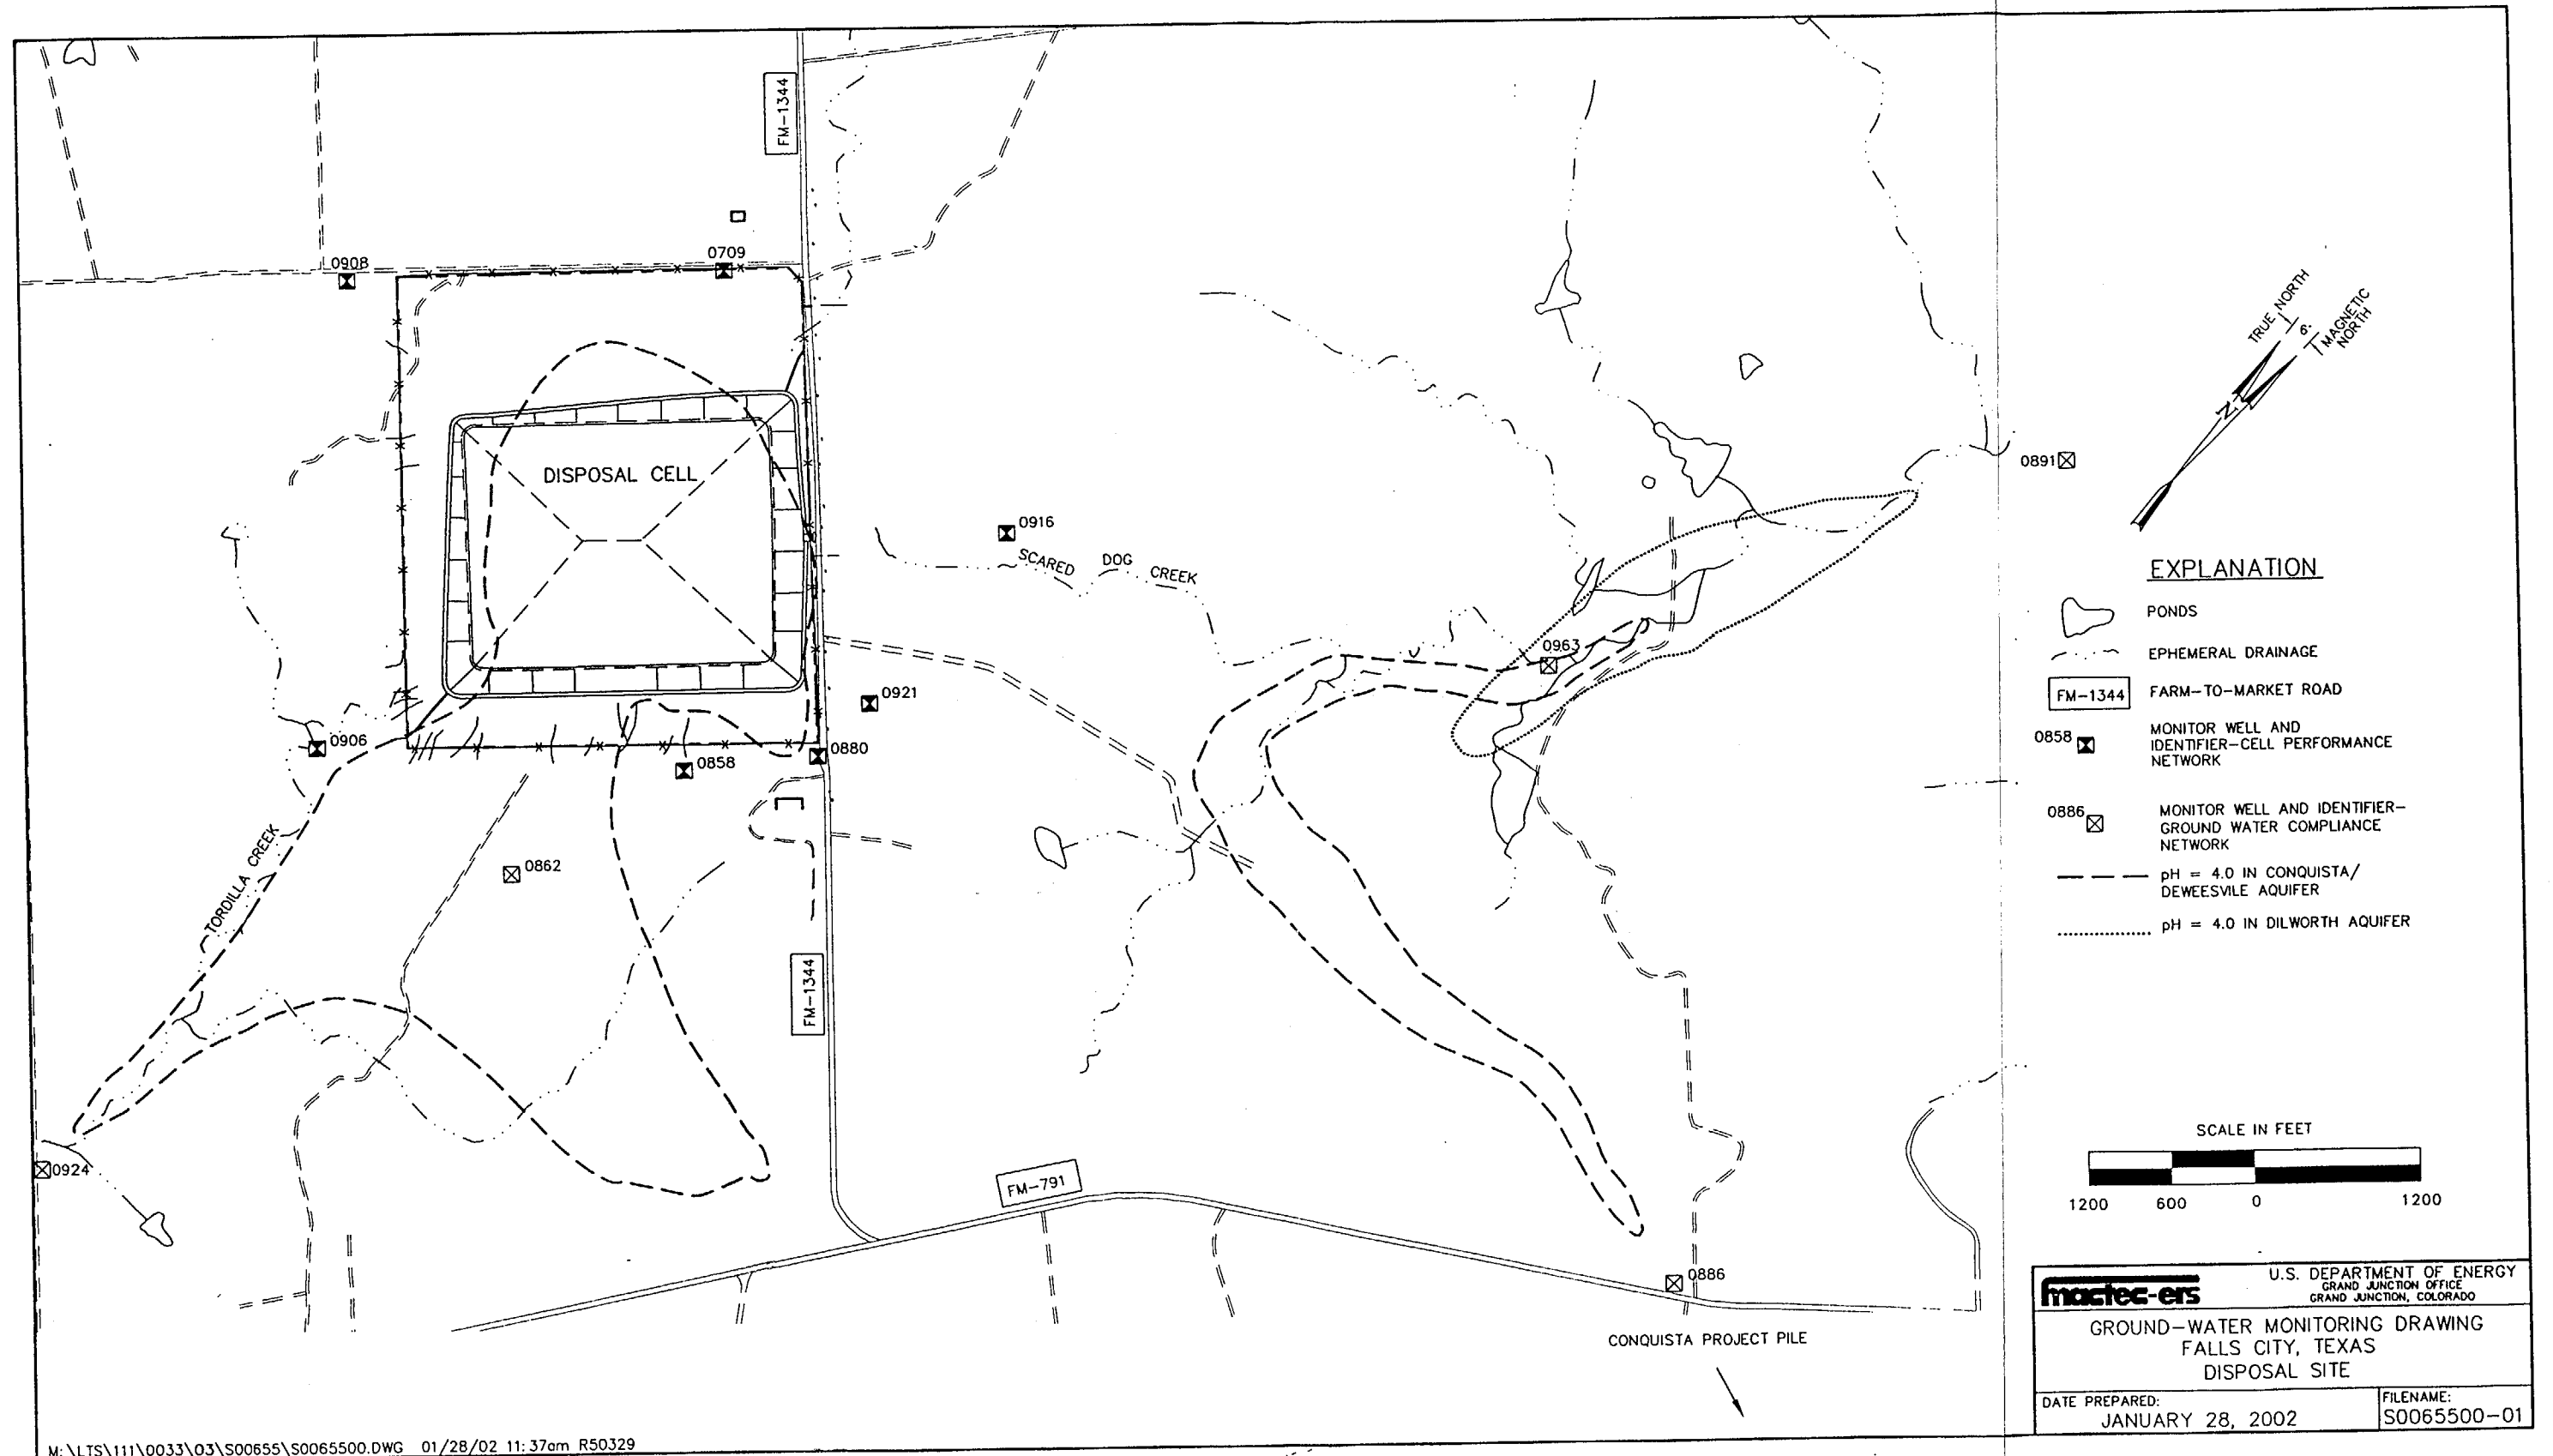
Figure FCT-2. Ground-Water Monitoring, Falls City, Texas, Disposal Site

The pH of the ground-water samples collected in 2000 and 2001 was essentially unchanged and consistent with previous results for all wells except 0858 and 0880. Seasonal variation in pH continued to be noticeable at most wells. The pH tends to be higher (more neutral) in fall and lower (more acidic) in spring. This seasonal variation was in all cases less than 0.5 standard pH units during 2000 and 2001.

Ground-water pH at monitor wells 0858 and 0880 has decreased gradually since baseline data were collected. The reason for the decrease is unclear. The decrease may be the result of dissipation of the pre-existing ground water mound and the consequent outward movement of the low-pH plume. Transient drainage from the cell may be contributing low pH fluids to the aquifer. Clearly, nothing in the data, such as a sharp or sudden decrease in pH, suggests excessive leaching from the disposal cell.

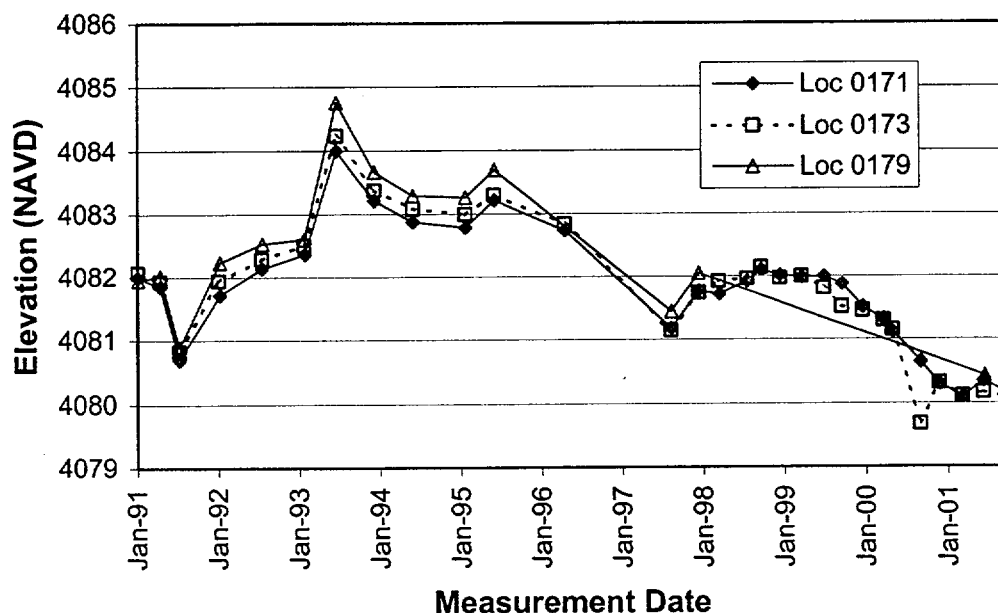
Figure 7-2. Ground Water Levels at the Green River, Utah, Disposal Site

Ground-Water Level Monitoring—Water level hydrographs for wells 0171, 0173, and 0179 indicate a drop of approximately 3 feet in all three wells since 1993 (Figure 7-2).

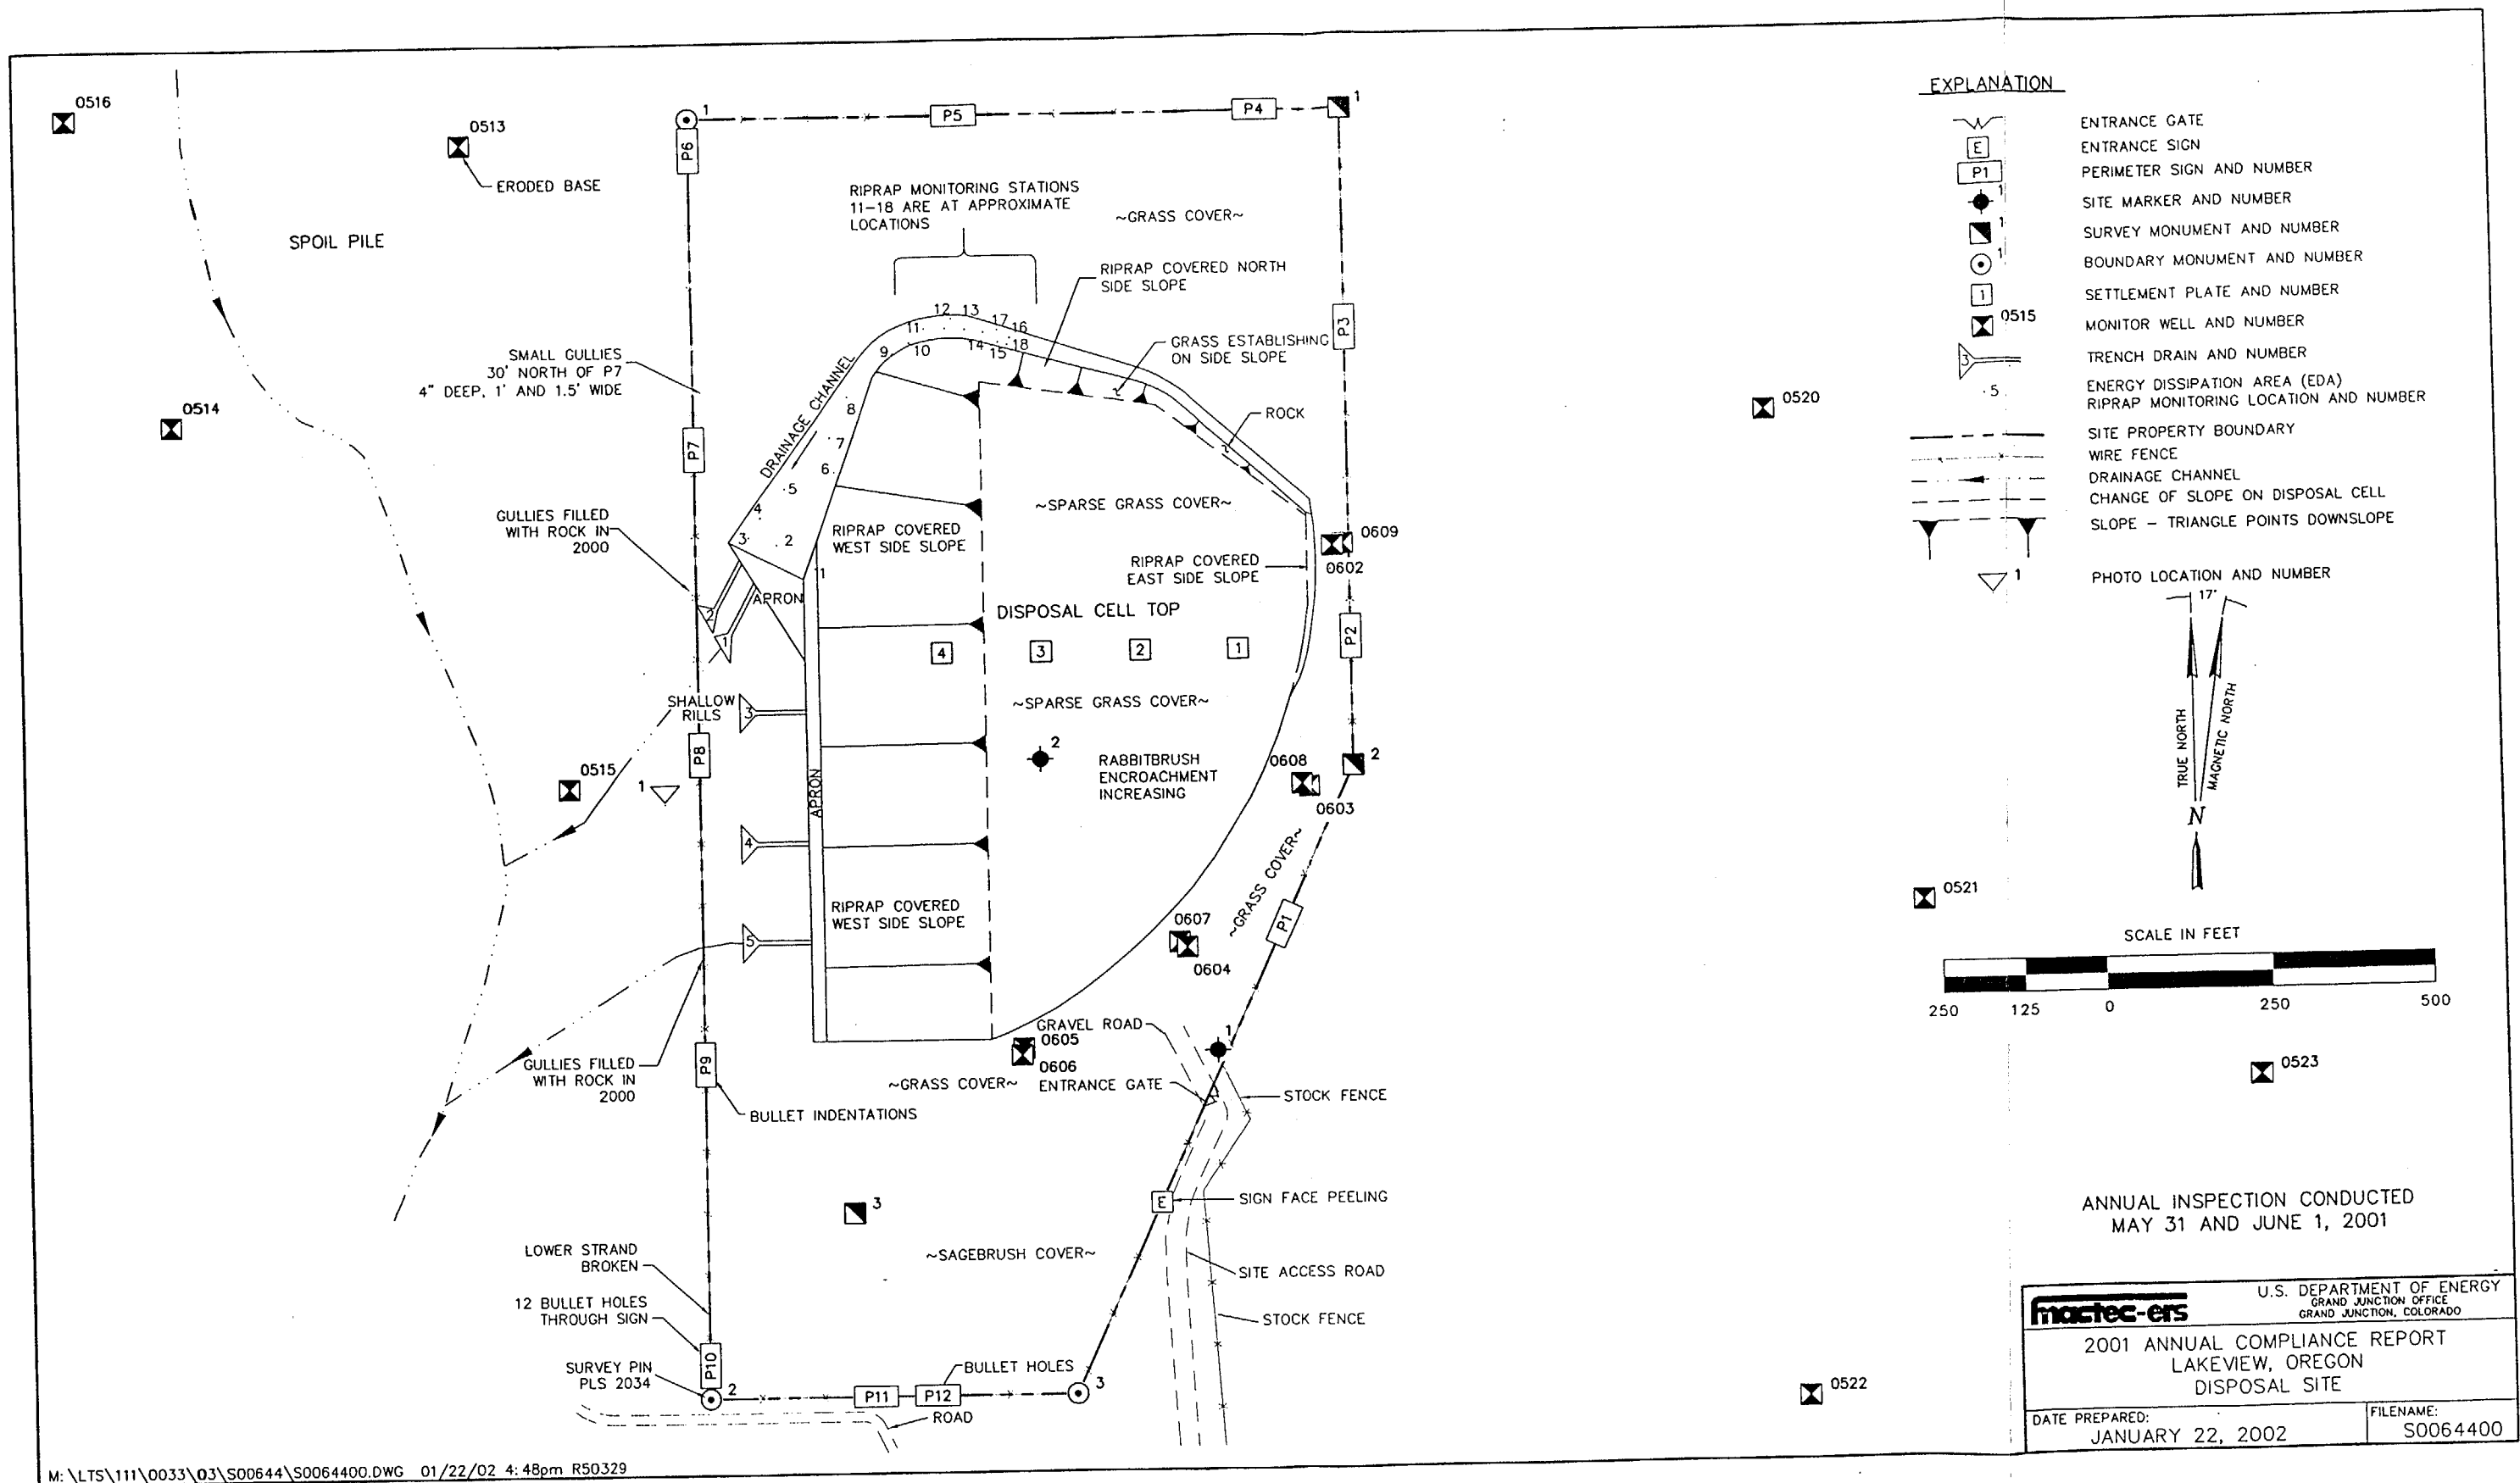
Figure 9-1. 2001 Compliance Drawing for the Lakeview, Oregon, Disposal Site

9A **Top of the Disposal Cell**—The design for the top of the disposal cell has created conditions that favor the growth of deep-rooted plants, including rabbitbrush, sagebrush, and bitterbrush. The top slope was seeded with grasses after construction; sparse cover of relatively shallow-rooted grasses is a consequence of the thin (nominal 4-inch-thick) topsoil layer. The low water-storage capacity of the topsoil layer will continue to limit growth of relatively shallow-rooted perennial grasses. Movement of precipitation through the riprap and bedding layers and into the radon barrier favors the growth of shrubs. Many mature rabbitbrush plants and a few mature sagebrush and bitterbrush plants grow on the top of the disposal cell. Shrub density has increased episodically over the past few years and will continue to increase until it approaches or exceeds abundance levels observed in native plant communities adjacent to the site.

Side Slopes of the Disposal Cell and Adjacent Drainage Channel, Aprons, and Trench Drains—Deterioration of riprap on the west and north side slopes and in the energy dissipation area at the mid and lower end of the drainage channel is an ongoing concern, because the riprap was sized to withstand the erosive energy of a probable maximum precipitation event. The percentage of crumbling rocks on the surface has increased noticeably since the riprap was placed in 1989.

Gullies that formed in seeded areas extending west of Trench Drains 1, 2, 3, 4, and 5 past the site boundary were filled with rock in 2000; headcutting observed in 2000 in these areas has been curtailed (PL-1). The soil downslope from all five trench drains was dry on the date of the inspection; these areas were saturated during previous inspections.

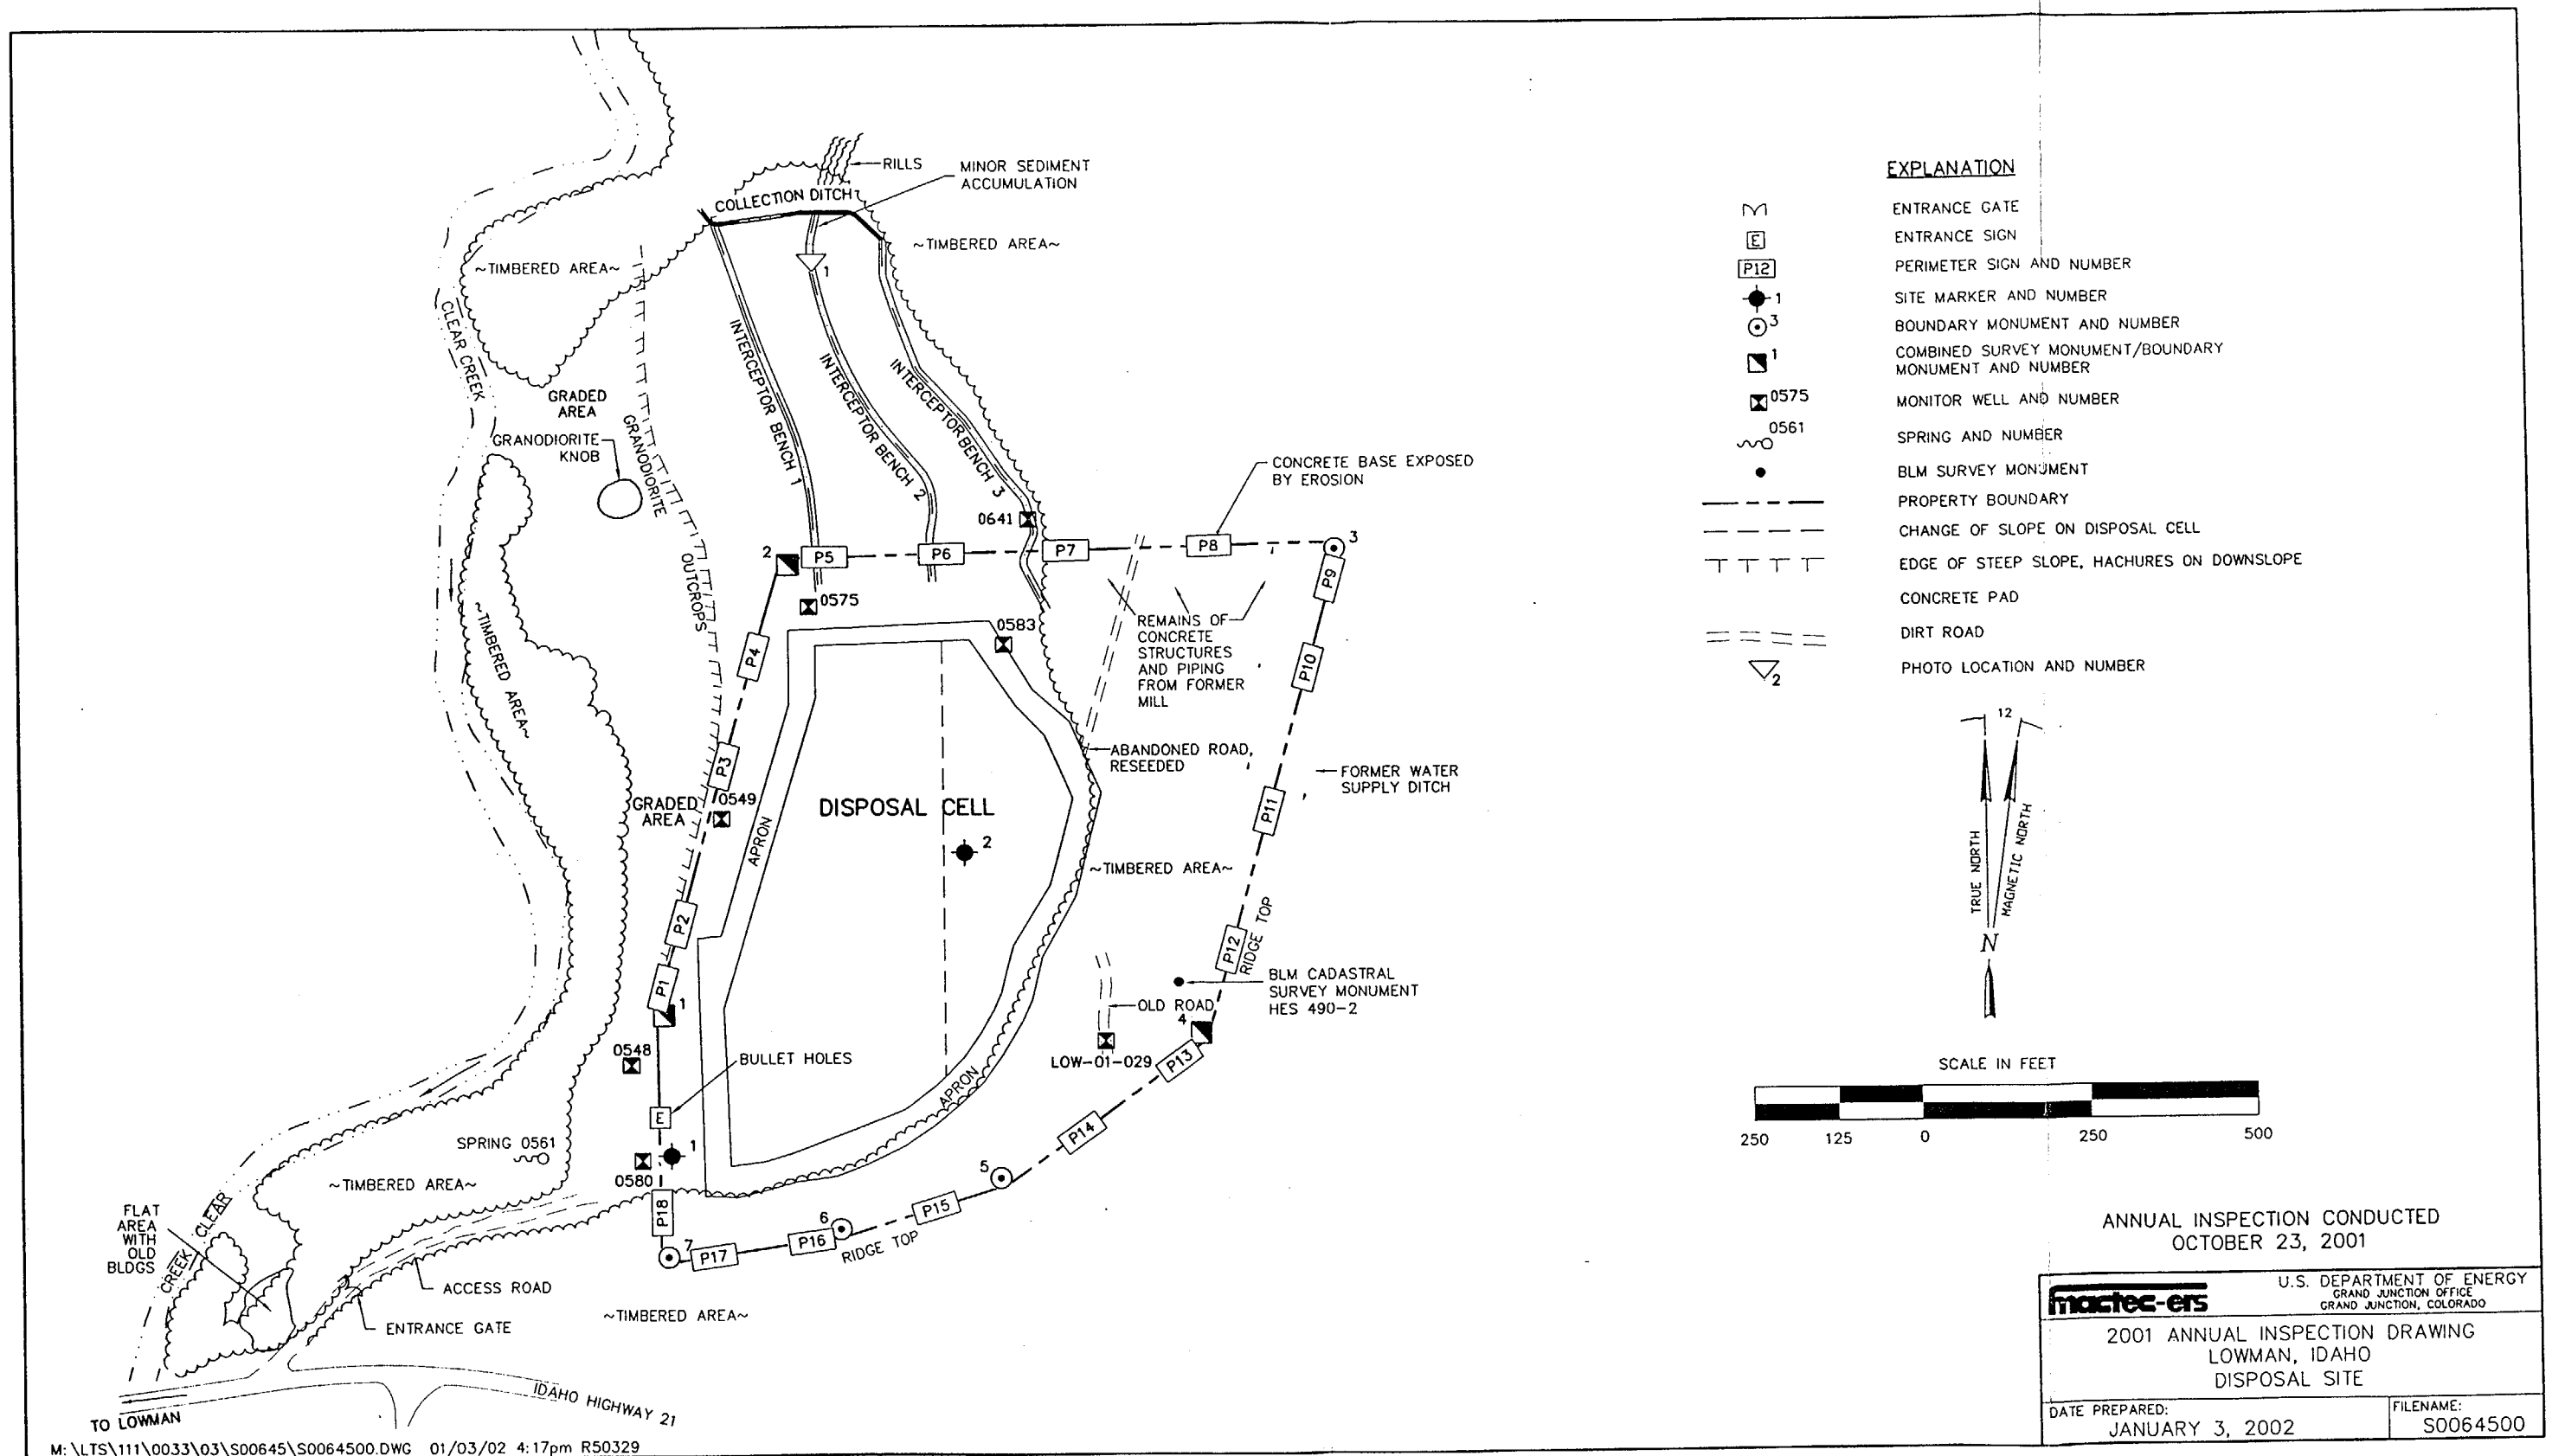
Figure 10-1. 2001 Compliance Drawing for the Lowman, Idaho, Disposal Site

At the time of the 2001 inspection, the interceptor benches, collection ditch, and vegetation were effectively controlling soil erosion in the revegetated area. Repairs made to the interceptor benches and collection ditch from the early 1999 washouts continue to be effective. Overall, the benches and collection ditch were in good condition. Inspectors noted that a small area of sediment accumulation was present at the north end of Interceptor Bench 2 (PL-1).

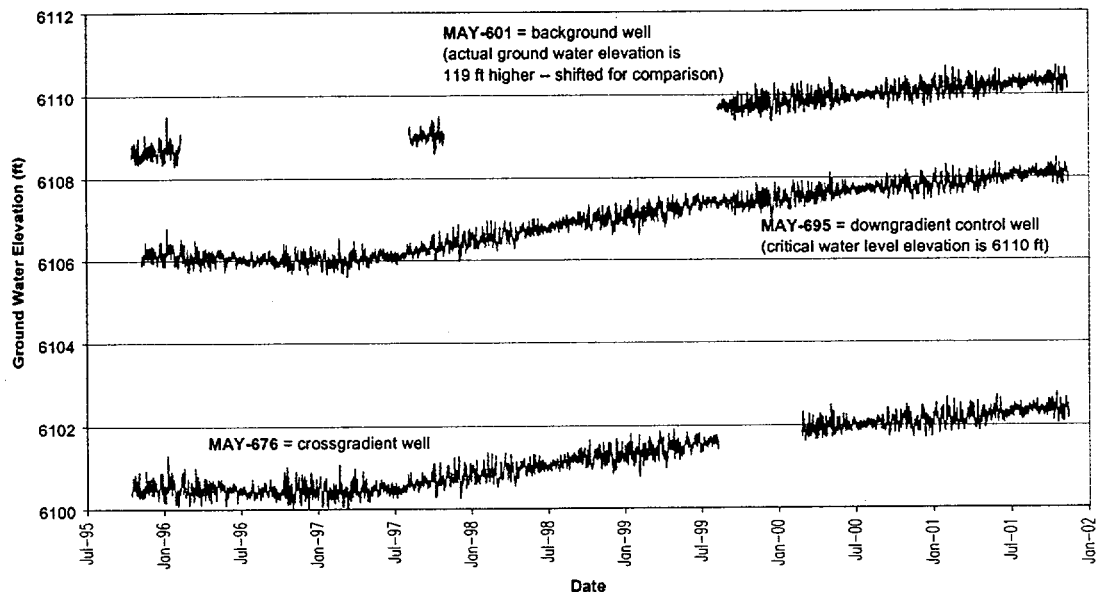
Figure 11-2. Water Level Measurements at the Maybell, Colorado, Disposal Site

Water level measurements through November 2001 are shown in Figure 11-2. Breaks in two of the hydrographs are due to data logger malfunction. Measurements are not shown for backup monitor well 0696.

- 11D Water levels continue to rise at a similar rate at all measuring stations. Slopes of the hydrographs in Figure 11-2 are remarkably parallel. Data from background well 0601 are of primary interest. They show that rising water levels are regional, at least in their major component, and cannot be related to any local effect around the disposal cell. A regional rise in water level can reasonably be attributed to long-term precipitation patterns perhaps of decadal or longer-term duration.
