Subject: 2001 Annual Site Inspection and Monitoring Compliance Report for UMTRCA
Title I Disposal Sites

2001 Annual Site Inspection and Monitoring Report for Uranium Mill Tailings Radiation Control Act Title I Disposal Sites

January 2002

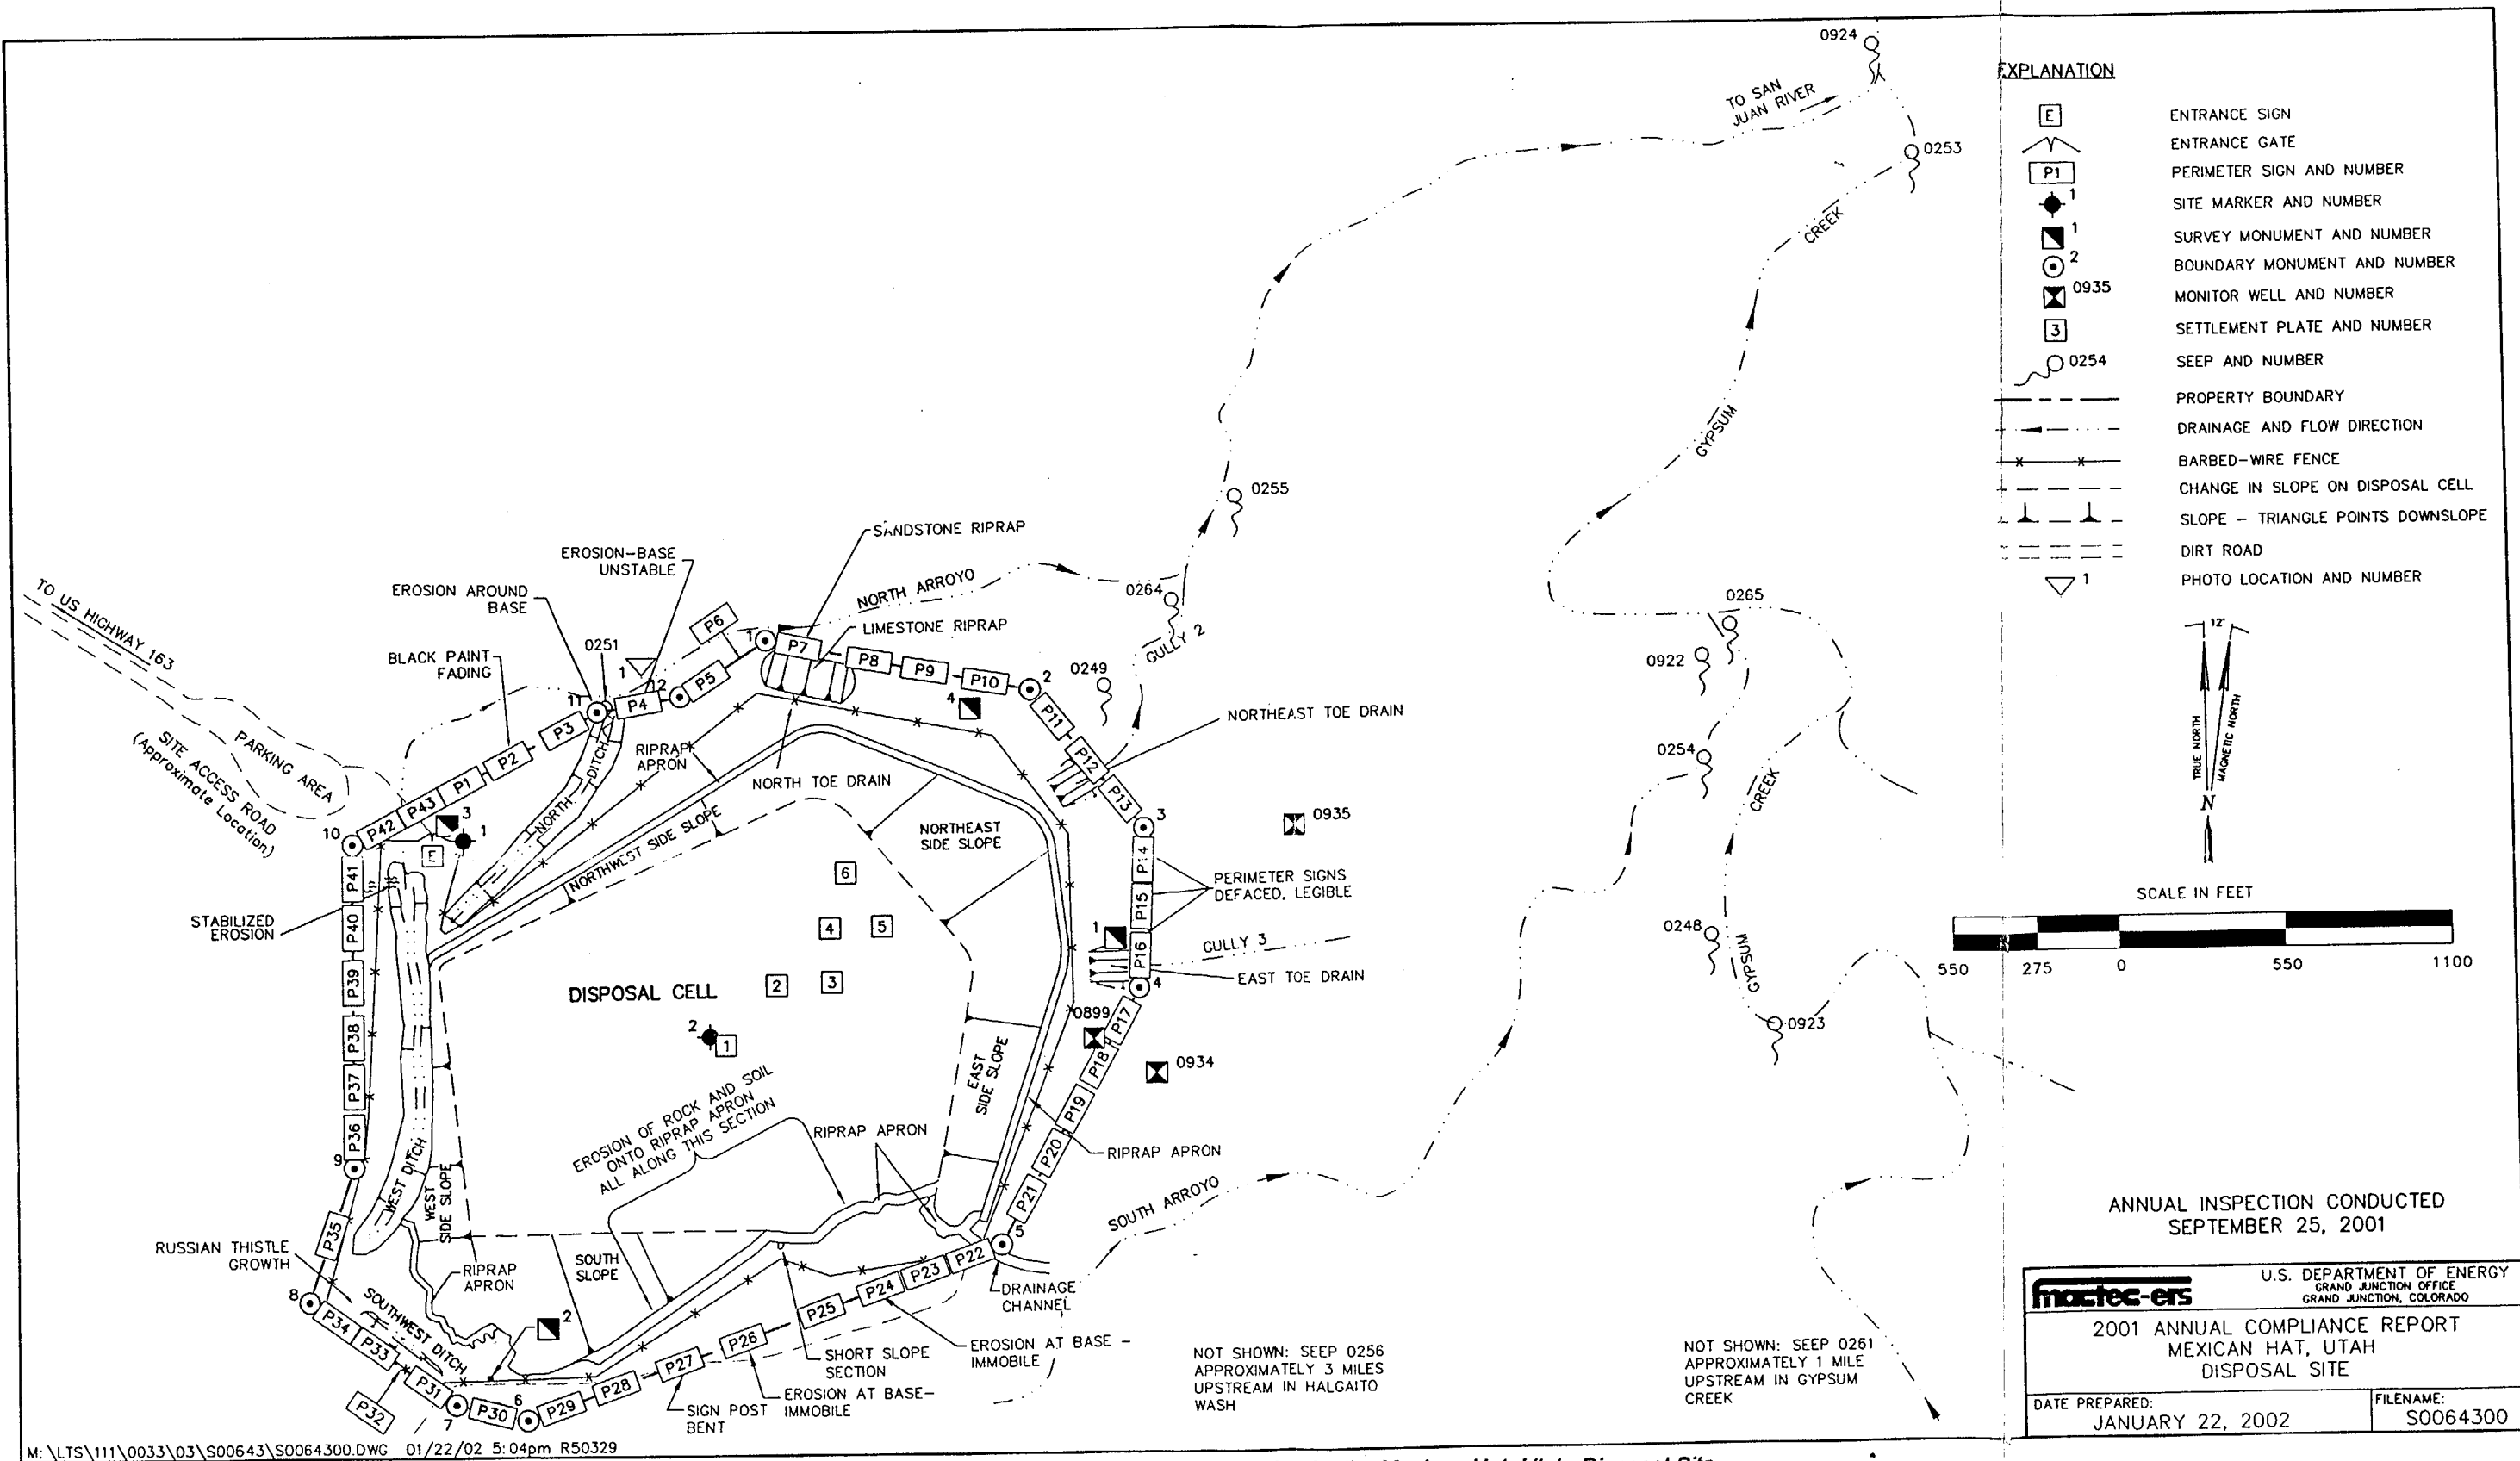
Figure 12-1. 2001 Compliance Drawing for the Mexican Hat, Utah, Disposal Site

The sloughing of red-colored country rock and soil (the “scree slope”) along the south apron does not appear to have increased significantly during the past year; the accumulation remains approximately 18 to 24 inches high against the base of the vertical face of native rock. Some larger pieces of sandstone (up to 12 inches in diameter) have rolled down the cliff face and out onto the riprap apron, as noted during previous inspections. As in previous years, inspectors did not find evidence of channel erosion in this area, and the sloughed material does not appear to have filled the void spaces in the riprap beyond the toe of the scree slope.

Area Between the Disposal Cell and the Site Boundary—During the 2001 inspection, erosion previously noted near perimeter sign P41 appeared unchanged. The slope at this location is approaching a stable condition and intervention is not warranted. Other slopes around the disposal cell remain stable, with abundant rock exposures at the surface of the slopes and only minor accumulations of loose material or scree at the toe of the slopes.

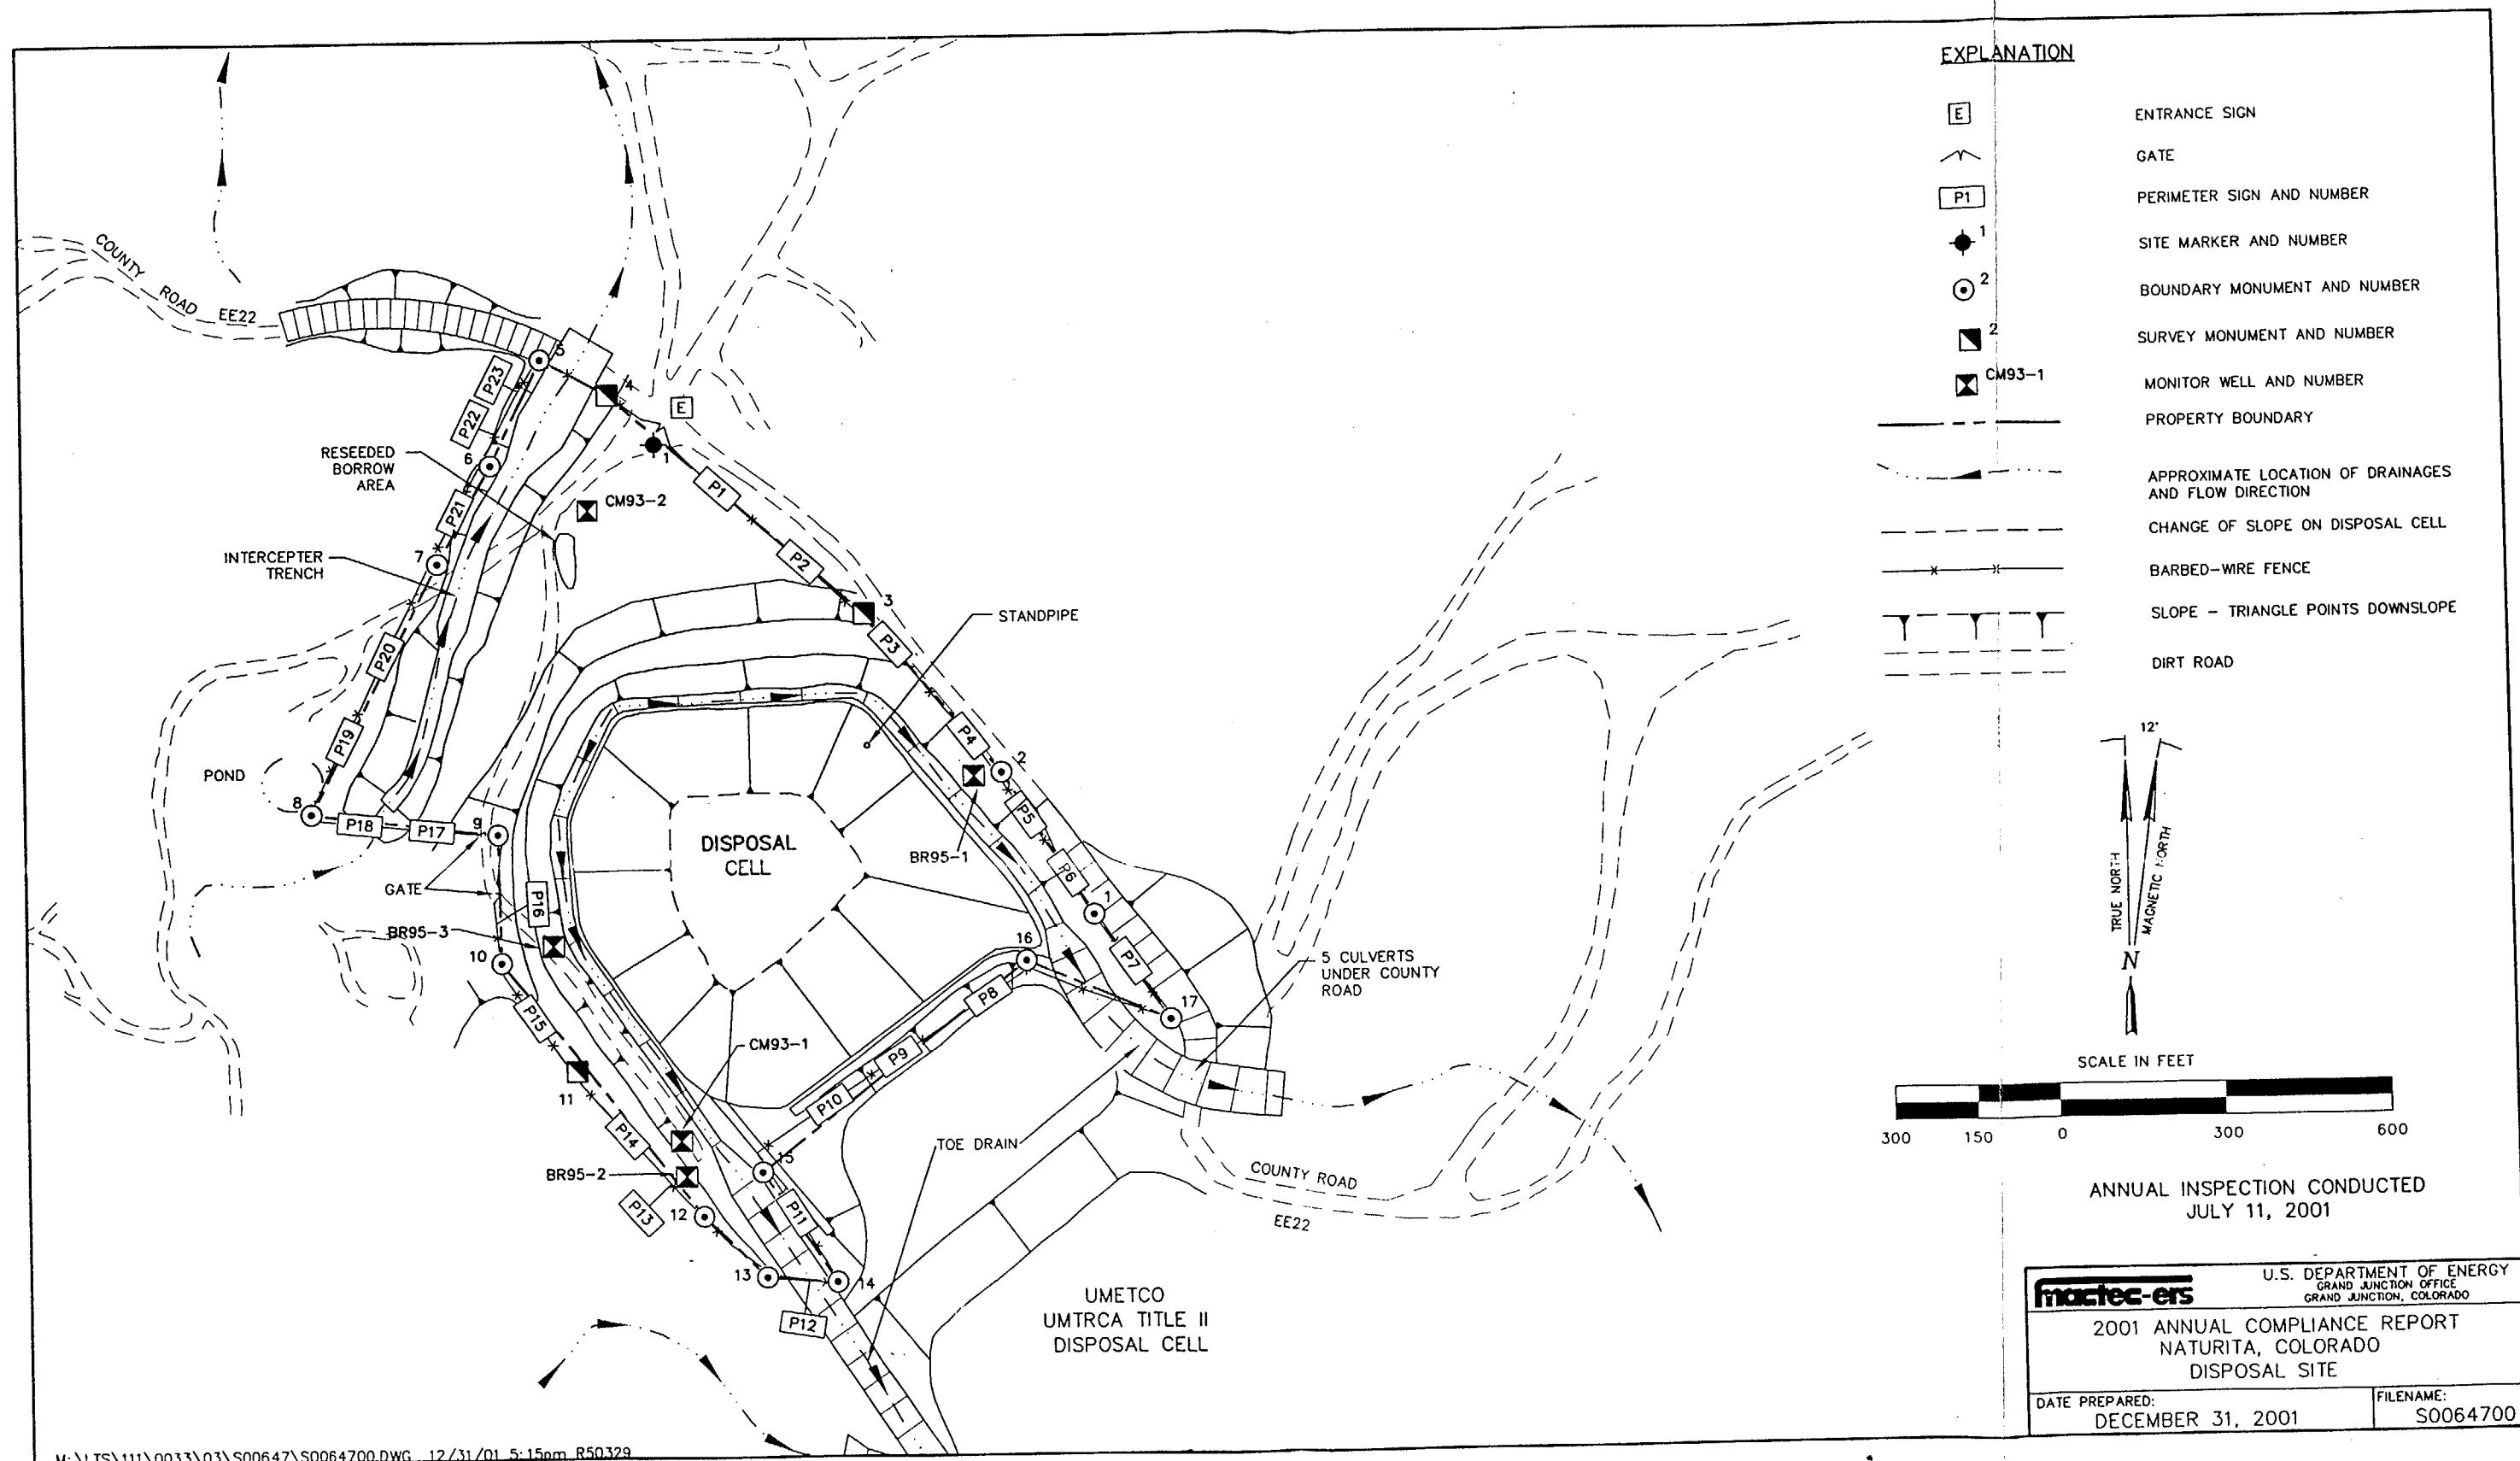
Figure 13-1. 2001 Compliance Drawing for the Naturita, Colorado, Disposal Site

- 13A **Area Between the Drains and the Site Boundary.**—Grass and shrub density has increased, but much of the cover still consists of annual weeds, primarily kochia. The success of revegetation may not be evident for several years and will be dependent on moisture.

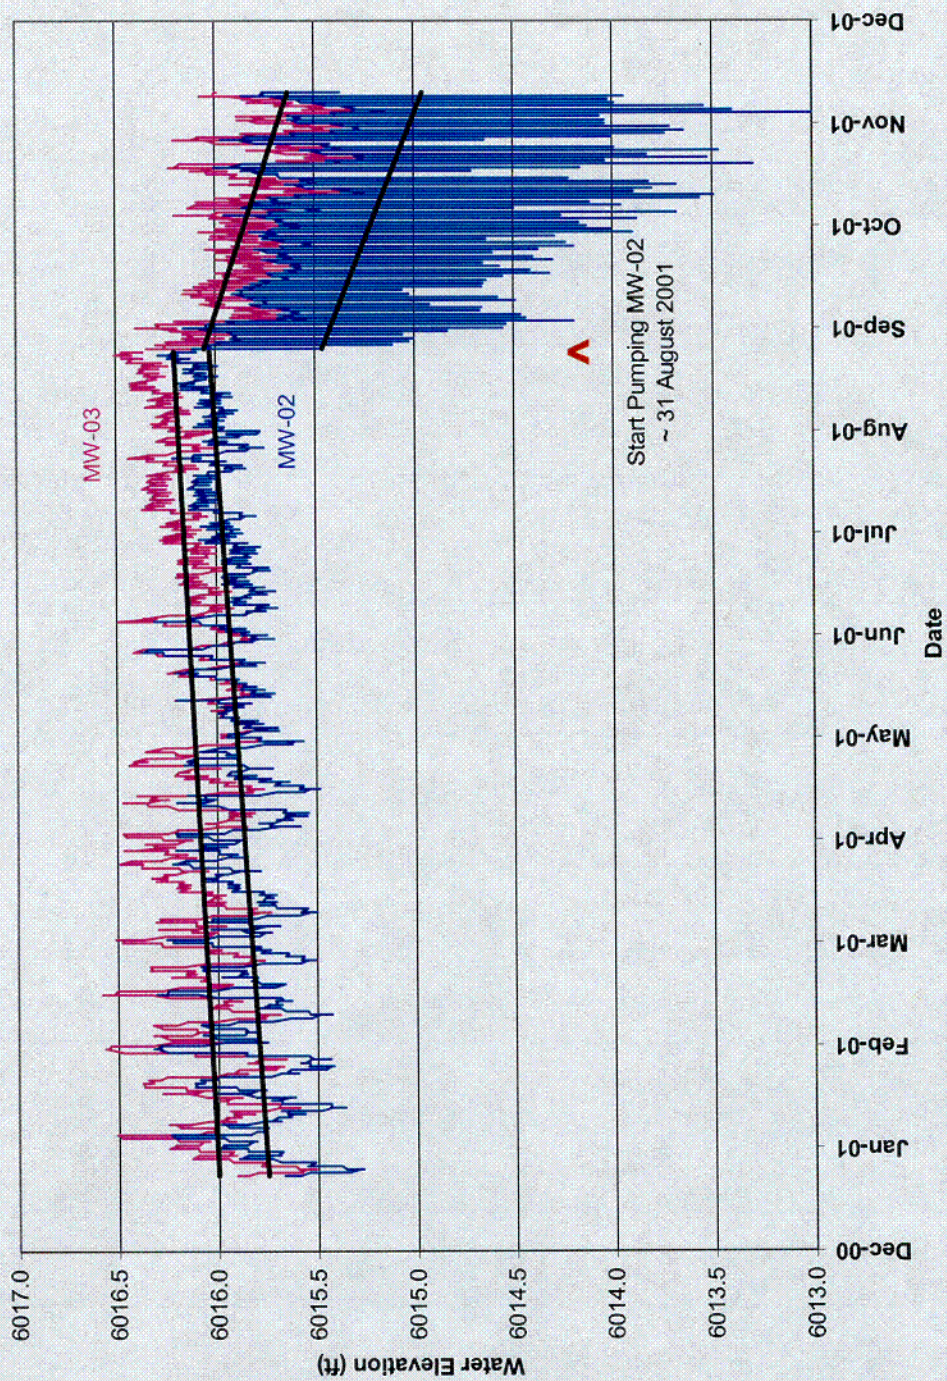
Figure 14-2. Water Levels in Standpipes MW-2 and MW-3 During 2001

When average water levels (as calculated using linear regression) in MW-2 approached the action level in August 2001, DOE installed a pump in standpipe MW-2, constructed an evaporation pond, and began pumping from the standpipe to the pond. Since then, water levels have slowly dropped 4 to 6 inches. Water level measurements for 2001 are shown on Figure 14-2. The linear regression trend line is superimposed on each hydrograph.

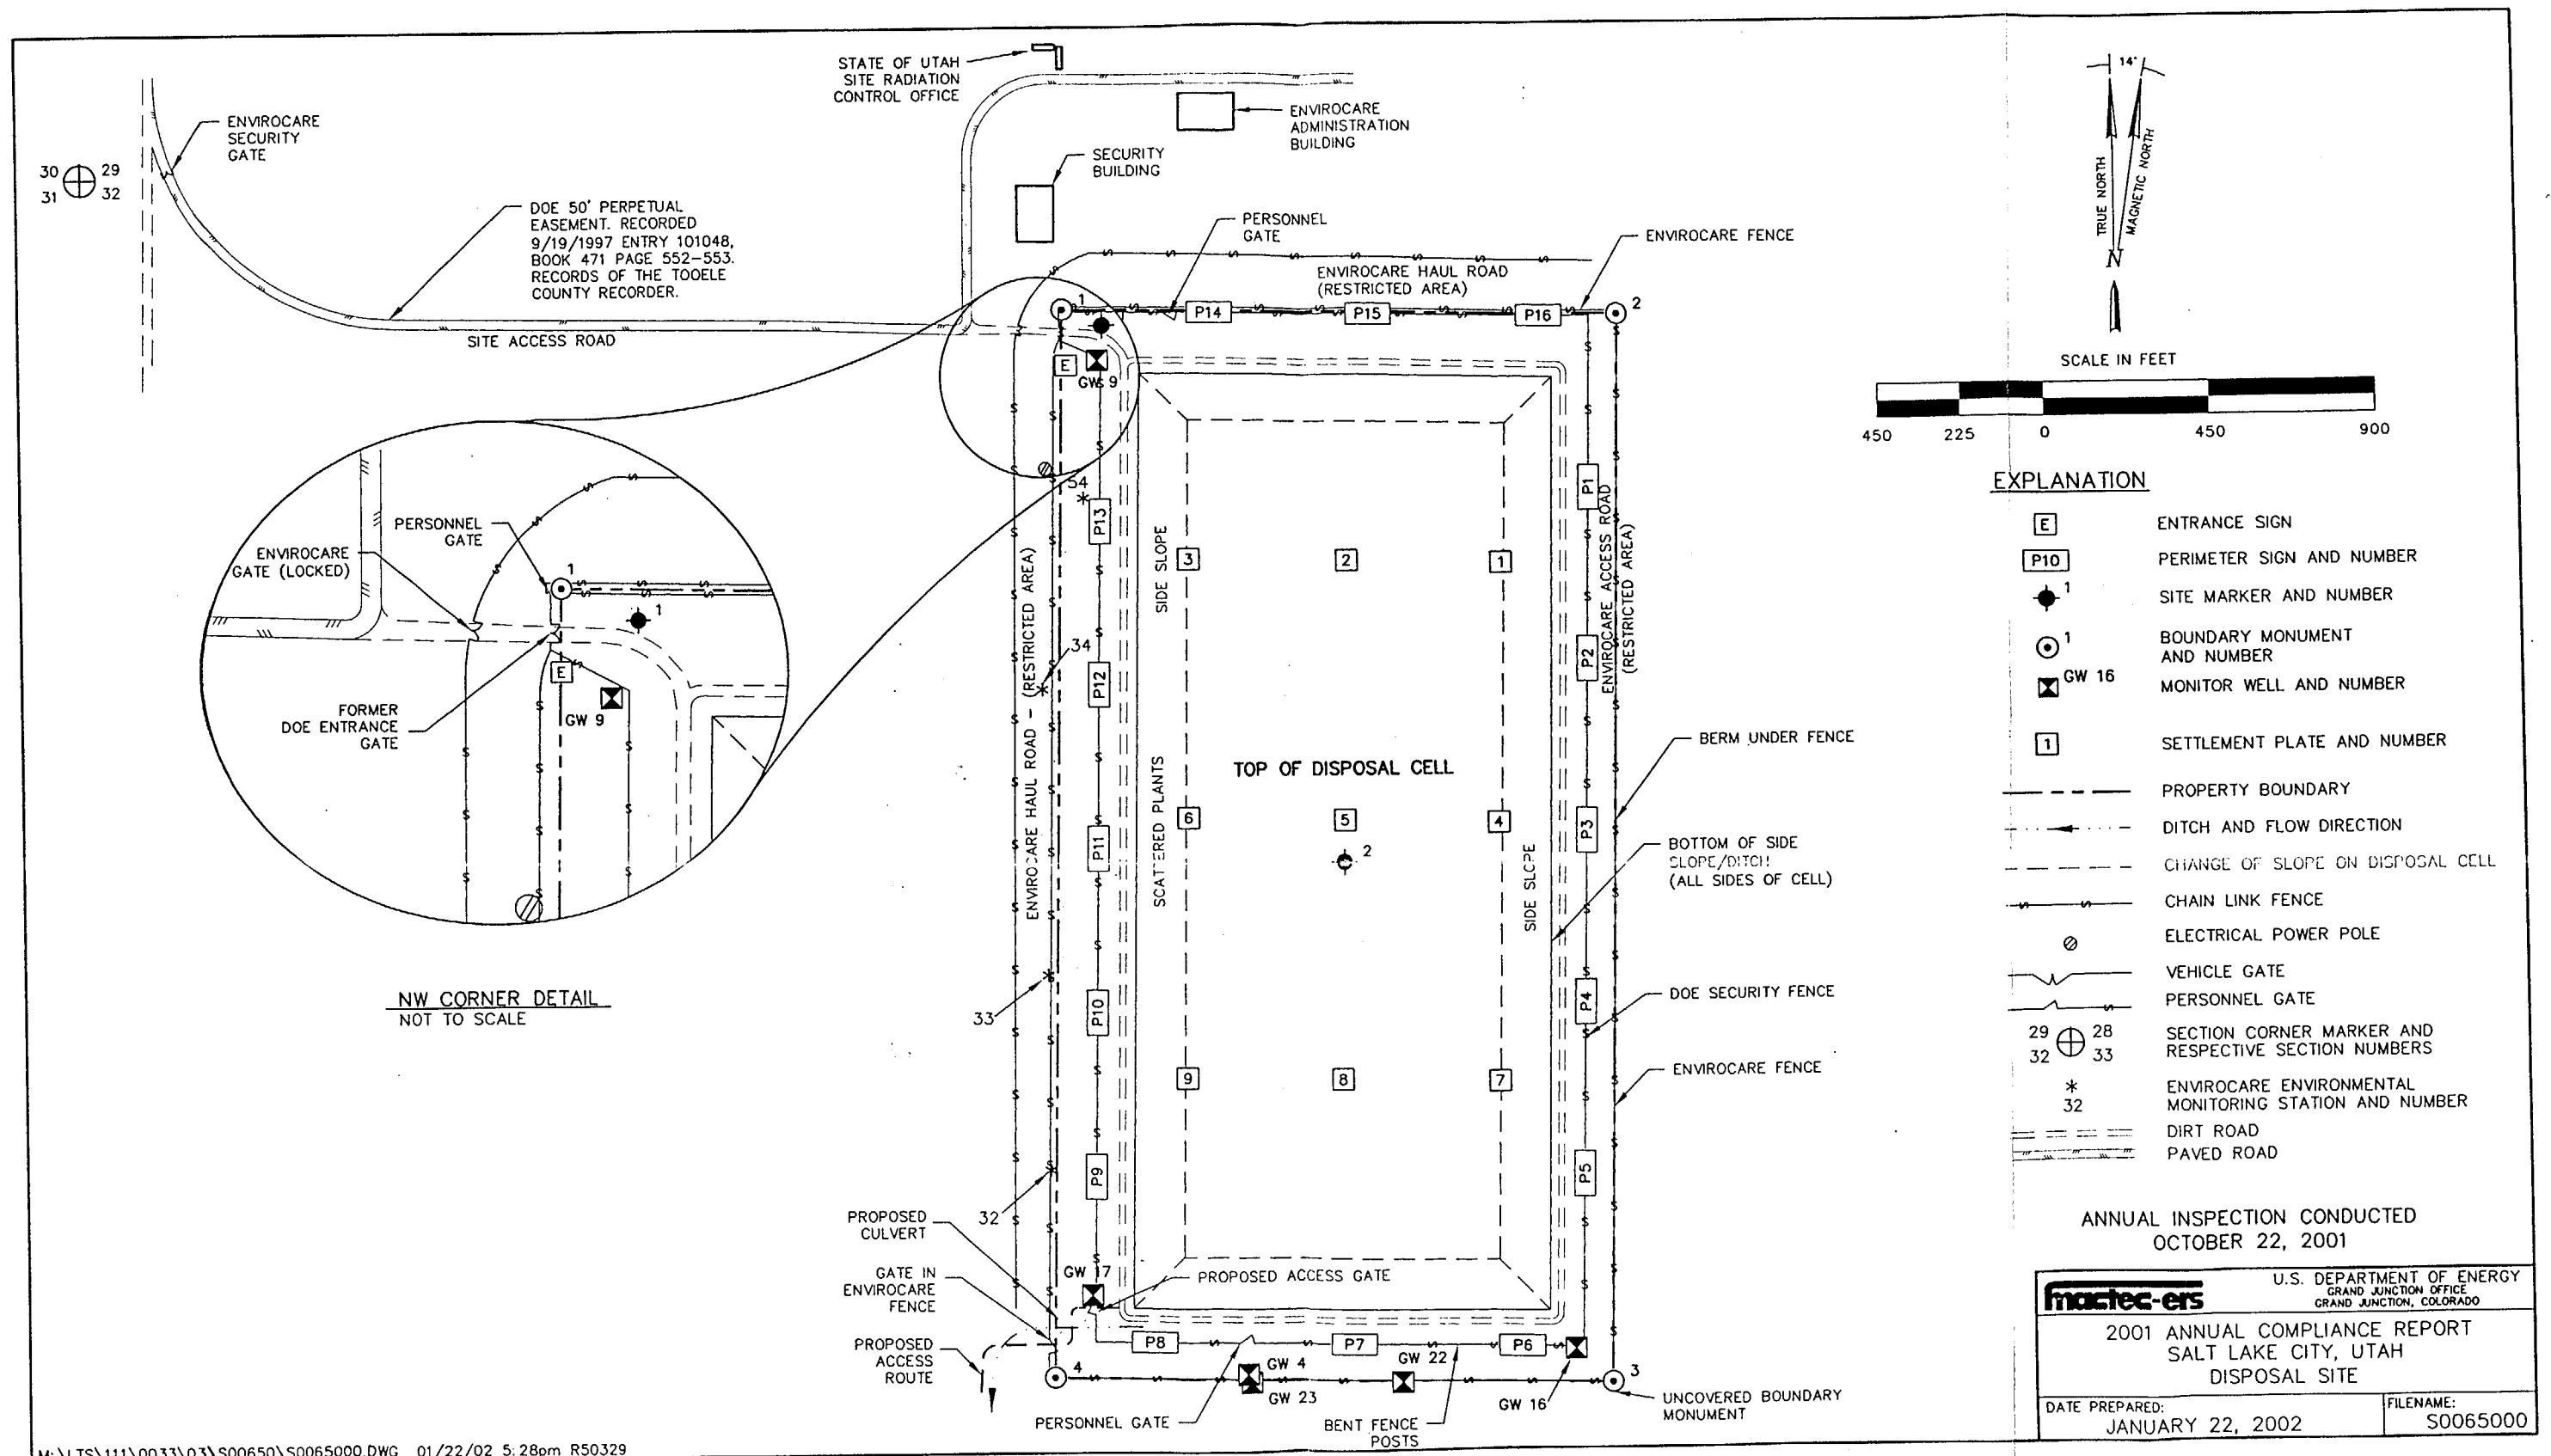
Figure 15-1. 2001 Compliance Drawing for the Salt Lake (South Clive), Utah, Disposal Site

Area Between the Disposal Cell and the Site Boundary—Inspectors examined the area between the toe of the disposal cell and the security fence. No evidence of slumping, settling, or significant vegetation encroachment was seen.

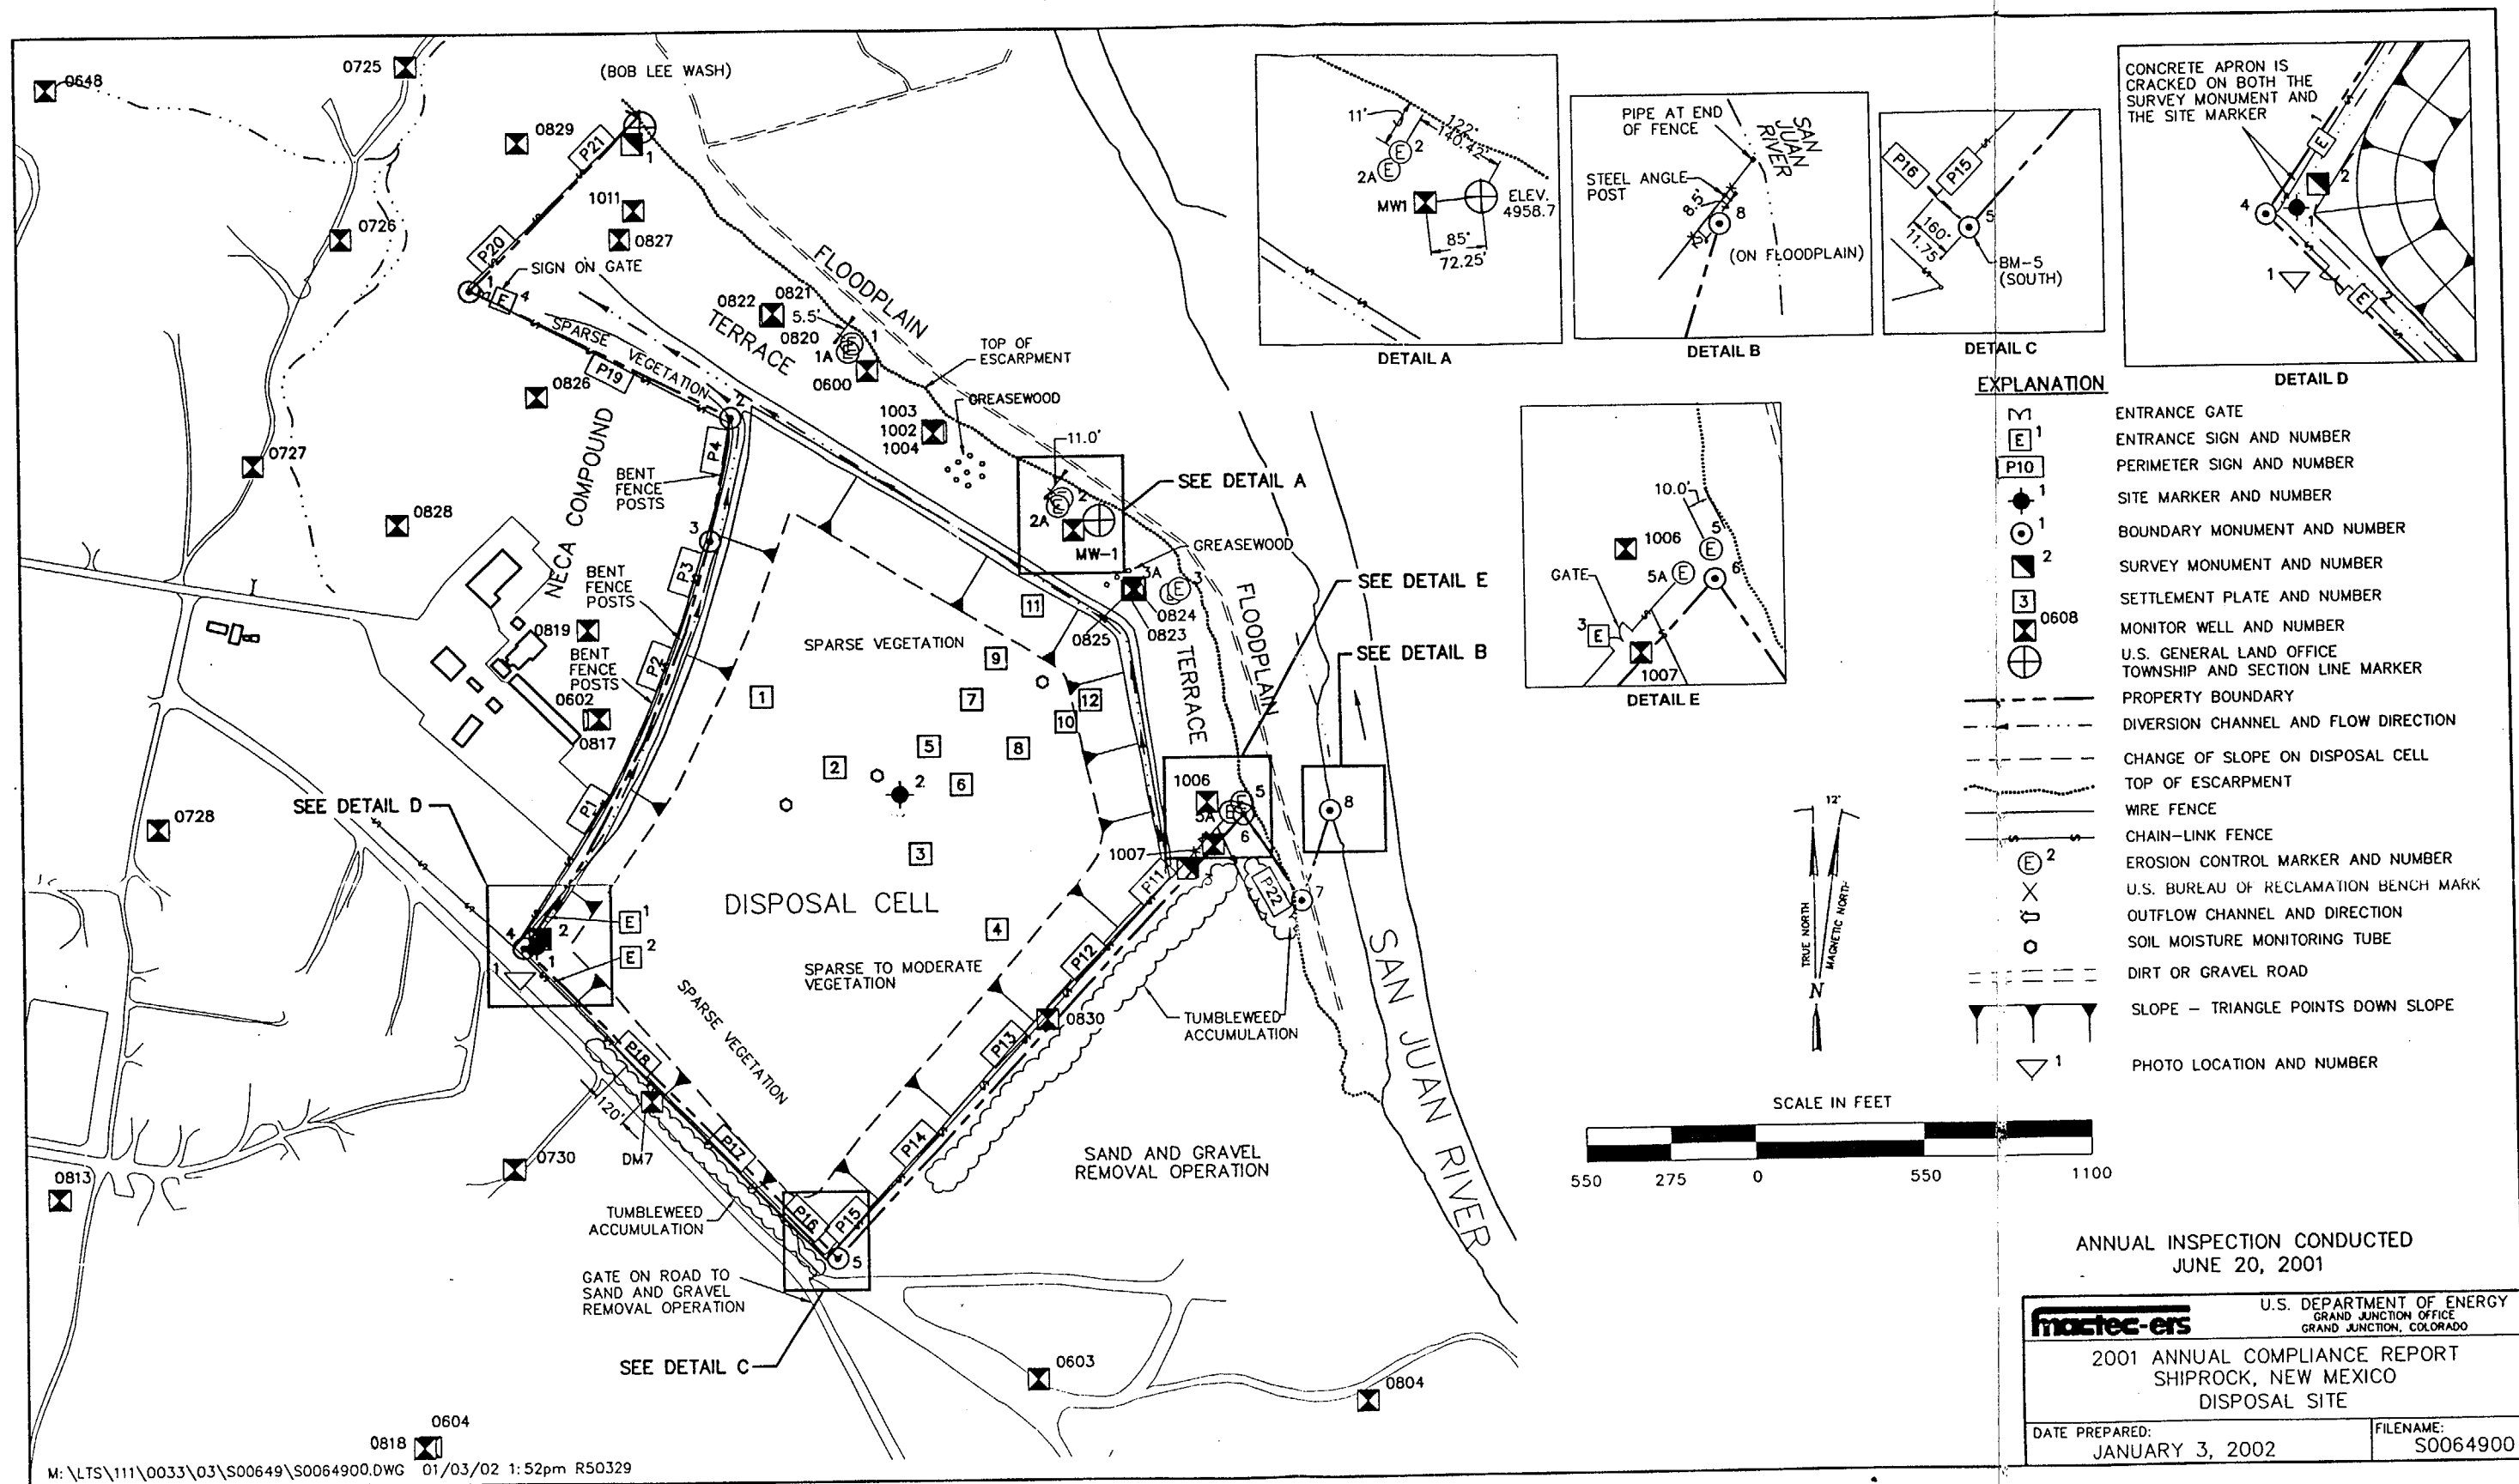
Figure 16-1. 2001 Compliance Drawing for the Shiprock, New Mexico, Disposal Site

16B Due to weed accumulations along the fence lines and the site perimeter, not all boundary monuments could be located during the 2001 inspection. There is no evidence; however, that the monuments have been disturbed or damaged. DOE will verify the locations of all boundary monuments during the 2002 site inspection. All three survey monuments were in good condition.

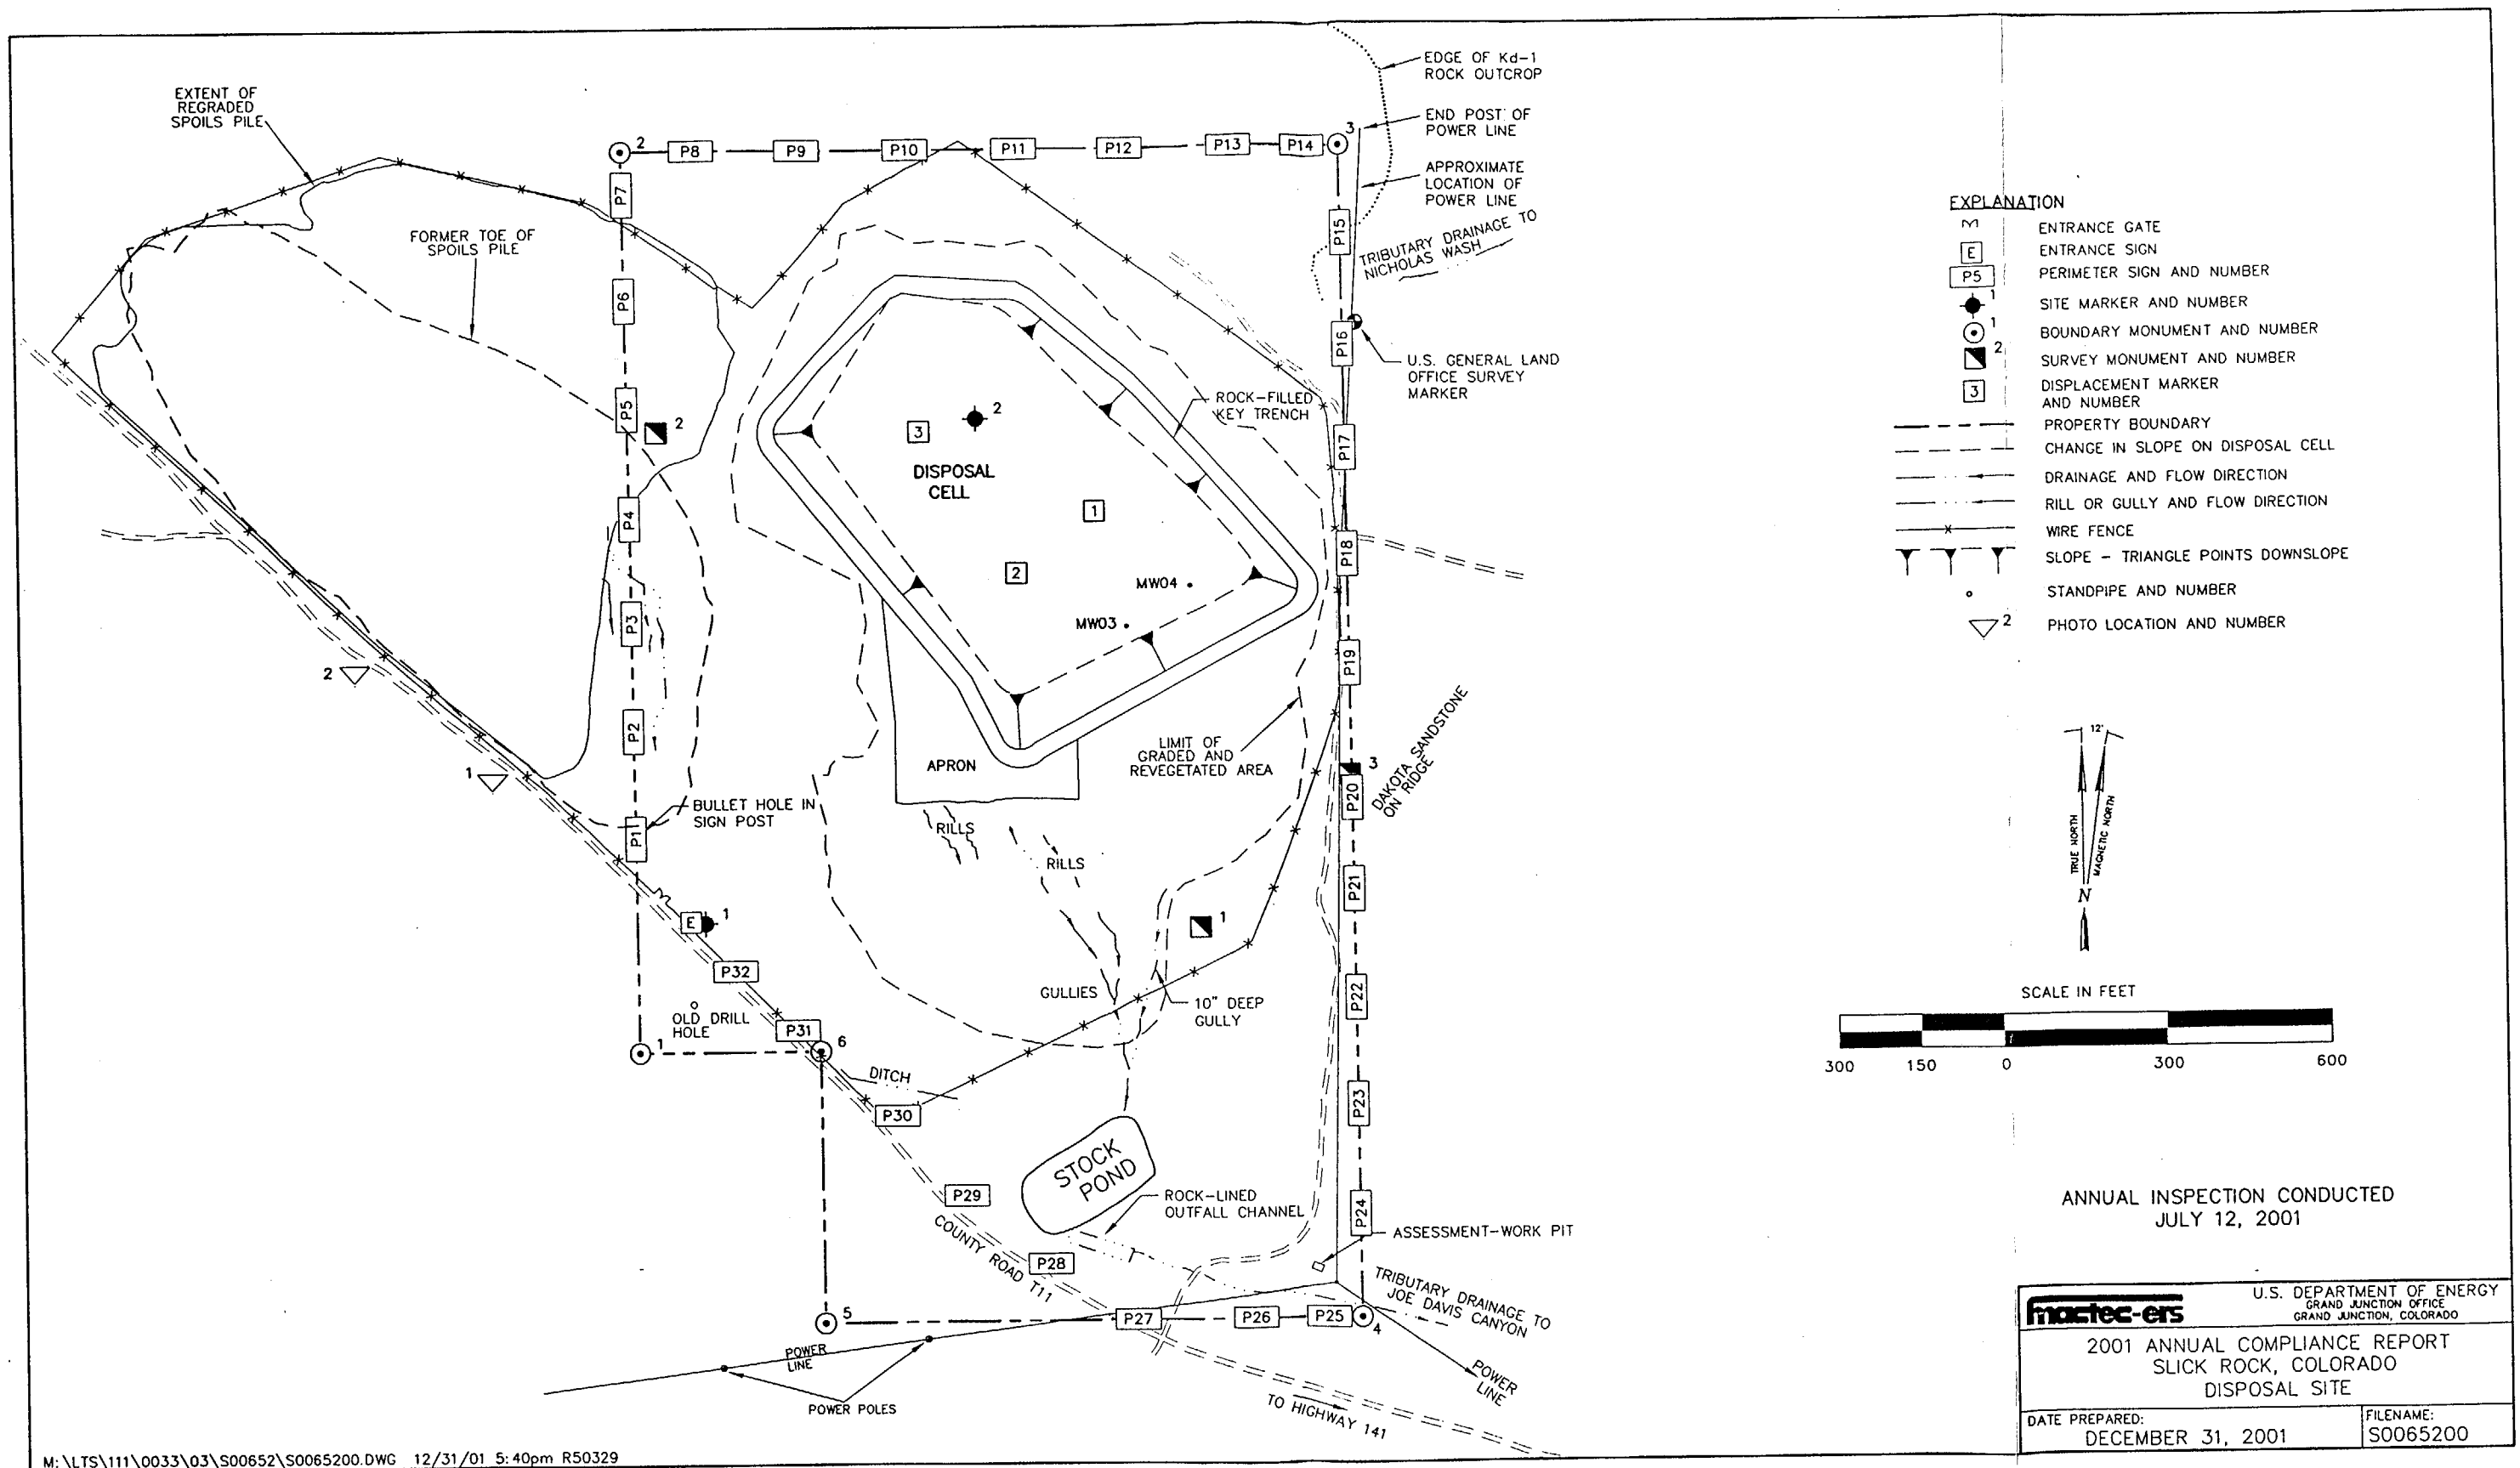
Figure 17-1. 2001 Compliance Drawing for the Slick Rock, Colorado, Disposal Site

The disposal cell, side slopes, key trench, and apron are armored with rounded cobble- and pebble-sized rock. The rock is in excellent condition. No evidence of settling, slumping, or erosion was observed on any of the rock-covered surfaces of the disposal cell.

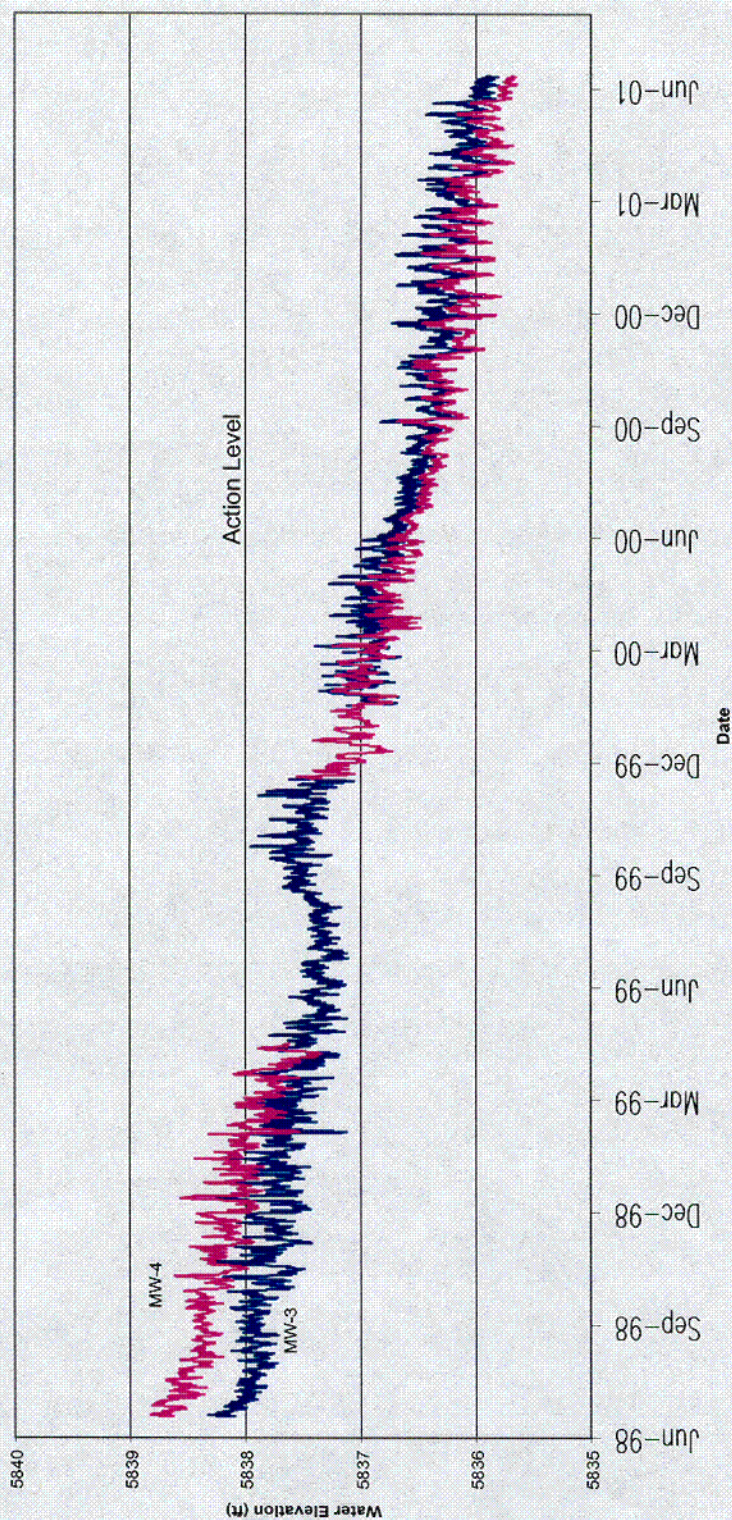
Figure 17-2. Water Levels at MW-03 and MW-04 at the Slick Rock, Colorado, Disposal Cell

Data from data loggers installed in both standpipes are downloaded quarterly. Water-level measurements began in June 1998 (Figure 17-2). At that time, water levels were less than 1 foot above the 5,838-foot datum. Since then, water levels have dropped below the 5,838-foot datum and are continuing to drop. Most recently, in July 2001, water levels in both standpipes were measured at elevations between 5,835.7 and 5,835.9 ft. (Noise or oscillations in the Figure 17-2 hydrograph result from variations in atmospheric pressure. Breaks in the hydrograph are due to malfunctioning data loggers. New equipment was installed after each failure.)

DOE's obligation, as stated in the Long-Term Surveillance Plan, is to monitor water levels until water levels in both standpipes are continuously at or below the 5,838-foot datum for three consecutive quarters. The hydrograph in Figure 17-2 clearly shows water levels in both standpipes have been below the 5,838-foot datum since April 1999. Therefore, the monitoring requirement is fulfilled, and the project is considered closed out. DOE will decommission the standpipes upon concurrence of the U.S. Nuclear Regulatory Commission.
