Subject: 2001 Annual Site Inspection and Monitoring Compliance Report for UMTRCA
Title I Disposal Sites

2001 Annual Site Inspection and Monitoring Report for Uranium Mill Tailings Radiation Control Act Title I Disposal Sites

January 2002

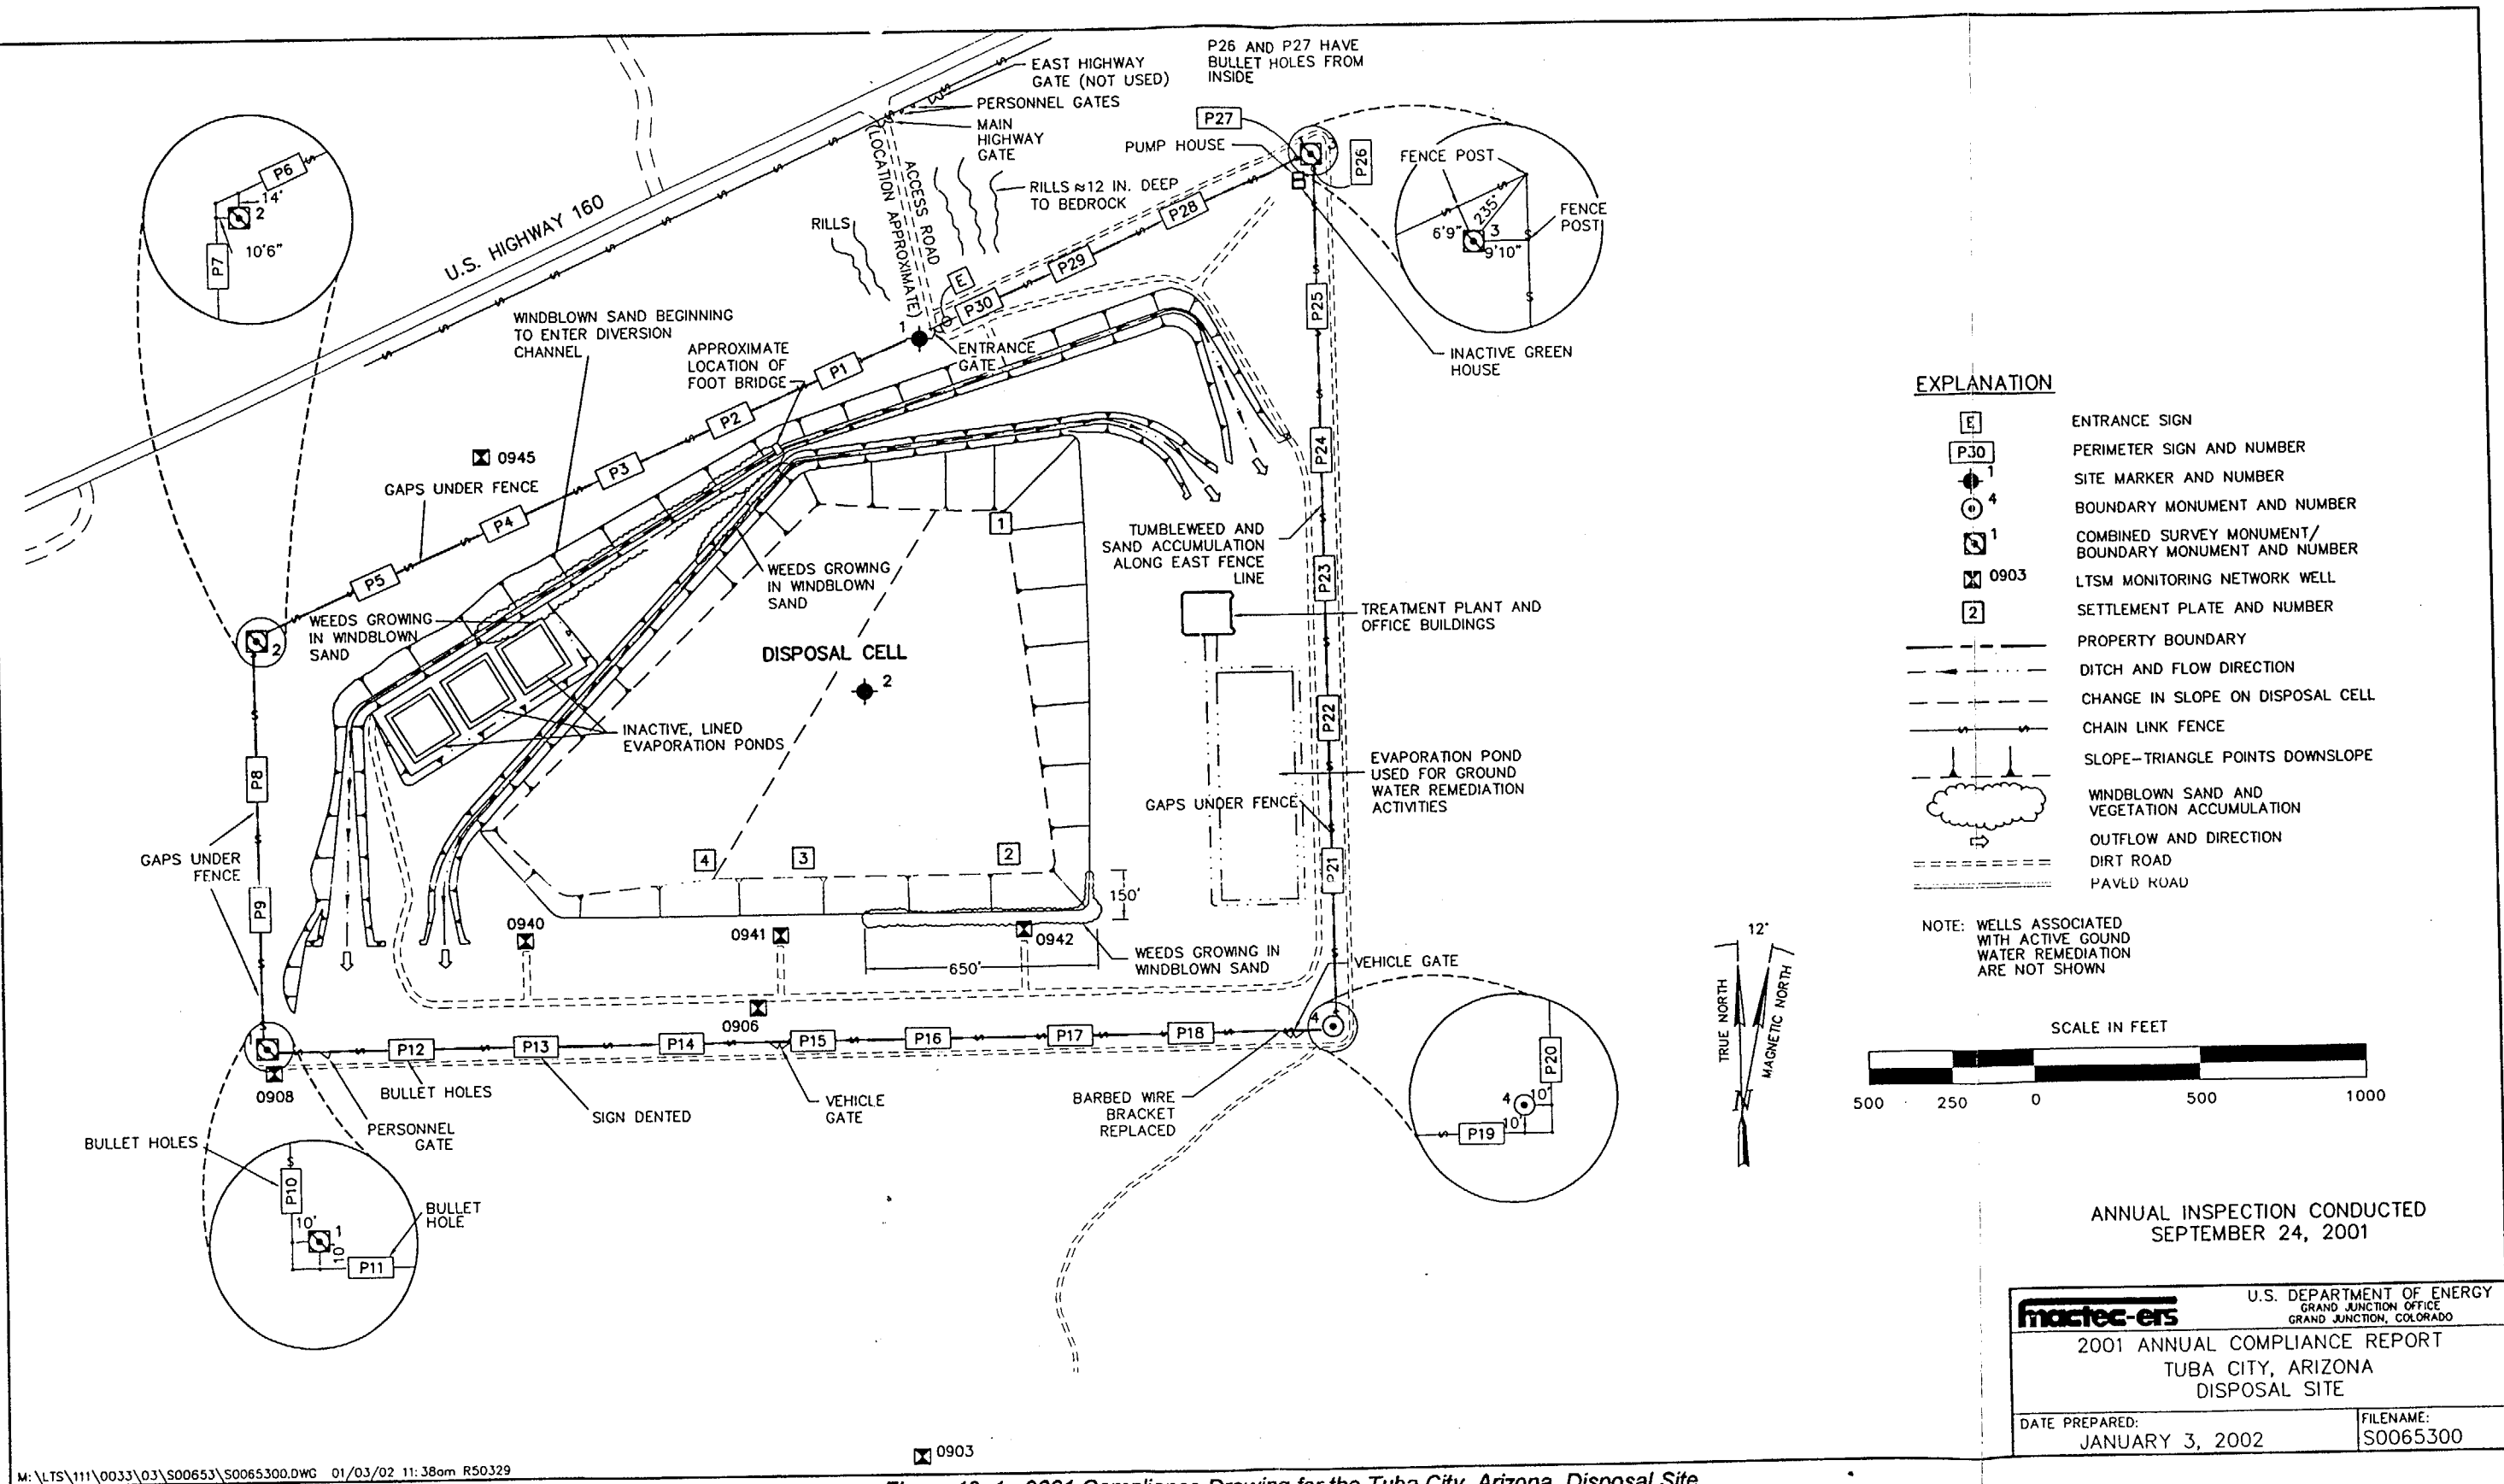
Figure 19-1. 2001 Compliance Drawing for the Tuba City, Arizona, Disposal Site

- 19C Scattered patches of kochia, Russian thistle, and other annual weeds persist on the top and south side slope of the disposal cell. Smaller and fewer patches of these weeds also remain on the west and north side slopes. The number of plants is slowly increasing, encouraged perhaps by deposition of windblown sand and soil. Inspectors continue to monitor changes in plant cover with photographs, which are taken from selected vantage points on an annual basis.

Although annual accumulation is small, sand continues to accumulate on the south rock apron, where it fills interstices in the riprap. This has encouraged establishment of shrubs and perennial grasses in the rock apron. Neither the sand nor the plants appear to compromise the erosion protection. However, the Long-Term Performance Project is evaluating the long-term effect of these plants, particularly the deep-rooted plants, on the disposal cell and the rock apron.
