EA No. 00-179

SUBJECT: NRC SPECIAL INSPECTION REPORT 05000247/2000-010
STEAM GENERATOR TUBE FAILURE

Docket No. 05000247
License No. DPR-26

IR 05000247-00-010, March 7 thru July 20, 2000; Consolidated Edison of New York, Inc.; Indian Point Unit 2; Special Team Inspection reviewing the causes for the February 15, 2000, steam generator tube failure, in accordance with NRC Inspection Procedure 93812. Findings in steam generator eddy current test examination program corrective actions and technique qualification.

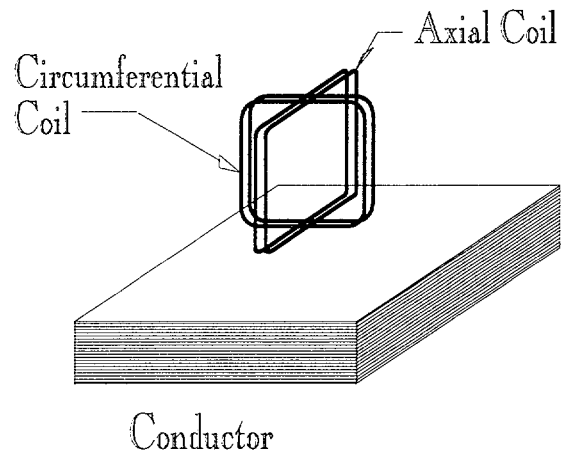
Figure 2 Directional pancake probe

Single coil probes as shown in Figure 2 will induce the eddy current in only one direction, which is a compressed mirror image of the current in the coils. If the defect is not in the direction which interrupts the eddy current flow (parallel to the defect direction rather than perpendicular to the current flow), then that particular coil will not detect the defect. Specially designed ECT probes can classify defects as axial cracks, circumferential cracks or both.

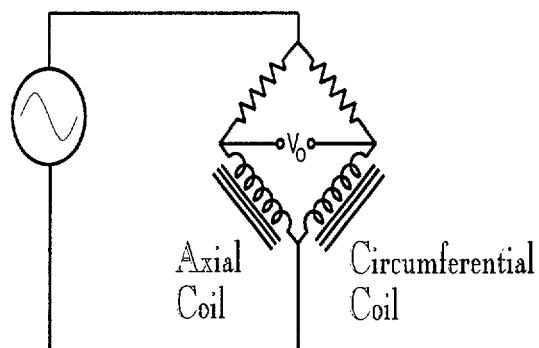
Figure 3 Plus Point probe

The Plus Point probe consists of two coils wound at 90 degrees to each other, as shown in Figure 3. The coils are mounted on a shoe that rotates as it passes through the tube to allow a complete examination. The turns of the two coils are interleaved so that both are effectively the same distance from the surface of the conductor. The coils are connected in a bridge circuit, as shown in Figure 4, and the voltage difference between the two signals is amplified. The two coils allow the scanning for both axial and circumferential defects. The mid-range Plus Point probe used during the 1997 examination is a multifrequency probe, operating at 10, 100, 300, and 400 kHz.
