VIRGINIA ELECTRIC AND POWER COMPANY
NORTH ANNA POWER STATION UNIT 2
SUPPLEMENTAL INFORMATION - NRC BULLETIN 2001-01 CIRCUMFERENTIAL
CRACKING OF REACTOR VESSEL HEAD PENETRATION NOZZLES
RESULTS OF METALLURGICAL INVESTIGATION OF ALLOY 82/182 CRACKING

Metallurgical Investigation of Cracking of the Alloy 82/182 J-Groove Weld of the Reactor Vessel Head Penetration Joint at North Anna Unit 2 Station

WCAP-15777

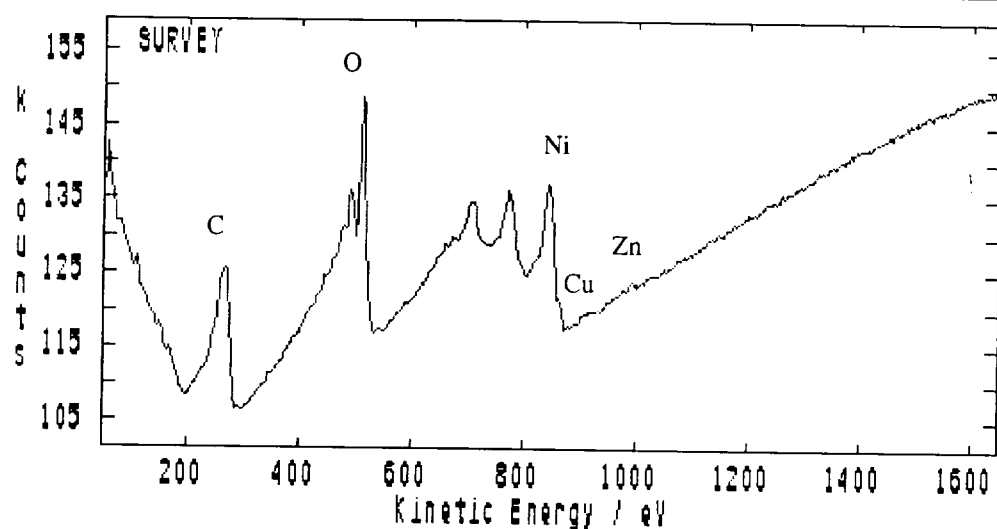
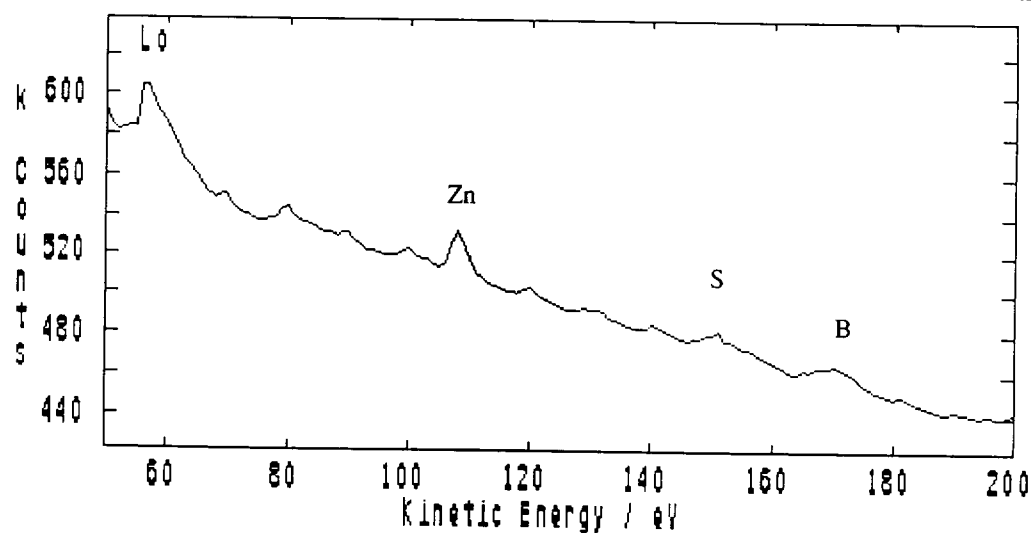
Figure 23 Summary of Auger Electron Spectroscopy (AES) results of the freshly opened fracture face. (Area 'C' in Figure 16)

000979.DAT Region 1 / 2 Level 1 / 1 Point 2 / 2 eV
 Regions : SURVEY Lo Counts
 27 mm from center of specimen, IG failure

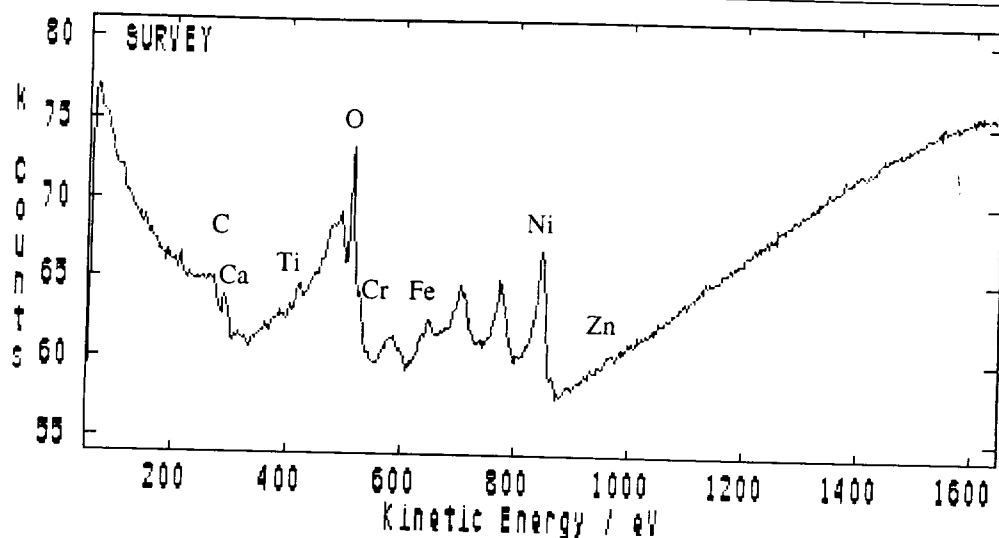
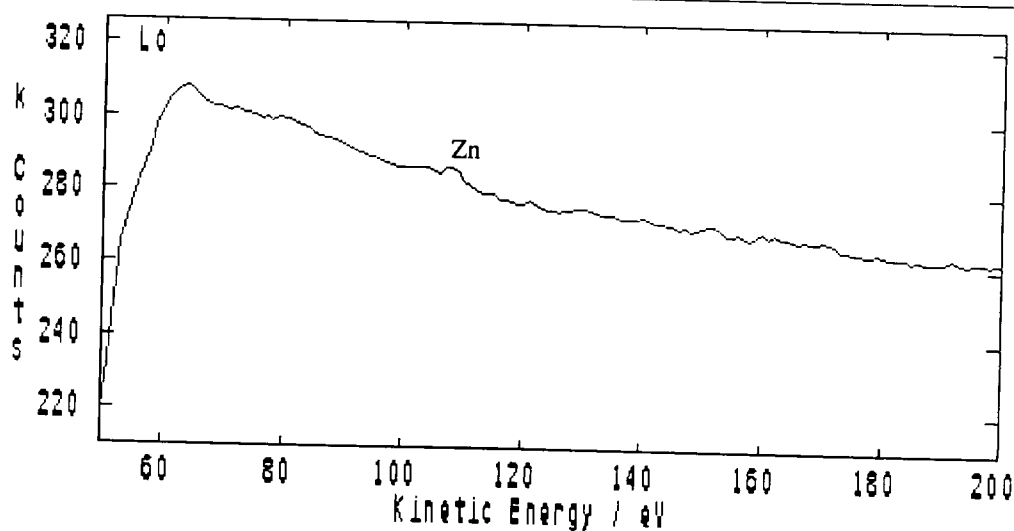
Figure 24 Auger Electron Spectrum (AES) of interdentritic fracture face near the dimpled fracture at ID. (Area 'C' in Figure 16)

000938.DAT Region 1 / 2 Level 1 / 1 Point 1 / 1 eV
 Regions : SURVEY Lo Counts
 edge of specimen 2 min etch
