Transmitted herewith are forty (40) copies of a report, WTR-49, which contains a description, analysis and conclusions concerning the partial destruction of a fuel element in the Westinghouse Testing Reactor on April 3, 1960.

**REPORT ON  
WTR FUEL ELEMENT  
FAILURE APRIL 3, 1960**  
JULY 7, 1960

**REPORT ON  
WTR FUEL ELEMENT  
FAILURE APRIL 3, 1960**

FUEL ELEMENT FAILURE  
IN THE  
WESTINGHOUSE TESTING REACTOR

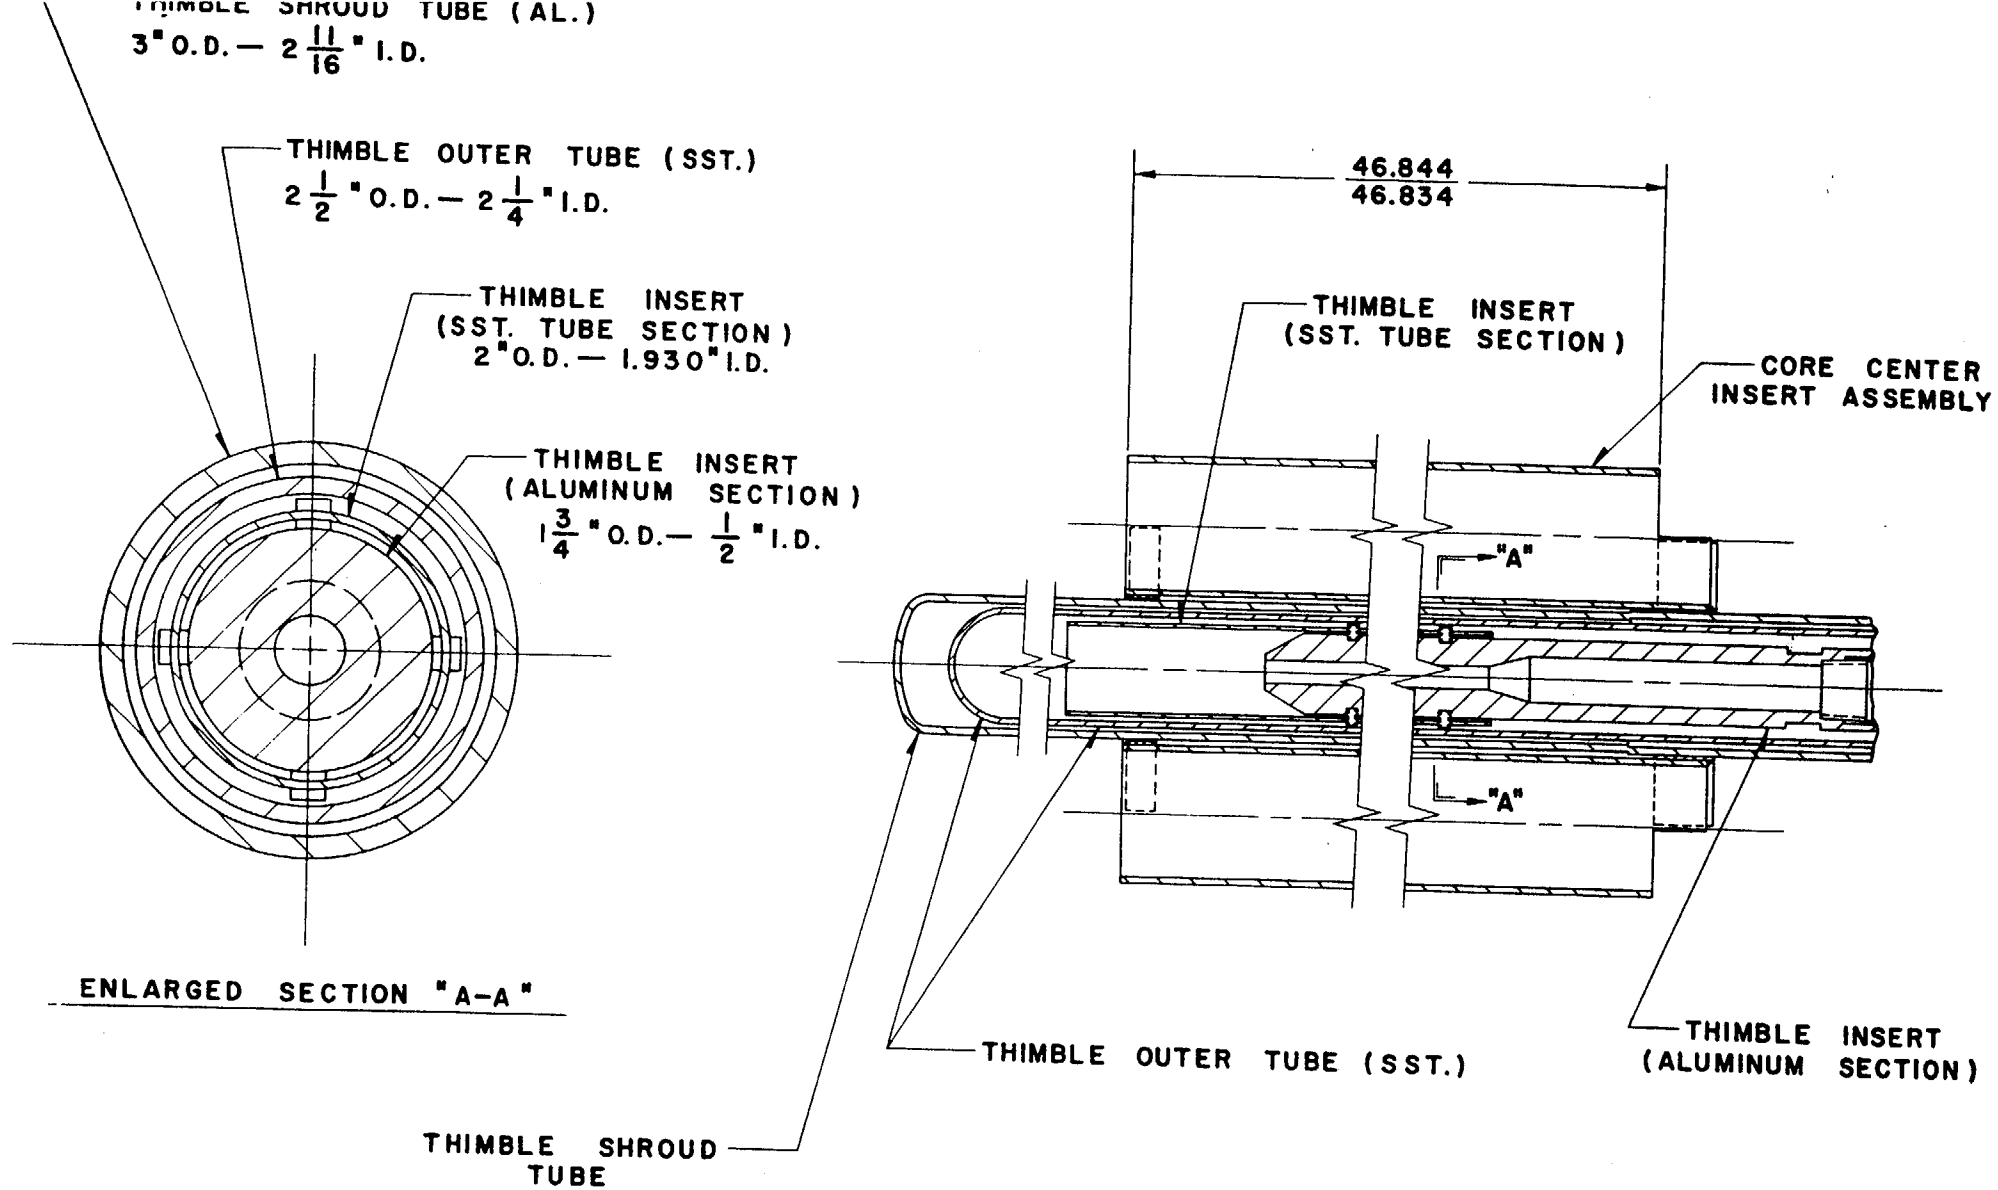
FIGURE 17  
CROSS SECTION VIEW OF  
CENTER TEST THIMBLE POSITION OF W.T.R.

1. The center thimble position was loaded as shown in Figure 17.
2. Five of the peripheral thimble positions were loaded as shown in Figure 18.
3. The remaining position (To-4-8) was occupied by a high pressure thimble containing control rod material coupons cooled with a boric acid solution.

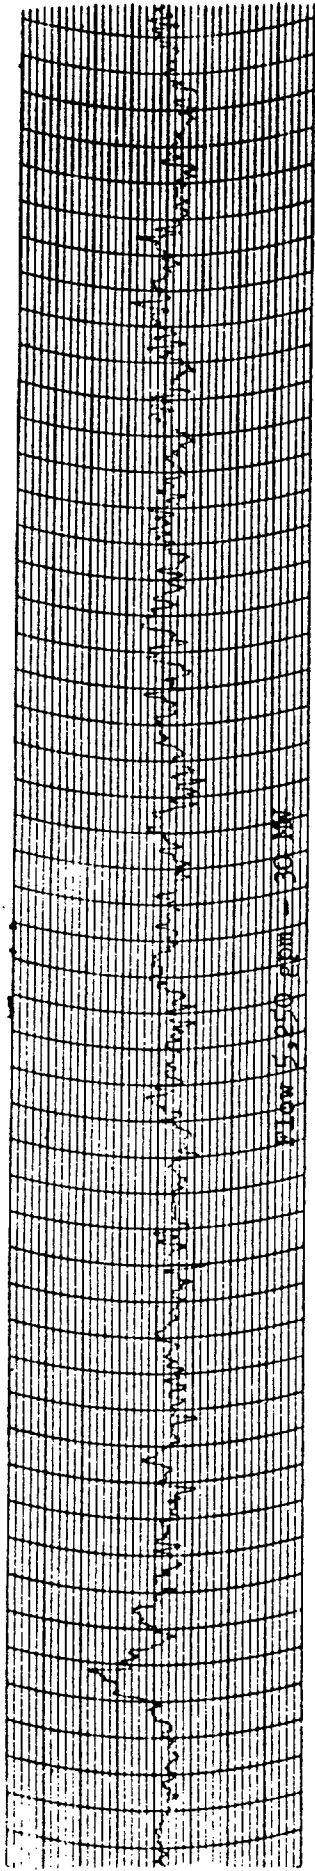
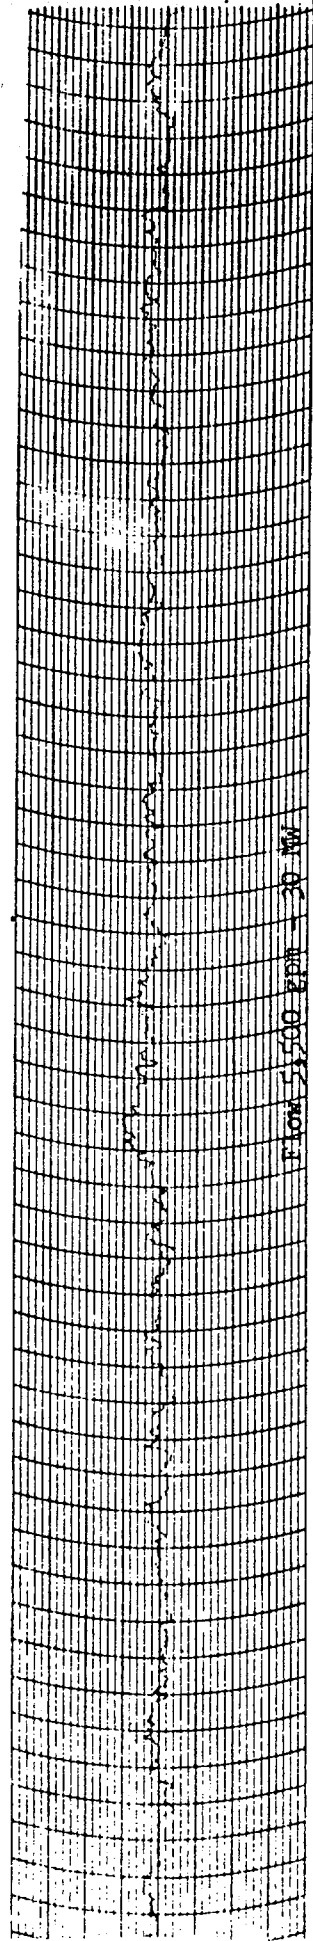
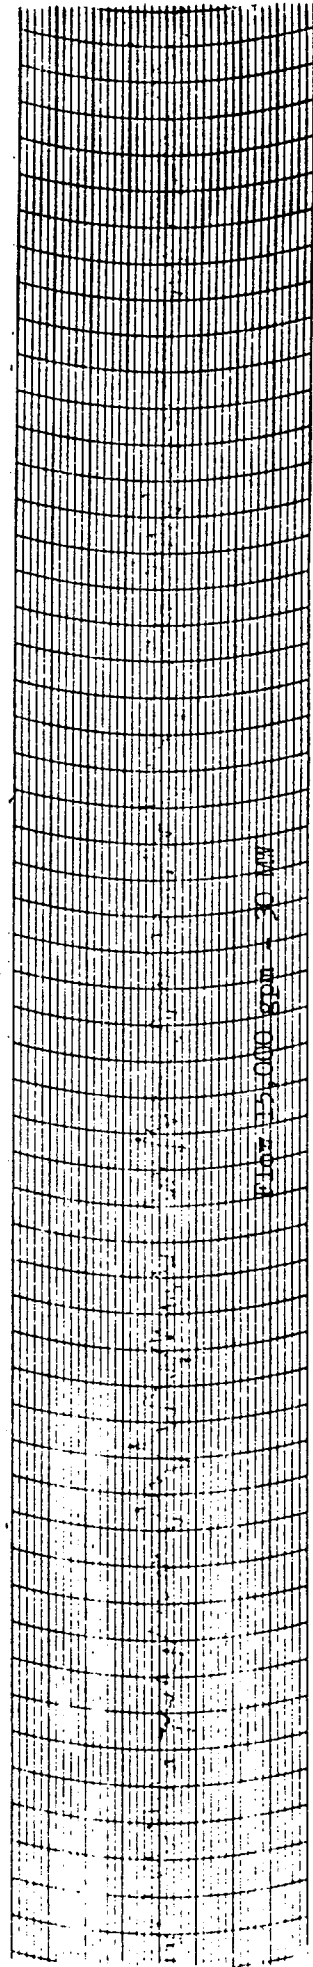
FIGURE 20

Figure 19 is a copy of the nuclear power recorder chart covering this and the following time interval. As can be observed from this chart, the reduction in flow was accompanied by a slight reduction in power caused by the temperature coefficient. This power dip was compensated for by the automatic control system. Prior and subsequent to the reduction in flow, the boiling detector record was observed and samples of these records are shown in Figure 20.

NUCLEAR NOISE LEVEL AT 30 MW DURING FLOW REDUCTION  
FROM 15,000 GPM TO 5,250 GPM

Using a flow velocity of 6.26 ft/sec. and a less conservative hot channel factor for film temperature rise of 3.45, boiling would be expected at 30 MW. There is some indication from the boiling detector that boiling did begin at 30 MW as the primary coolant flow was reduced from 5500 gpm to 5250 gpm. This effect can be seen from Figure 20.

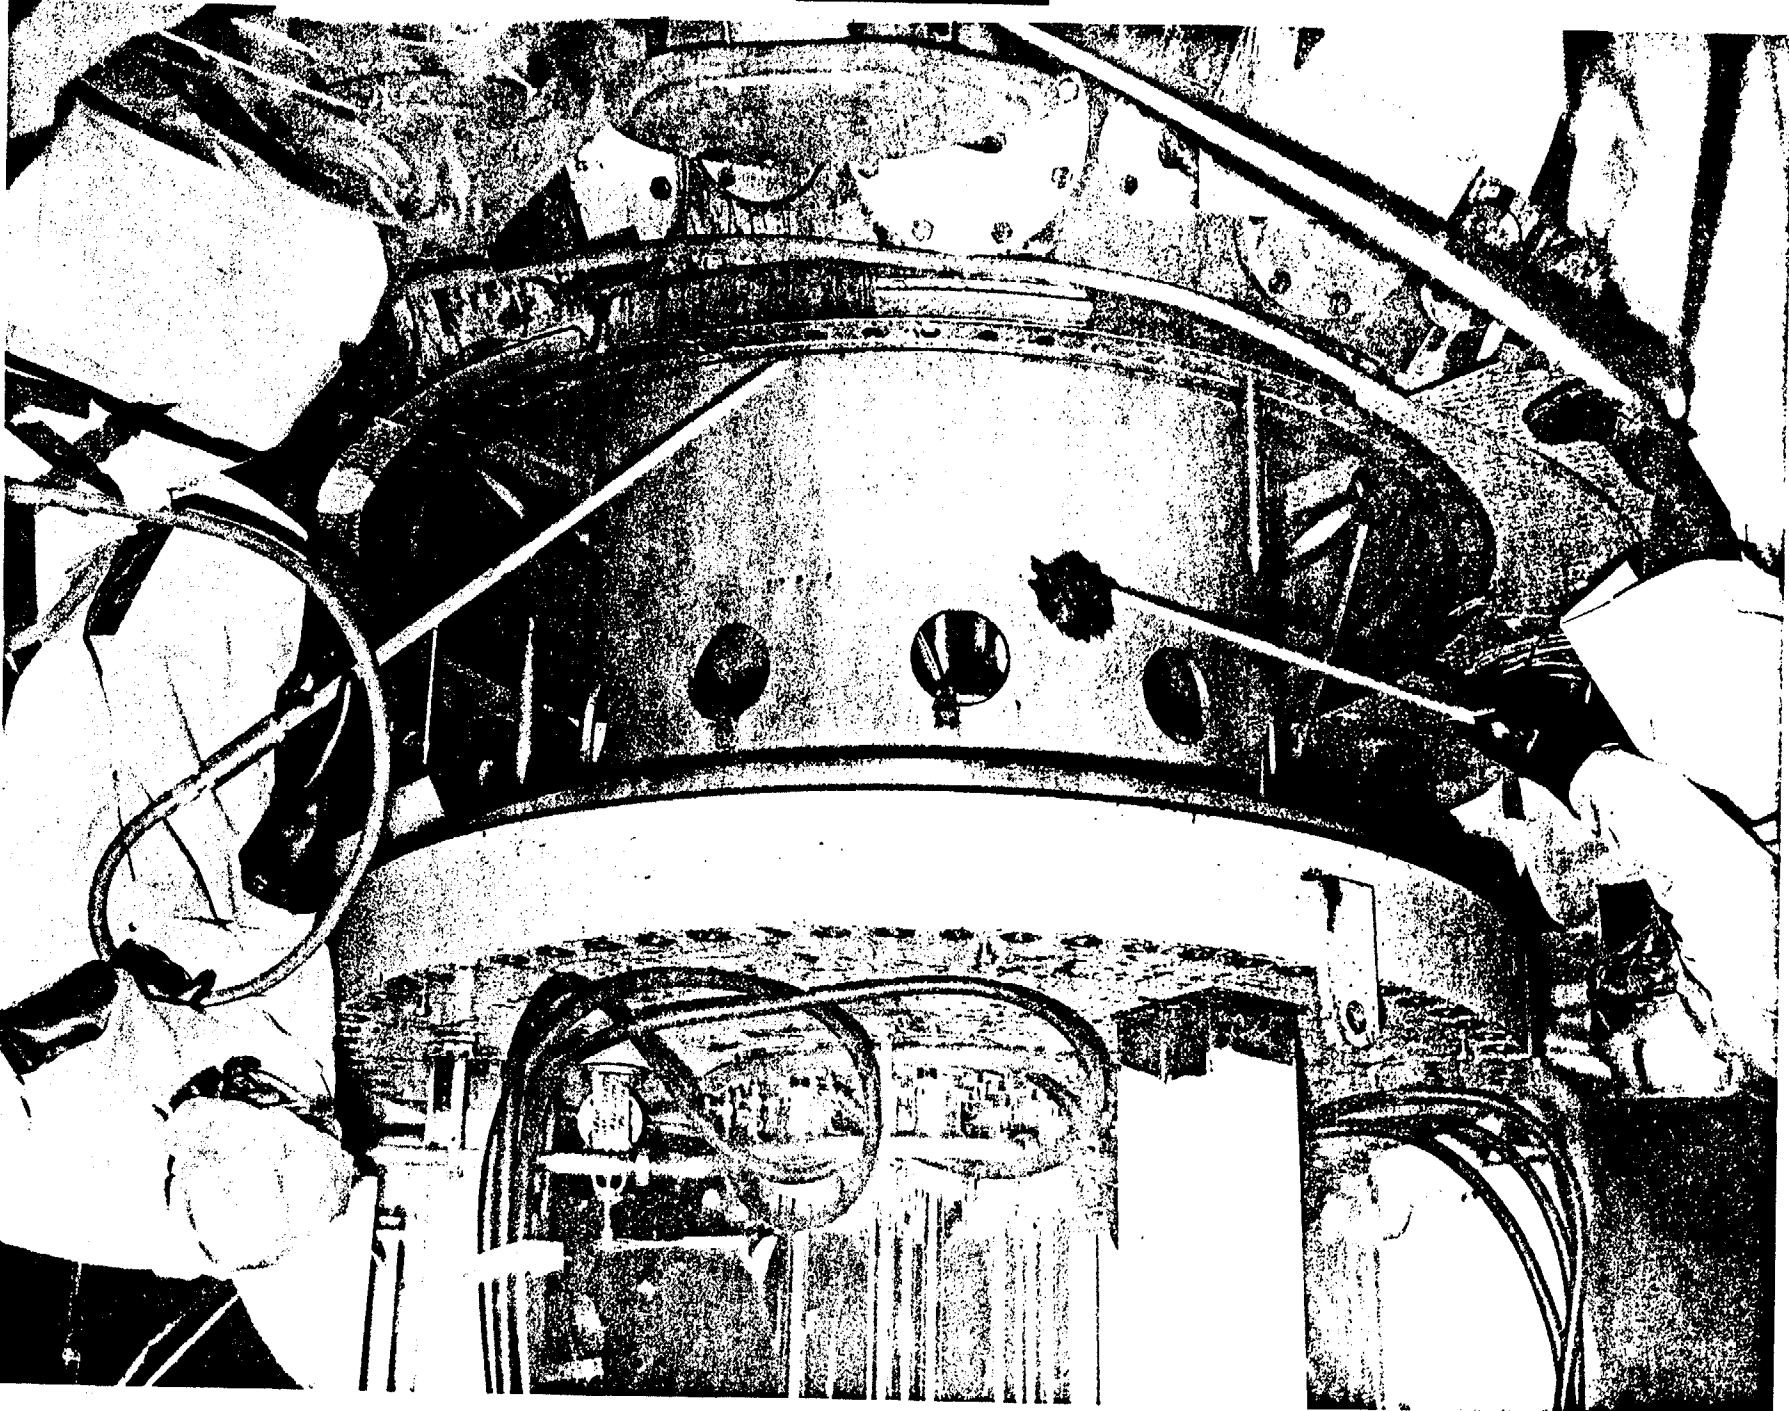
FIGURE 23  
HEAD REMOVAL AND DECONTAMINATION

brushes hooked up for continuous scrubbing during the raising of the head. On April 11 the head was removed and decontaminated on external surfaces as shown in Figure 23. General radiation level in the vicinity of the reactor head was 1 rem/hr beta-gamma at one foot.

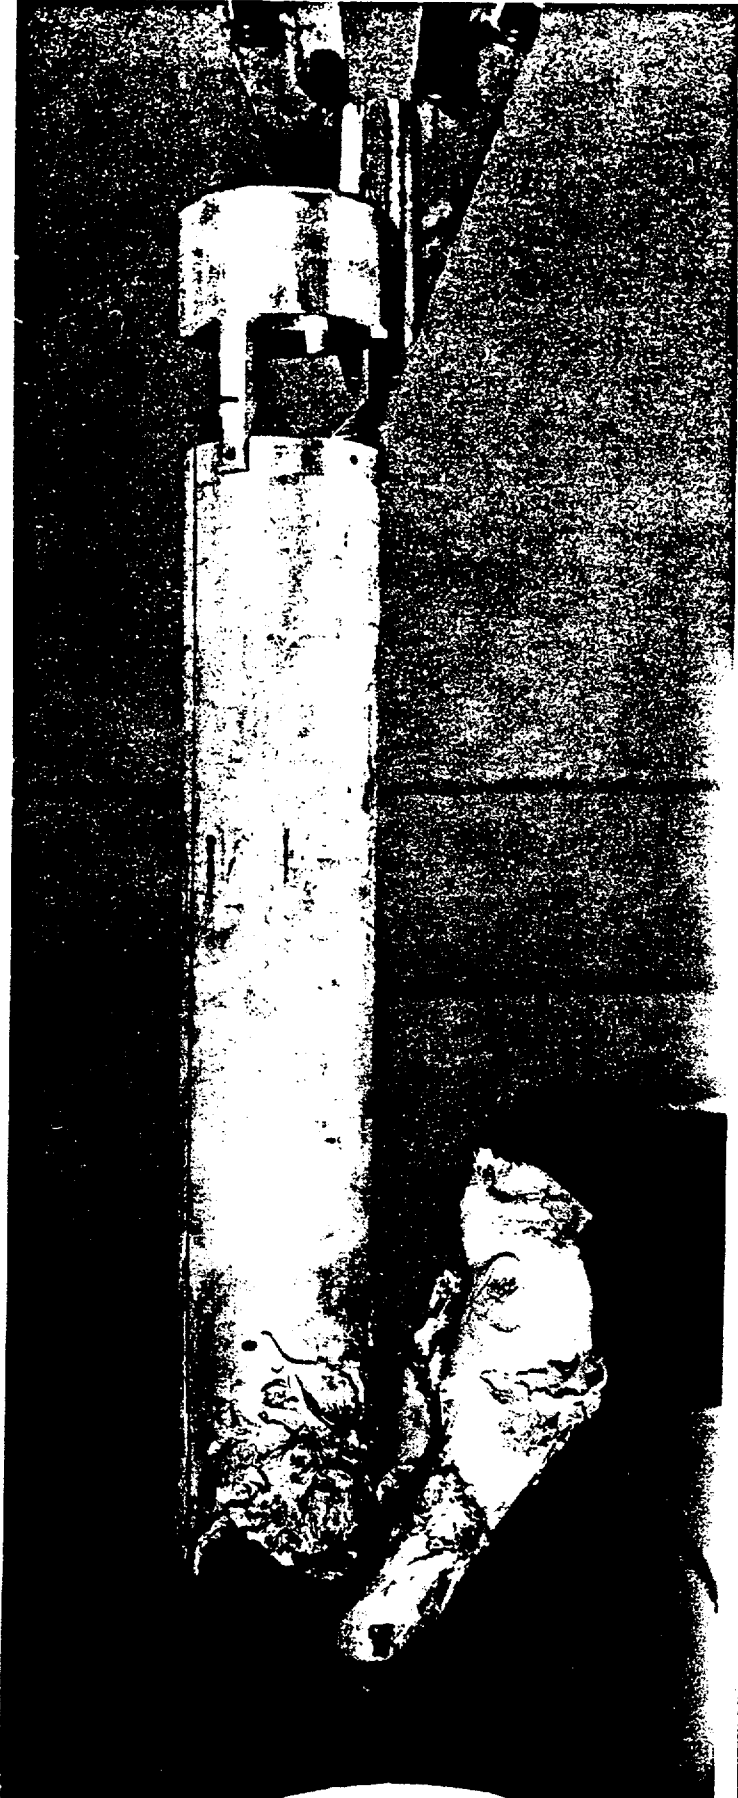
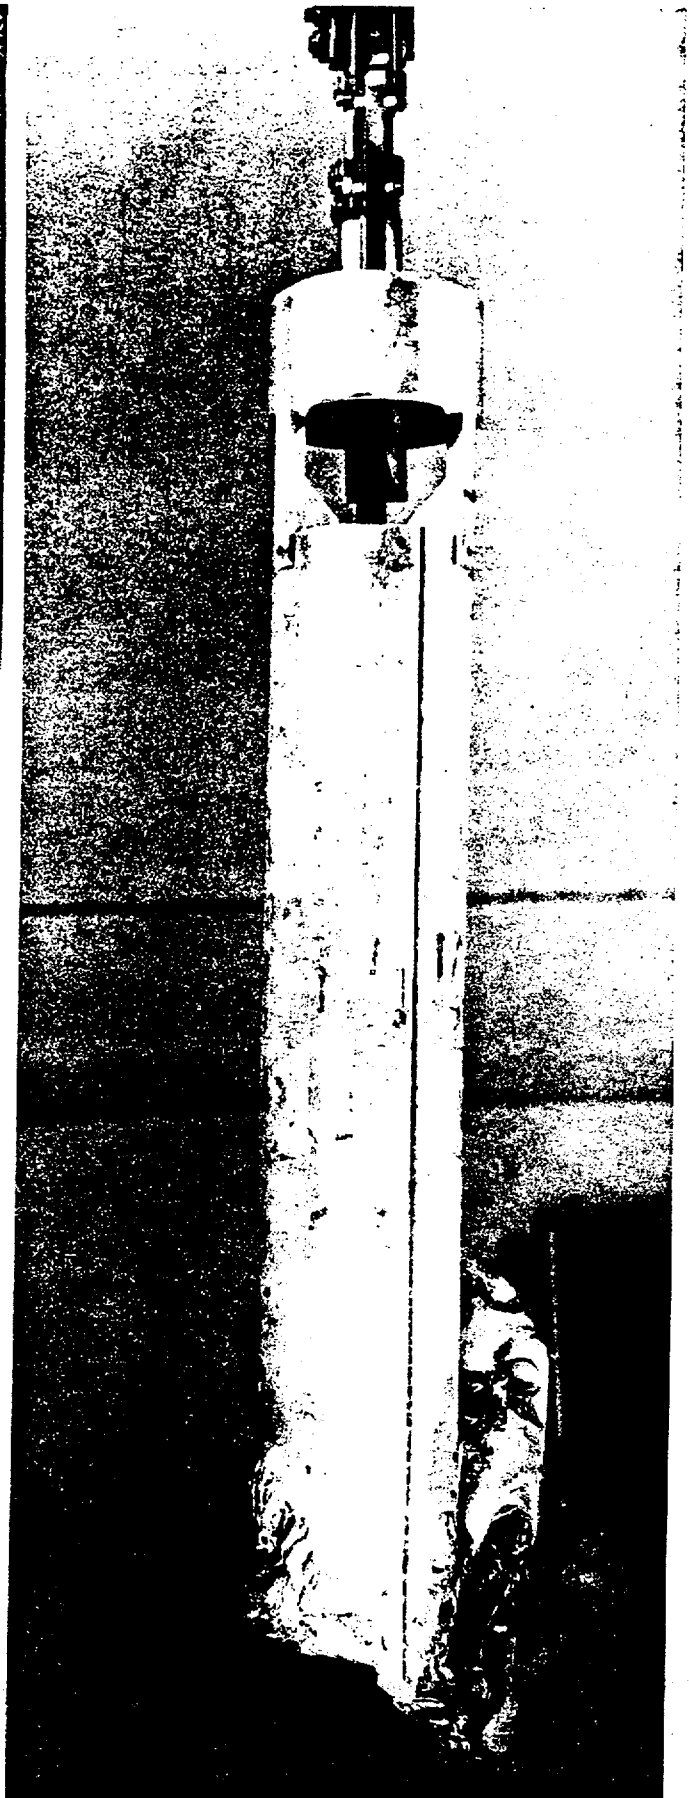
FIGURE 27

Both the upper and lower portion of the failed element were removed to the hot cells. Photographs were taken through the cell windows and through a stereomicroscope. Some of the photographs are shown in Figures 26 to 32. The appearance of the fragments is indicative of the violence and suddenness with which the melting took place. Some evidence of poor bonding between the aluminum cladding and the meat is suggested in many of the photographs, particularly in Figure 31.

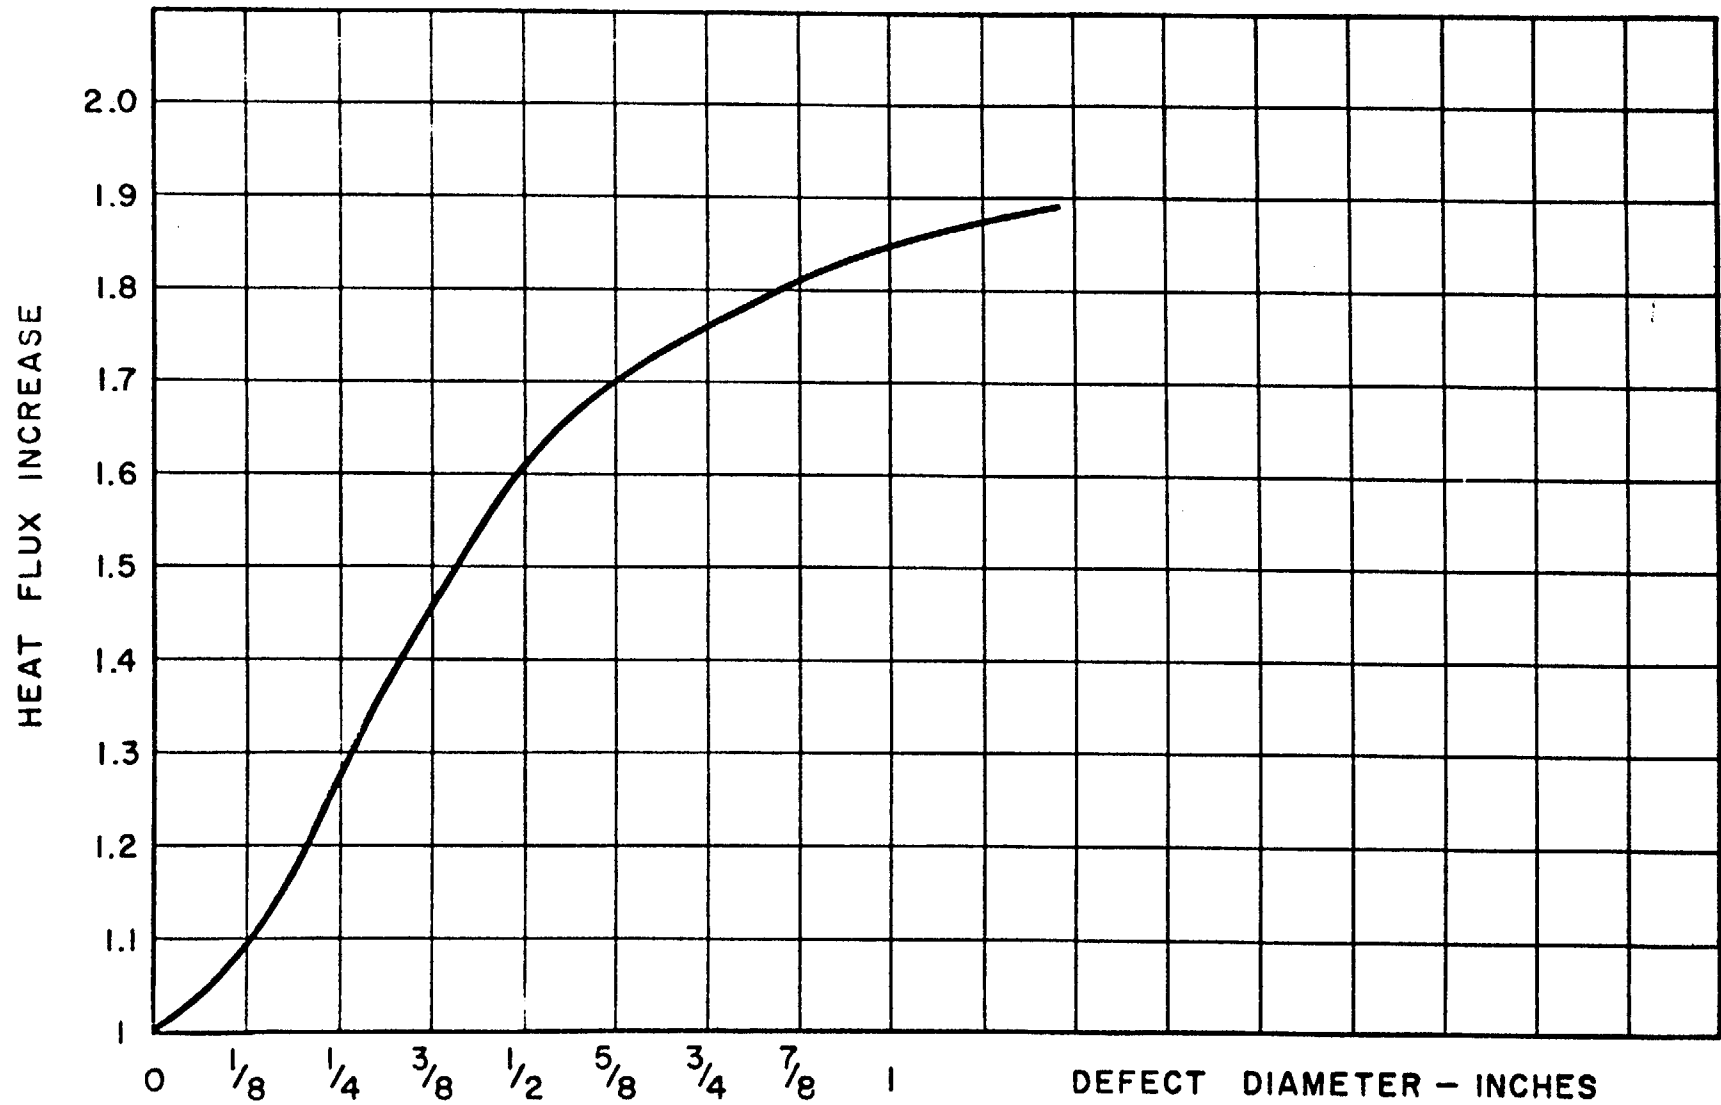
FIGURE 39

In an effort to determine what size defect might be acceptable, new heat transfer calculations were made by computing machine. The problem that was set up provided a temperature profile of an element section that contained thermal insulating voids of various sizes at the boundary of the meat and the cladding. The heat flux could then be obtained over any given surface area. The results of these calculations are shown in Figure 39 which indicates the relative increase in heat flux as a function of defect size. Illustratively, a 1/4-inch defect would create a hot spot increase of 28% and a 1/2-inch defect of 61%. It will be recognized that an infinite

DEFECT HOT CHANNEL FACTOR INCREASE  
AS A FUNCTION OF DEFECT SIZE

defect in bonding on one side will produce a 100% increase in heat flux through the other side. Thus, for practical purposes, a 1-inch diameter defect may be regarded as infinite. Specifications for future new fuel will call for no defects greater than approximately 1/8-inch as determined by ultrasonic methods and thus providing only an approximate 10% increase in heat flux.

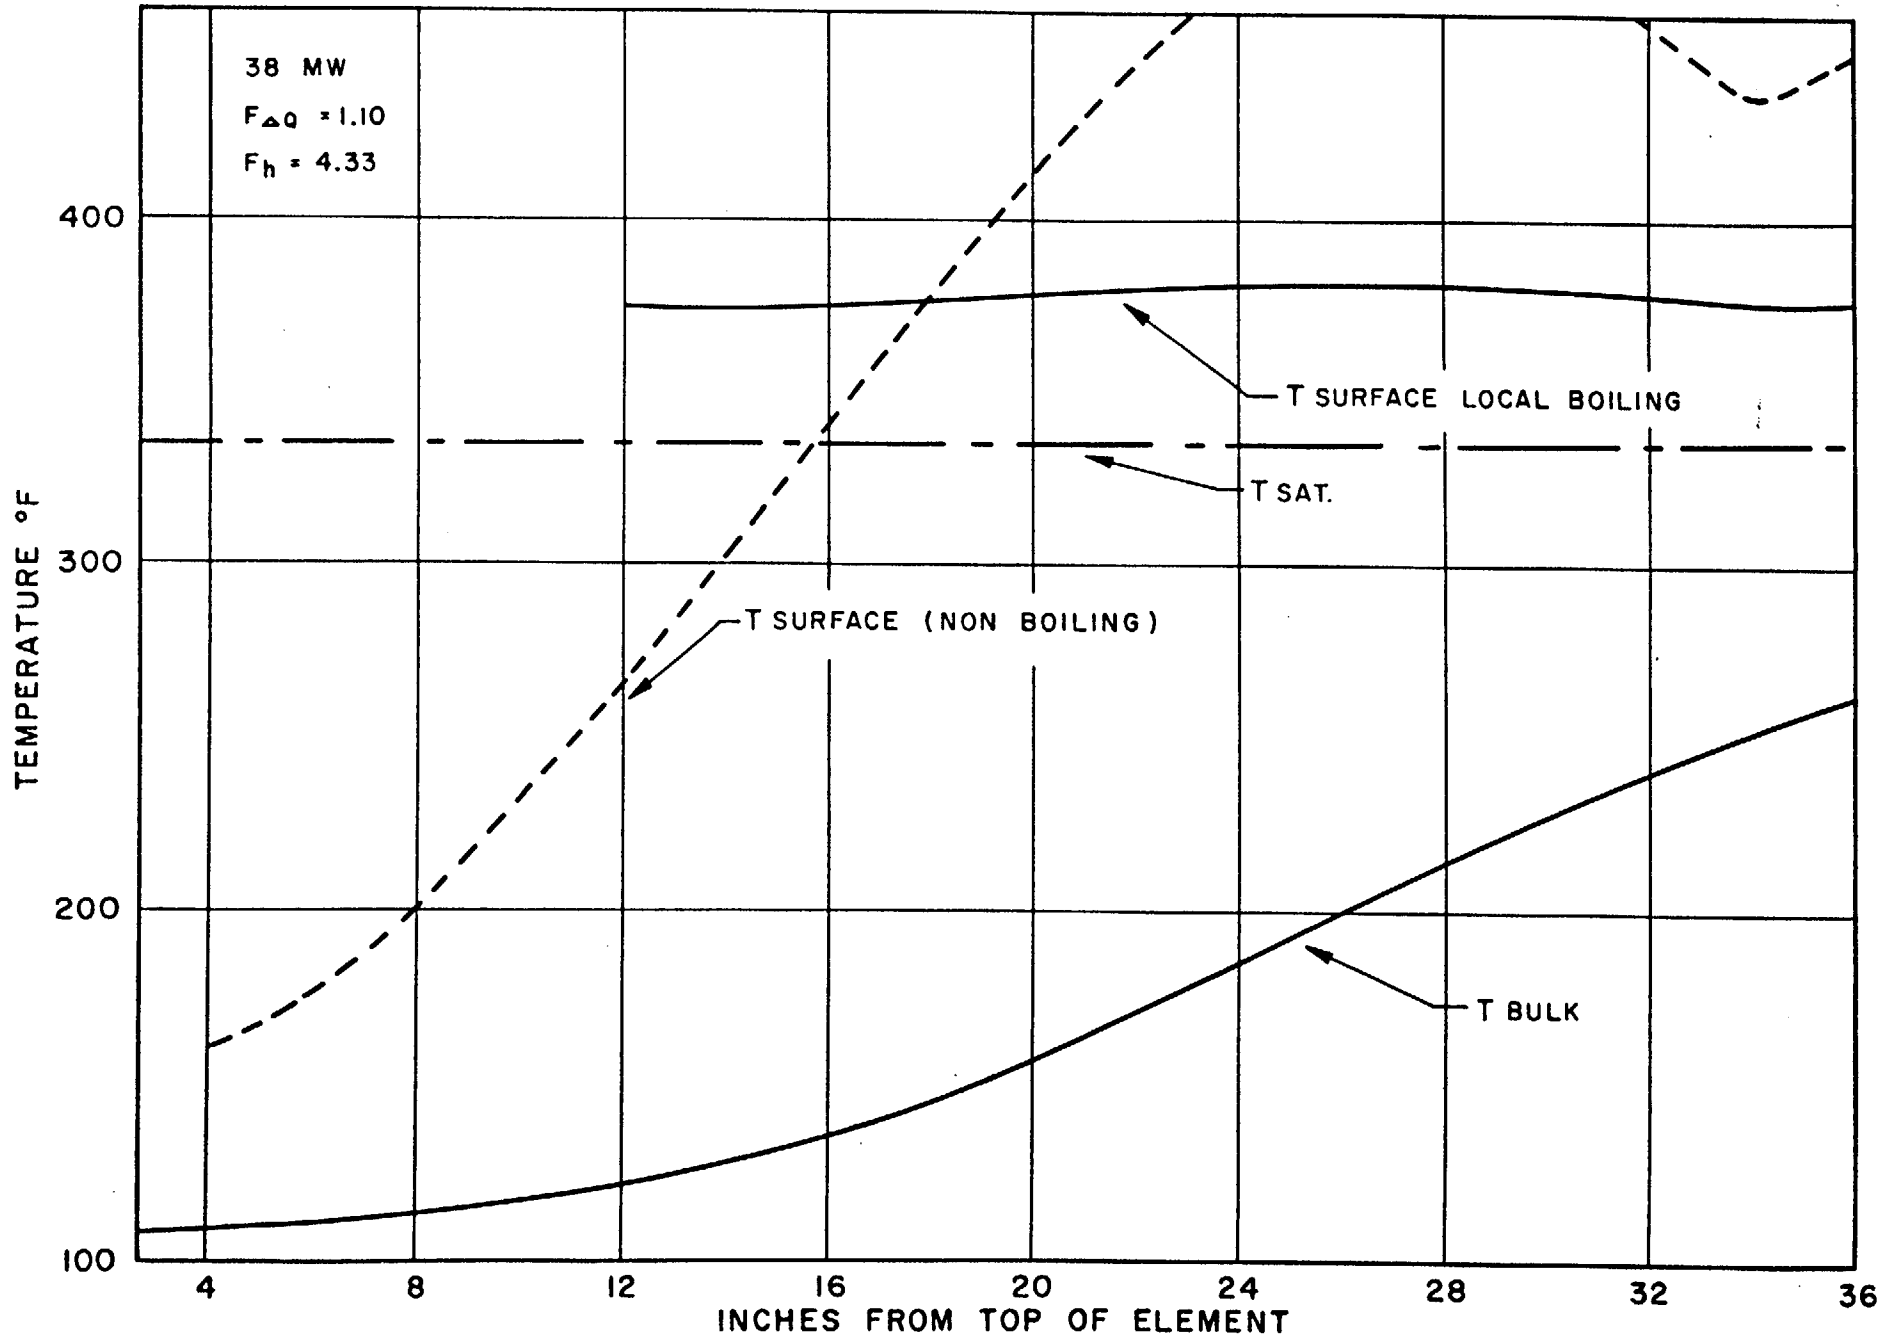
Figure 40 indicates the bulk coolant temperature and the fuel surface temperature for the hot channel of a fuel element in the core position of the failed fuel element. The initial cold critical axial flux distribution given in WTR-25 was used in deriving this curve. The bulk coolant temperature rise was taken as 1.10 times the bulk coolant temperature rise measured during the experiment. This number includes a power distribution factor across a fuel element of 1.04, a

FIGURE 40  
LOCAL BOILING ZONE  
COOLANT VELOCITY 6.2 fps

fuel content tolerance per fuel plate of 1.01 and a channel to channel coolant velocity variation of 1.05. These factors are those considered in WTR-25. A hot channel factor  $F_{\phi}$  of 4.33 was applied to the average heat flux of 191,000 BTU/hr-ft.<sup>2</sup> to obtain the film temperature rise at the axial maximum heat flux.

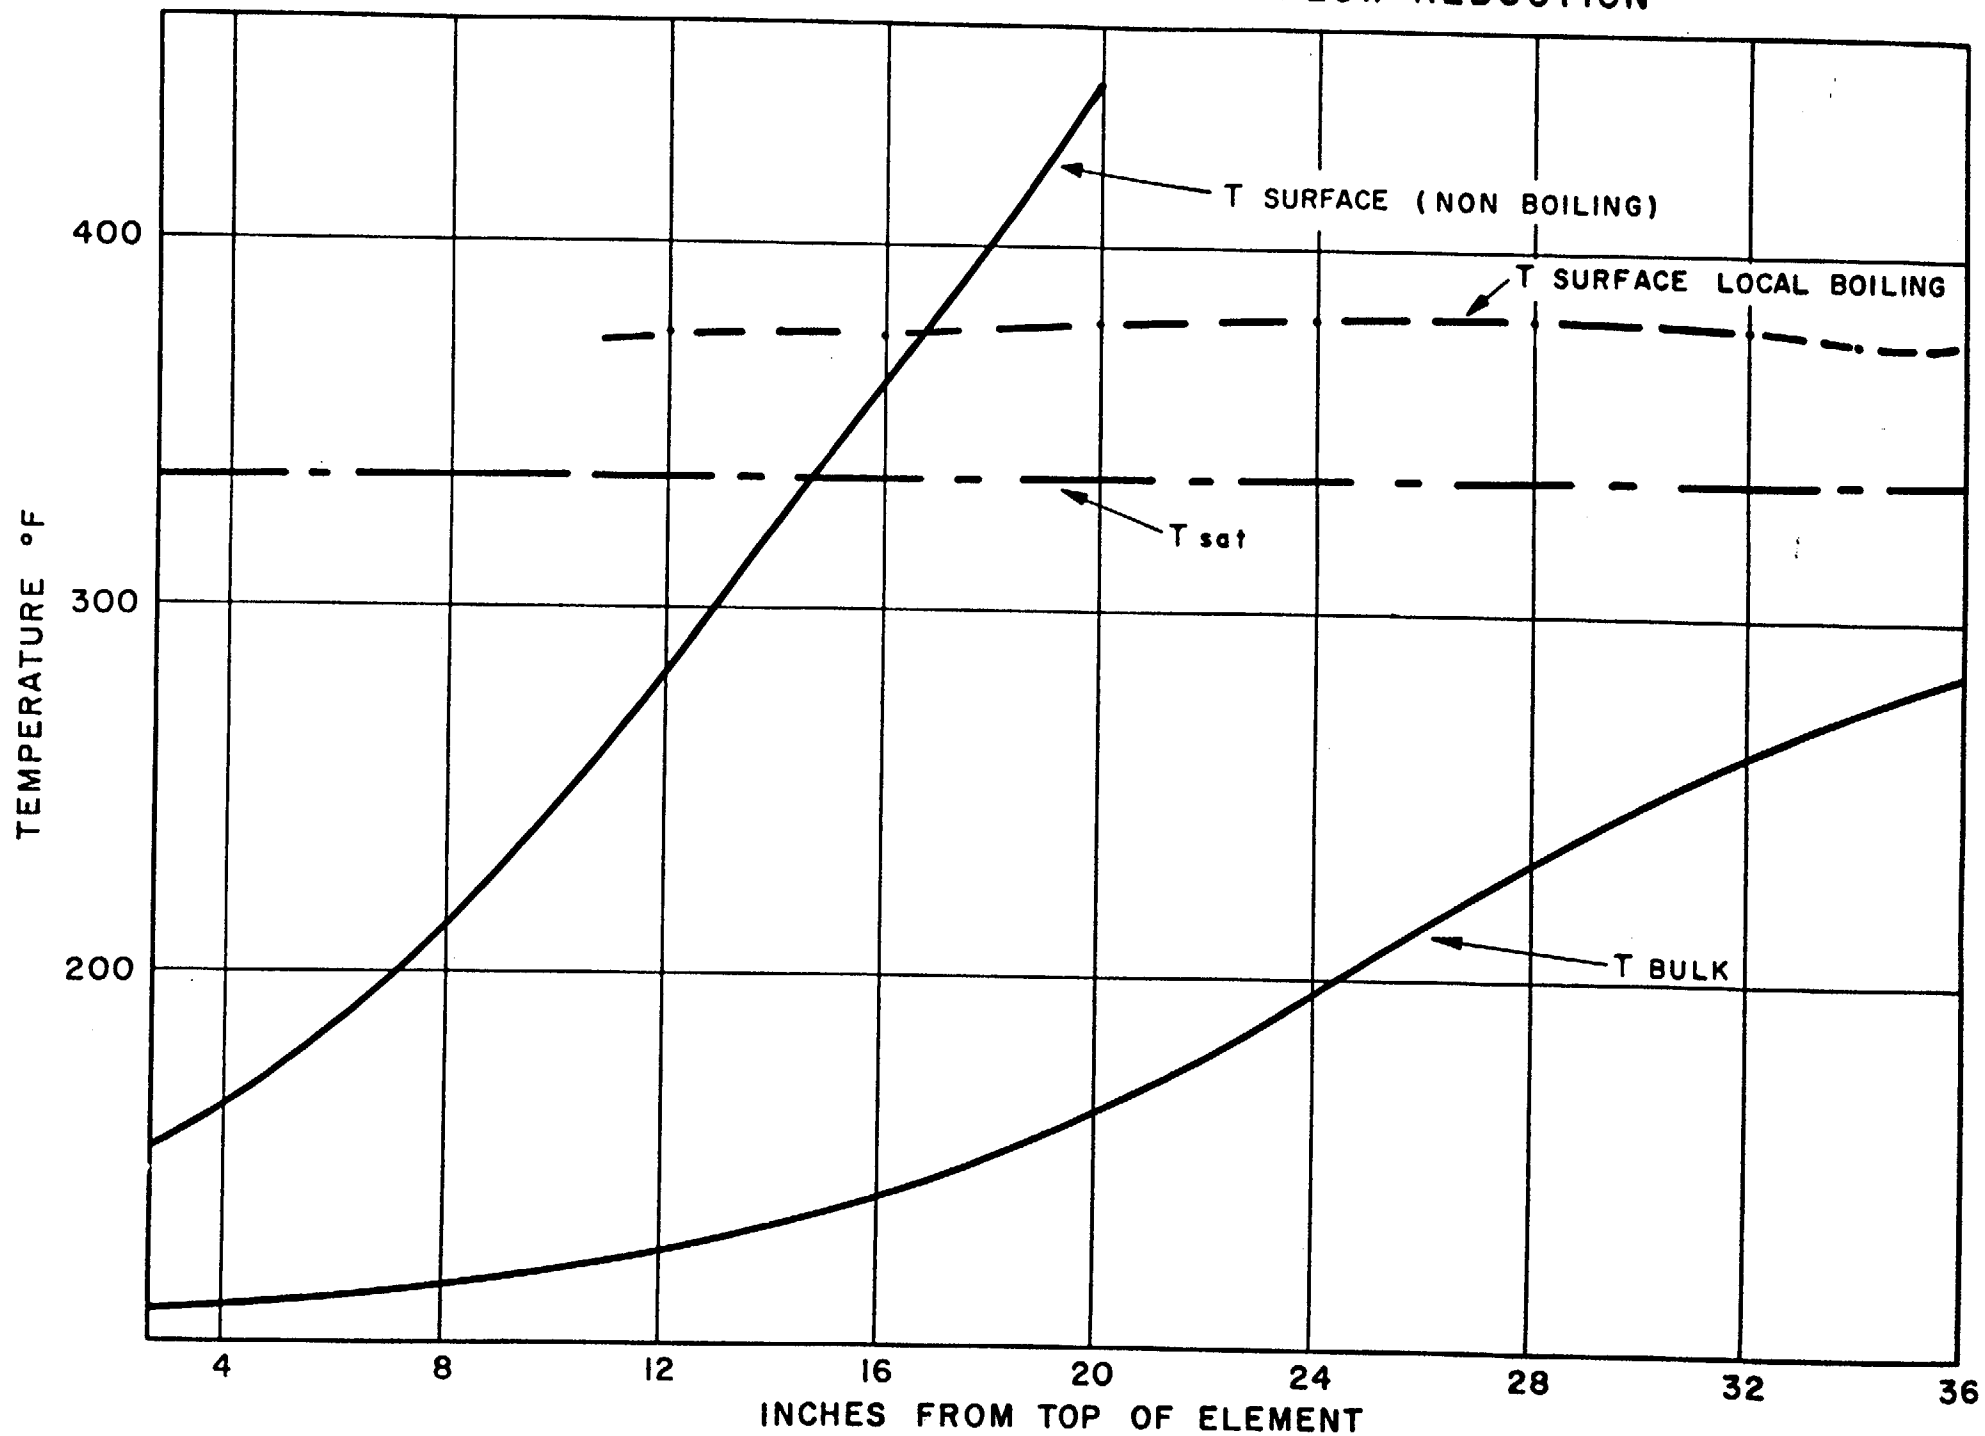
FIGURE 41

Figure 41 indicates the bulk coolant temperature and the fuel surface temperature for the hot channel with an assumed 15% additional

LOCAL BOILING ZONE WITH 15% FLOW REDUCTION

reduction of flow. The bulk coolant temperature rise increases to 170°F and the discharge temperature to 278°F. The hot channel factor for film temperature rise increases by 1.12.

Comparing Figure 41 with Figure 40 local boiling occurs over a greater length of the fuel element with the reduced flow. This creates an increase pressure drop whose effect is not considered significant. Using the data reported by J. B. Reynolds in ANL-5178, it can be shown that the increased pressure drop caused by local boiling is not adequate to account for even the assumed 15% reduction in flow. Additional flow restrictions must be postulated to produce a dangerous condition.
