From: Mark Kirk *RES*
To: Bass, Richard - ORNL
Date: 10/29/02 9:28AM
Subject: Permanent set "Measured" in DB Clad

Davis-Besse Reactor Head Sample Characterization

Phase 3 Status Report, 9/19/02

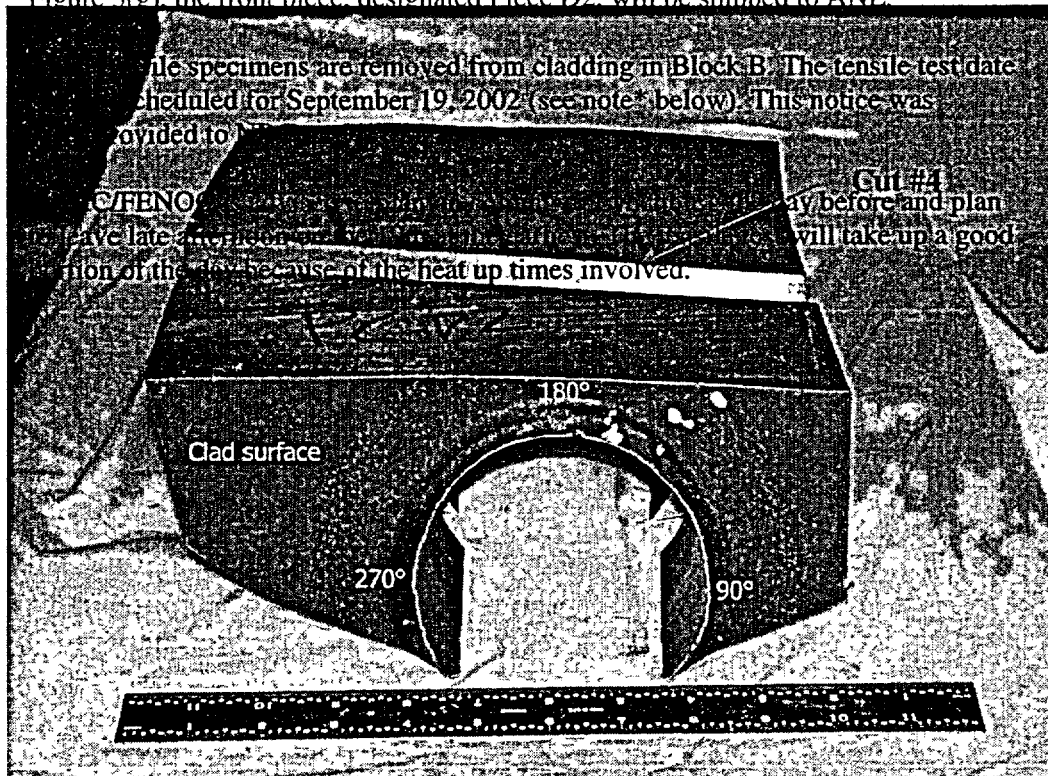
- (g) Cut #4 completed on 8/26/02 (see photo below); NRC and FENOC shipment authorization and ANL contact information received on 09/03/02. Shipment was received by ANL on 09/17/02, contact: John R. McDade, (630)252-5168, Fax (630)252-7367, jmcdade@anl.gov.

Figure 3(e), the front piece, designated Piece D2, will be shipped to ANL.

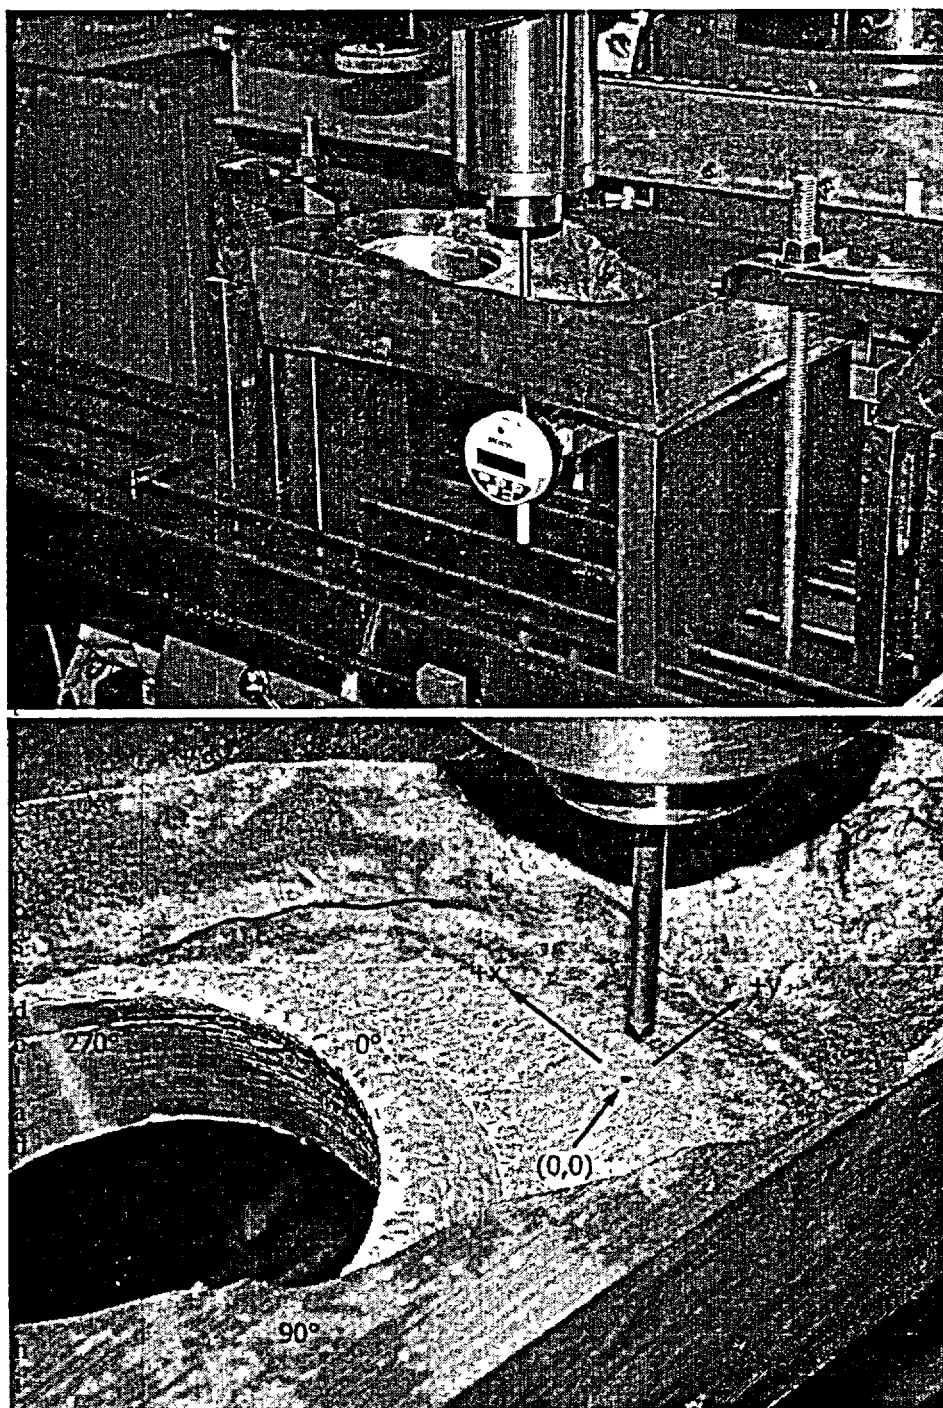
kness measurement. The two opposing dials are mechanically connected to ensure their identical X-Y positioning.
