Reactor Vessel Head Inspection Current Status and Future Plans

Calvert Cliffs
Nuclear
Power Plant
Unit 2

March 18,
2003

Enclosure 2

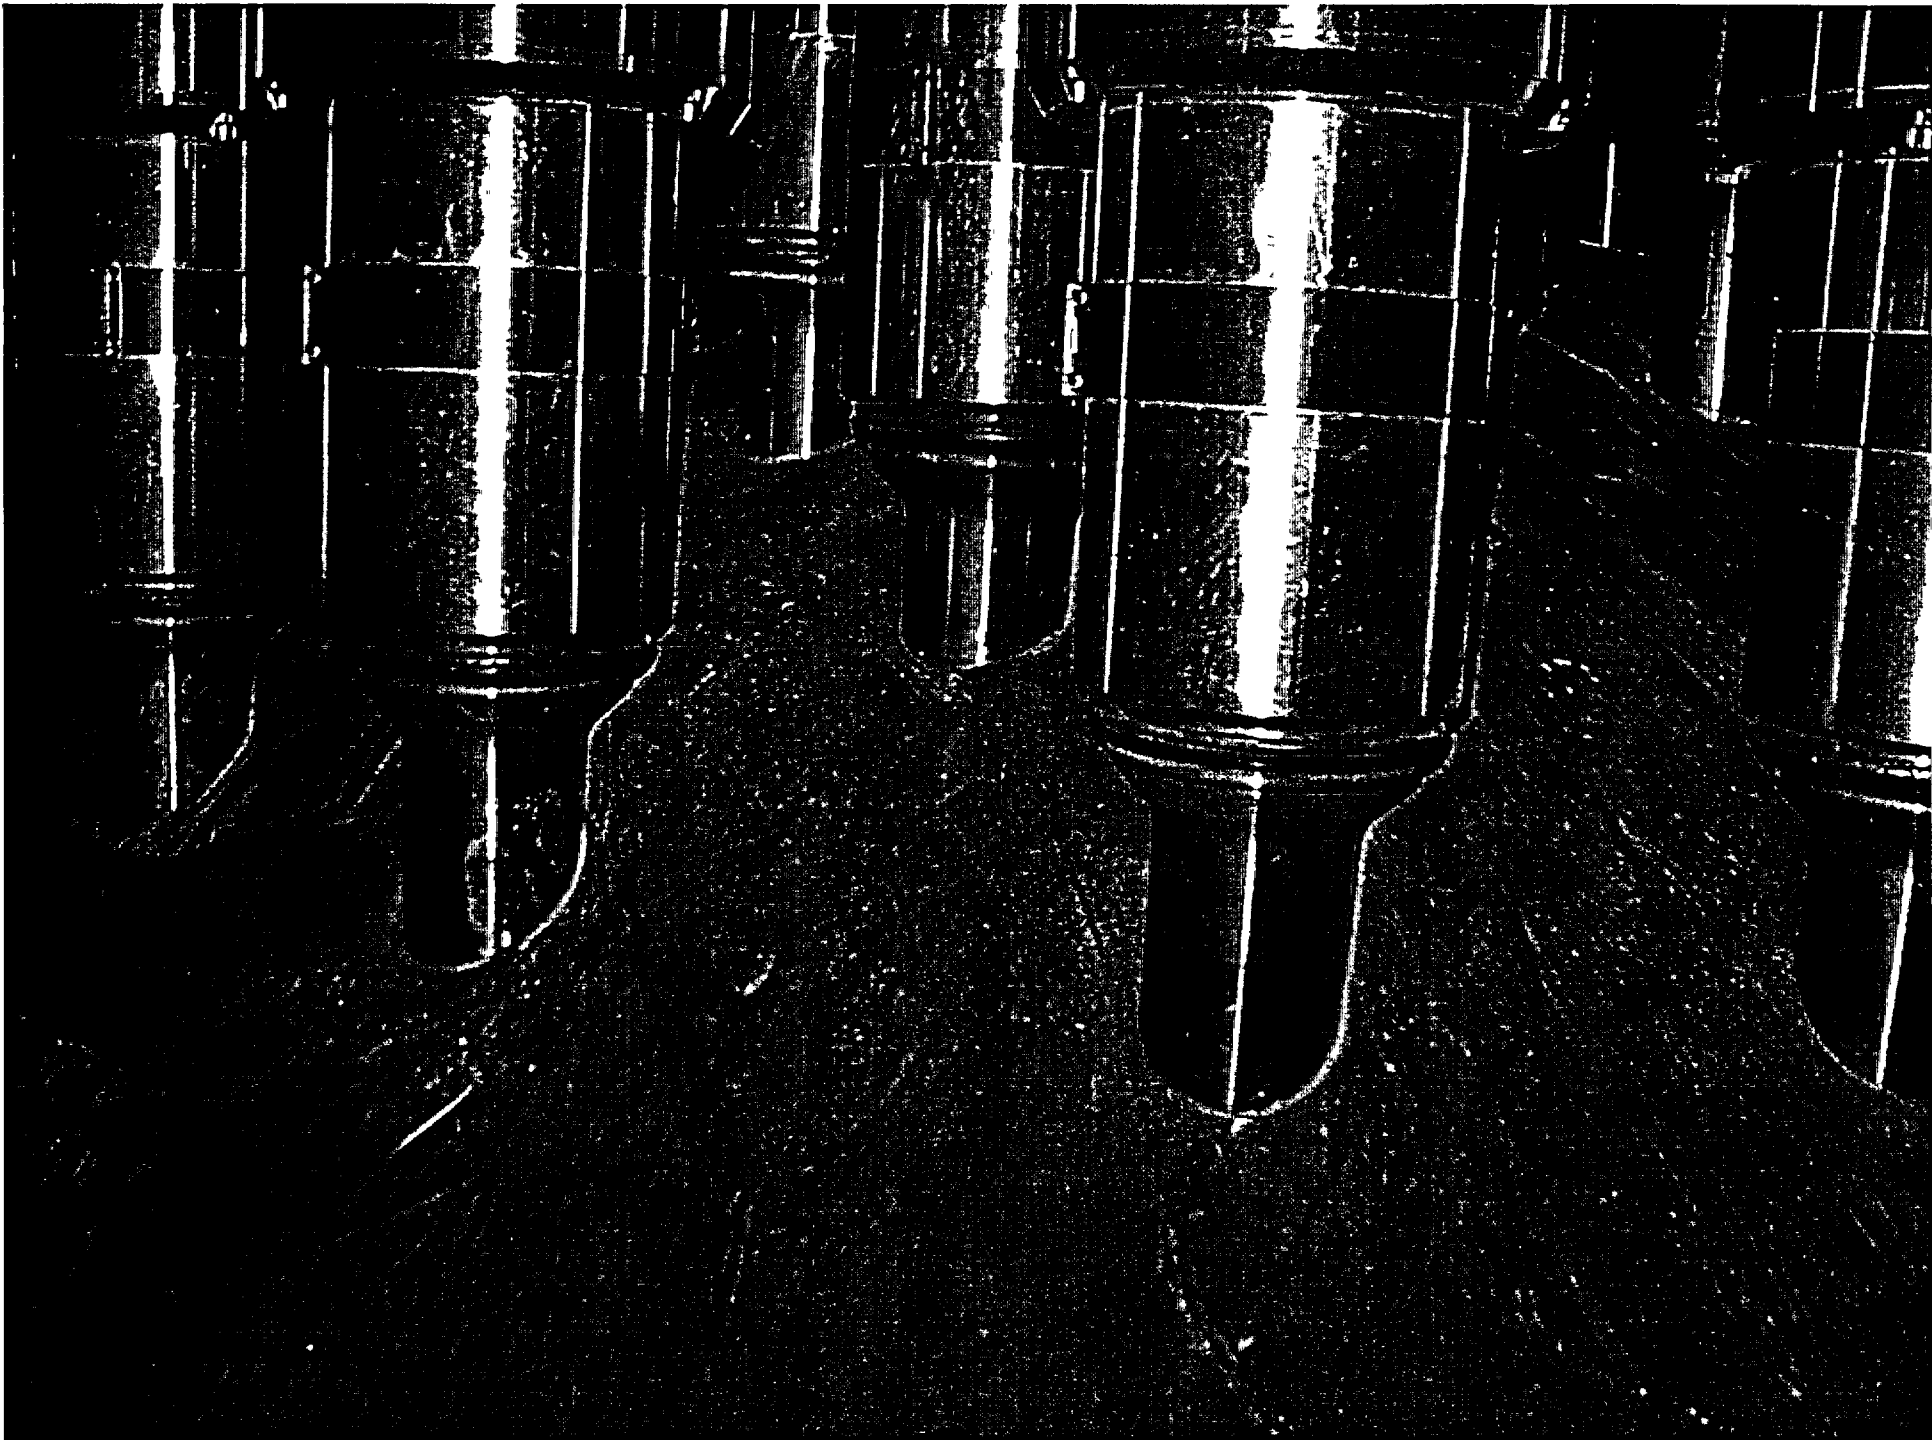
RV Head Materials

- PWSCC driven by stress
 - Lower yield strength results in lower driving force for cracking
 - PWSCC also driven by time at temperature
- All CEDM nozzles consist of only 2 heats

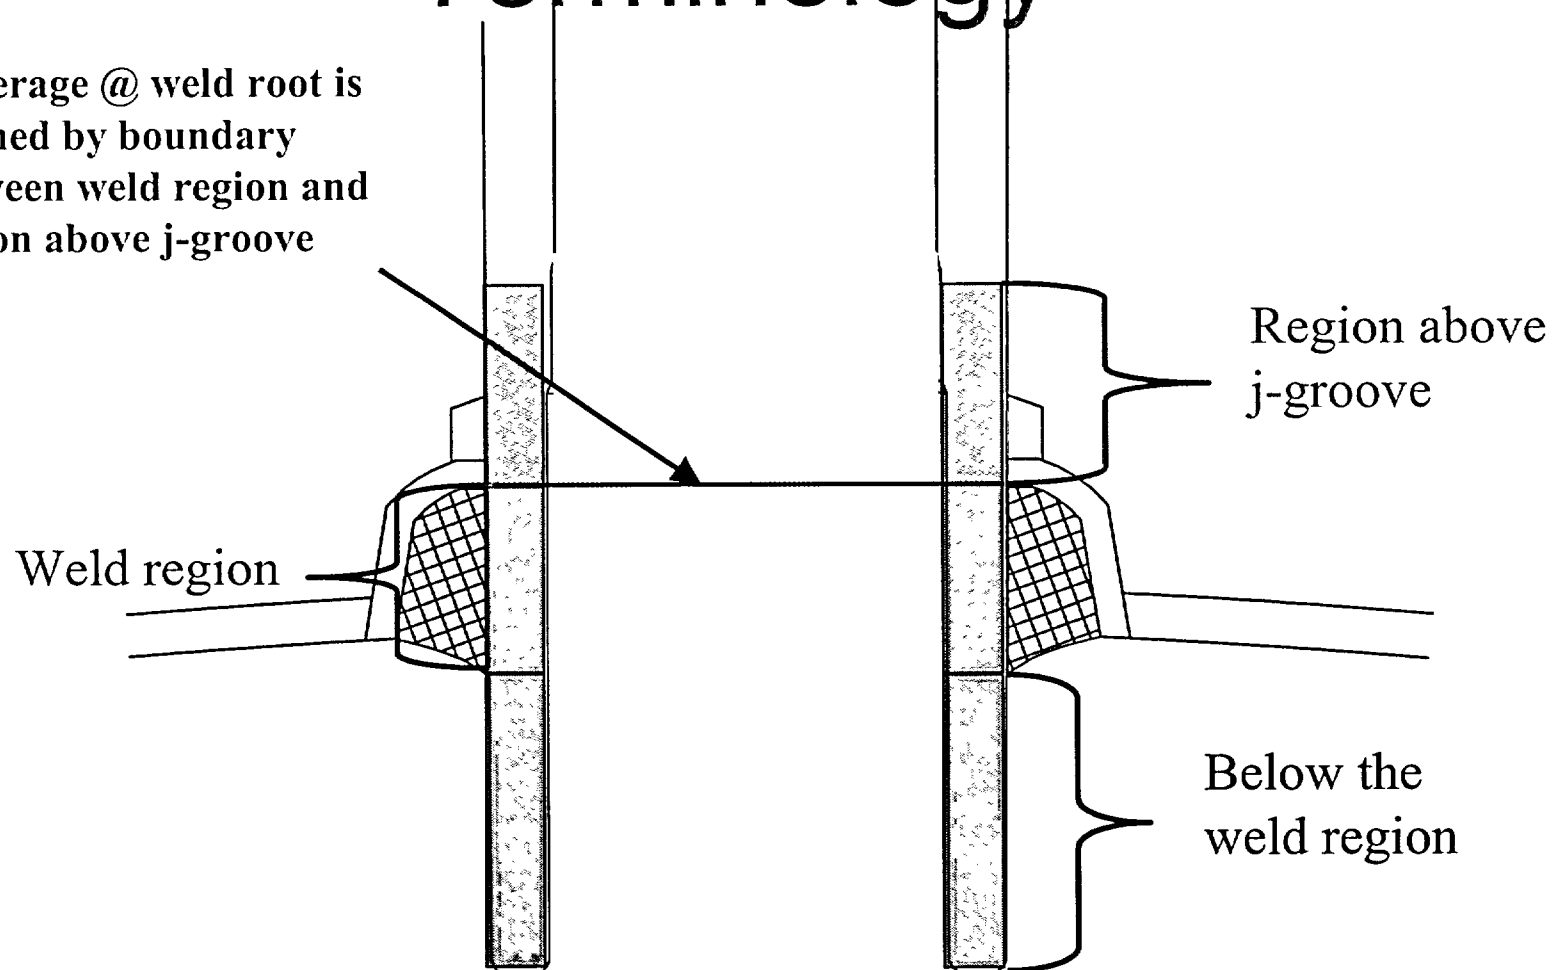
Nozzle Exam Coverage Terminology

Coverage @ weld root is defined by boundary between weld region and region above j-groove weld

- Have achieved examination of approximately 214 of 227 in²
- Unavailable azimuths assessed deterministically for structural integrity
 - 11 nozzles have 360° coverage
 - One has 355° coverage
 - One has 117° coverage
