Analysis of Rail Car Components Exposed to a Tunnel Fire Environment

A.S. Garabedian, P.E.¹, D.S. Dunn² and A.H. Chowdhury²

Southwest Research Institute

May 8, 2003

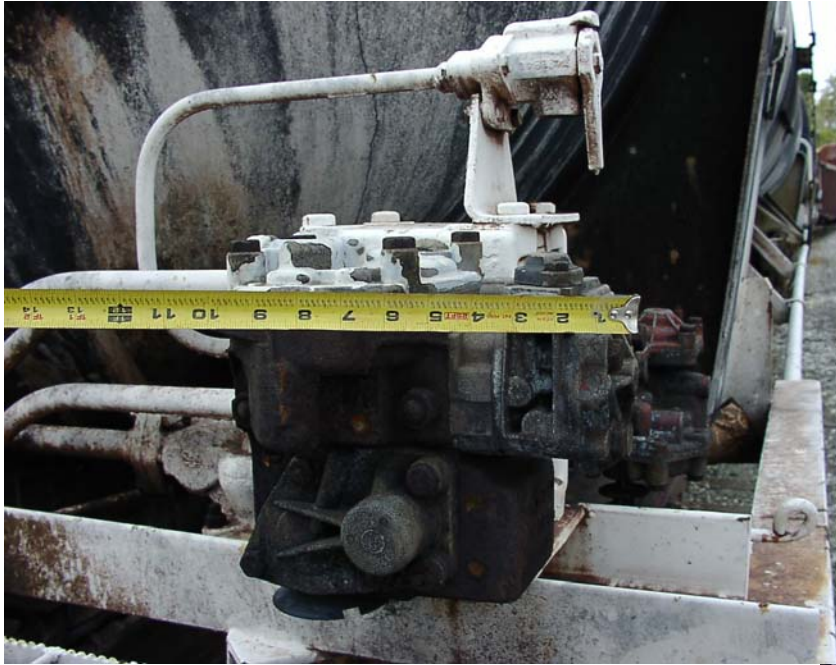
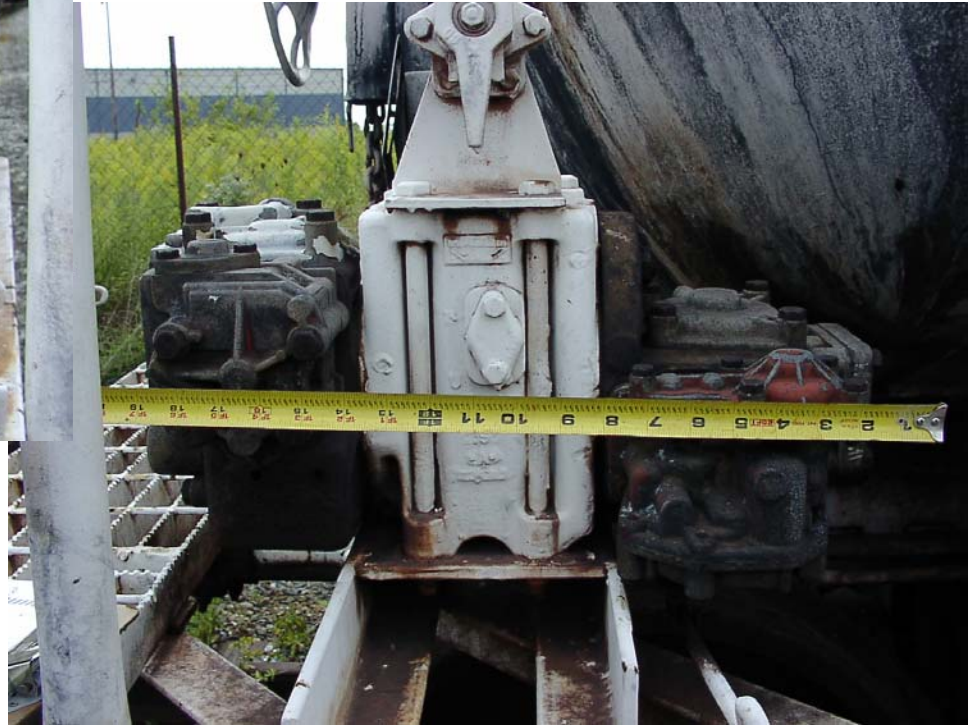
Railcar Components

- Steel Scale (Car 51)
 - Collected from Brake End (30 ft “uphill”)
- Section of Roof Plate (Car 50)
 - Source of substantial exposure due to long-burning paper car fire
- Sand Sample from Base of Rail #44
 - Near point of derailment
 - Illustrated some “clumping”

- Remainder of ABDX-L Air Brake Valve
 - Exhibited the most notable damage
 - Comparable to other air brake valves
- Exposed Bolts on Air Brake
 - Bolts in the vicinity of the completely melted aluminum cover
- New Air Brake Valve Cover
 - Supplied directly from manufacturer

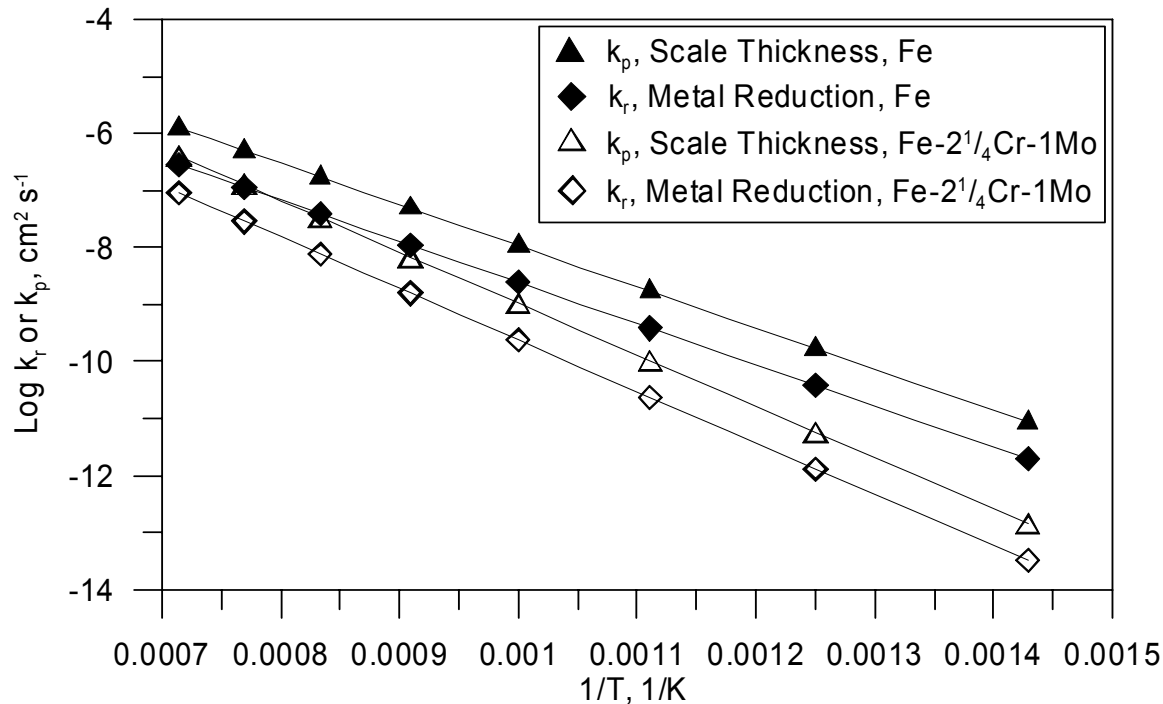
Oxidation of Steel Components

$X^2 = k_p t$
where t is time
and X is thickness

Rate constants for Fe-2¹/₄Cr-1Mo from Simms and Little (1987)

Rate constants for Fe from Kubaschewski and Hopkins (1962)

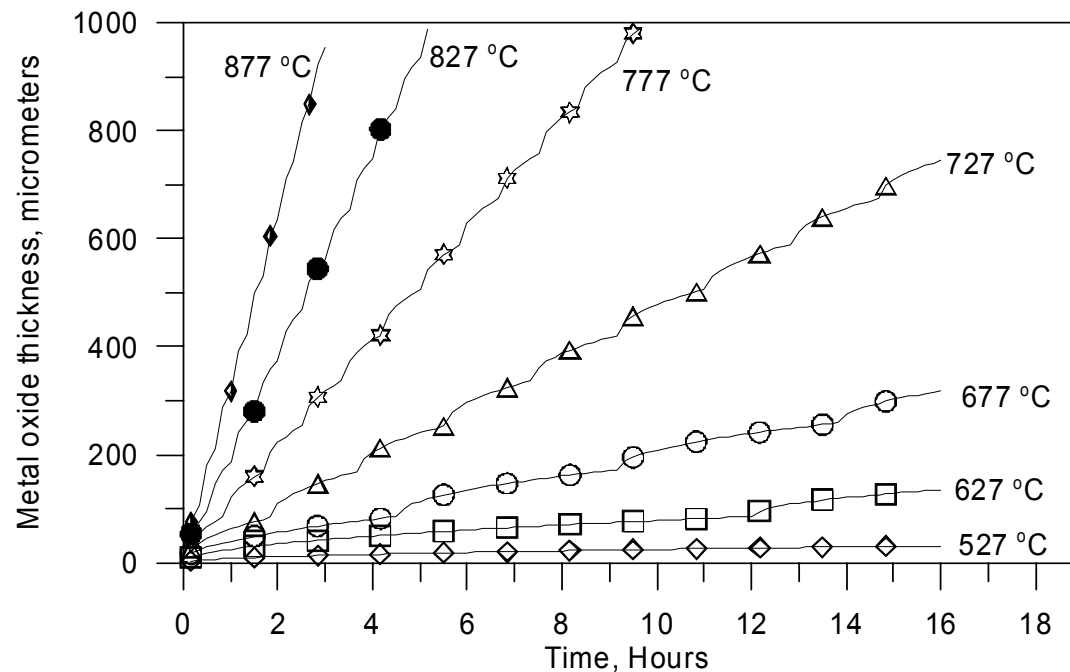
Oxide Layer Thickness

- Based on oxidation kinetics of iron
- Spalling of oxide assumed when oxide reaches a thickness of 85 micrometers
- Total oxidized layer thickness

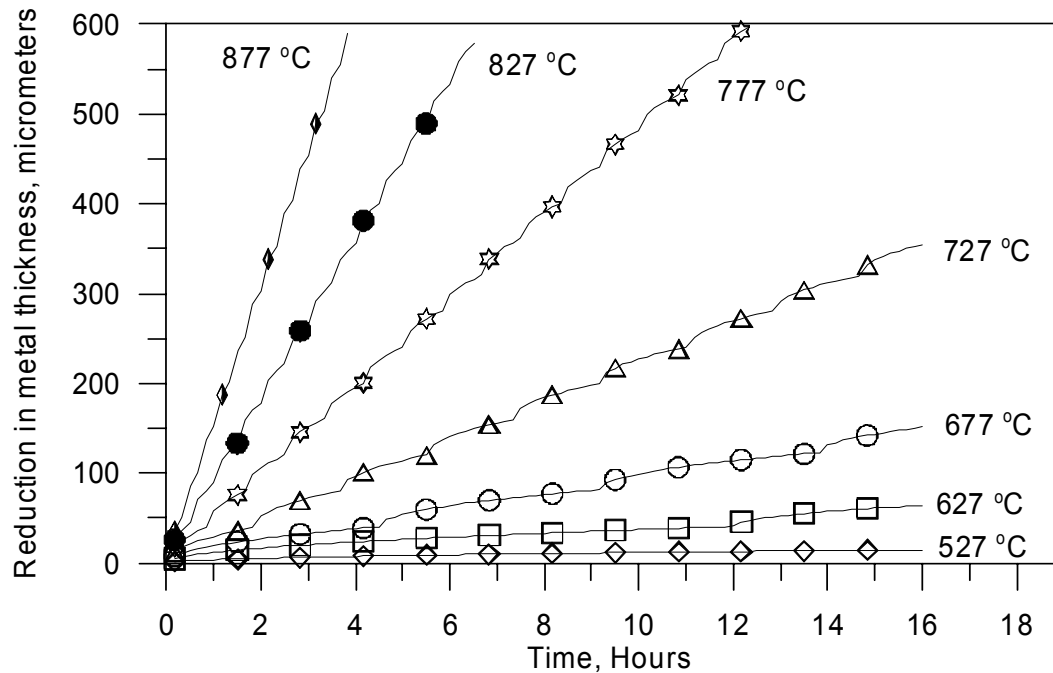
Reduction in Metal Thickness

- Based on oxidation kinetics of iron
- Spalling of oxide assumed when oxide reaches a thickness of 85 micrometers
- Total reduced metal thickness
