Subject: Submission of Intermediate Milestone 06003.04.041.340, Baltimore Tunnel Fire
Analysis Report—Final Letter Report

This report documents the analysis of rail car components for estimating temperature and duration of exposure during the Howard Street Tunnel Fire.

ANALYSIS OF RAIL CAR COMPONENTS EXPOSED TO A TUNNEL FIRE ENVIRONMENT

CNWRA 2003-04
Revision 1

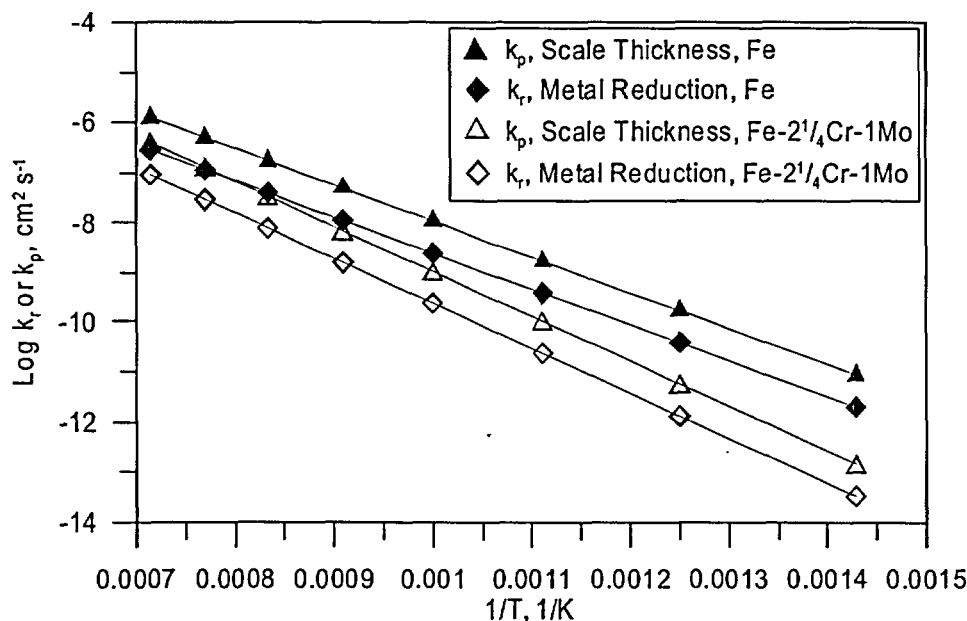
Figure 4-1 shows the rate constants for metal reduction (k_r), and scale thickness (k_p) obtained for an Fe-2 $\frac{1}{4}$ Cr-1Mo steel and iron. Rate constants for Fe-2 $\frac{1}{4}$ Cr-1Mo were reported by Simms and Little (1987) and Larose and Rapp (1997) over a temperature range from 550 to 700 °C [1,022 to 1,292 °F]. Kubaschewski and Hopkins (1962) reported rate constants for iron from 500 to 1,100 °C [932 to 2,012 °F]. The composition and microstructure of the steels are known to affect oxidation kinetics. Additions of carbon increases the oxidation kinetics of steel. Oxidation kinetics are faster for fine pearlite compared to coarse pearlite or a spheroidized microstructure (Runk and Kim, 1970). Based on data published by Kubaschewski and Hopkins, (1962), the reduction in metal thickness as a consequence of oxidation under isothermal conditions is shown in Figure 4-2. The change in the rate of metal loss as a function of time is a result of oxide spalling. Similarly, the metal oxide thickness as a function of time and temperature can be calculated and is shown in Figure 4-3. It should be noted that the calculated values for reduction in metal thickness and oxide scale thickness shown in Figures 4-2 and 4-3 do not consider the effects of composition because the calculations are based on results observed for iron. The effect of microstructure was also not considered (Runk and Kim, 1970). Oxide cracking and spalling are assumed when the oxide scale is greater than 85 μm in thickness (Simms and Little, 1987; Kubaschewski and Hopkins, 1962). Error in the assessment of temperature as a consequence of neglecting compositional and microstructural effects

Figure 4-1. Oxidation Rate Constants for Fe-2 1/4 Cr-1 Mo Steel and Iron as a Function of Temperature (Simms and Little, 1987; Kubaschewski and Hopkins, 1962)

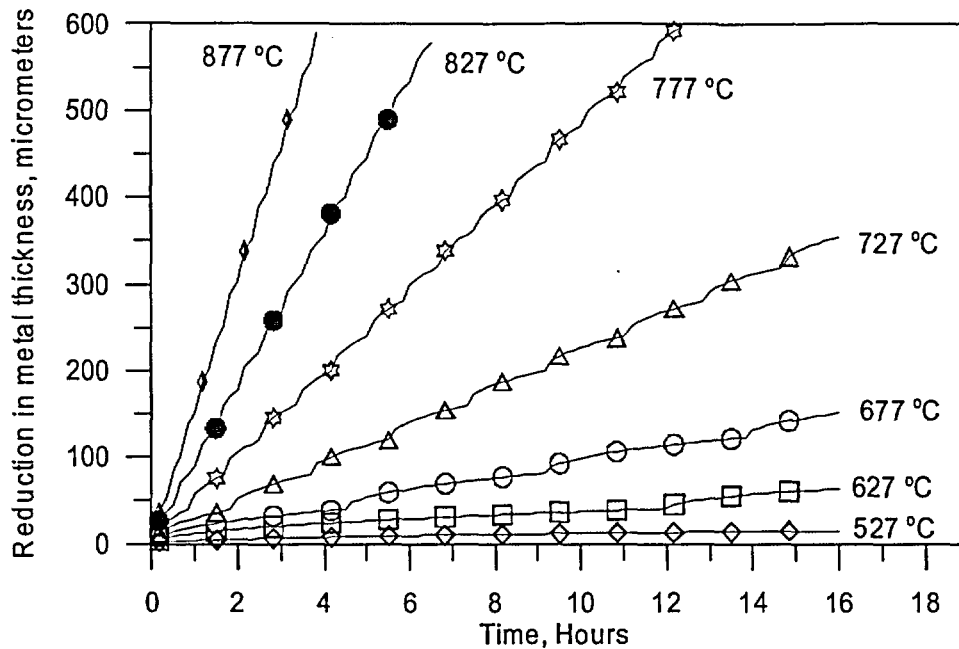
Figure 4-2. Reduction in Metal Thickness as a Function of Time for Isothermal Exposures of Iron in the Range of 527 to 877 °C [980 to 1,610 °F]

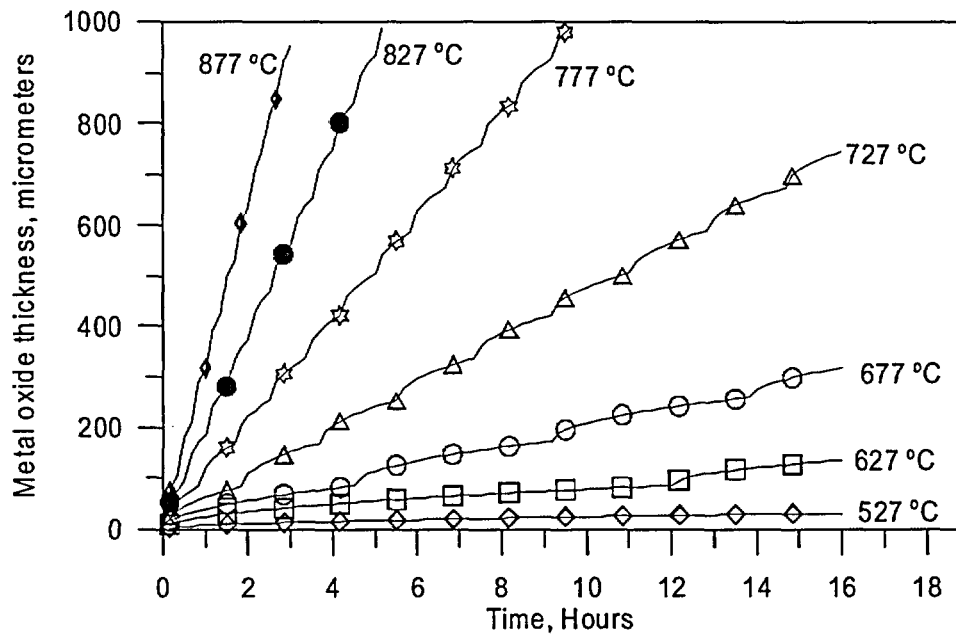
Figure 4-3. Metal Oxide Thickness as a Function of Time for Isothermal Exposures of Iron at Temperatures Ranging from 527 to 877 °C [980 to 1,610 °F]

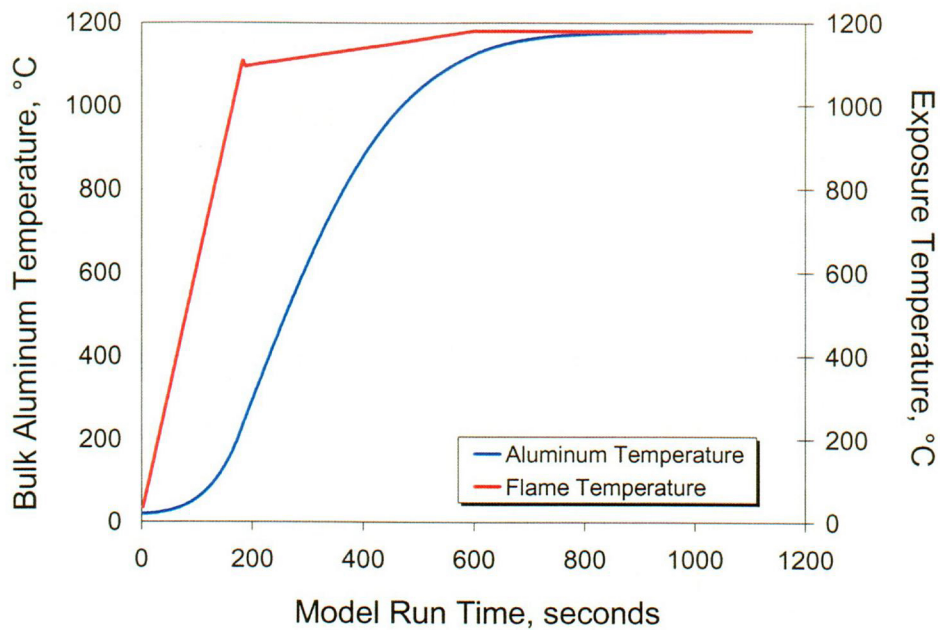
When modeled using this fire exposure, the sample aluminum element exhibits melting at 300 seconds into the exposure (see Figure 5-1).

Figure 5-1. ASTM E 1529 (1993) Ramp Function and Corresponding Aluminum Thermal Profile (Melting Predicted at 300 seconds)

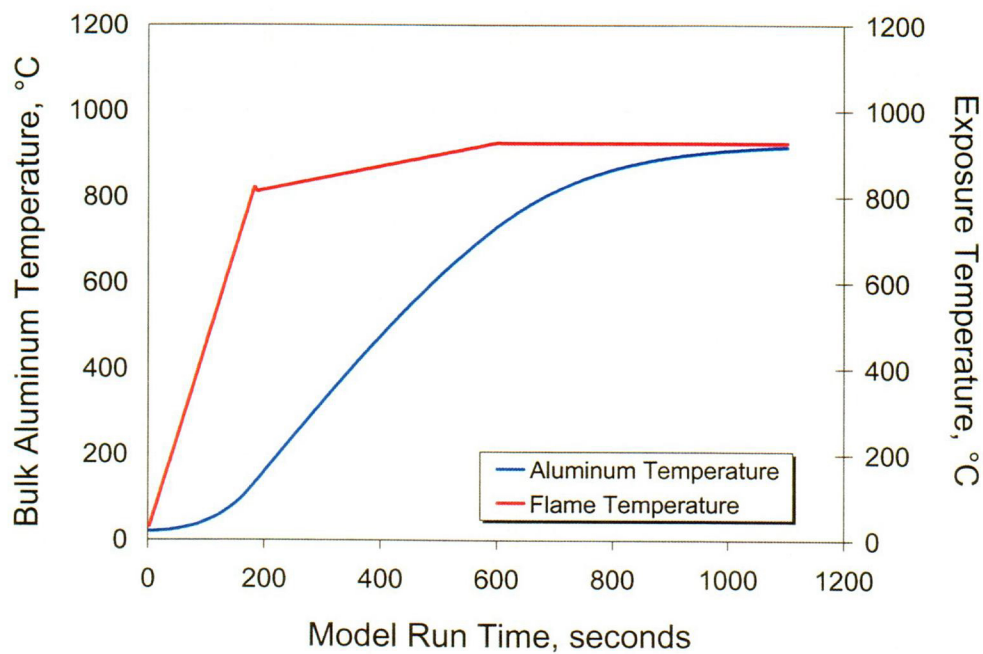
Figure 5-2. Published Flame Temperature Ramp Function and Corresponding Aluminum Thermal Profile (Melting Predicted at ~500 seconds)

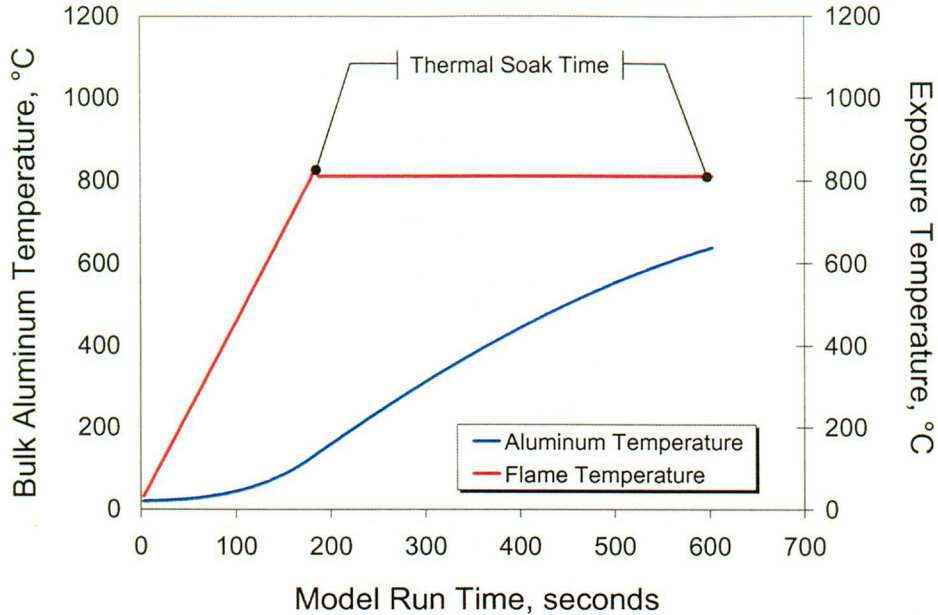
Figure 5-2 illustrates that, when taking the published flame temperature as the maximum temperature experienced by the valve, any exposure time greater than 360 seconds will produce melting conditions.

Figure 5-3. Ramp-Plateau Function Demonstrates Melting at Published Flame Temperature for Exposure Times Greater than 360 Seconds

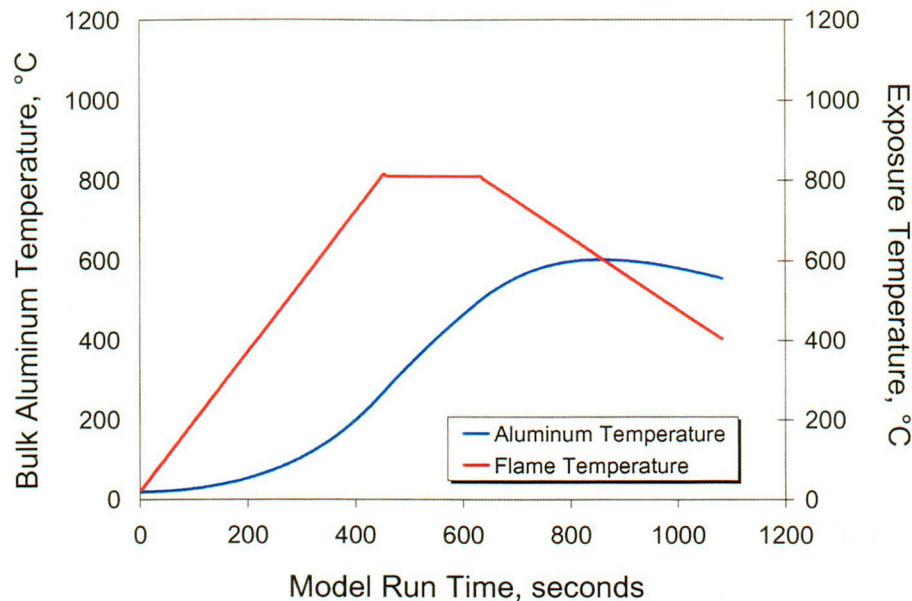
Figure 5-4. Ramp-Plateau-Decay Function and Corresponding Aluminum Thermal Profile (Melting Predicted at ~800 seconds)

The conditions depicted in Figure 5-4 may be more difficult than originally assumed because 810 °C [1,490 °F] is the actual, published flame temperature of the fuel. The valve would have had to be completely engulfed in flames for it to realize these temperatures. Considering the location of the valve, 10 m [33 ft] uphill, and its position in the tunnel (low to the floor), total flame engulfment may have only occurred intermittently and, possibly, for only a short duration.
