**FRAMATOME ANP REPORT 51-5027436-00**  
**"EXAMINATION OF DIABLO CANYON UNIT 2 SG TUBES – FINAL REPORT"**

## **Examination of Diablo Canyon Unit 2 Steam Generator Tubes**

**51-5027436-00**

**Final Report, May 2003**

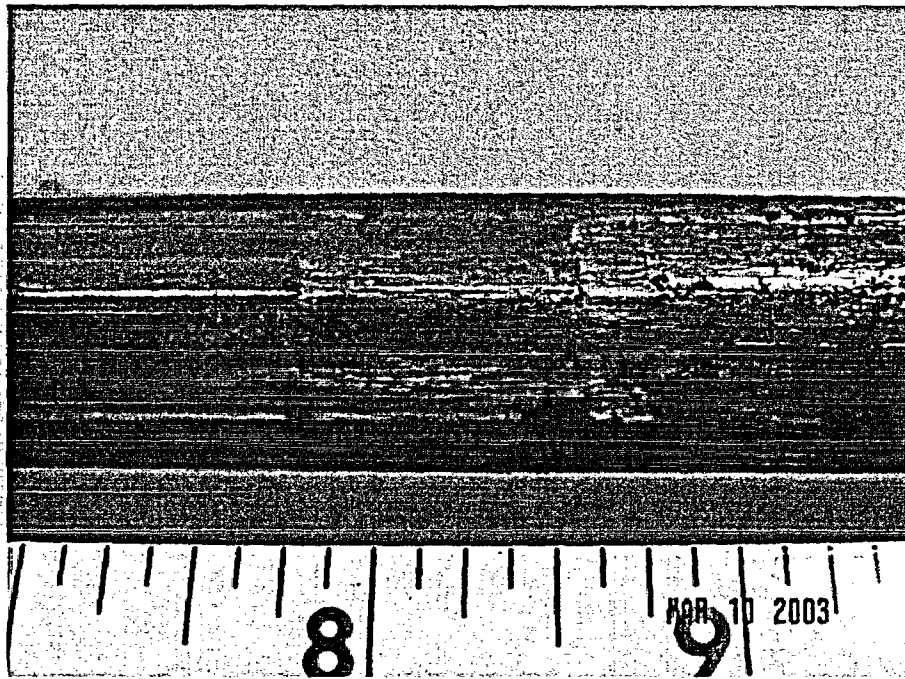
Figures 2 and 3 illustrate the typical appearance of tube numbers R35C57 and R44C45 at the 2H intersections. As can be seen in the photographs, the locations at which the support plates contacted the tubes are clearly visible.

Note the axial scrape marks and almost complete absence of scale on the OD of R35C57 (Figure 2). With the exception of the 2H TSP location, the OD of all sections of R44C45 inspected were uniformly covered with a black scale. Portions of this scale had spalled away from the tube surface above and below the TSP elevation during tube removal operations (Figure 3).

Figure 2. Receipt photograph of 02H TSP intersection at  $\sim 180^\circ$  of tube no. R35C57 (section 8). Top (in SG) is to the right.

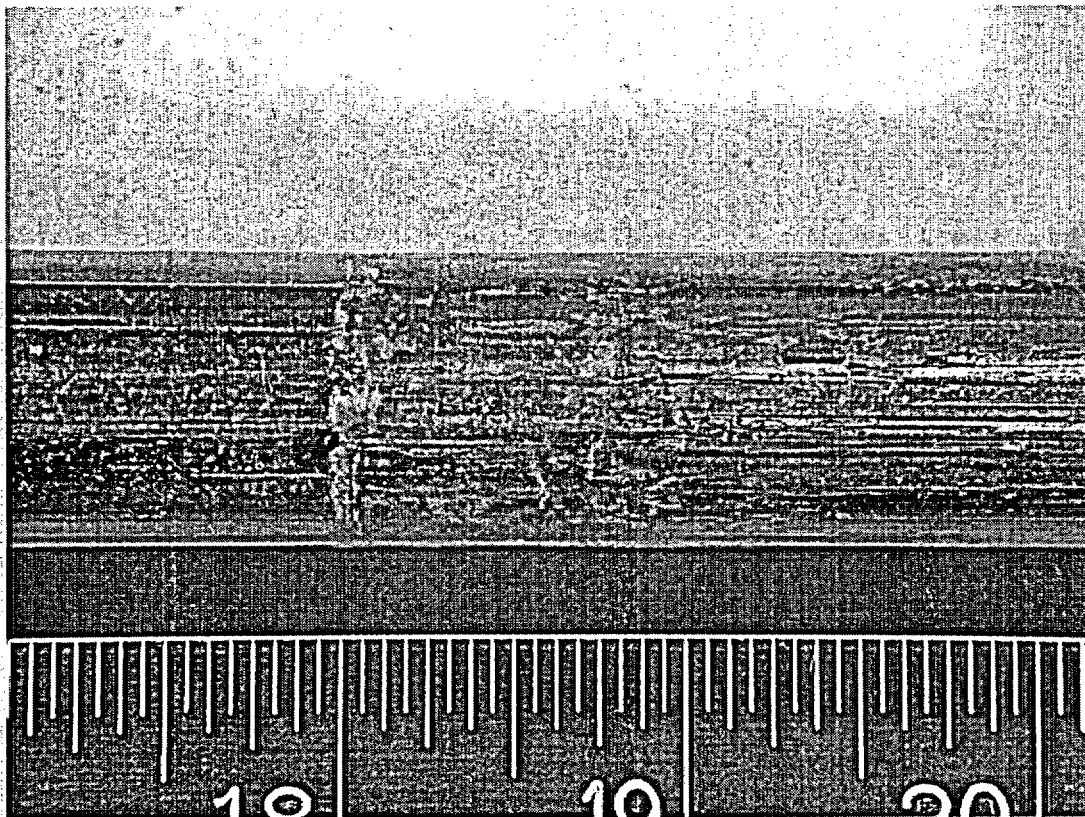
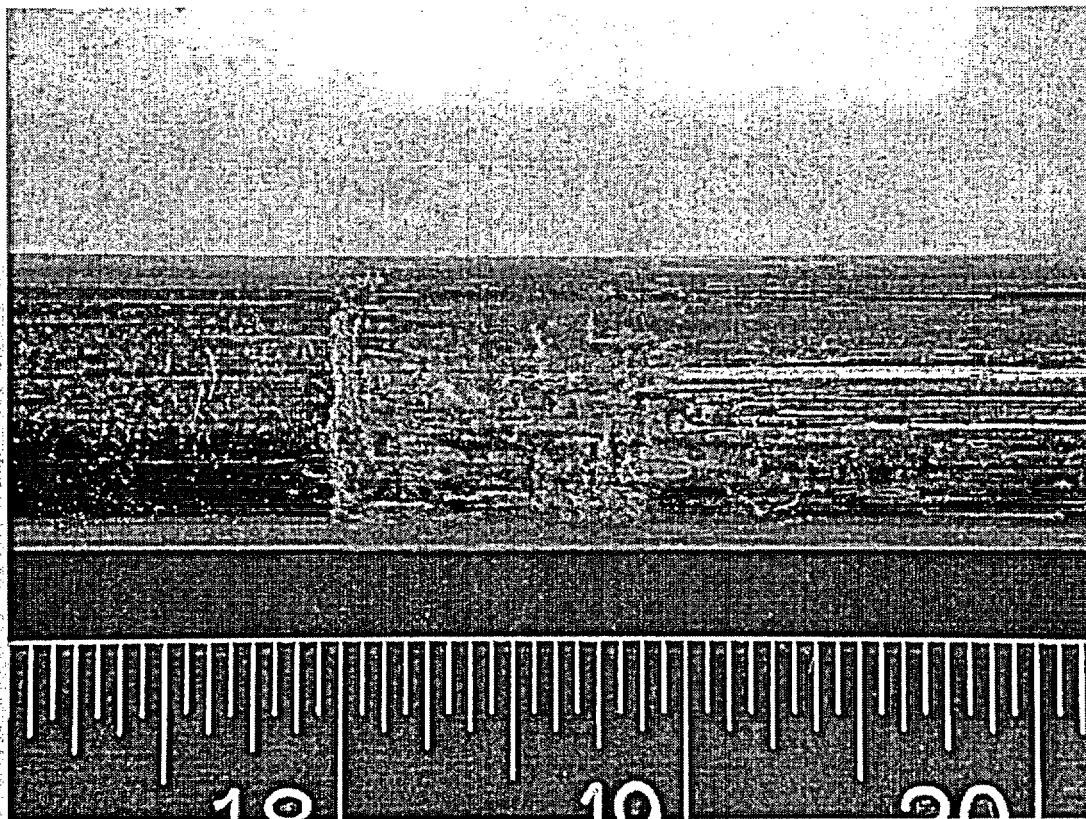
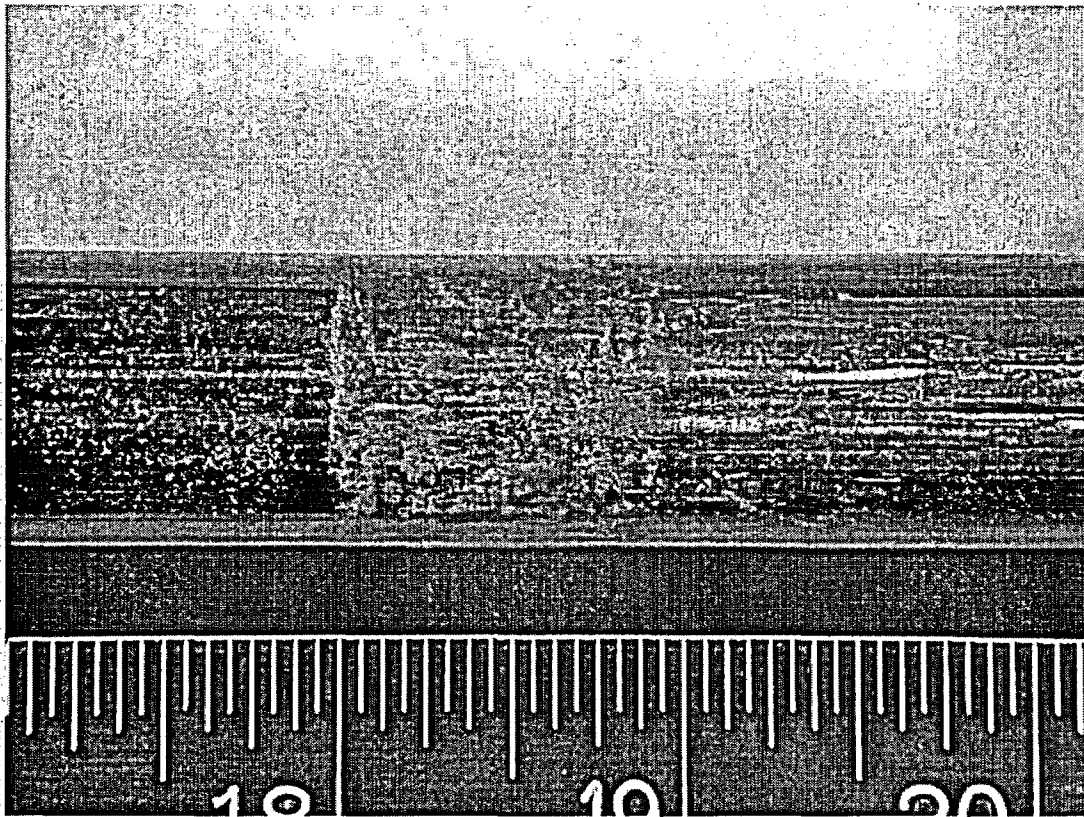
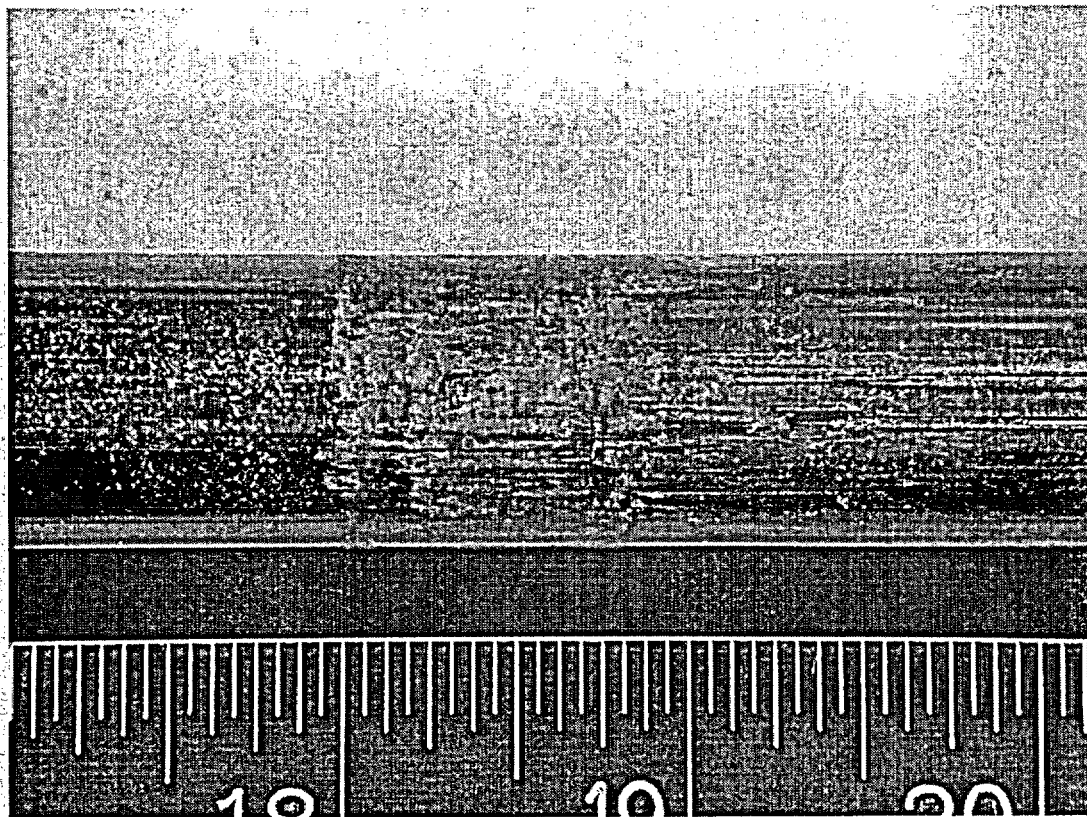
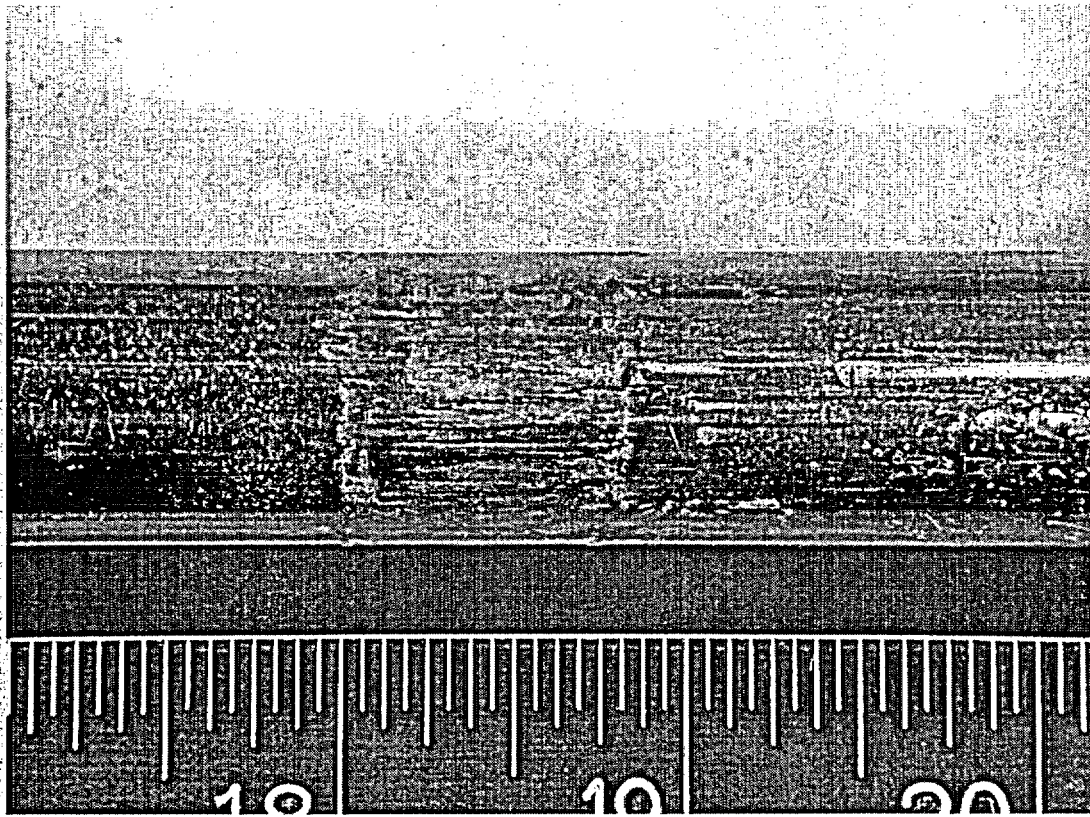
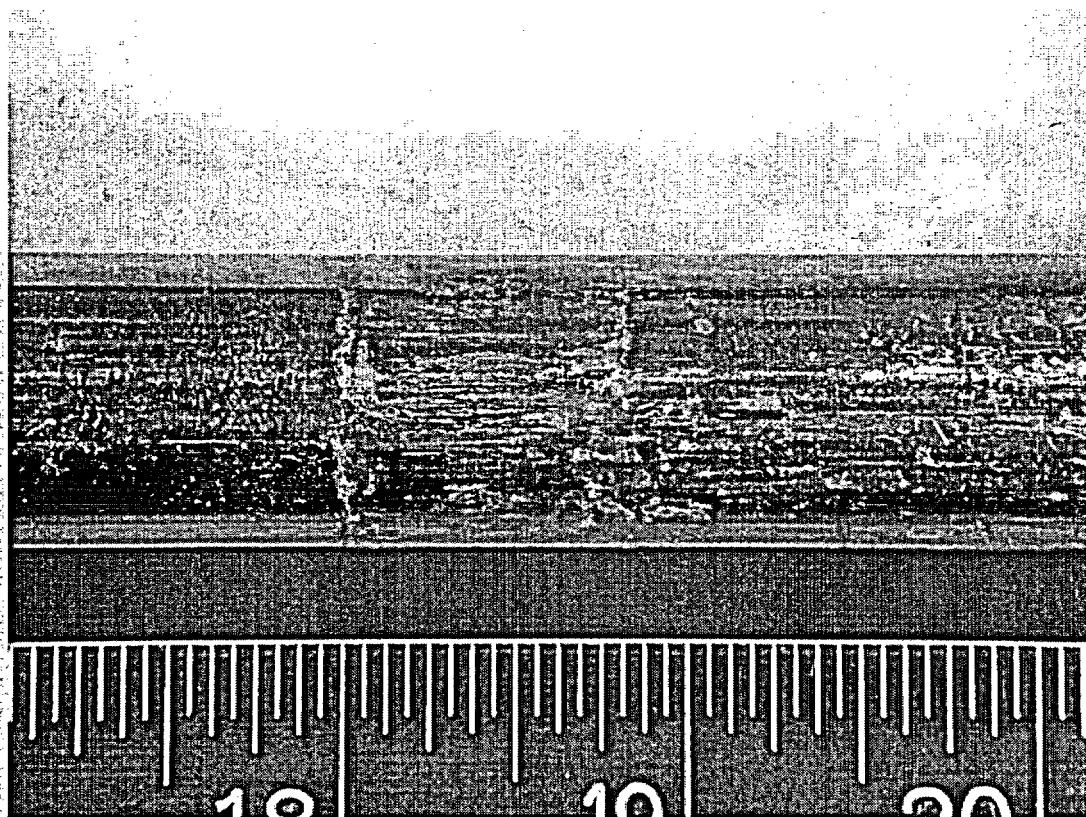
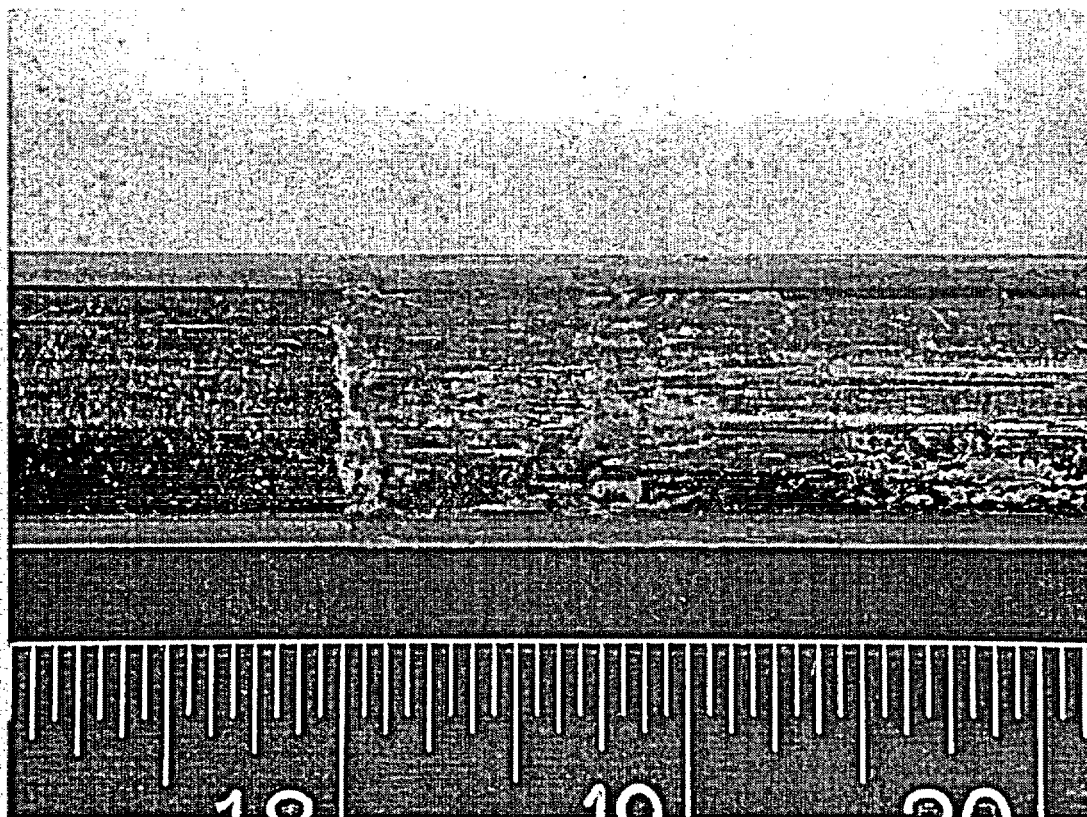
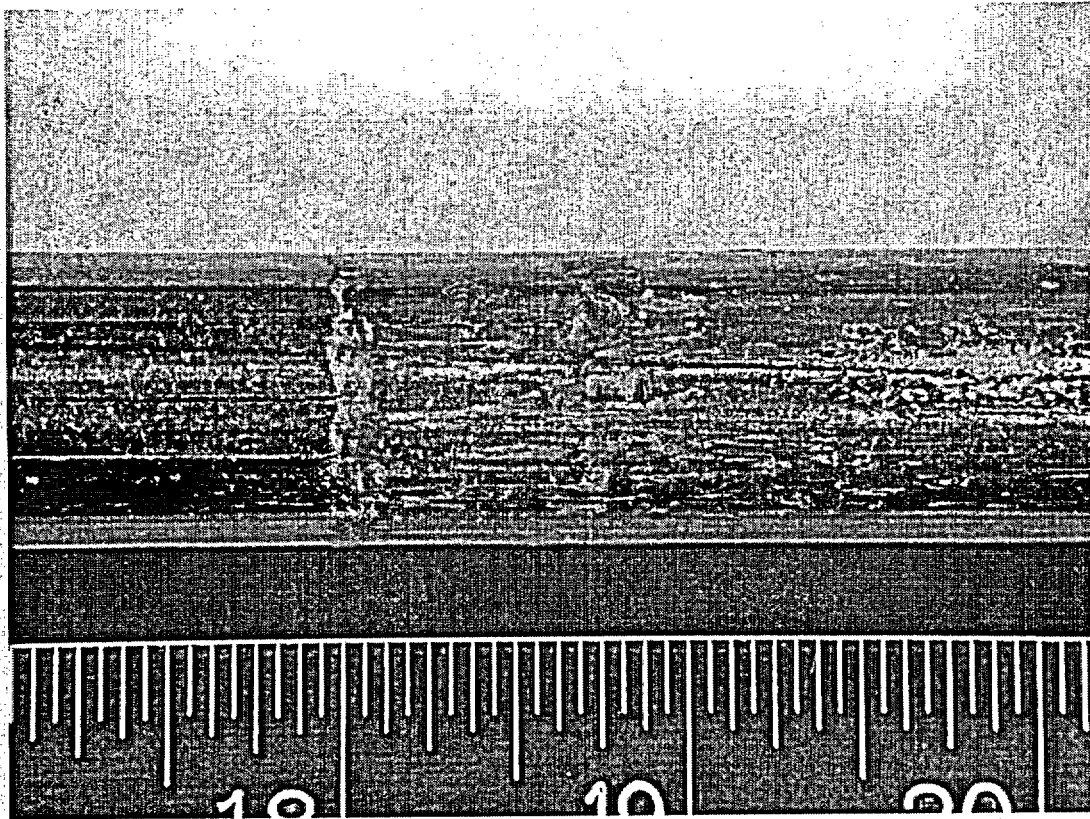
Figure 11. R35C57-8B at 0° 1.9X

Figure 12. R35C57-8B at 45° 1.9X

Figure 13. R35C57-8B at 90° 1.9X

Figure 14. R35C57-8B at 135° 1.9X

Figure 15. R35C57-8B at 180° 1.9X

Figure 16. R35C57-8B at 225° 1.9X

Figure 17. R35C57-8B at 270° 1.9X

Figure 18. R35C57-8B at 315° 1.9X

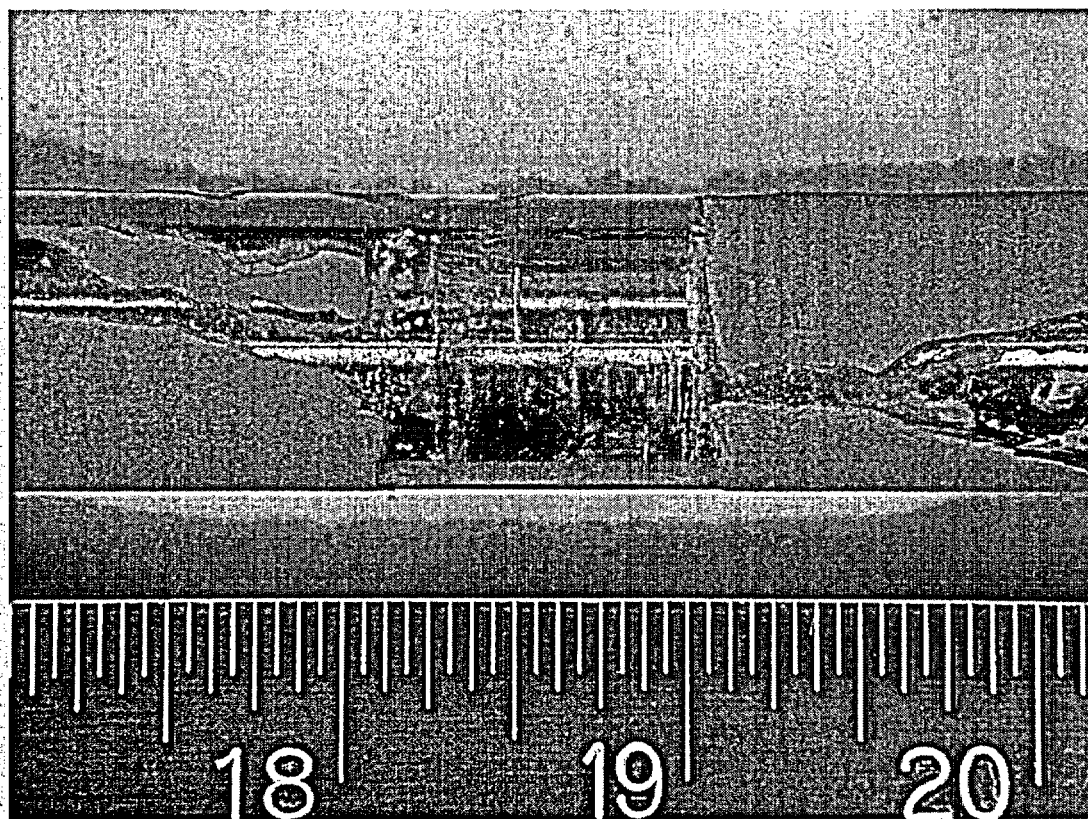
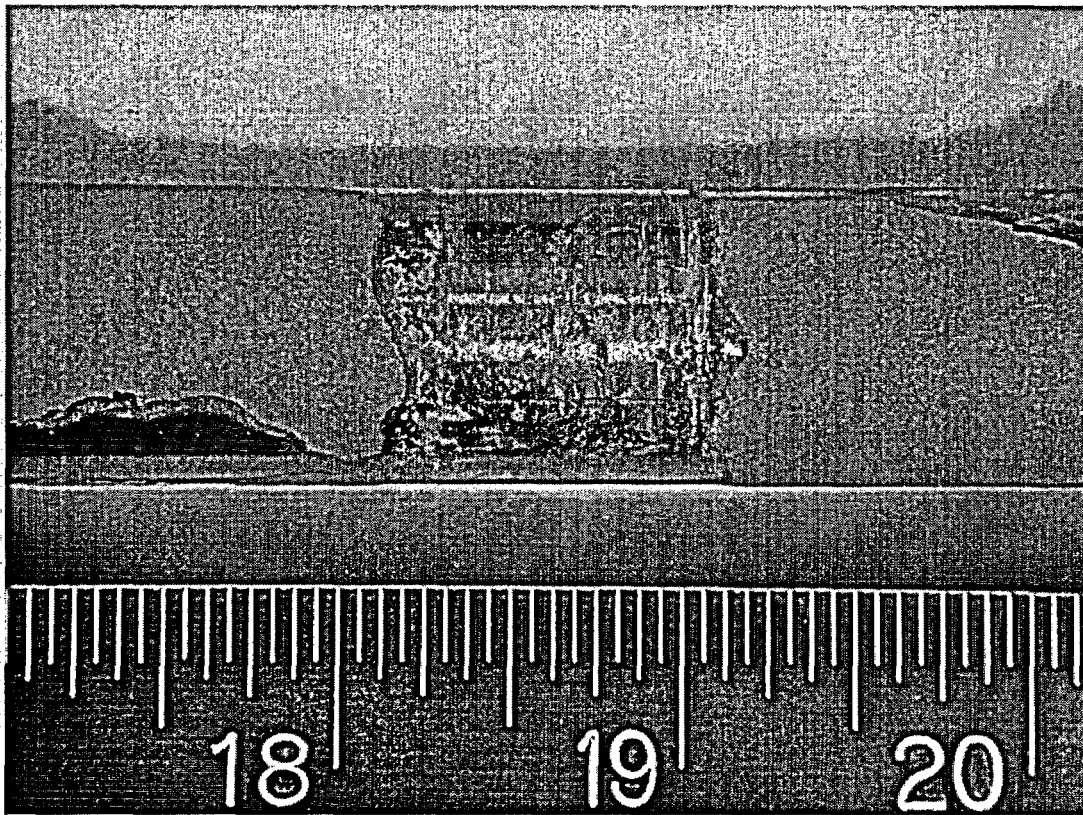
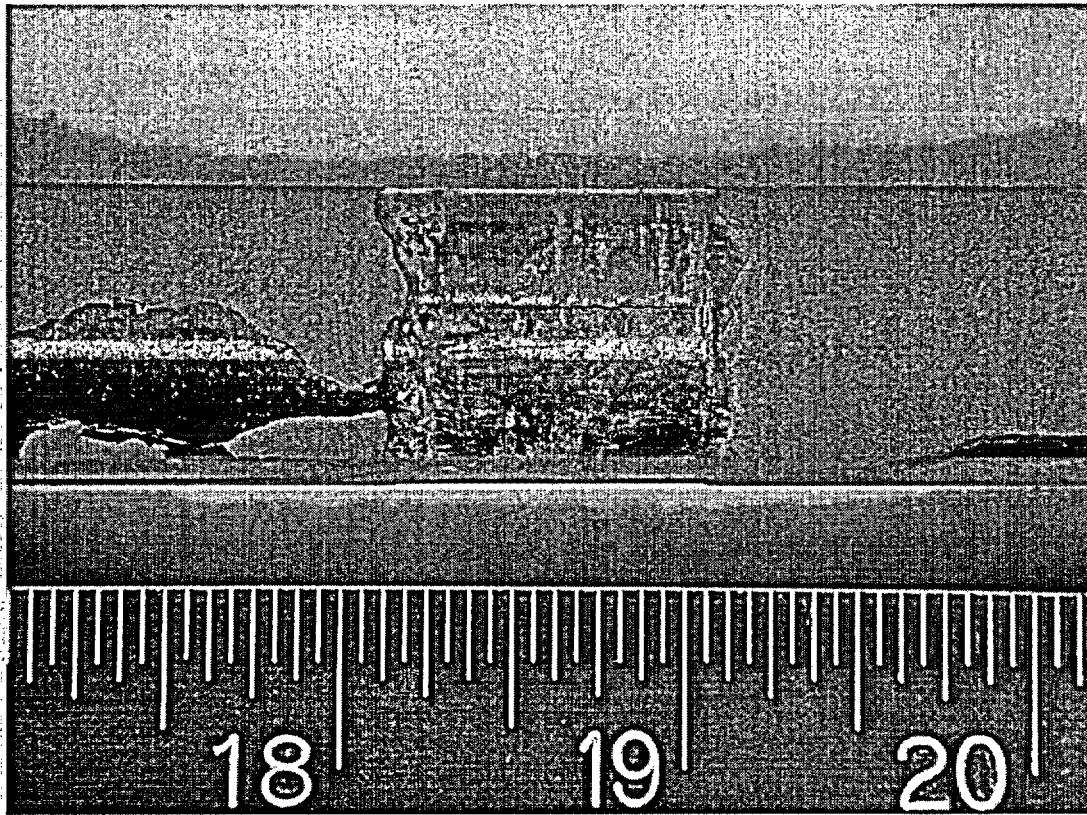
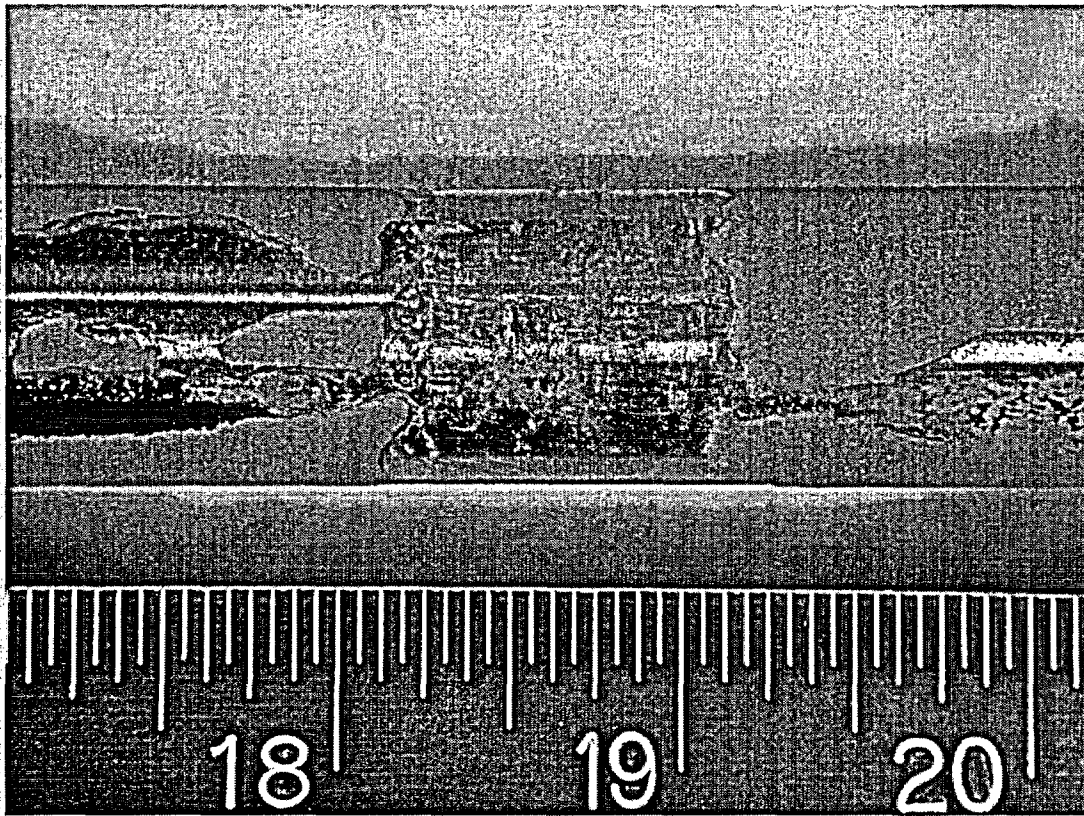
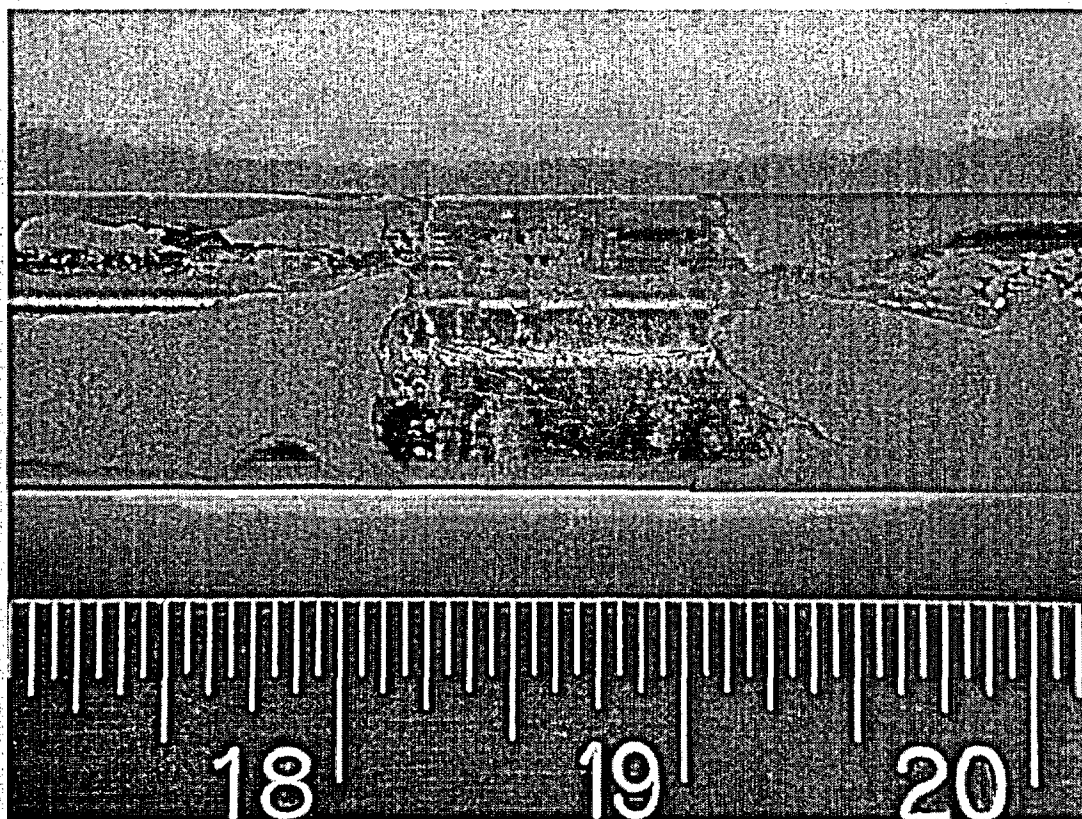
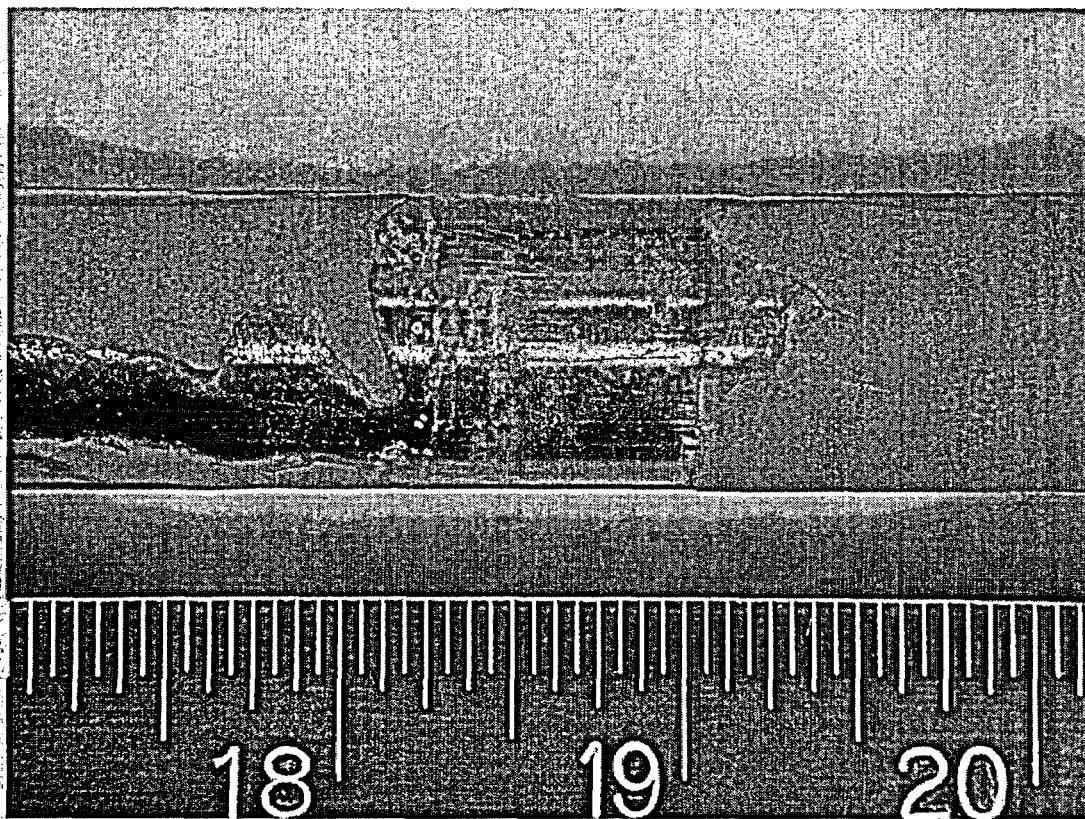
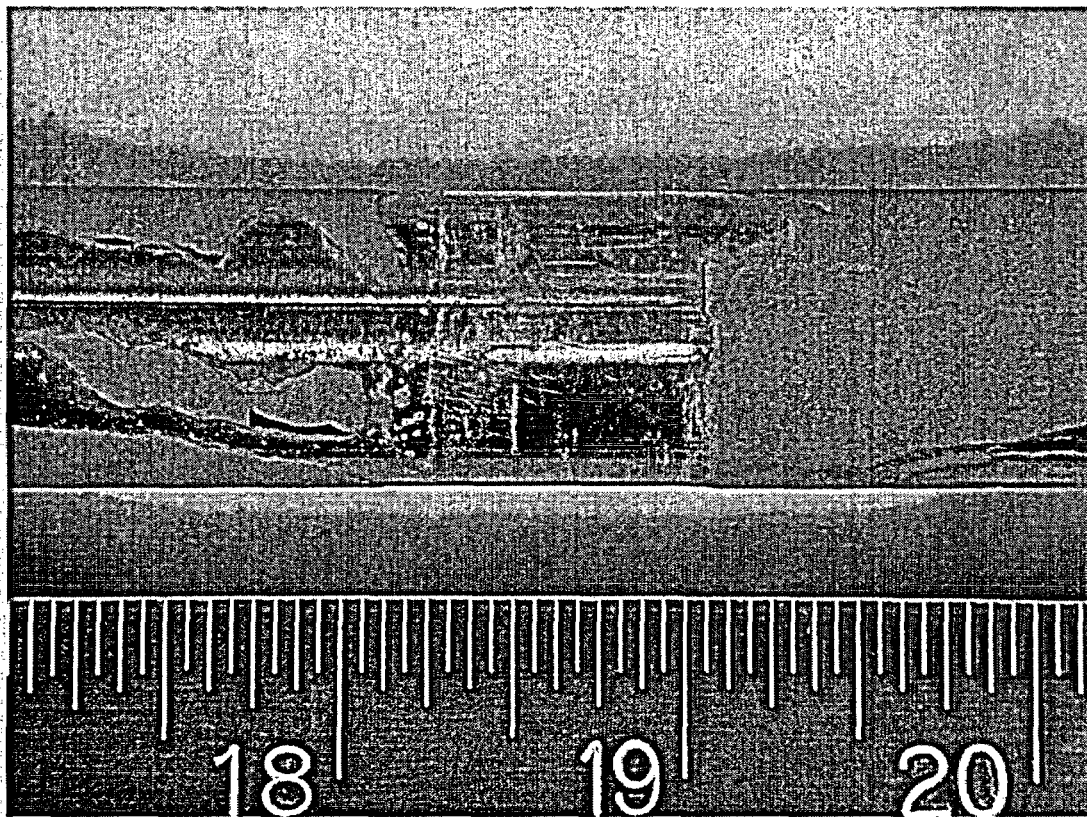
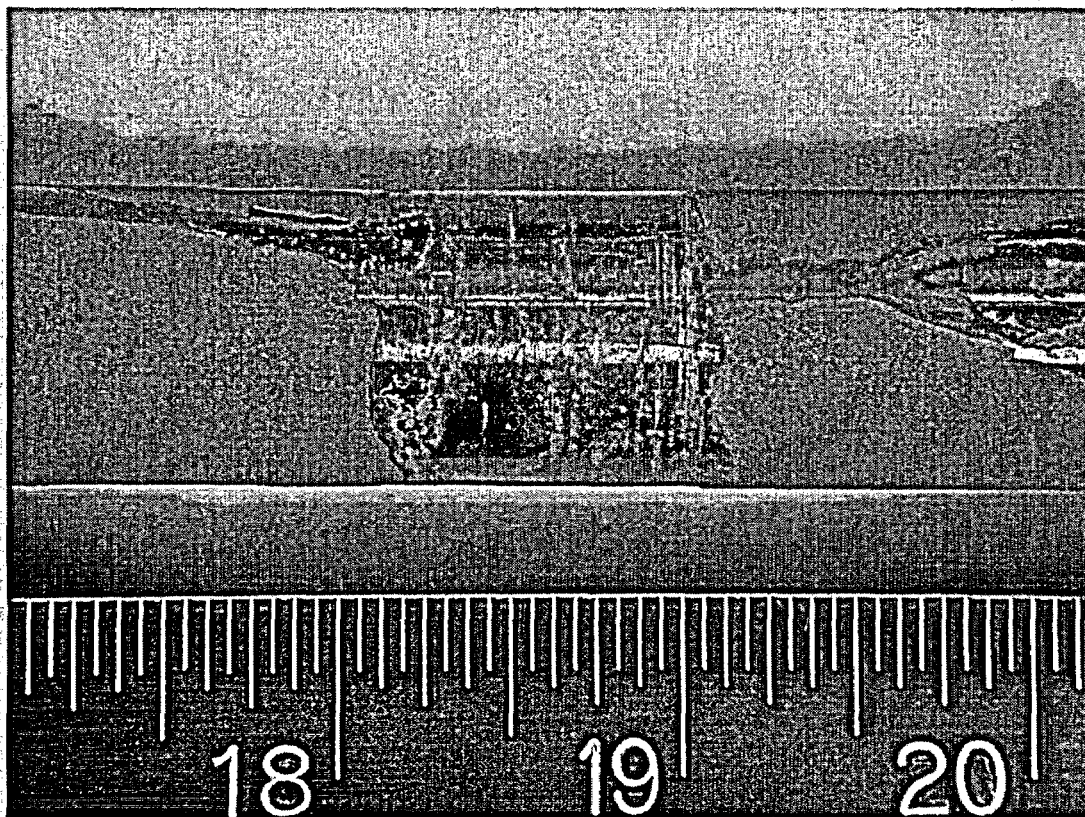
Figure 19. R44C45-13A at 0° 1.9X

Figure 20. R44C45-13A at 45° 1.9X

Figure 21. R44C45-13A at 90° 1.9X

Figure 22. R44C45-13A at 135° 1.9X

Figure 23. R44C45-13A at 180° 1.9X

Figure 24. R44C45-13A at 225° 1.9X

Figure 25. R44C45-13A at 270° 1.9X

Figure 26. R44C45-13A at 315° 1.9X

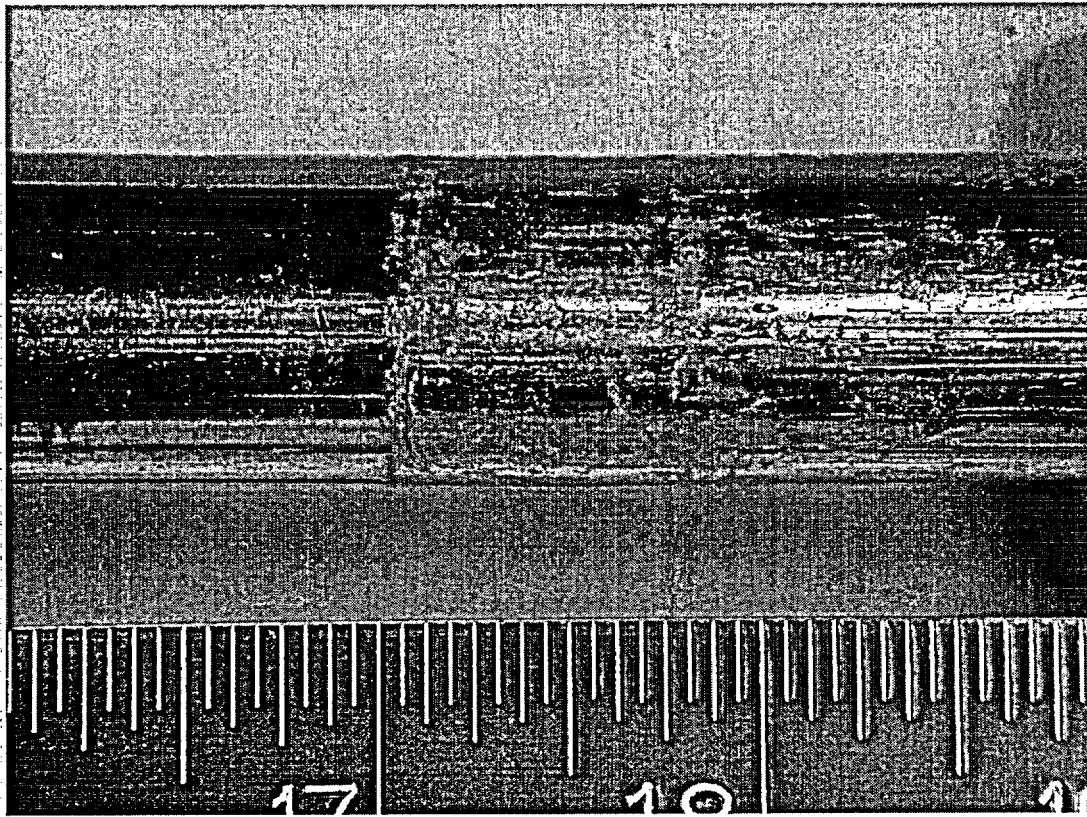
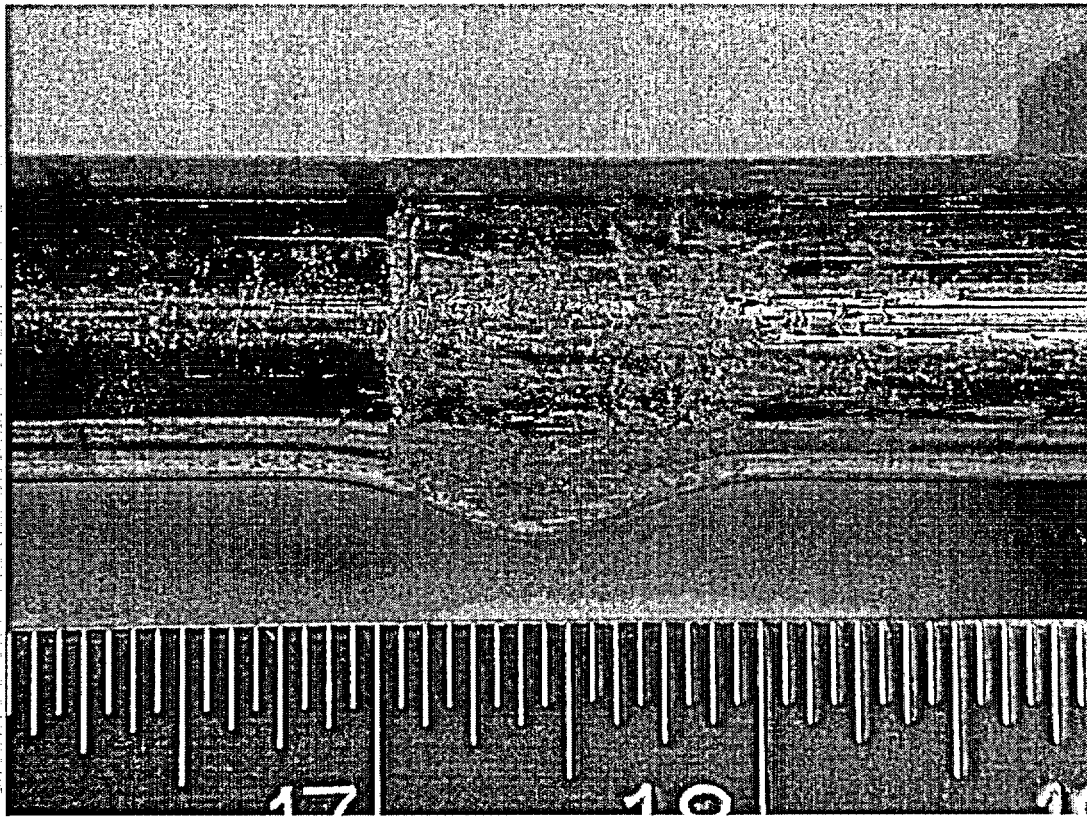
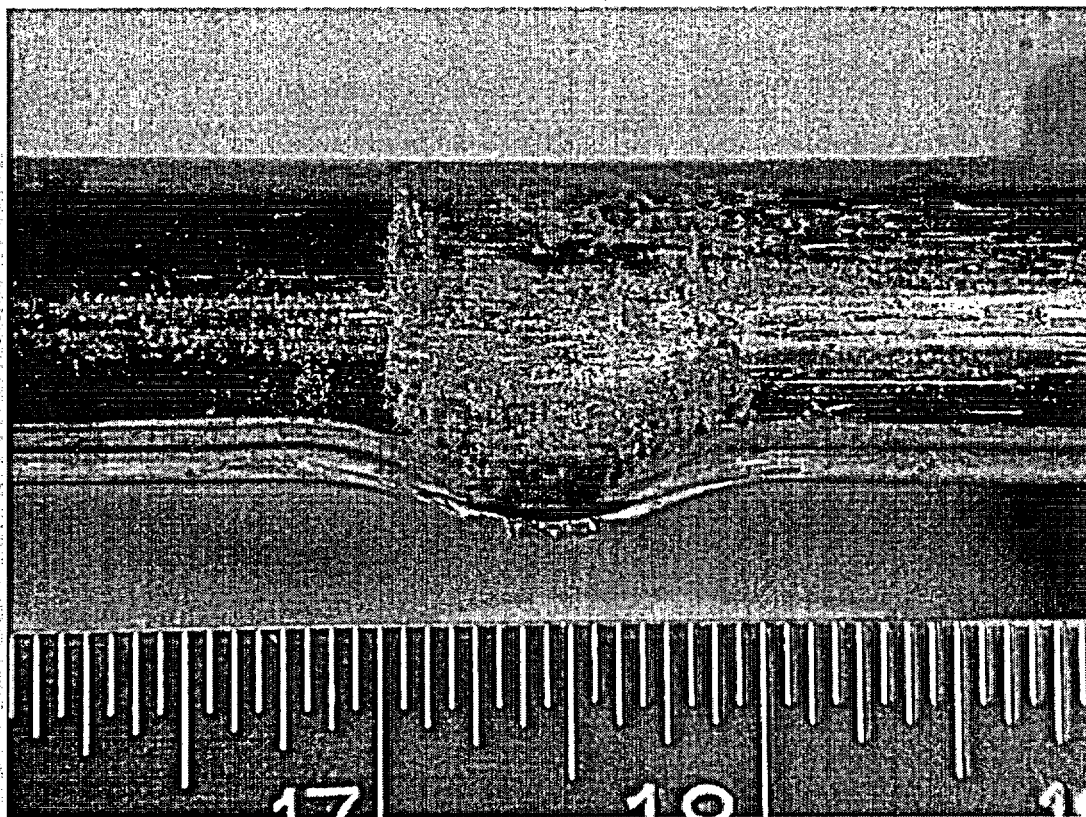
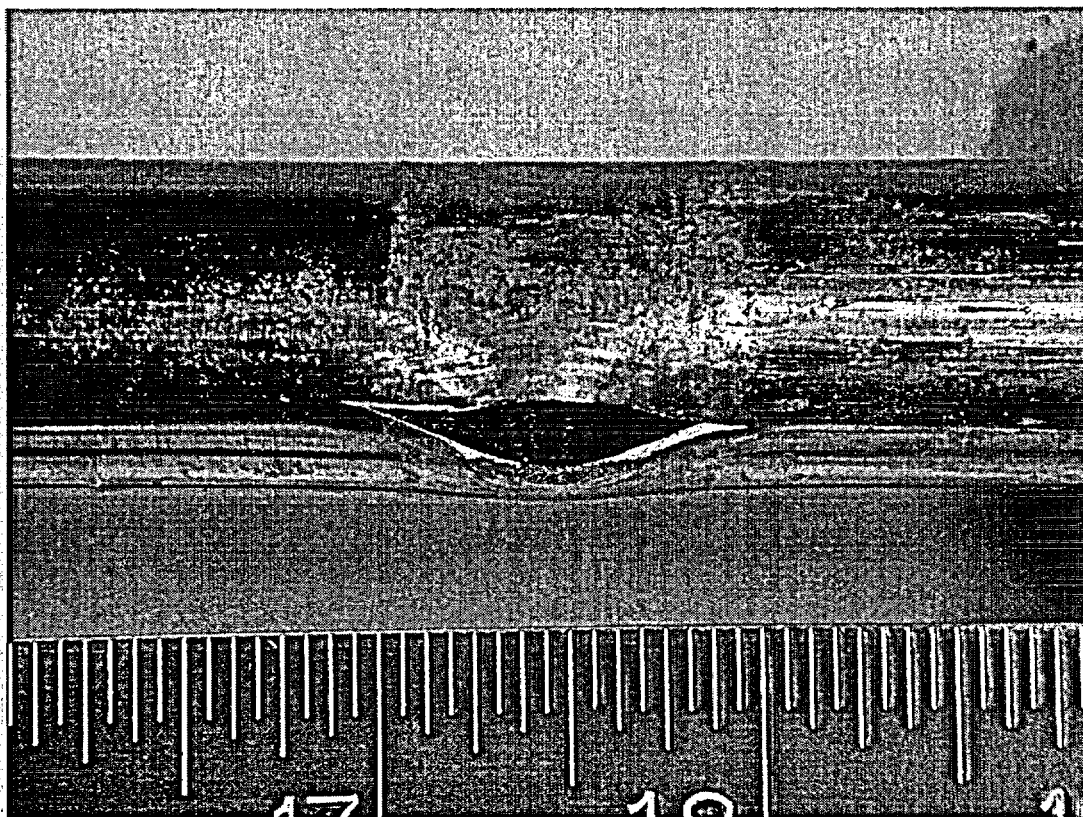
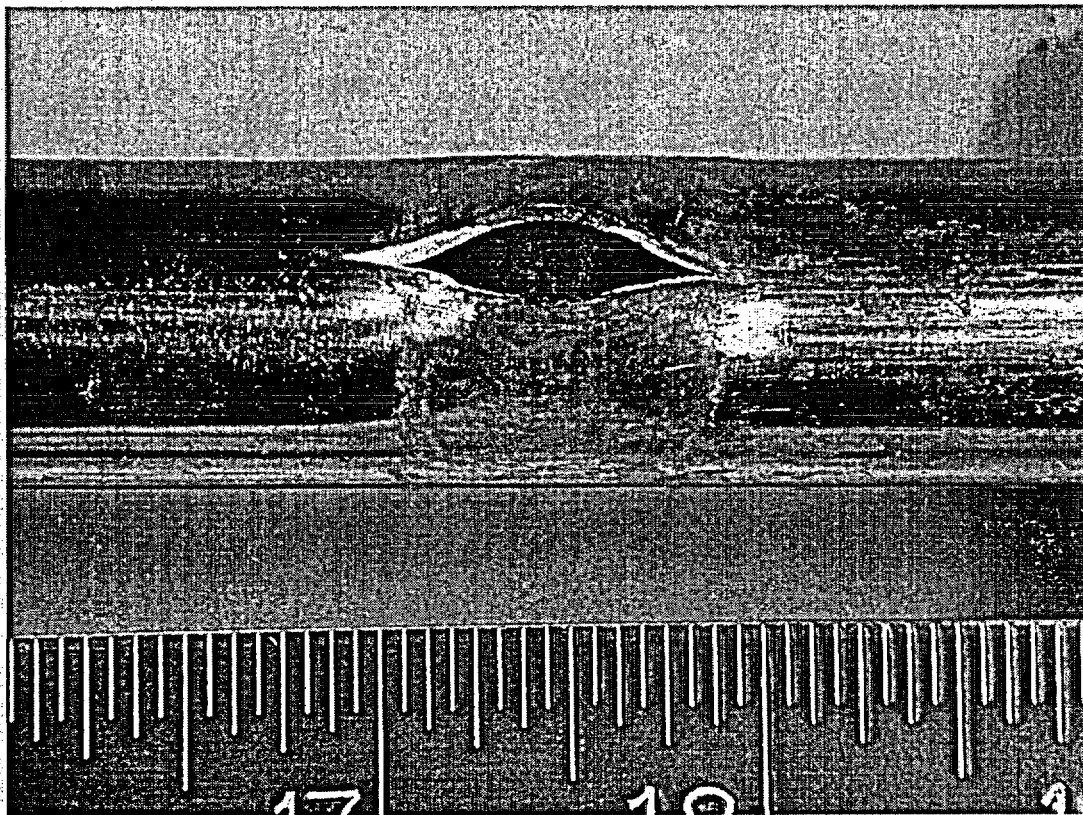
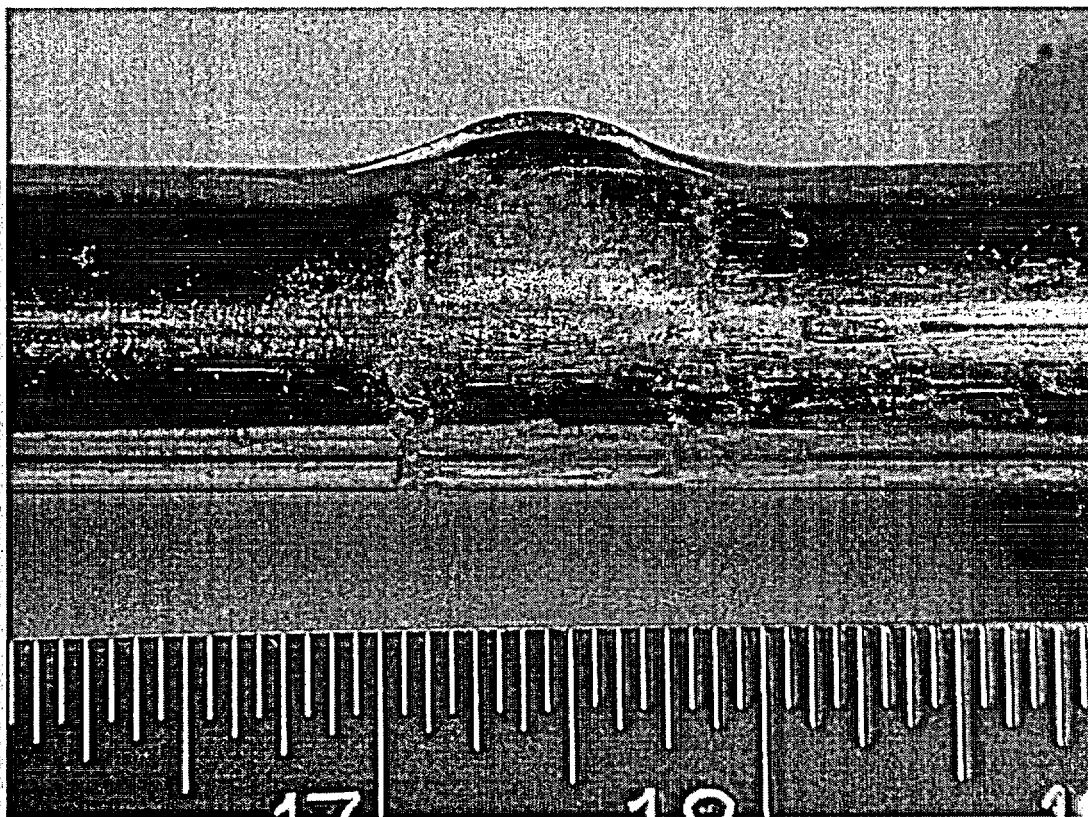
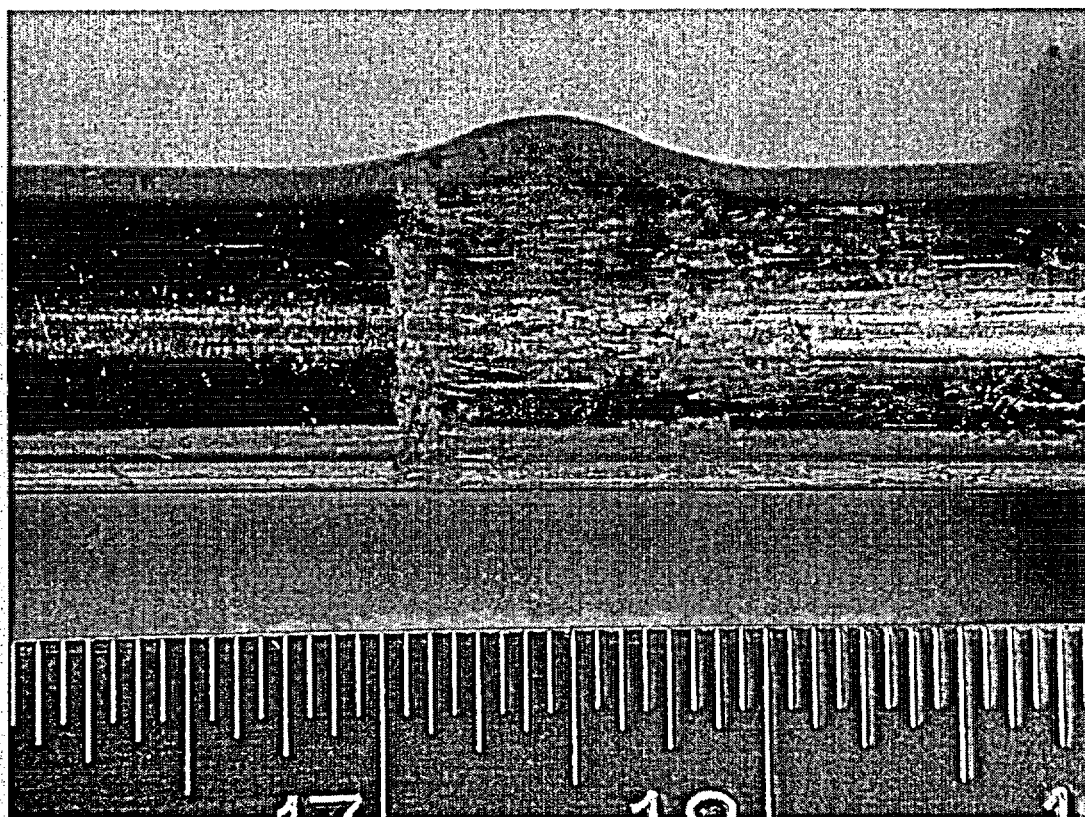
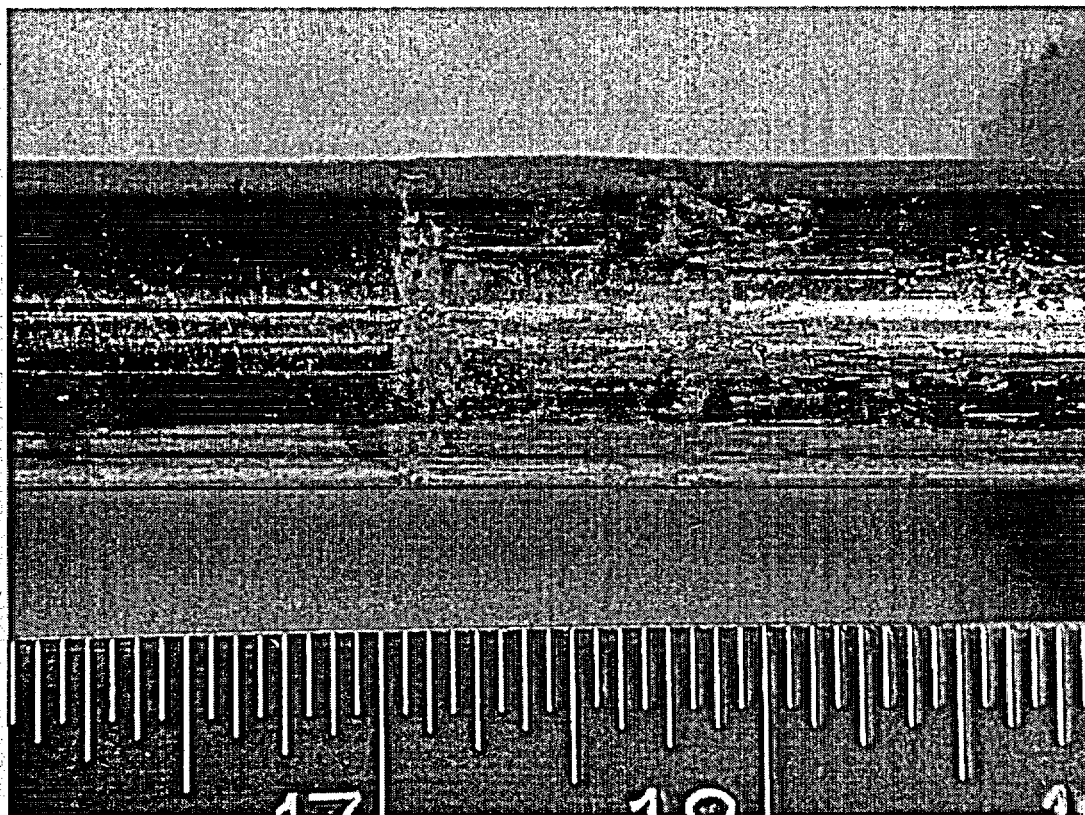
Macro photographs of this tube section in 45° intervals are provided in Figures 38-45, and a similar photograph centered over the fish mouth opening at 170° is provided in Figure 46. Higher magnification photographs of the fracture surfaces showing the extent of oxidation from the post-leak oxidation process is provided in Figures 47 and 48. The burst region was at approximately 170°, with the bottommost extent of the oxidized defect region at ~0.2" from the bottom of the TSP. SEM fractography (Section 2.9) later revealed a total axial extent of ~0.52", and a through wall length of ~0.23".

Figure 38. R35C57-8B at 0° after burst testing. 2.1X

Figure 39. R35C57-8B at 45° after burst testing. 2.1X

Figure 40. R35C57-8B at 90° after burst testing. 2.1X

**Figure 41. R35C57-8B at 135° after burst testing. 2.1X**

Figure 42. R35C57-8B at 180° after burst testing. 2.1X

Figure 43. R35C57-8B at 225° after burst testing. 2.1X

Figure 44. R35C57-8B at 270° after burst testing. 2.1X

Figure 45. R35C57-8B at 315° after burst testing. 2.1X
