**FRAMATOME ANP REPORT 51-5027436-00**  
**"EXAMINATION OF DIABLO CANYON UNIT 2 SG TUBES – FINAL REPORT"**

## **Examination of Diablo Canyon Unit 2 Steam Generator Tubes**

**51-5027436-00**

**Final Report, May 2003**

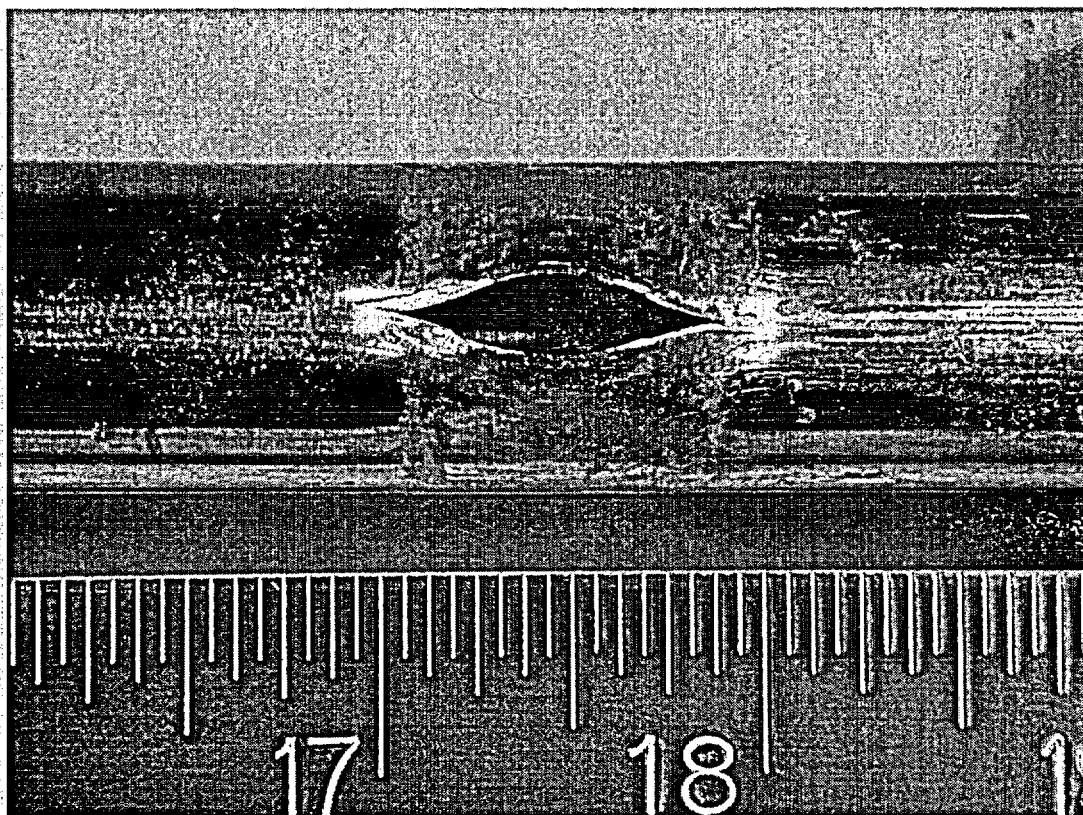
Macro photographs of this tube section in 45° intervals are provided in Figures 38-45, and a similar photograph centered over the fish mouth opening at 170° is provided in Figure 46. Higher magnification photographs of the fracture surfaces showing the extent of oxidation from the post-leak oxidation process is provided in Figures 47 and 48. The burst region was at approximately 170°, with the bottommost extent of the oxidized defect region at ~0.2" from the bottom of the TSP. SEM fractography (Section 2.9) later revealed a total axial extent of ~0.52", and a through wall length of ~0.23".

Figure 46. R35C57-8B at fish mouth opening at 170° after burst testing. 2.1X

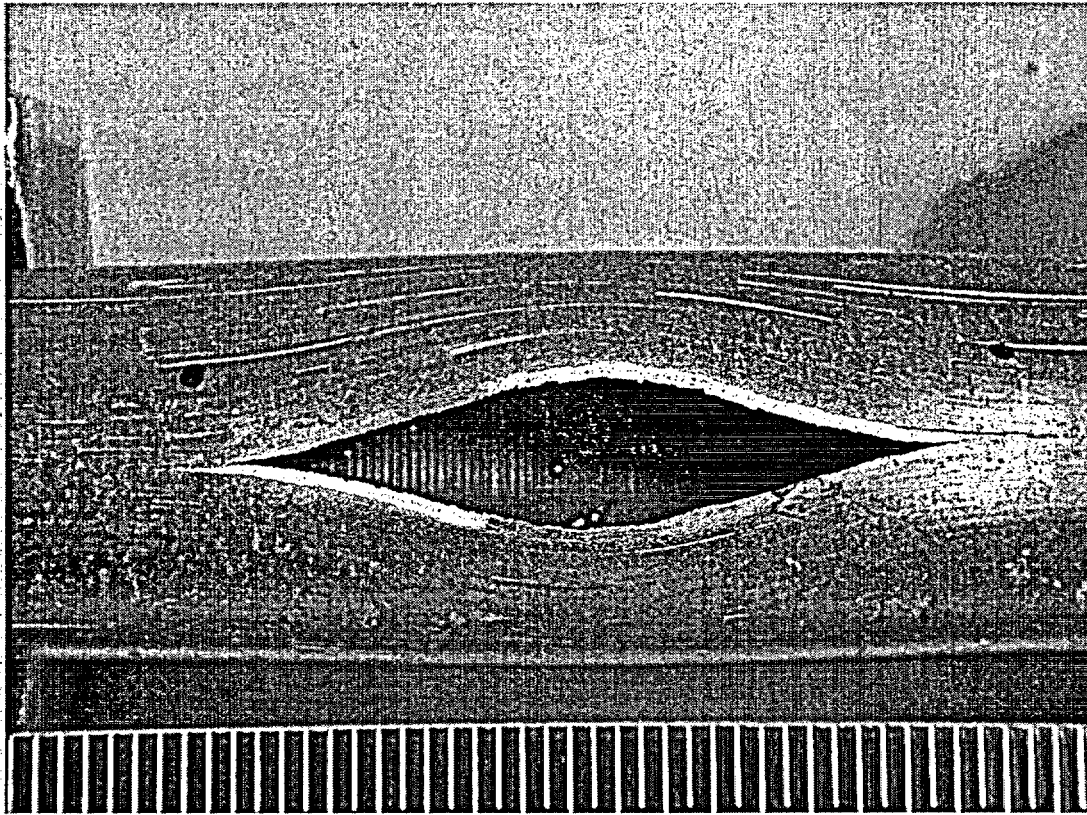
The fish mouth rupture on free span specimen R35C57-9B occurred near 135°, and a photograph of the burst rupture is provided in Figure 49. As described in Section 2.9, SEM fractography later verified that the failure was completely ductile, with no IGSCC.

Figure 49. Free span burst region on R35C57-9B. 2.1X

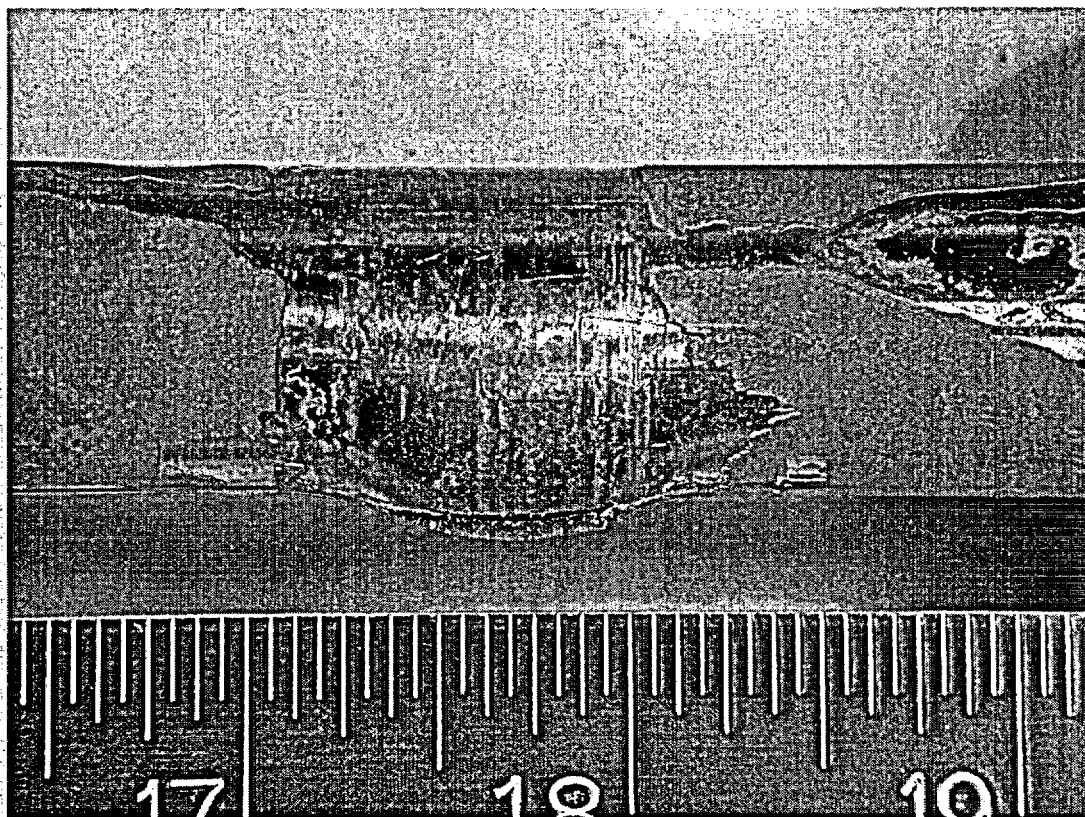
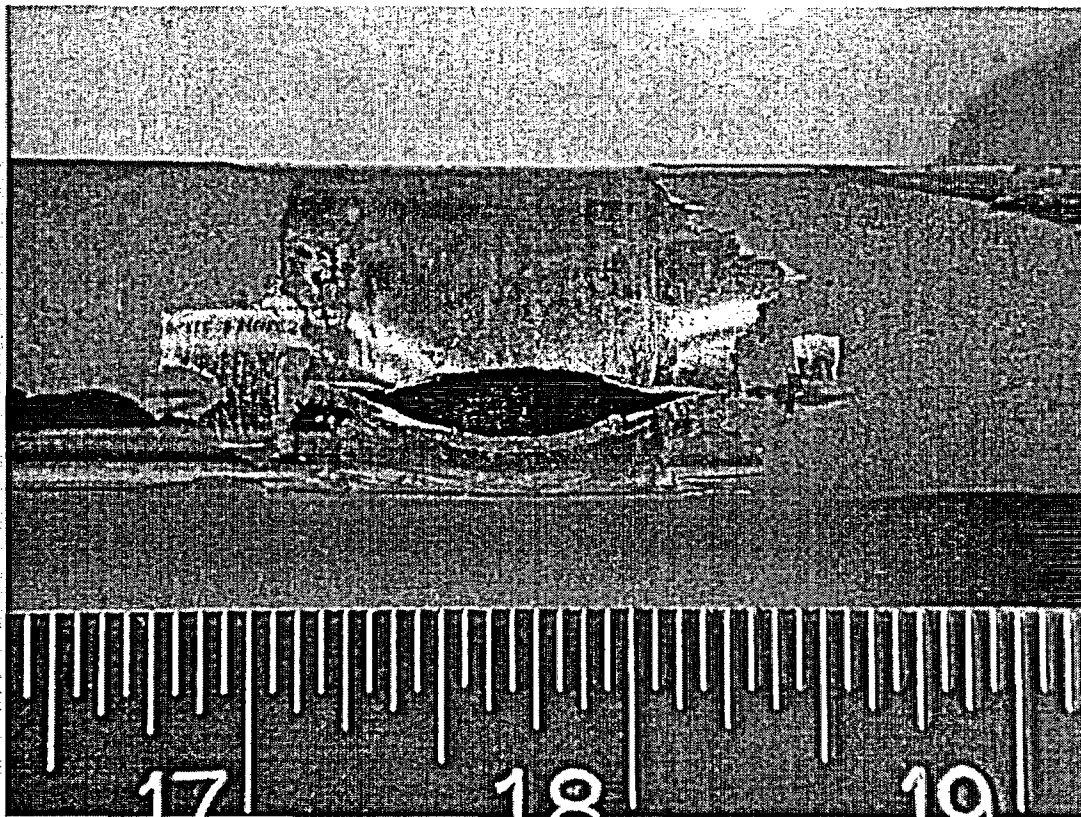
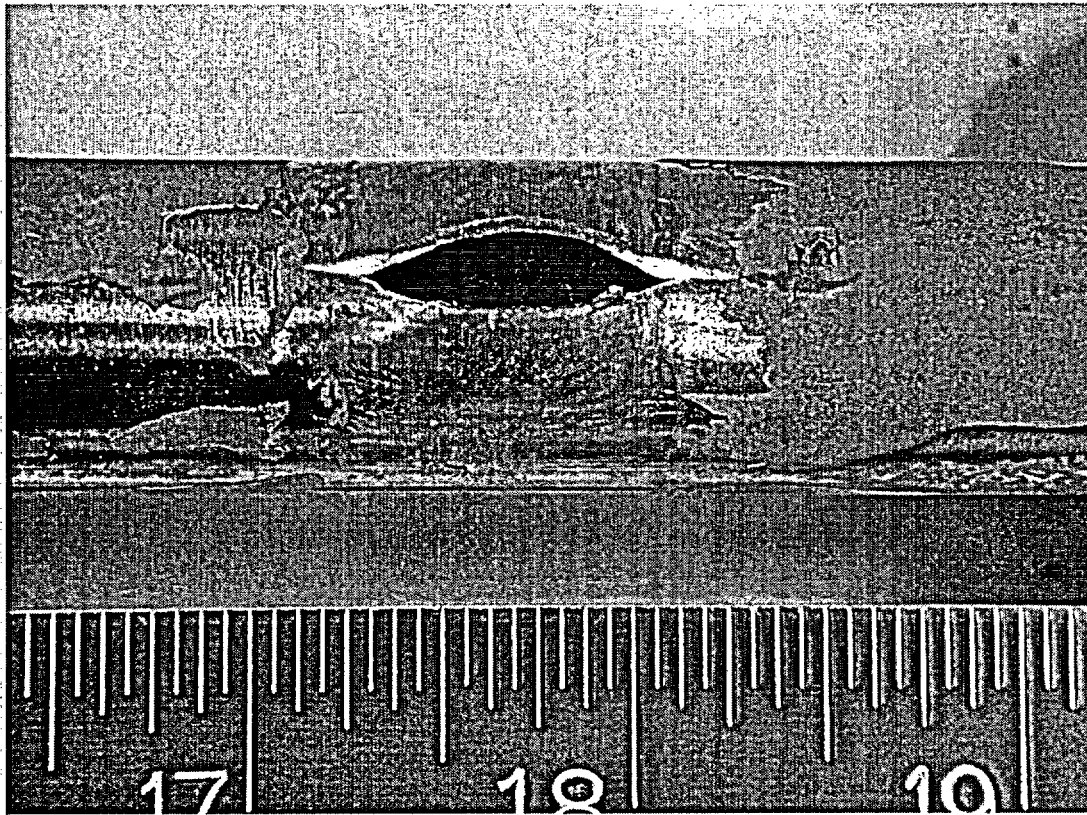
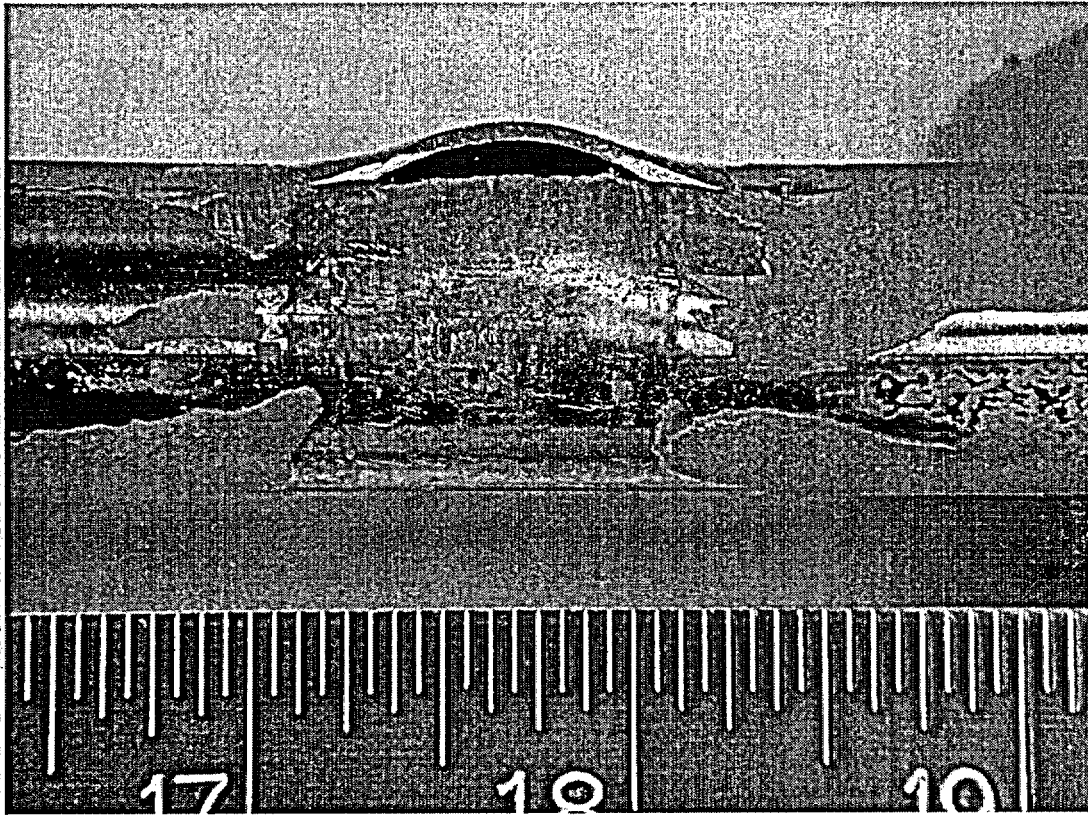
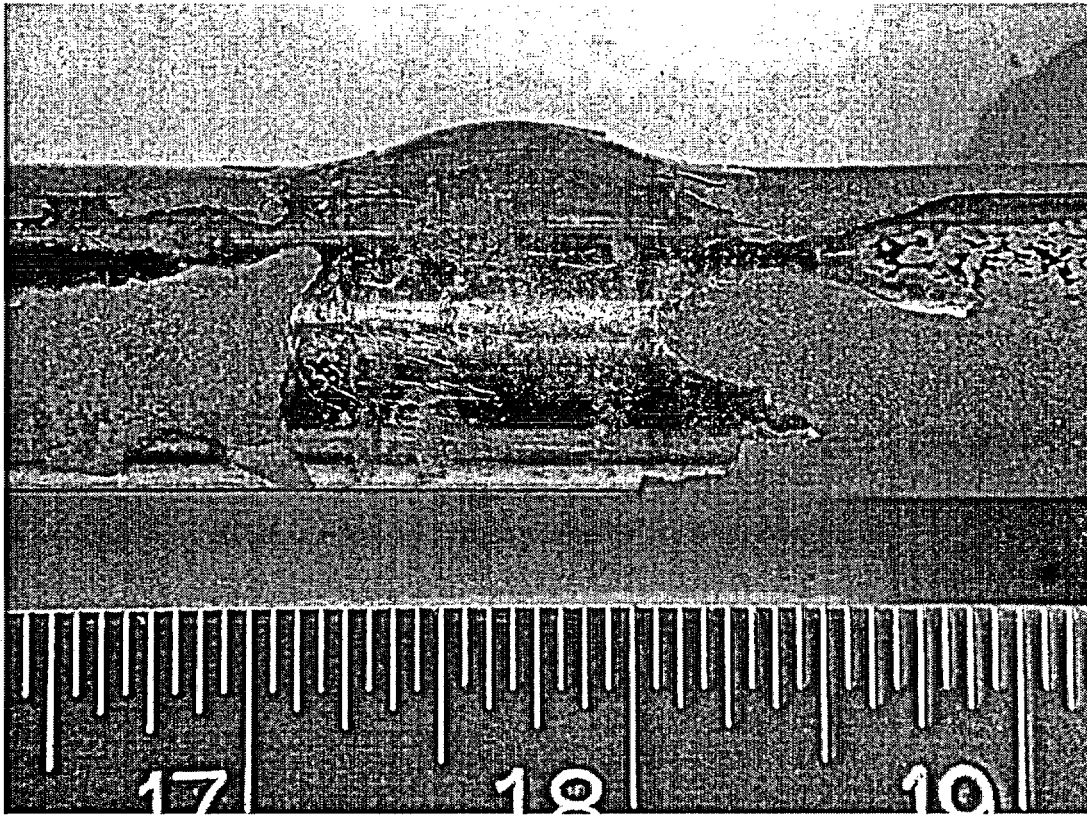
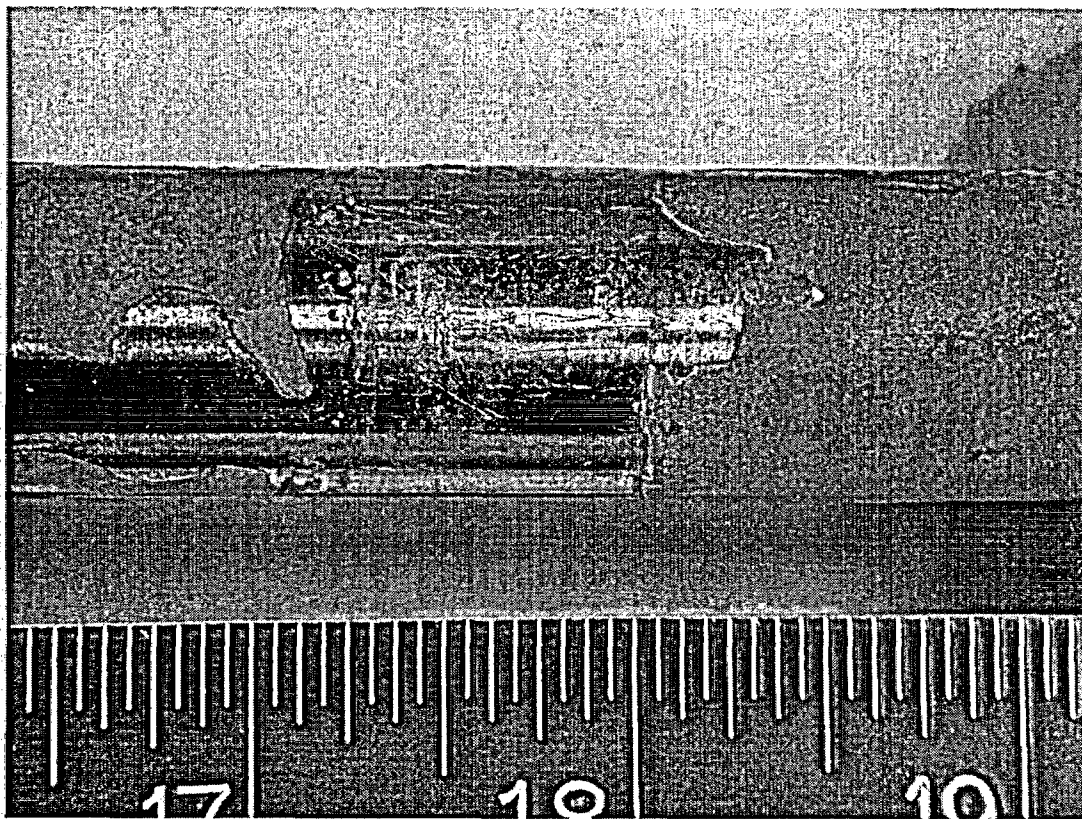
Figure 51. R44C45-13A2B1 at 0° after burst testing. 2.1X

Figure 52. R44C45-13A2B1 at 45° after burst testing. 2.1X

Figure 53. R44C45-13A2B1 at 90° after burst testing. 2.1X

Figure 54. R44C45-13A2B1 at 135° after burst testing. 2.1X

Figure 55. R44C45-13A2B1 at 180° after burst testing. 2.1X

Figure 56. R44C45-13A2B1 at 225° after burst testing. 2.1X

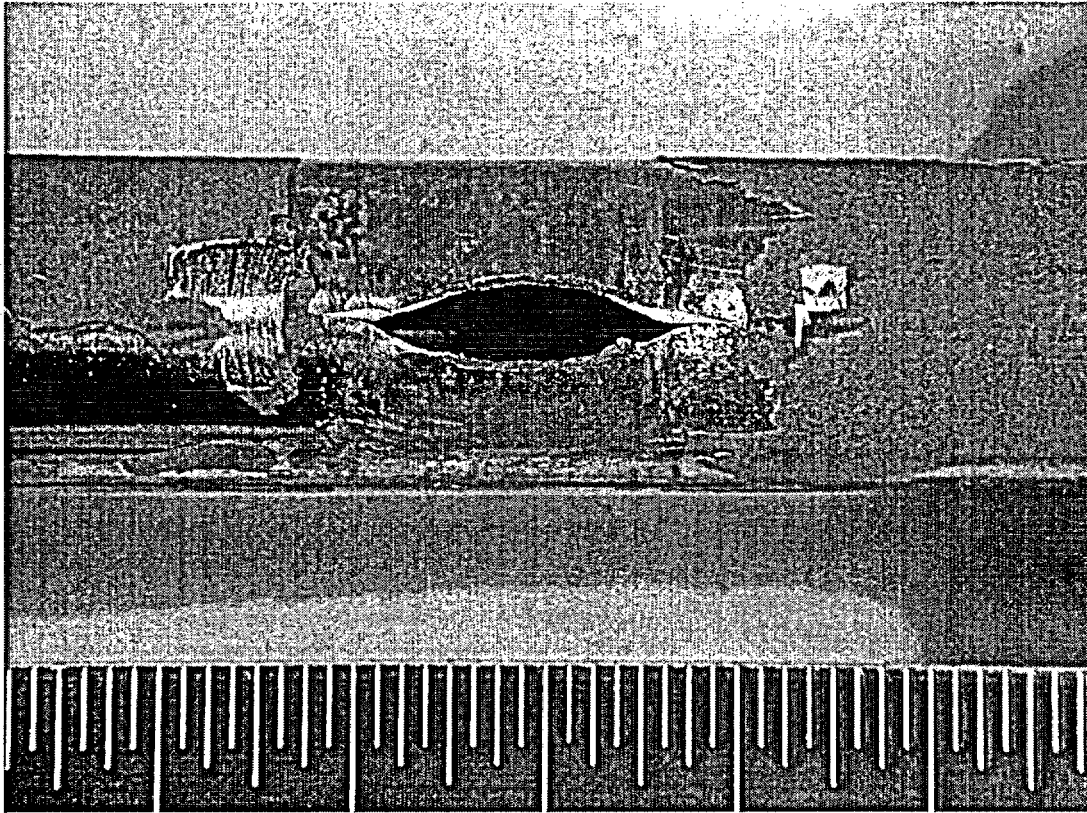
Figure 59. R44C45-13A2B1 at fish mouth opening at 90° after burst testing. 2.1X

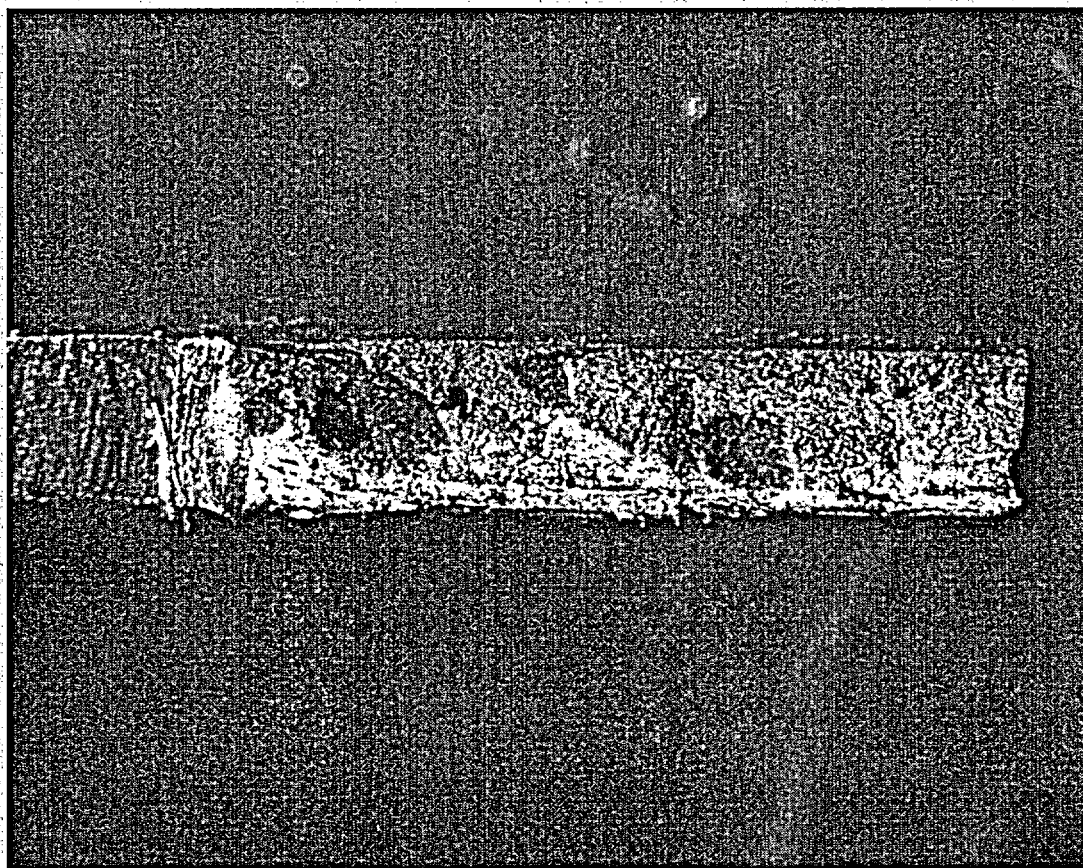
Figure 64. CCW fracture surface of lower half of section through crack at 25° on R44C45 in 2H TSP. 16.6X

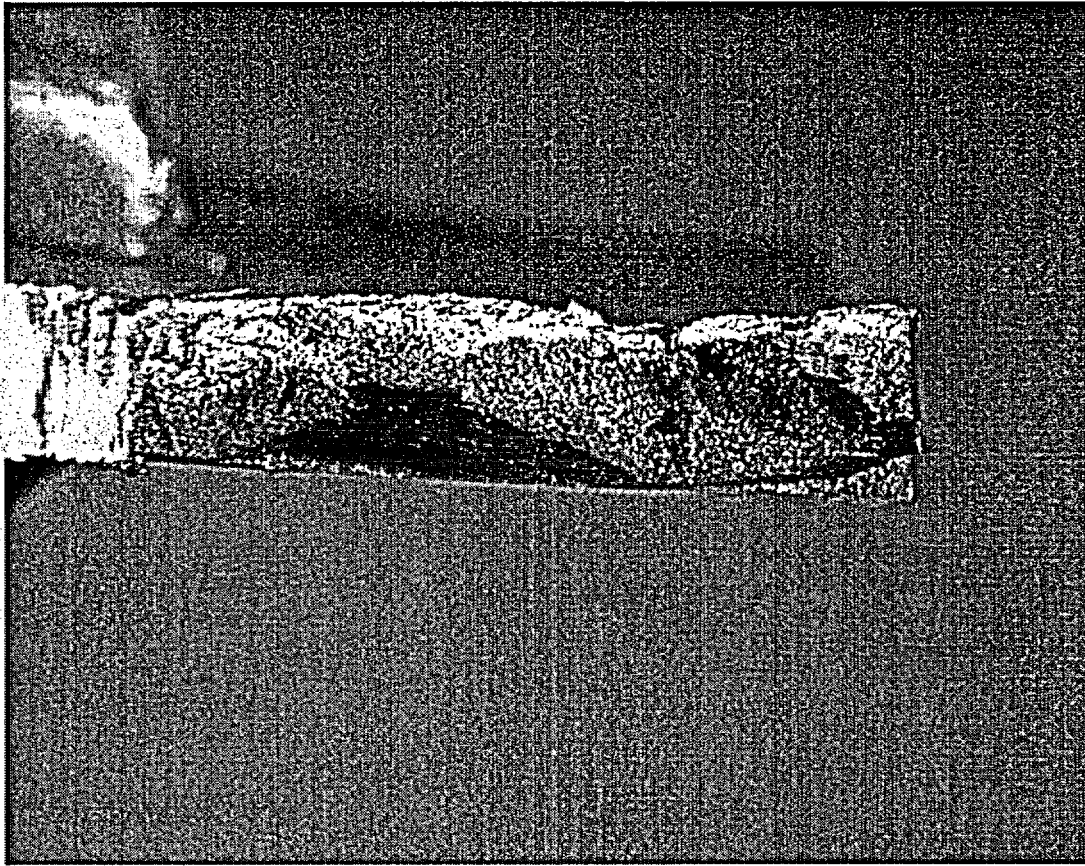
**Figure 65. CW fracture surface of lower half of section through crack at 25° on  
R44C45 in 2H TSP. 16.6X**

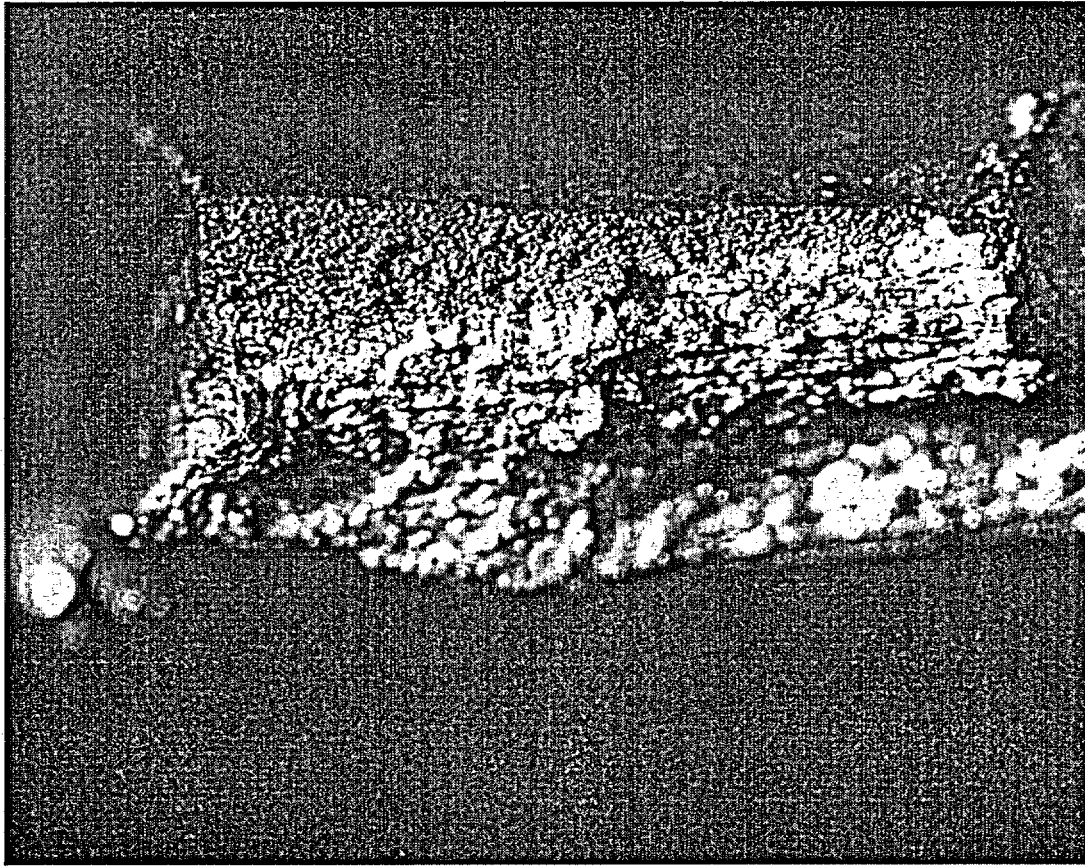
Figure 66. CCW fracture surface of upper half of section through crack at 25° on R44C45 in 2H TSP.

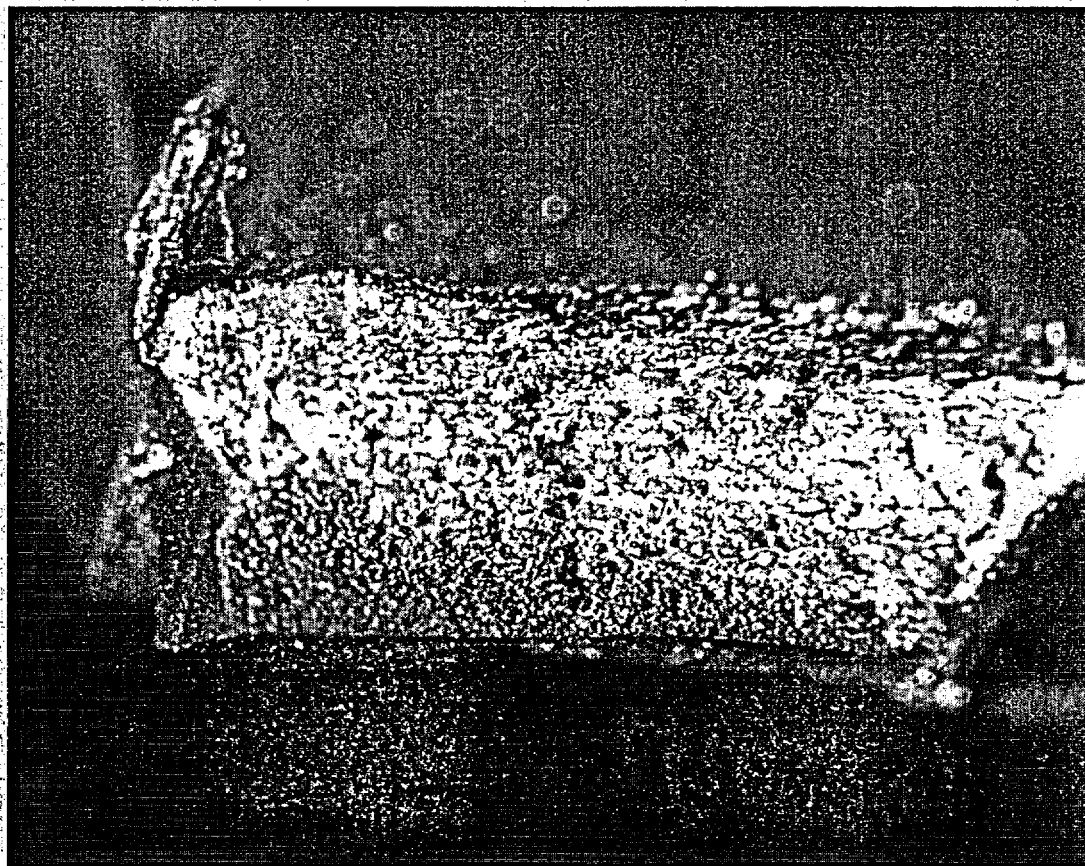
Figure 67. CW fracture surface of upper half of section through crack at 25° on R44C45 in 2H TSP.

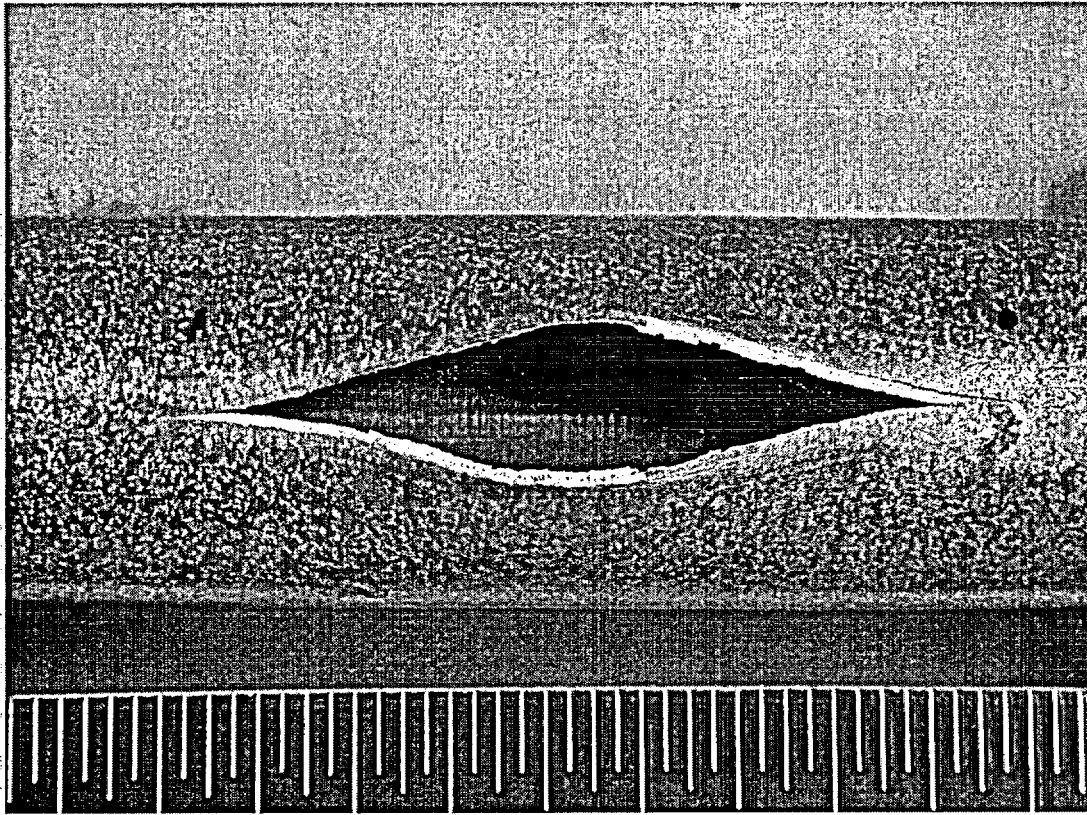
Figure 68. Free span burst region on R44C45-13B2. 2.1X

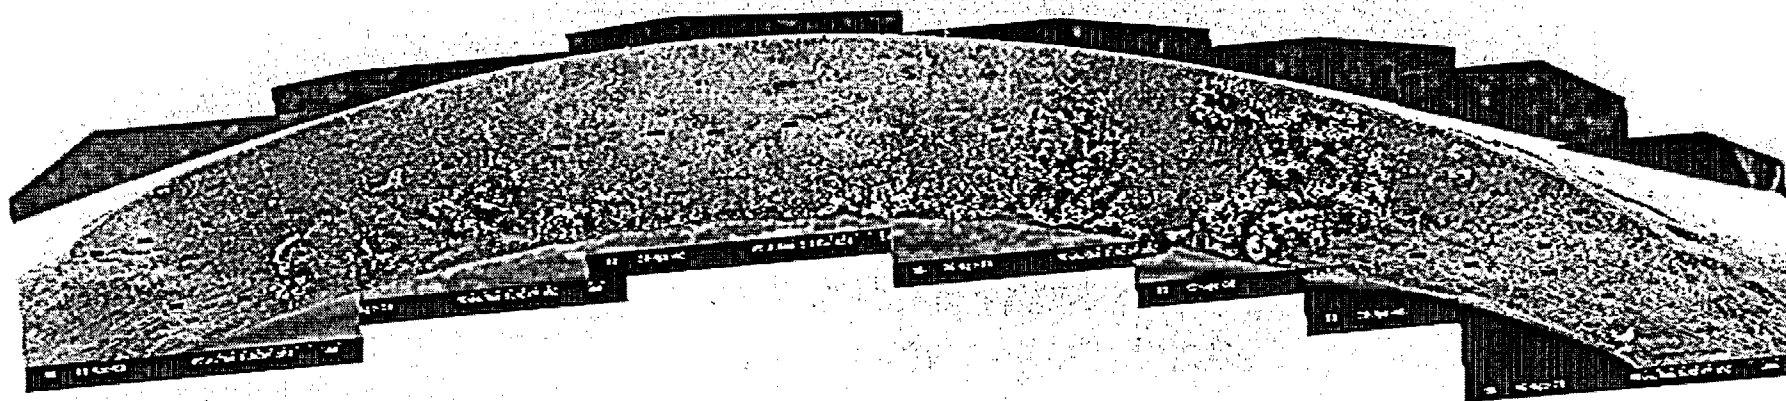
Figure 70. Overall mosaic of R35C57-8B2B. SE 20X

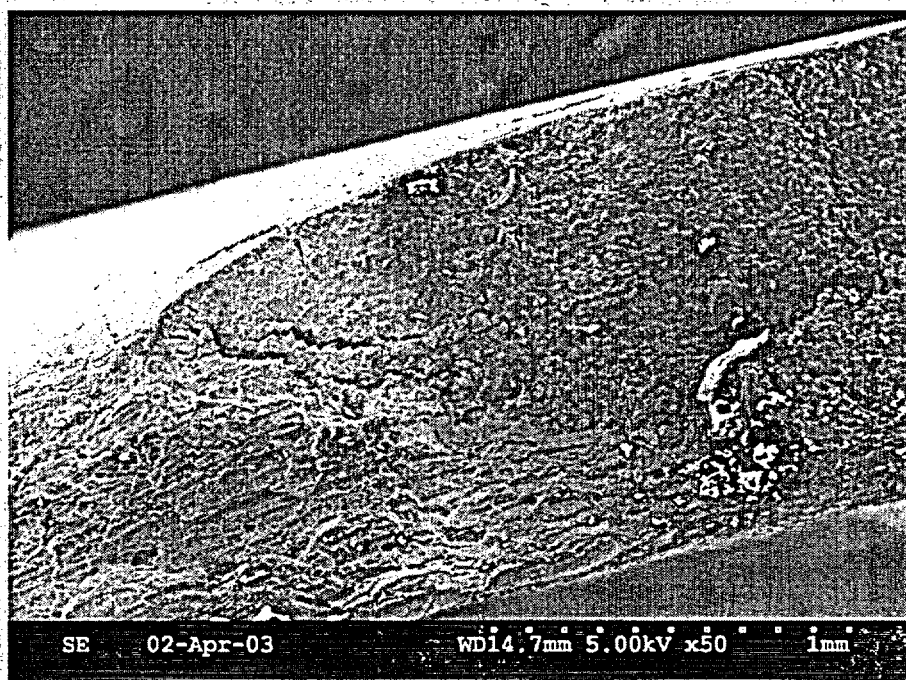
Figure 71. Bottom edge of IGSCC region on R35C57-8B2B.

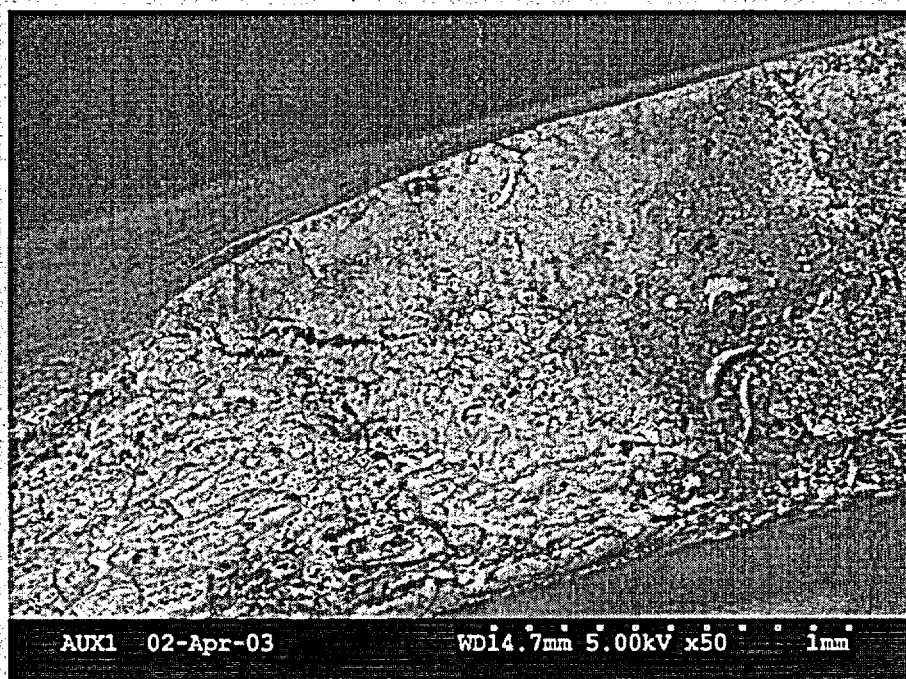
Figure 72. Bottom edge of IGSCC region on R35C57-8B2B.

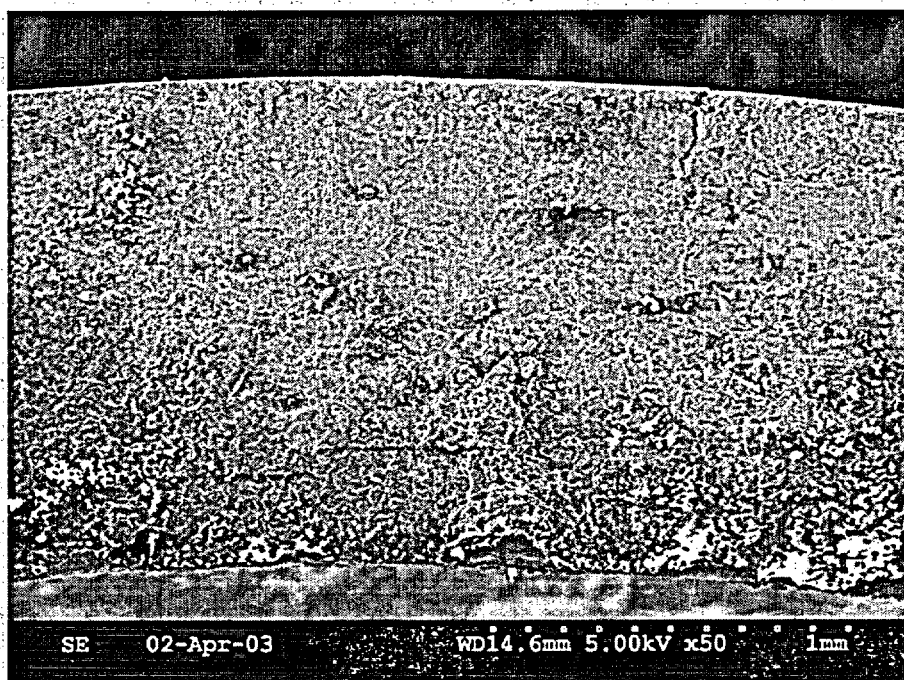
Figure 73. Near center of IGSCC region on R35C57-8B2B.

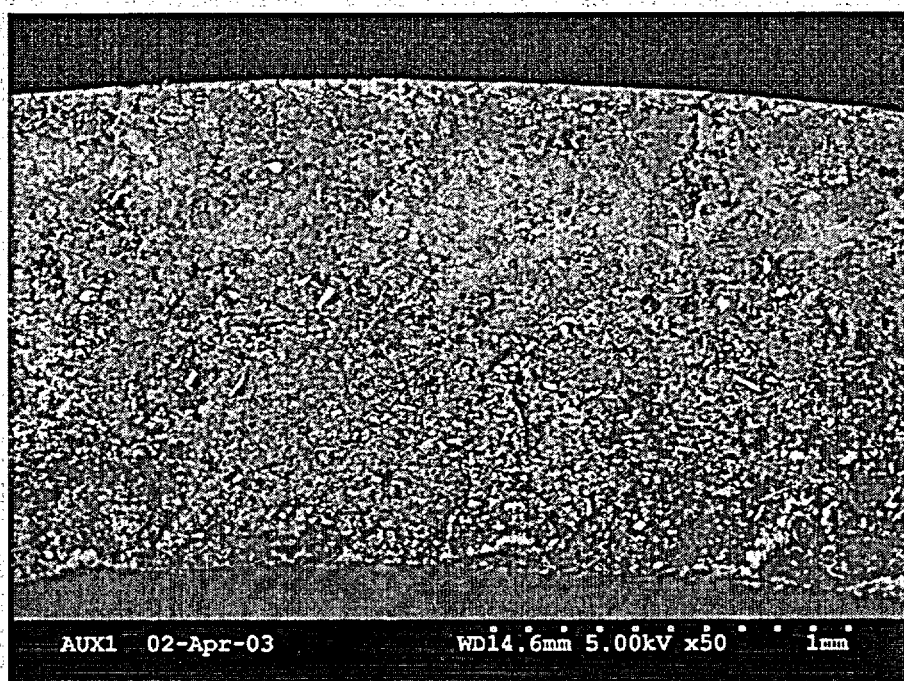
Figure 74. Near center of IGSCC region on R35C57-8B2B.

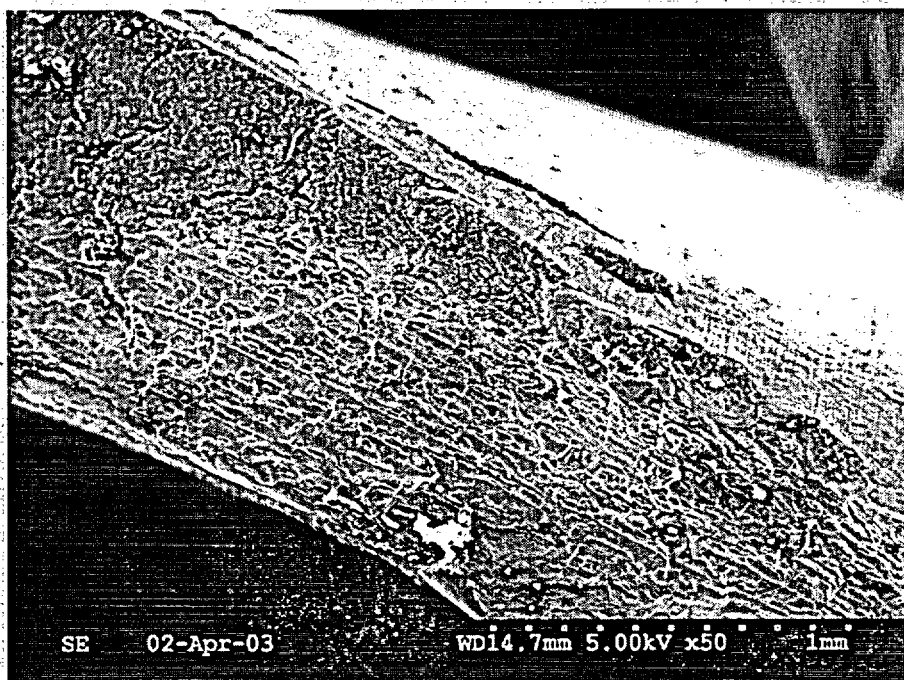
Figure 75. Near top edge of IGSCC region on R35C57-8B2B.

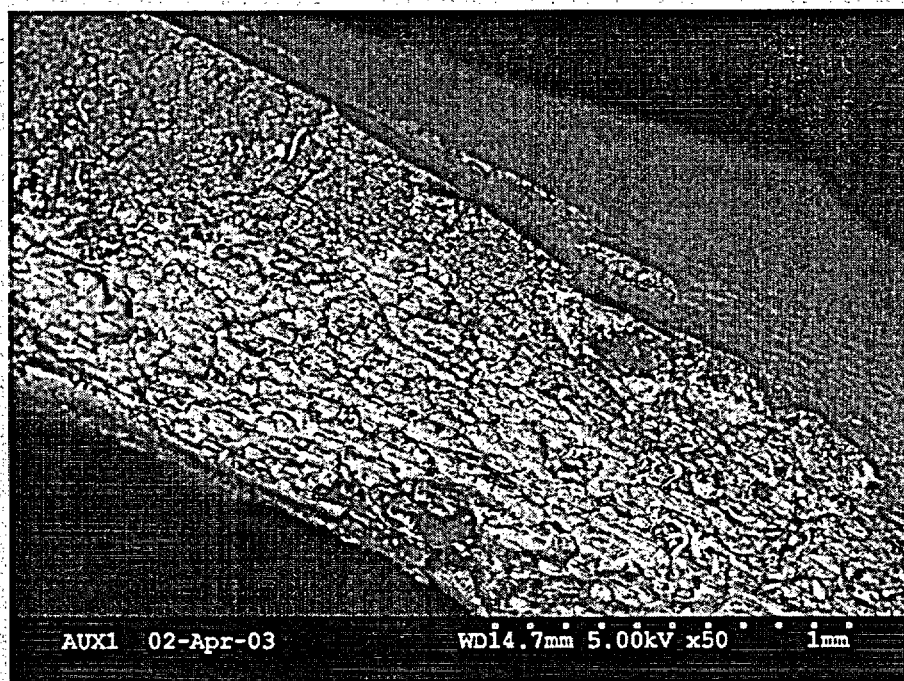
Figure 76. Near top edge of IGSCC region on R35C57-8B2B.

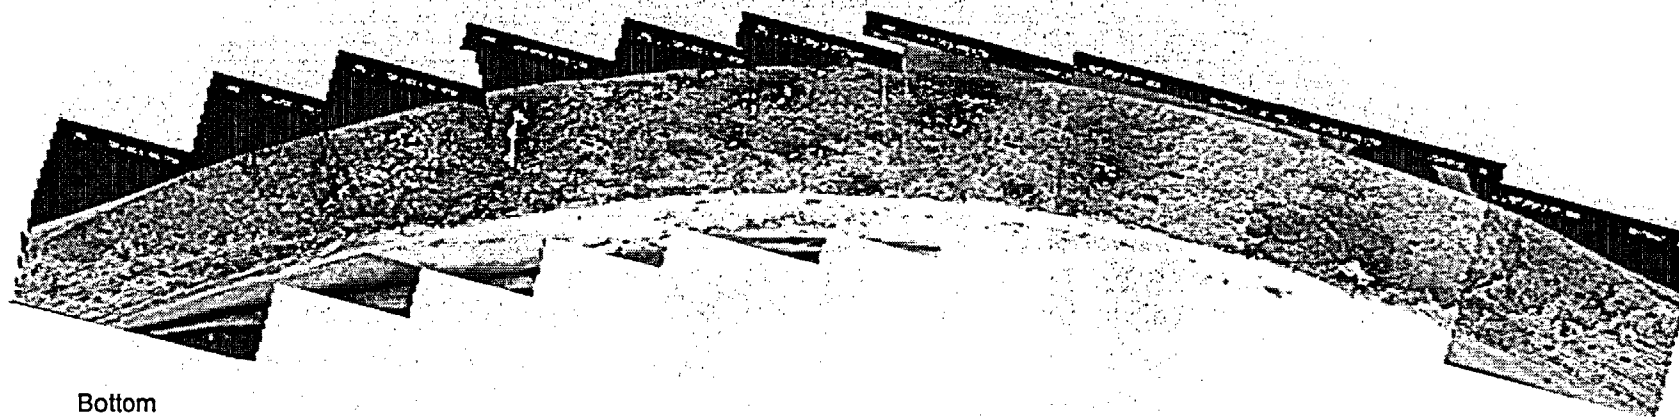
A low magnification photo mosaic of the counterclockwise (CCW) fracture surface from R44C45-13A2B1 is provided in Figure 77. Surface details are largely obscured due to the heavy oxide layer on this surface (most of which is believed to have occurred in service, and not from the post-leak oxidation process). The black rectangles in this photo mosaic are from calibrated depth measurements made on the SEM.

**Figure 77. Overall mosaic of R44C45-13A2B1. SE 14X**

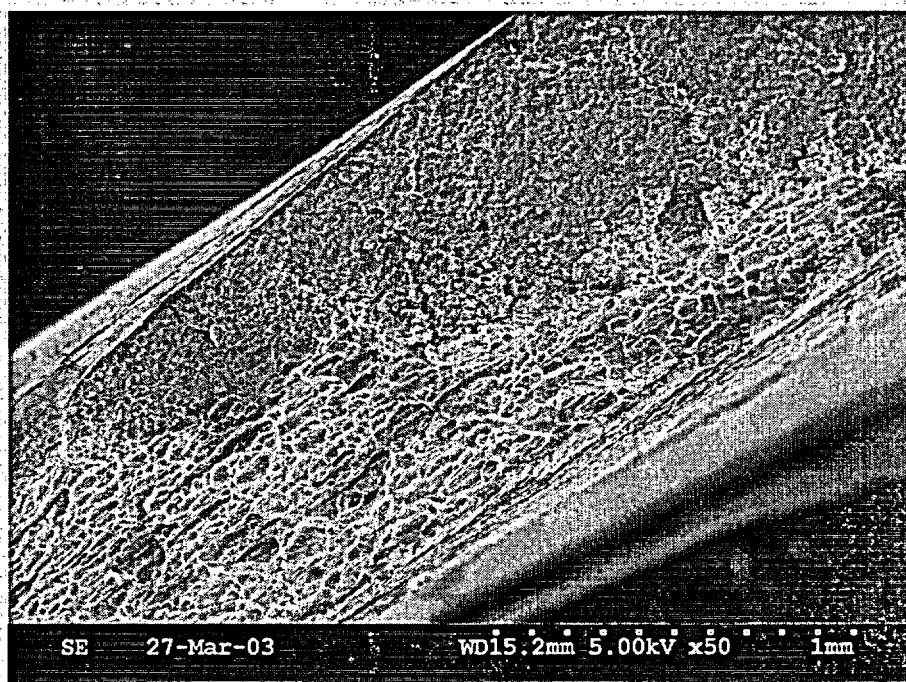
Figure 78. Bottom edge of IGSCC region on R44C45-13A2B1.

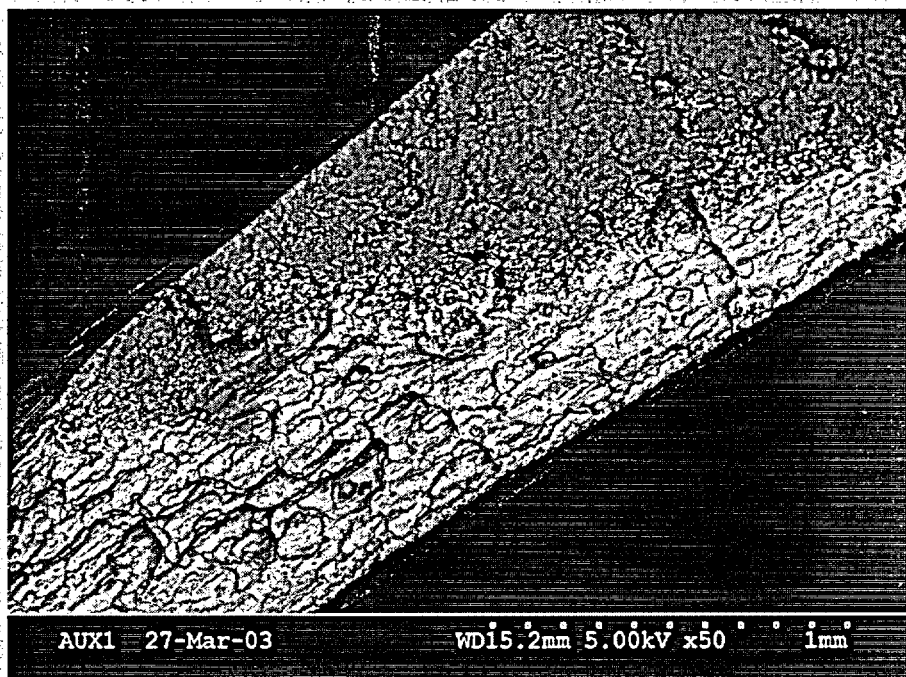
Figure 79. Bottom edge of IGSCC region on R44C45-13A2B1.

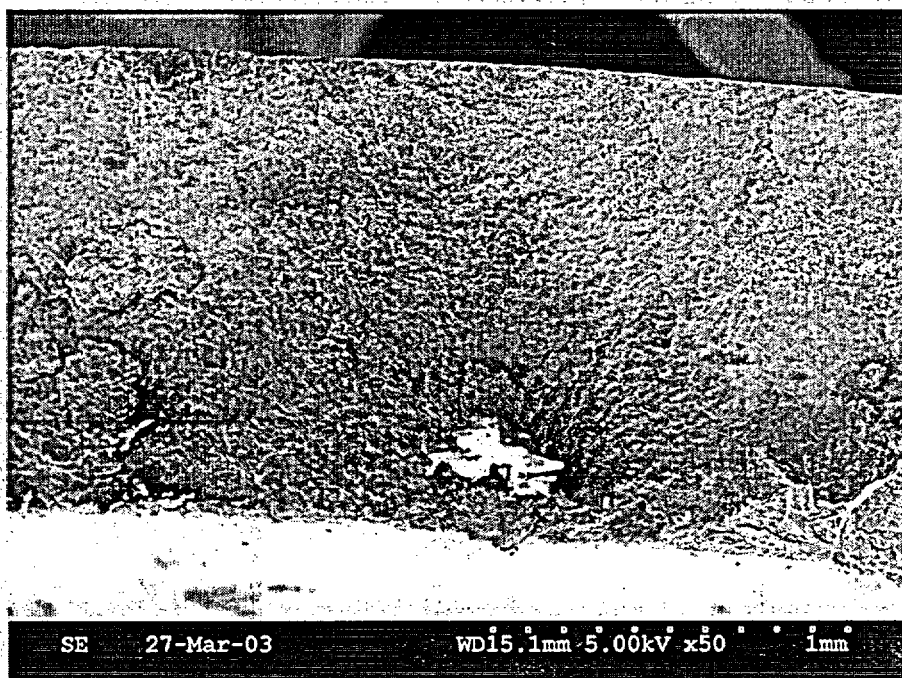
Figure 80. Near center of IGSCC region on R44C45-13A2B1.  
SE 50X

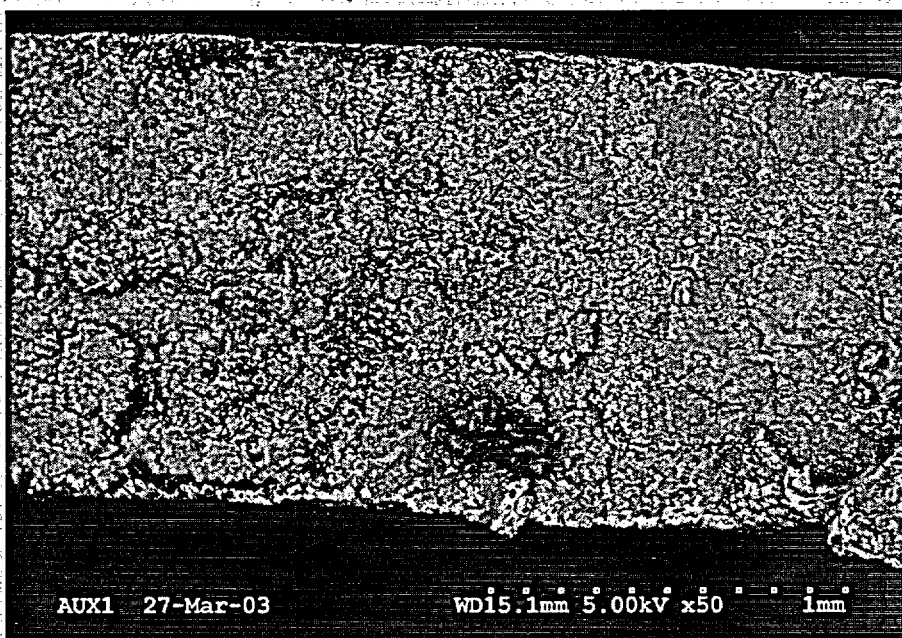
Figure 81. Near center of IGSCC region on R44C45-13A2B1.  
BSE 50X

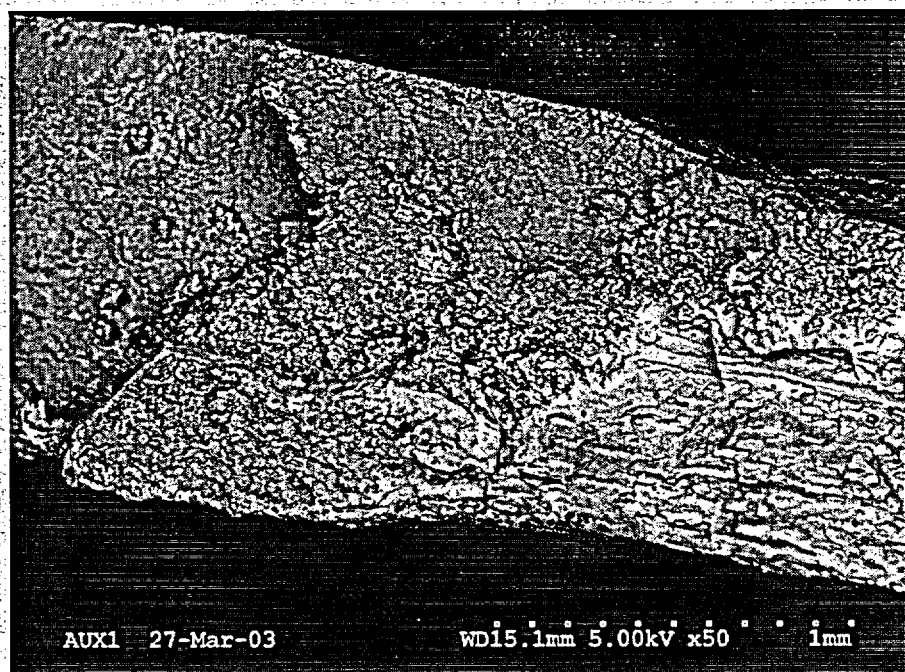
As can be seen in Figures 82 and 83, there is a small region of intergranular corrosion that is ~0.025 inches out-of-plane from the main crack. This region is typical of the main fracture surface, which is made up of several small crack segments joined together by intergranular corrosion. More discussion of the features observed in this region can be found in Appendix A.

Figure 83. Near top edge of IGSCC region on R44C45-13A2B1.

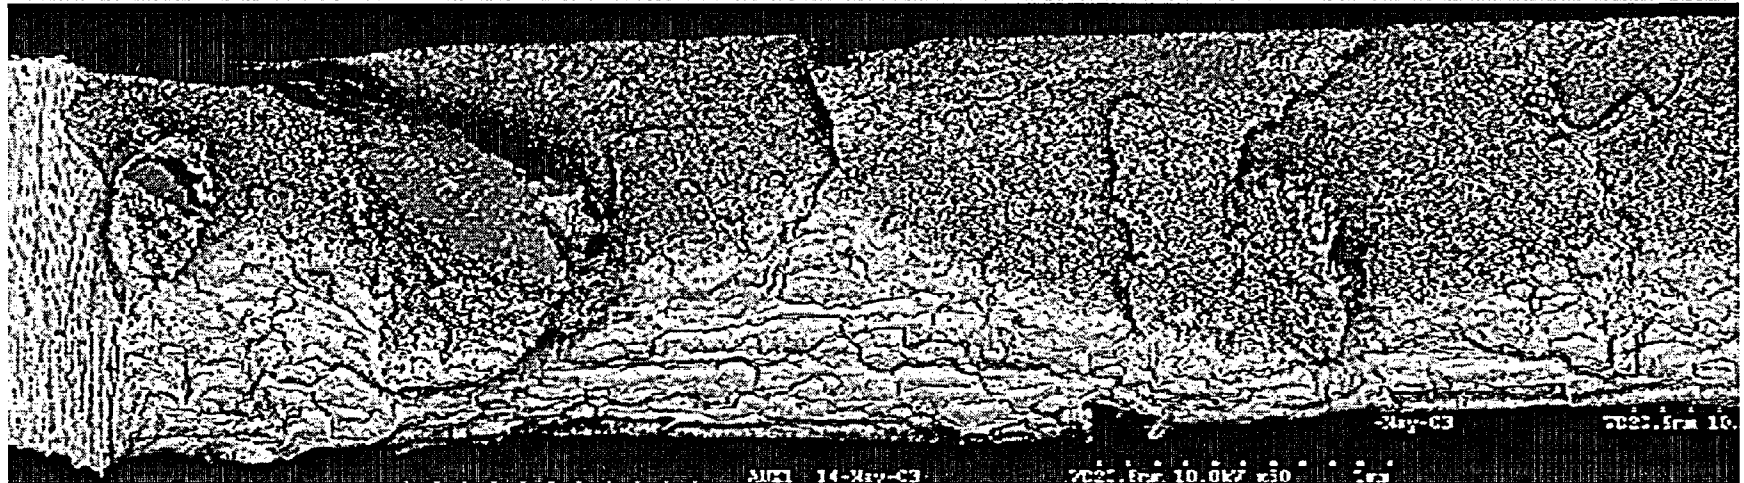
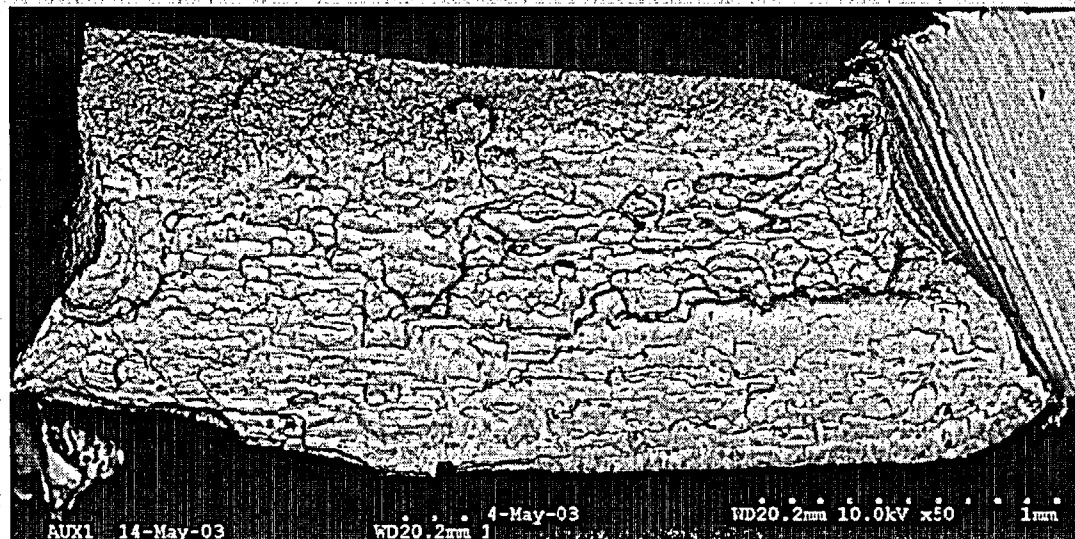
Figure 84. Mosaics of two sections comprising crack at 25° on R44C45

A photo mosaic of the two sections are provided in Figure 84. The missing saw kerf<sup>4</sup> between these two sections is ~0.02", and it is apparent that the very bottommost portion of IGSCC was cut into during the section removal process. However, the extent of this IGSCC is believed to be very minimal, based upon the small amount at the edge of the cut and visual examinations of the OD surface prior to removal.

Figure 84a. Overall BSE mosaic of R44C45-13A2B2A (bottommost section). 36X

Figure 84b. Overall BSE mosaic of R44C45-13A2B3A (topmost section). 42X
