**FRAMATOME ANP REPORT 51-5027436-00**  
**"EXAMINATION OF DIABLO CANYON UNIT 2 SG TUBES – FINAL REPORT"**

## **Examination of Diablo Canyon Unit 2 Steam Generator Tubes**

**51-5027436-00**

**Final Report, May 2003**

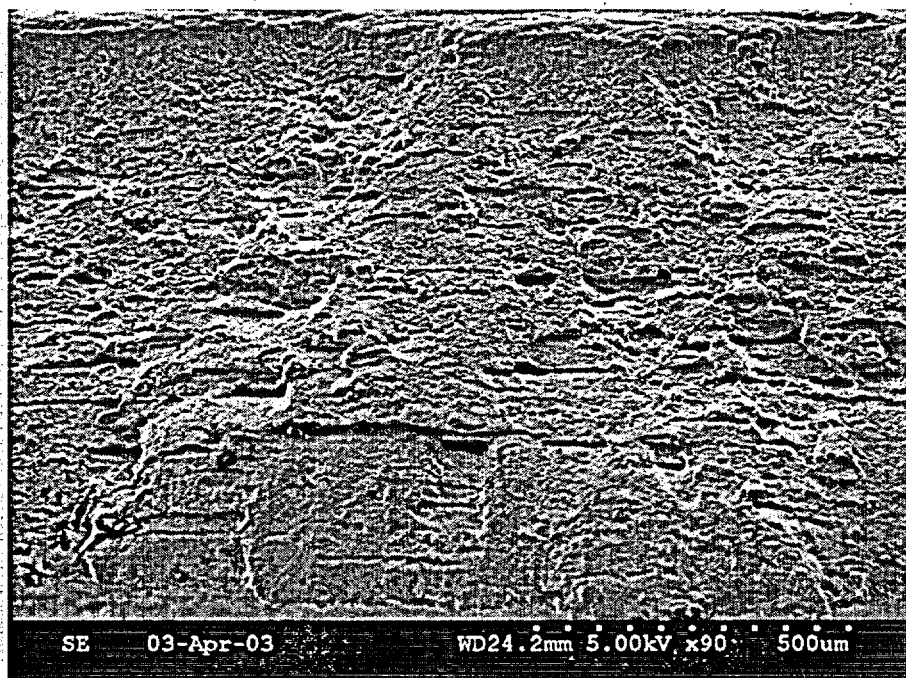
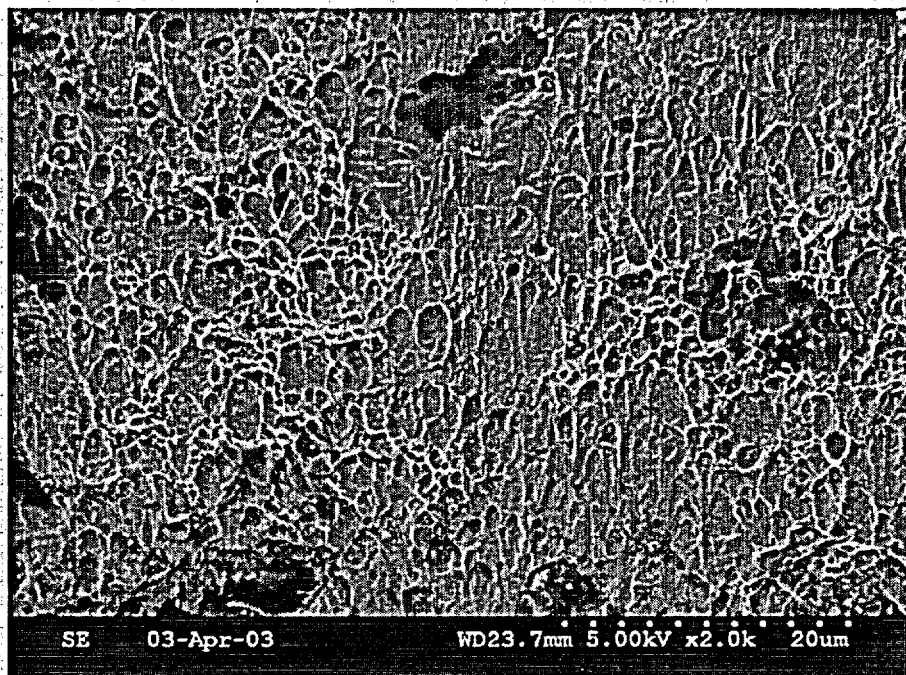
SEM photographs showing the ductile nature of the nondefect free span burst sample from R35C57-9B are provided in Figures 85 and 86. Photo mosaics were not obtained in this instance because the fracture mode was 100% ductile, with no IGSCC.

Figure 85. Typical ductile region on R35C57-9B2A.  
SE 90X

Figure 86. Typical ductile region on R35C57-9B2A.  
SE 2000X

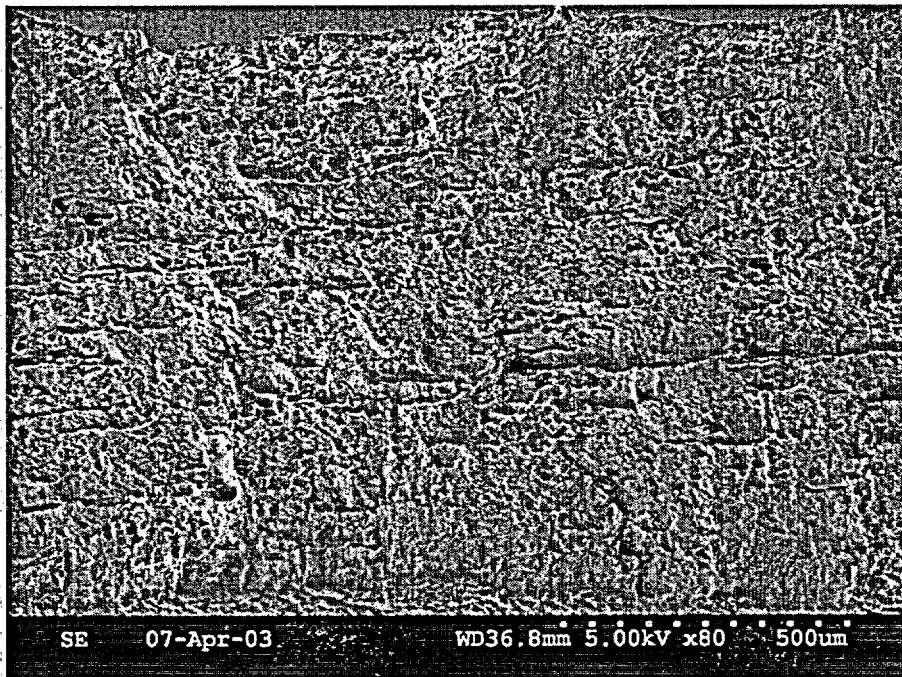
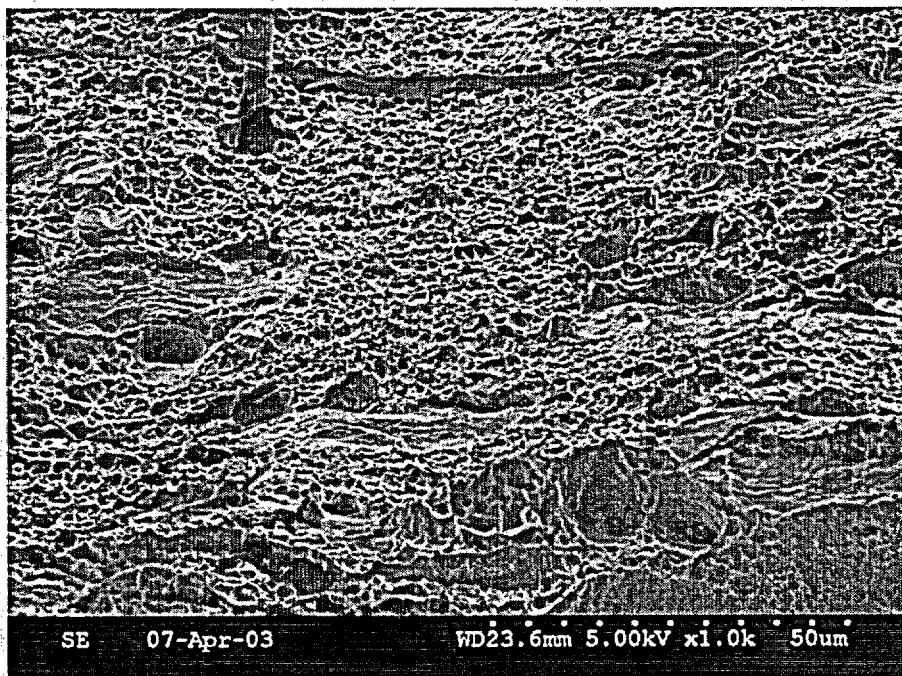
SEM photographs showing the ductile nature of the nondefect free span burst sample from R44C45-13B2 are provided in Figures 87 and 88. Photo mosaics were not obtained in this instance because the fracture mode was 100% ductile, with no IGSCC.

**Figure 87. Typical ductile region on R44C45-13B2B1.  
SE 80X**

**Figure 88. Typical ductile region on R44C45-13B2B1.  
SE 1000X**

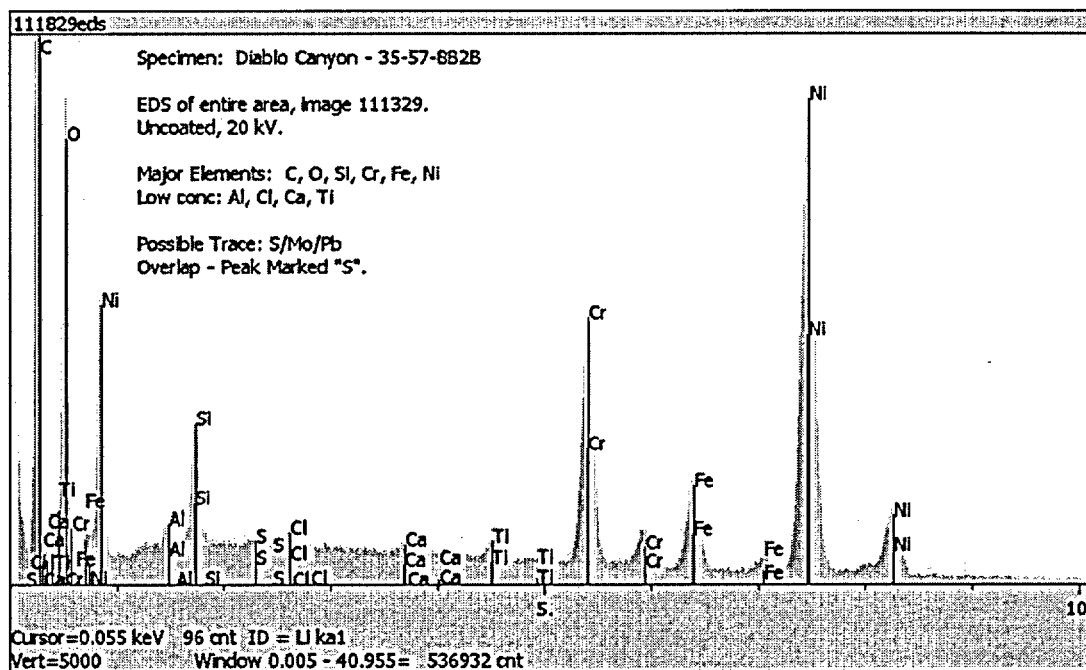
SEM fractography and EDS analysis in the IGSCC fracture surface region is provided in Figure 91 and 92. Significant amounts of silicon were detected

Figure 92. EDS of entire IGSCC area in Figure 91.

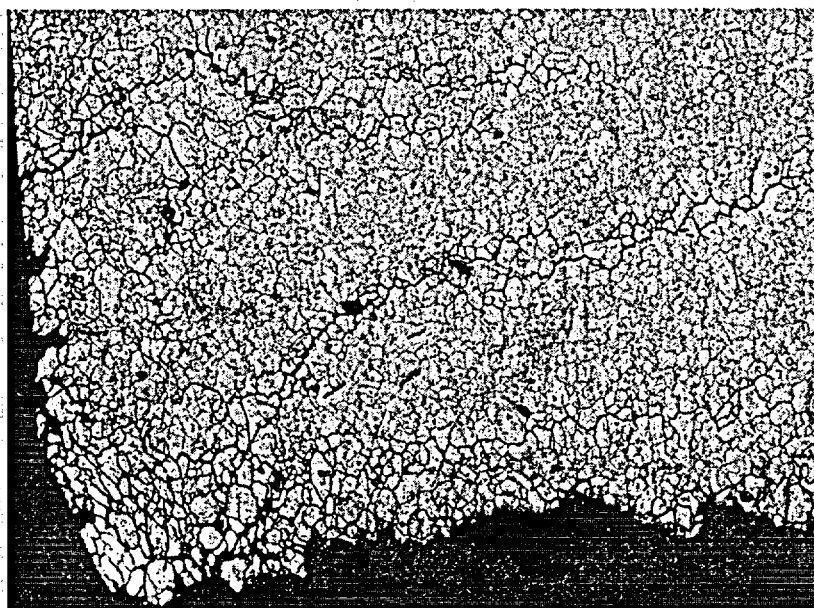
Figures 97 and 98 are polished and etched cross-sections showing the rupture surface along with numerous intergranular stress corrosion cracks in the nearby vicinity. In addition, two closely-spaced secondary cracks were present near 25° as shown in the transverse cross section of Figure 99. The two cracks shown in this view were 0.027" (53% TW) and 0.033" (65% TW) deep based on a 0.051" nominal wall thickness for this tube. SEM fractography of this region after the tube section was bent open revealed a maximum penetration of 78% TW (see Section 2.9 and Figure 84). This region of IGSCC corresponds to the 57% TW single axial indication (SAI) detected in the lab (with the +Point coil) prior to leak rate testing and the 67% TW SAI after leak rate testing.

Figure 98. Etched microstructure near rupture surface on R44C45-13A2B2. 189X

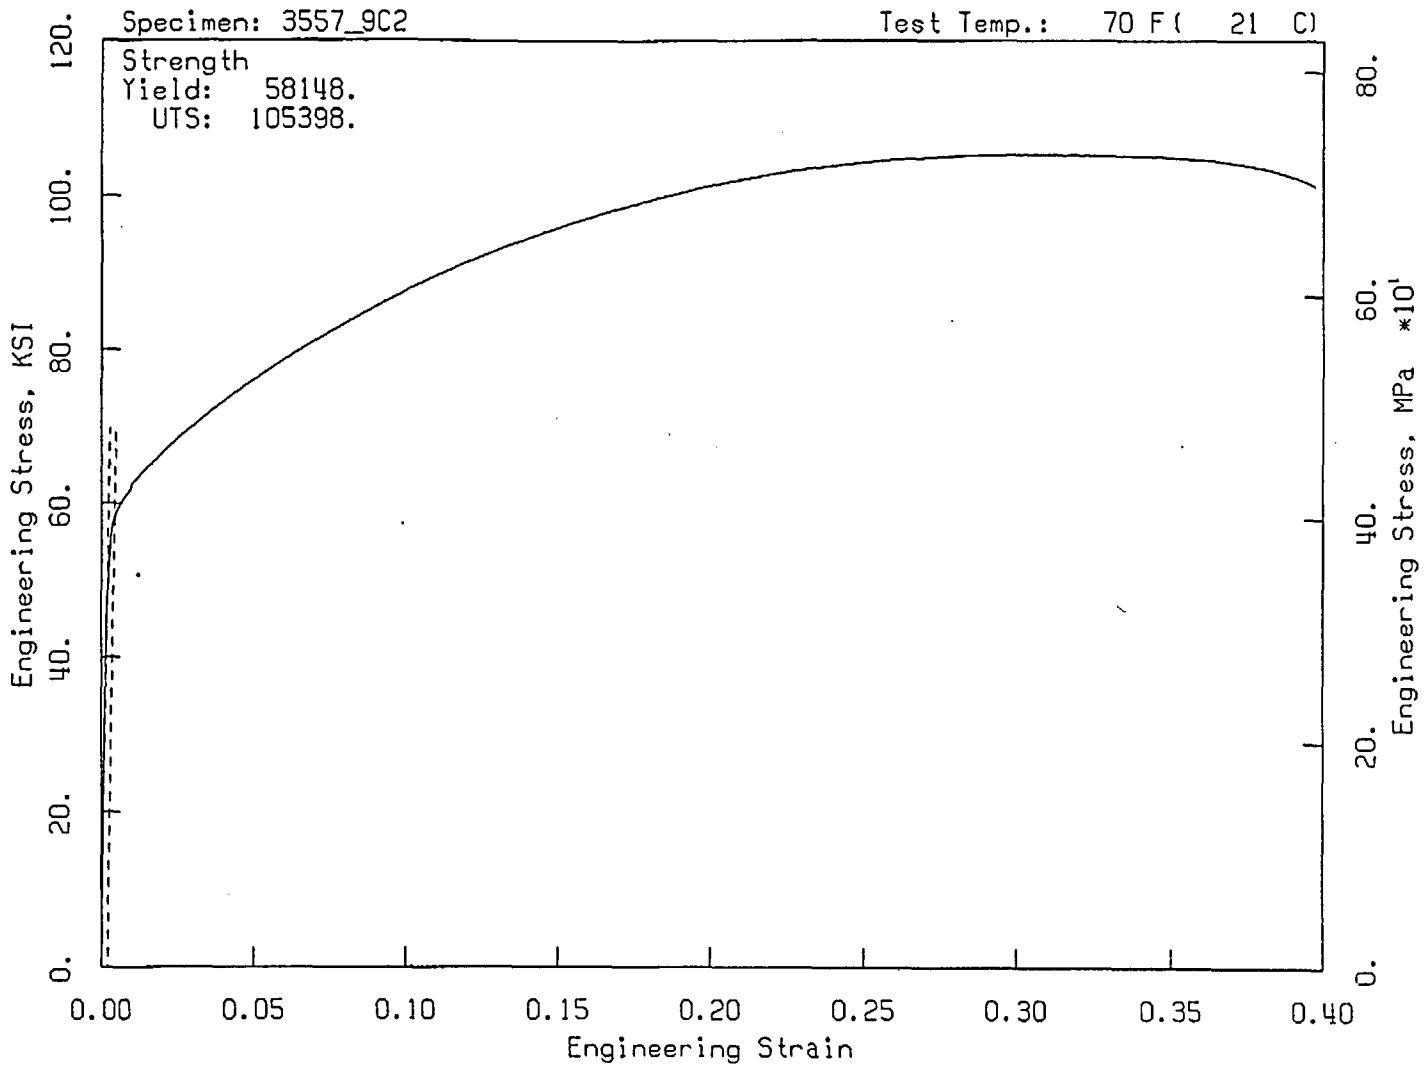
Two free span regions from each tube were tensile tested at ambient temperature. As shown in Table 16, the sample from tube R35C57 had a slightly higher yield and tensile strength than the sample from tube R44C45. The engineering stress/strain curves for these tube specimens are provided in Figures 100 and 101.

Figure 100. Engineering Stress/Strain Curve for R35C57-9C2

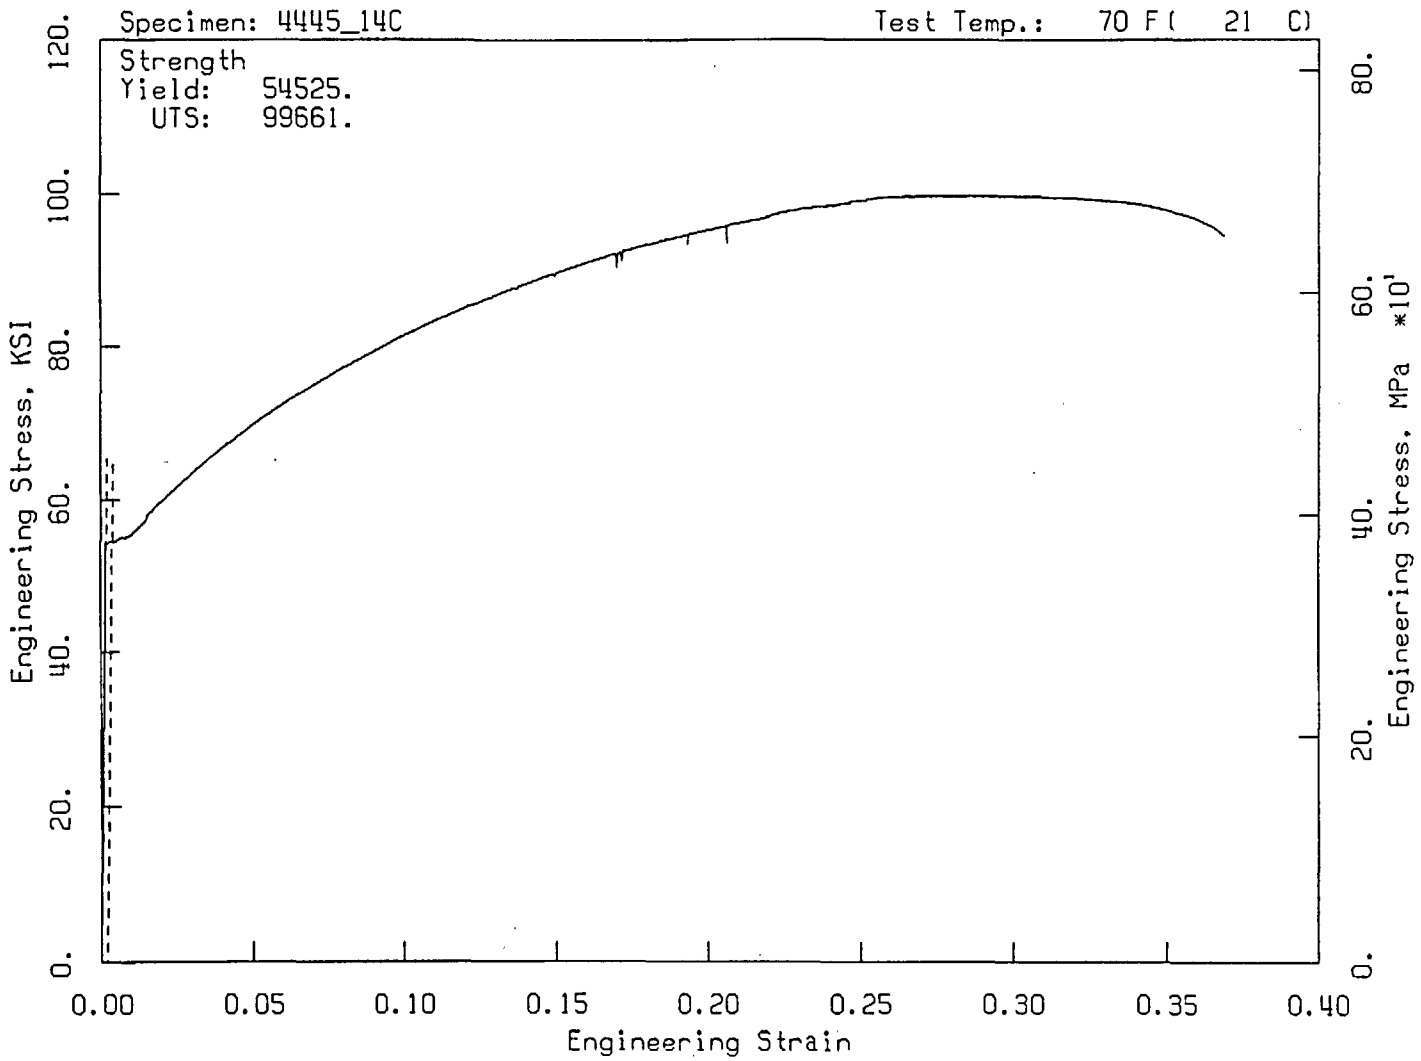
Figure 101. Engineering Stress/Strain Curve for R44C45-14C

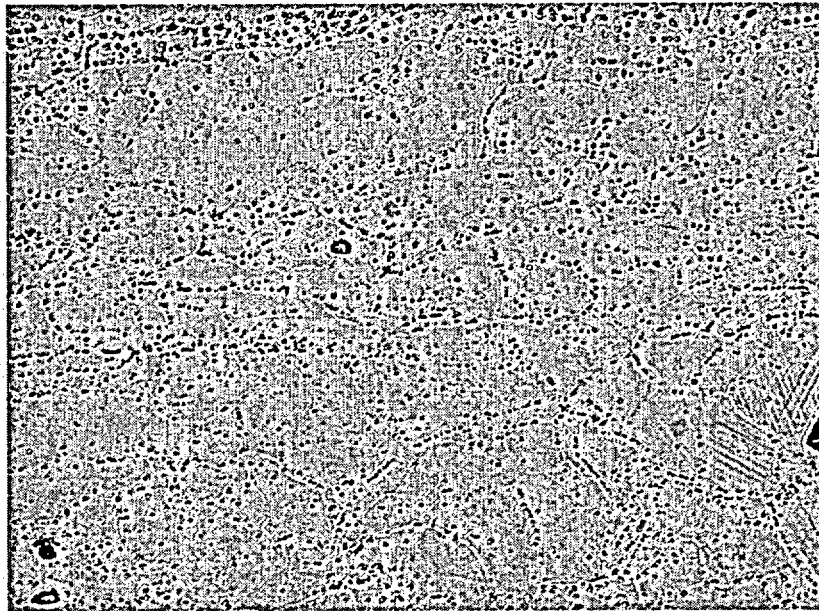
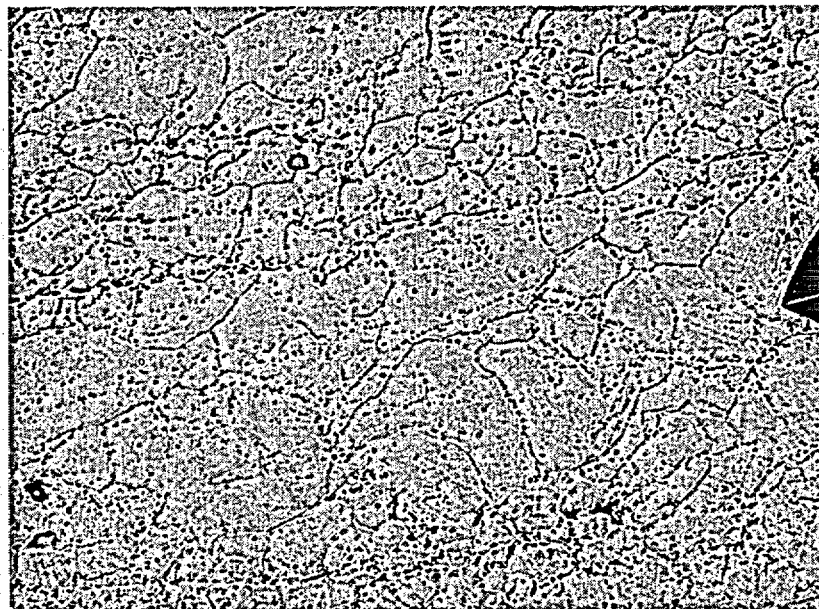
Longitudinal metallographic samples were prepared from the free span regions of each tube as shown in the sectioning diagrams in Figures 29 – 36. A dual etch procedure using phosphoric and nital acid solutions was used on these samples to characterize the carbide distribution and grain microstructure. The results are shown in Figures 102 and 103 for tube R35C57, and Figures 104 and 105 for tube R44C45. In both instances the carbide distribution along the grain boundaries was relatively light, as is typical for mill annealed Alloy 600 tubing. Intragranular matrix carbides were also present in both cases, sometimes in the form of longitudinally oriented bands.

Figure 102. Carbide distribution in R35C57-9C3B1. 685X

Figure 103. Grain boundary and carbide distribution in R35C57-9C3B1. 685X

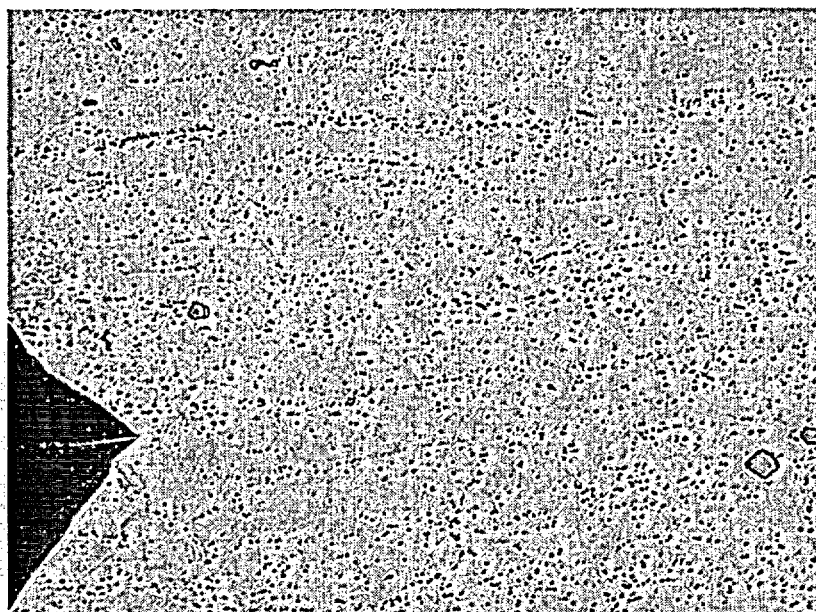
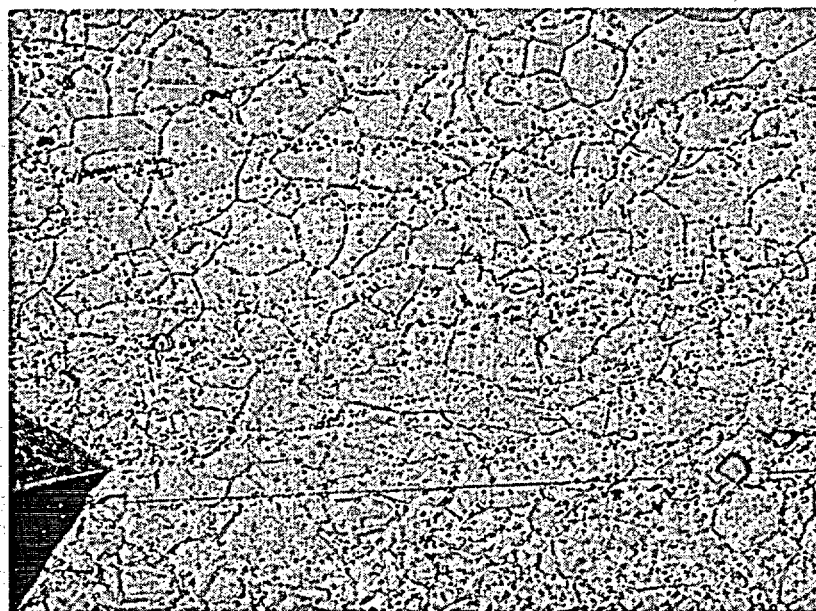
Figure 104. Carbide distribution in R44C45-14D2A. 685X

Figure 105. Grain boundary and carbide distribution \ in R44C45-14D2A. 685X

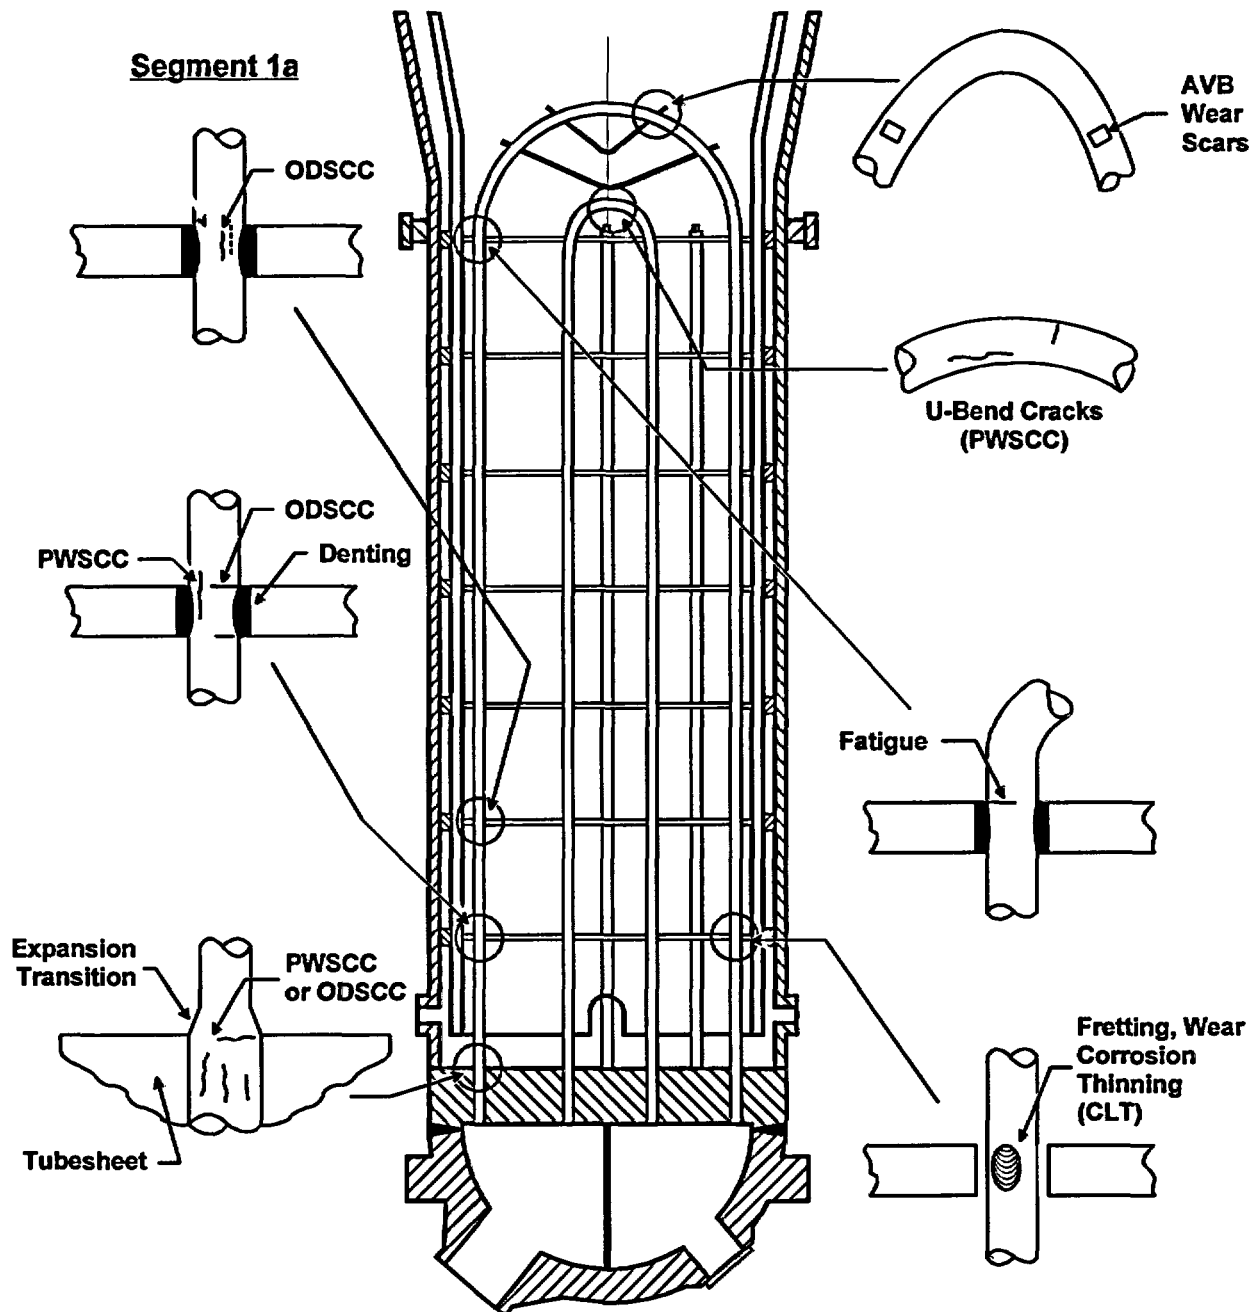
# Figure 1 - S/G Tube Degradation Mechanisms

- The tubes with axial ODSCC indications that are left in service are within the TSP sections of the tubes (See Segment 1a of Figure 1). These indications are covered by the TSPs, do not directly communicate with (i.e., leak to) the SGs, and their leakage to the SGs under normal operating conditions is restricted by the tight gap between the TSPs and the tubes. This is part of the basis in Generic Letter (GL) 95-05 (Reference 1) for allowing tubes with such indications to remain in service.

3. The ODS/CC indications that are left in service are within the TSP sections of the tubes (See Segment 1a of Figure 1). Such indications are covered by the TSPs, do not directly communicate with (i.e., leak to) the SGs, and their leakage to the SGs under normal and most accident conditions is restricted by the gap between the TSP and the tube. However, following certain events, such as a major MSLB initiating event, the TSP may be displaced, exposing the cracks and potentially resulting in a SGTR event.
