## **Bottom Mounted Instrument Penetration Tube Condition Update**

## **PROGRESS SUMMARY**

## Summary

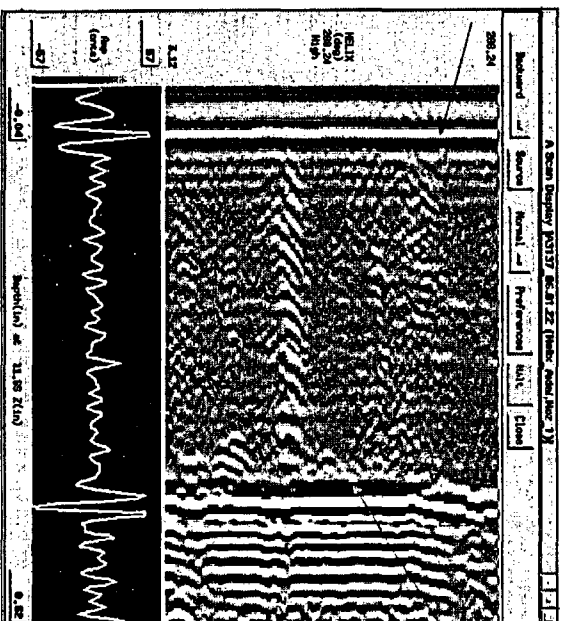
## Penetration #1 Axial Probe

- Penetration #1
  - Three axial indications, one leak path
  - No crack-like indications on J-Groove weld
  - Visual grinding marks in side of tube
- Penetration #46
  - Two axial indications, one leak path
  - No crack-like indications on J-Groove weld

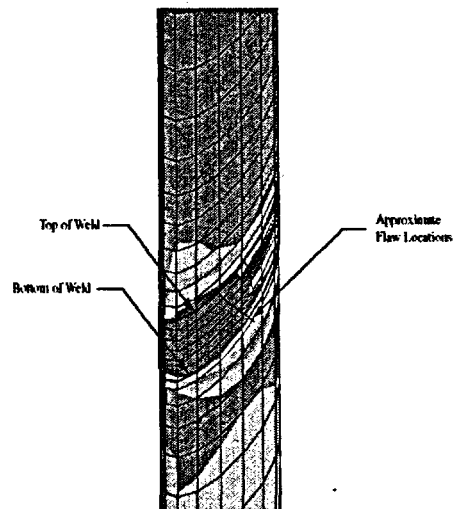
## Flaw Locations and Stresses

- Residual stresses favor axial crack orientation
- No circumferential cracks

Nozzle Alone, Showing Approximate Flow Locations and Stresses in the Direction Parallel to the Plane of the Weld

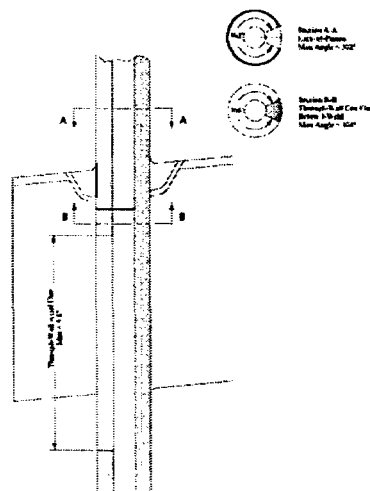
Figure 5-1

Locations of Analyzed Axial and Circumferential Flaws
