**SOUTH TEXAS PROJECT UNIT 1
BOTTOM MOUNTED INSTRUMENTATION NOZZLE
LEAKAGE ISSUE**

**Matthew A. Mitchell, Senior Materials Engineer
Materials and Chemical Engineering Branch
Office of Nuclear Reactor Regulation**

**Advisory Committee on Reactor Safeguards Full Committee Meeting
July 11, 2003**

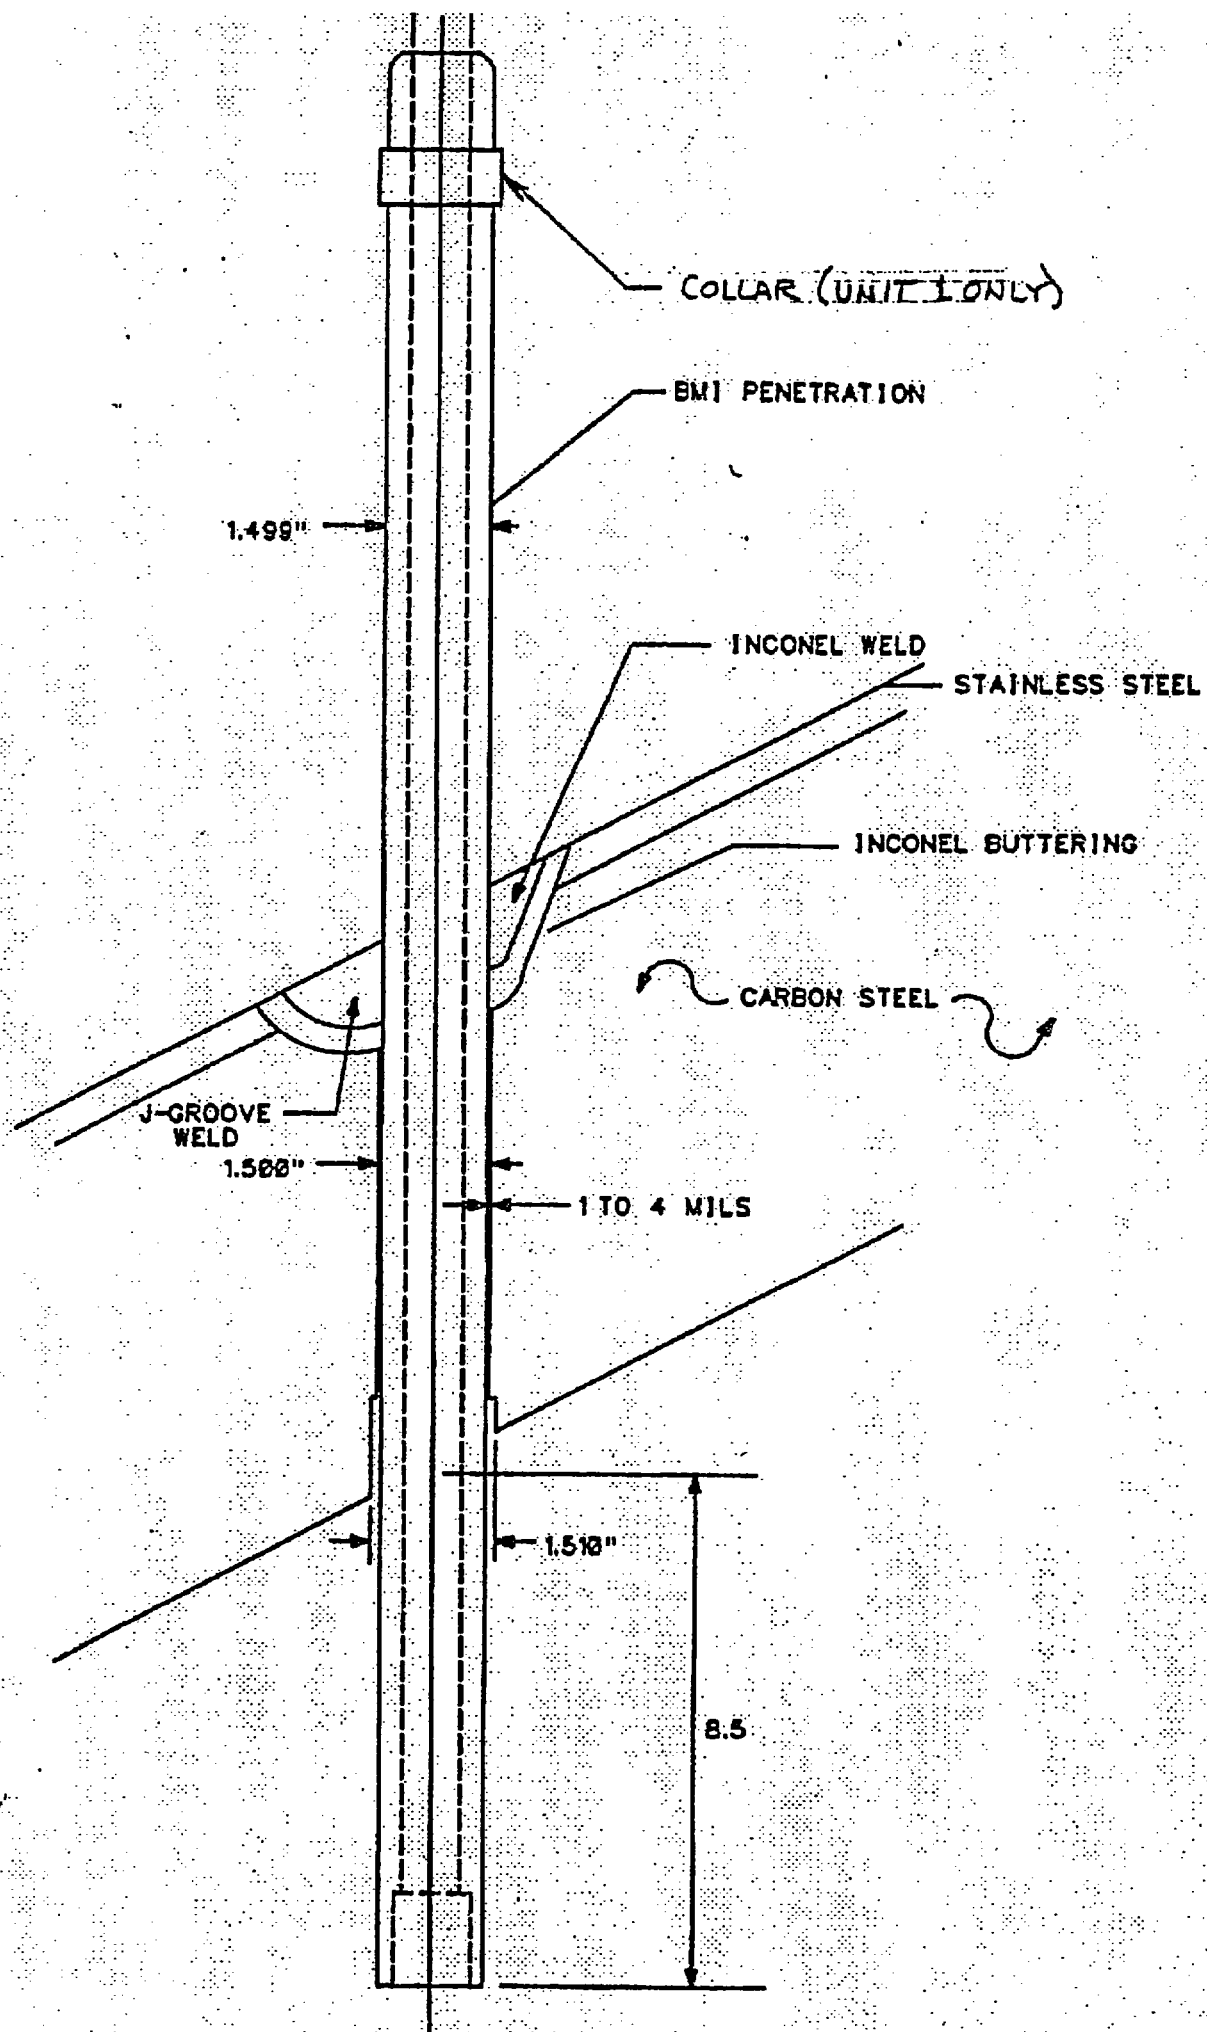
Penetration #1

- In April 2003, the licensee discovered deposits characterized as, in total, “about the size of one half of an aspirin tablet” around bottom mounted instrumentation (BMI) penetrations #1 and #46.
- Chemical analysis showed evidence of boron and lithium, indicating the reactor coolant system (RCS) to be the most likely source of the deposits.
- Radiochemical analysis based on cesium isotope dating indicated that the deposits were approximately four years old.

- The licensee has repaired STP Unit 1 nozzles #1 and #46 using a “half nozzle repair” similar in design to those used to repair other Alloy 600 penetrations.
- The repair was made using Alloy 690 nozzle material and Alloy 52/152 weld material, including the installation of a temper bead weld pad on the outside of the RPV lower head. The RCS pressure boundary weld was moved to the outside surface of the RPV.
- Questions regarding future inspections of the repair, along with inspections of the ferritic base material which will be left exposed to the reactor coolant, are being addressed by the licensee in support of NRC staff review and approval of the repair.
