South Texas Project Electric Generating Station P.O. Box 289 Wadsworth, Texas 77483

South Texas Project
Units 1 & 2
Docket Nos. STN 50-498, STN 50-499
Additional Information Regarding STP's Commitment to Investigate and Repair
Bottom Mounted Instrumentation Penetration Indications

South Texas Project Status Report on Resolving the Unit 1 BMI Issue

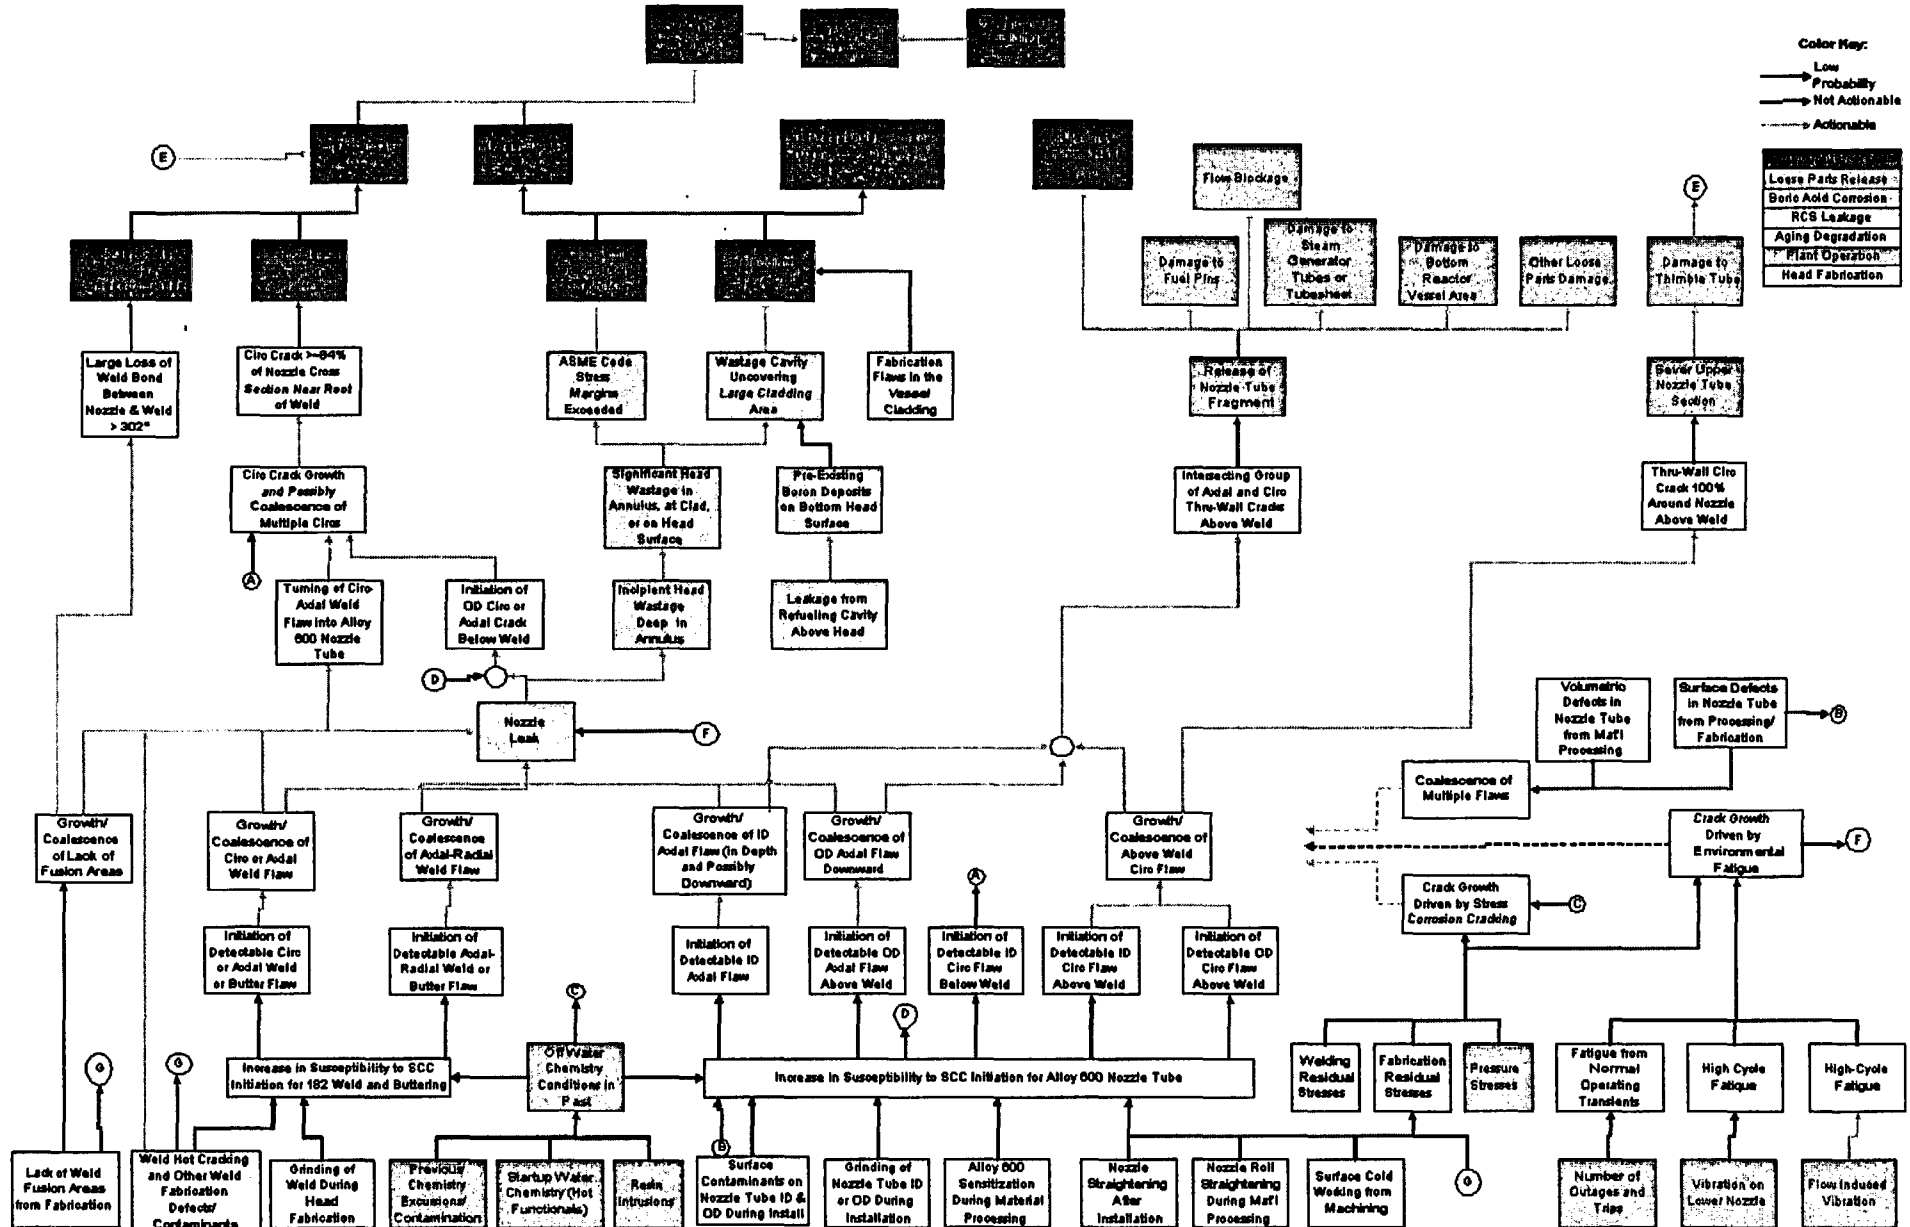
Failure Modes and Effects Analysis Chart

South Texas Project's Failure Modes and Effects Analysis for Bottom Mounted Instrument Nozzle Leakage

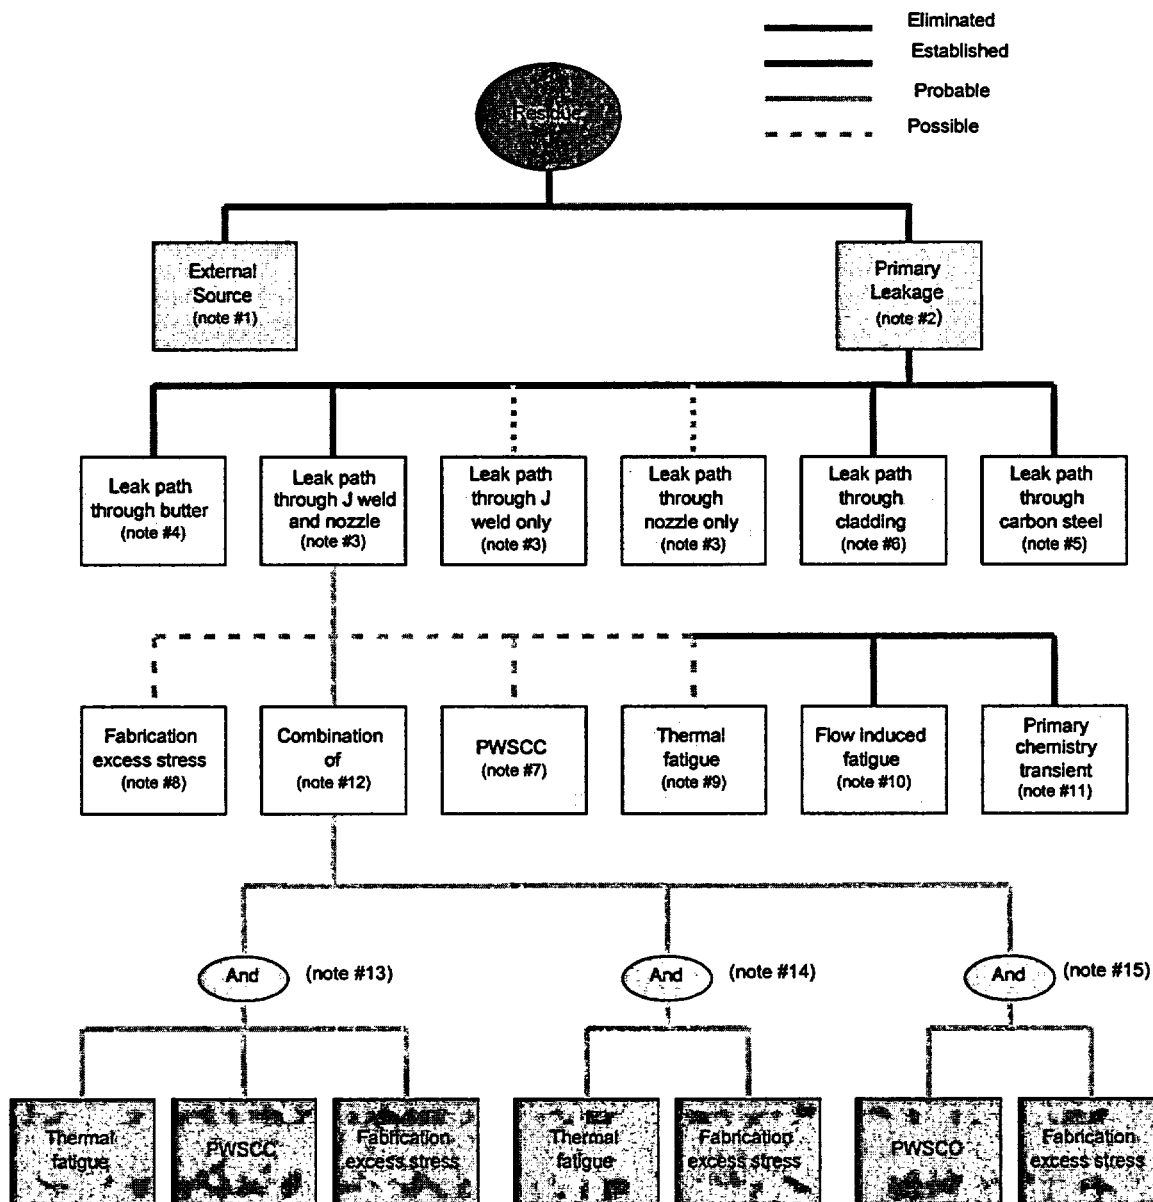
South Texas Project Status Report on Resolving the Unit 1 BMI Issue – Attachment 3 Fault Tree Analysis

Note #1: Swipes and visual inspection of the outside surface of the RPV do not support outside source for the boron residue.

Note #3: UT examination and the pressure test identified a leak through the weld and nozzle 1. UT examinations suggest the cracks in nozzles 1 and 46 originated at the nozzle weld interface. A crack originating at this location most likely involves both the nozzle and the weld. The investigation path for nozzle, weld and combined nozzle and weld is the same. The boat sample result will be the best opportunity to separate between the nozzle and the weld.

Note #7: PWSCC requires three things; 1) susceptible metal, 2) residual stress, and 3) an aqueous environment. Only two of five nozzle cracks are confirmed to be in contact with primary water. Although these cracks appear to have their origin within the welded zone, it is possible, but unlikely, they could exist by PWSCC alone.

Note #9: This is low cycle fatigue due to temperature and pressure changes. If fatigue alone were responsible for the flaws there should be more flaws in other nozzles. Fatigue is a possible source of the cracks but more likely in combination with pre-existing fabrication defects.

Note #11: There are no records of significant RCS chemical transients. STP experience with the Alloy 600 steam generator tubes, which are much thinner, have not indicated any degradation due to RCS chemical contaminants.

Note #12: Cracks that do not extend beyond the weld zone, (i.e., not in contact with primary water) Are most likely the result of a combination of fabrication flaws

and low-cycle fatigue. However, cracks that are in contact with primary water may be a combination of PWSCC, fabrication flaws, and low-cycle fatigue.

Note #13: Possible for cracks that appear to have their origin within the weld and extend to the point of contact with primary water.

Note #14: Most likely source of cracks totally imbedded in the weld zone but could also be possible for cracks that extend beyond the weld.

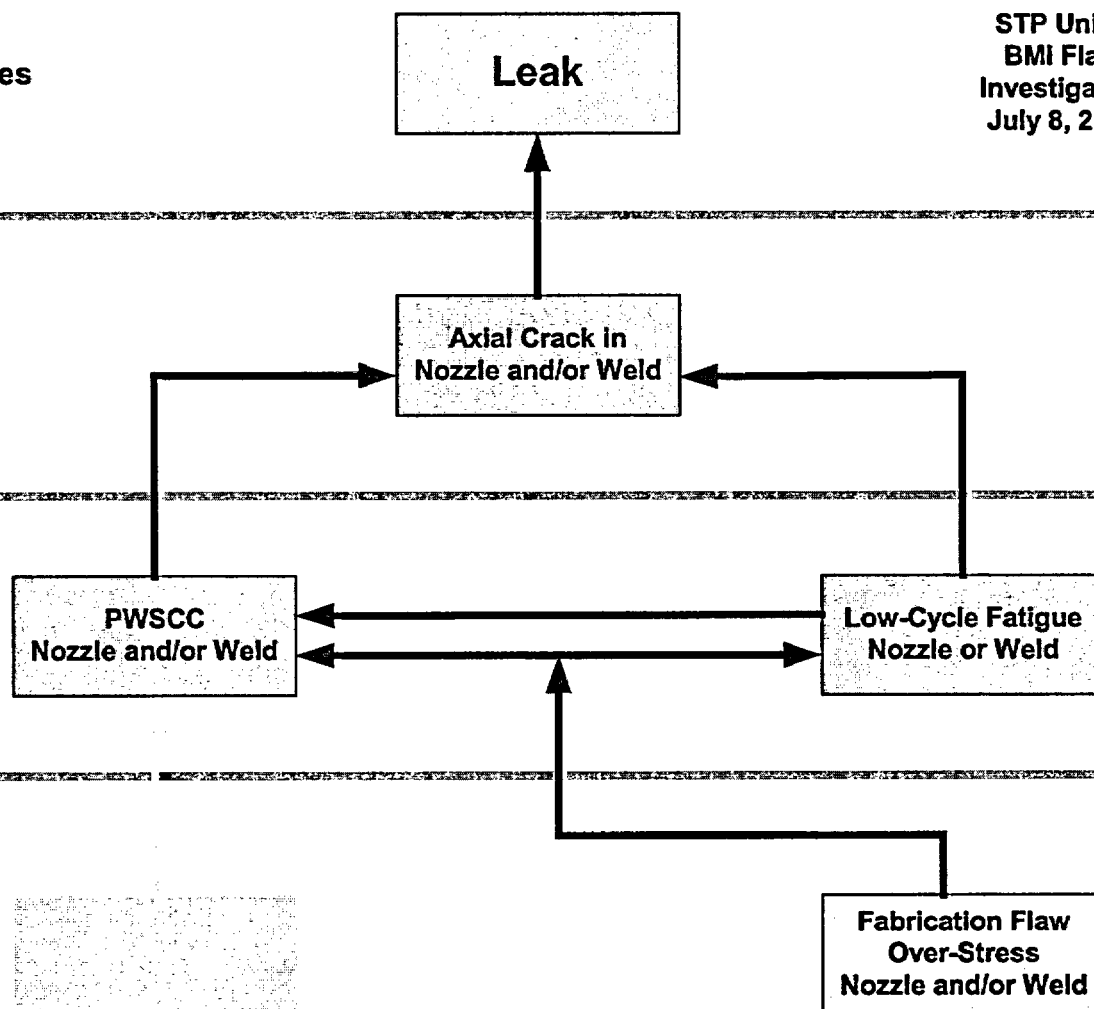
South Texas Project Status Report on Resolving the Unit 1 BMI Issue – Attachment 4 Refined Failure Modes and Effects Analysis

STP Unit 1
BMI Flaw
Investigation
July 8, 2003
