Appendix G: Posttest Data Correction

G.2 Post Test Data Conversion and Correction

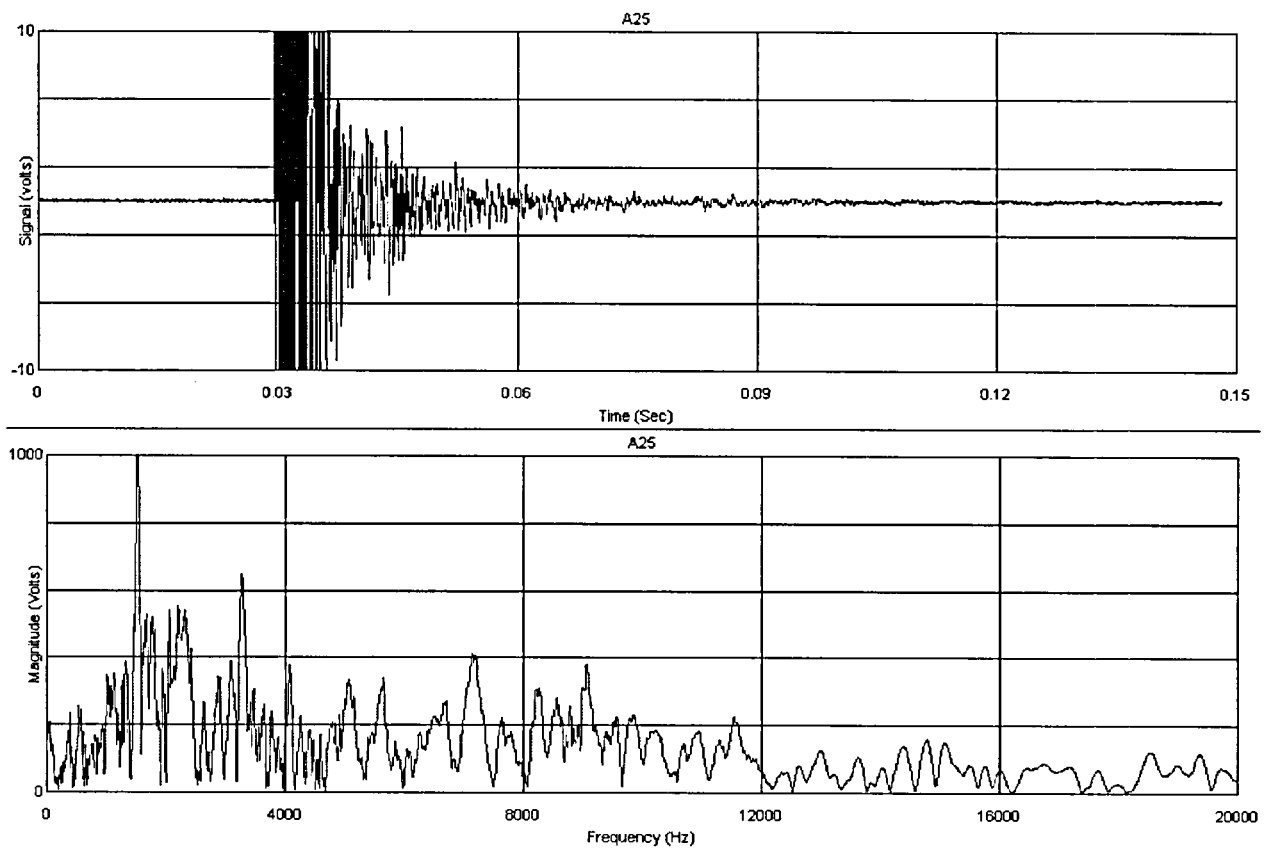
Figure 8: Time Domain and Frequency domain plots of a typical wire break recorded by a nearby sensor

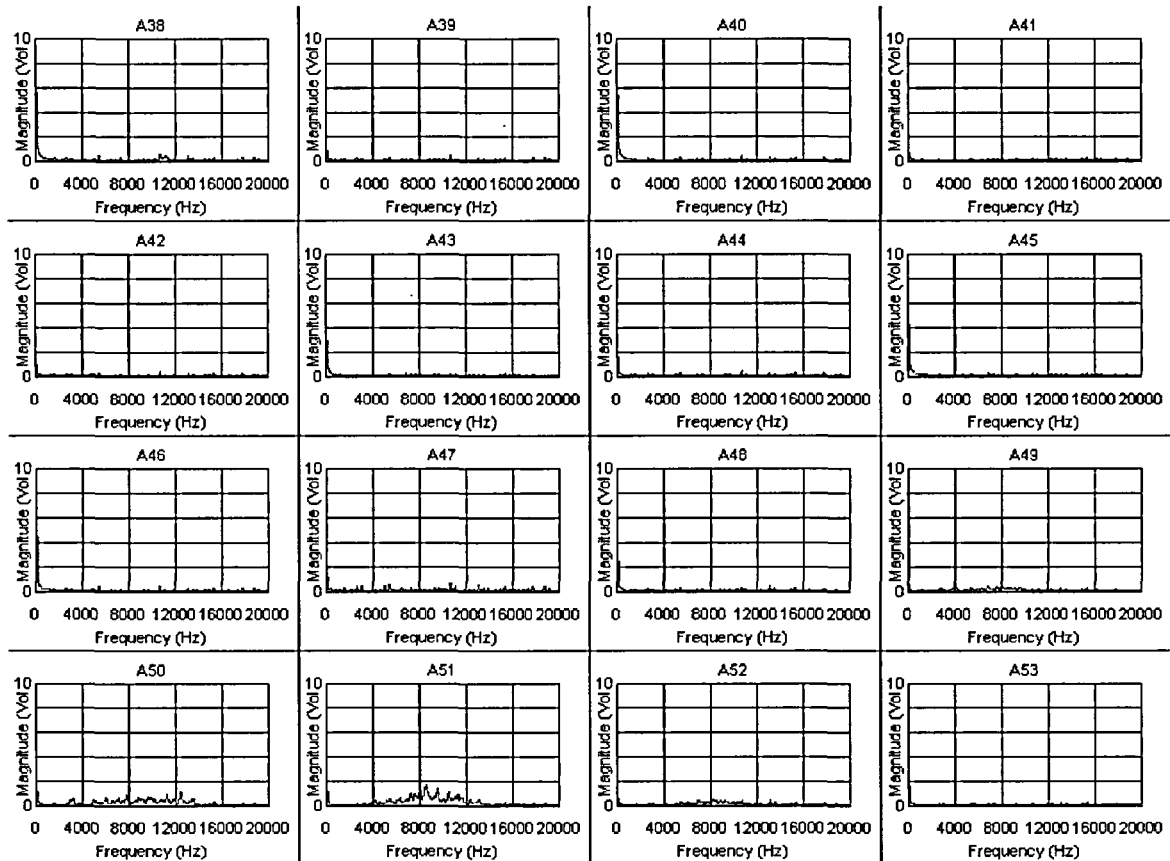
Figure 2 below shows the development of a suspected tear in the liner near the equipment hatch. Notice that sensors A50, A51, and A52 all show a broadband white noise centered around 8 KHz.

Figure 2. FFT of internal sensors showing noise from liner tear near equipment hatch

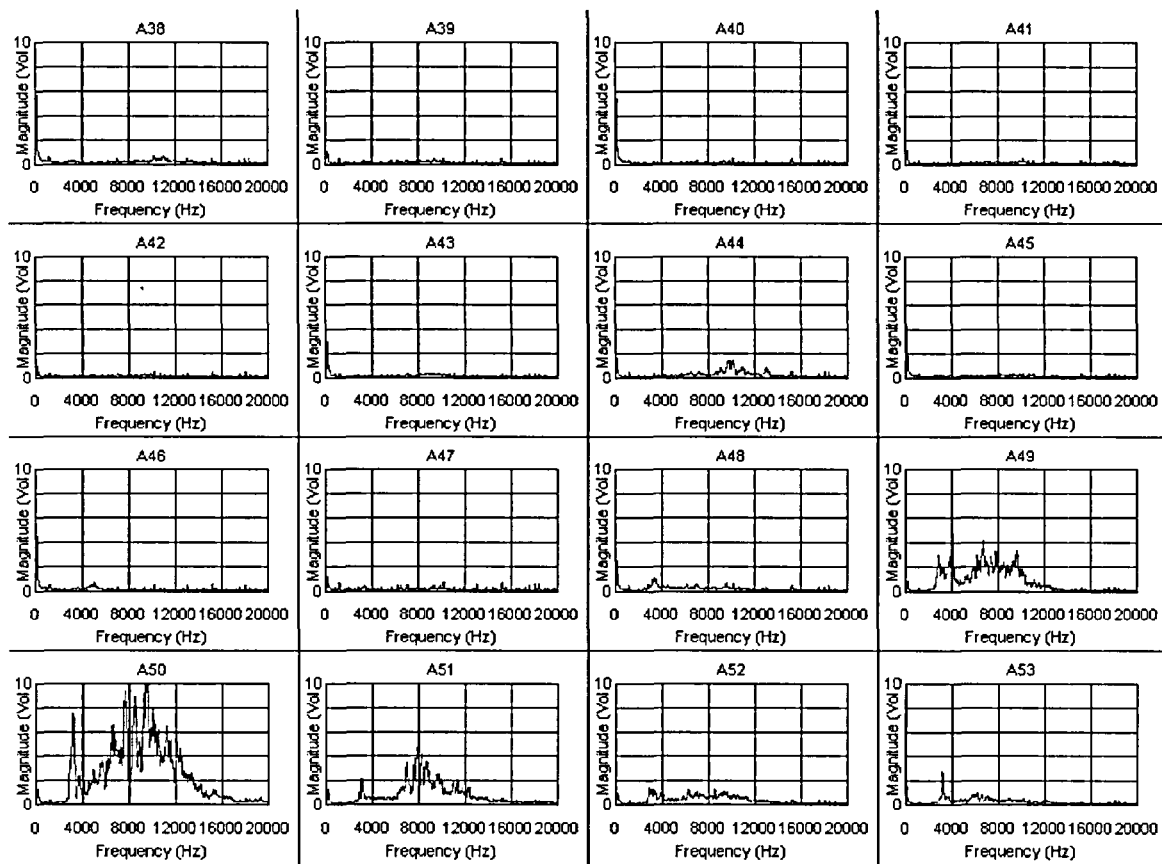
Figure 3 below shows anomalies that have developed in several places on the liner. Notice that the amplitude of the noise has increased sharply in A50, 51, and 52, indicating that the tears in that area are increasing in size and flow. These anomalies were also detectable on the external sensors.

Figure 3. FFT of Internal Sensors showing well developed flow noise from suspected tearing of the liner.

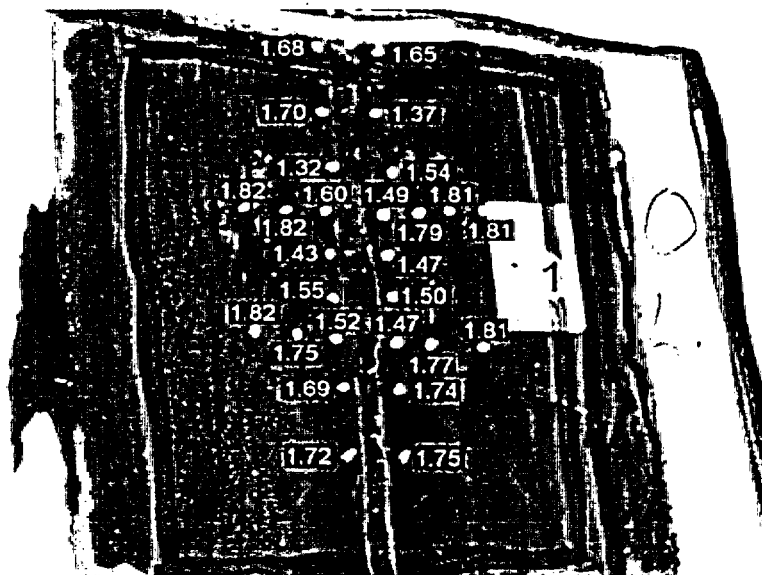
Tear #1: Tear #1 was distinct from all other tears in that it initiated at a weld defect. Tear #1 is described in Tables 1 and 6, and pictured in Figures 2, 19, 49, 66 and 67. At its midpoint (presumably the initiation site), the tear was oriented at 90 degrees to the primary tensile stress and there was no microstructural indication of plastic deformation having preceded fracture (Figure 66). Detailed examination of the fracture profile in the initiation region revealed that the surface was covered with a foreign substance, perhaps residue from the primer paint (too dark to be seen in Figure 66) – this indicated that welding had failed to completely melt and join the adjacent pieces in this area. The microstructure on opposite sides of the tear were distinctly different: recrystallized fusion zone from the original weld on the repair weld side, and unaltered heat affected zone from the original weld on the opposite side. No effort was made to remove the surface residue to permit SEM examination of the underlying surface. It seems clear, however, that this represented a weld defect, likely a lack-of-fusion defect similar to the one seen in one of the welded tensile bars. Assuming that no plastic deformation occurred adjacent to this defect, the measured thickness indicated that 22% of the liner thickness had been ground off in this area.

Figure 19. Liner thicknesses (in millimeters) measured ultrasonically in the vicinity of tear #1.

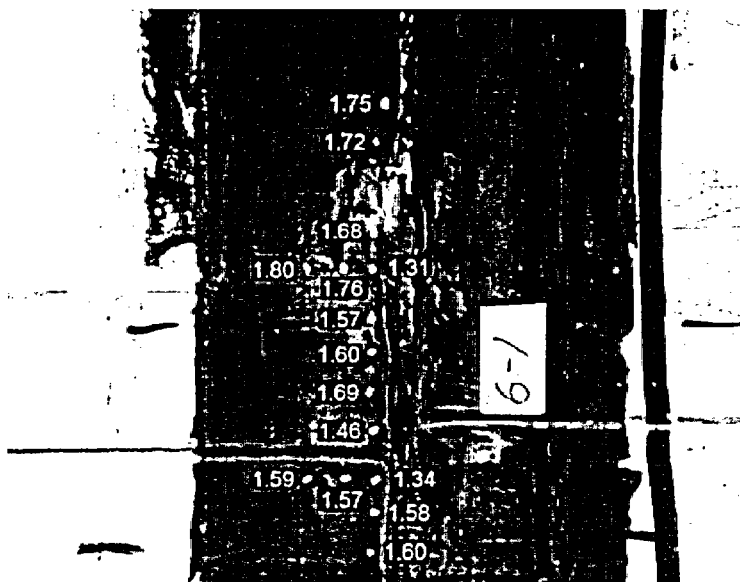
Tear #6-2: This tear was examined as a proxy for four tears, 6-1, 6-2, 11-1, and 11-2, which all occurred along the left-hand side of the same vertical field weld. They are described in Tables 1 and 6, and pictured in Figures 5, 6, 22, 23, 24, 55 and 73. While ultrasonic thickness measurements failed to detect a great deal of thinning adjacent to this tear, far greater thinning was observed below the end of the tear (Figure 23). The metallographic cross-section showed that highly localized grinding had been done on the exterior side adjacent to the edge of the back-up bar. This resulted in a narrow band of thinned material immediately next to the back-up bar, consistent with the ultrasonic measurements. The other distinguishing aspect of these tears was the unusually large number of short back-up bar segments along this weld (Figures 5 and 6). While metallography indicated a single repair weld in sample #6-2, the number of back-up bar segments attests that numerous/repeated repairs had been made at various heights along this joint. It is not clear whether the large number of short back-up bar segments

Figure 22. Liner thicknesses (in millimeters) measured ultrasonically in the vicinity of tear #6-1.

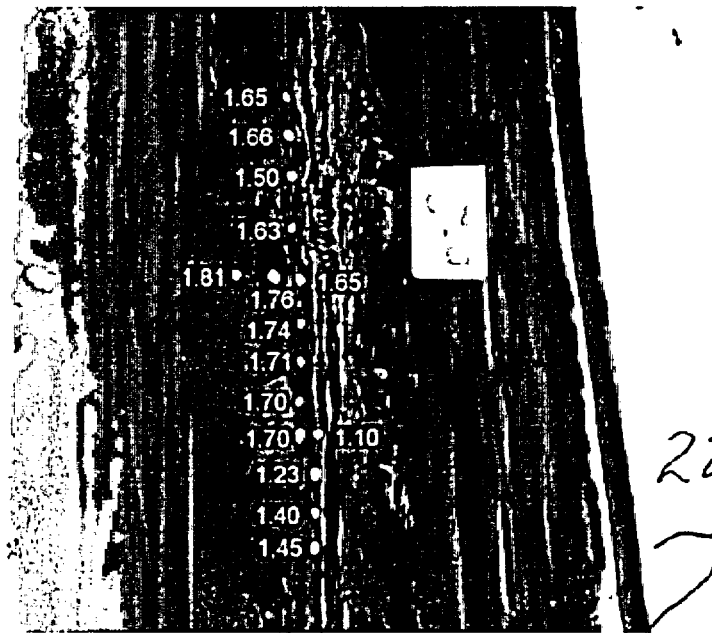
Figure 23. Liner thicknesses (in millimeters) measured ultrasonically in the vicinity of tear #6-2.

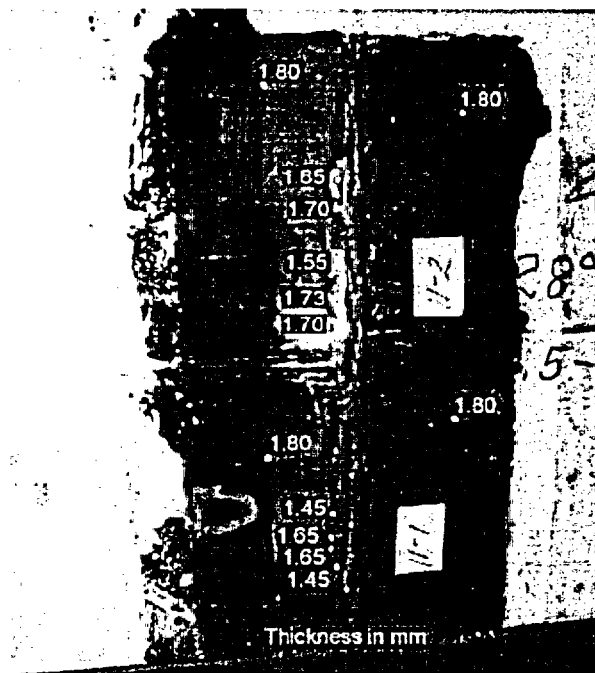
Figure 24. Liner thicknesses (in millimeters) measured ultrasonically in the vicinity of tear #11 (11-1 and 11-2).

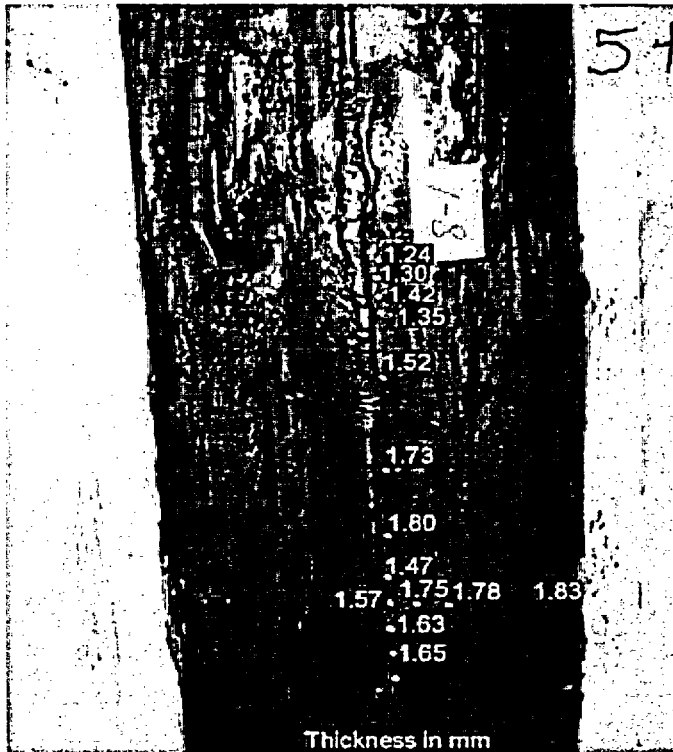
Tear #8-1: This tear is described in Tables 1 and 6, and pictured in Figures 7, 25, 56 and 78. It represented a tear that occurred in an area where a segment of back-up bar had been left missing during repair welding. This may have exacerbated strain localization in this region, but the estimated 30% grinding reduction of liner thickness observed in this area was, by itself, likely sufficient to cause severe plastic strain localization and subsequent ductile tearing.

Figure 25. Liner thicknesses (in millimeters) measured ultrasonically in the vicinity of tear #8-1.

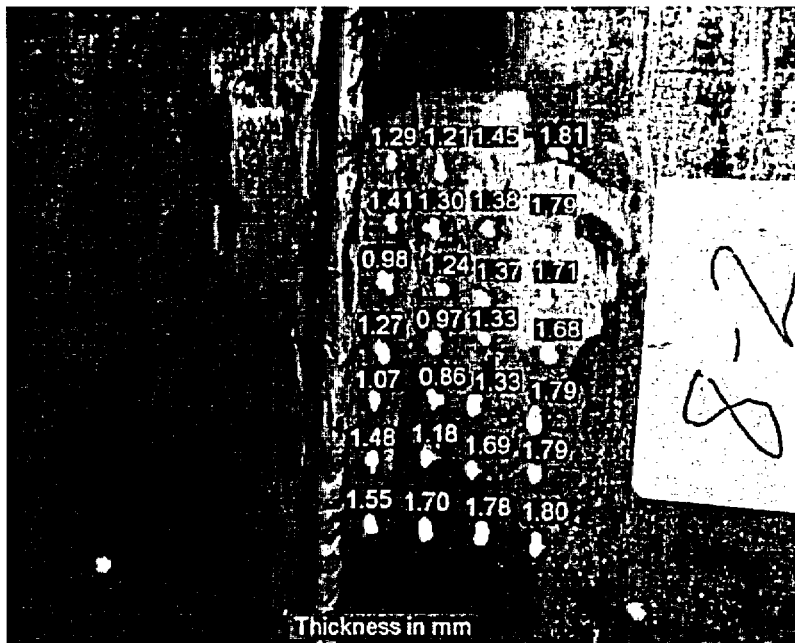
Tear #8-2: Tear #8-2 is described in Table 1 and 6, and pictured in Figures 26, 57 and 75. It was unique in that it occurred relatively distant from the weld in an area where macroscopic examination revealed evidence of substantial grinding (Figure 26), but no apparent repair weld. Metallographic examination revealed, however, that at least two repair welds had been made adjacent to the vertical joint, apparently to repair an inadvertent "grind-through" made in association with repairs on the main weld. Following repair of this "grind-through", the weld bead of this repair had been ground off from both front and back sides, leaving no obvious evidence of this defect having been made or repaired. However, this grinding reduced the wall thickness in the repaired "grind-through" area by approximately 60%, resulting in severe localization of plastic deformation culminating in ductile tearing when the structure was tested.

Figure 26. Liner thicknesses (in millimeters) measured ultrasonically in the vicinity of tear #8-2. Note the extensive grinding extending distant from main weld.

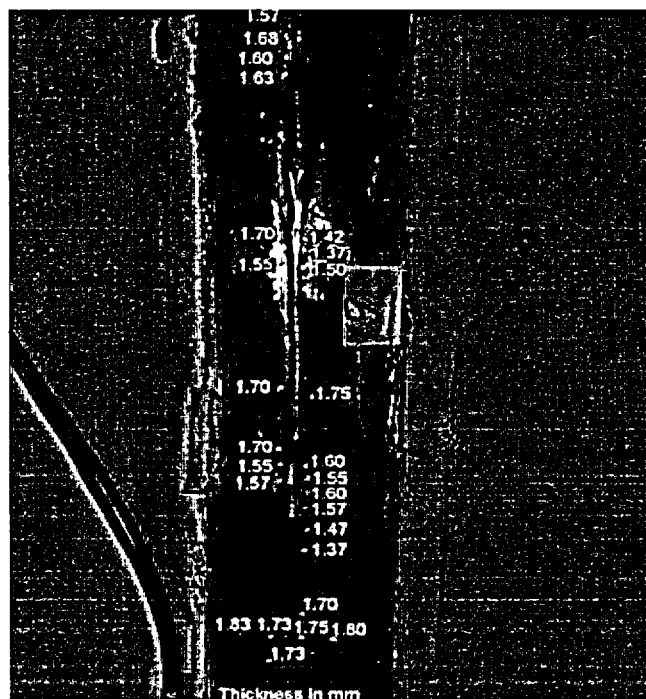
Tear #9: This tear is described in Tables 1 and 6, and pictured in Figures 8, 27, 58 and 76. It represented a typical repair welded joint far from either anchors or horizontal stiffeners. In other respects it was similar to tear #6-2, one where a narrow band of thinning resulted from heavy grinding adjacent to the back-up bar, and where numerous back-up segments indicated a series of repairs at various heights along a vertical field weld. Metallographic examination revealed no unusual microstructural features. While this sample showed the greatest discrepancy in percent grinding estimated by different methods, all methods indicated that sufficient grinding had been done to cause substantial strain localization and ductile tearing when the structure was tested. Approximately 40 to 45% thinning appears to have been done by grinding based on two of the three estimation methods.

Figure 27. Liner thicknesses (in millimeters) measured ultrasonically in the vicinity of tear #9.

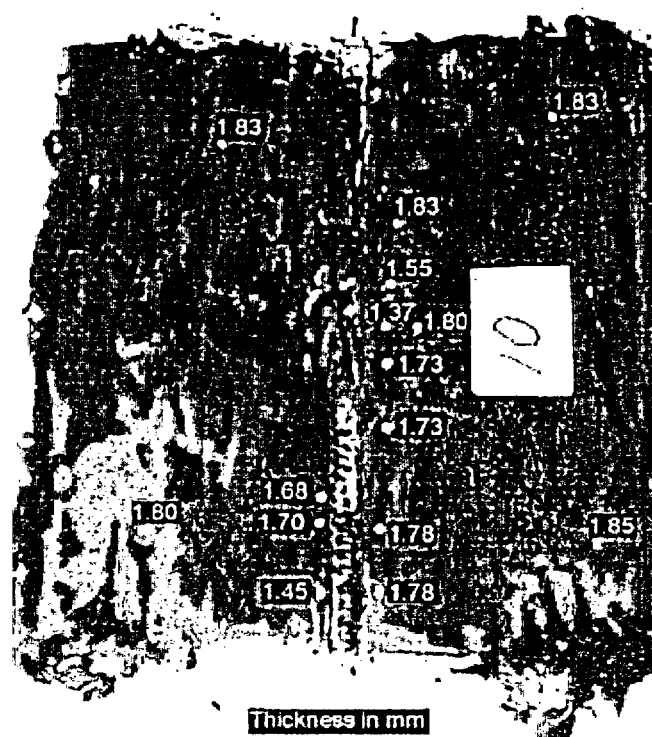
Figure 28. Liner thicknesses (in millimeters) measured ultrasonically in the vicinity of tear #10.

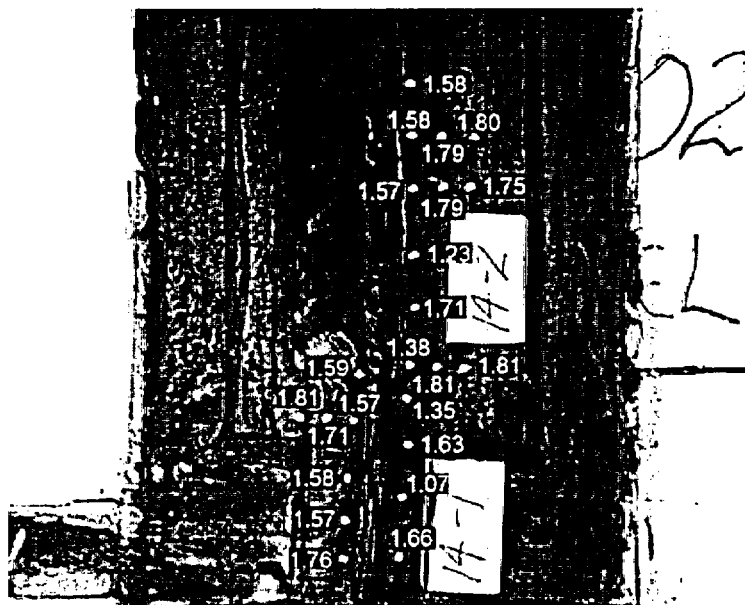
Figure 29. Liner thicknesses (in millimeters) measured ultrasonically in the vicinity of tear #14 (14-1 and 14-2).

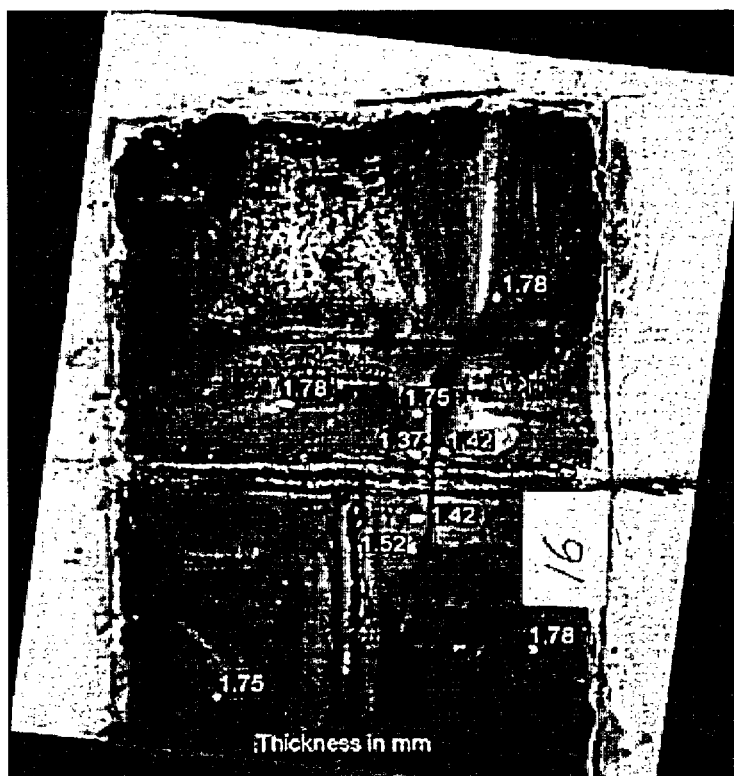
Figure 30. Liner thicknesses (in millimeters) measured ultrasonically in the vicinity of tear #16. Note distance of tear from vertical weld and extensive buckling above tear.

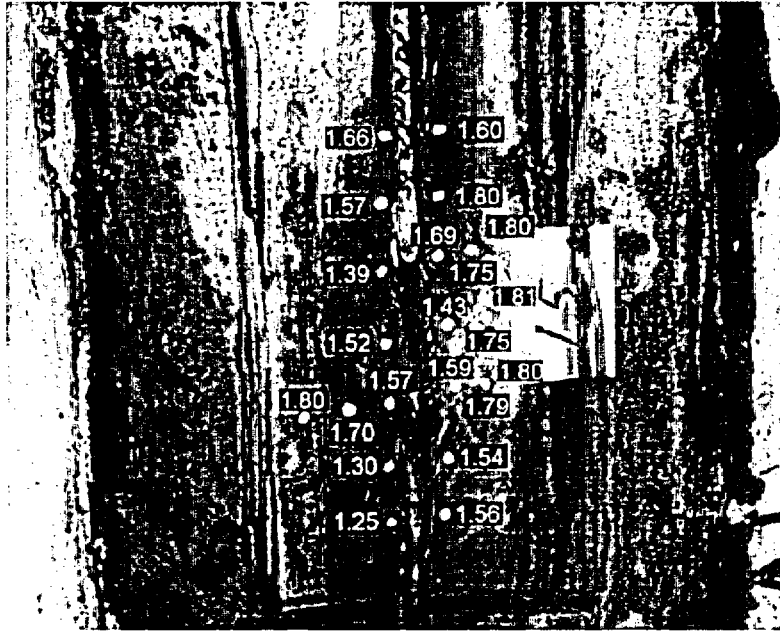
Figure 33. Liner thicknesses (in millimeters) measured ultrasonically in the vicinity of tear #15.

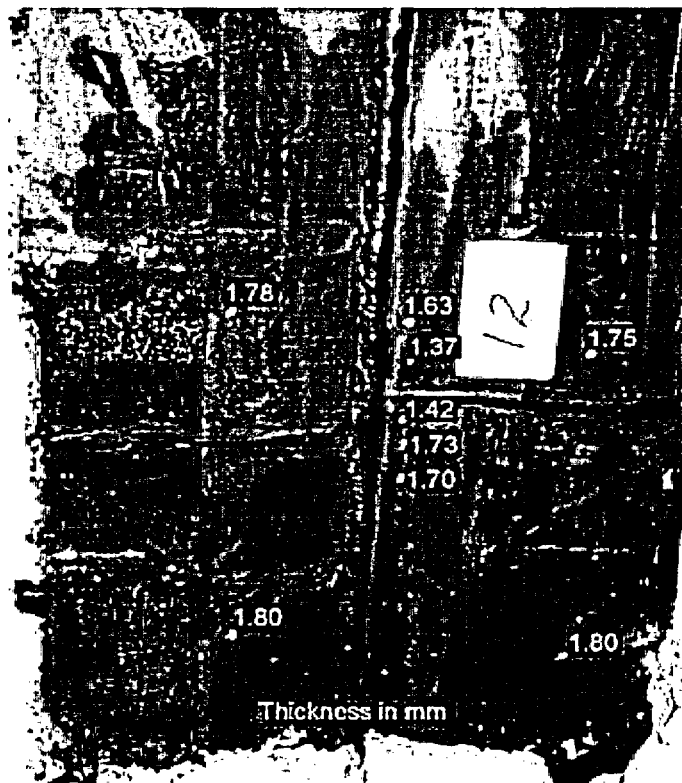
Tears #12 and 13: These tears also occurred along the equipment hatch transition joint, but near its midpoint, rather than the corners. They are described in Tables 2 and 7, and pictured in Figures 17, 18, 34, 35, 62, 63, 64, 82 and 83. Both formed near horizontal field welds and the associated “rat-hole” discontinuities in horizontal stiffeners, although back-side photographs indicated that patches were welded in between the adjoining stiffener segments, minimizing strain localization in these regions (unless the welds at the ends of these patches failed). Evidence of ~30% thinning from grinding was found at tear #13.

Figure 34. Liner thicknesses (in millimeters) measured ultrasonically in the vicinity of tear #12.

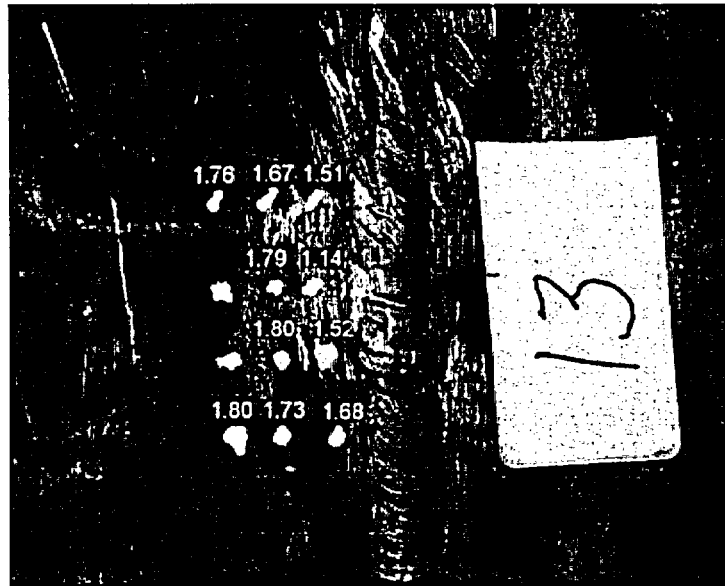
Figure 35. Liner thicknesses (in millimeters) measured ultrasonically in the vicinity of tear #13.

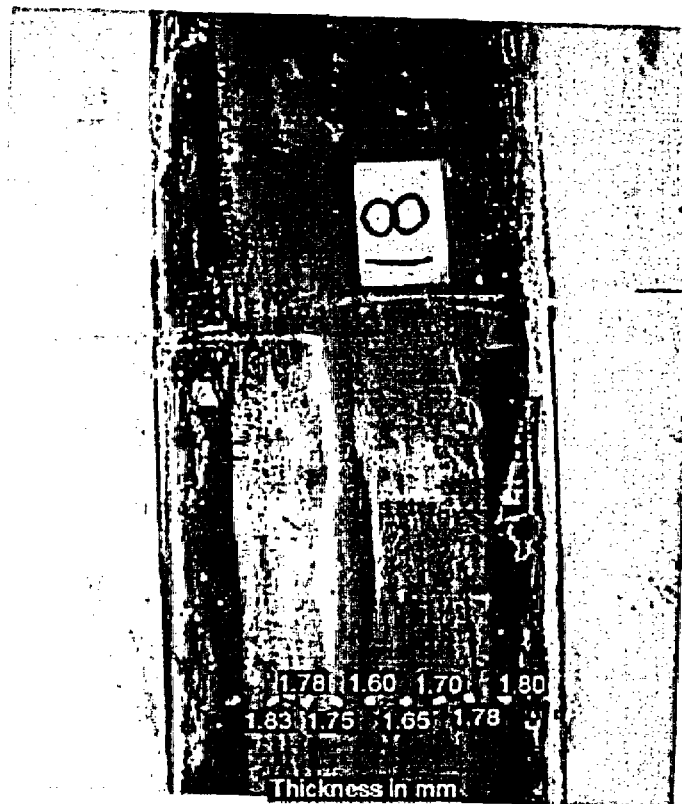
Region #18-1 and 18-2: The observations made in these areas are described in Table 8 and pictured in Figures 36, 85, 86, 89 and 90. The cross-section of #18-1 (Figure 89) showed that a modest amount of localized plastic deformation had occurred adjacent to the weld on both sides of the fusion zone. The greatest amount of deformation thinning occurred in the HAZ near the fusion line (13% on one side, 9% on the other side – note that these amounts of thinning are consistent with the ultrasonic thickness measurements, shown in Figure 36). Approximately 5% thinning was uniformly observed over a ~15 mm wide band in the adjacent base metal. Thinning then tapered out gradually to zero over the next ~15 mm. The amount of thinning in the HAZ is in the vicinity of the 12% to 13% required for the onset of necking, as was determined from analysis of the welded tensile samples. However, considerable additional local deformation would be required before tearing would be expected to occur. Consistent with this, no evidence of void formation or shear banding, which would be indicative of incipient failure, was observed.

Figure 36. Liner thicknesses (in millimeters) measured ultrasonically in region #18. Buckling and “orange-peel” evidence of substantial plastic deformation, but no tearing, was apparent in this area.

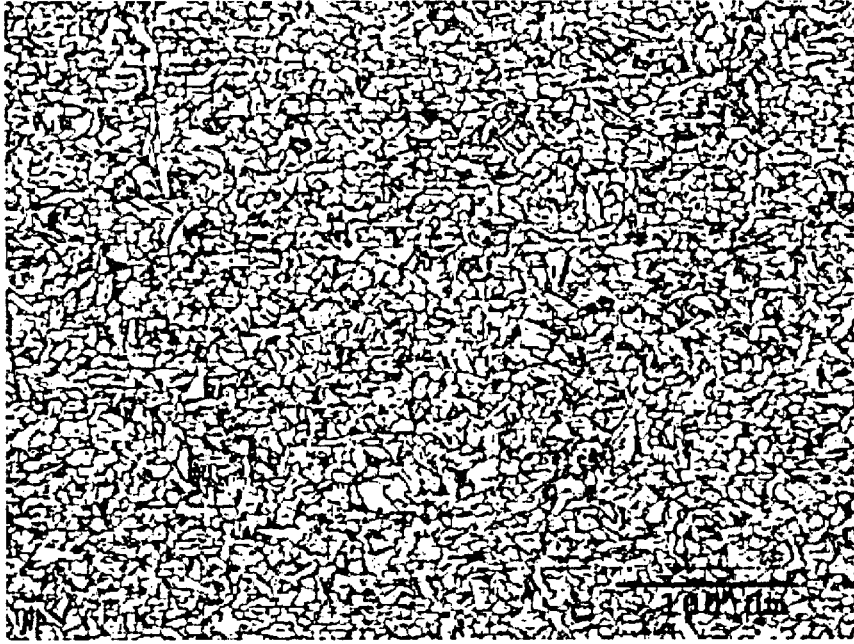
- base metal consisting of fine-grained equiaxed ferrite and pearlite (Figure 37), to
- fine-grained heat affected zone (HAZ) consisting of equiaxed ferrite and pearlite (Figure 38), to
- progressively coarser-grained heat affected zone consisting of acicular ferrite and pearlite (Figure 39), to
- fusion zone consisting of coarse columnar grains (formed during solidification) which have transformed on cooling to mixed ferrite and pearlite (Figure 40).

Figure 37. Microstructure of base metal in practice weld panel. Microstructure consists of ferrite (light) and pearlite (dark), typical of hot rolled carbon steel plate. Note the presence of chemical banding parallel to the rolling plane of the plate.

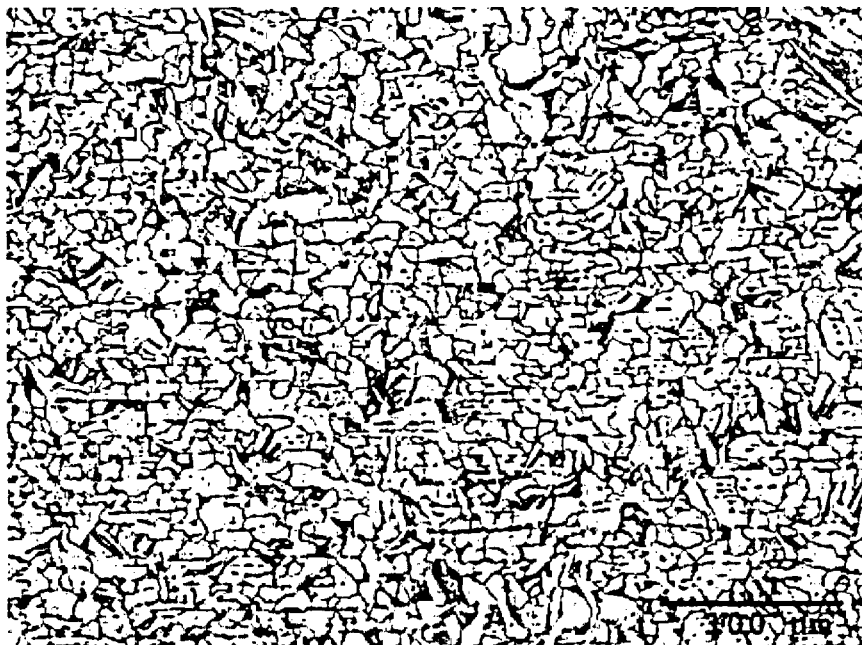
Figure 38. Microstructure of fine-grained portion of heat affected zone (several millimeters from weld) in practice weld panel. Microstructure consists of ferrite (light) and pearlite (dark). Note that the chemical banding persists in this region, indicating that the material, while re-austenitized, had not been heated to a high temperature in the austenite region.

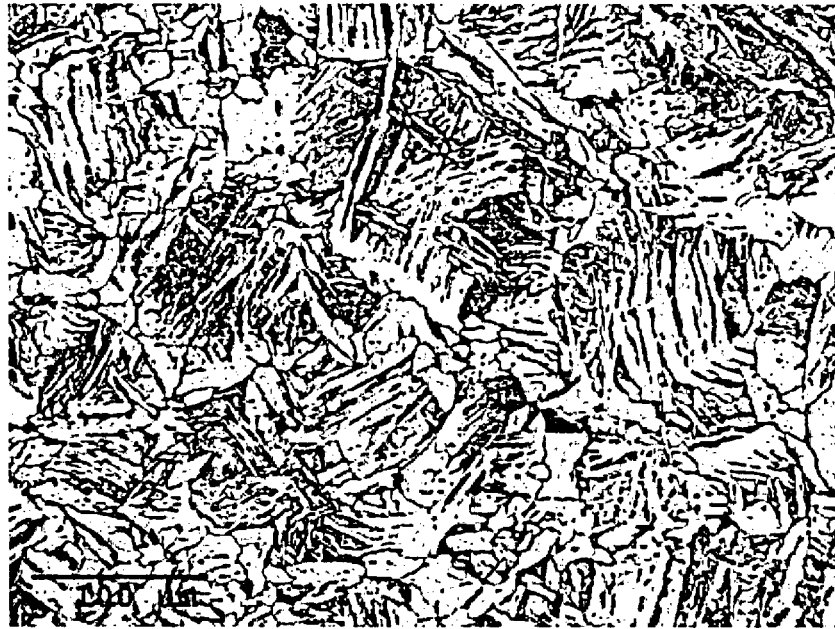
Figure 39. Microstructure of coarse-grained portion of heat affected zone (very close to weld) in practice weld panel. Microstructure consists of acicular ferrite (light) and pearlite (dark), typical of material that had been austenitized at high temperature and cooled fairly rapidly. Note that the chemical banding is no longer present in this region, indicating that the material had been heated to a high temperature in the austenite region.

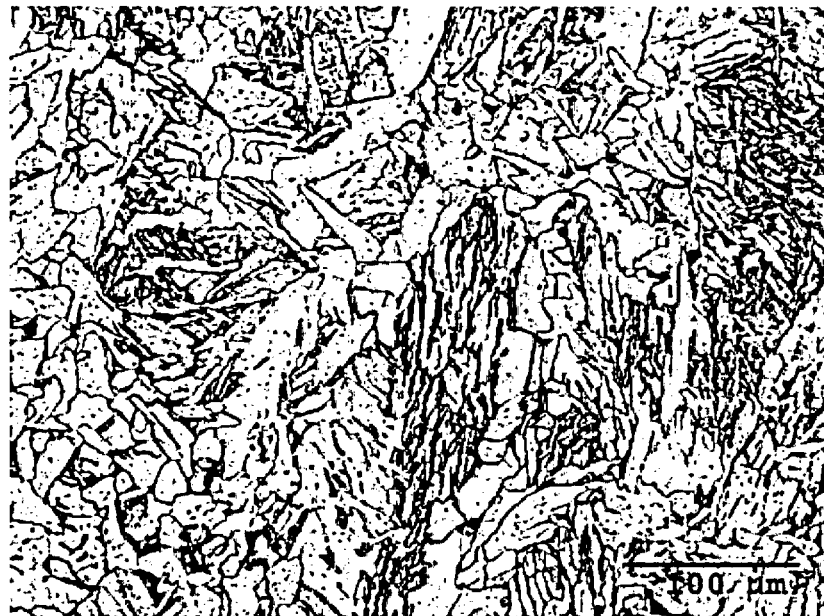
Figure 40. Microstructure of as-solidified fusion zone in practice weld panel. Microstructure consists of columnar prior austenite grains (characteristic of melted and resolidified material) that have transformed on cooling to ferrite and pearlite.

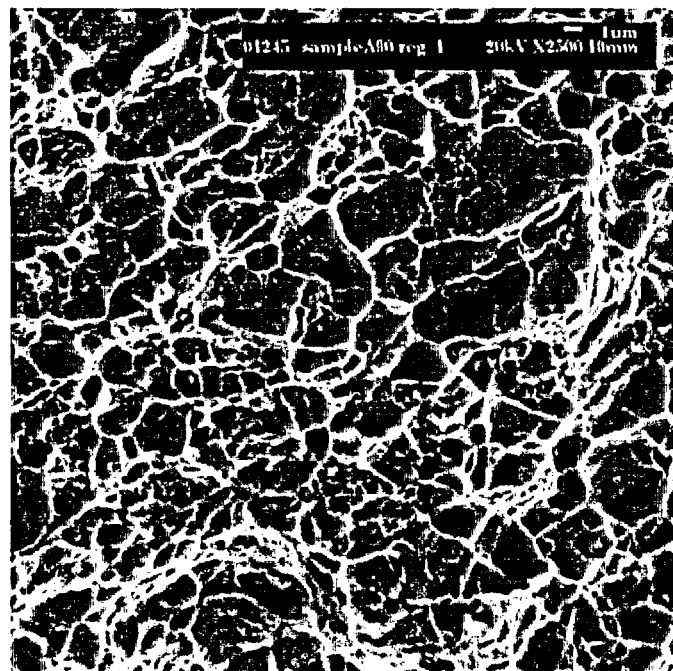
Scanning electron microscope characterization of the fracture surfaces showed that all of the samples failed by microvoid coalescence, as is typical of ductile failure following extensive plastic deformation (Figures 42 to 44). There may have been some tendency for the microvoids to be less fully developed in samples with substantial weld offsets (compare Figure 44 with 42 and 43), but not a dramatic one. Even in the sample that failed prematurely due to weld lack-of-fusion defects, the adjacent fracture surface (beyond the defect) exhibited typical microvoid coalescence failure.

Figure 42. Scanning electron micrograph of fracture surface from tensile sample without any weld. Microvoids indicate that failure occurred by ductile rupture, typical of tearing of mild steel plate following extensive plastic deformation.

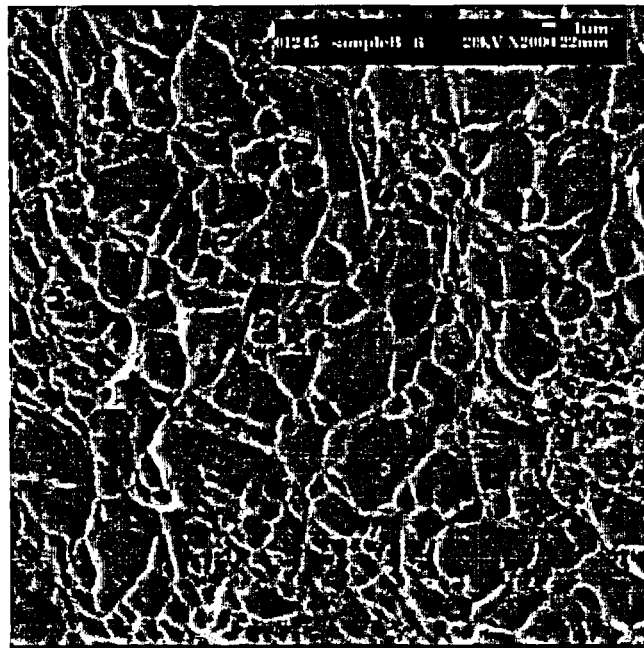
Figure 43. Scanning electron micrograph of fracture surface from welded tensile sample with lack of fusion defect. The location pictured is away from the weld defect, here deformation and fracture occurred in the heat affected zone. Failure here also occurred by ductile rupture.

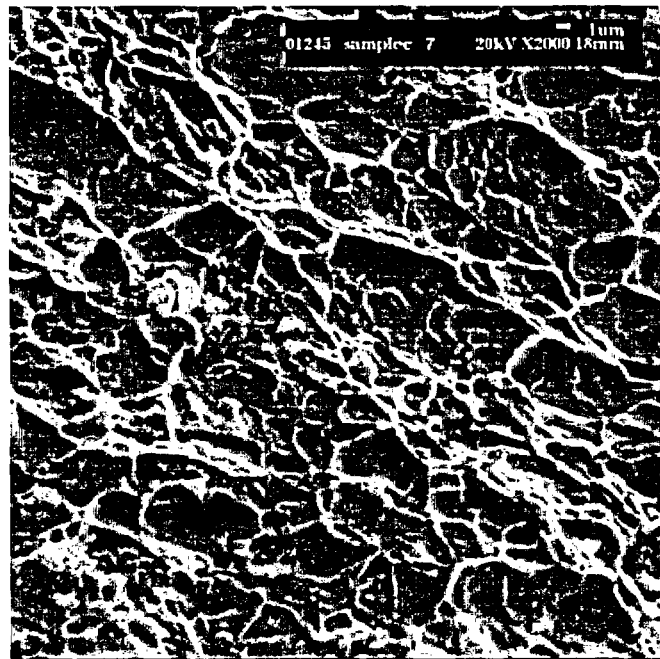
Figure 44. Scanning electron micrograph of fracture surface from welded tensile sample with substantial offset between plates. Failure here also occurred by ductile rupture.

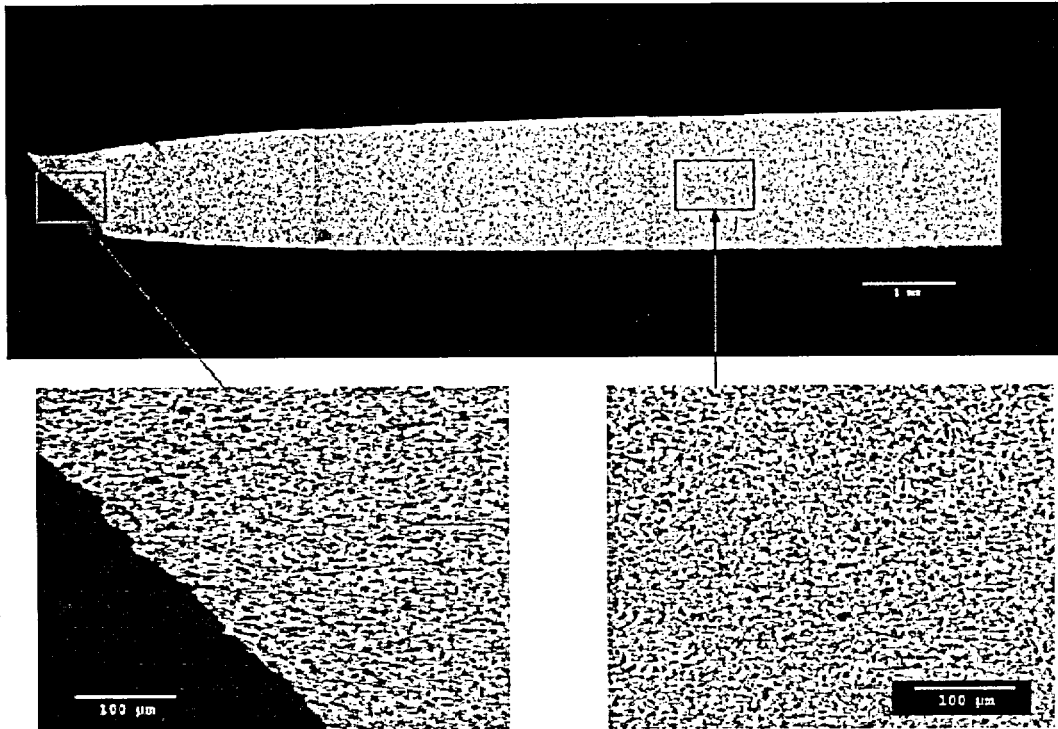
Figure 45. Metallographic cross-section of tensile sample of unwelded base metal (Sample A-3).

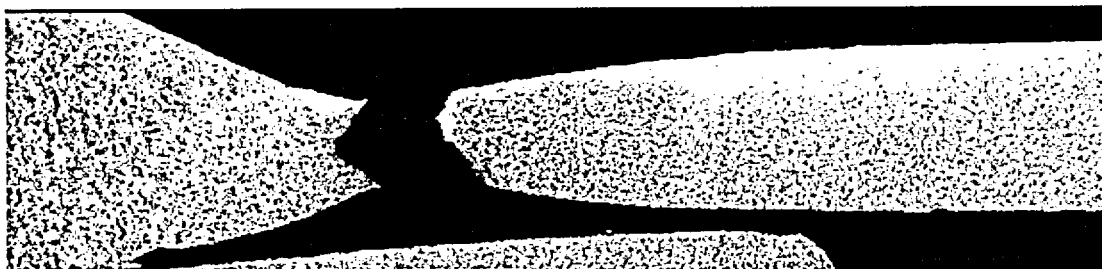
Figure 46. Metallographic cross-section of tensile sample from practice weld panel in area without substantial offset between plates (Sample B-2). This sample broke along the fusion line at an apparent lack of fusion defect. Cross-section is not through defect, but through a sound region adjacent to the defect where ductile tearing occurred.

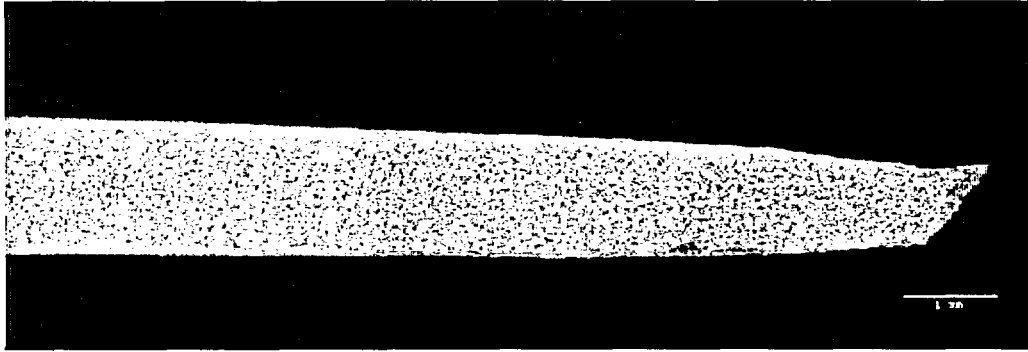
Figure 47. Metallographic cross-section of tensile sample from practice weld panel in area with substantial offset between plates (Sample C-1).

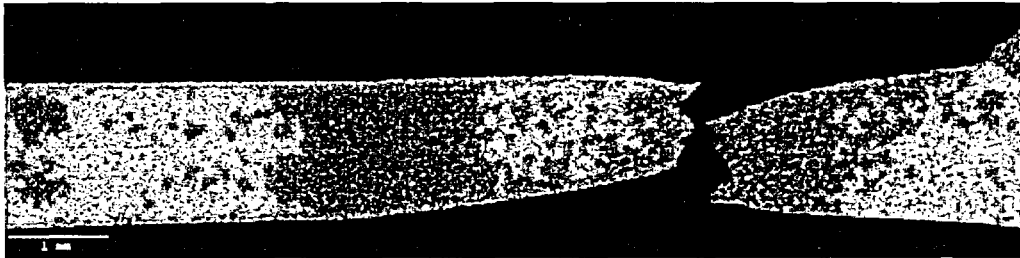
Figure 48. Metallographic cross-section of tensile sample from practice weld panel in area with substantial offset between plates (Sample C-2).

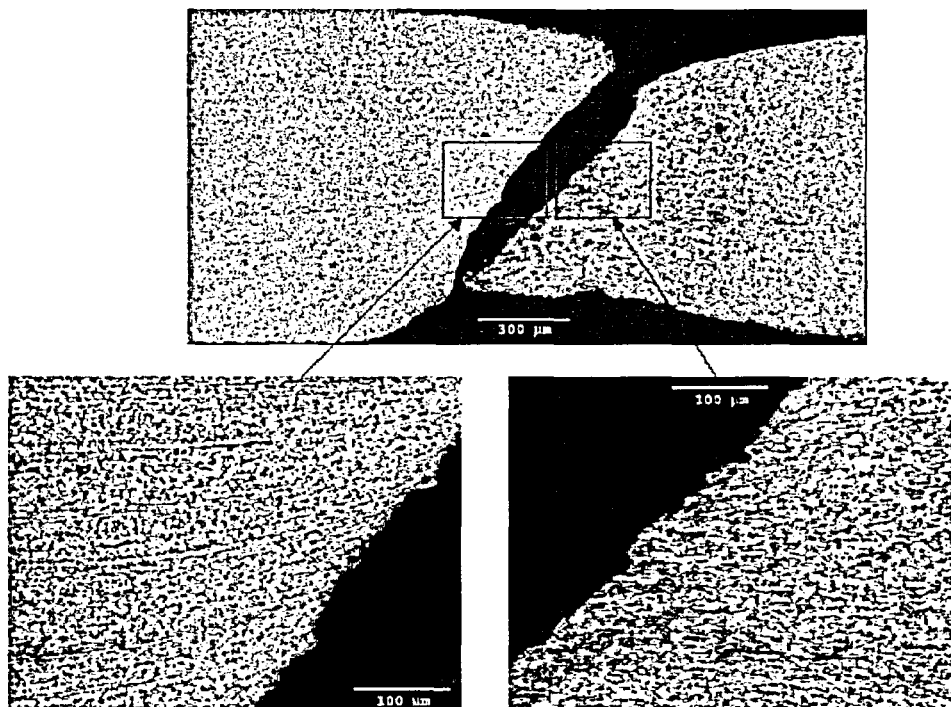
Figure 82. Metallographic cross section of tear #12. Tearing occurred in base metal (or perhaps far out in fine grained portion of heat affected zone). Note that two halves do not match perfectly across tear; this results in uncertainty regarding the amount of grinding done.

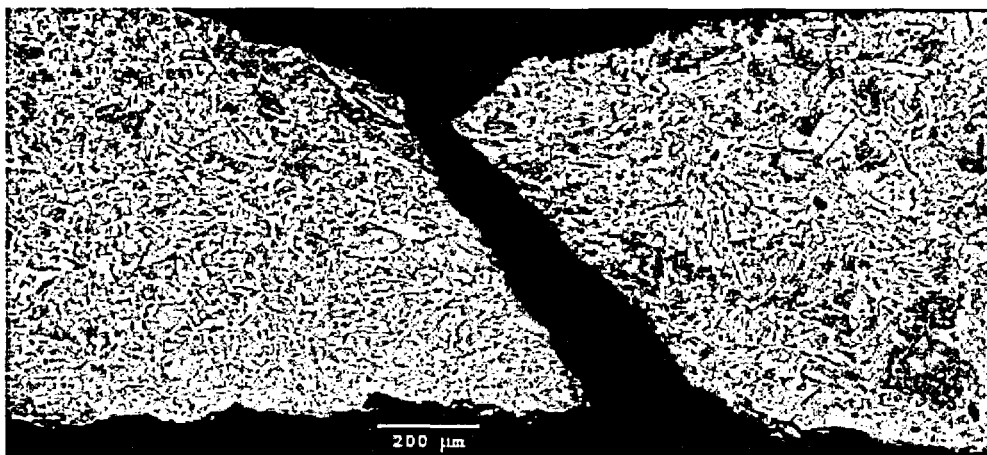
Figure 83. Metallographic cross section of tear #13. Tearing occurred in coarse grained portion of heat affected zone).

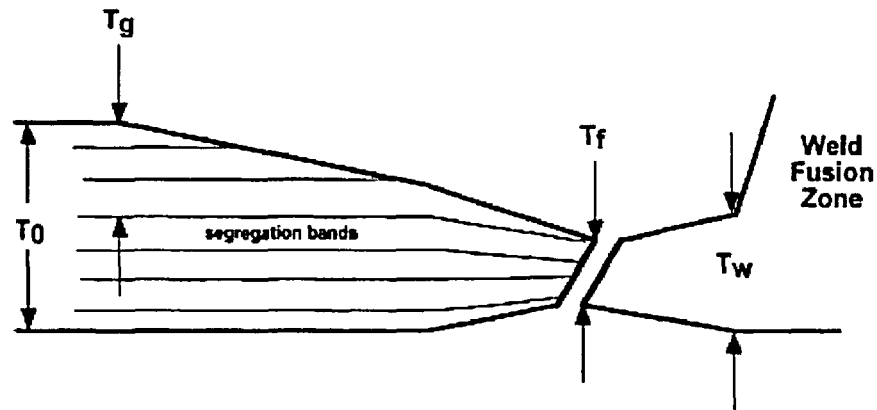
Estimates of the amounts of grinding associated with each tear were obtained based on the previously described knowledge that ~ 49% reduction in thickness occurs due to plastic deformation prior to fracture. The method used is illustrated in Figure 84. The liner thickness at each tear location was measured using a calibrated scale internal to the metallograph. This tear thickness was then divided by 0.51 to obtain the local pre-deformation thickness at/near each tear location. This pre-deformation thickness was subtracted from the initial liner thickness to determine the amount of material removed by prior grinding. Finally, the amount of material removed by grinding was divided by initial liner thickness to determine the percentage of grinding-related thickness reduction associated with each tear initiation site. These results are given in Tables 6 and 7. These percentages of original liner thickness removed by grinding are estimated to be accurate to +/- 5% absolute, i.e., 40% grinding implies 35% to 45%.

Two additional methods were used to confirm these estimates in selected cases, as illustrated in Figure 84. The amounts of grinding deduced from these two additional methods are also included in Tables 6 and 7.

Thickness at Tear: % Grinding = $((T_0 - T_f/0.51) / T_0) \times 100$

Thickness at Weld: % Grinding = $((T_0 - T_w) / T_0) \times 100$

Segregation Bands: % Grinding = $(T_g / T_0) \times 100$

Figure 84. Illustration of three methods used to estimate extent of liner thickness reduction due to grinding from metallographic cross sections.
