## 5. TESTING

The basic objectives of the PCCV test were specified by NUPEC in the Master Project Plan [34]. The stated objective of this plan was to... “investigate the ultimate behavior of PCCV under pressure beyond the design basis accident and to prove the pressure retaining capacity of PCCV.” NUPEC originally specified a series of five tests, illustrated in Figure 5.1: 1) trial pressurization to 0.4 kg/cm<sup>2</sup> (5.7 psig or 0.1 P<sub>d</sub>), 2) structural integrity and integrated leak rate tests to 4.5 and 3.6 kg/cm<sup>2</sup> (64.1 and 51.2 psig or 1.125 and 0.9 P<sub>d</sub>), respectively, 3) two design pressure tests to 4.0 kg/cm<sup>2</sup> (57 psig or 1.0 P<sub>d</sub>), and 4) a Limit State Test (LST) terminating with excessive leakage or structural failure.

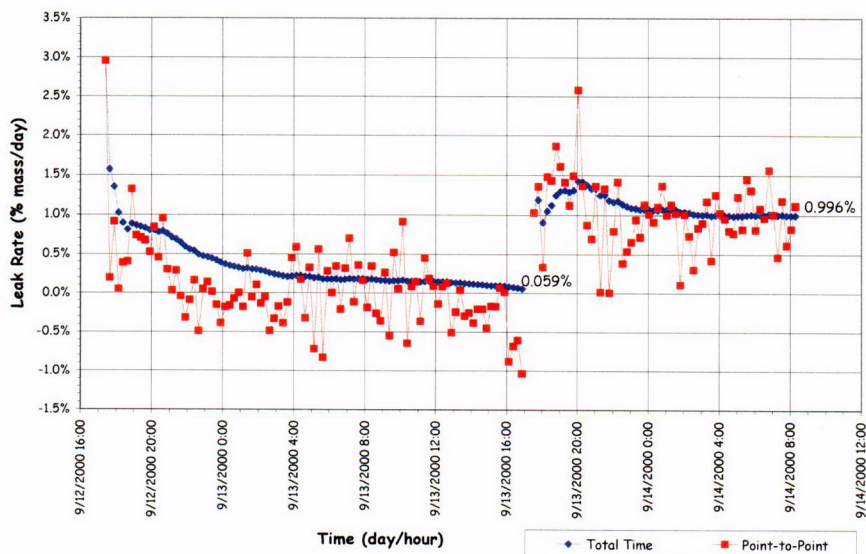
Figure 5.9 Integrated Leak Rate Test Leak Rates

The ILRT for the PCCV model was a hybrid of these procedures. The ILRT pressure,  $P_{ILRT}$ , was 0.9 Pd (0.35 MPa or 51.2 psig) based on JEAC 4203 and the Absolute Method for a Type A Test per ANSI/ANS N56.9 (Section 5.0) was followed. After depressurizing from the  $P_{SIT}$  to  $P_{ILRT}$ , the model was held at  $P_{ILRT}$  for approximately one hour to allow the model atmosphere to stabilize before the start of the leakage rate test. The ILRT commenced after all stabilization criteria were achieved and the duration of the test was “sufficient to enable adequate data to be accumulated and statistically analyzed so that a leakage rate ... can be accurately determined” but no less than 24 hours. Data was collected at least once every hour. The measured leakage rate at  $P_{ILRT}$ ,  $L_{tm}$ , was determined using both the (a) total time analysis and (b) point-to-point analysis techniques. The nominal atmospheric pressure at the elevation of the test site (verified by checking the Sandia Photovoltaics Weather Station reading) was used for leak rate calculations. The calculated leak rate after 24 hours at 0.9  $P_d$ , was 0.059% mass/day.

After the ILRT was completed, the model was initially depressurized by venting through the 1mm orifice plate, calibrated for a leak rate of 1% mass/day. After approximately 16 hours, a stable leak rate of 0.996% mass per day was calculated, again confirming the accuracy of the leak rate instrumentation.

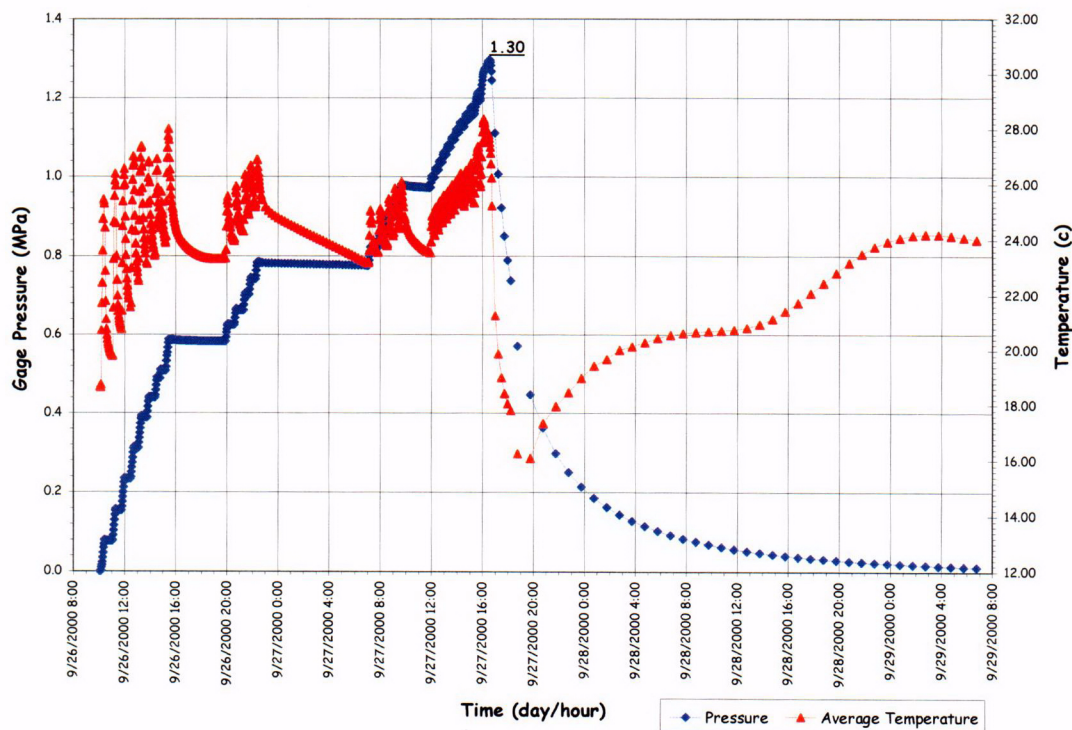
Figure 5.15 Limit State Test Pressure and Average Temperature

The pressure and average temperature time histories during the LST, including depressurization, are plotted in Figure 5.15. The LST followed the planned pressurization sequence up to the point where the model began leaking.

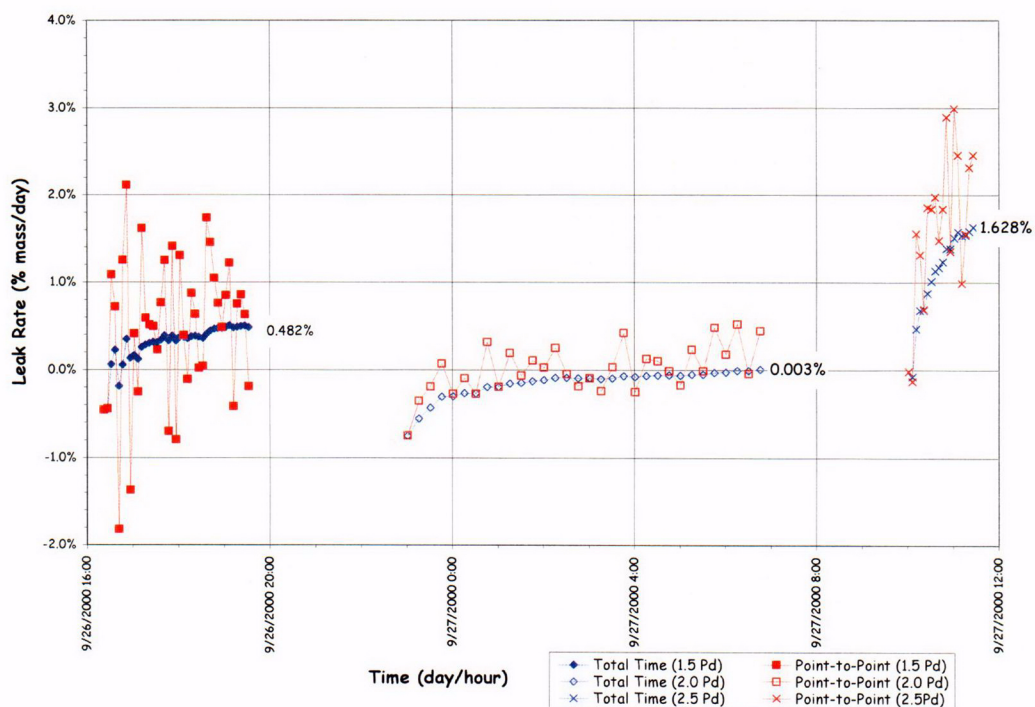
**Figure 5.16 LST Calculated Leak Rates at 1.5, 2.0 and  $2.5 P_d$**

Pressurization of the model resumed at 7:00 AM in increments of  $0.1P_d$ , with increasing dwell time between pressure steps (~30 minutes) required to meet the gage stability criteria. As the pressure was increased to the next planned leak check at  $2.5P_d$ , liner strain gages in the vicinity of the E/H (LSI-C-K5-12) began registering rapidly increasing strains in excess of 1%. At  $2.4P_d$  the acoustic system operator (AO) reported hearing a change in the acoustic output which might indicate that "something had happened." At approximately 10:00 AM at a pressure of  $2.5P_d$  ( $10.0 \text{ kg}_f/\text{cm}^2$  or 142.2 psig), the model was isolated for the third planned leak check. After approximately 1-1/2 hours, a fairly stable leak rate of 1.628% mass per day was calculated. The leak rate calculations at 1.5, 2.0, and  $2.5P_d$  are plotted in Figure 5.16. Coupled with the acoustic data that continued to confirm some new event had occurred, it became clear that the model was leaking, most likely from a tear in the liner in the vicinity of the E/H. Plots of the output of the four internal acoustic sensors surrounding the E/H at 2.3, 2.4, and  $2.5 P_d$  are shown in Figure 5.17.

After consulting with NUPEC and the NRC, the TC concluded that the model had functionally failed between 2.4 and  $2.5 P_d$  and directed a change in the pressurization plan. Since the model was leaking, the next goal was to pressurize the model as highly as possible to collect data on the inelastic response of the structure and to observe, if possible, a structural failure mode. Pressurization continued in increments of  $0.05 P_d$ , as planned. However, the gage stability criteria was abandoned and the hold time at each pressure step was reduced to less than 10 minutes.

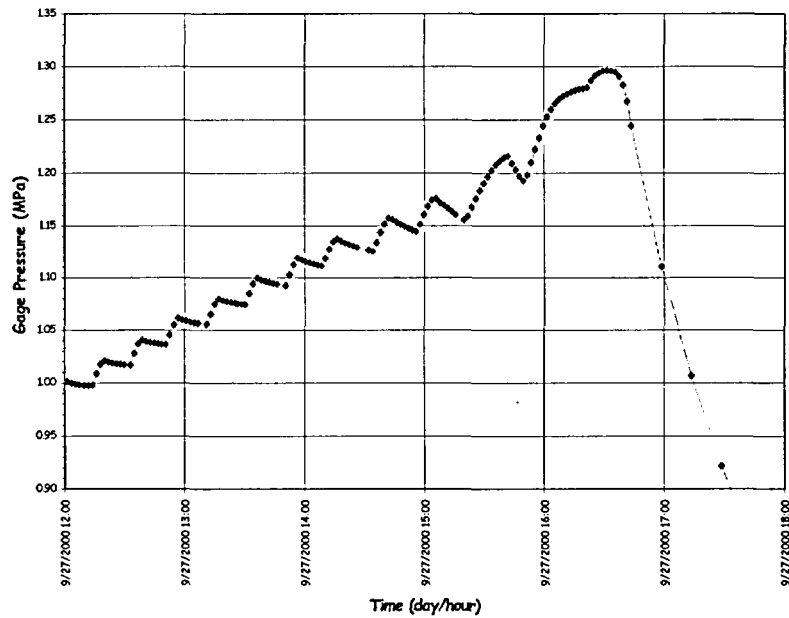
Figure 5.18 LST Pressure Time History, 2.5 to 3.3  $P_d$

The PCCV model was pressurized to approximately  $3.0P_d$ , with increasing evidence of leakage and increasing liner strains. At  $3.0P_d$ , it became increasingly difficult to pressurize the model, and the nitrogen flow rate was increased to 99 std.m<sup>3</sup>/min (3500 scfm). At this flow rate, the pressure in the model was increased to  $3.1P_d$ . However, the pressure dropped steadily after reaching this pressure. The leak rate at this point was estimated to be 100%.

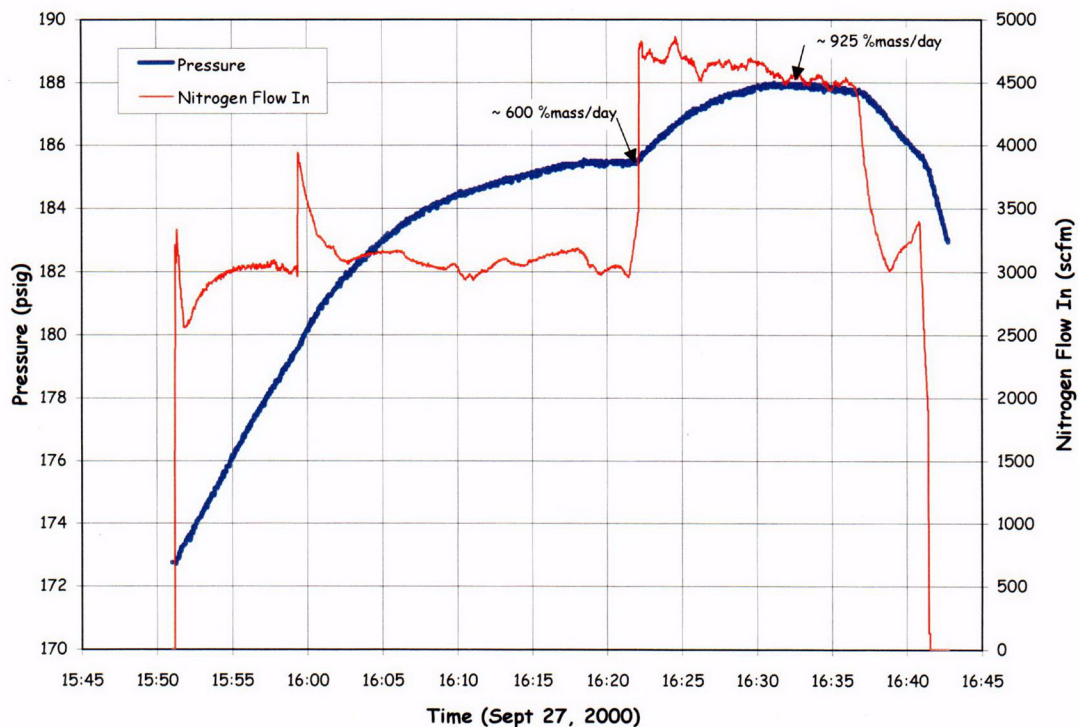
**Figure 5.19 LST Pressure and Flow Rates at Maximum Pressure**

The nitrogen flow rate was increased to the maximum capacity of the pressurization system, 142 std.m<sup>3</sup>/min (5000 scfm), and the pressure was increased to slightly over  $3.3 P_d$  before the leak rate exceeded the capacity of the pressurization system. The pressure time history and flow rates during the final phase of the test are shown in Figures 5.18 and 5.19. Since it was no longer possible to increase the pressure in the model and the supply of nitrogen was nearly exhausted, the TC decided to begin terminating the test.

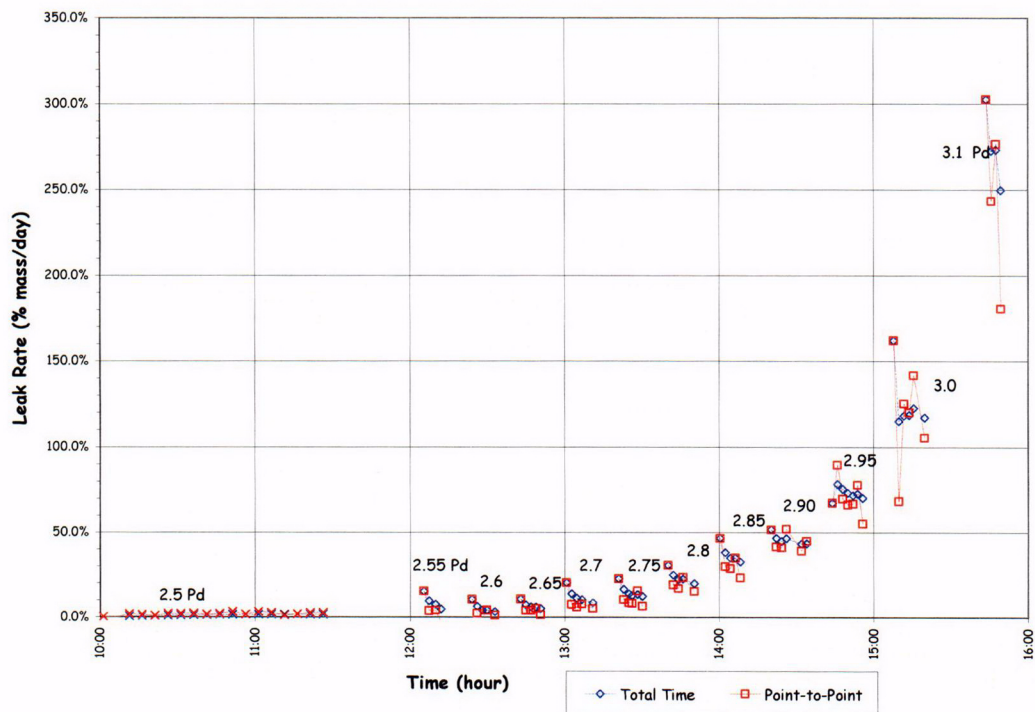
Figure 5-20. LST - Estimated Leak Rates (2.5-3.1 P<sub>d</sub>)

The isolation valve was closed and the model was allowed to depressurize on its own. The terminal leak rate was estimated to be on the order of 900% mass/day. (The maximum flow rate of nitrogen, 5000 scfm, is equivalent to a leak rate of 1000% mass/day.) Estimated leak rates during the final pressurization and depressurization phases are shown in Figures 5.20 and 5.21.

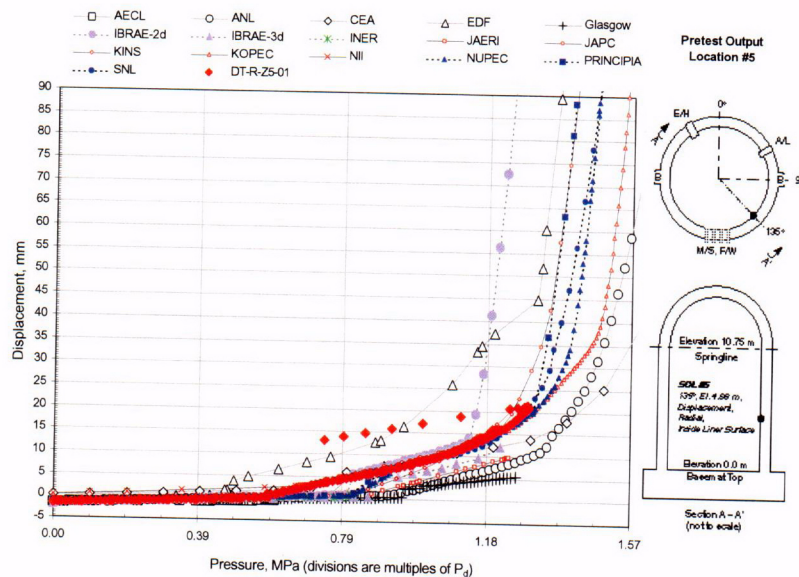
**Figure 5.23 LST Radial Displacement at Azimuth 135 degrees, Elev. 4680**

Two issues needed to be addressed to determine the technical feasibility of reloading the PCCV model. First was the question of whether the LST had caused damage to the structure such that any data obtained by reloading the structure would be compromised and of limited value for comparison with analytical results. The LST data was thoroughly reviewed and, with the exception of the liner and cracking of the concrete, there was no evidence of excessive structural damage. There was also no indication that the tendons had been strained beyond their yield limit and, except for a few isolated measurements, the same was true for the rebar. (Only 27 of the rebar gages registered strains in excess of 0.4% with a maximum of 1.7%—which likely reflects the local perturbation caused by the presence of the gage.) Comparing the radial displacement at the mid-height of the cylinder to the pretest Round Robin predictions in Figure 5.23 clearly illustrates that the structure was on the verge of global yielding but had not undergone a significant amount of inelastic

deformation. (In this context, only the yielding of the steel and rebar is addressed. Obviously, the loss in stiffness that occurs with global concrete cracking at approximately  $1.5P_d$  cannot be recovered.) This was a positive finding for the prospect of reloading the model since most, if not all, of the capacity of the rebar and tendons was still available. Another important conclusion from the consideration of the LST data was that if, in fact, the model was on the verge of global structural yielding, the additional pressure required to cause larger; inelastic deformations was not very large; perhaps only on the order of a few tenths to half the design pressure, i.e. an additional 1.0 to 2.0  $\text{kg}_f/\text{cm}^2$  (14 to 30 psig).

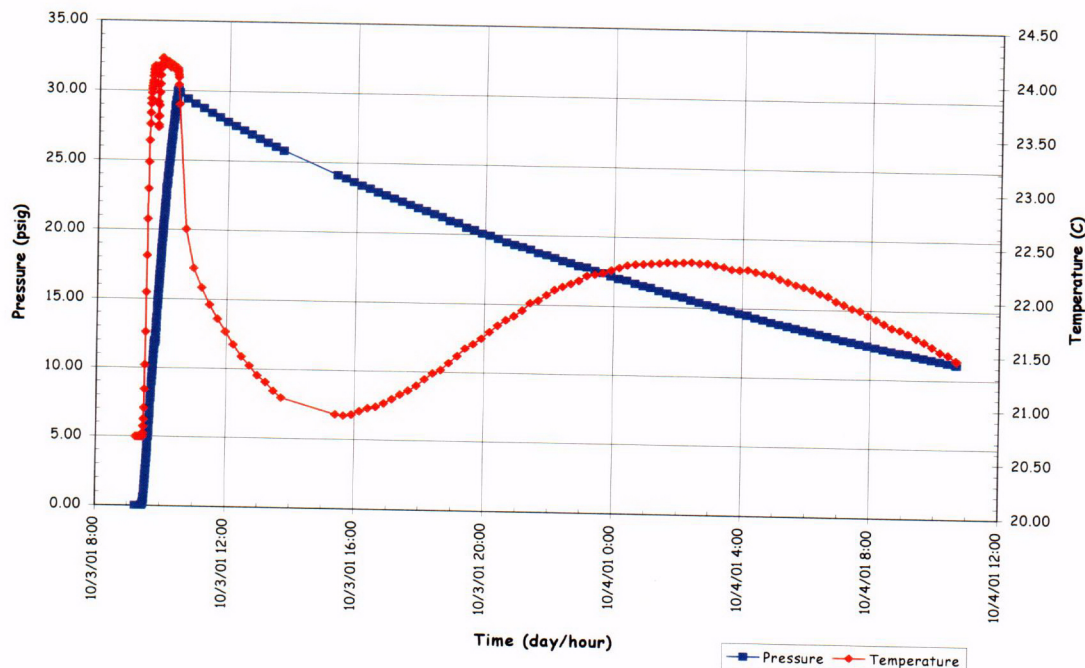
**Figure 5.27 Pre-SFMT Leak Test Pressure and Temperature**

After completing the installation and all test-readiness checks, the E/H cover was installed and sealed. A low pressure pneumatic test was conducted to check for leaks on October 3, 2001. The pressure and temperature time histories for the leak test are shown in Figure 5.27. The leak test began at approximately 09:30 and a leak was detected (via the acoustic system) at approximately 0.2 Pd (~12 psig). Pressure was increased to the target pressure of 0.5Pd (30 psig), at which time the vessel was isolated and monitored for a 24-hour leak test. The acoustic system (multiple sensors) continued to output signals consistent with a leak in the model and several potential leak locations were identified.

Once the model was deemed stable, the nitrogen supply was isolated and a close inspection of the model was conducted. Through a combination of visual/auditory inspection, hand-held acoustic monitoring, and the application of soap-water solution, a number of locations were discovered where nitrogen gas was leaking from the model.

- The largest apparent leak was from a crack on the left-hand side of the 90-degree buttress at an elevation of approximately 6 m (20') above the top of the basemat (Level 6 in the cardinal coordinate system). This leak was the first detected by the acoustic system and was immediately confirmed during the close-up inspection.

- Secondary leaks, identified by the acoustic system, were confirmed at 150 degrees/3 and 6 m (10 and 20') and 210 degrees/4.5 m (15'). These leaks appeared to be through previously existing cracks in the concrete. The leak at 150 degrees was along the horizontal construction joints between C1, C2, and C3 as well as along a vertical crack extending between C2 and C3. The leak at 210 degrees also appeared to be through a previous crack.

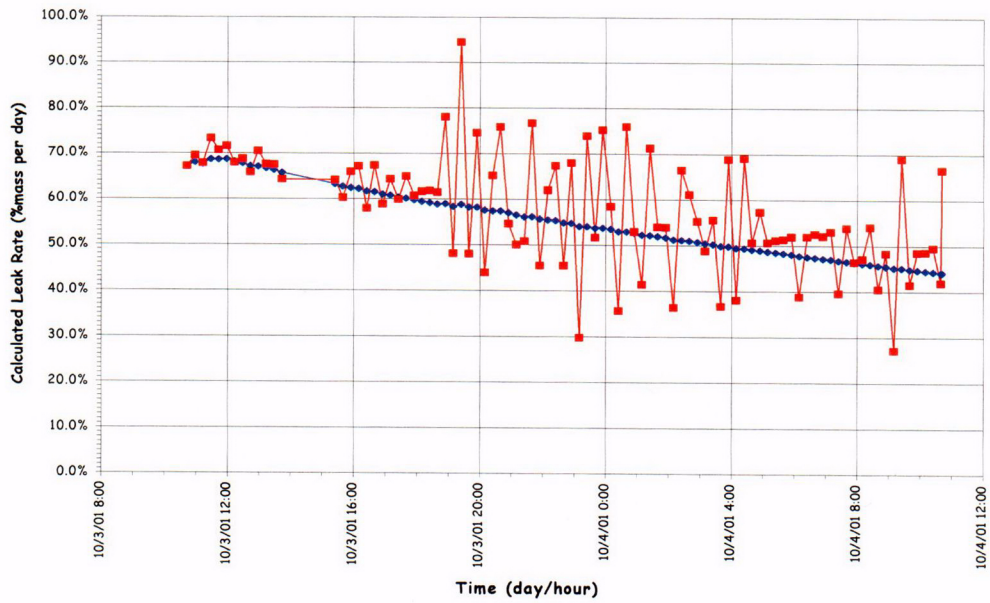
Figure 5.28 Pre-SFMT Leak Rate Test

The calculated leak rate, shown in Figure 5.28, was initially 70% mass/day at the maximum pressure of 2.1 kg<sub>f</sub>/cm<sup>2</sup> (psi) decaying to 45% at 0.77 kg<sub>f</sub>/cm<sup>2</sup> (11 psi) over 24 hours. The sound levels as detected by the SoundPrint system (shown in Figure 5.29), which are roughly proportional to the rate of gas escaping, indicated a stable leak rate that was, to a large extent, independent of the pressure.

Based on these results, it was concluded that the leak was most likely due to a pre-existing hole(s) in the sprayed on liner which did not increase (or decrease) significantly during pressurization or during the leak test. (The equivalent orifice size reduced from about 6 mm (0.25") at 2.1 kg<sub>f</sub>/cm<sup>2</sup> (30 psi) to 5 mm (0.20") at 0.8 kg<sub>f</sub>/cm<sup>2</sup> (12 psi), based on the calculated leak rates.) As a result, the SFMT could be conducted without repairing the sprayed-on liner while maintaining a reasonable chance that the leak would not grow significantly and overwhelm the capacity of the pressurization system. (Nevertheless, during an unscheduled one-month postponement of the SFMT, the surface was retested with a 'spark-tester,' and a few small holes were discovered and sealed. The model was then resealed and readied for filling with water.)

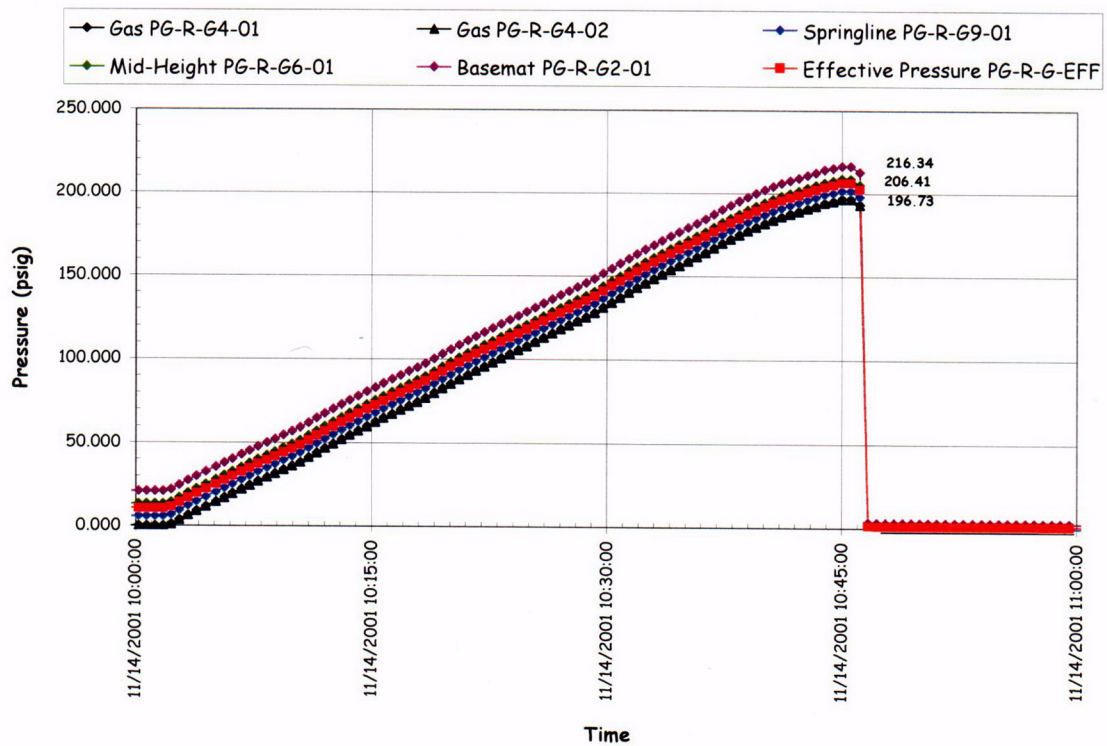
Figure 5.31 SFMT Pressure Time Histories

The SFMT began shortly after 10:00 AM on Wednesday, November 14, 2001. The pressure time histories are shown in Figure 5.31. The pressure time history of all five gages are shown along with the effective model pressure, which is calculated as a volume-weighted average. Any references to the SFMT pressures are to the effective pressure, unless noted otherwise.

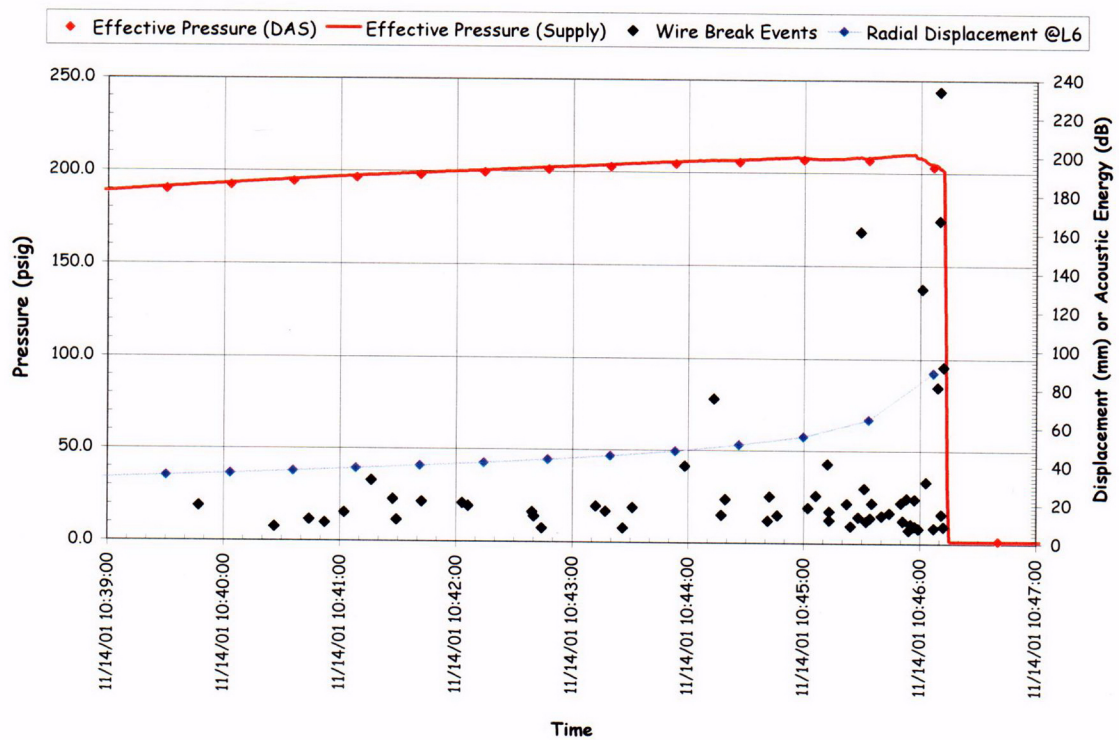
Figure 5.32 SFMT Wire Break Events vs. Pressure vs. Displacement

The model was continuously pressurized at a rate of approximately 0.35 kg<sub>f</sub>/cm<sup>2</sup> (5psi)/min. All active sensors were continuously scanned at intervals of approximately 30 seconds and the video cameras continuously recorded the response of the model. As the pressure increased, evidence of leakage was visible as increasing wetting of the concrete surface. At 10:38 AM, the effective pressure in the model equaled the peak pressure achieved during the LST, 3.3 Pd (1.29 MPa or 188 psig). At approximately 10:39 AM, the acoustic system recorded a very high noise level event, which was interpreted as the breaking of a tendon wire. At this point in the test, events occurred very quickly. Shortly after detecting the wire break, a small spray of water was observed at approximately 0 degrees Azimuth and additional tendon wire breaks were detected by the acoustic system with increasing radial frequency. The wire break events are plotted in Figure 5.32, along with the effective pressure and the radial displacement at Azimuth L (324 degrees), elev. 6 (6280), as a function of time.

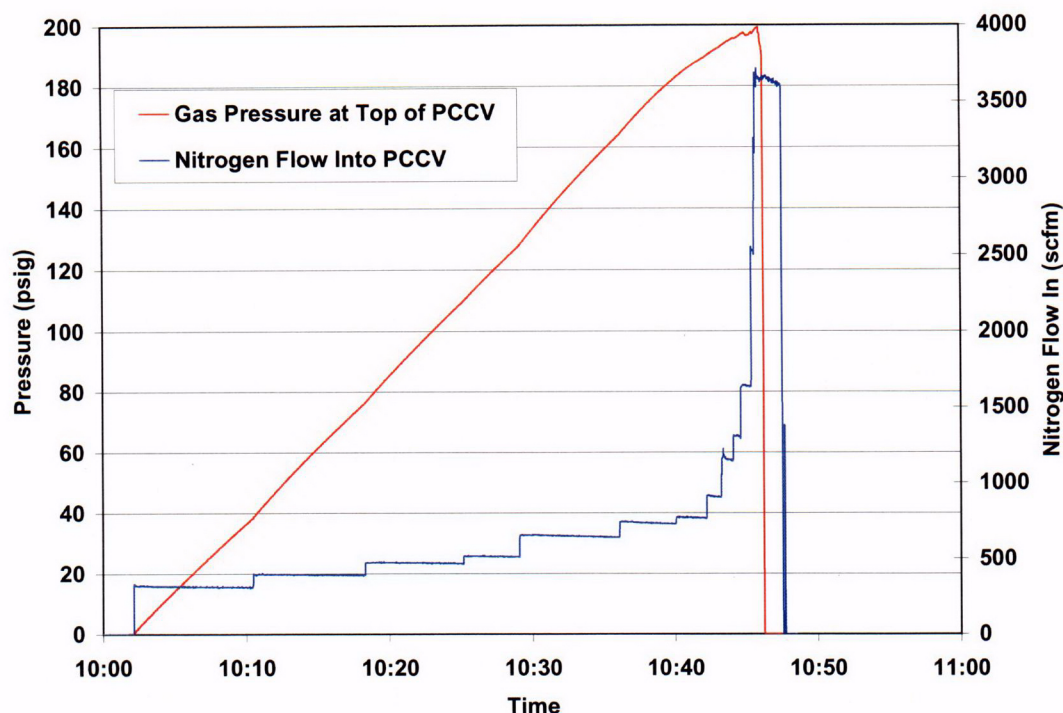
Figure 5.33 SFMT Pressurization System Data

The rate of pressurization decreased and the nitrogen flow rate was increased to maintain the pressurization rate. The gas pressure and flow rates are shown in Figure 5.33. The water surface inside the model, viewed through the internal video camera, was dropping slowly, but it was unclear if this was due to leakage or radial expansion of the vessel.
