5.3.2 Limit State Test Results

5.3.2.2 Posttest Inspection

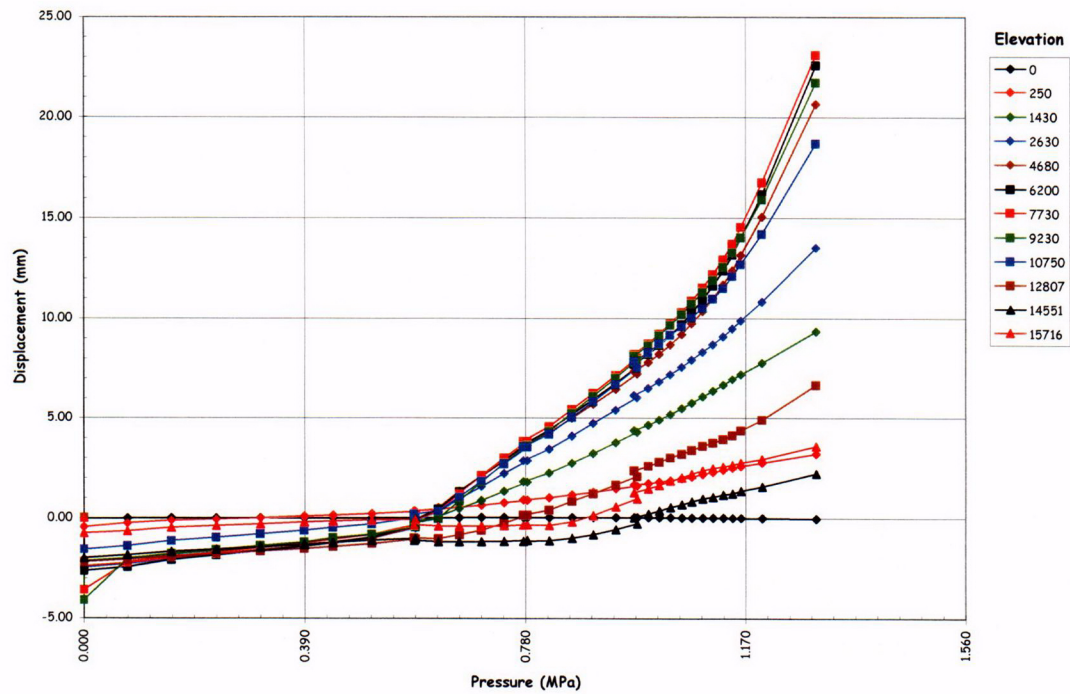
Figure 5.39 LST - Radial Displacement at Azimuth 135 degrees

The radial displacement of the model at the cardinal elevations along Azimuth 135 degrees, selected to represent the 'free-field' or axisymmetric response of the model, is shown in Figure 5.39. This plot illustrates several features of the response data that should be noted. The initial values (i.e. at $P=0$) reflect the inside surface motion of the liner between March 3rd and the start of the LST, thereby reflecting the influence of prestressing, changes in ambient temperature, creep, etc. The response due to pressure alone is the reported displacement minus the displacement at the start of the LST (i.e., at $P=0$ on 10:03 a.m., 26 September, 2000).

The initial data also suggests that the liner most likely separated from the concrete wall at some locations, as evidenced by the relatively large displacements that occurred during the first pressure step. At these locations, the first increment of pressure 'pushed' the liner back into contact with the concrete surface. This behavior can also be observed in the SFT and SIT/ILRT data, including a restoration of the gap after depressurization. The liner separation is most likely a result of differential thermal expansion and prestressing, resulting in compressive stresses that may have bowed or slightly buckled the liner.

The response remains essentially elastic up to 1.3 to $1.5 P_d$, after overcoming the prestress ($\sim 1.2 P_d$) and tensile cracking of the concrete. It is interesting to note that even though drying and shrinkage cracks were present prior to pressure testing, the onset of generalized concrete tensile cracking is quite distinct. Beyond $1.5 P_d$ to approximately 2 to $2.5 P_d$, the response is still linear, although the loss of concrete tensile stiffness is quite distinct. Beyond $2.5 P_d$, the response becomes increasingly nonlinear, particularly in the mid-section of the cylinder, as the model exhibits generalized yielding in the hoop direction.

The data also exhibits some apparent discontinuities at 1.5 , 2.0 , and $2.5 P_d$. These apparent discontinuities coincide with the leak checks of the model and reflect, primarily, the response to changes in ambient thermal conditions over the time the model was isolated. The jump in displacement at $2.5 P_d$, however, most likely includes creep effects, since the temperature was stable over the relatively short (1-1/2 hour) hold at this pressure.

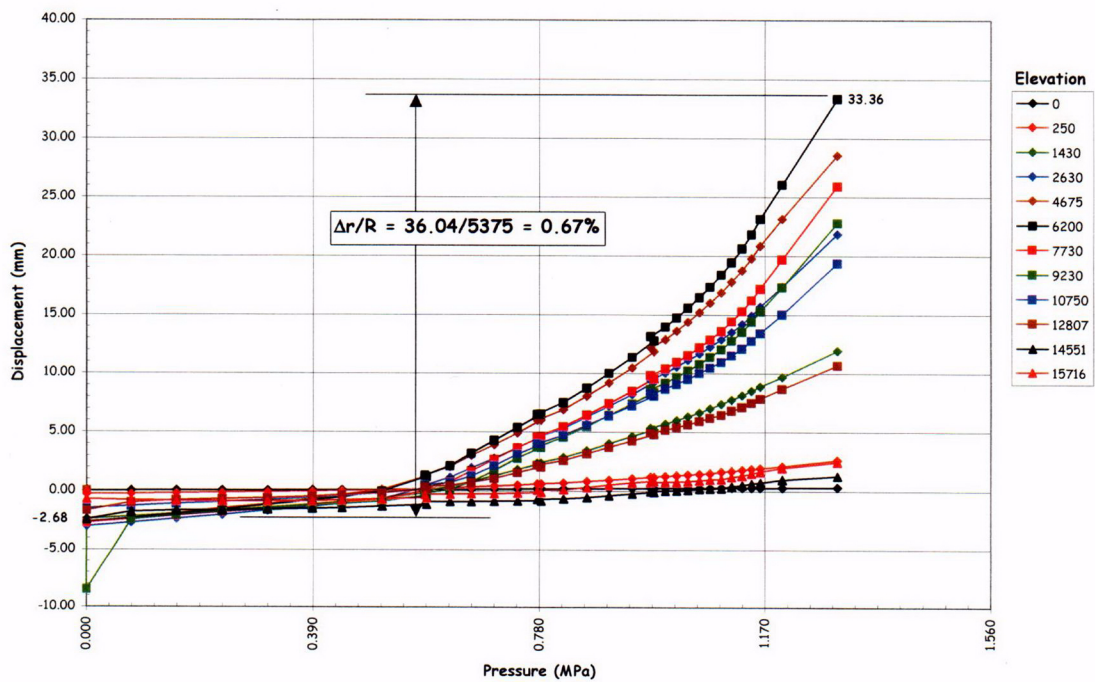
Figure 5.40 LST - Radial Displacement at Azimuth 324 degrees

Figure 5.40 displays the displacements at Azimuth 324 degrees, which coincides with the centerline of the E/H. The largest radial displacement recorded during the LST, 33.36 mm, occurred at this Azimuth at El. 6200, above the E/H. Computing the equivalent hoop strain due to pressure at this location from kinematics,

$$@P_{\max} = \frac{\Delta r}{R} = \frac{(33.36 + 2.68)}{5375} = 0.67\%$$

Similarly, calculating the local hoop strain in the vicinity of the equipment hatch at $2.5 P_d$, corresponding with the onset of liner tearing and leakage, yields a value of approximately 0.28% .

Figure 5.40 again illustrates the liner separation phenomena, previously described, at elev. 9230. In this case the large magnitude of the displacement clearly indicates that the liner buckled. (A review of the post-prestressing data indicates that this occurred shortly after the completion of prestressing, most likely in conjunction with thermally-induced compressive strains.) This behavior did not, however, compromise the integrity of the liner and no tears were discovered at this location.

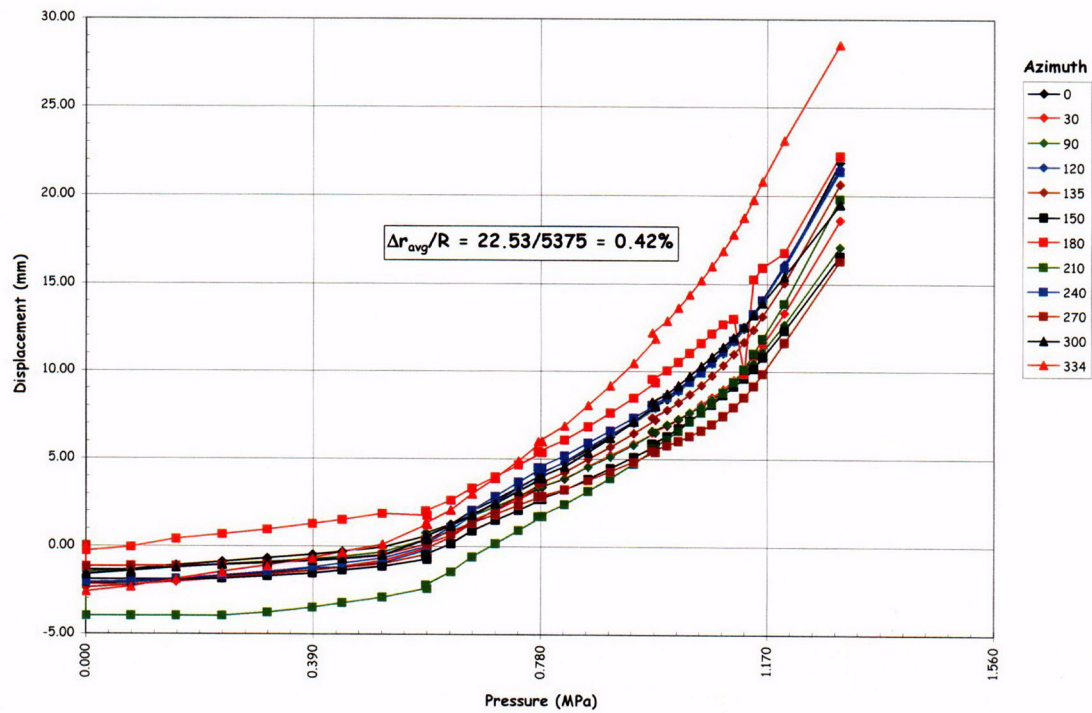
Figure 5.41 LST-Radial Displacement (DOR) at EL 4680

Figure 5.41 compares the displacement response as a function of Azimuth at elev. 4680, nominally the mid-height of the cylinder and the centerline of the E/H, A/L, and M/S penetrations. Ignoring some variation in initial conditions, reflecting some 'out-of-roundness' following prestressing, the response is fairly uniform, i.e. axisymmetric, except at 324 degrees, where largest deflections were already noted to occur. Averaging the radial deformation due to pressure yields a nominal average hoop strain of 0.42% at the peak pressure $3.3 P_d$. Similarly, the average hoop strain at $2.5 P_d$, coinciding with the onset of liner tearing and leakage, was 0.18% .

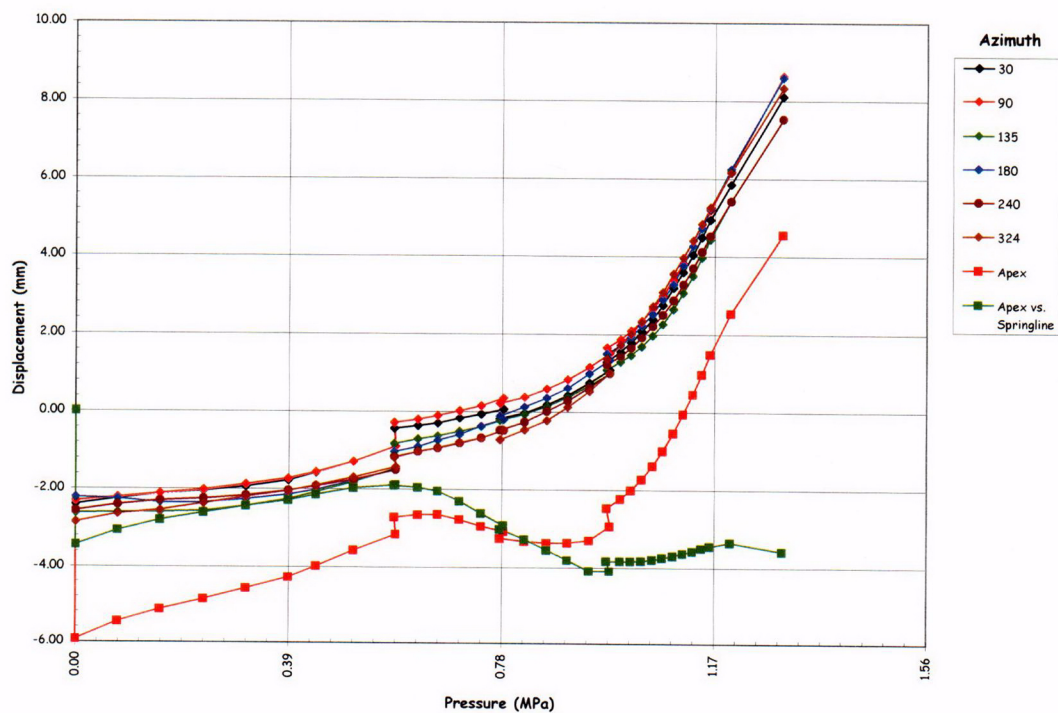
Figure 5.42 LST-Vertical Displacements (DOR) at Springline, El. 10750

Figure 5.42 shows the vertical displacement of the springline at various azimuths. The vertical displacement at the apex and the differential displacement between the average springline displacement and the apex are also plotted. The vertical displacement exhibits similar behavior to the hoop displacements. In the vertical direction, however, the loss of stiffness due to concrete cracking occurs around $2.5 P_d$. Yielding in the vertical direction does not appear to occur. This is due to the higher level of vertical prestress in the cylinder wall and the lower tensile forces induced by the pressure. The

vertical displacement is nearly uniform at the springline and the average meridional strain in the cylinder wall is less than 0.1%.

Figure 5.42 also shows that beginning around $1.5P_d$, the dome apex deflects downward relative to the springline, most likely due to increasing force in the vertical tendons once the initial prestressing force is overcome by the pressure. (The vertical prestressing applies a compressive force on the cylinder wall approximately equal to the tensile force exerted by a pressure of $1.88P_d$.)

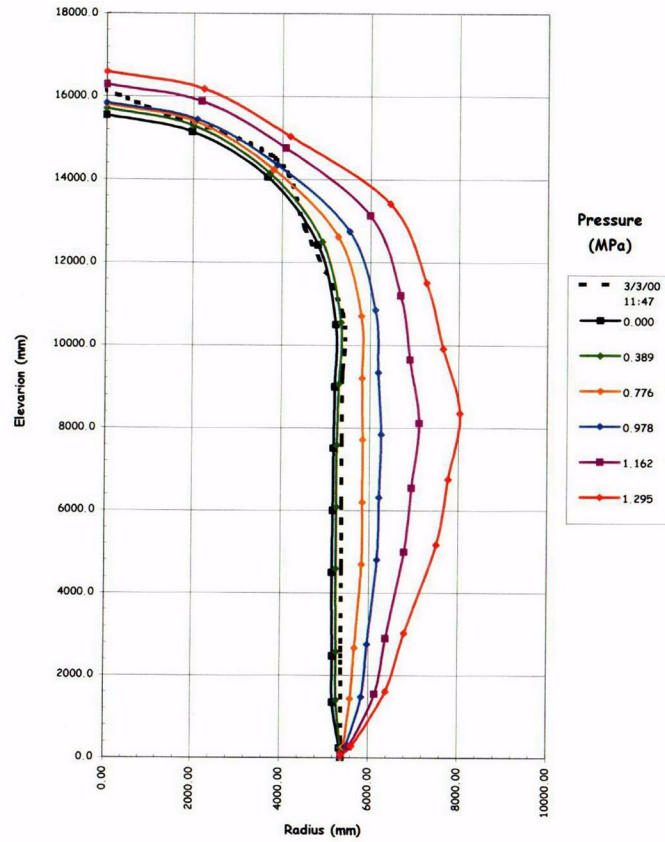
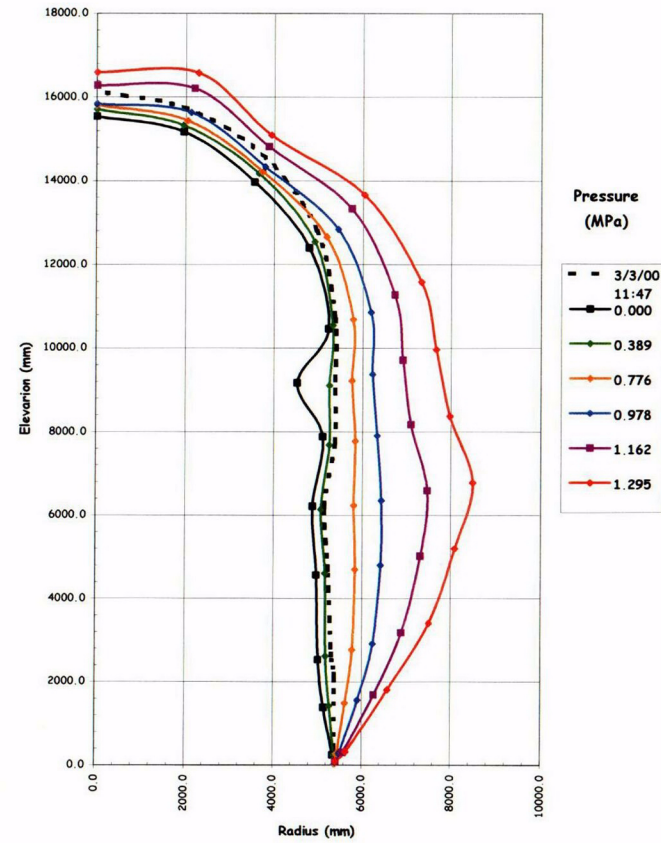
Figure 5.44 LST - Deformation at Azimuth 240 degrees and 324 degrees (I and L) $\times 100$

- The unusual deformation patten in the dome at 135 degrees and 324 degrees coincides with the regions where the East-West and North-South sets of vertical tendons overlap with the hoop tendons in the dome, where higher prestressing forces are present than in other regions of the dome.
- The initial buckling of the liner at Azimuth 324 degrees, elev. 9230 is clearly shown in Figure 5.44.

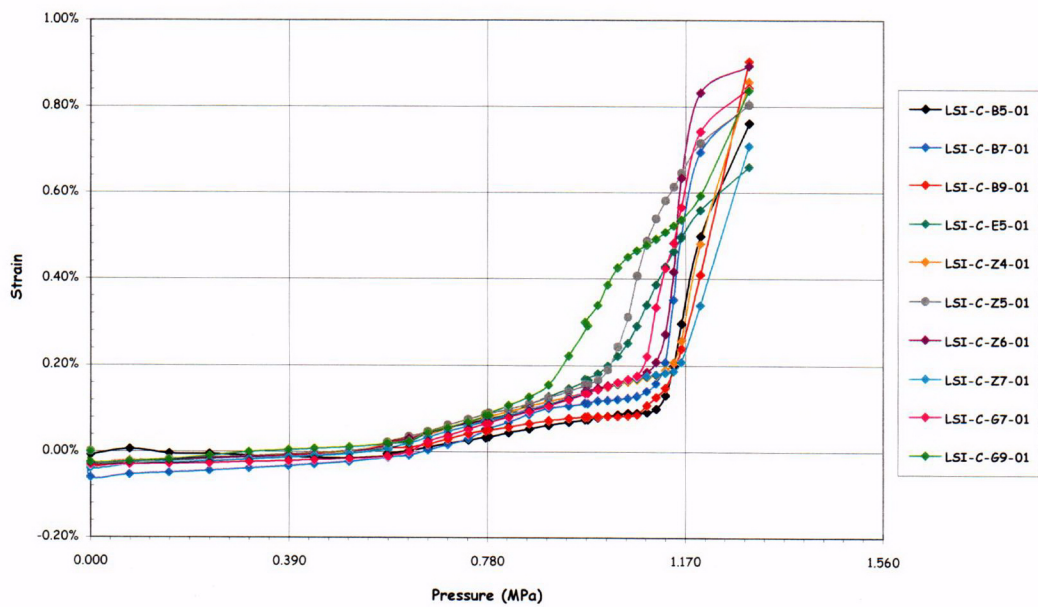
Figure 5.46 LST – Free-Field Liner Hoop Strains

Figure 5.46 shows all the free-field liner hoop strain gages that exceeded 0.5% at the end of the test. It is interesting to note that up to 2.5 Pd, the free-field liner strain hoop strains were almost all below 0.2%, which compares favorably with the average hoop strain computed from the displacements, 0.18%.

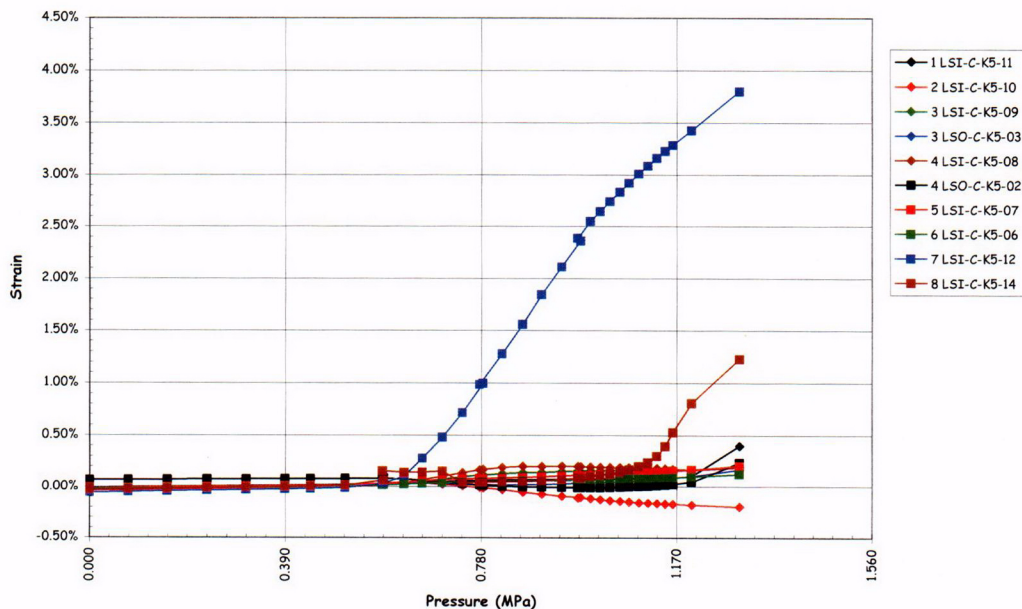
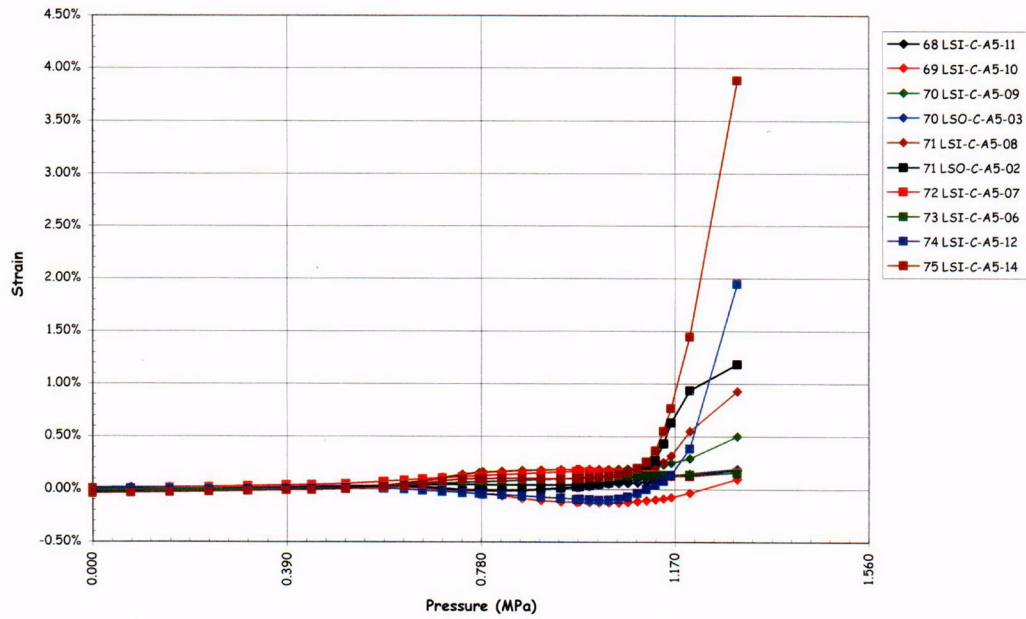
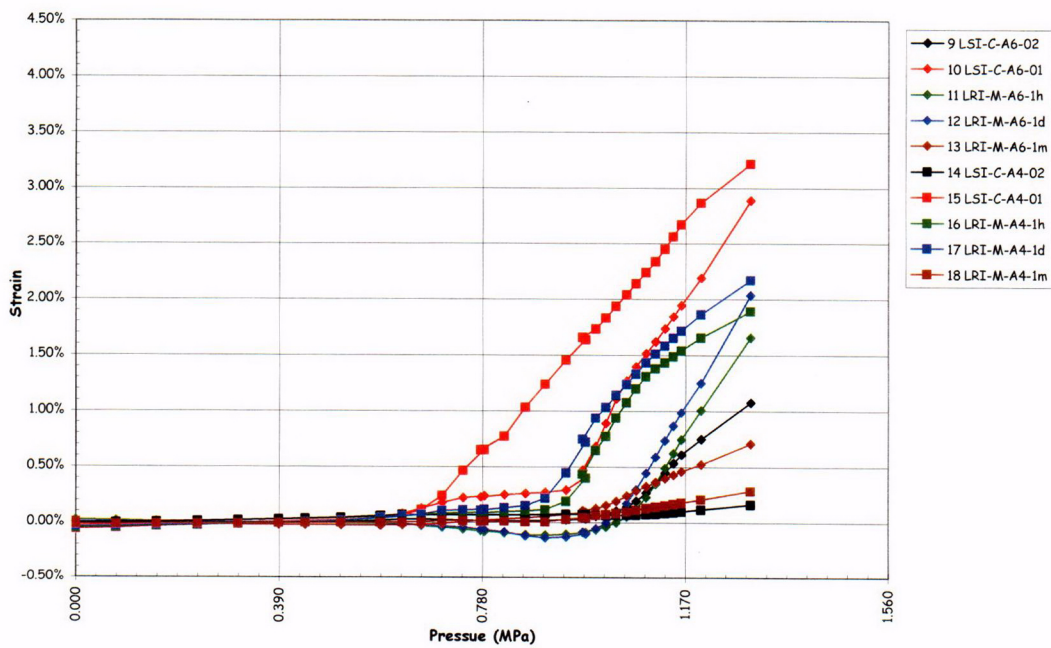
The strains at the middle of the 'left' (#1-8) and right (#68-75) edges of the embossment are shown in Figures 5.49 and 5.50. The strains at the upper and lower 'left' corners are shown in Figure 5.51. With the exception of gage #7, the strains at the mid-sides of the embossment are all very small until global yielding of the model occurs just below $3P_d$. At the corners, however, liner strains begin increasing earlier, with gage #10 showing increasing strains beginning at $1.5P_d$, while most of the other gages show significant increases beginning at $2.5P_d$, when liner tearing was believed to

have occurred. At first glance, it appears unfortunate that the liner tore on the opposite side from the strain gages (pretest analyses suggested the highest strains would occur on the 'left' side). However, it has been found that strain gages near tears often see lower strains than would be expected, since the tear acts as a strain relief mechanism. While it is apparent that the strains on the 'right' side were higher, it is unlikely that gages at those locations would have recorded higher strains than those on the left side. This is demonstrated by comparing gages #7 on the left and its mirror image, #74, on the right.

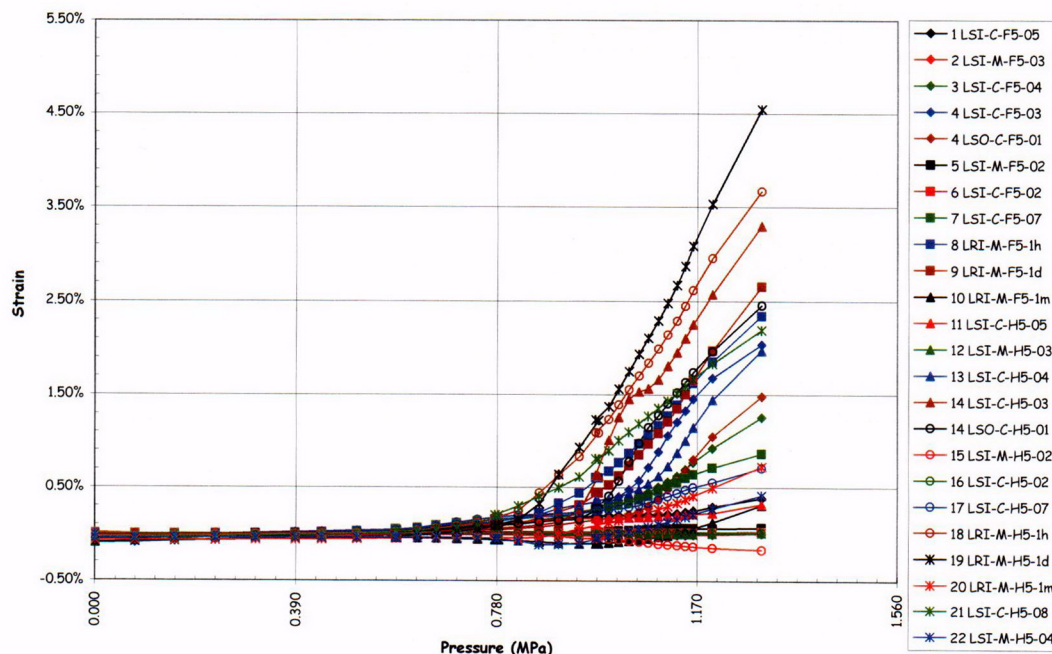
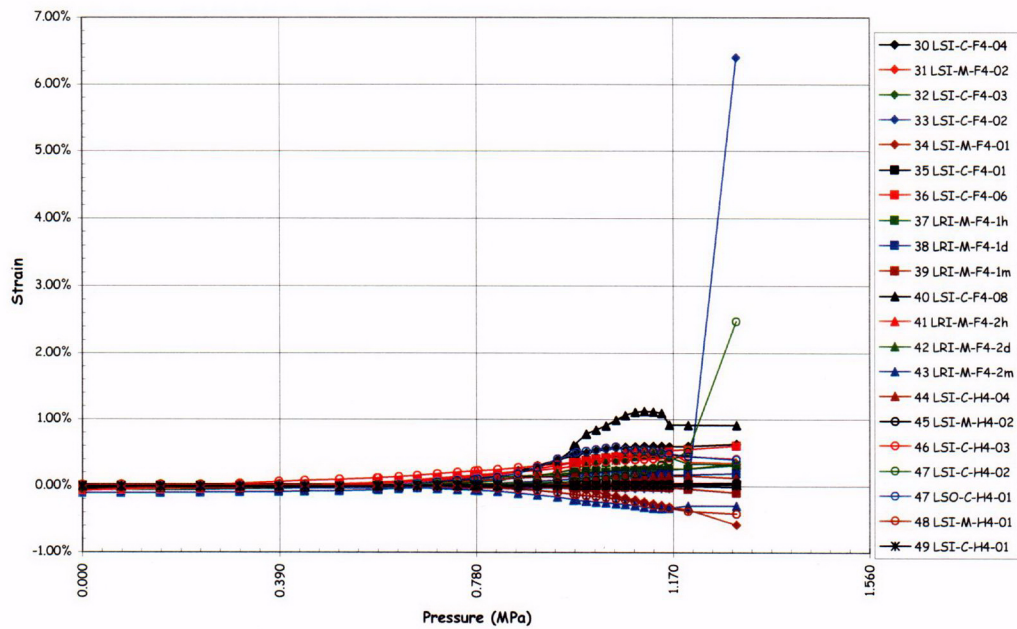
Liner strains at the M/S and F/W penetrations are shown in Figures 5.52 and 5.53. The layout of the liner strain gages is shown on Drawing D-SN-P-220 (Appendix E).

Several large tears occurred at each end of the F/W penetration, beginning at the weld between the thickened insert plate and the liner; however, no tears occurred at the M/S penetration event, though the free-field hoop strains at the M/S are higher since it is closer to the mid-height of the cylinder. There are a number of reasons why this occurred, primarily liner fabrication issues discussed in Section 5.3.2.2. It is interesting to note that even though the strain gages at the F/W penetration were located near the tear (see Figure 5.54), measured strains were relatively low until the very end of the LST, when some strains increased very rapidly. This might indicate that a tear in the vicinity of a strain gage can act as a strain relief mechanism on the surrounding material. The 'jump' in the strain near the end of the test may also be due to material distortion in the vicinity of the tear as the tear propagated. On the other hand, the strains recorded at the M/S penetration begin to climb rapidly at 2.0 to $2.5 P_d$, reaching values as high as 4.5% without resulting in any liner tearing. Detailed inspections of this location did not reveal any evidence of the fabrication problems that were present at the F/W penetration.

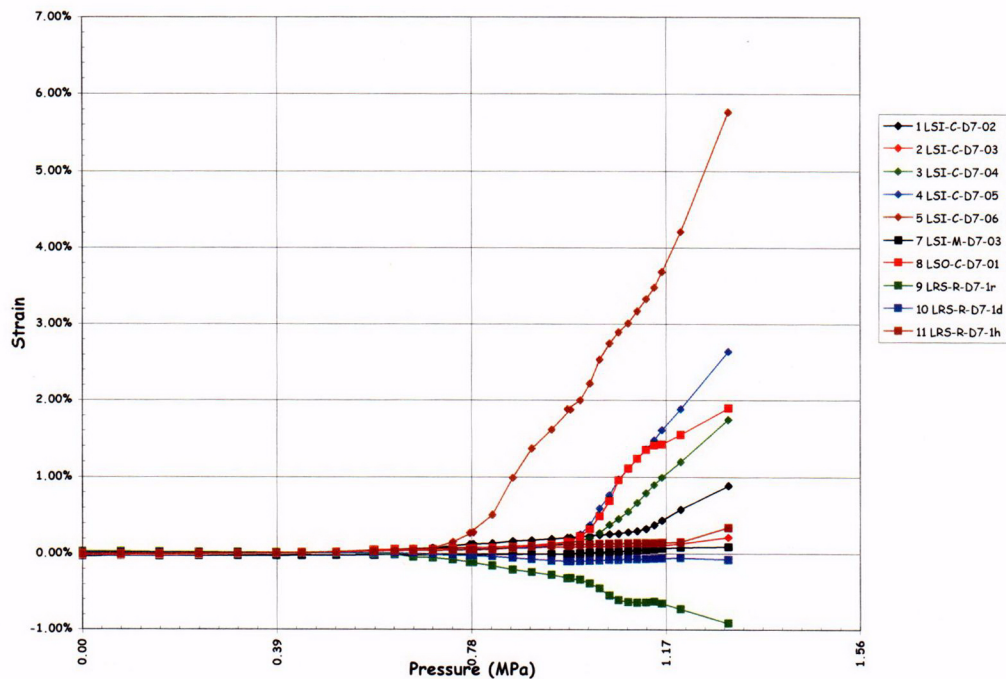
Figure 5.56 Liner Strains (DOR) at D7 Anchor Detail (Ref. R-SN-P-209, a.4)

The interior strain gages at D7 are also shown after the LST in Figure 5.56. The arrangement of these gages is shown on Drawing D-SN-P-209, Detail a.4 (Appendix E). Strains begin increasing between 2.0 and 2.5Pd, reaching a maximum of 5.7% at the maximum pressure. Nevertheless, the liner did not tear. A subsequent comparison of this detail to similar rathole details that did tear, but were not instrumented, revealed a lack of any weld repairs, which was not true of the other locations. This detail appears to demonstrate that the liner is capable of undergoing significant local strain without tearing in the absence of any other factors that might degrade the liner.

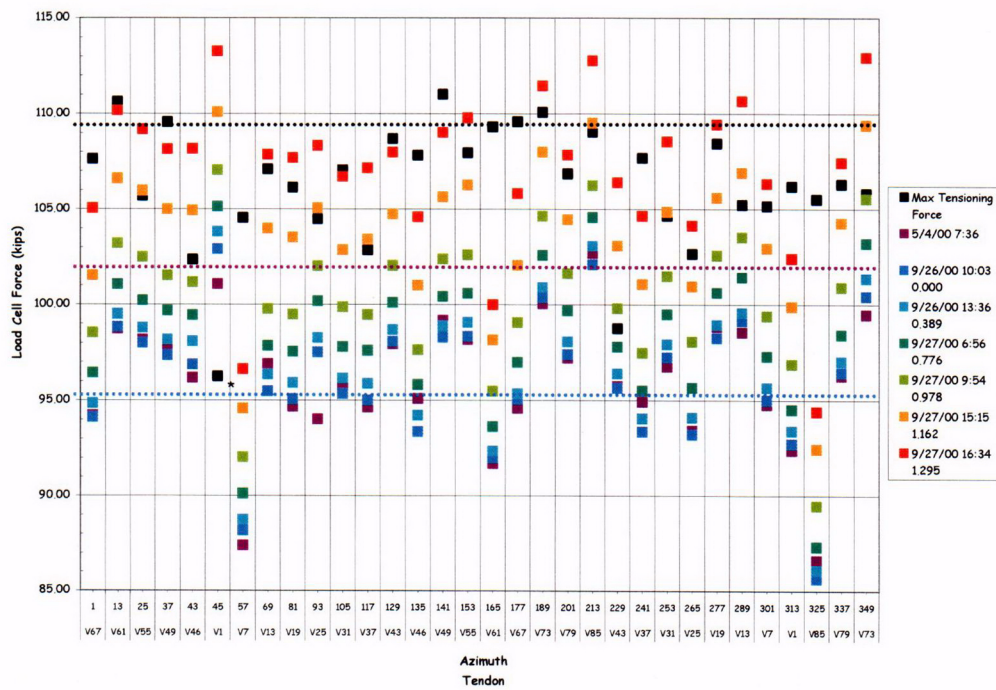
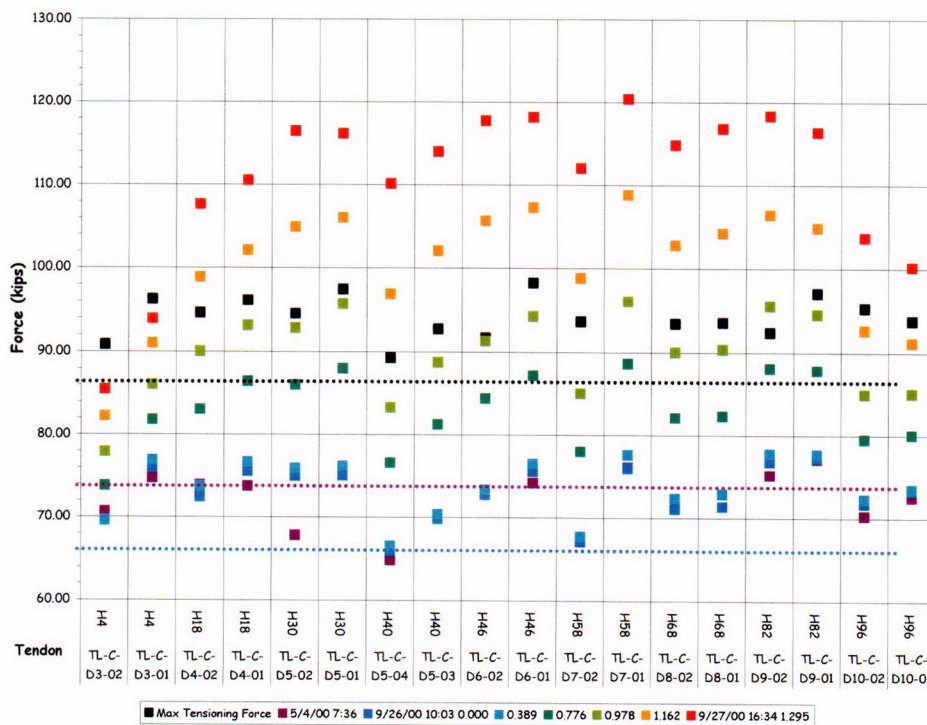
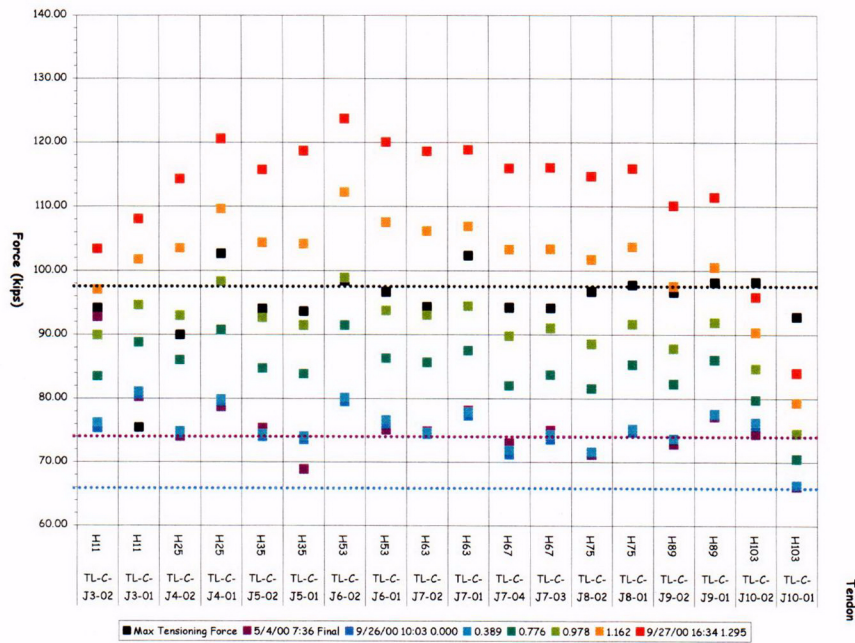
One-sixth of the tendons in the model were equipped with load cells at each anchor prior to prestressing. Figures 5.60 through 5.62 illustrate the tendon anchor forces during the LST. The anchor forces for the vertical tendons with load cells are shown in Figure 5.60. The anchor forces are shown for the maximum tensioning force during prestressing, after the completion of prestressing (on 5/4/00) and during the LST at $0.0P_d$, $1.0P_d$, $2.0P_d$, $2.5P_d$, $3.0P_d$ and at maximum pressure, $3.3P_d$. Similarly, Figures 5.61 and 5.62 show the anchor forces for the hoop tendons anchored at the 90 degree

and 270 degree buttresses. In general, the vertical tendon anchor forces did not exceed the initial tensioning force. The average vertical tendon force at the peak pressure of $3.3P_d$ was 466 kN (104.7 kips) compared to the average tensioning force of 472 kN (106.3 kips). The hoop tendon anchor forces, however, did exceed the initial tensioning force of 424 kN (95.3 kips). The maximum anchor force recorded at the peak pressure of $3.3P_d$ was 550 kN (123.64 kips) for tendon H53. The average anchor force for all the hoop tendons at the peak pressure was 496 kN (111.6 kips). The tendon yield strength (0.2% offset) is approximately 590 kN (132.6 kips), so hoop tendon forces at the anchors were approaching, but had not exceeded their yield strength.
