5.3.3 Structural Failure Mode Test Results

5.3.3.2 Posttest Inspection

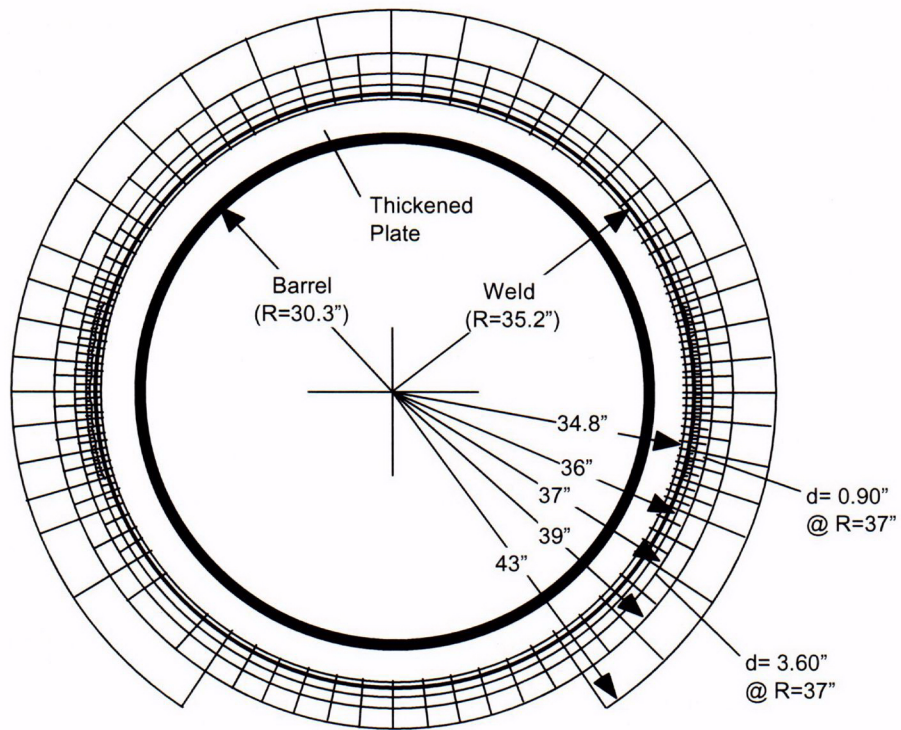
Figure 5.89 E/H Displacement Grid

As described in Section 3.2.5.4, a grid was constructed around the E/H to measure the residual strain field after the test. The pretest analysis predicted large strains near the perimeter of the thickened insert plate surrounding the E/H barrel and near the anchors and stiffeners that terminated near the insert. The grid, shown in Figure 5.89, was drawn, and the position of the grid points was obtained using a 3D digital position mapping tool. After the LST, the grid points were mapped again and the pre- and posttest positions were plotted in Figure 5.90.

Unfortunately, as noted previously, the strains in this region were very small and the resulting residual displacements are barely distinguishable from the pretest positions, given the precision of the digital probe. As a result, no useful information was obtained by this effort.

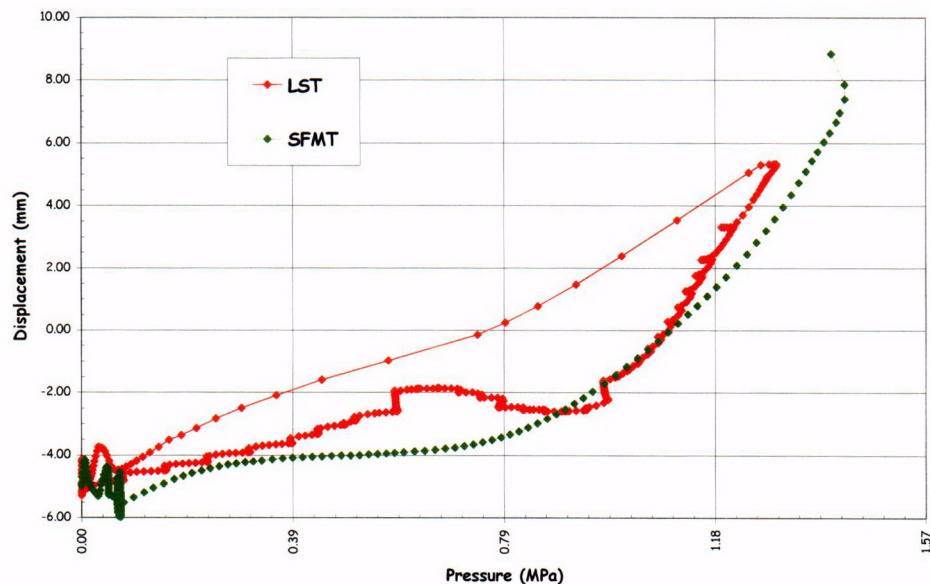
Figure 5.95 SFMT – Vertical Displacement at Apex

identical to that measured during the SFMT. Similarly, the vertical displacements at the apex (offset again) are compared in Figure 5.95.

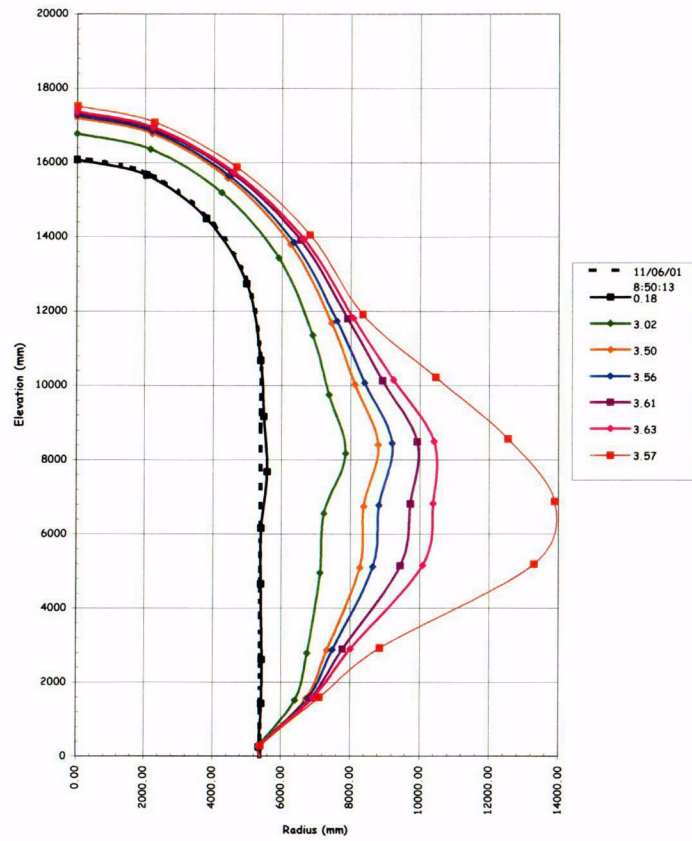
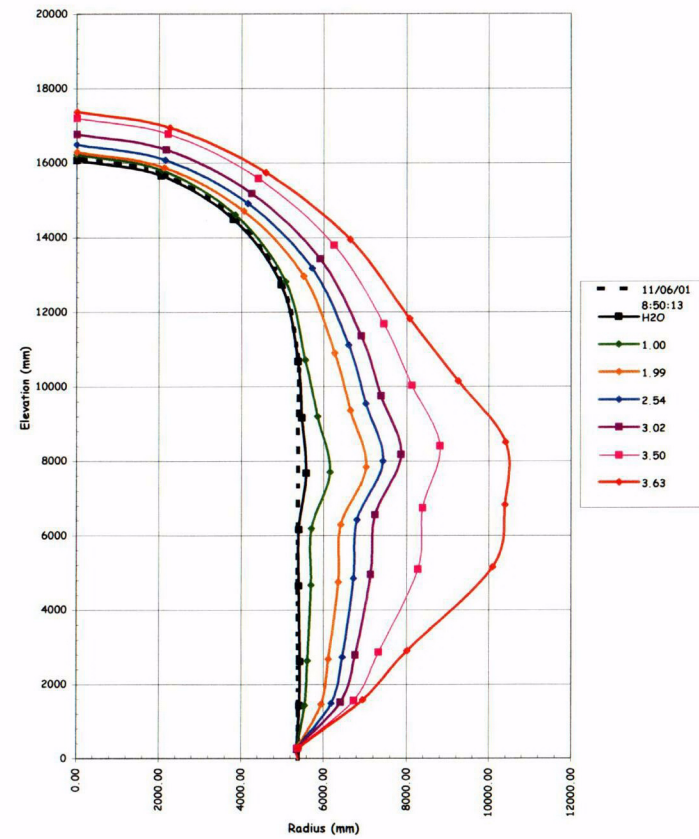
(b) $3.0P_d$ to $3.63P_d$ Figure 5.97 SFMT - Deformation at Azimuth 135 Degrees (Z) $\times 100$

Deformed profiles of the PCCV model, constructed from the displacement data in a similar manner as those constructed for the LST, are shown in Figures 5.97 through 5.100. For the SFMT, the initial position was again assumed to be defined by the as-built model survey data (Appendix C). However, since the gages were zeroed prior to the start of the SFMT, any deformations of the liner surface or the wall are not reflected in the data.

The as-built position of the PCCV model is plotted in the first portion of the figures, along with the deformed shapes due to the hydrostatic pressure (H_2O) and at approximately $1.0P_d$, $2.0P_d$, $2.5P_d$, $3.0P_d$, $3.5P_d$, and $P_{max} = 3.63P_d$. The second portion of each figure provides a more refined breakdown between $3.0P_d$ and $3.63P_d$ and the profile at $P_{final} = 3.57P_d$, immediately prior to rupture of the vessel. These figures dramatically illustrate the large deformations that occur as the vessel yields, even though the pressure is dropping. The displacement nearly doubles as the pressure drops from $3.63P_d$ to $3.57P_d$.

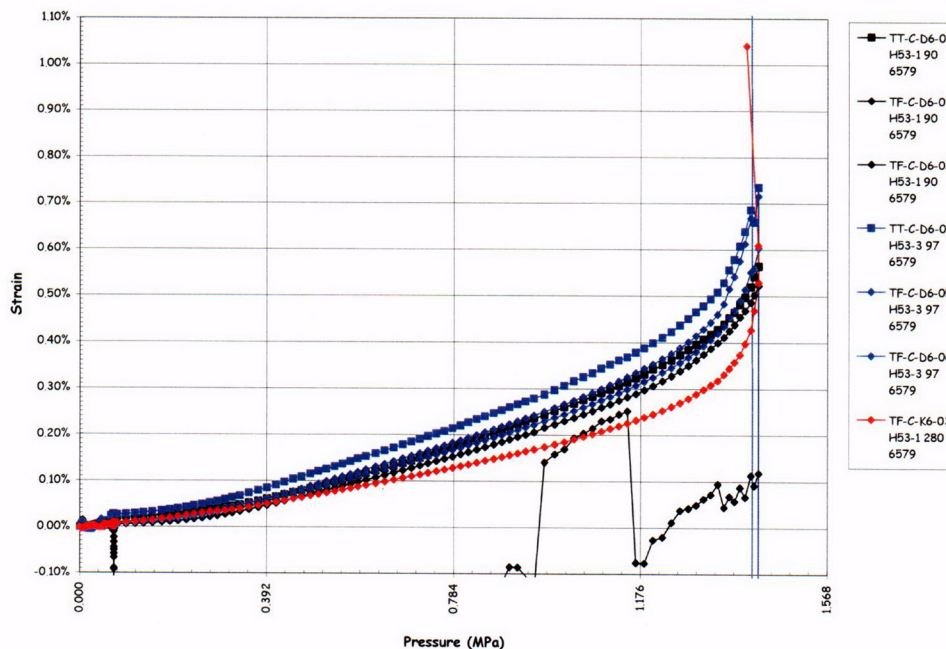
Figure 5.108 SFMT – Tendon H53 Strains

Tendon strains were also recorded using the surviving foil gages mounted on individual strand wires. Figures 5.108 and 5.109 show the strains for hoop tendons H53 and H68, and Figure 5.110 shows the strains for vertical tendon V46. These results are typical of the other instrumented tendons, although the magnitude of the strains vary. Since the strain gages were 're-zeroed' before the SFMT, only the strain due to pressure is plotted. The total tendon strain is the measured strain plus the residual prestressing strain, typically on the order of 0.4% for the hoop tendons and 0.6% for the vertical tendons. The hoop tendon strains at maximum pressure were therefore on the order of 1.0%, 0.4% due to prestressing plus 0.6% due to the maximum pressure of $3.65P_d$. Similarly, the maximum hoop tendon strain measure prior to rupture is on the order of 1.4% to 1.5%. There may be some local strain concentrations that were not captured by the strain gages, but this limiting tendon strain is significantly less than the ultimate strain obtained from laboratory tests of a straight tendon sample, typically on the order of 4% for the tendon and 7% for individual strands. Furthermore, none of the model tendons ruptured at the anchors where strain concentrations might be expected, but all ruptured where the deformation of the model was greatest, approximately azimuth 6 degrees.

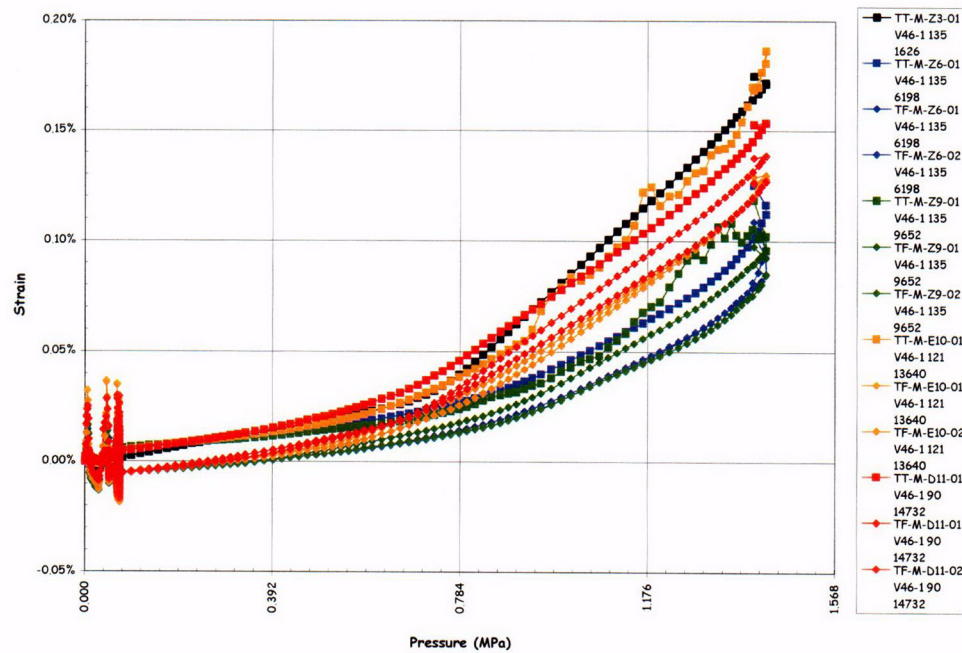
Figure 5.110 SFMT – Tendon V46 Strains

Similarly, the strain in the vertical tendons at the maximum pressure are on the order of 0.1 to 0.2%, and the total strain is on the order of 0.7% to 0.8%. Both are well below the strain at which the hoop tendons were believed to have ruptured, reinforcing the belief that the vertical tendons did not fail prior to the rupture of the vessel.

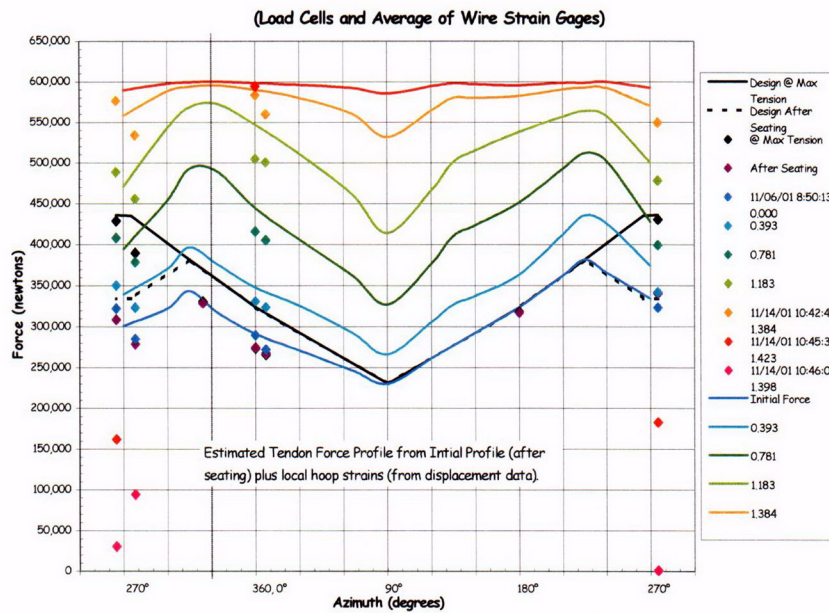
Figure 5.116 SFMT – Tendon H35 Computed and Measured Force Distribution

An attempt was made to determine this by calculating the local, displacement-based strain in the wall and, assuming the tendon behaved as if bonded, adding it to the initial prestressing strains and computing the force profile from these strains. Figure 5.116 compares the force distribution obtained in this manner with the forces based on the tendon strain measurements for tendon H35 near elev. 4680 where the displacements were measured. The results compare favorably and seem to reinforce the idea that the tendons behave as if they were bonded after prestressing. While this is a compelling argument, it must also be admitted that these results are not entirely conclusive and further tests may be required to resolve this issue.

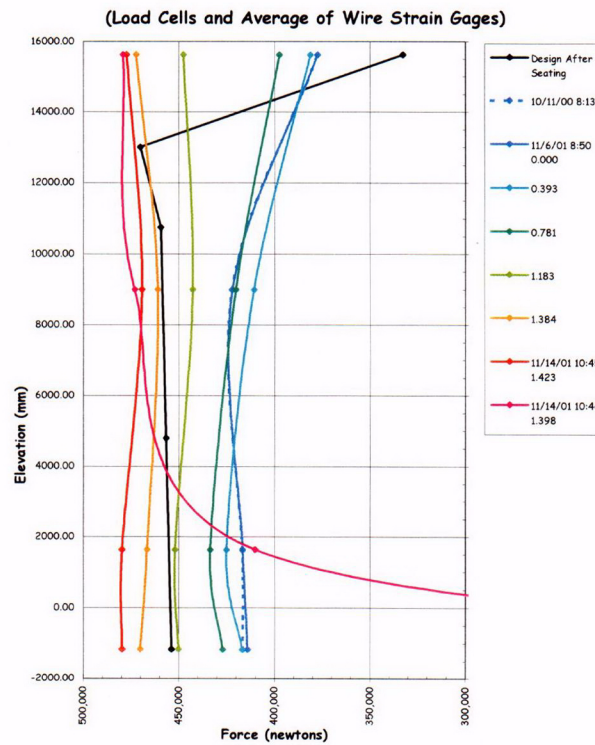
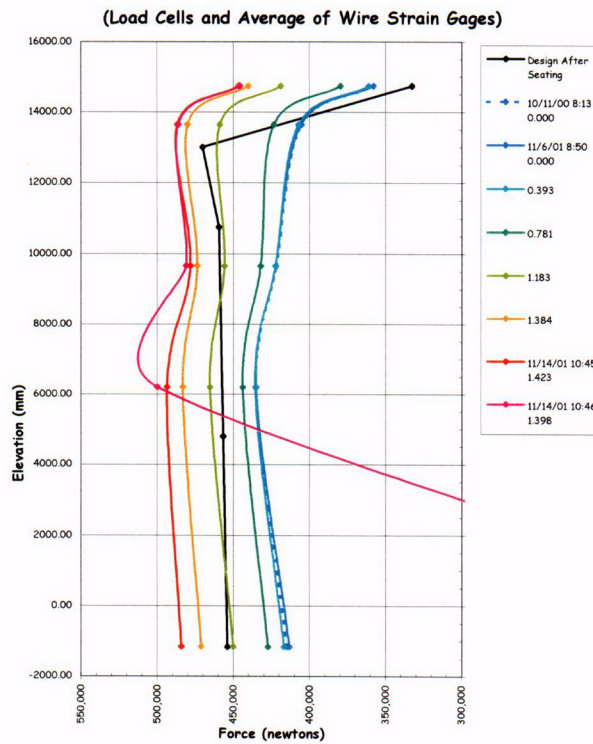
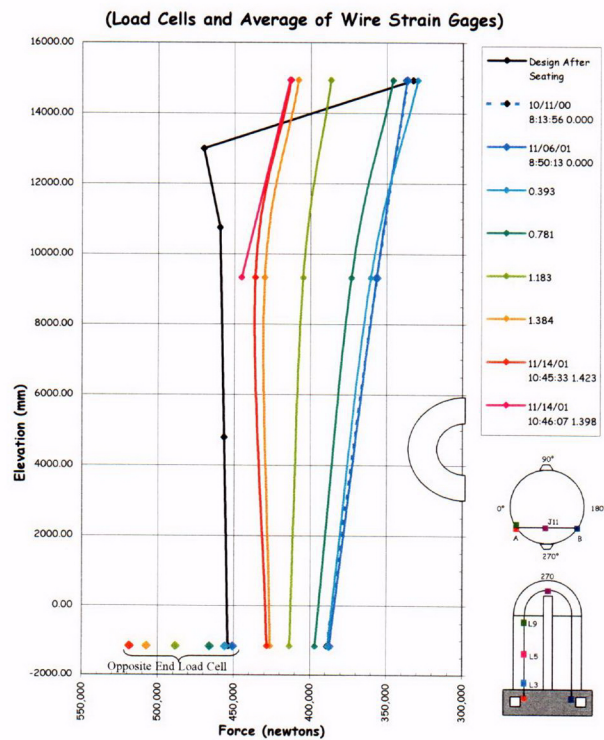
Figures 5.117 to 5.119 show the force profiles for the instrumented vertical tendons. Again, as was observed with the response during the LST, the force profile appears to become more uniform with pressure. Since the vertical tendons do not yield, tendons must slip relative to the sheath or concrete wall, even in the dome where the tendons are curved. This counters the observation made for the hoop tendons that the tendons behave as if they were bonded to the concrete. No explanation for this apparent inconsistency has been proposed, reiterating the need for further investigation of this behavior, including additional testing.
