BWX Technologies, Inc.

**EXAMINATION OF THE REACTOR VESSEL (RV) HEAD DEGRADATION
AT DAVIS-BESSE**

**PREPARED FOR
FRAMATOME ANP, INC.**

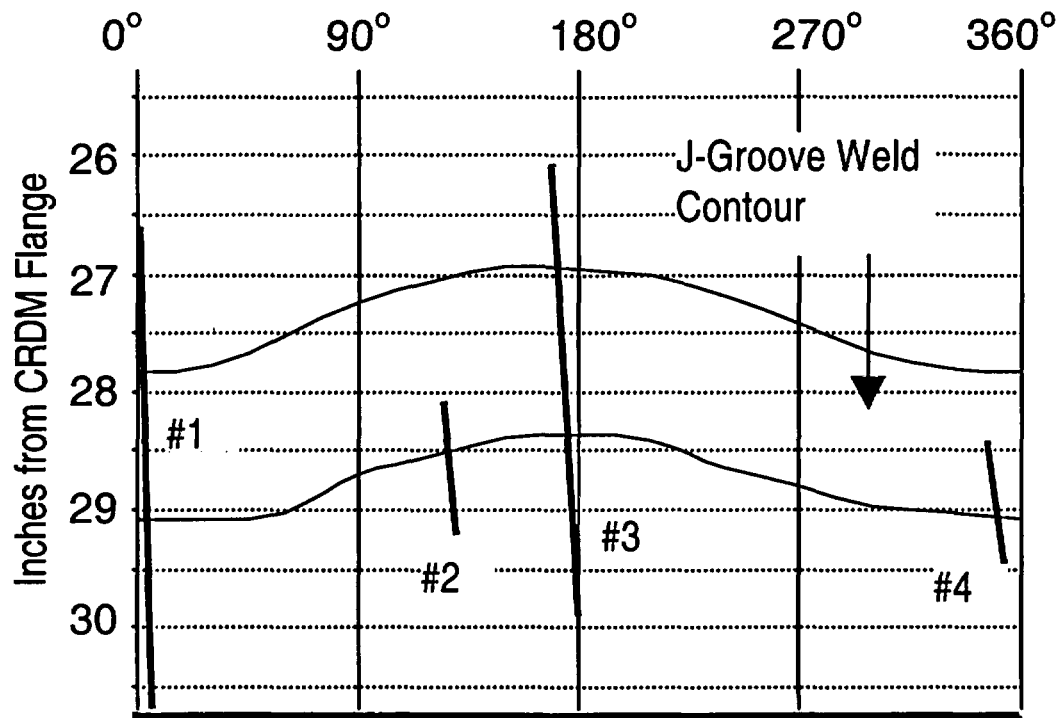
Figure 1.1.2: On-site NDE of nozzle #3 showed 4 axial cracks. Cracks #1 and #3 were through-wall, while cracks #2 and #4 were partially through-wall.

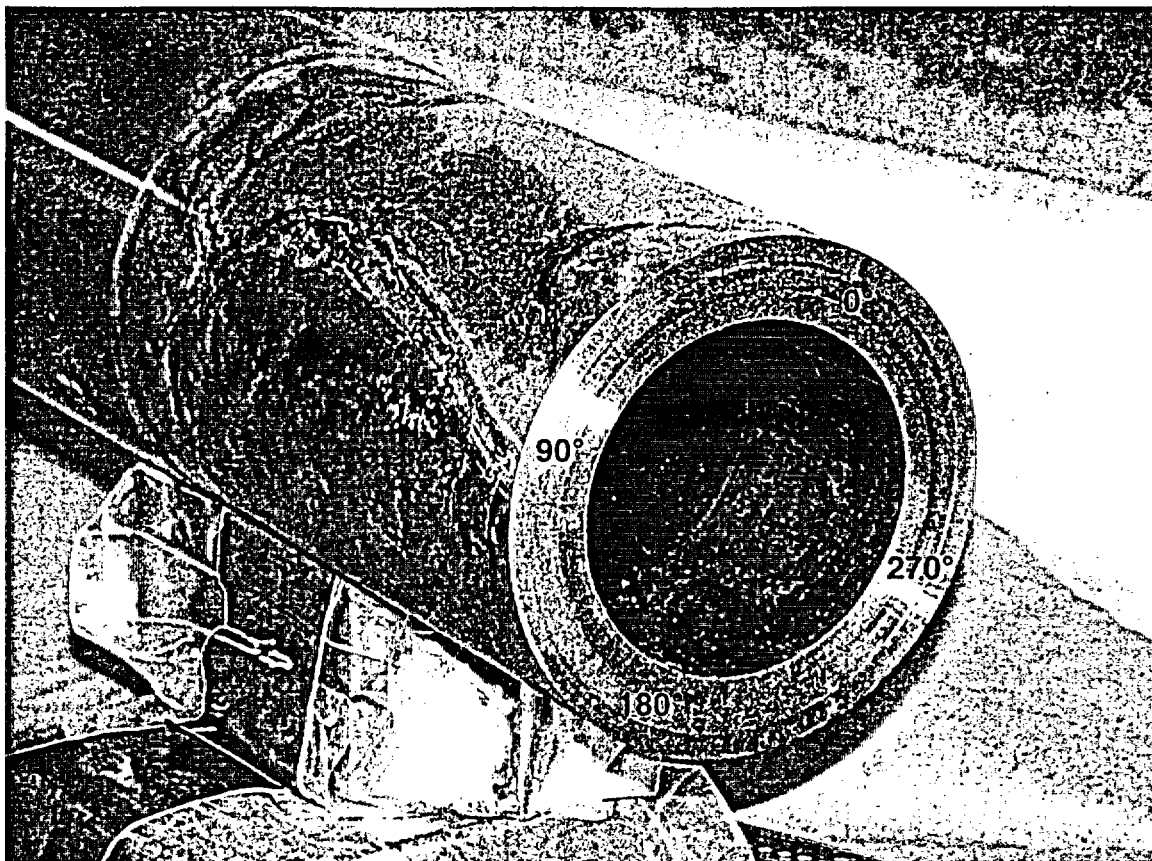
Figure 2.2.3: Photograph showing end view of nozzle #3.

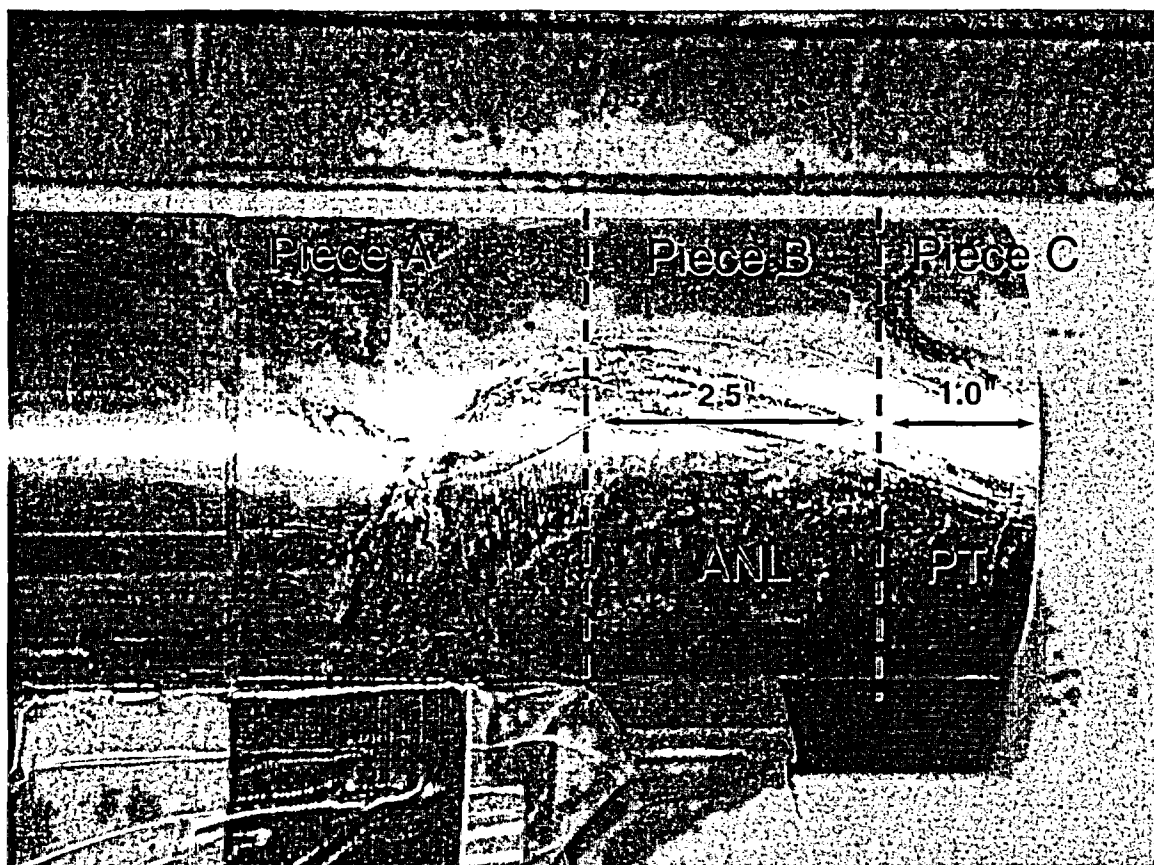
Figure 2.3.1: Sectioning photo for nozzle #3. Piece B was shipped to Argonne National Laboratory and piece C was further tested at BWXT.

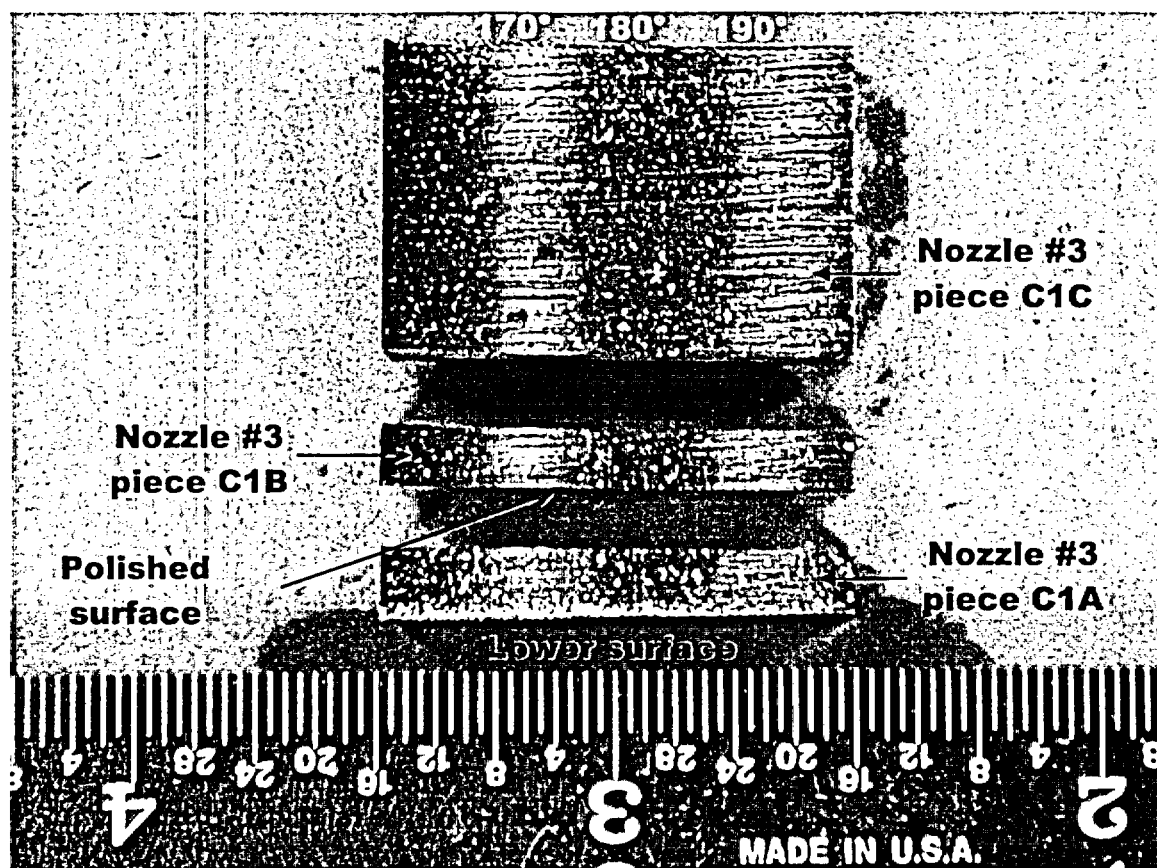
Sectioning for nozzle #3 piece C1 prior to opening lower portion of crack.
Looking at nozzle ID surface; the largest crack is located near 180°.

Figure 2.5.2: Photograph of nozzle #3 samples C1A, C1B, and C1C.

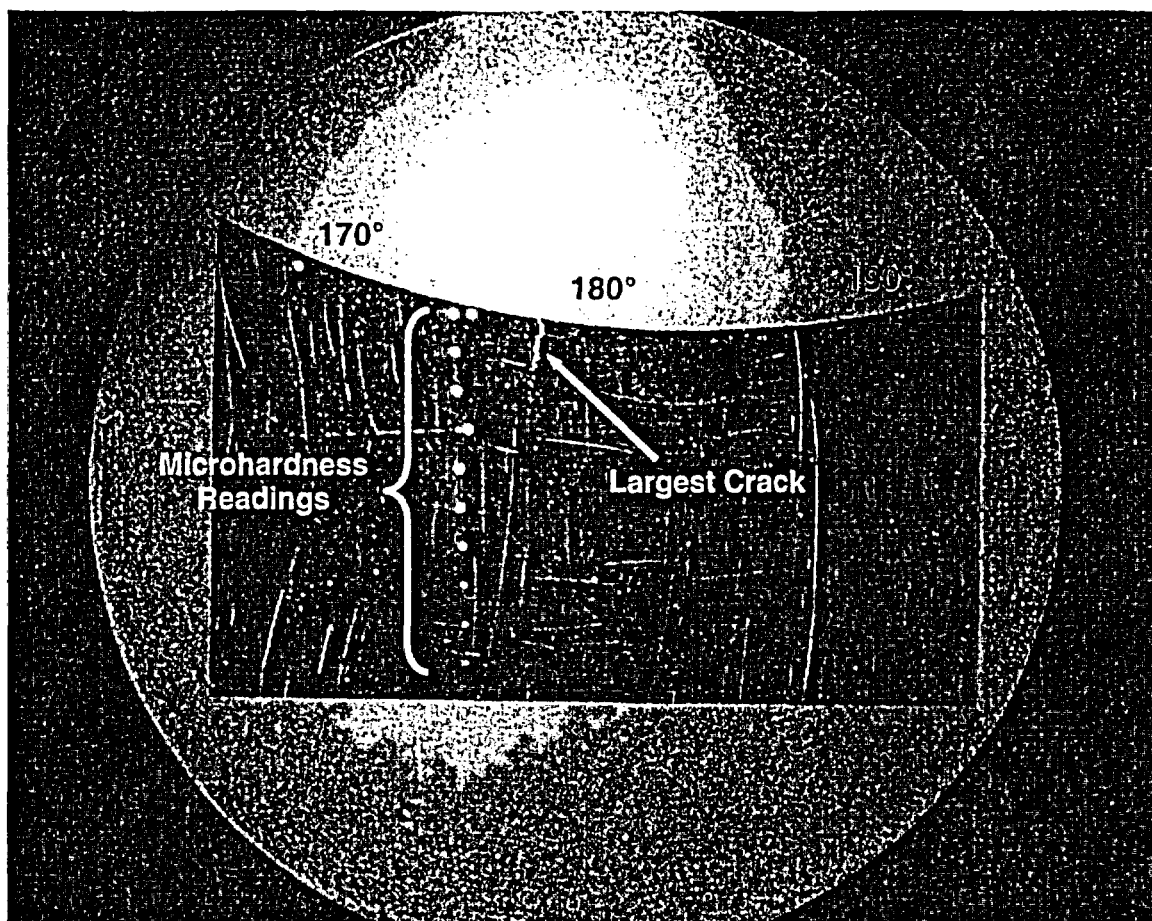
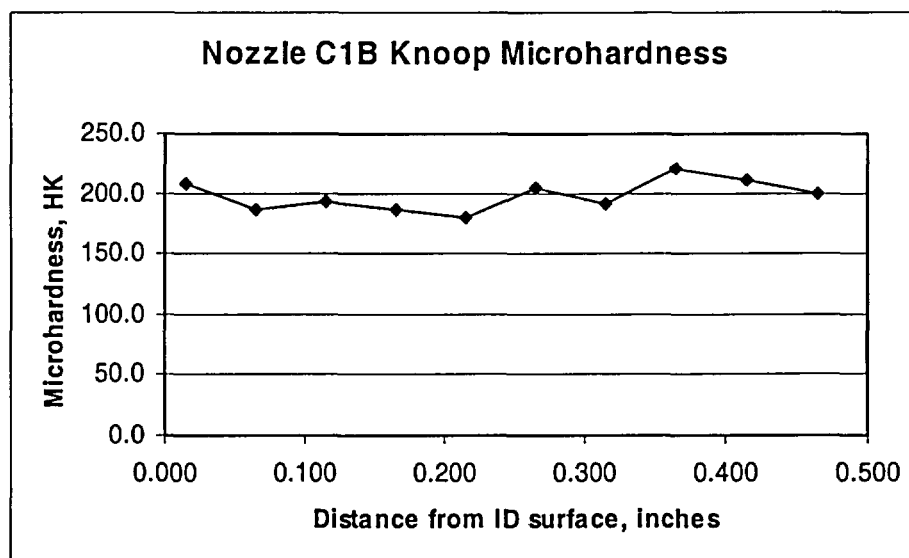
Figure 2.6.1: Low magnification photograph of the nozzle #3 C1B metallographic mount showing location of largest crack and Knoop microhardness indents (top) and microhardness results (bottom).

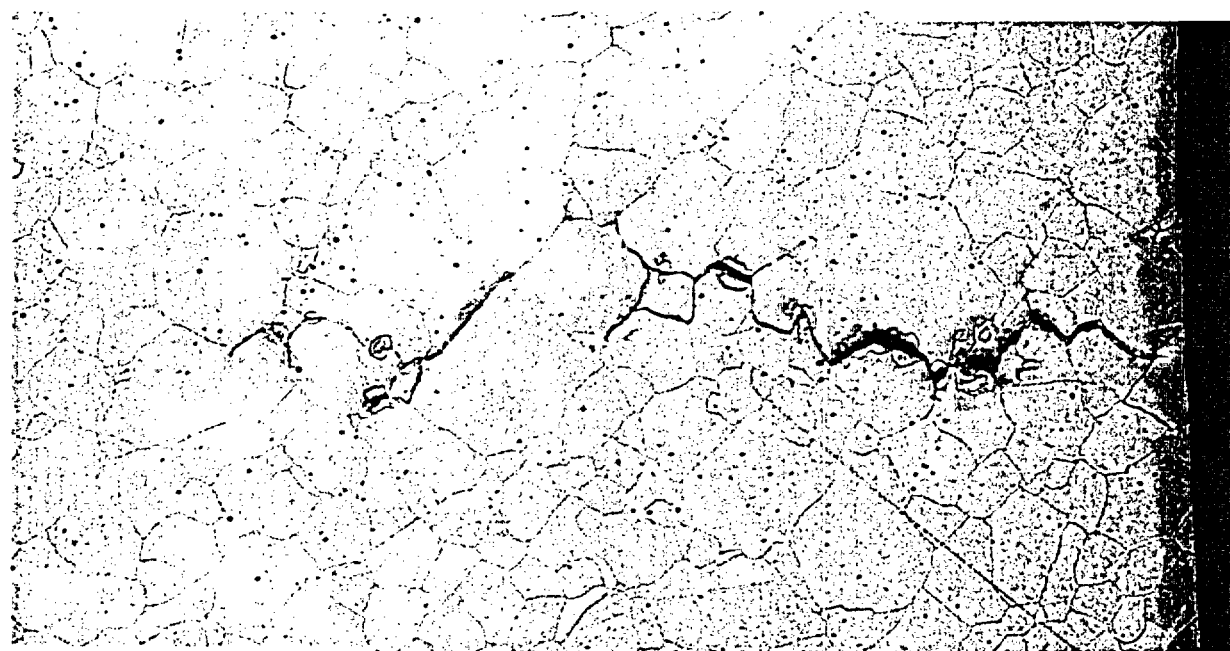
Figure 2.6.2: Micrographs showing the intergranular nature of the largest crack near 180°. The crack extended approximately 0.1" below the nozzle ID surface (located to the right in these micrographs).

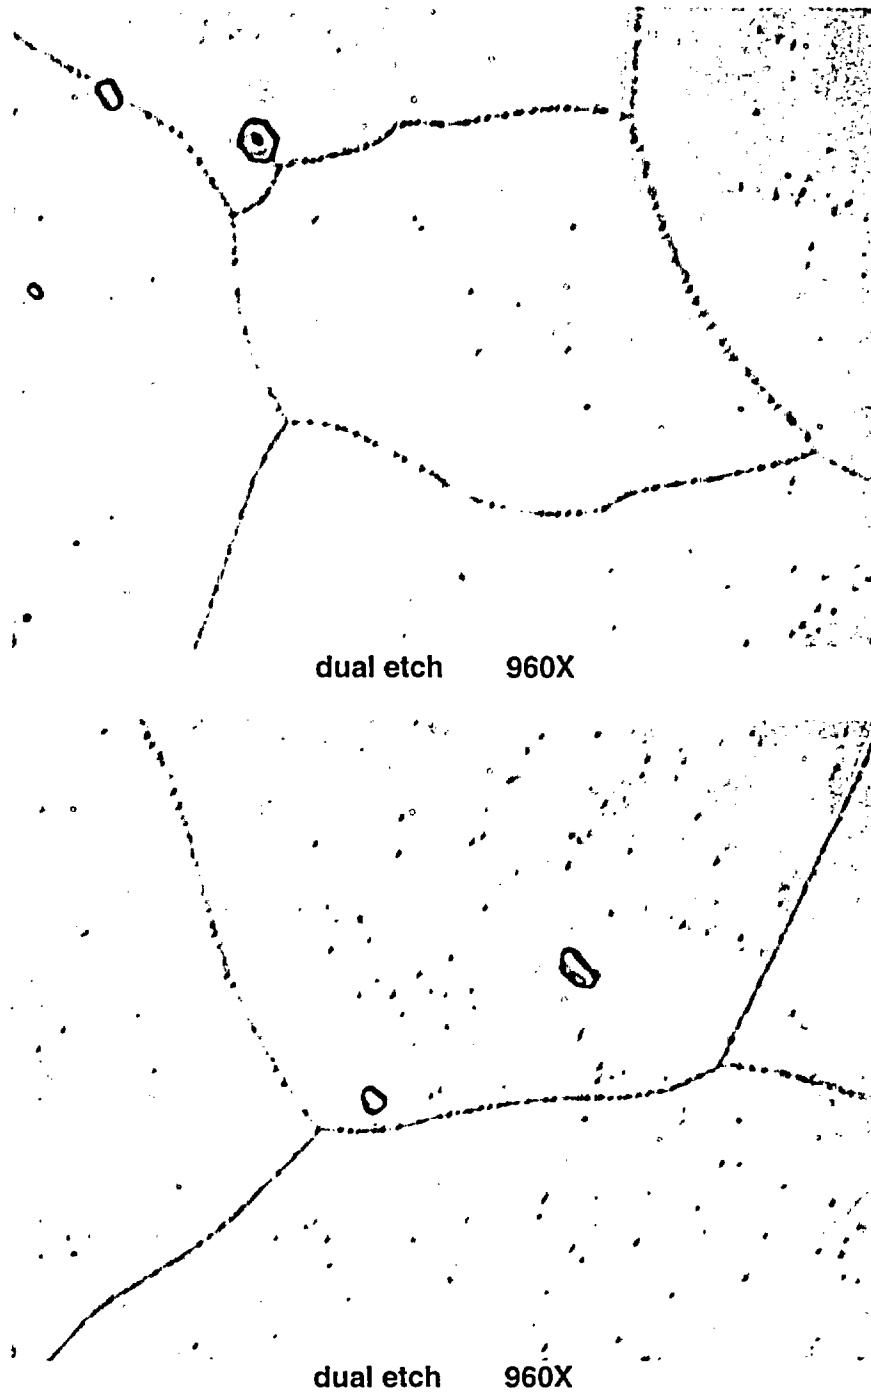
Figure 2.6.6: Higher magnification micrographs showing the discontinuous nature of the carbides at the grain boundaries.

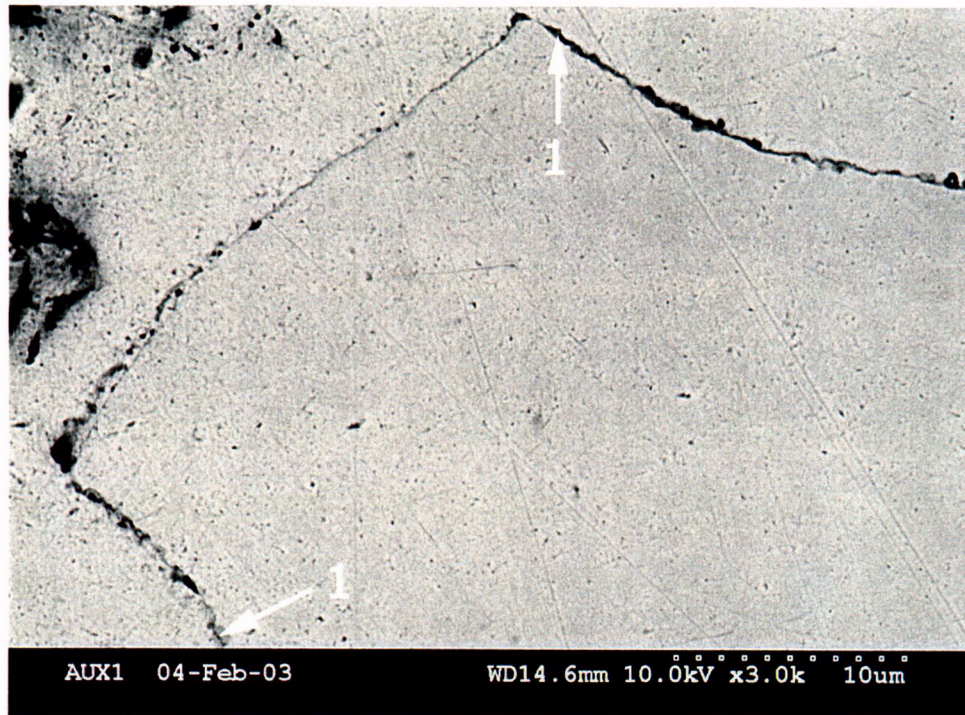
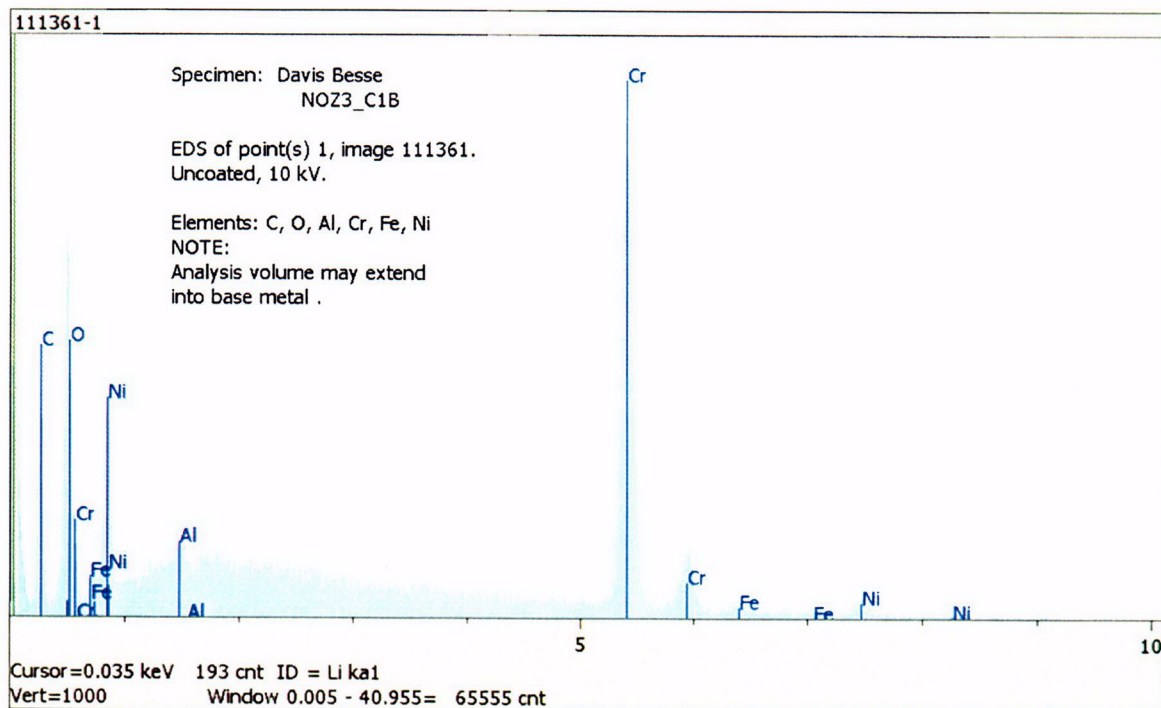
Reference micrograph for EDS results below

Figure 2.7.3: The grain boundary (points designated "1") contained carbon, oxygen, aluminum, chromium and nickel.

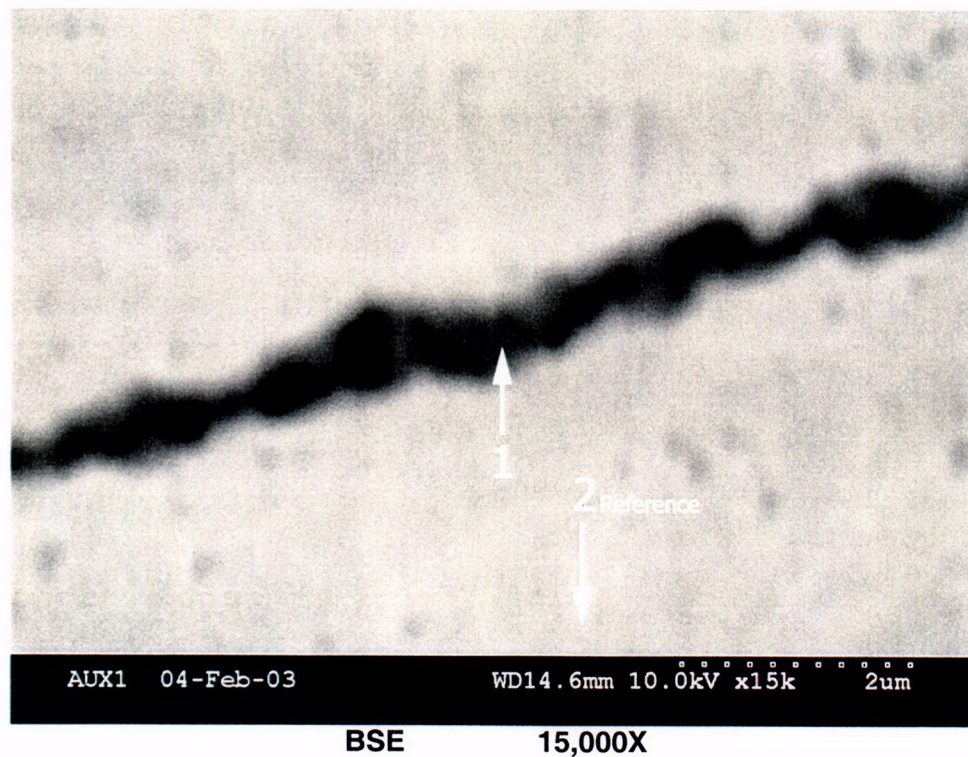
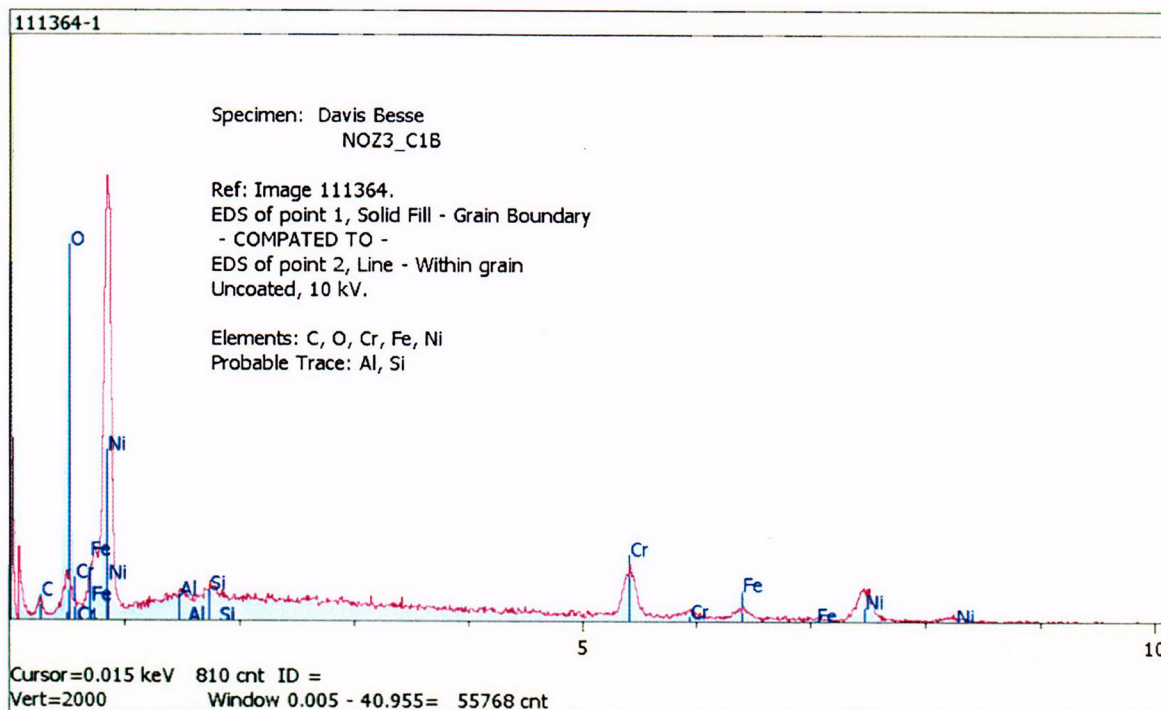
Figure 2.7.4: The grain boundary (solid fill) contained higher oxygen and chromium compared to the bulk grain (line spectrum) (Note: The BSE image was defocused in order to optimize the EDS count rate.)

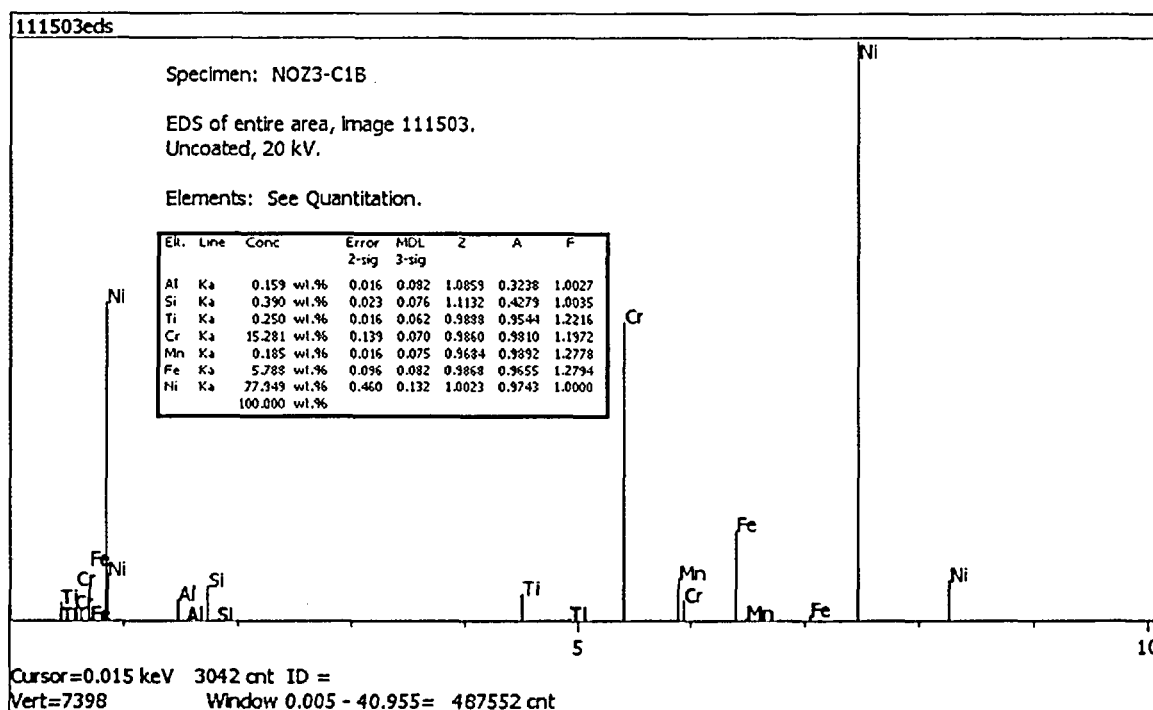
Reference micrograph for EDS semi-quantitative analysis

Figure 2.7.5: Reference micrograph and semi-quantitative EDS results for nozzle material. The results appeared consistent with those expected for Alloy 600.

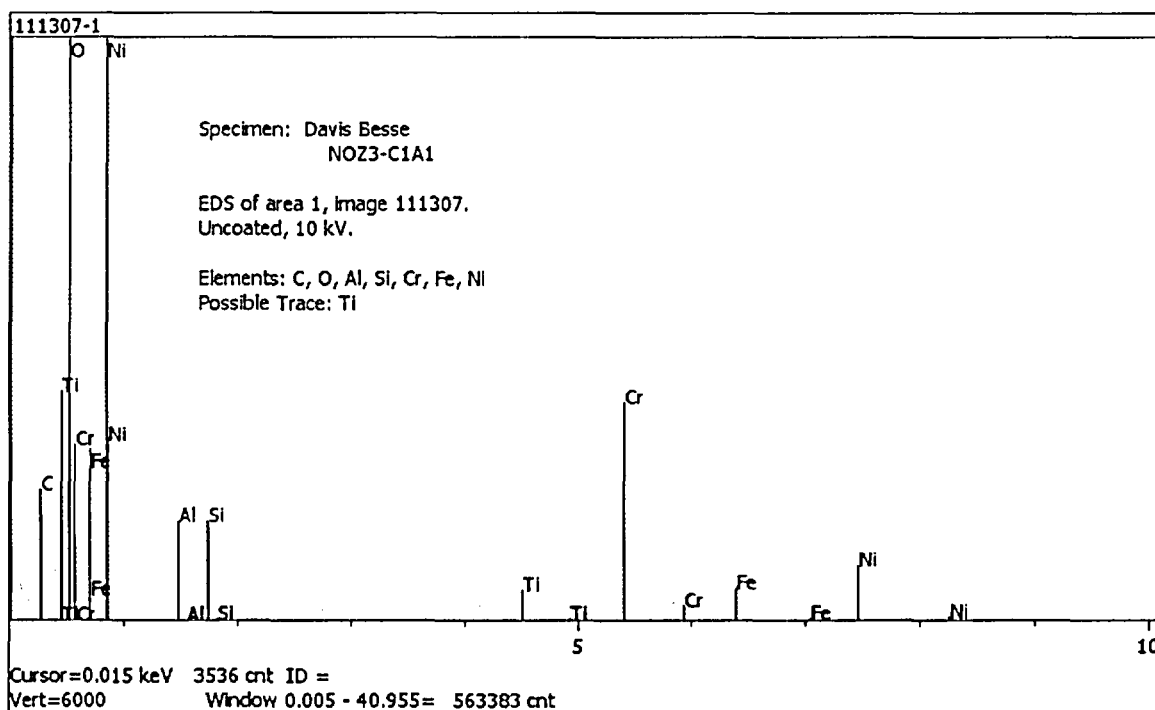
Figure 2.7.9: EDS spectrum collected from area 1 above. This area contained carbon, oxygen, aluminum, silicon, chromium, iron, and nickel, along with a trace amount of titanium.

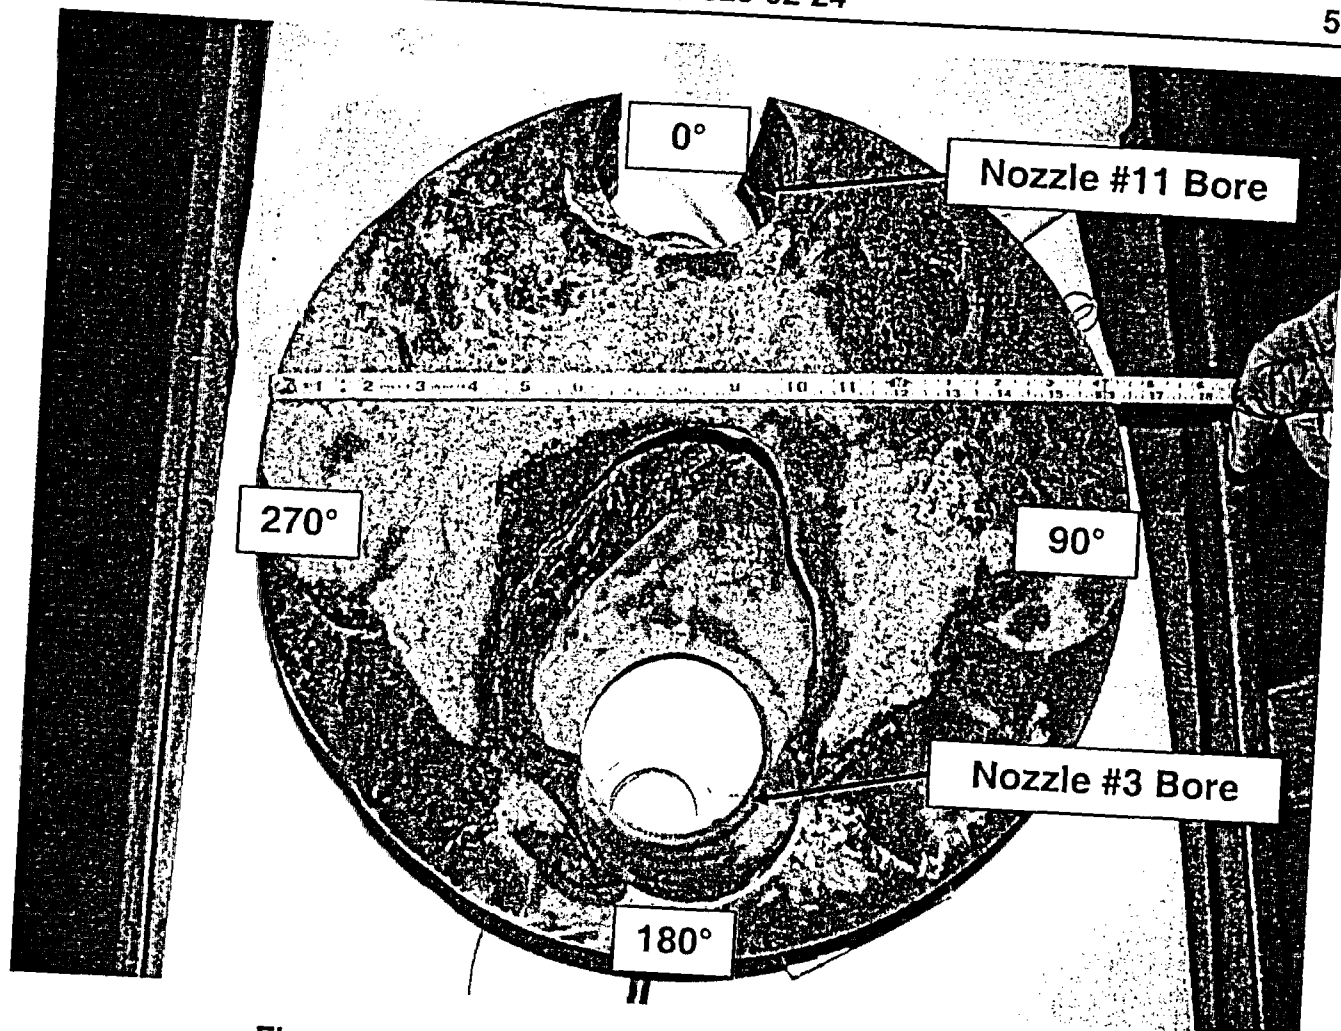
Figure 3.1.1: Top view of as-received cavity sample.

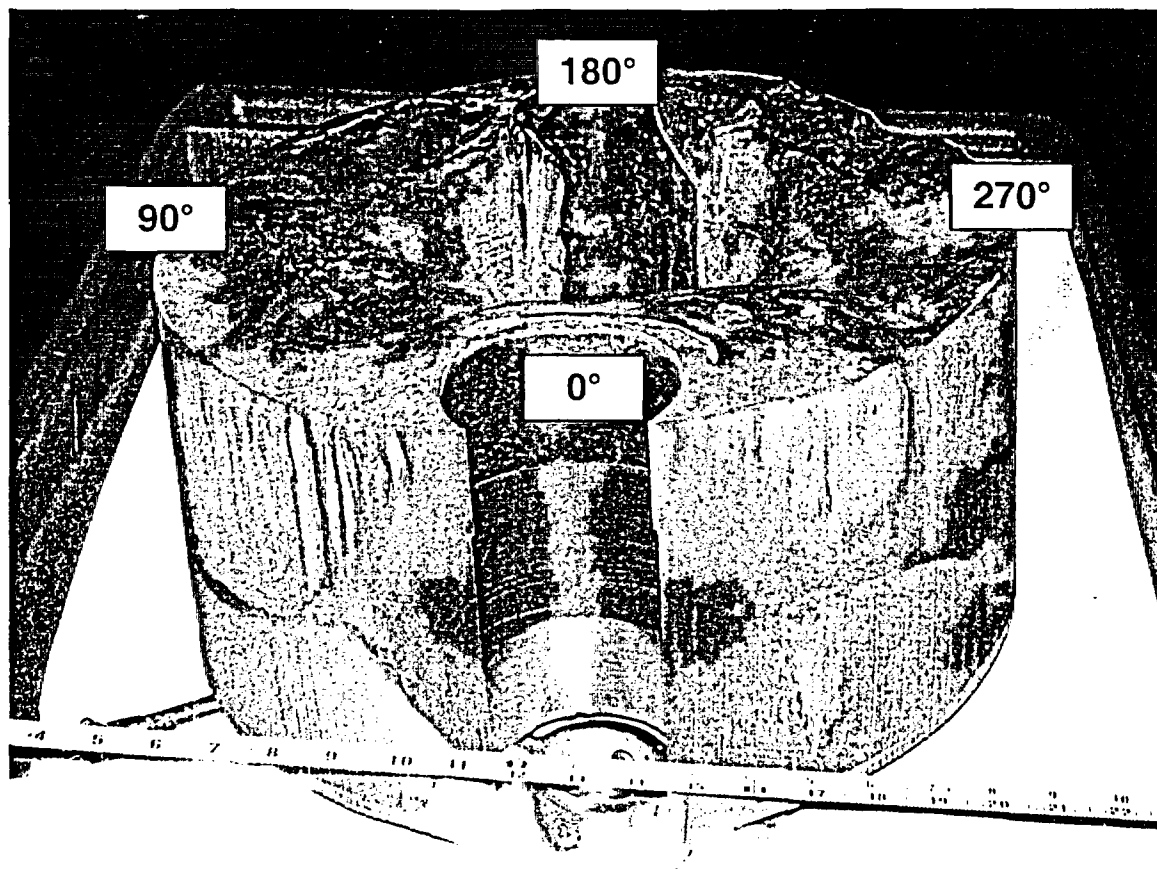
Figure 3.1.2: View of as-received cavity sample from nozzle #11 bore side.

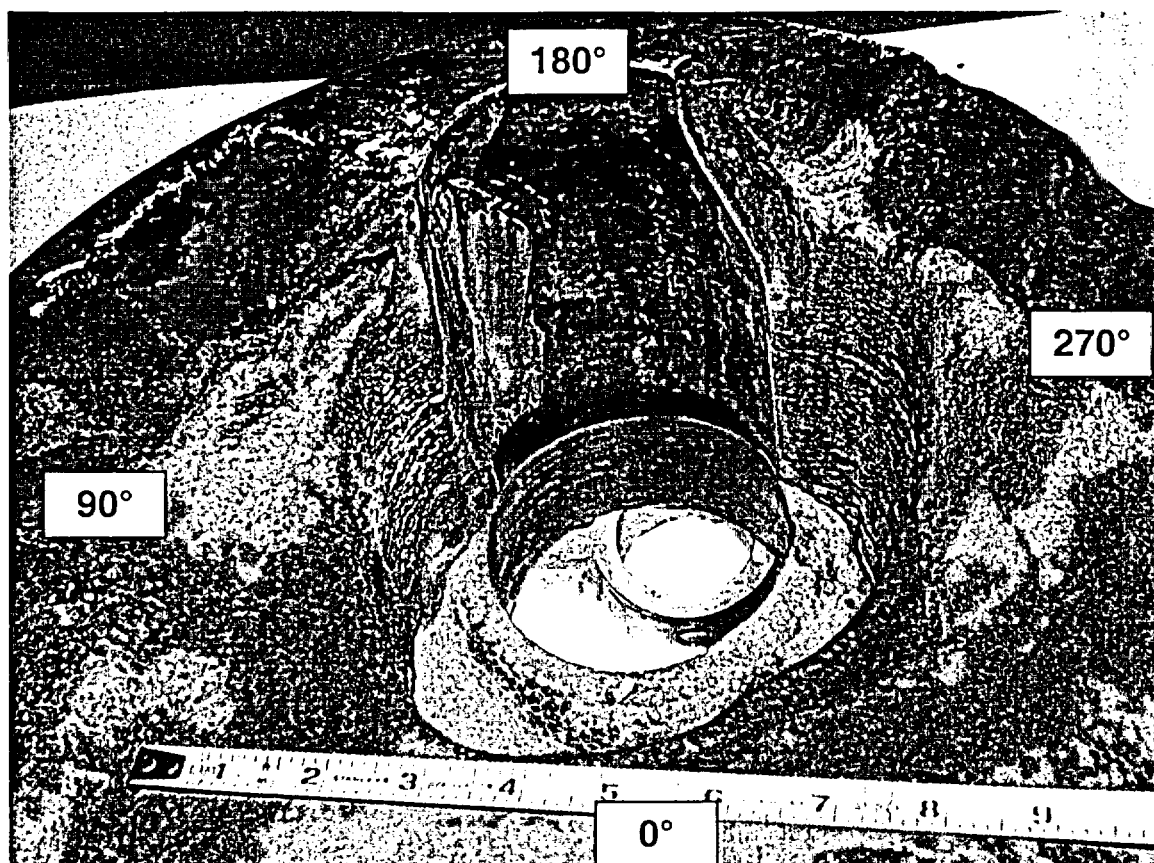
Figure 3.1.5: Looking toward 180°.

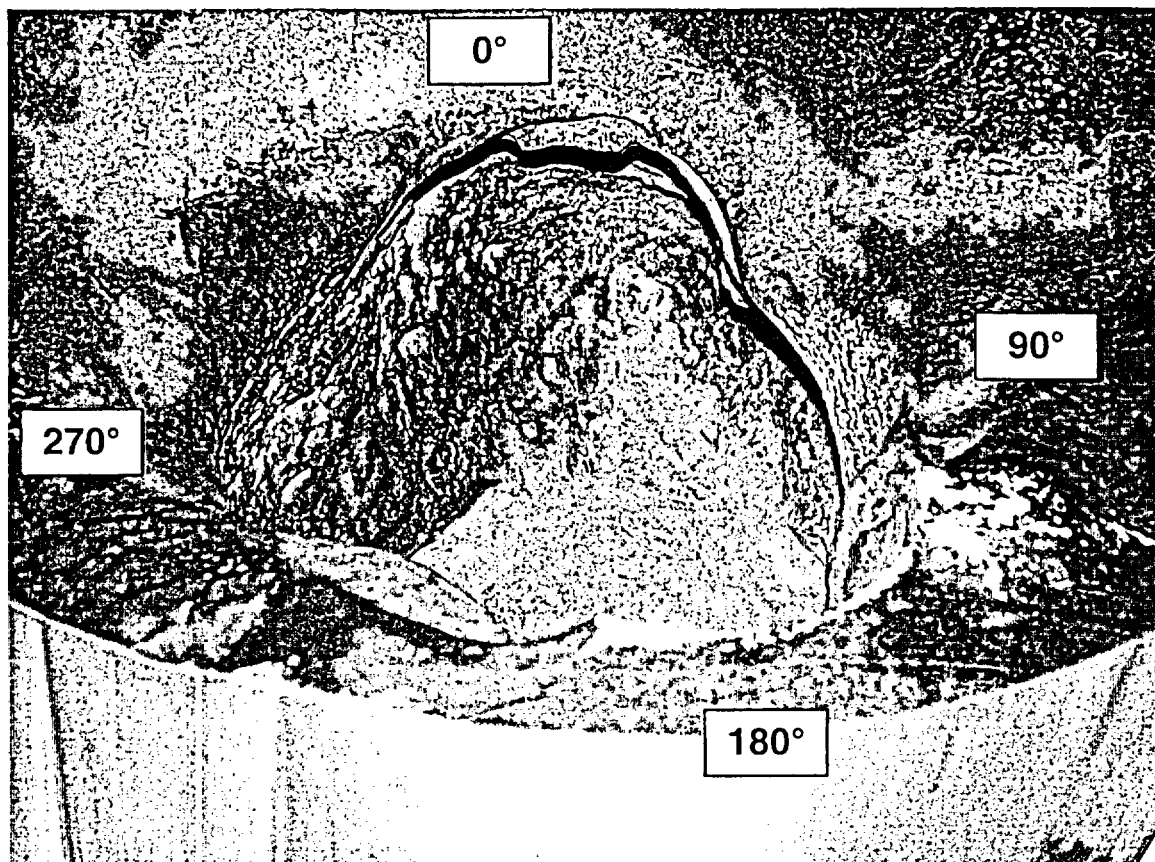
- The striations on the cavity side wall appear to be influenced by boric acid solution level initially and the RV head microstructure afterward. The banded microstructure of the low alloy steel plate showed good correlation with the preferential corrosion that produced the striated texture. There was no evidence of erosion present on the as-found cavity walls; however, erosion may have played a part in the initial cavity formation.

Figure 3.1.6: View of cavity looking toward nose (~10°).

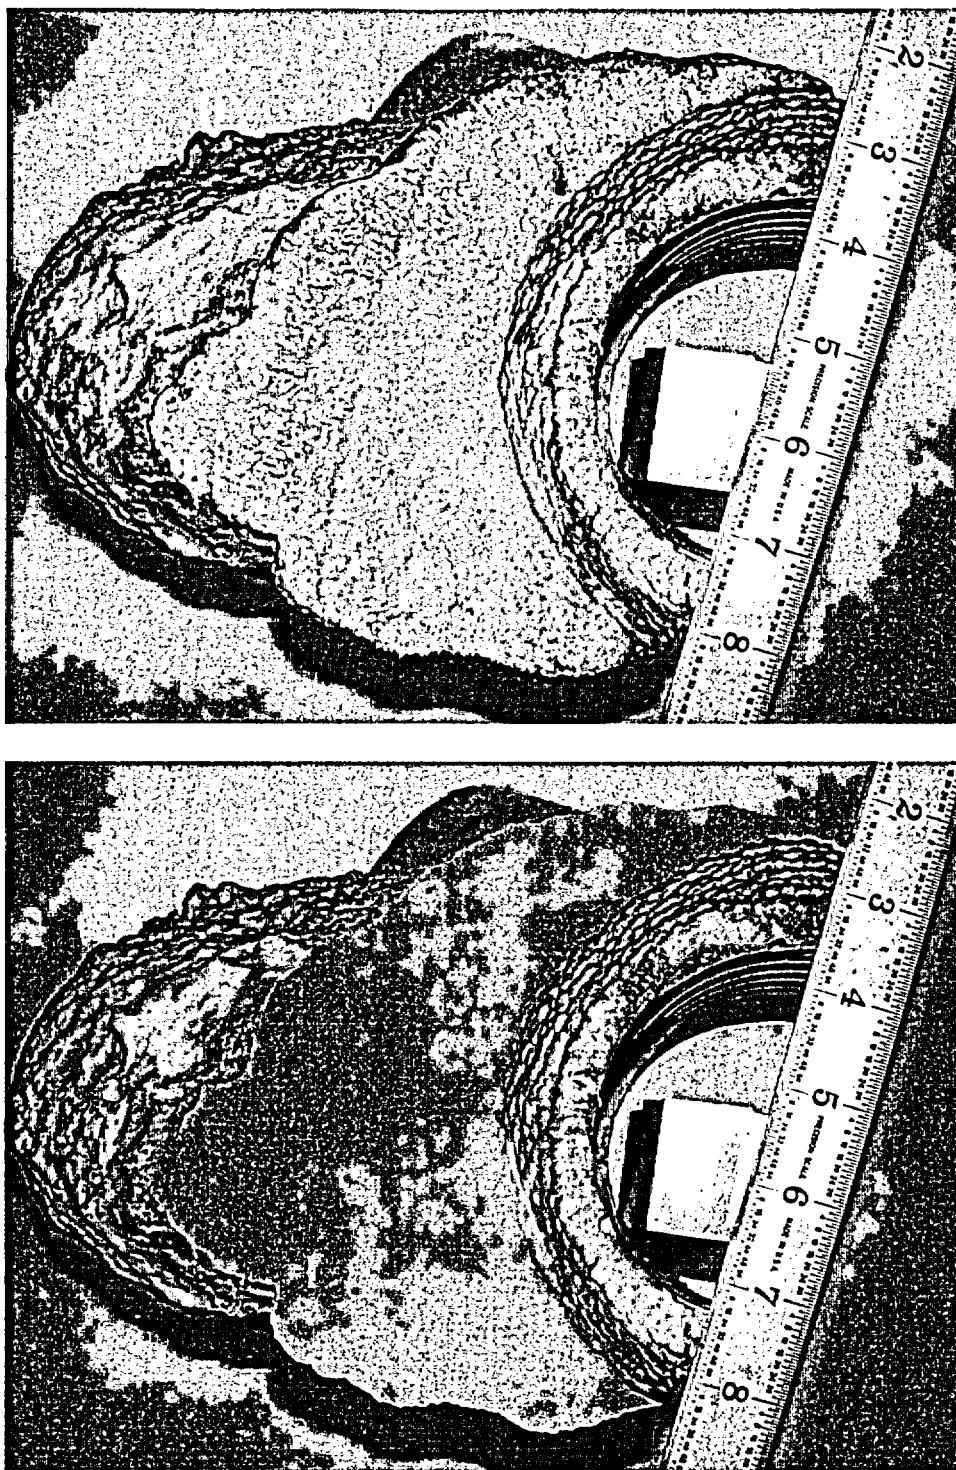
The dental mold (Section 3.2) was used to determine the area of exposed cladding on the lower surface of the cavity. Two different techniques were employed. The first method involved directly tracing the exposed cladding profile onto graph paper, then calculating the area using image analysis. This method yielded an exposed cladding area of 16.5 square inches. For the second method, a photograph was taken of the underside of the dental mold. A gray mask was then digitally applied to the portion of the photograph corresponding to the exposed cladding (Figure 3.5.1). The area was calculated using image analysis and was determined to be 17.3 square inches. The two measurements were in good agreement with each other, but it is believed that the direct tracing method was more reliable since some distortion (i.e., parallax) may have been introduced during photography of the dental mold.

- The undercut regions observed around the perimeter of the exposed cladding were due to localized galvanic corrosion between the low alloy steel and the stainless steel. There was no evidence of cracking or disbond associated with any of these areas.

Figure 3.5.1: Photographs showing exposed cladding surface. The gray mask in the lower photograph was used to calculate the exposed cladding surface area.

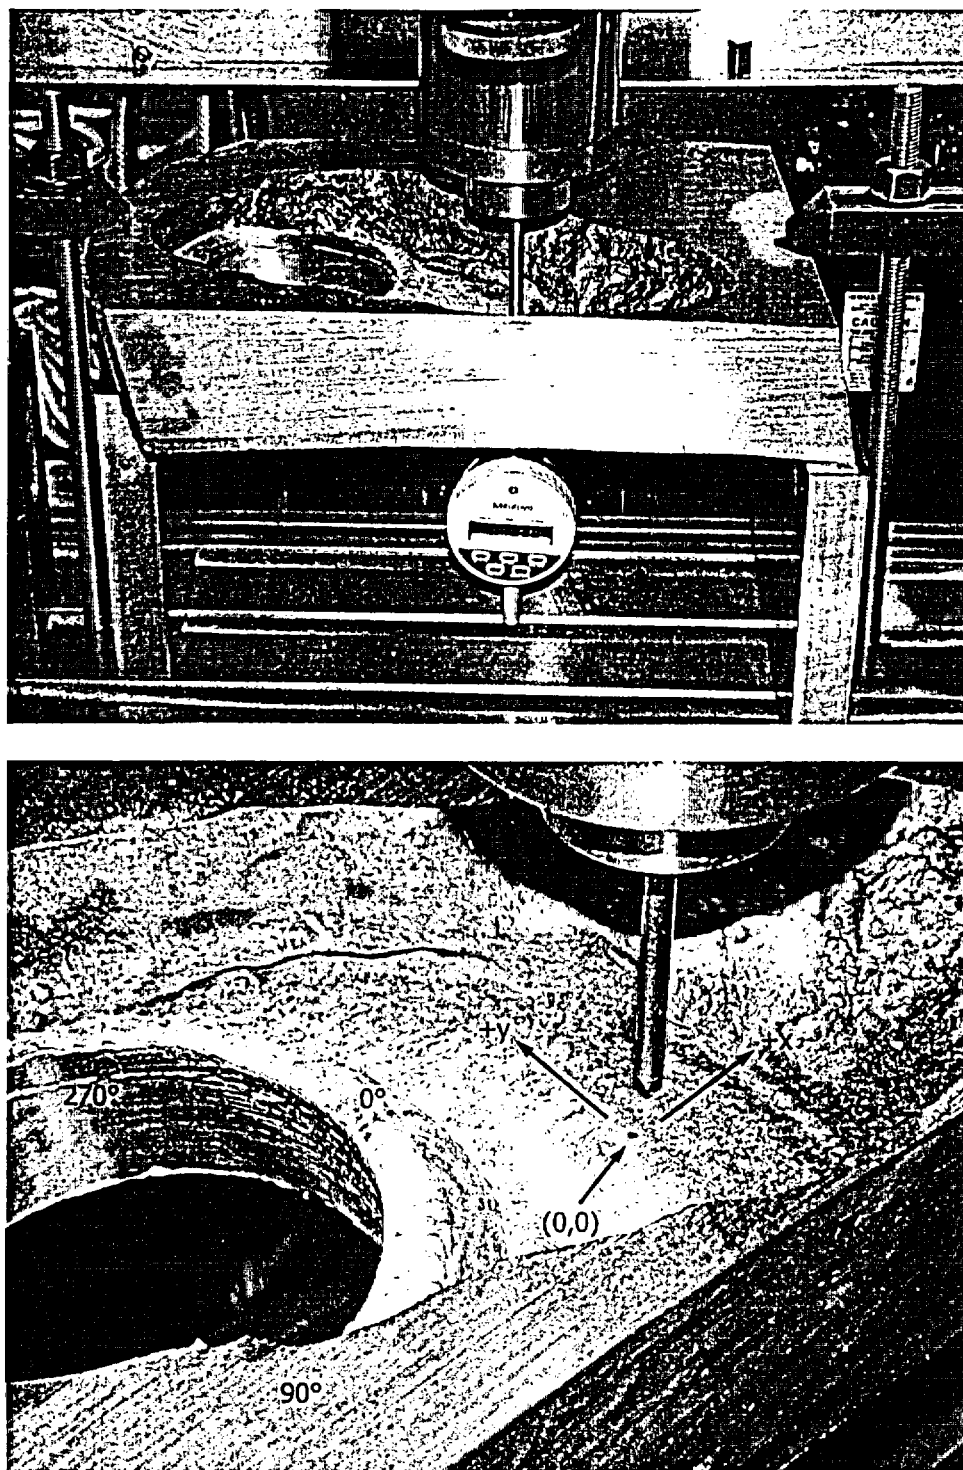
Two opposing dial indicators affixed to a computer numerical controlled (CNC) mill were used to perform the exposed cladding thickness measurements. These dial indicators were initially placed in contact with each other and zeroed. Piece A2 was then secured in the mill (Figure 3.5.2) and the cladding thickness was determined by difference. The thickness measurements were determined in an X-Y grid pattern with a 0.5" spacing. The X-Y origin was selected as the point of maximum upward deflection of the stainless steel cladding (red dot in Figure 3.5.2). The cladding thickness data are shown in Figure 3.5.3. The average thickness of all 78 readings was 0.256", with a minimum reading of 0.202" and a maximum of 0.314". The minimum thickness values occurred near the J-groove weld at the 90° (0.202") and 270° (0.208") locations. The thickness data is presented in a colorized fashion in Figure 3.5.4. It is clear in this figure that the thin cladding (dark blue) was near the 90° and 270° locations. It is also apparent that the weld bead travel was in the 90° to 270° direction (i.e., vertical in the figure). The colorized data for each dial indicator are presented separately in Figure 3.5.5 (upper surface indicator) and Figure 3.5.6 (lower surface indicator). These figures capture the relative height of the cladding, which clearly reached a maximum near the centroid of the exposed cladding. Figure 3.5.7 provides the colorized thickness data superimposed on the exposed cladding macro photograph. The vertical weld bead orientation is again evident.

Figure 3.5.2: Photographs showing clad thickness setup (top) and coordinate system (bottom).

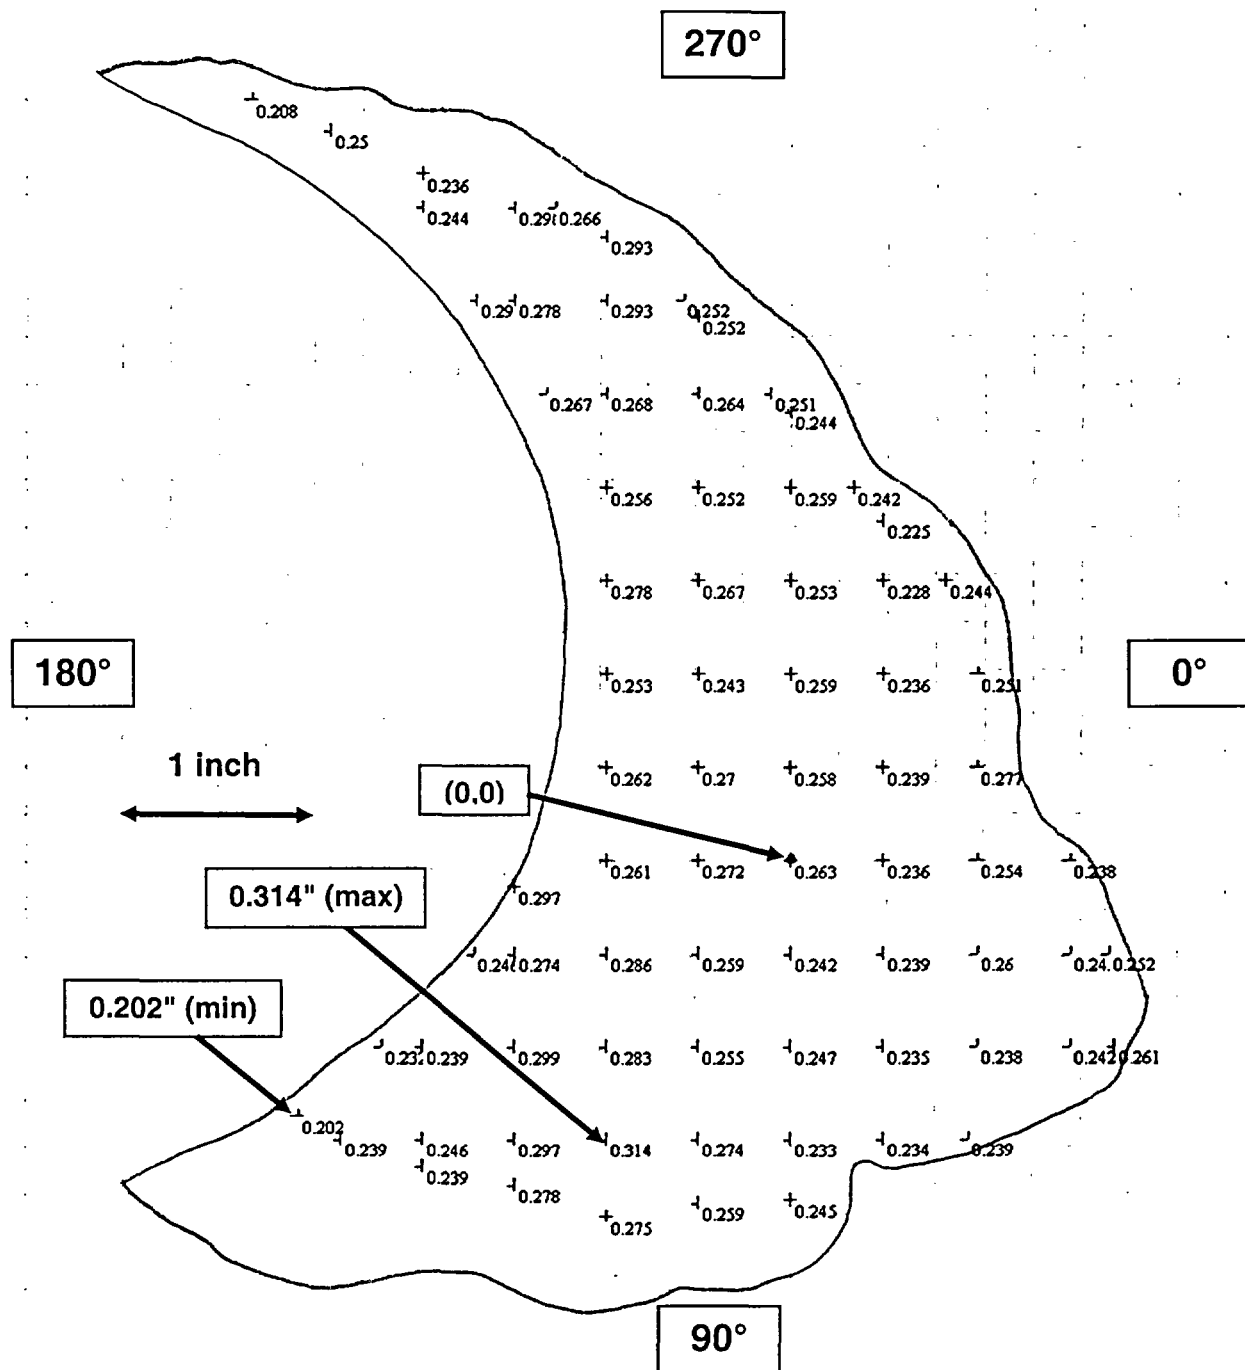
Figure 3.5.3: Cladding thickness measurements.
