BWX Technologies, Inc.

**EXAMINATION OF THE REACTOR VESSEL (RV) HEAD DEGRADATION
AT DAVIS-BESSE**

**PREPARED FOR
FRAMATOME ANP, INC.**

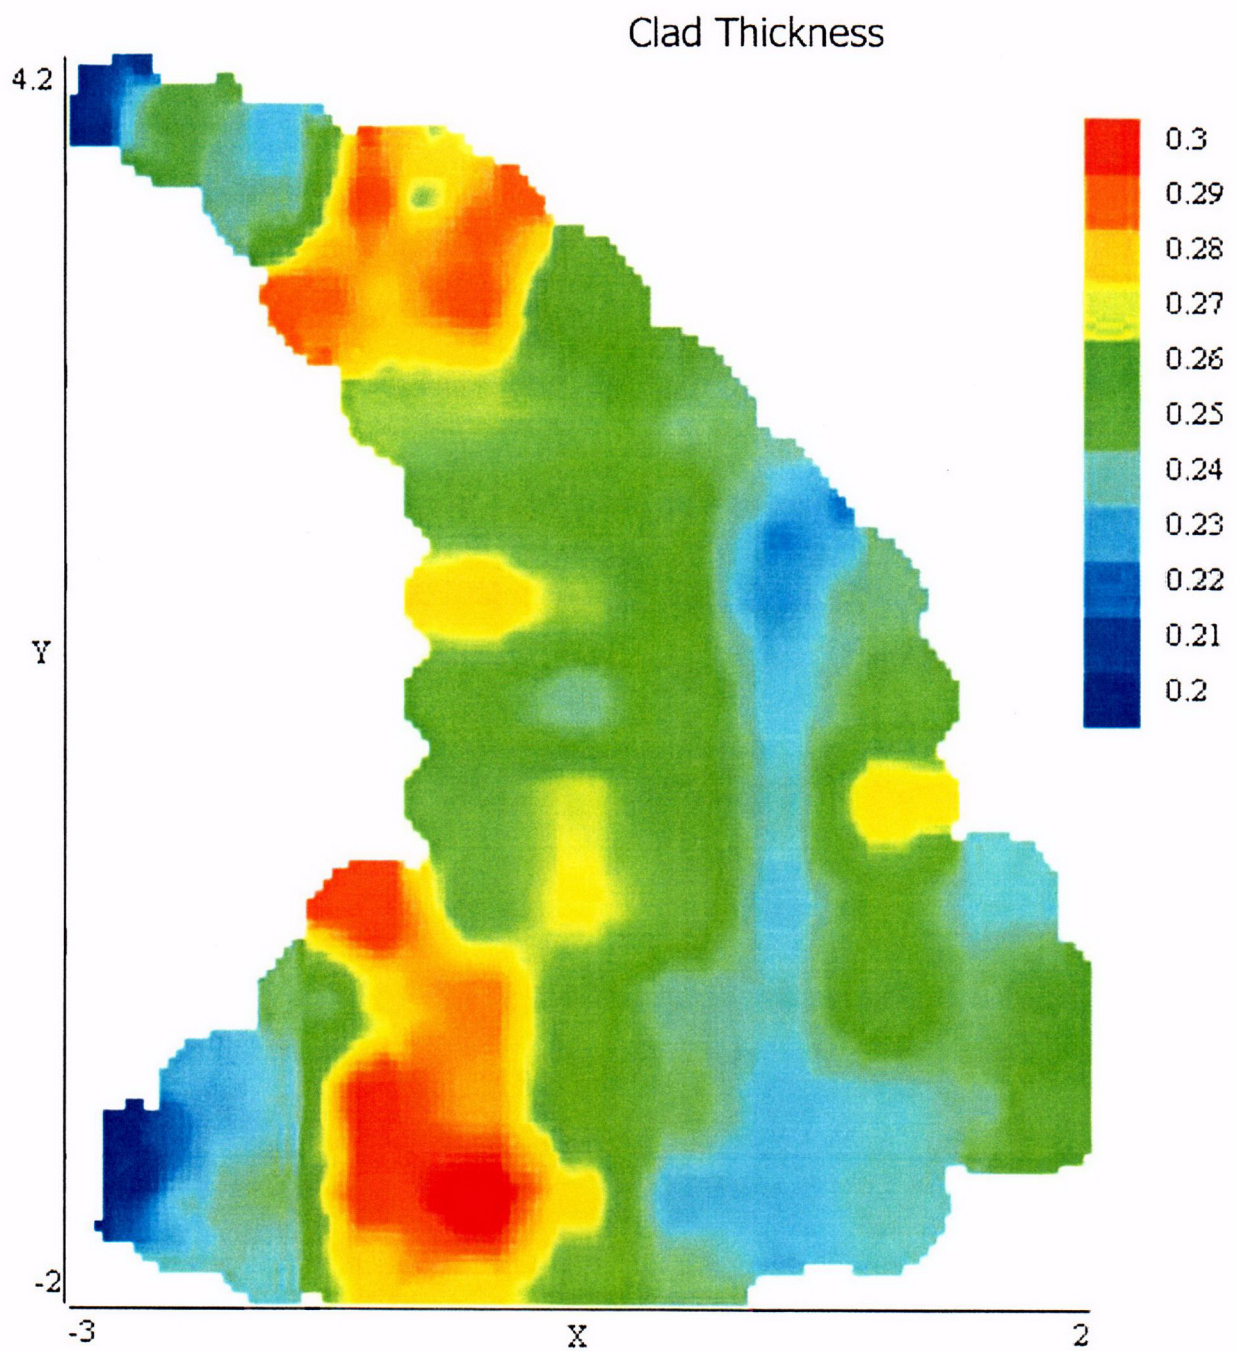
Figure 3.5.4: Colorized representation of clad thickness measurements.

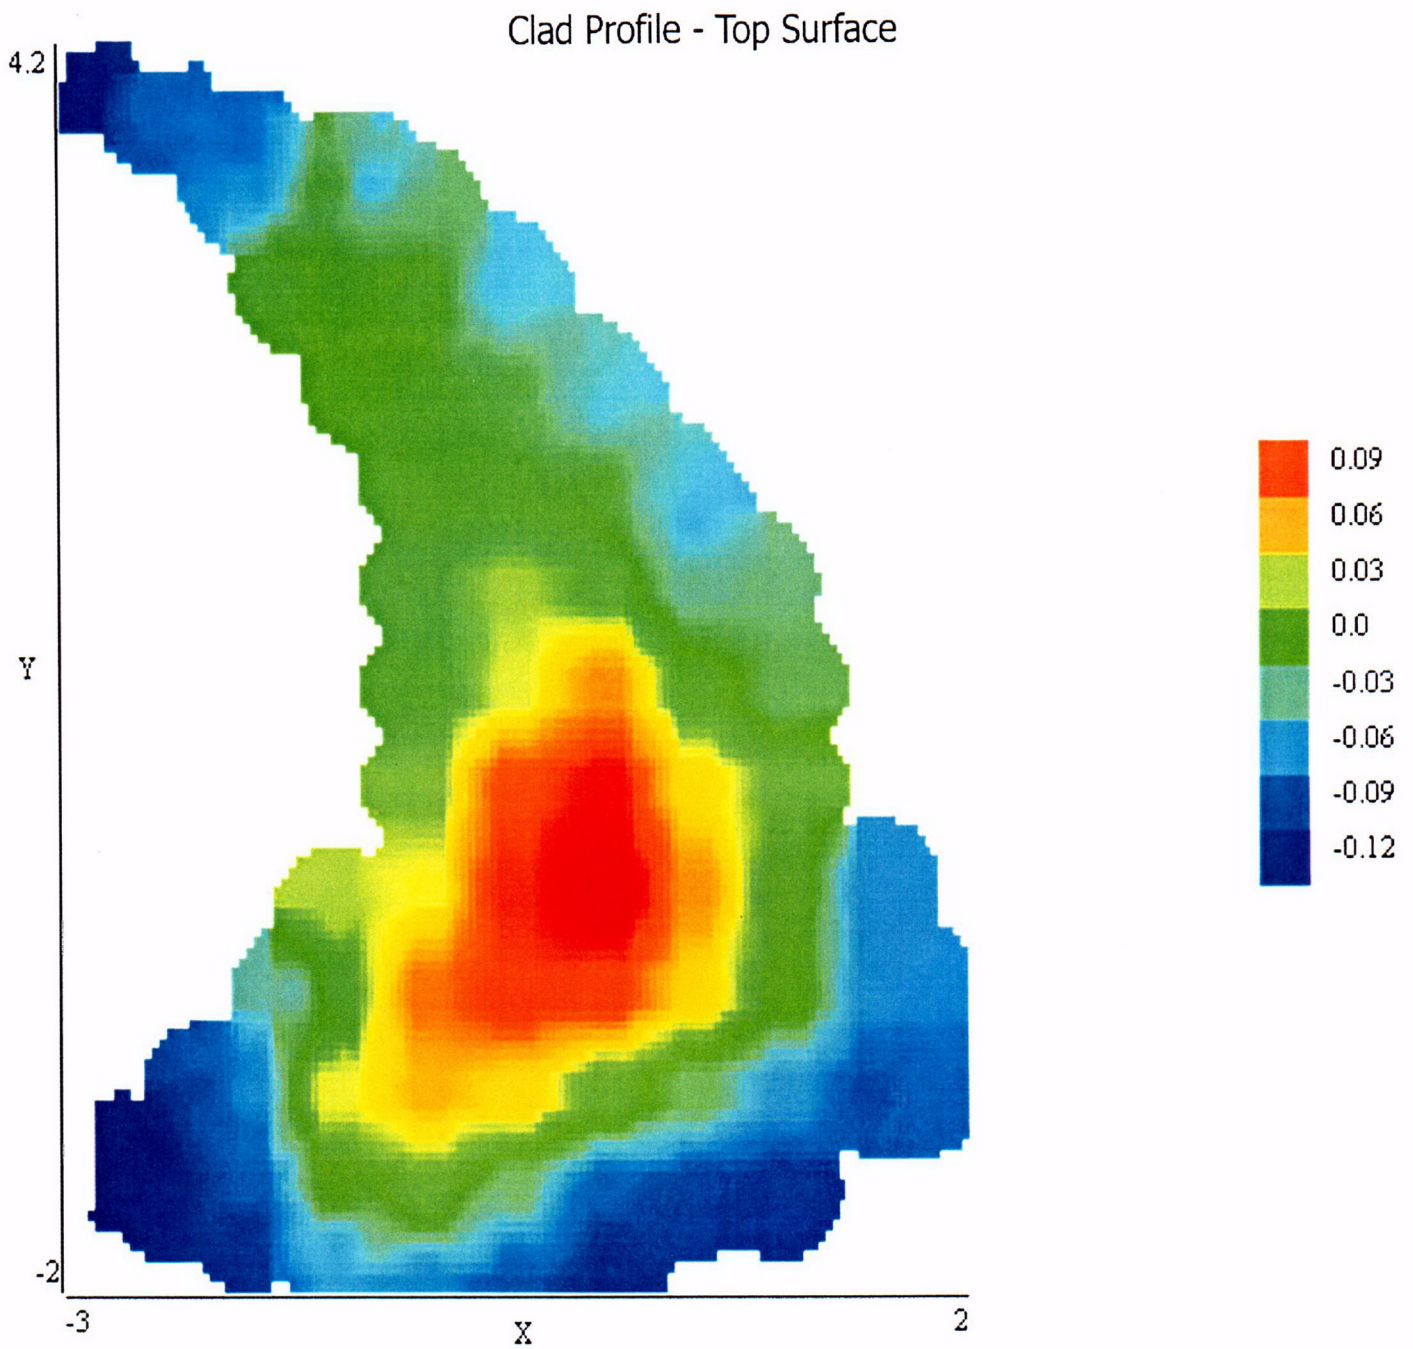
Figure 3.5.5: Colorized representation of exposed cladding profile. Red area denotes area of maximum deflection.

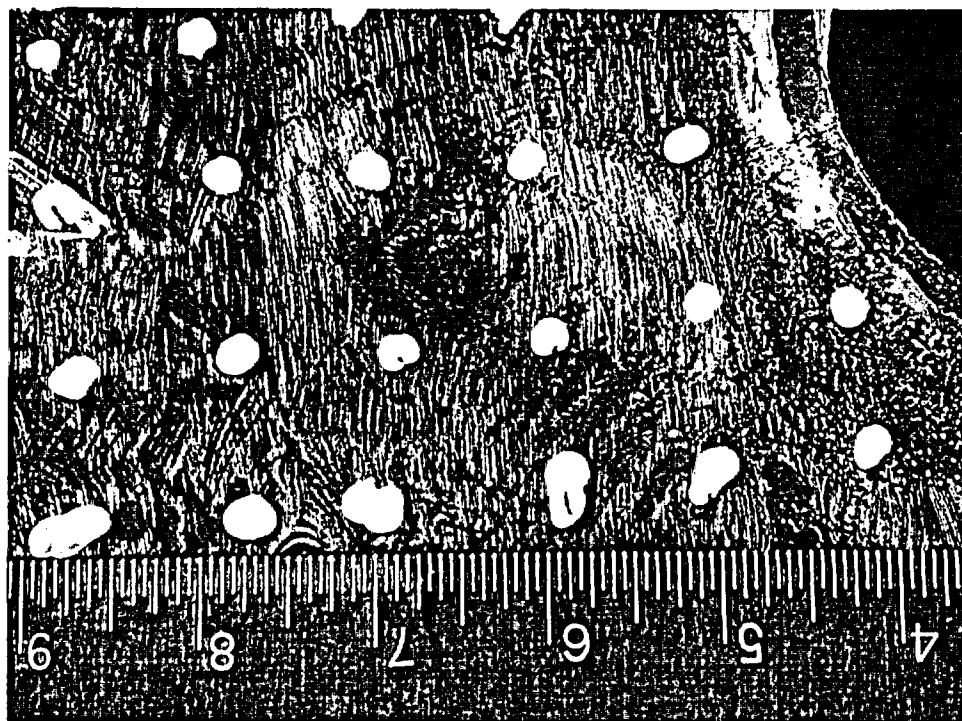
~0.9X

Figure 3.6.5: Low magnification photograph of the cavity underside. The red circle shows the area of maximum deflection. The white dots were applied at Davis-Besse for the UT thickness measurements. The two parallel lines toward the left indicate the Nozzle 11 position, which is outside the photo on the left. This maximum bulging area is shown at higher magnification in the next figure.

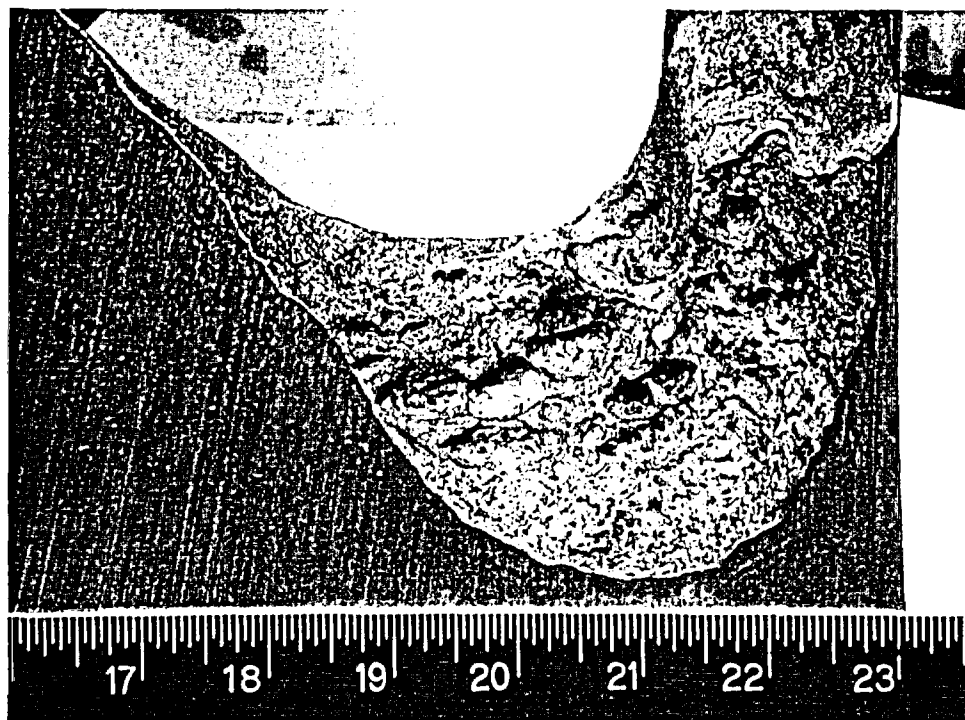
Detail of side wall near 270°. ~1.7X

Looking up at cavity nose. ~0.7X

Figure 3.6.11: Photographs showing the cavity sidewall near 270° (top) and looking up at the cavity nose (bottom).

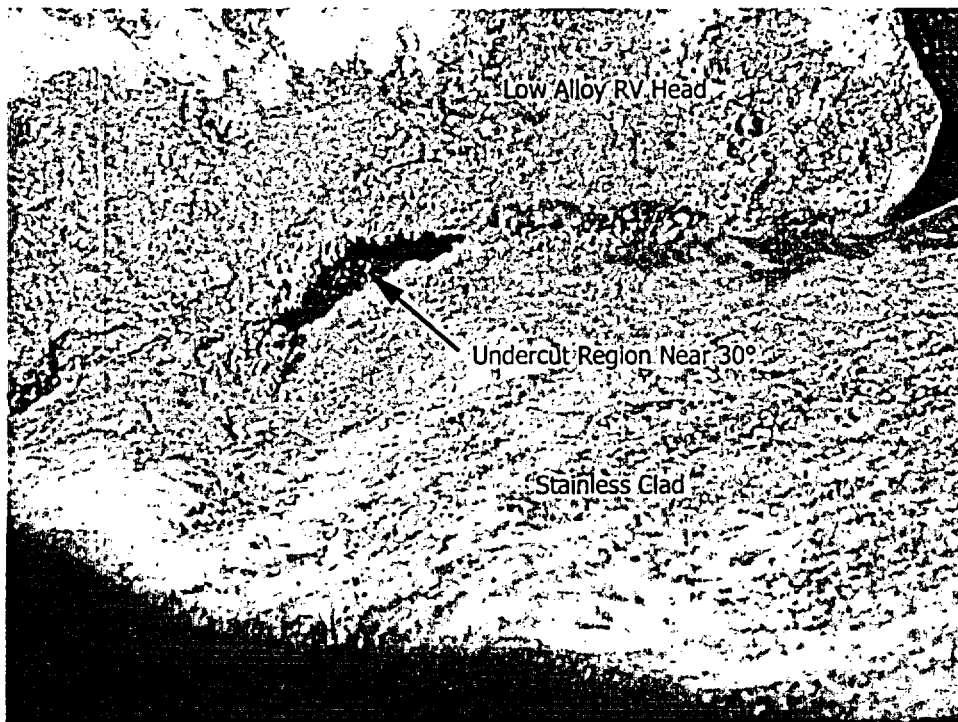
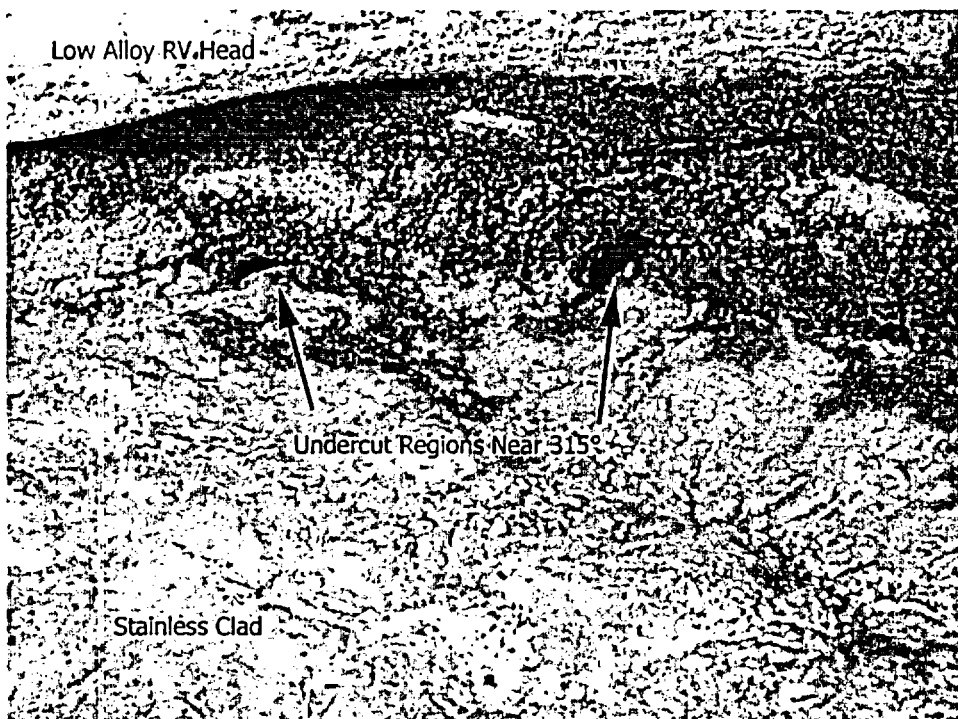
Figure 3.6.12: Photographs showing undercut regions of cavity near 30° (top) and 315° (bottom).

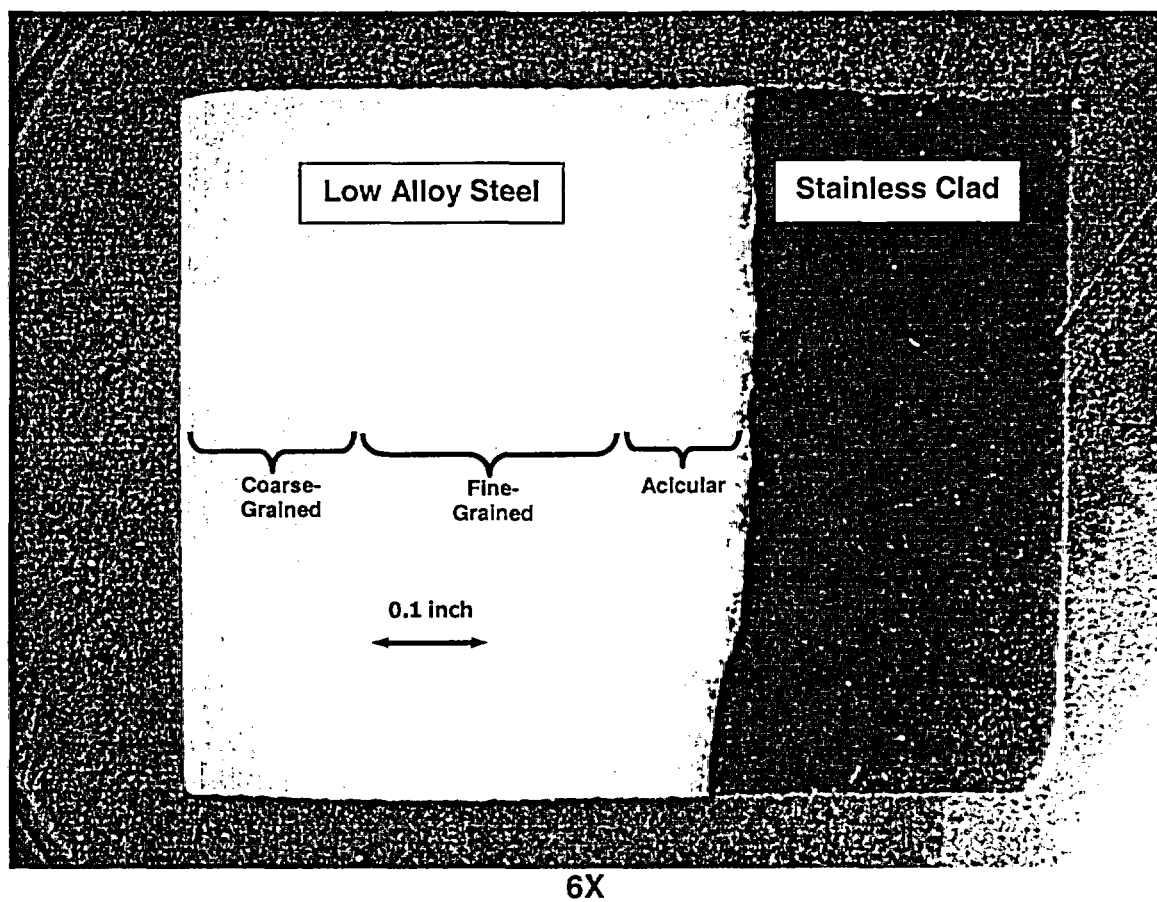
A macro photograph of the mount containing metallography sample B2C2B3 is provided in Figure 4.2.1. This photo was taken after chemically etching the sample with 2% nital, which revealed the microstructure in low alloy steel. Three distinct regions were present in the carbon steel heat-affected zone (HAZ). The microstructure was acicular near the stainless steel interface and transitioned to a fine-grained structure approximately 0.1" from the interface. A coarse-grained structure was observed approximately 0.3" from the interface. These three microstructures are shown at 100X and 375X in Figures 4.2.2, 4.2.3, and 4.2.4, respectively. Some microstructural banding (indicated by alternating lighter and darker streaks) was also observed in the coarse-grained structure approximately 0.5" from the interface (Figure 4.2.4).

Figure 4.2.1: Macro photograph of Sample B2C2B3 showing the low alloy steel stainless steel interface and various grain structures within the low alloy steel HAZ.

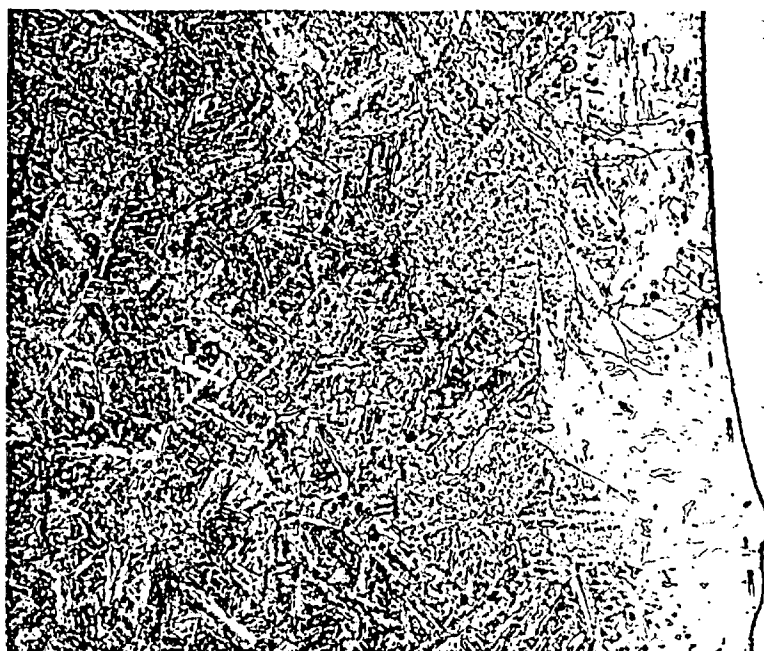
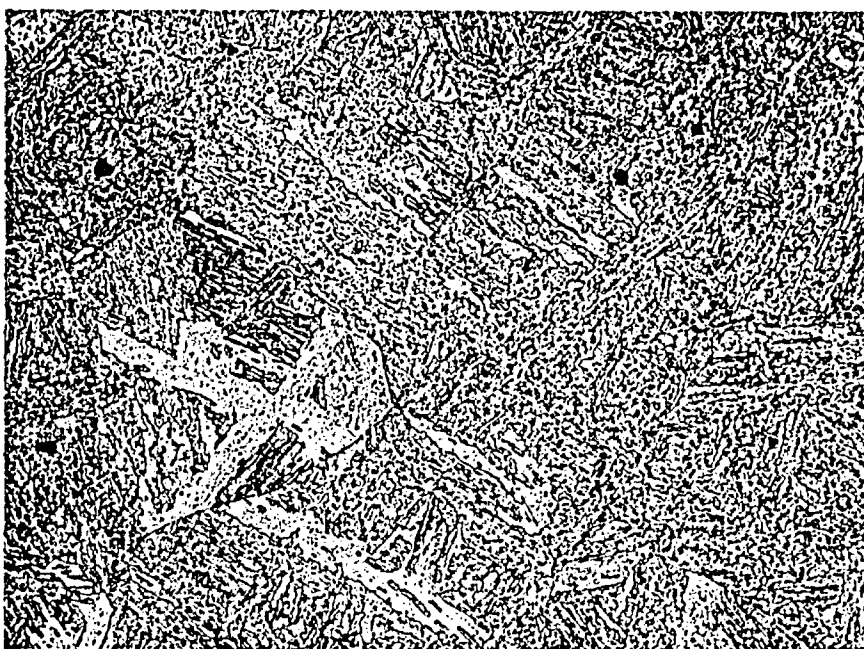
Figure 4.2.2: Typical low alloy steel microstructures near bond. 2% nital

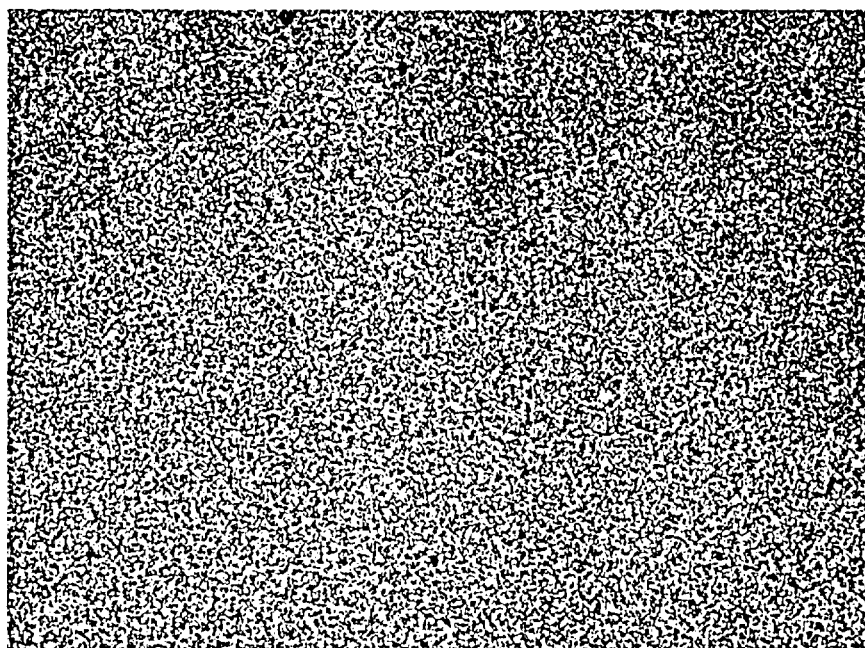
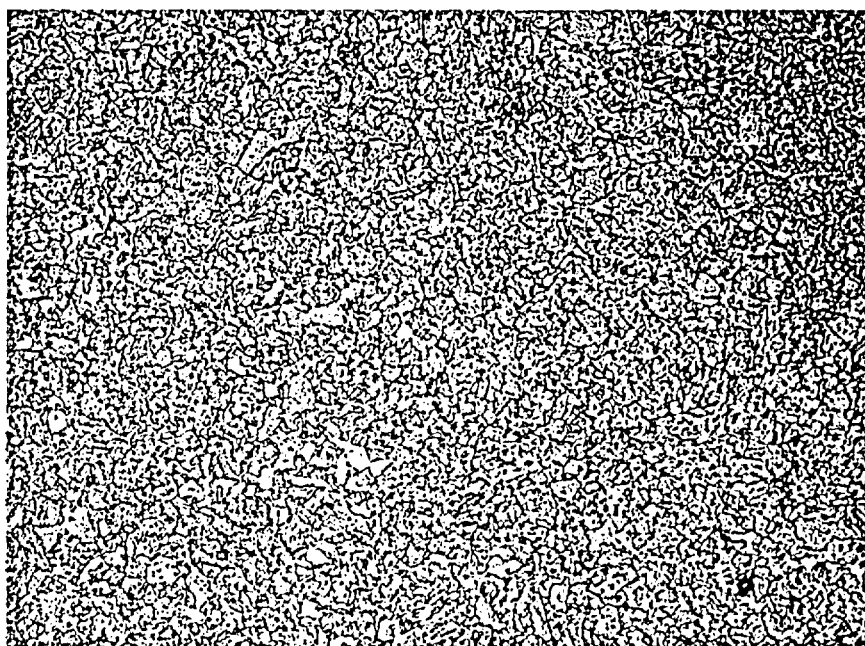
Figure 4.2.3: Typical low alloy steel microstructures 1/4" from bond. 2% nital

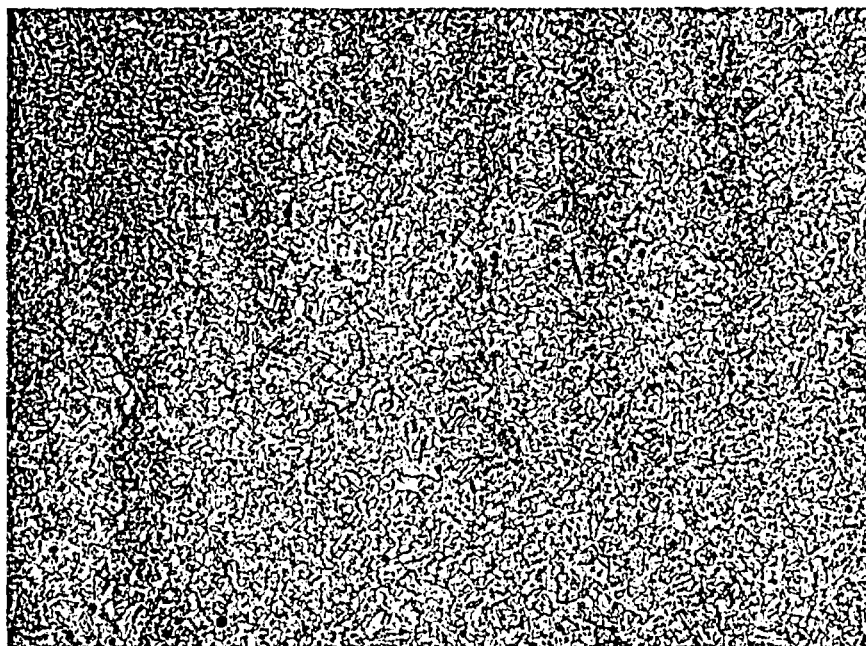
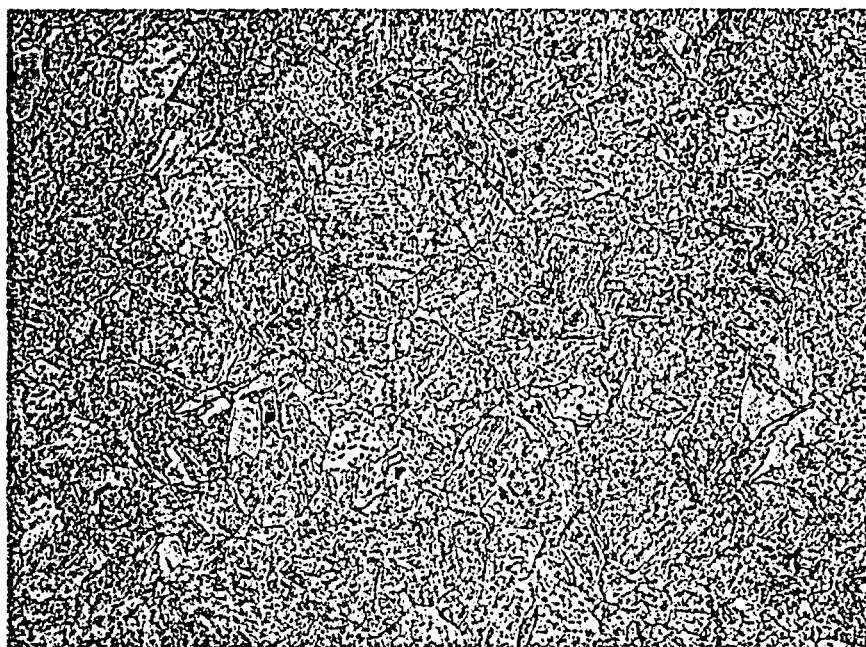
Figure 4.2.4: Typical low alloy steel microstructures ~1/2" from bond. 2% nital

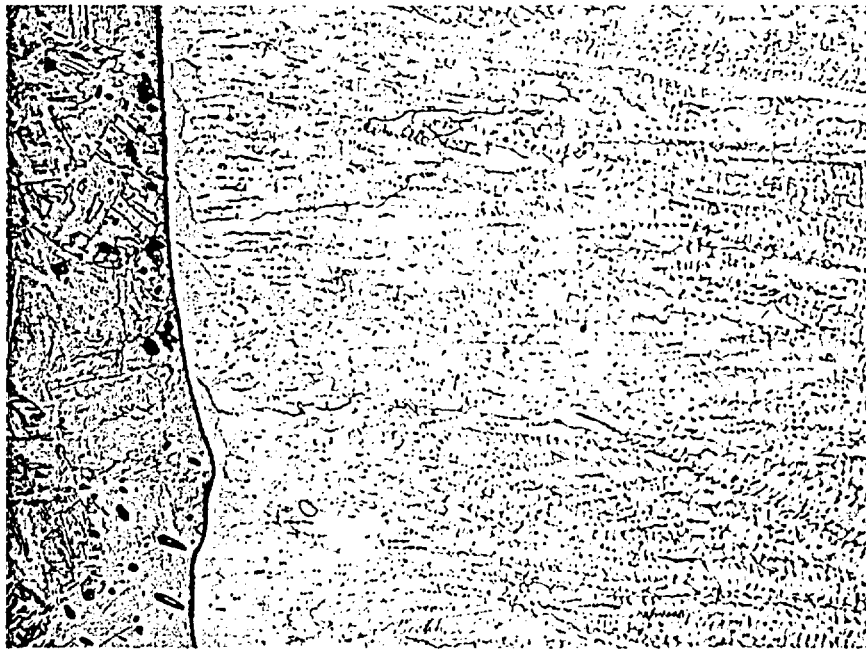
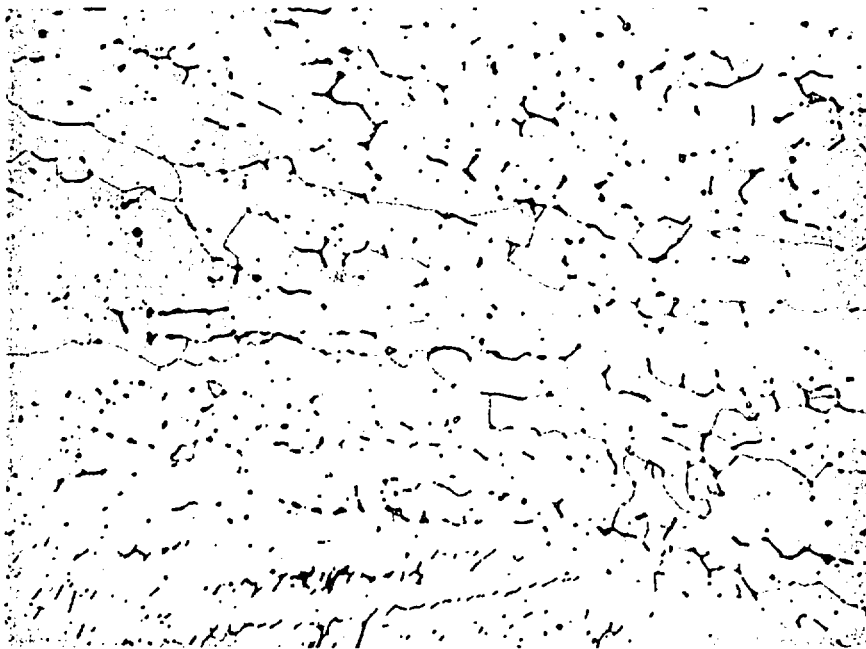
The stainless steel cladding microstructure was revealed by chemically etching with an acetic acid, nitric acid, and hydrochloric acid mixture. At the carbon steel interface, the stainless steel microstructure tends to mimic the carbon steel grain structure, but quickly changes to an elongated dendritic structure 0.002" to 0.003" from the bondline (Figure 4.2.5). The structure was generally consistent throughout the cladding cross section (Figure 4.2.6) and consisted of elongated delta ferrite pools in an austenitic matrix, which is the expected microstructure for Type 308 stainless steel cladding.

**Figure 4.2.5: Typical cladding microstructures near bond.
(Acetic-nitric-hydrochloric etch)**

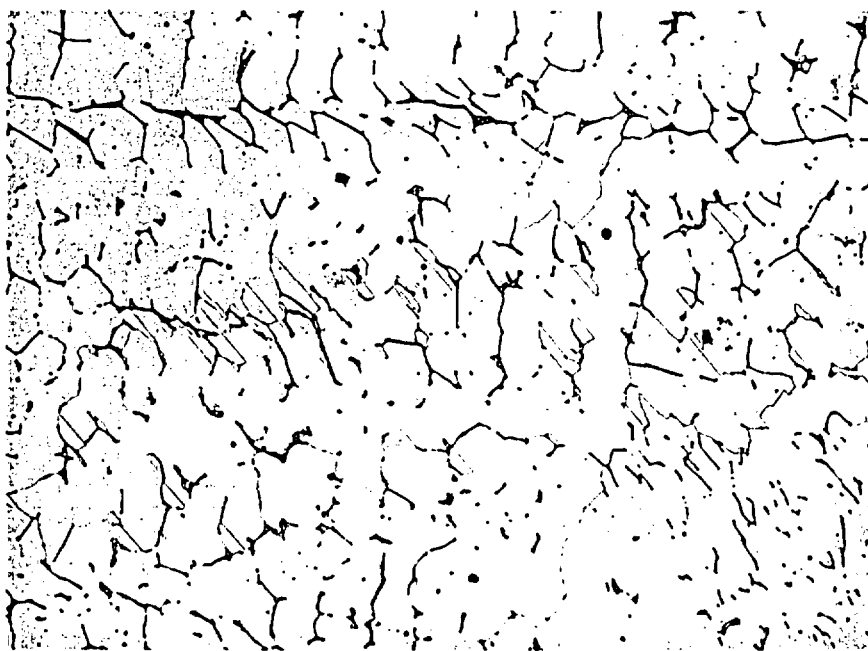
**Figure 4.2.6: Typical cladding microstructures away from bond.
(Acetic-nitric-hydrochloric etch)**

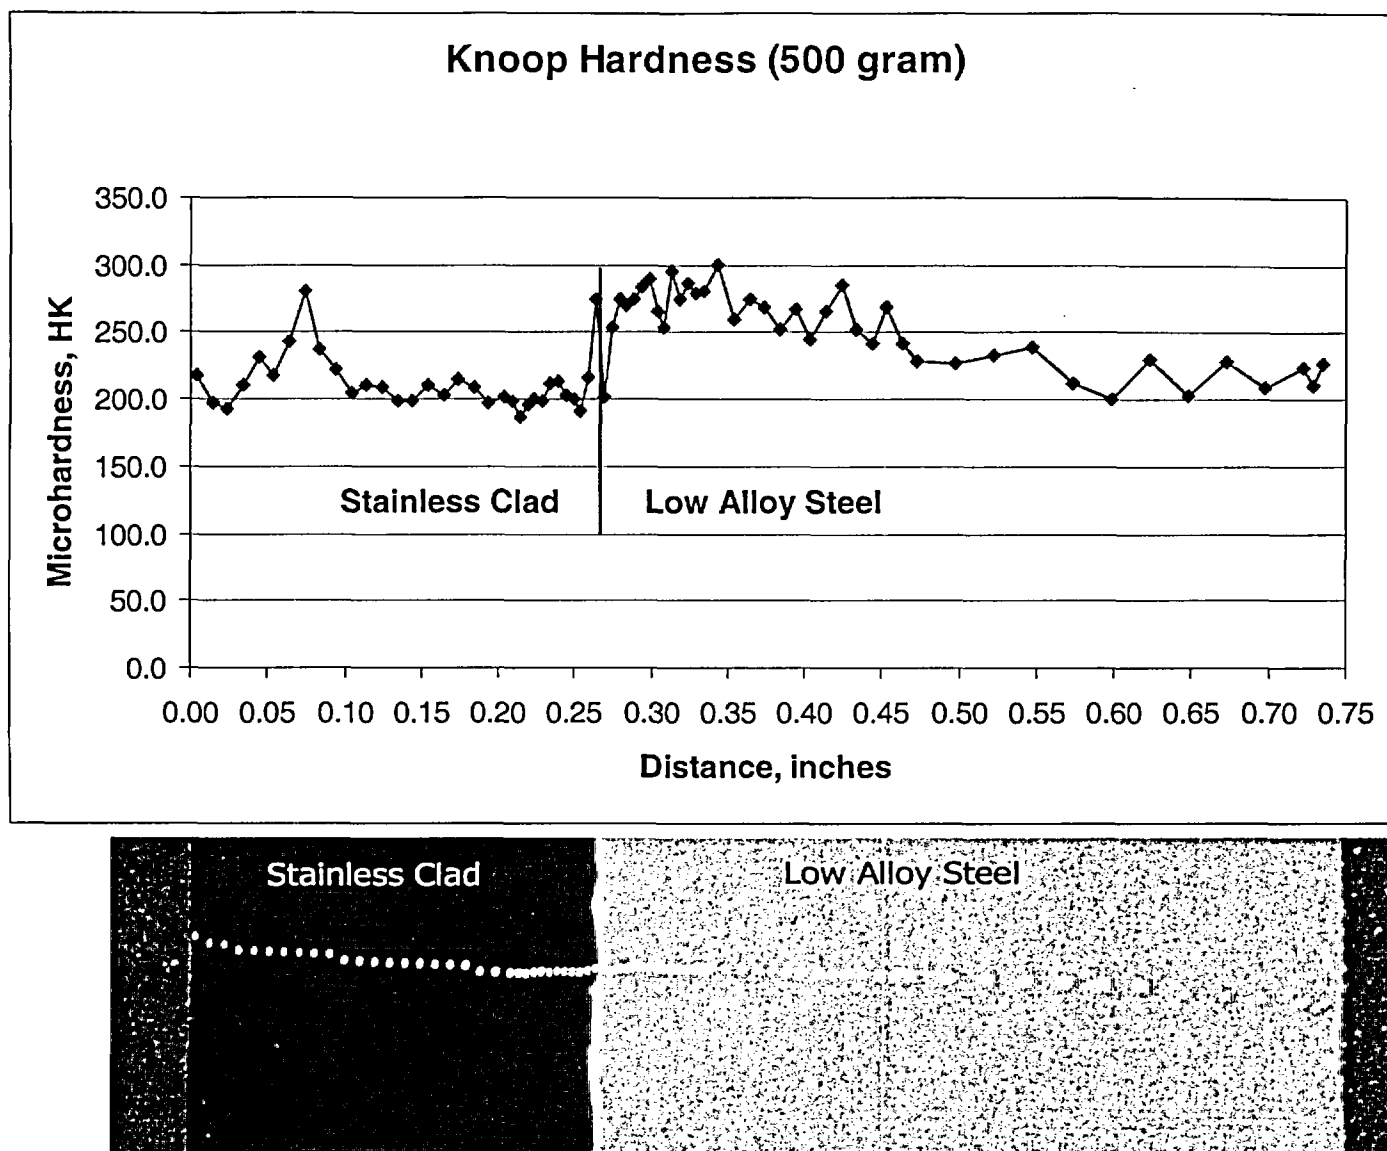
A Knoop microhardness profile was taken across the entire specimen width, from the stainless cladding to the low alloy steel. A 500 gram load was used during the test. The hardness indents were spaced nominally 0.010" apart except within 0.060" of the interface, where the readings were spaced 0.005" apart. The microhardness test results are presented along with a low magnification photograph showing the indent locations in Figure 4.2.7. There was some hardness variation noted on the RCS side of the cladding, then the hardness level remained at a consistent HK ~210 until the interface with the low alloy steel. Hardness levels of HK ~300 were noted in the low alloy steel adjacent to the bondline (corresponding to the acicular structure). The hardness readings gradually tapered down

Figure 4.2.7: Microhardness data and low magnification photograph for Sample B2C2B3.

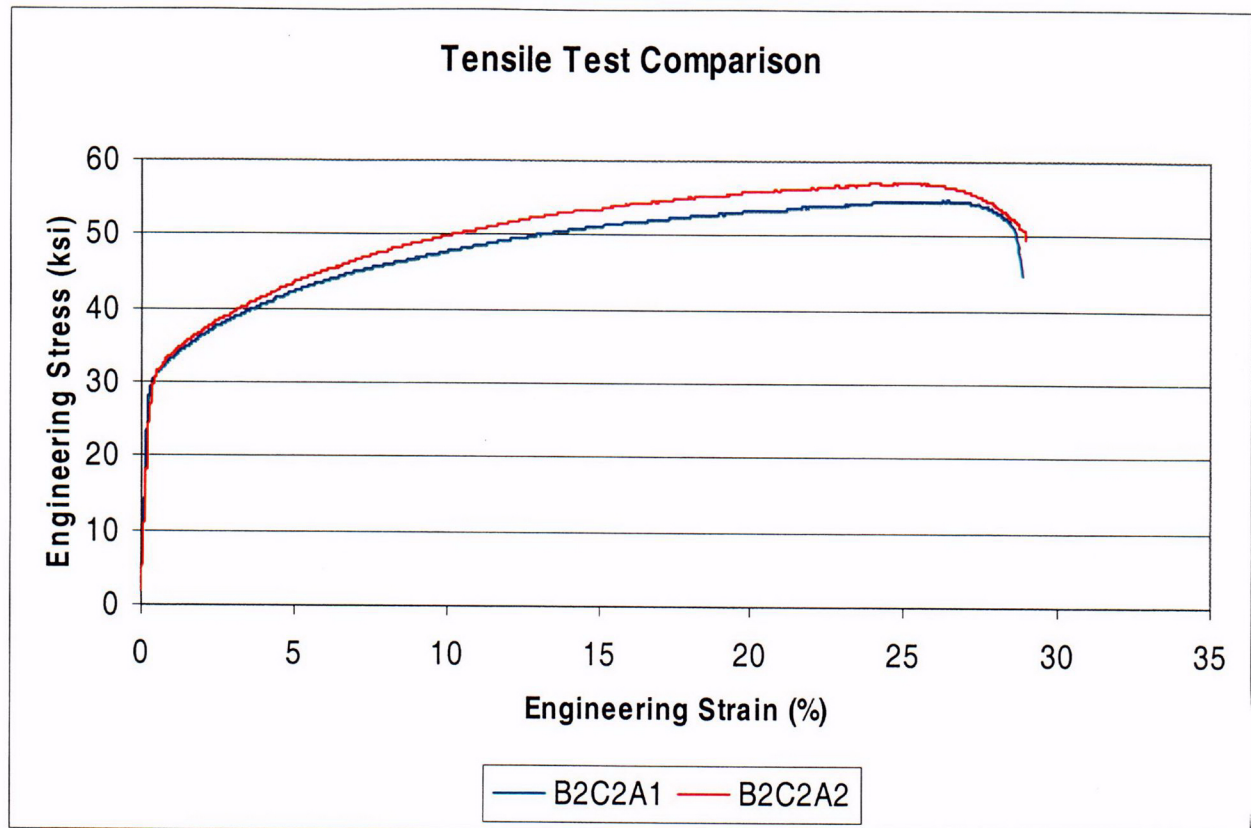
B2C2A1	B2C2A2
UTS	54,800 psi	57,100 psi
2% Offset YS	30,500 psi	31,300 psi
Elongation	28.7%	28.7%
Reduction in Area	39.3%	34.3%

Figure 4.3.2: Tensile test results for specimen B2C2A1 (near RCS) and specimen B2C2A2 (near low alloy steel).

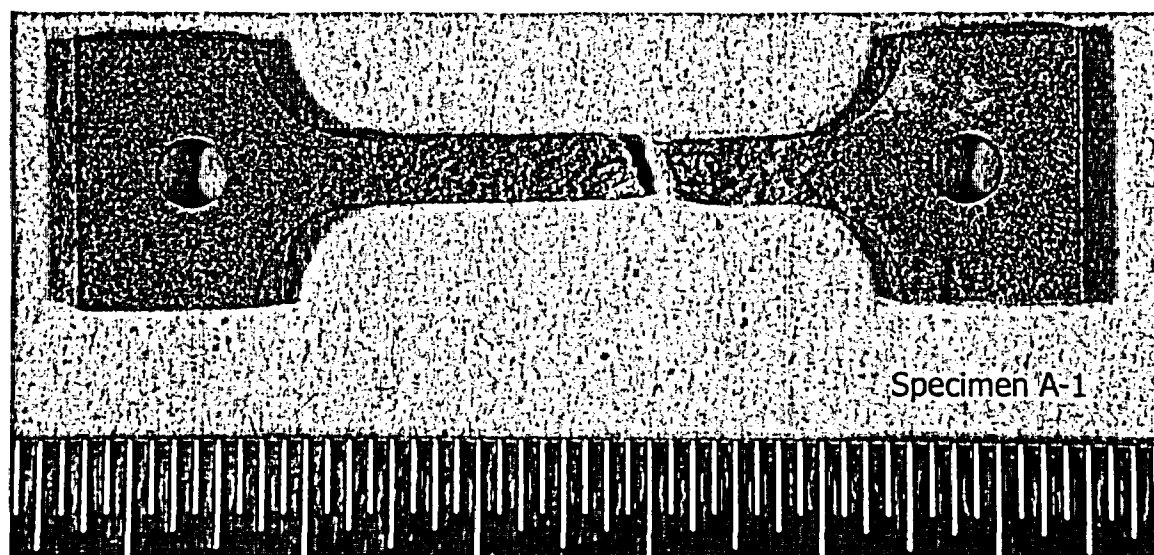
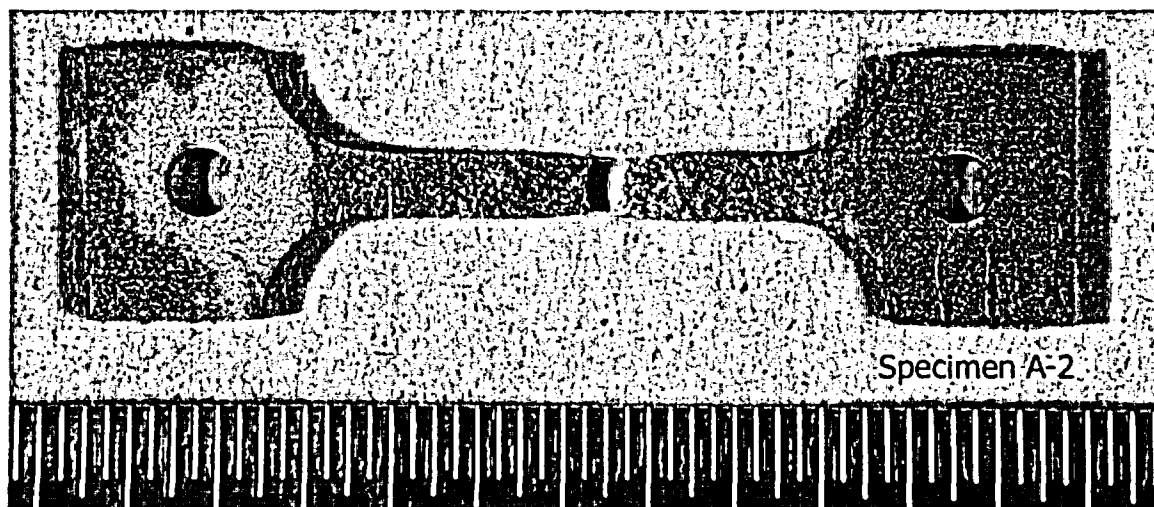
The specimens were machined from the same area of cladding, with one specimen located closer to the RCS side of the cladding and the other specimen located closer to the low alloy steel RV head. The intent of this sample configuration was to determine if a mechanical property gradient existed across the stainless steel cladding thickness. The engineering stress-strain curves for the two specimens are presented in Figure 4.3.2 along with the tabulated data for ultimate tensile strength, 0.2% offset yield strength, % elongation, and % reduction in area. The results for both specimens were considered to be within experimental scatter, so it was concluded that no mechanical property gradient was present. The data indicated a tensile strength of ~56 ksi, yield strength of ~31 ksi, 28.7% elongation, and ~37% reduction in area. Photographs of the two specimens taken after the test are provided in Figures 4.3.3 and 4.3.4. These photographs show the break location, which was within the gage length for both specimens. Also noted was ductile necking adjacent to the fracture surfaces.

Figure 4.3.3: Low magnification photographs of tensile specimens after test.
