Table 5.1: Sample identification listing for Piece A2A.

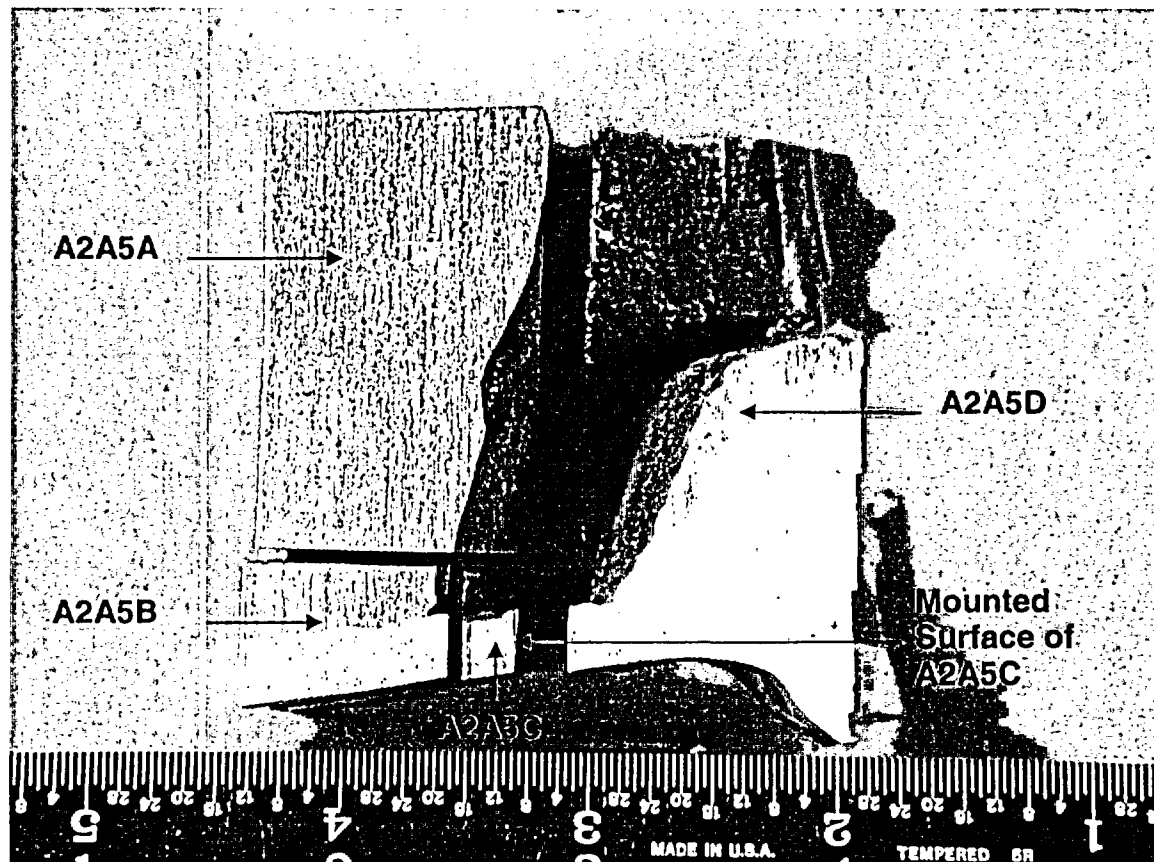
Figure 5.3: Piece A2A5 before sectioning. The mounted surface is indicated.

Figure 5.3 (cont.): Piece A2A5 after sectioning, looking down on the front face of previous photo. The mounted surface on sample A2A5C is indicated. This area contained the thinnest measured cladding (0.202").

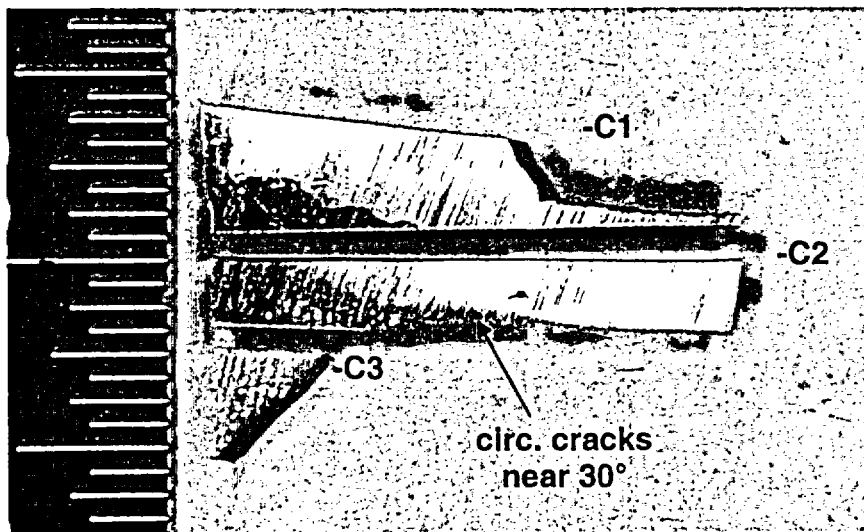
Figure 5.8: Piece A2A6A2C after sectioning (side view of Figure 5.6). The circumferential cracks were bent open for SEM.

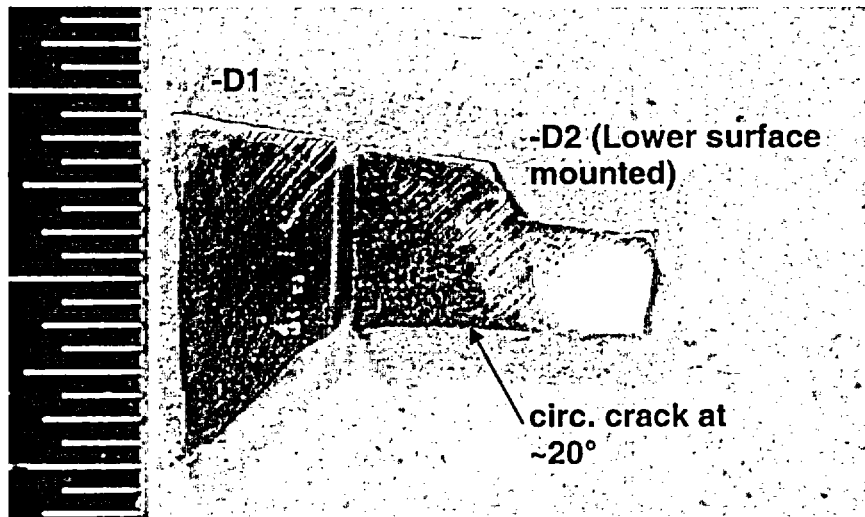
Figure 5.9: Section photo for Piece A2A6A2D (side view of Figure 5.6). The mounted surface of Piece A2A6A2D2 for optical and SEM examination is the lower surface (not visible) in the photo.

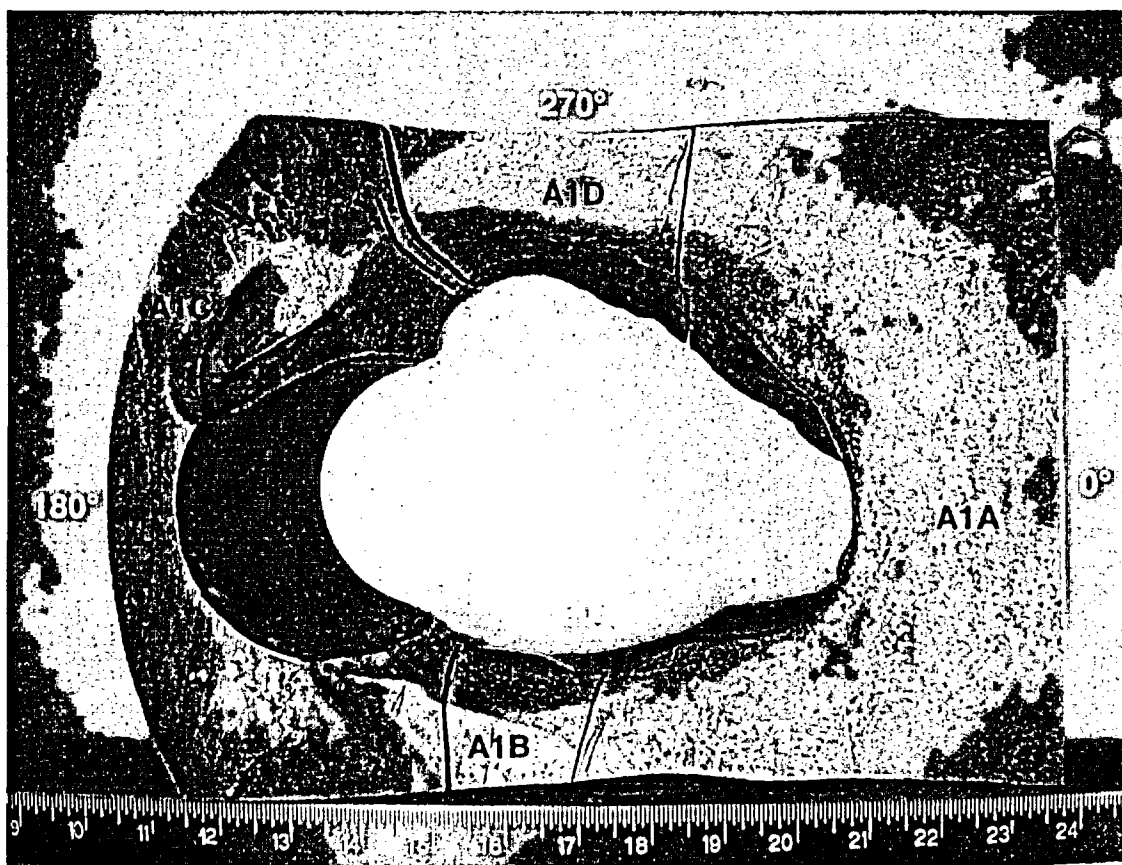
Figure 5.13: Sectioning of Piece A1 into four pieces. Pieces A1B and A1D were further sectioned for metallography and SEM. Refer to Figure 5.14 through Figure 5.16.

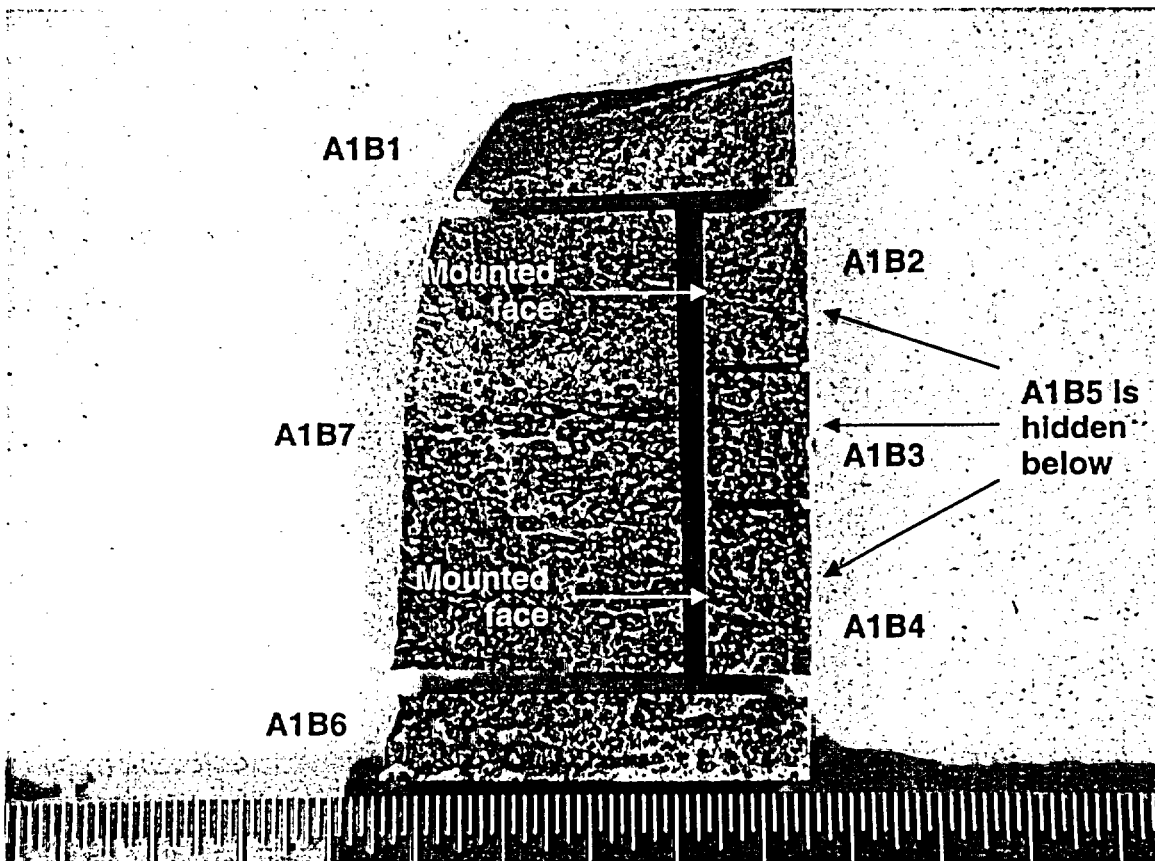
Figure 5.14: Section photo for Piece A1B, looking at the cavity side wall. The mounted surfaces of Piece A1B2 and Piece A1B4 is indicated.

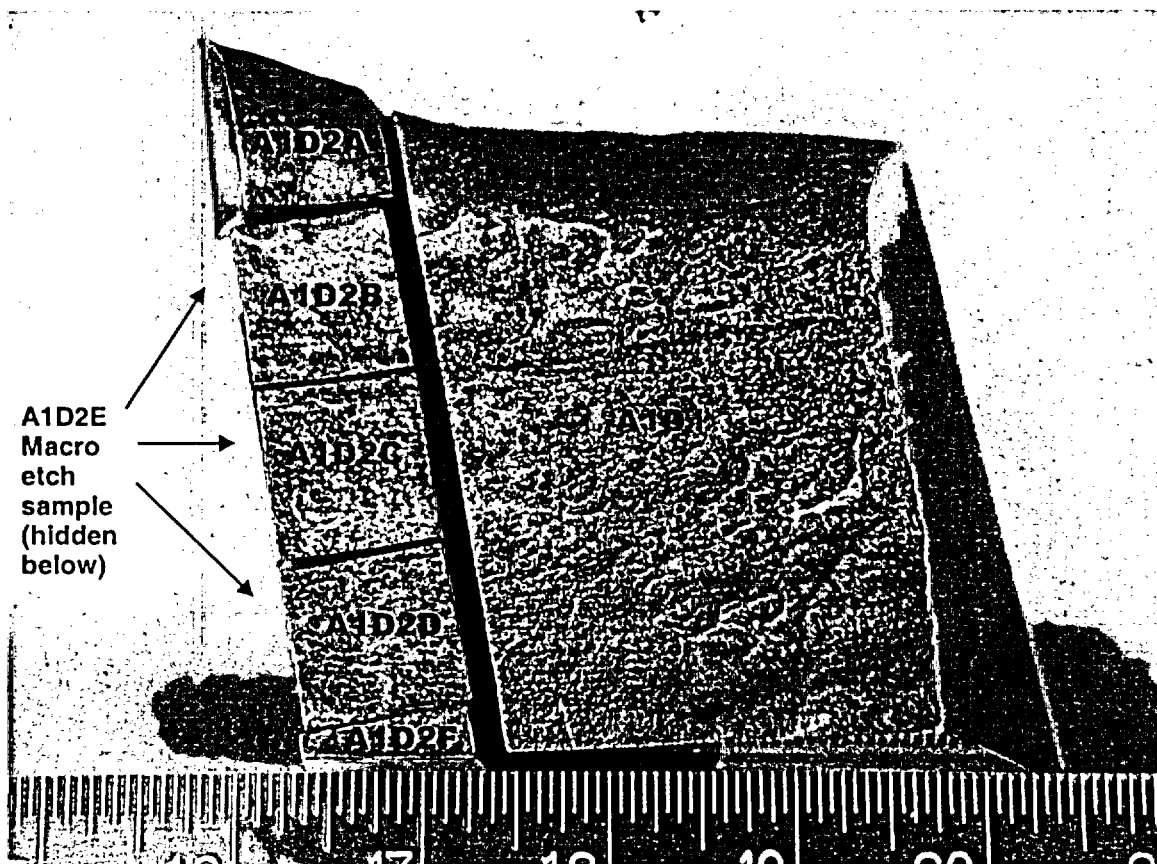
Figure 5.15: Section photo for Piece A1D, looking at the cavity side wall. Refer to Figure 5.16 for the mounted surface locations.

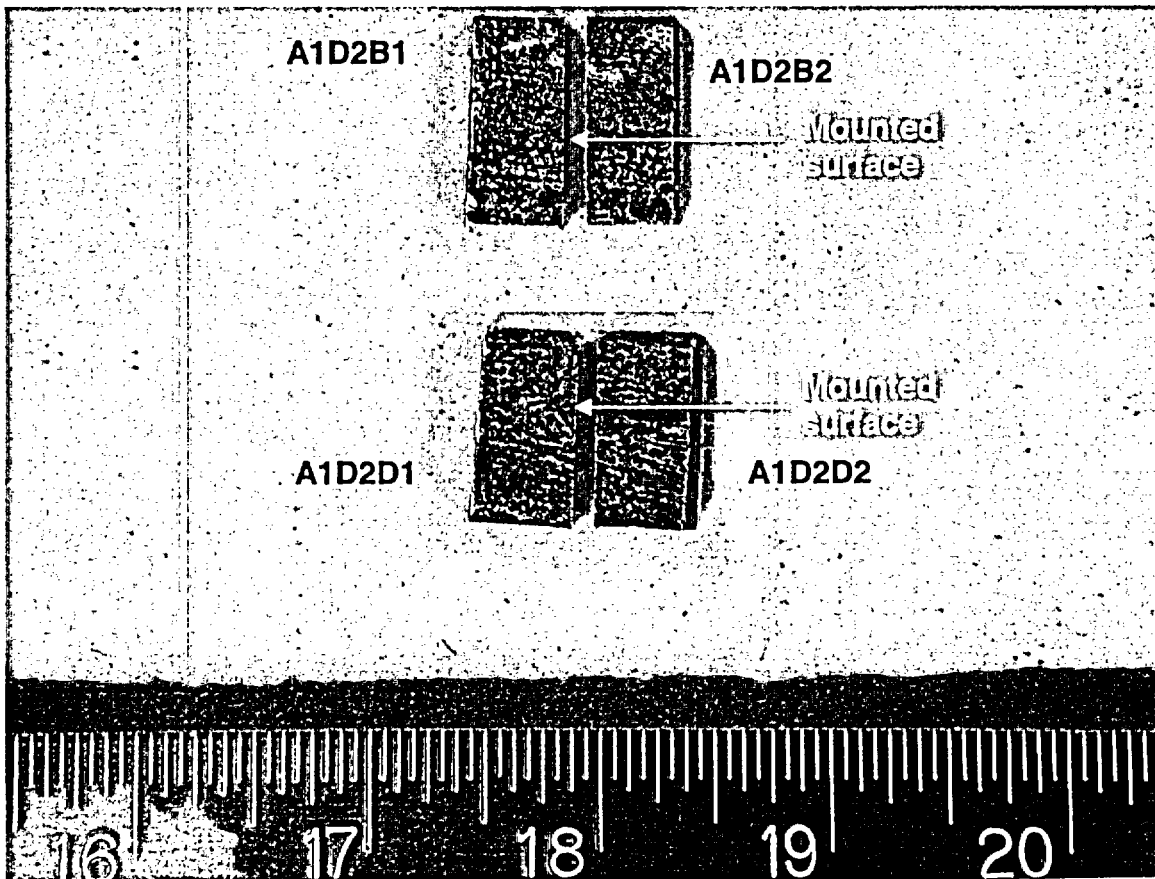
Figure 5.16: Section photo for Pieces A1D2B and A1D2D, looking at the cavity side wall. The mounted faces for Piece A1D2B1 and Piece A1D2D1 are indicated.

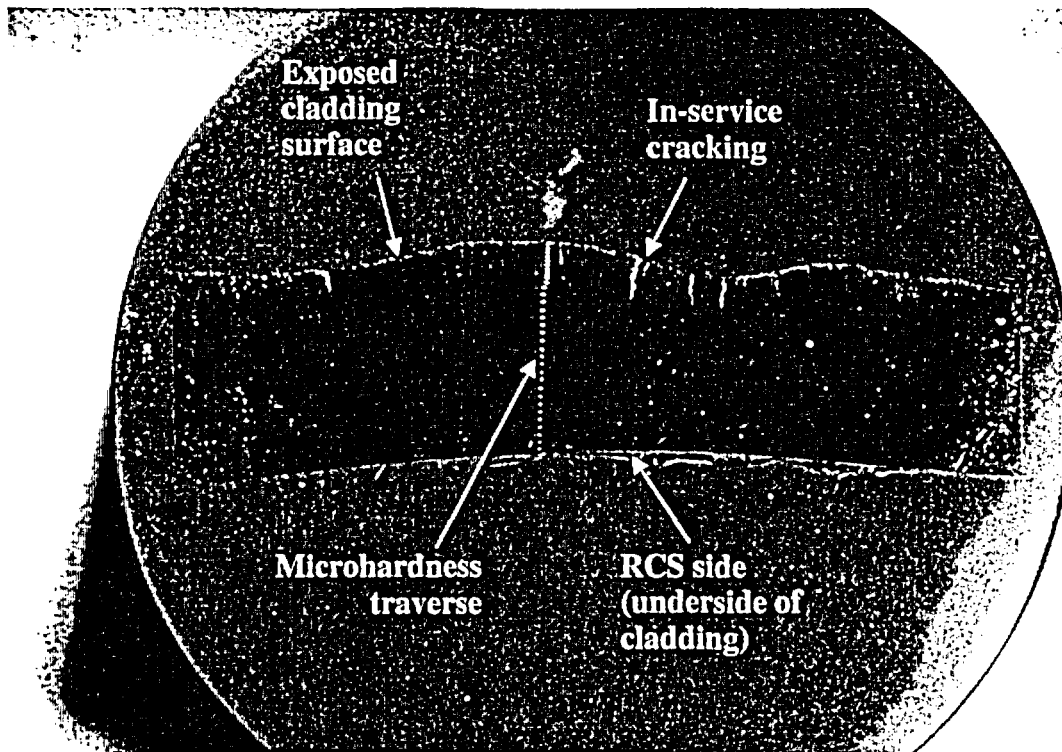
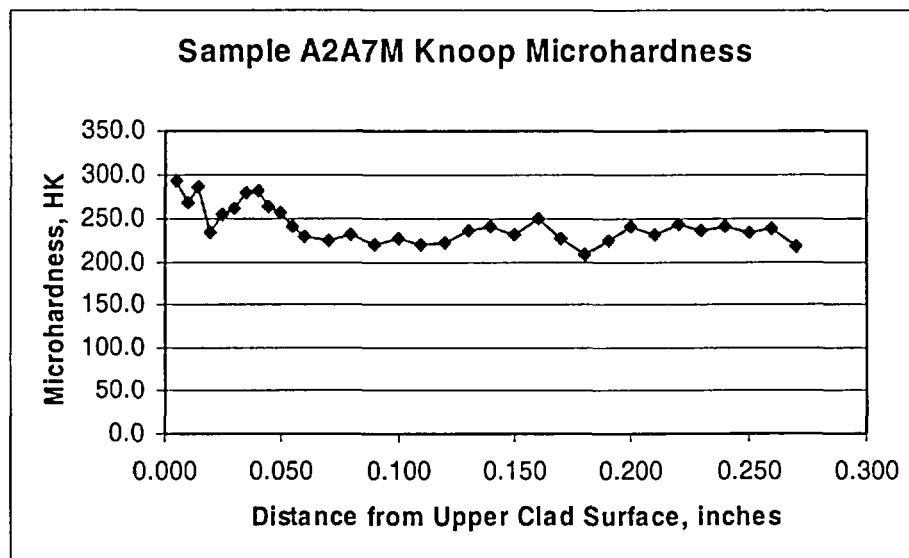
Figure 6.1.1.1: 4X macro photograph of metallurgical mount A2A7M. Refer to Figure 5.11 for the sample orientation. Cladding thickness ranged from 0.227" to 0.277" (5.77 to 7.04 mm). Knoop microhardness values exhibited a hardness elevation near the exposed cladding surface.

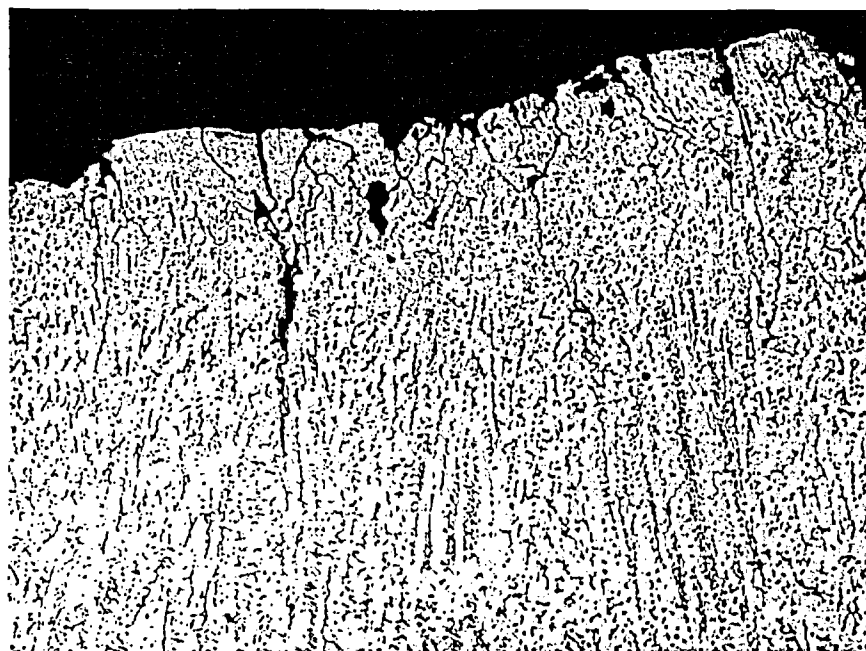
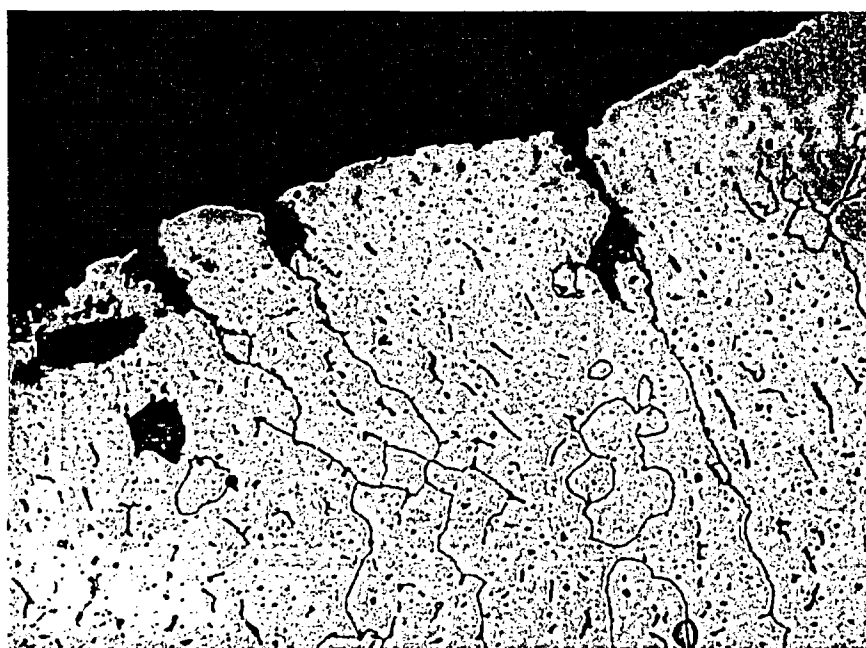
**Figure 6.1.1.2: Micrographs showing intergranular attack (IGA) and intergranular or interdendritic cracking on the exposed stainless steel cladding.**

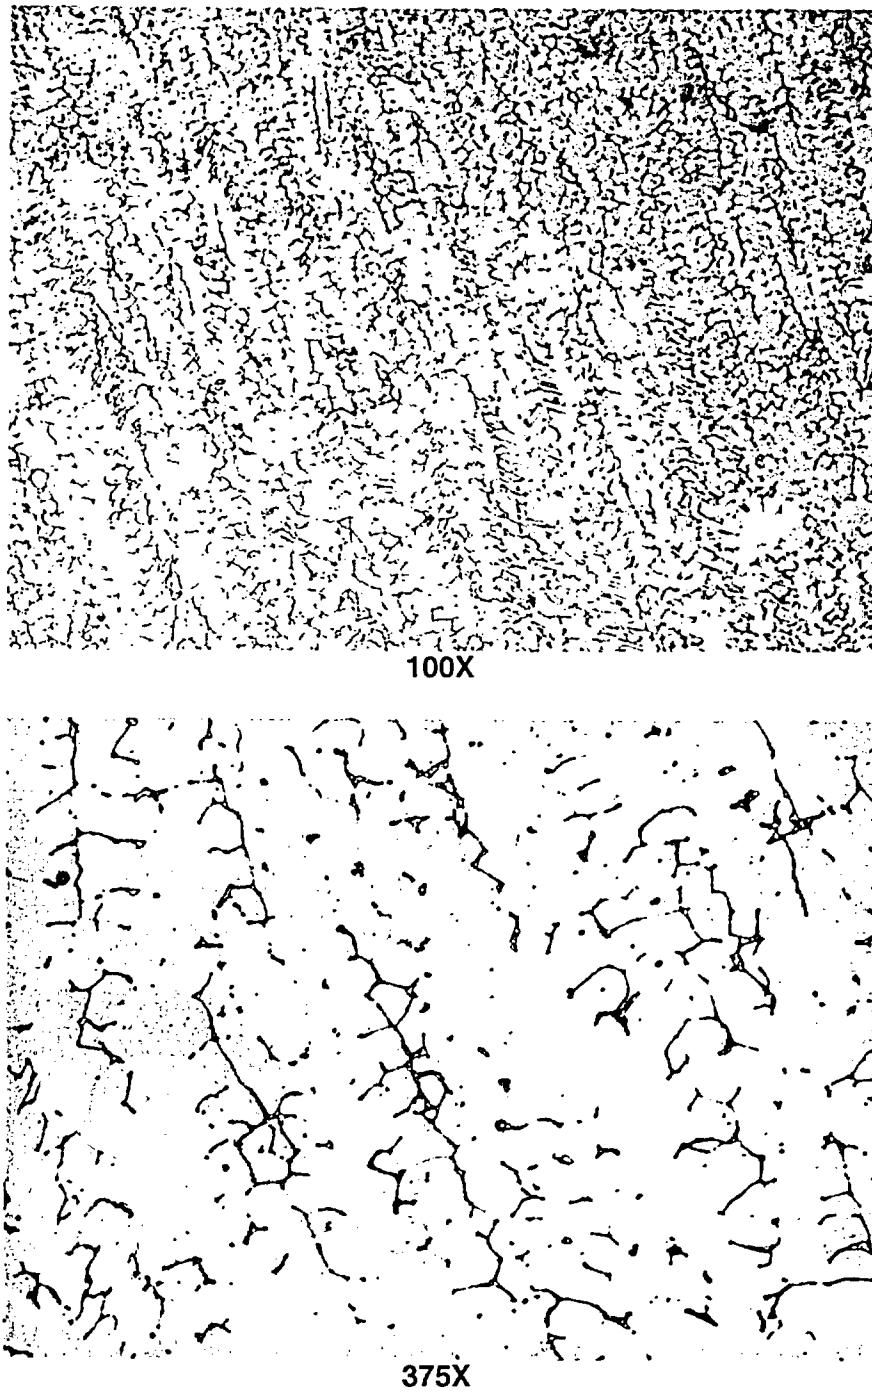
Figure 6.1.1.4: Typical clad microstructure in the mid-thickness of the cladding.

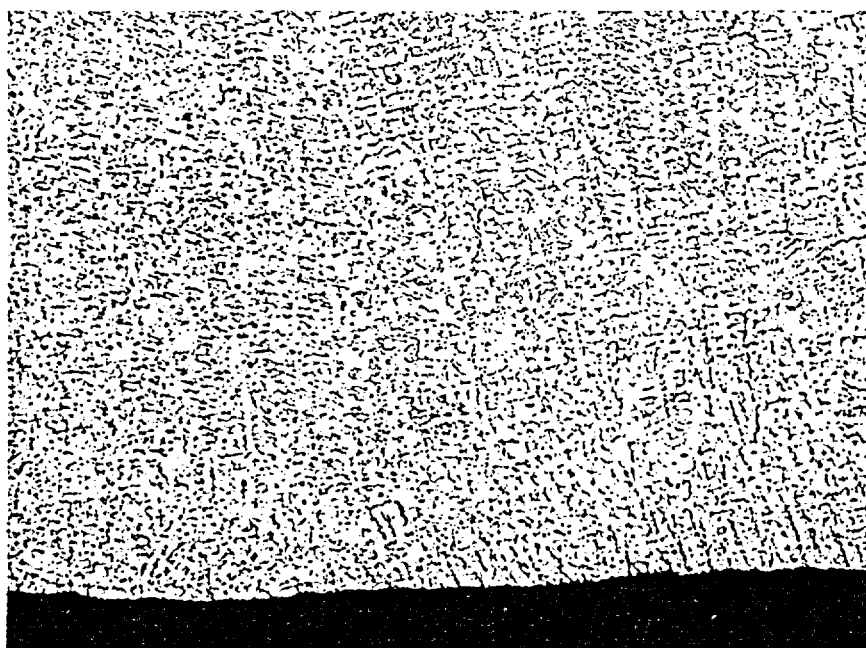
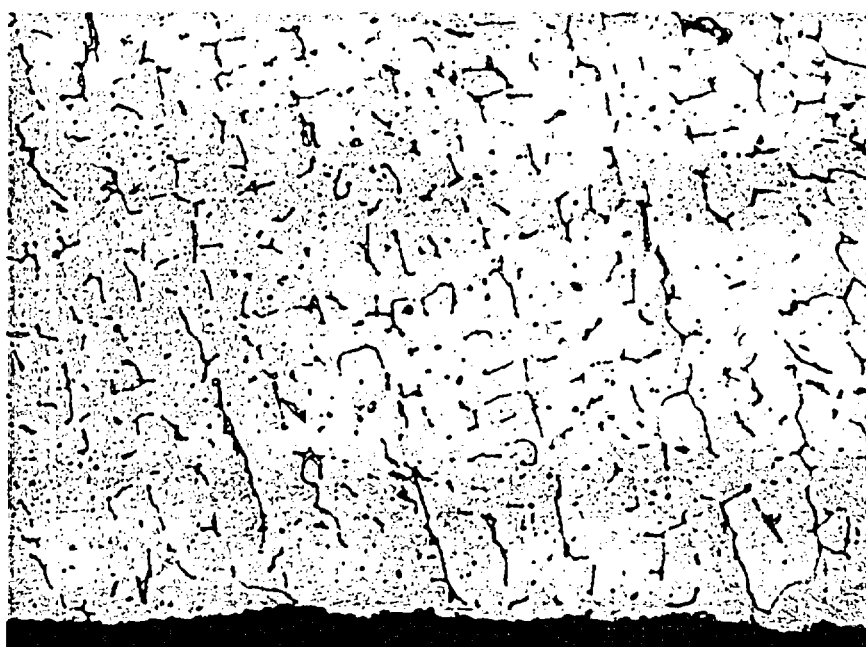
Figure 6.1.1.5: Typical clad microstructure near RCS side surface of the cladding. No intergranular attack (IGA) was present.

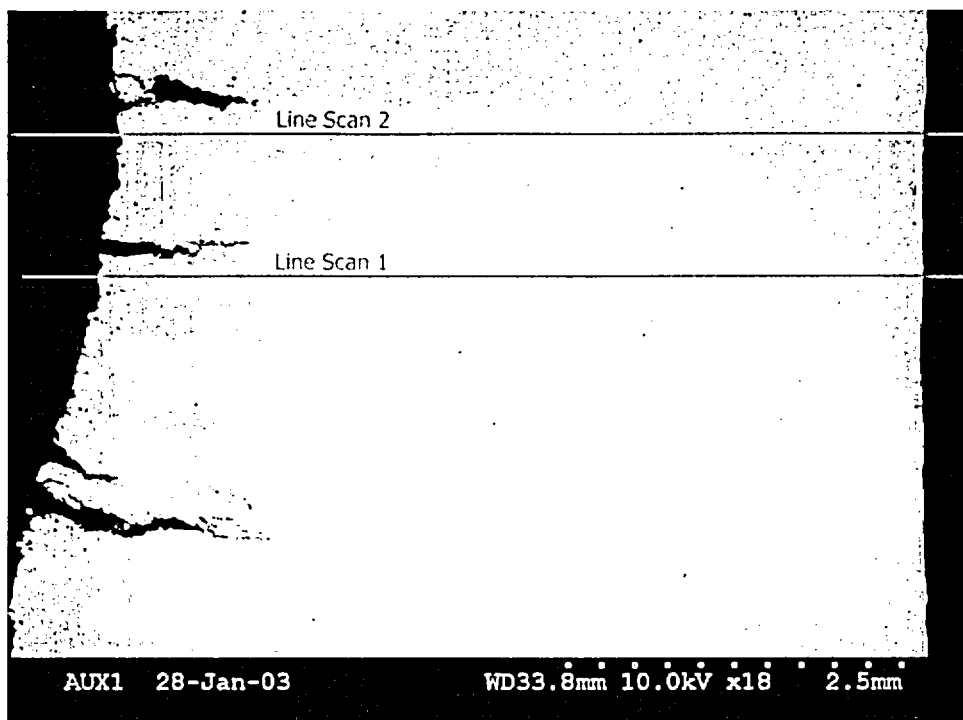
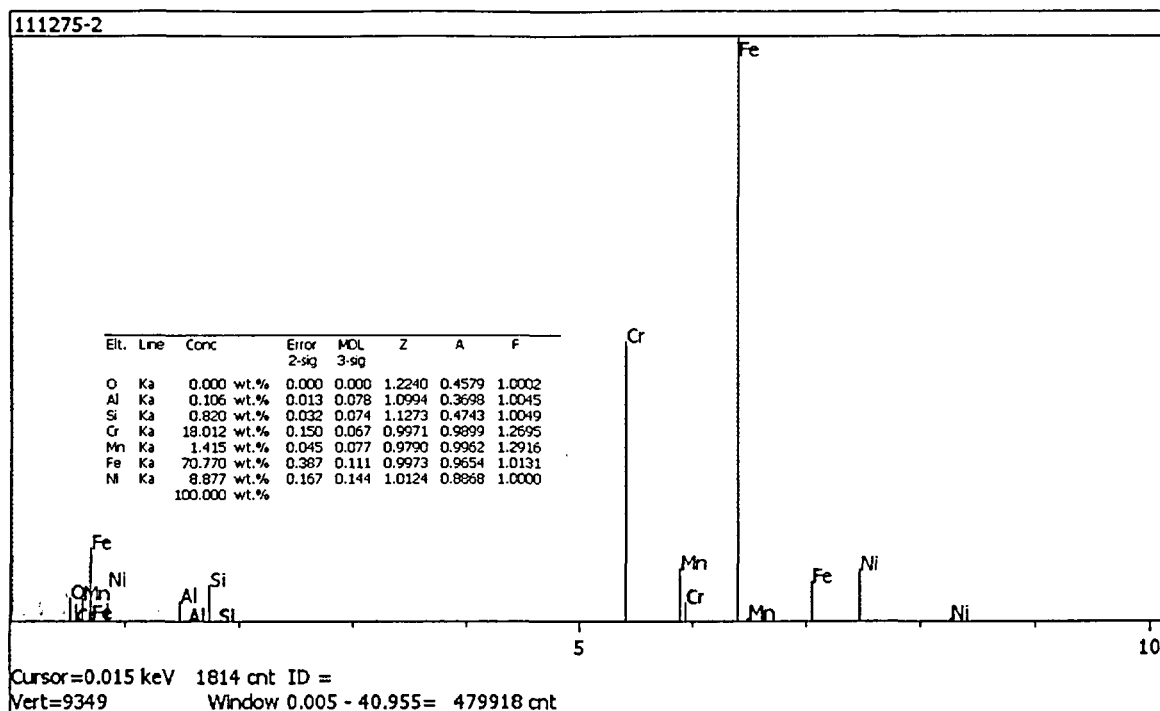
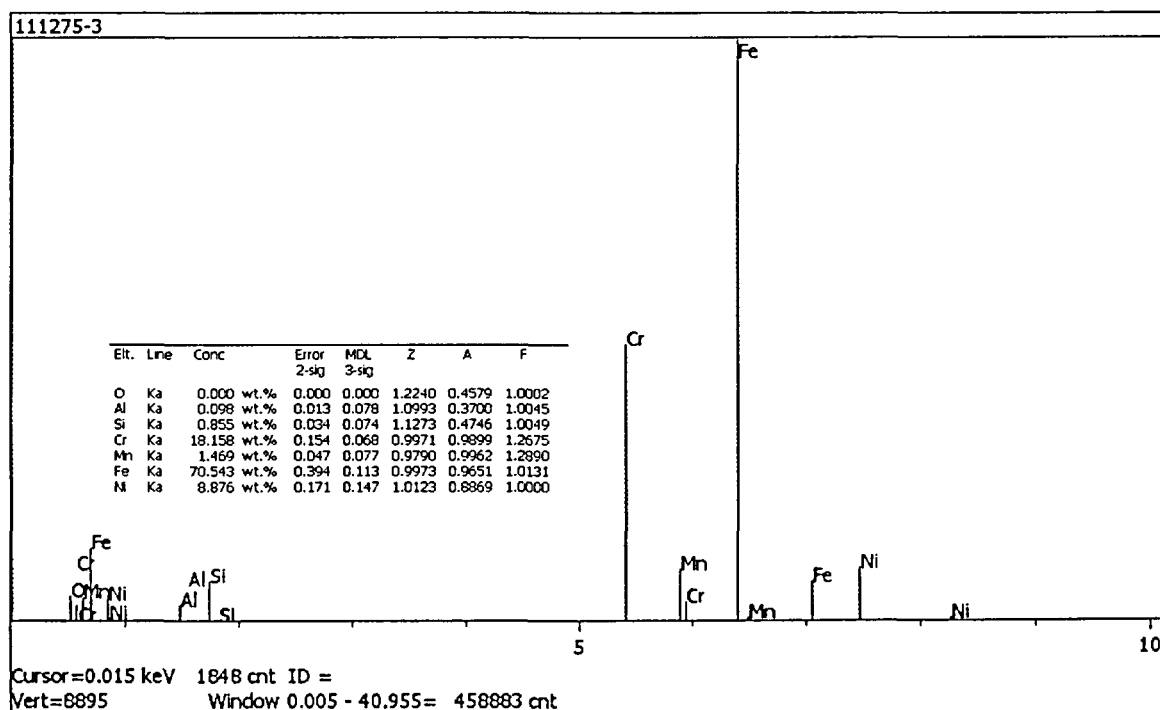
Figure 6.1.2.1: SEM micrograph showing the three deepest cracks in A2A7M. Crack tips are 0.042" to 0.069" (1.1 to 1.75 mm) below the surface. It is noted that these three crack tips are at approximately the same distance of 0.199" (5.06 mm) from the underside surface. EDS scans of areas 1, 2, and 3 and line scans 1 and 2 (not included) indicated a generally uniform chemical composition (including Cr content) across the cladding thickness.

Figure 6.1.2.1 (cont.): EDS results for Areas 2 and 3.

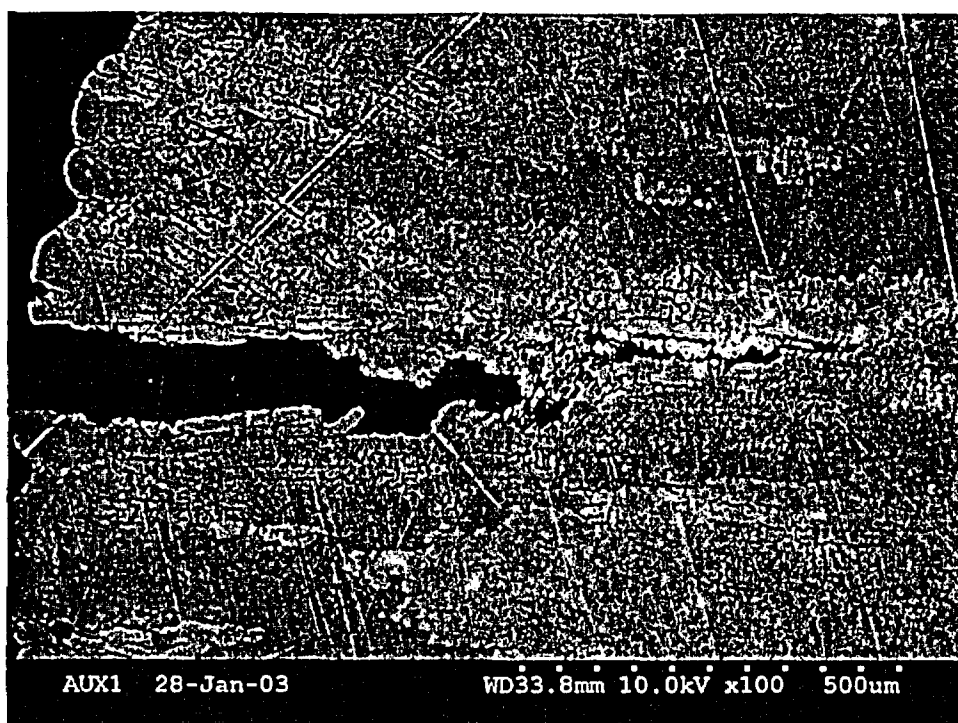
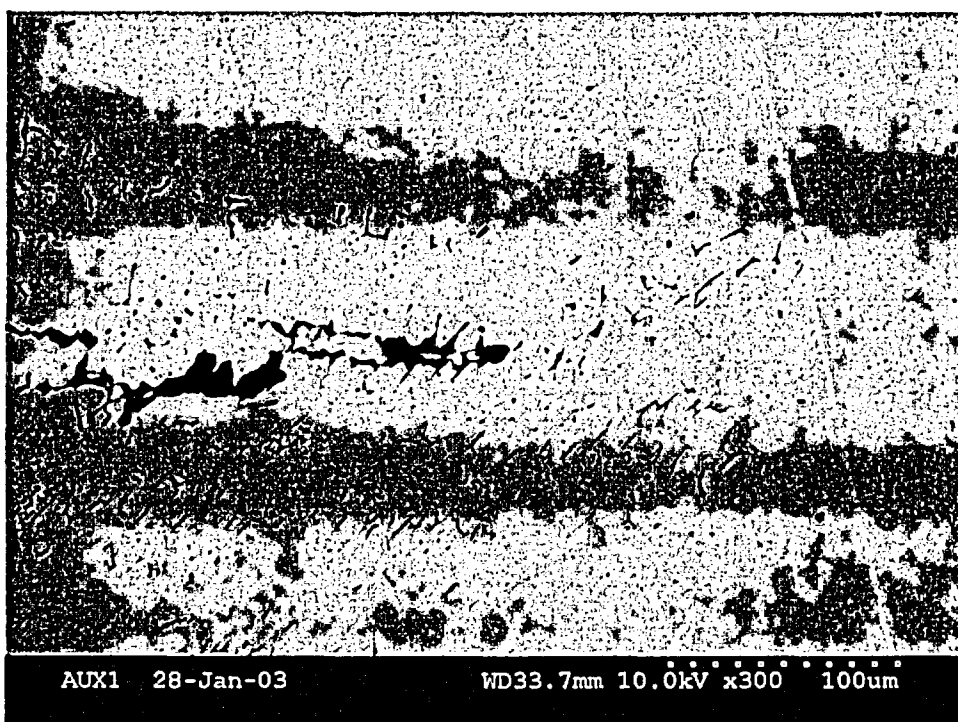
Figure 6.1.2.2: SEM micrographs showing interdendritic crack path along the elongated ferrite pools.

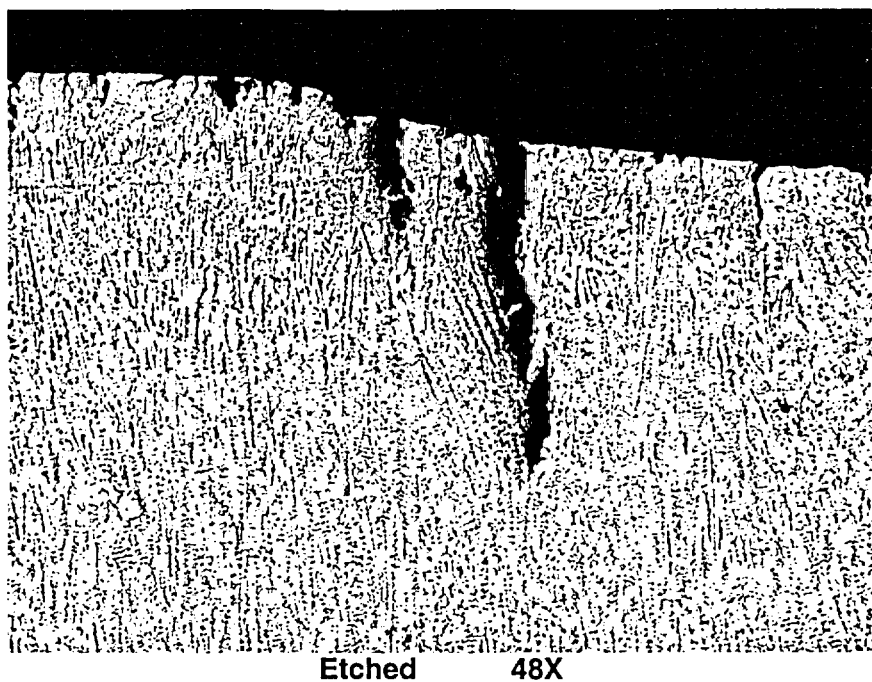
Figure 6.2.1.2: Micrograph of a crack observed on A2A7N. The crack tip is estimated to be approximately 0.036" (0.91 mm) below the surface.

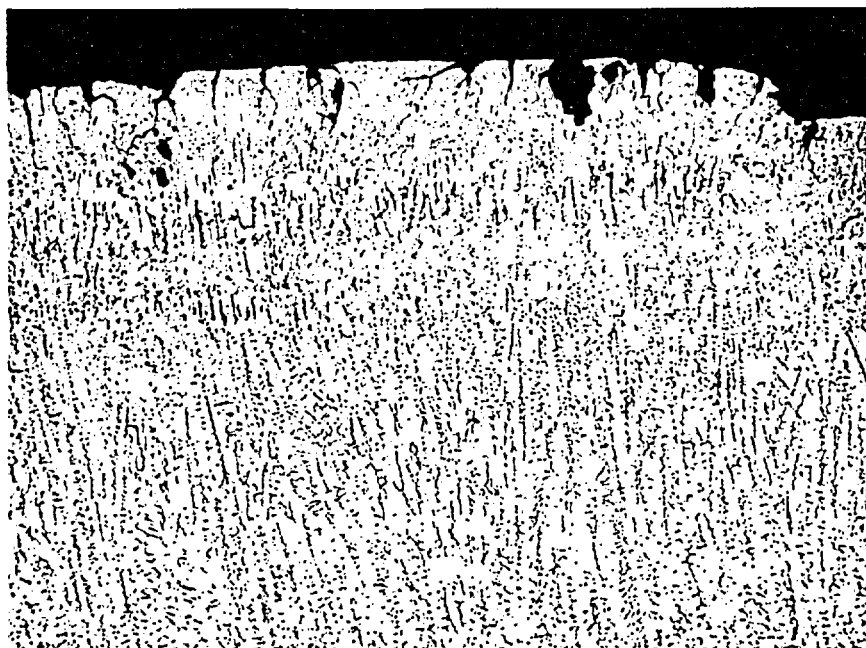
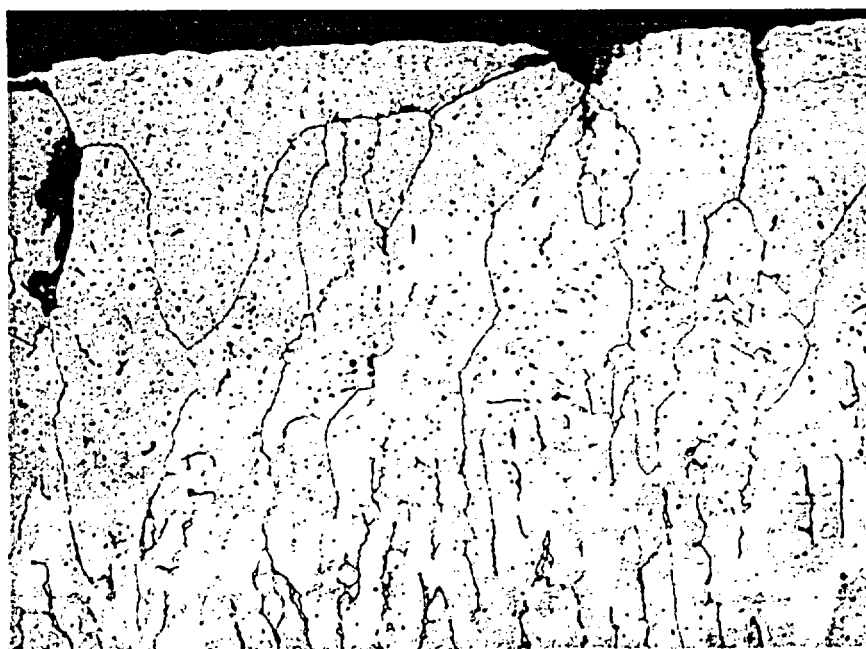
**Figure 6.2.1.3: Micrographs showing intergranular attack (IGA) and intergranular cracking on the exposed stainless steel cladding.**

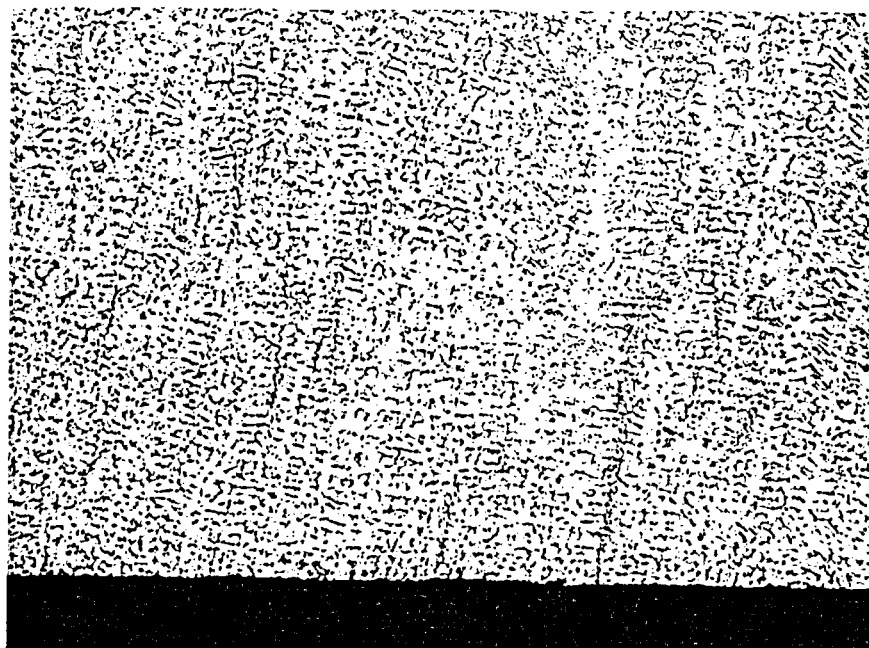
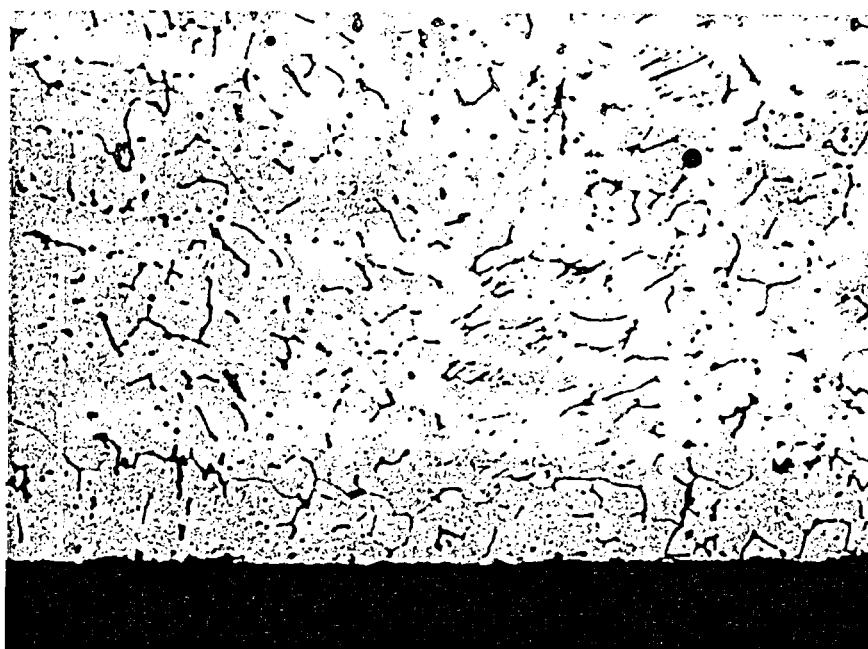
Figure 6.2.1.5: Typical clad microstructure near RCS side surface of the cladding. No intergranular attack (IGA) was present.

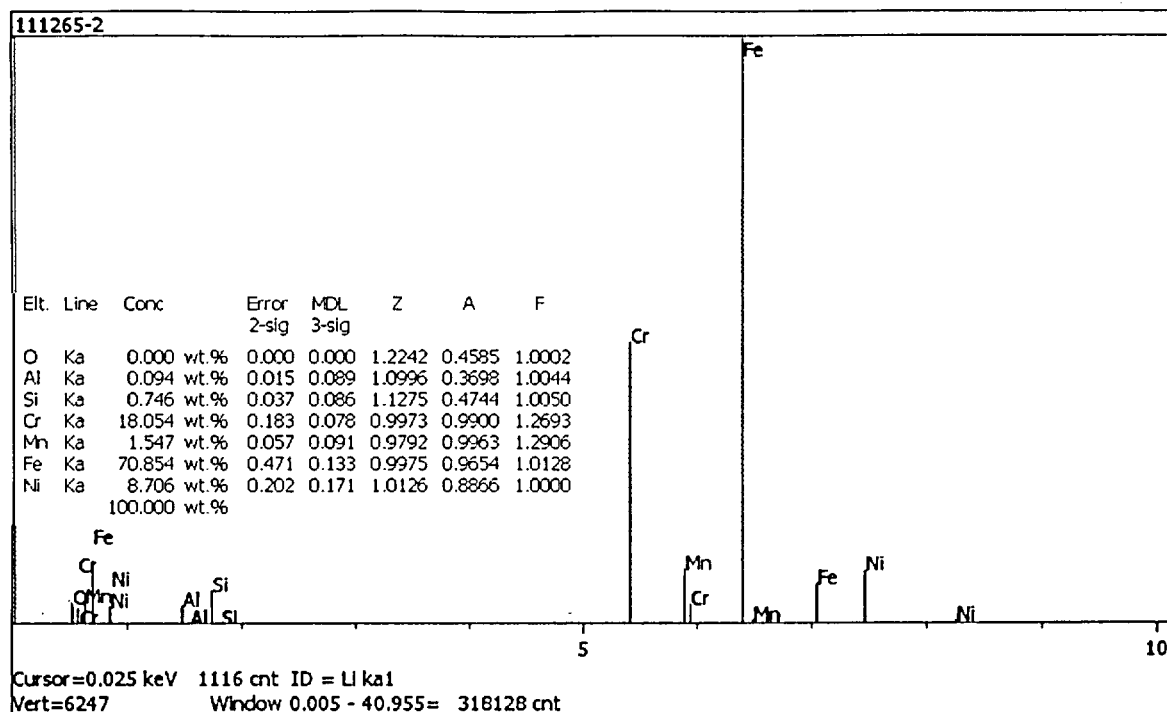
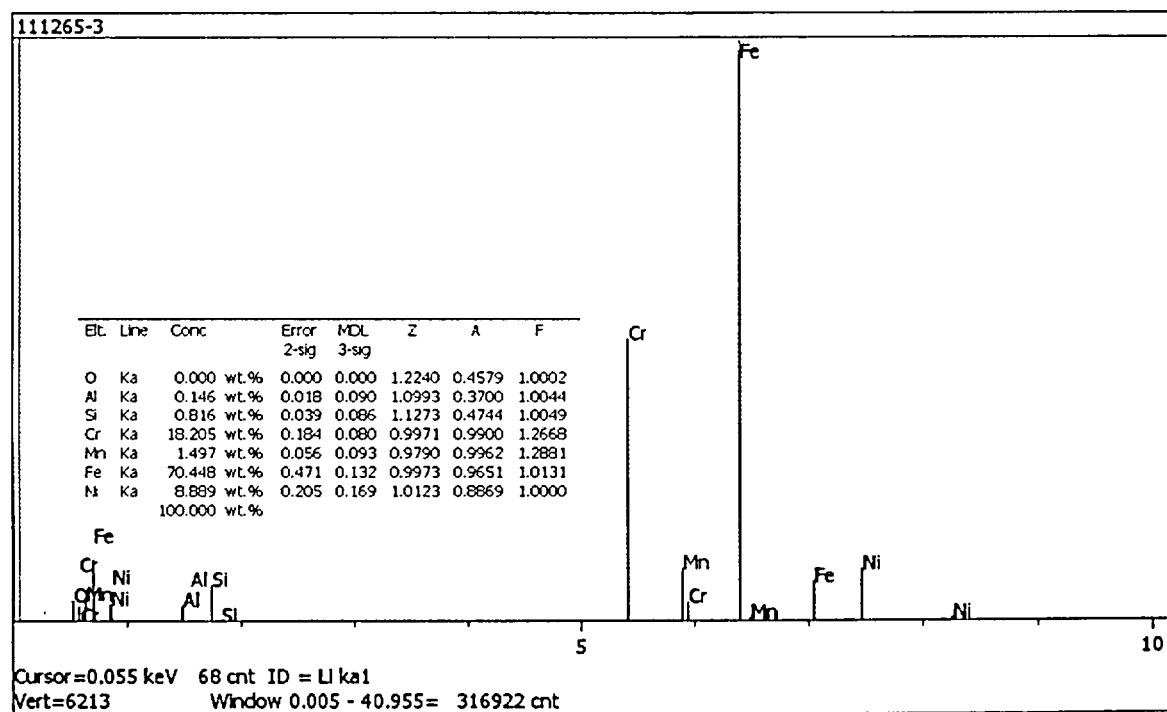
Figure 6.2.2.1: SEM micrograph showing the three deepest cracks in A2A7N. The maximum crack depth was approximately 0.056" (1.42 mm). EDS scans of areas 1, 2, and 3 and lines 1 and 2 (not included) indicated a generally uniform chemical composition (including Cr content) across the cladding thickness.

Figure 6.2.2.1 (cont.): EDS results for Areas 2 and 3.

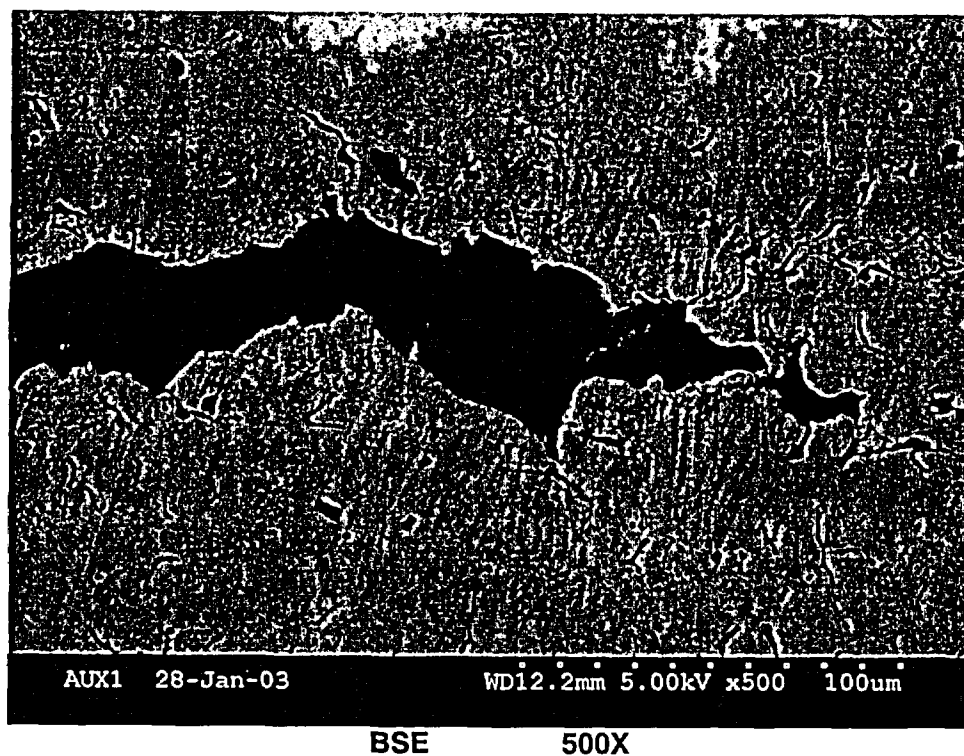
Figure 6.2.2.2: Higher magnification SEM micrographs of crack tip, showing the interdendritic crack path along the elongated ferrite pools.

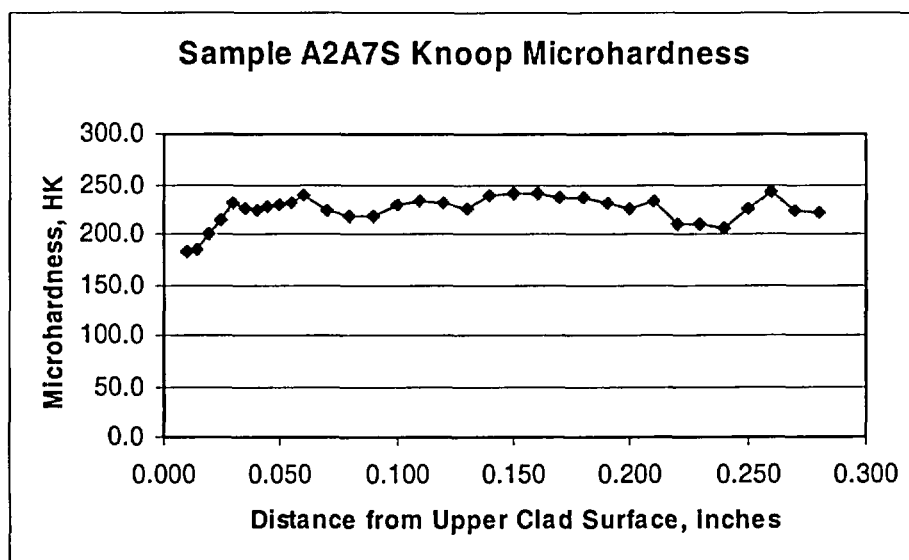
Figure 6.3.1.1: 4X macro photograph of metallurgical mount A2A7S. Refer to Figure 5.11 for the sample orientation. Knoop microhardness values exhibited lower hardness readings toward the exposed clad side (left side of graph), which was in contrast to A2A7M.

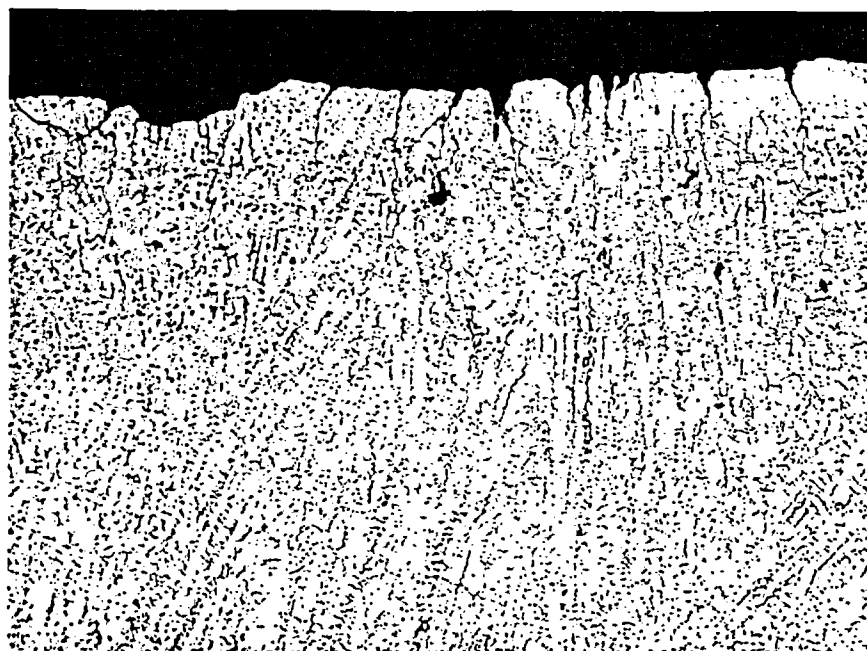
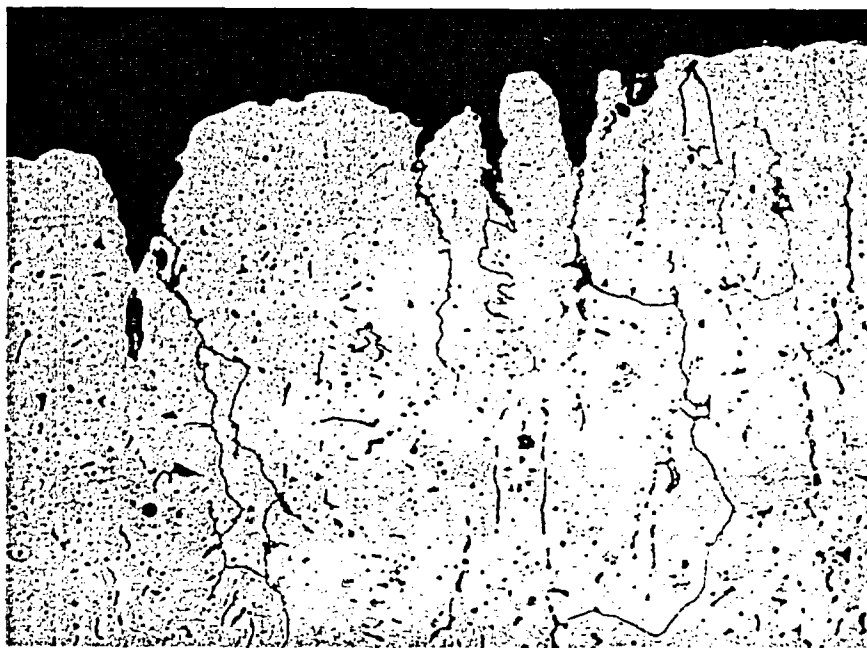
**Figure 6.3.1.2: Micrographs showing intergranular attack (IGA) and intergranular or interdendritic cracking on the exposed stainless steel cladding.**
