Table 5.1: Sample identification listing for Piece A2A.

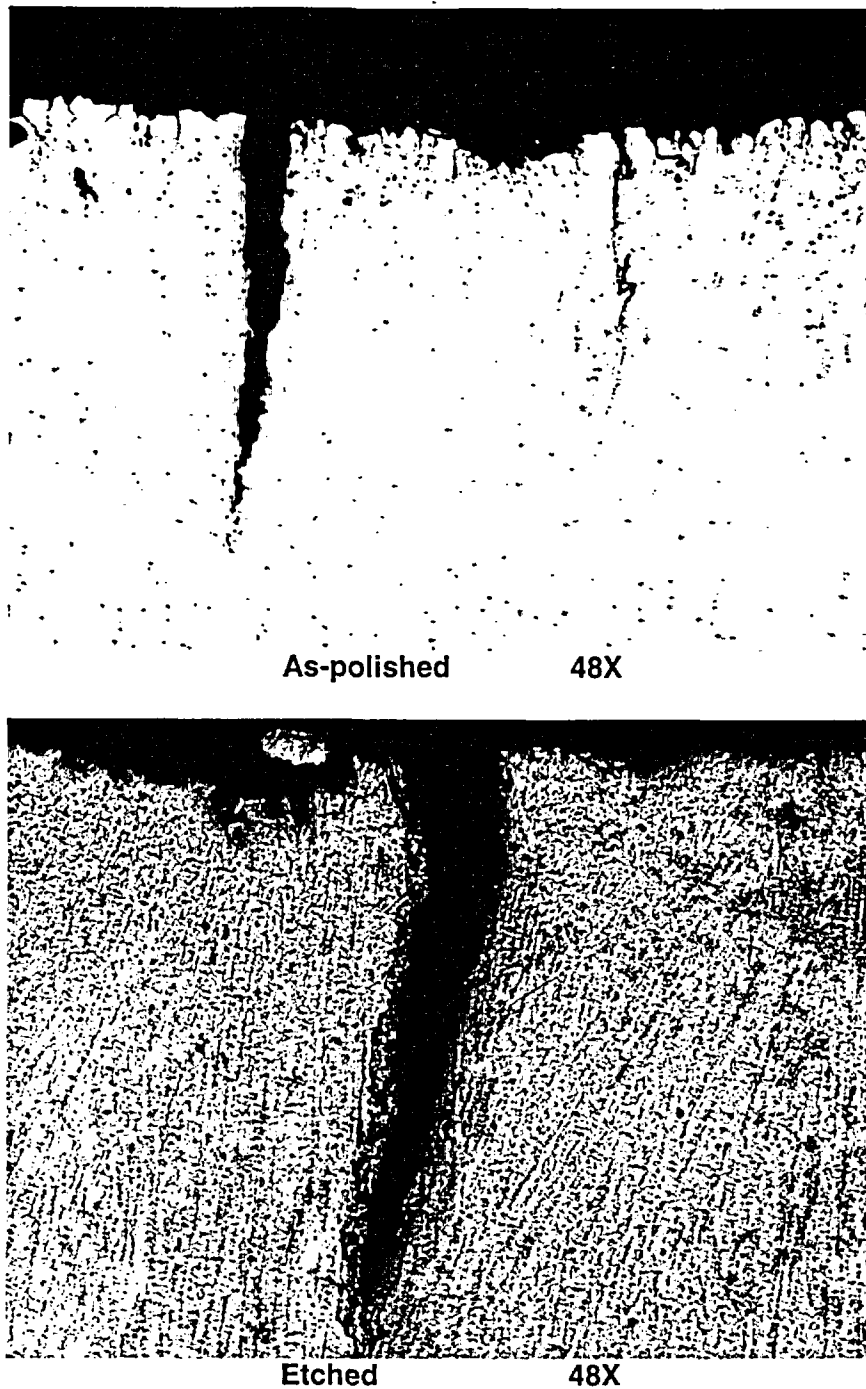
**Figure 6.3.1.3: Micrographs of cracking observed on sample A2A7S. Different cracks are shown.**

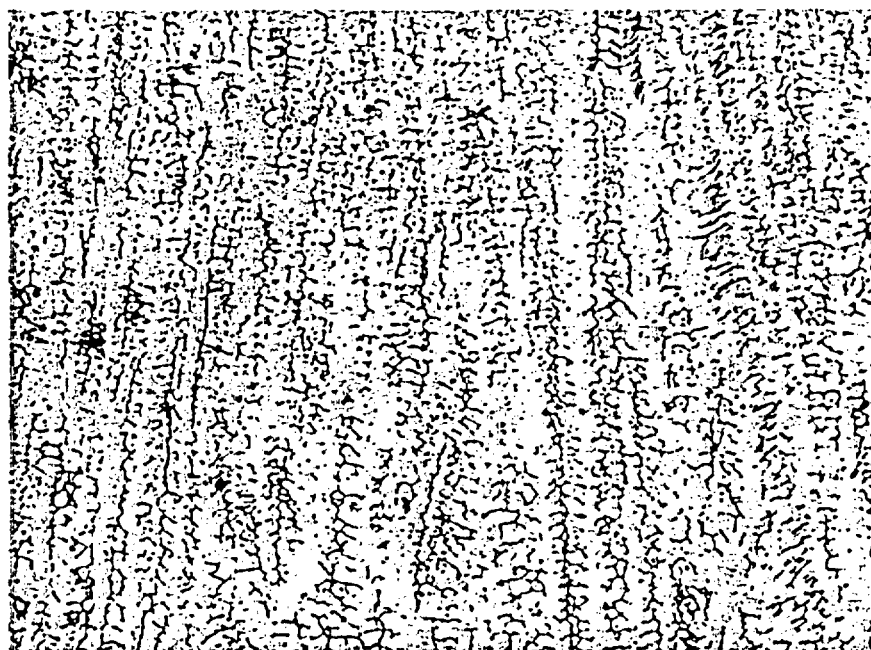
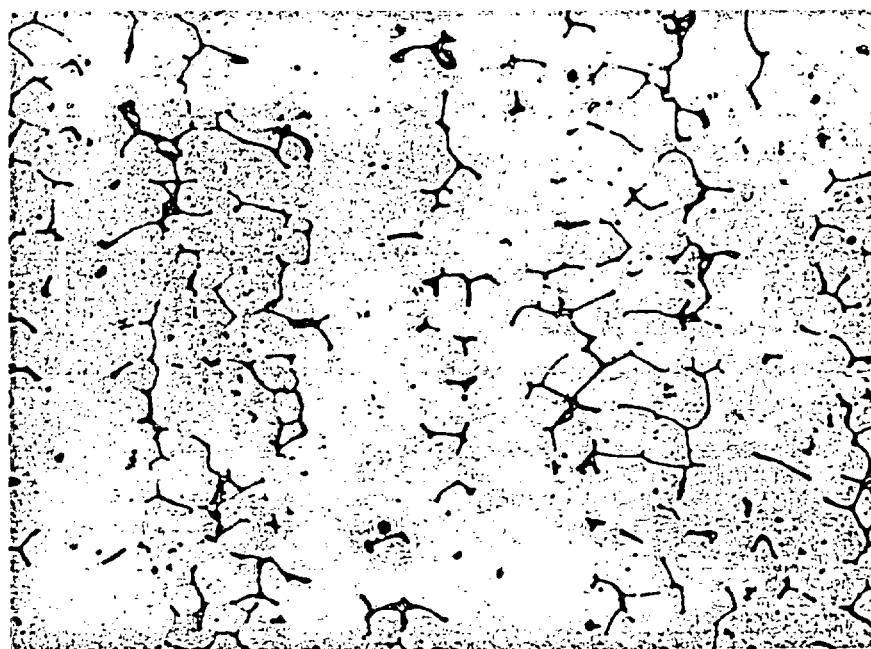
Figure 6.3.1.4: Typical clad microstructure in the mid-thickness of the cladding.

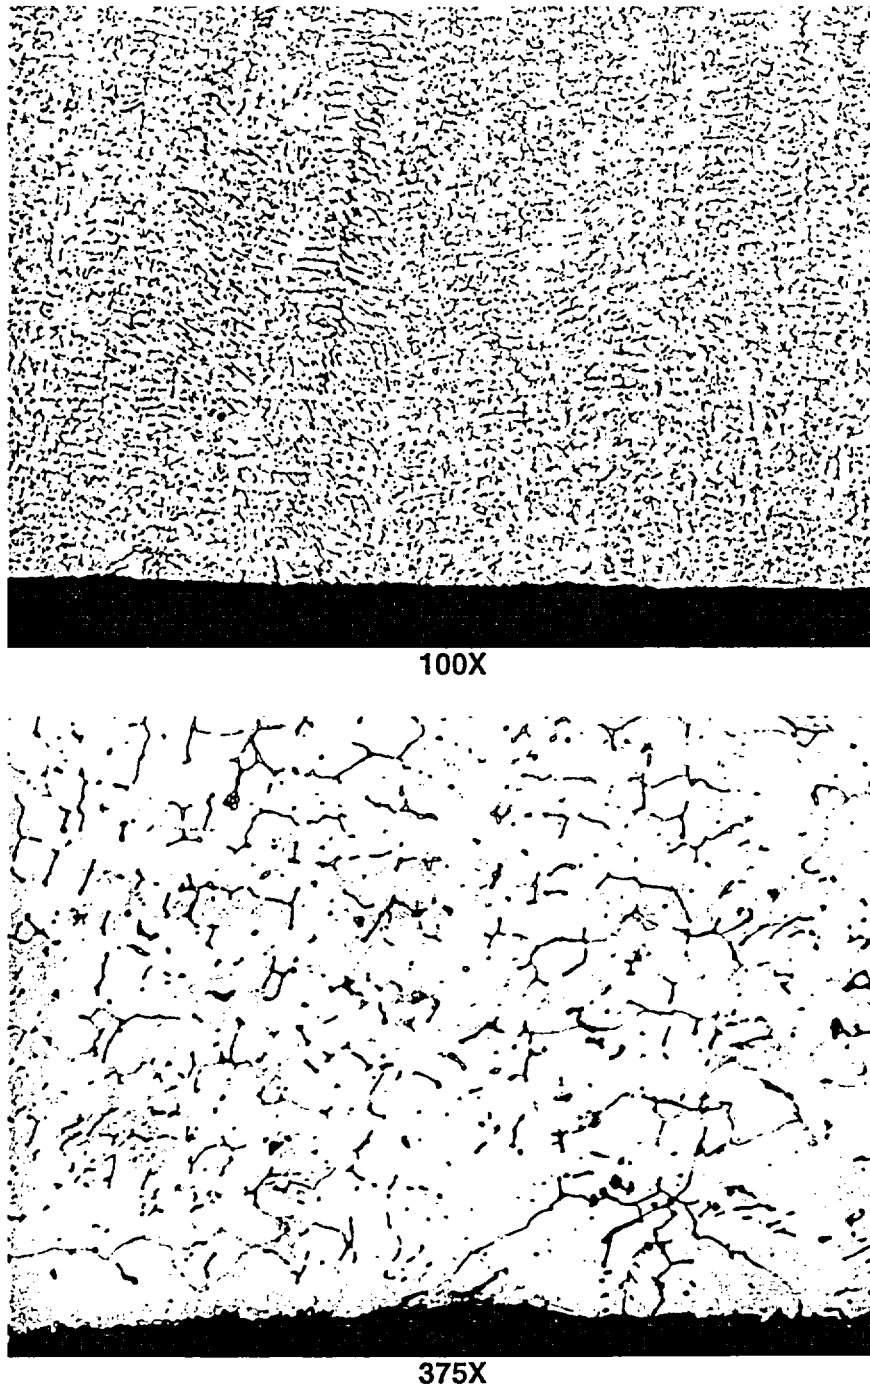
**Figure 6.3.1.5: Typical clad microstructure near RCS side surface of the cladding. No intergranular attack (IGA) was present.**

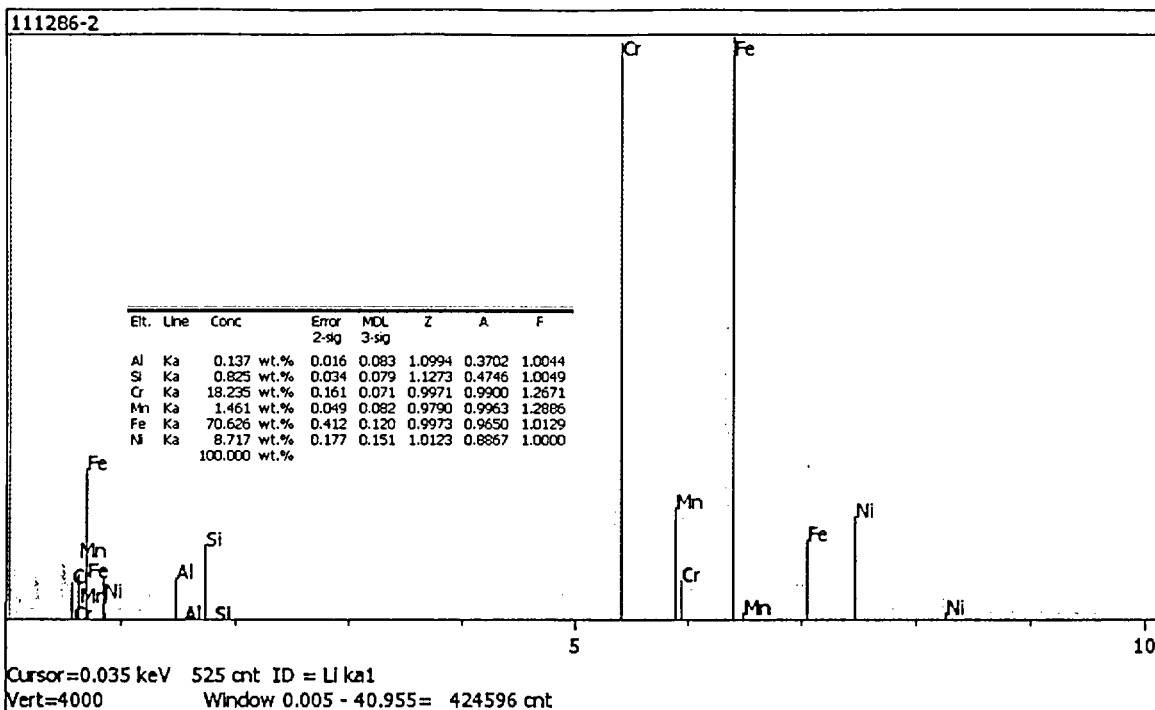
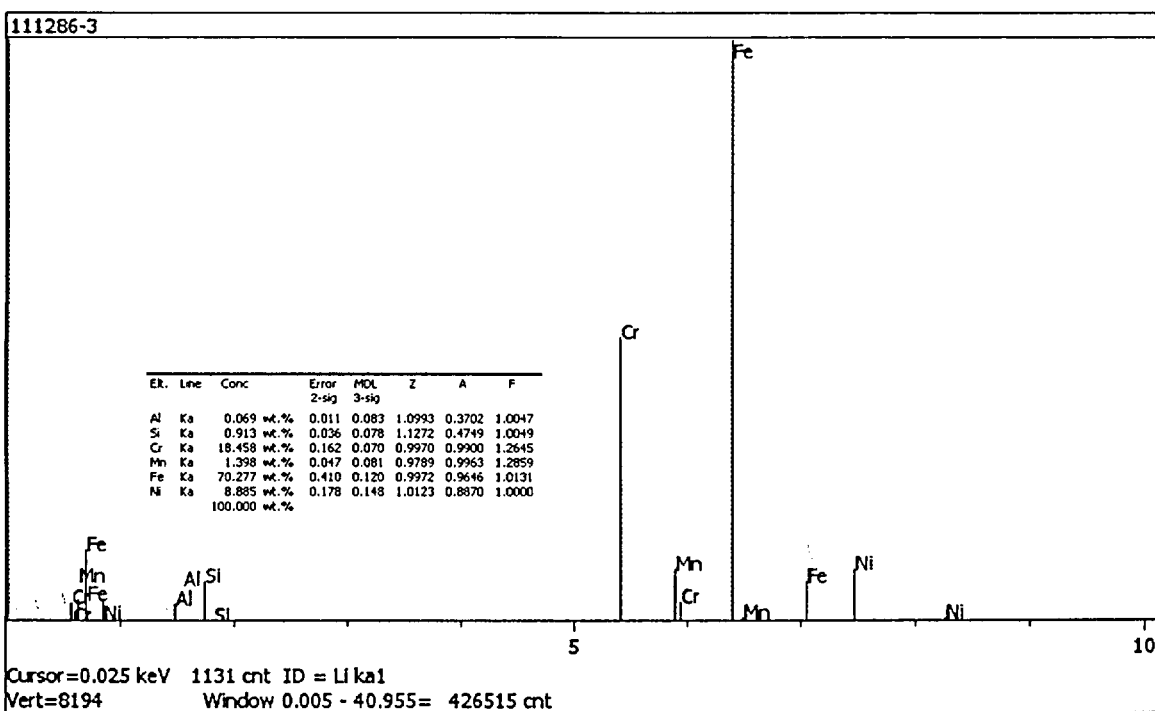
Figure 6.3.2.1: SEM micrograph of the three deepest cracks in A2A7S. The maximum crack depth was approximately 0.056" (1.42 mm). These three crack tips are approximately the same distance from the underside surface. EDS scans of areas 1, 2, and 3 and lines 1 and 2 (not included) indicated a generally uniform chemical composition (including Cr content) across the cladding thickness.

Figure 6.3.2.1 (cont.): EDS results for Areas 2 and 3. Note that the Cr peak was set at full screen height for Area 2.

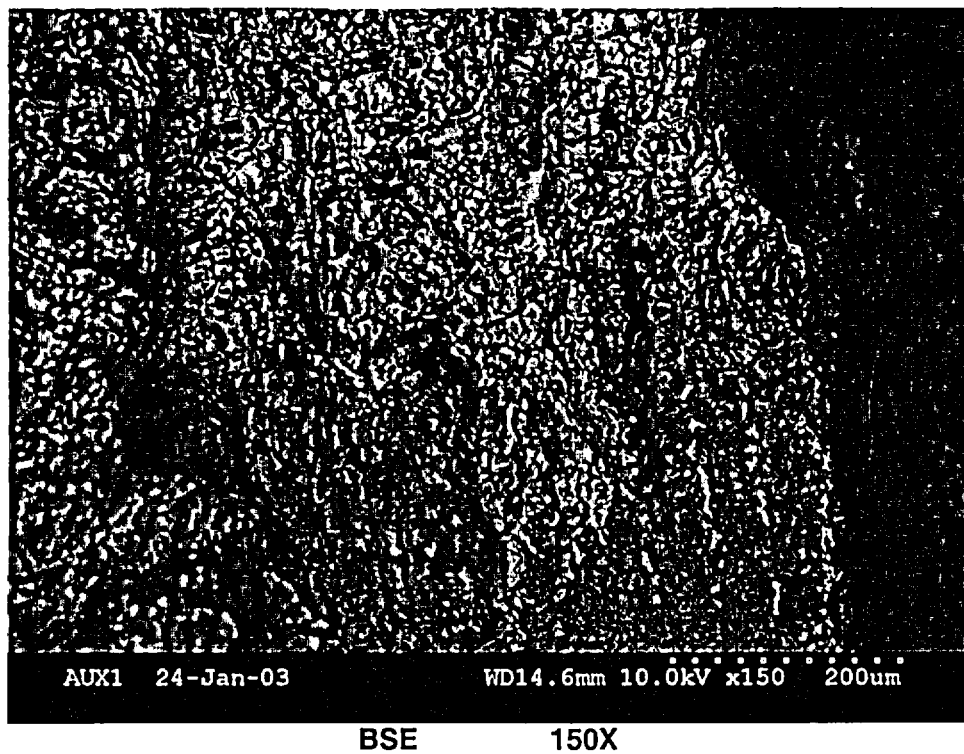
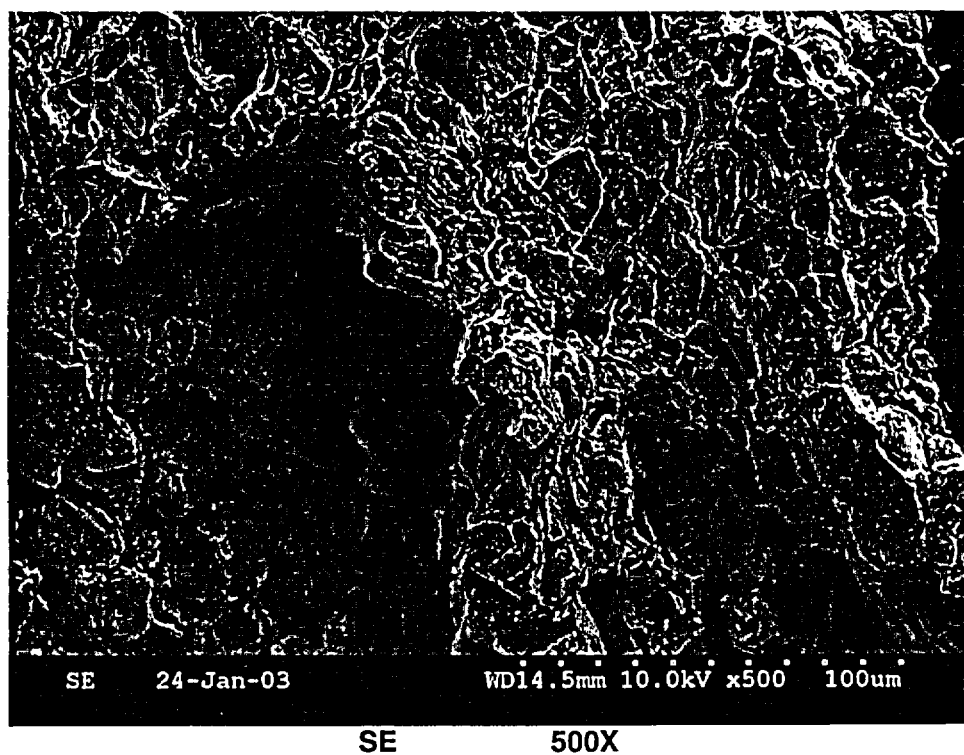
Figure 6.4.1.4: Near mosaic area "C". Fracture mode is intergranular or interdendritic for in-service cracking and ductile tearing for lab opened-up fracture.

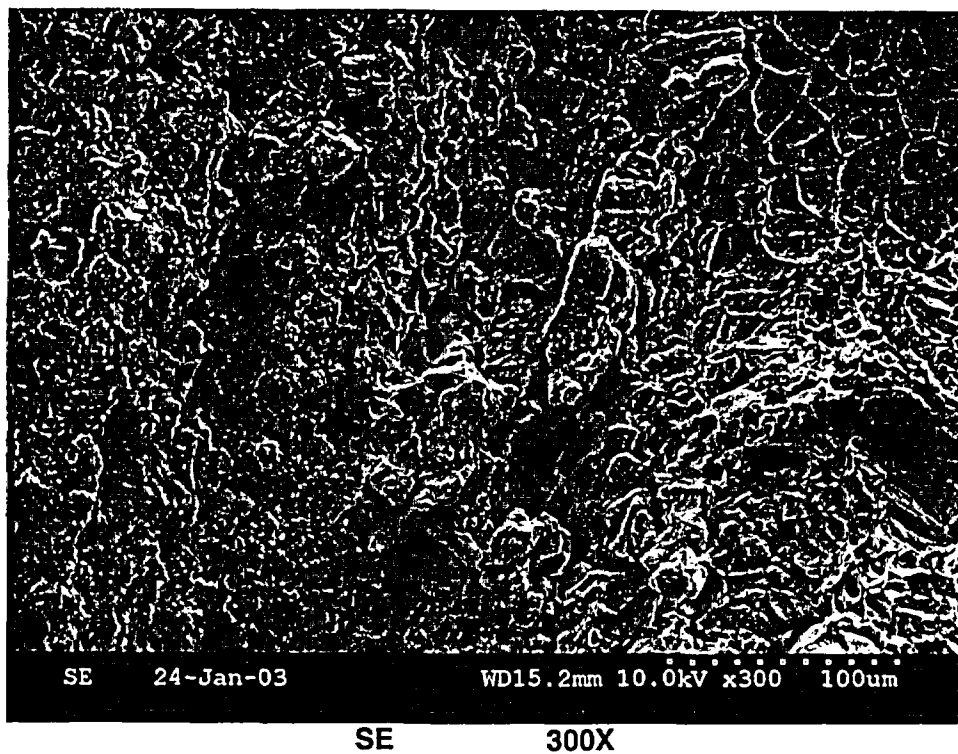
Figure 6.4.1.5: Near mosaic area "D". Fracture mode is intergranular or interdendritic for in-service cracking and ductile tearing for lab opened-up fracture (upper right).

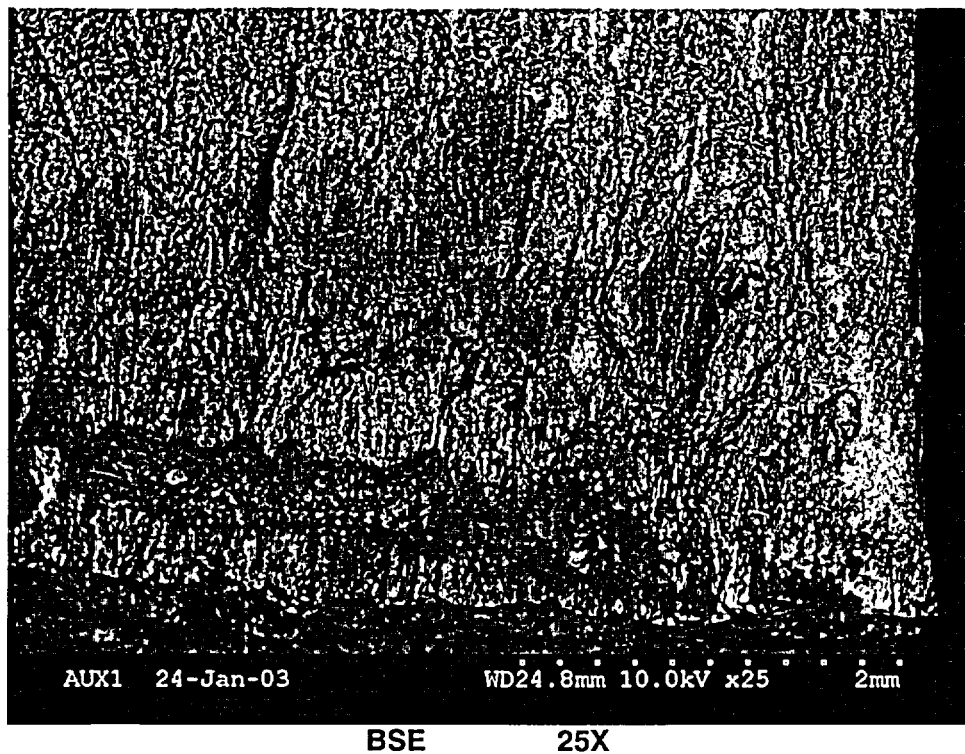
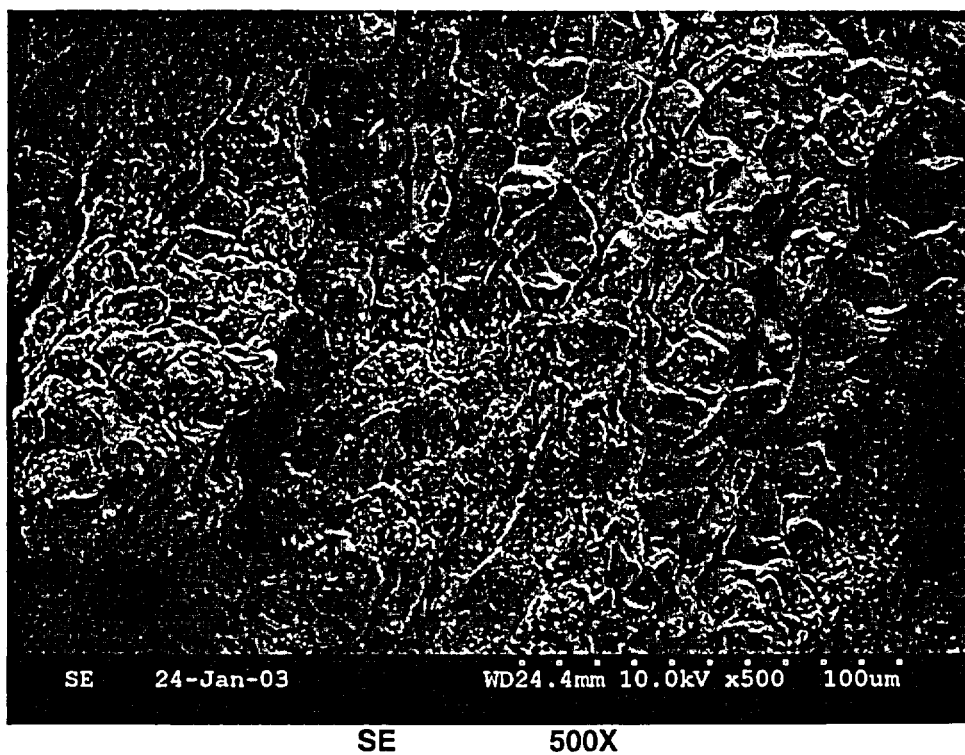
Figure 6.4.1.6: Near mosaic area "E". Cracking is intergranular/interdendritic.

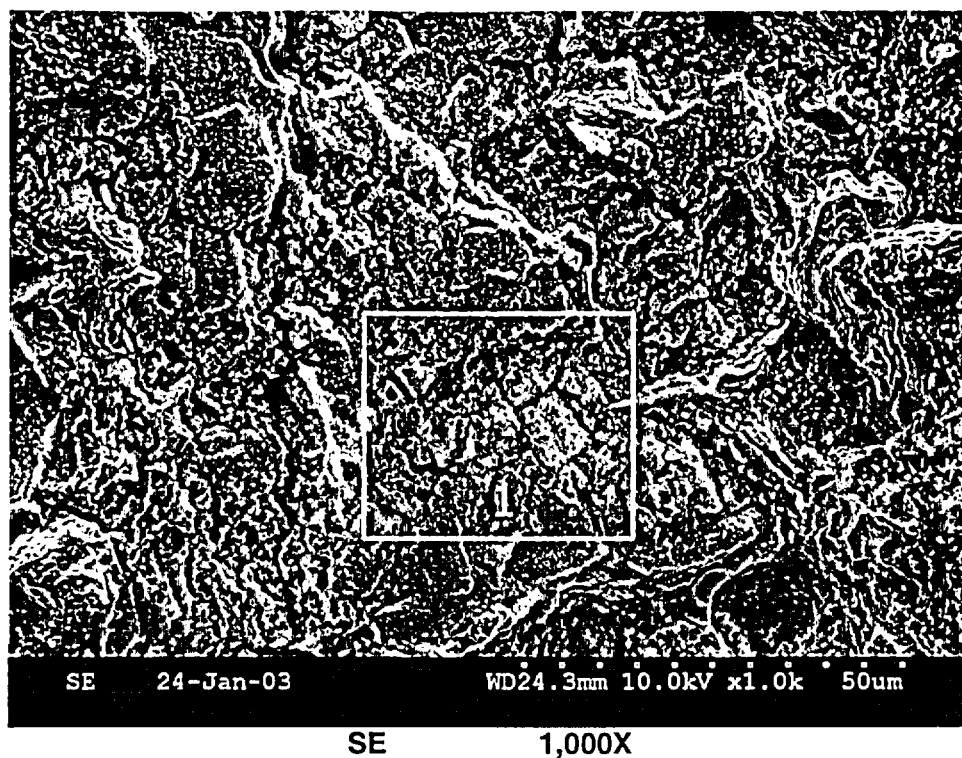
Figure 6.4.1.7: SEM micrograph and EDS results for deposited region near area "E". The corrosion deposits contained carbon, oxygen, along with iron, aluminum, silicon, and chromium. Possible trace levels of nickel and chlorine were also detected in this area.

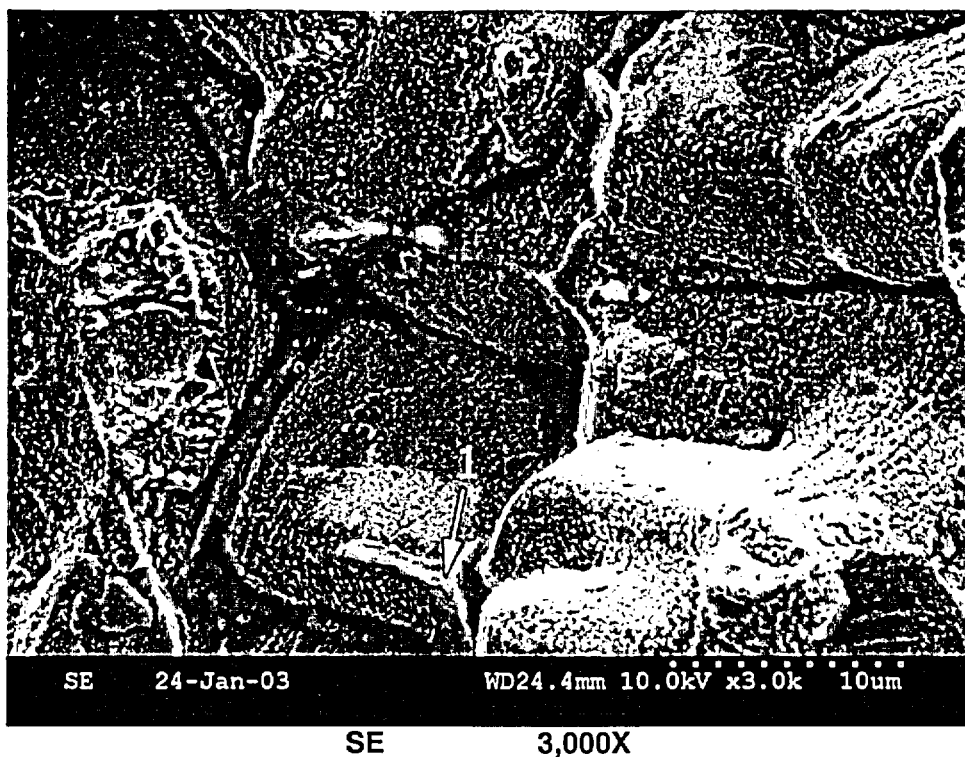
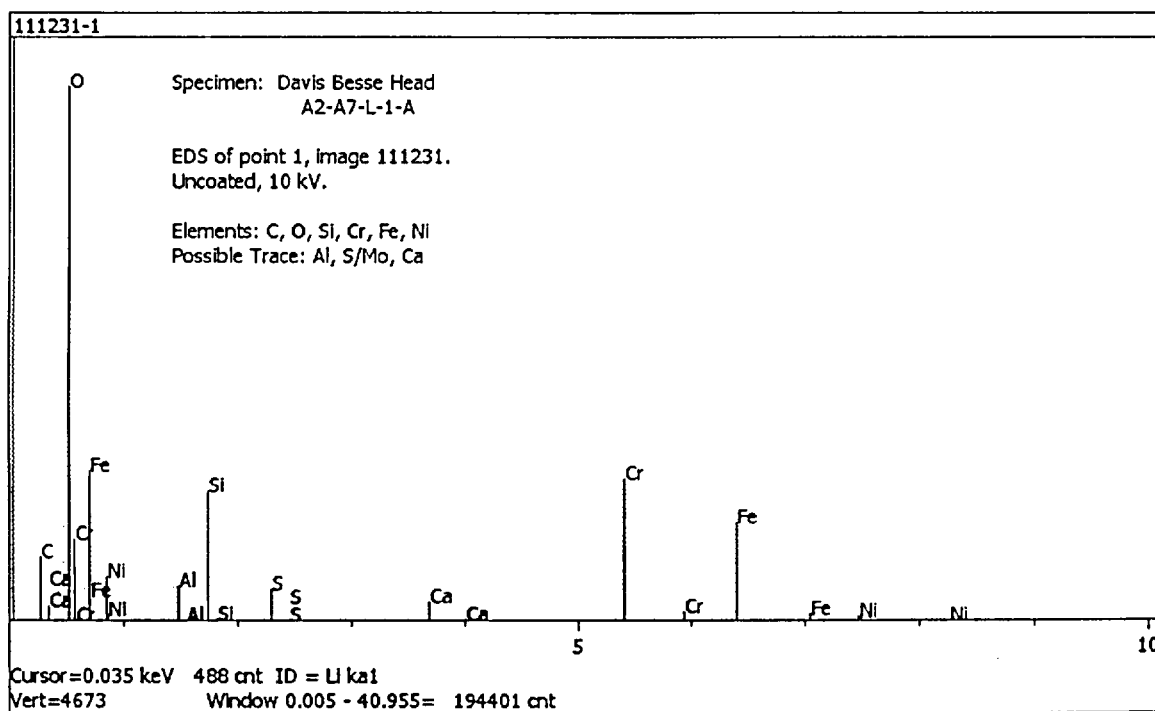
Figure 6.4.1.8: Higher magnification SE micrograph and EDS results for a grain boundary deposit near area "E". This area contained primarily carbon, oxygen, silicon, chromium, iron, and nickel. Lesser amounts of aluminum, sulfur, and calcium were also detected.

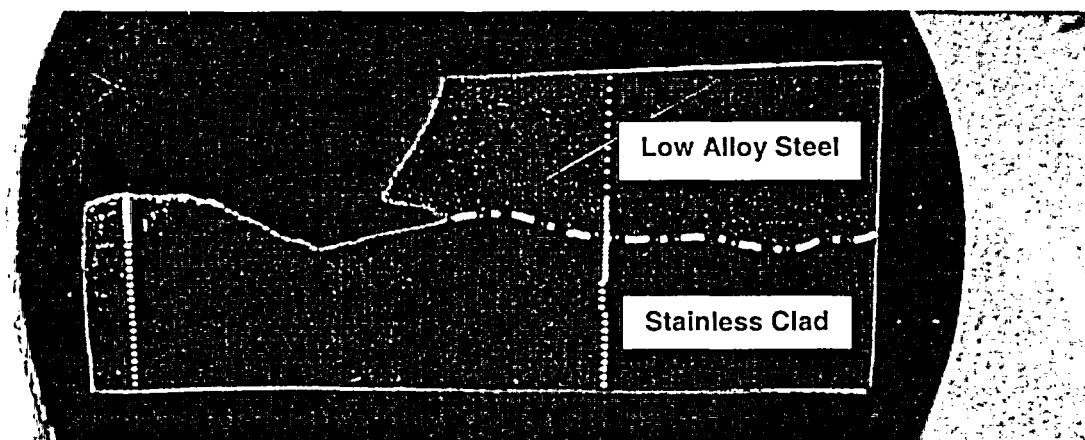
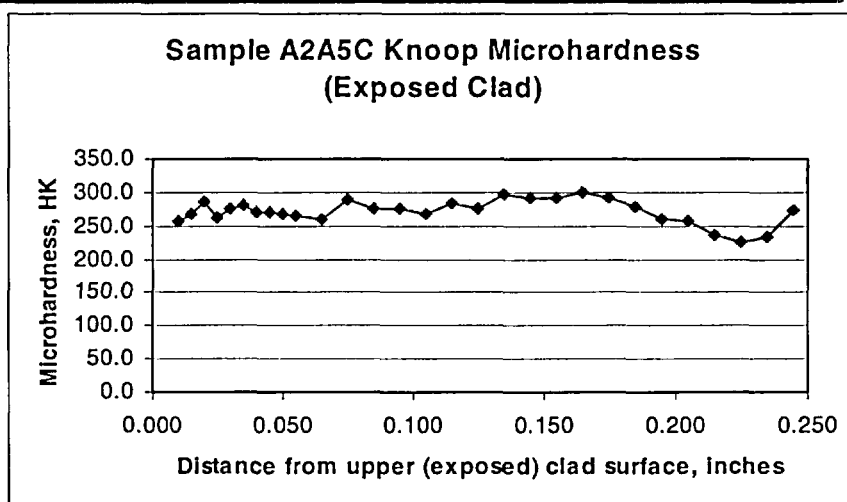
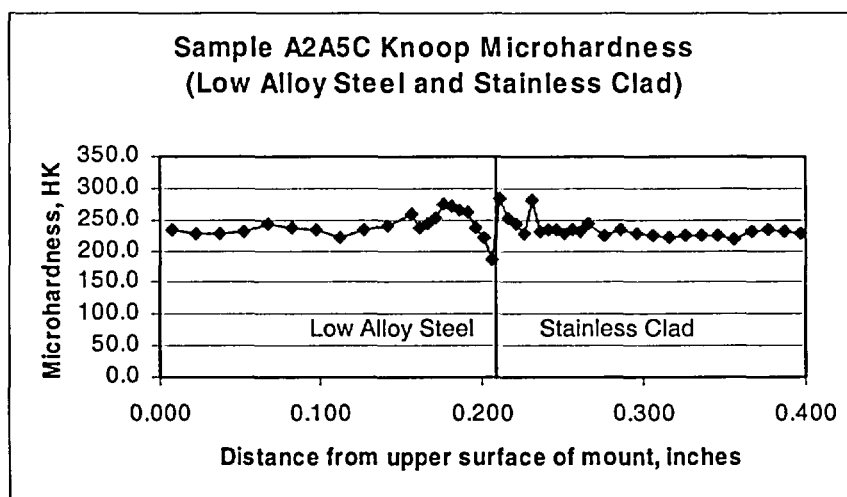
Figure 6.5.1.1: 4X macro photograph of metallographic mount A2A5C, along with Knoop microhardness data. Refer to Figure 5.13 for the sample orientation. The two Knoop microhardness traverse lines are visible in the macro photo. The significant microhardness variations occur in the heat affected zone of the low alloy steel and the cladding adjacent to the fusion line.

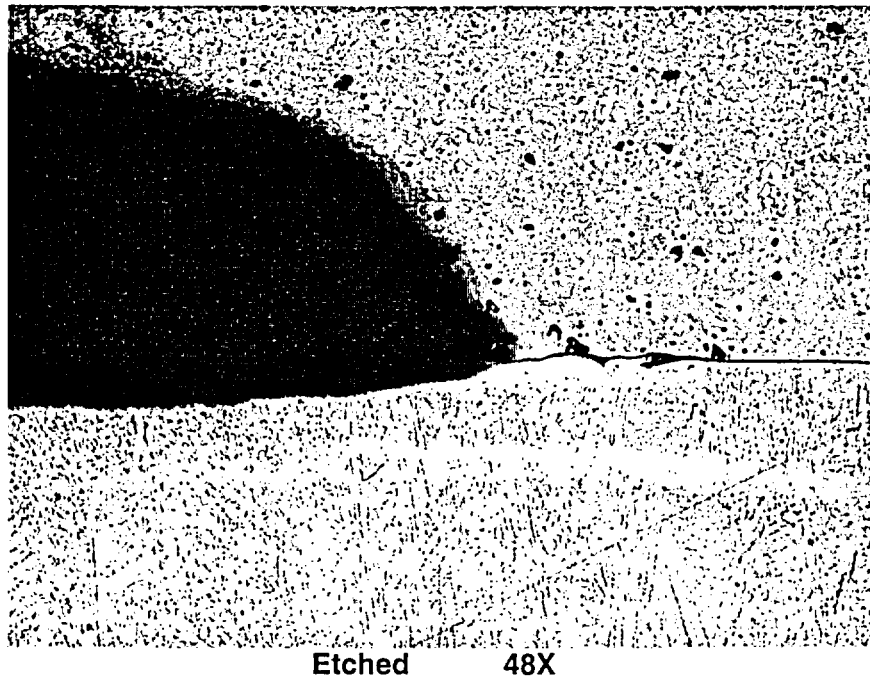
Figure 6.5.1.3: Micrograph showing the undercutting due to boric acid corrosion in the RV head low alloy steel at the interface between low alloy steel (above the notch) and stainless steel cladding (below the notch).

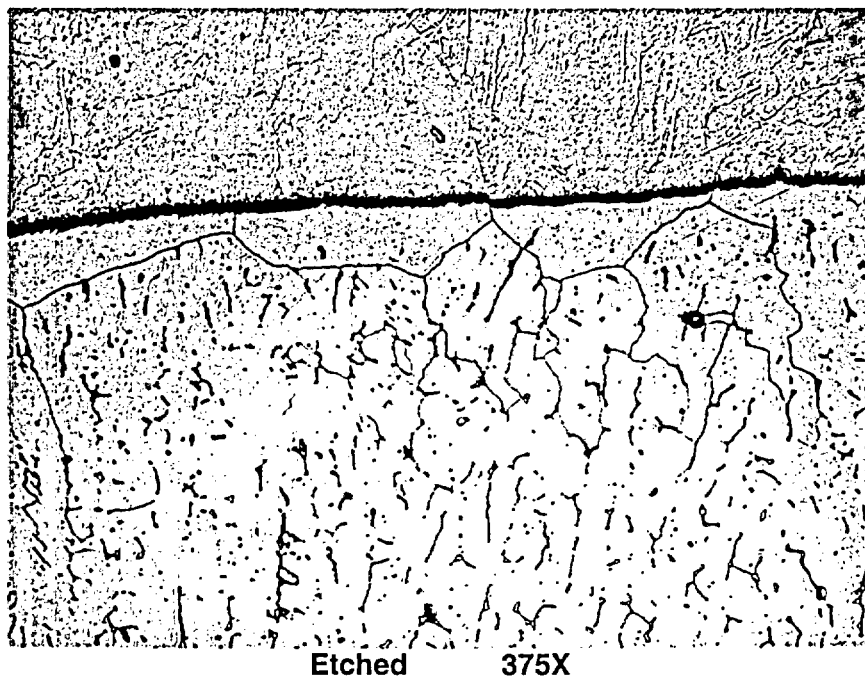
Figure 6.5.1.4: Micrograph showing the interface between low alloy steel (above) and stainless steel cladding (below). The austenitic grains in the first interface layer on the stainless steel cladding side are equiaxed and growing preferentially from the ferrite grains (low alloy steel). The subsequent grain growth in the cladding is columnar.

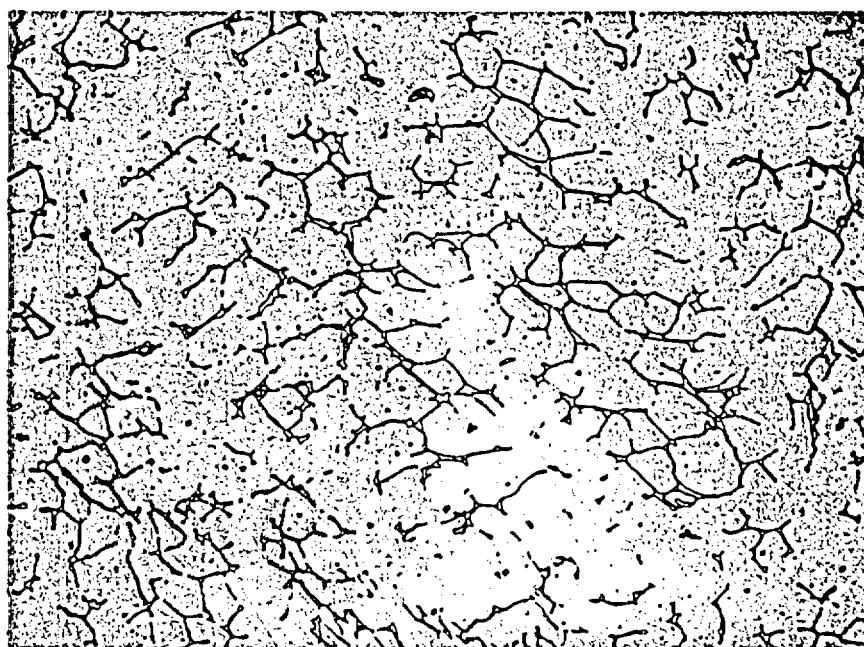
**Figure 6.5.1.6: Micrographs showing typical stainless steel cladding microstructure. The dendritic solidification structure is delineated by small pools (or islands) of ferrite in an austenitic matrix.**

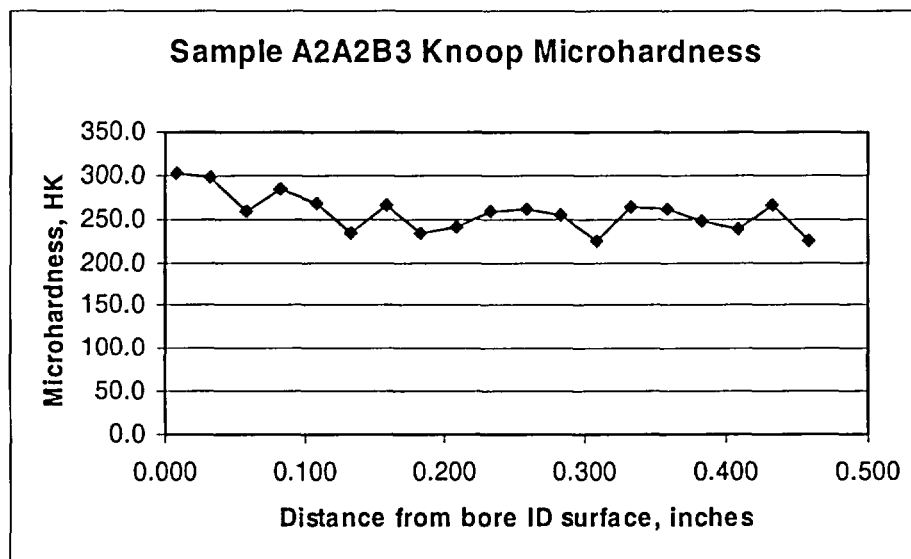
Figure 7.1.1.1: Macro photograph and Knoop microhardness results for metallographic sample A2A2B3 (see Figure 5.2 for the sample orientation). The lower concave surface is the I.D. of the nozzle 3 bore from the nozzle removal process. The crack tips of the two cracks are estimated to be approximately 0.24" and 0.20" below the surface, respectively. The indentations from the microhardness traverse are visible. The elevated microhardness level near the surface is due to the surface cold work layer from the boring of nozzle 3 removal process (see Figures 5.2 and 7.1.1.5).

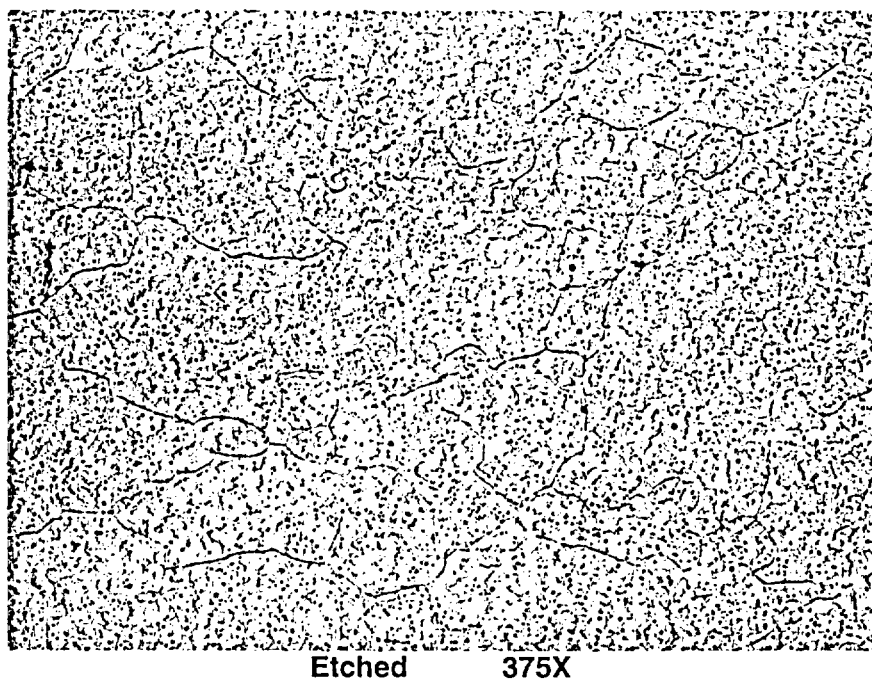
Figure 7.1.1.3: Typical microstructure of sample A2A2B3. The grain size and dendritic structure within each grain are consistent with typical Alloy 182 weld.

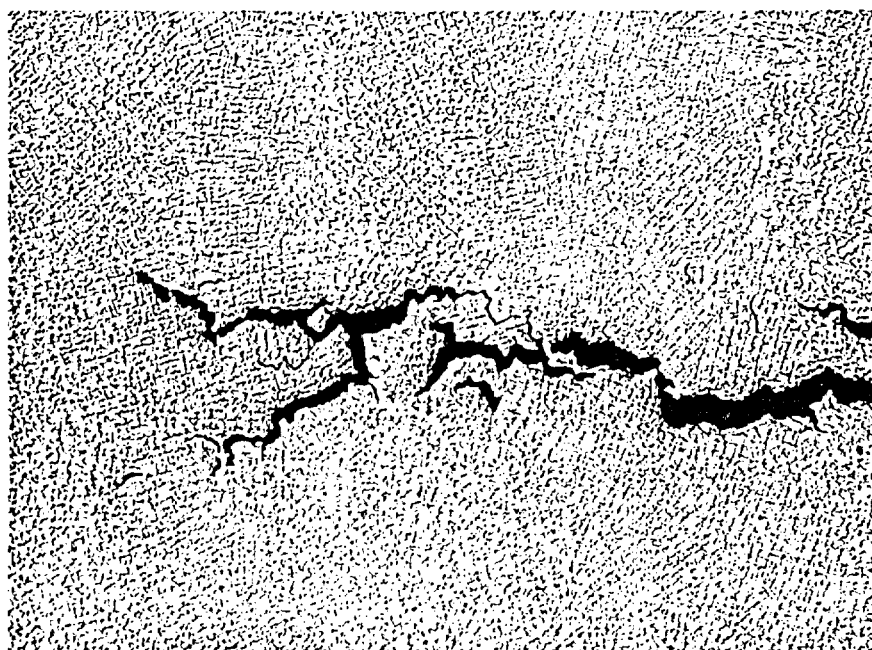
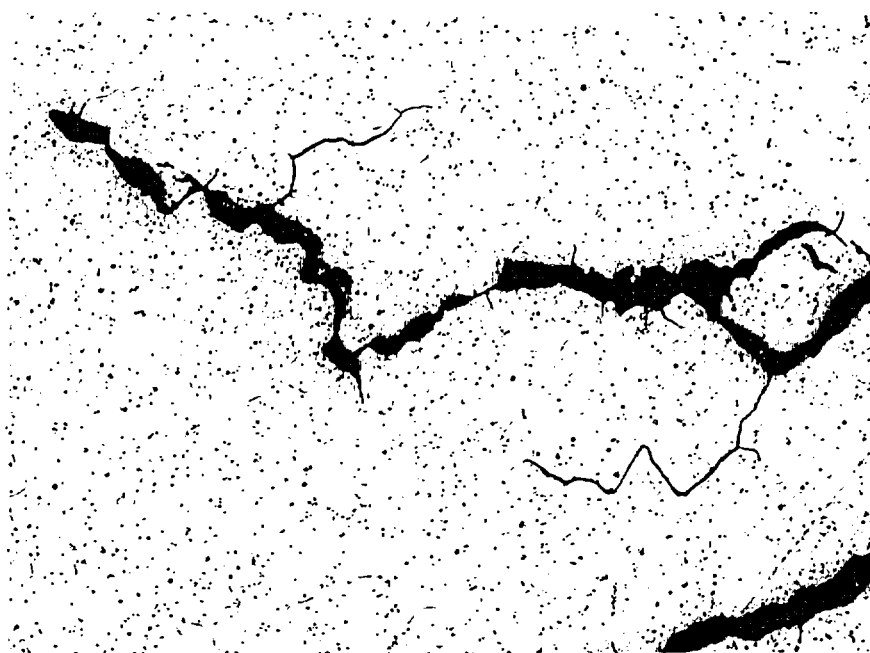
**Figure 7.1.1.4: Higher magnification micrographs of the crack tips. Cracking is intergranular or interdendritic.**

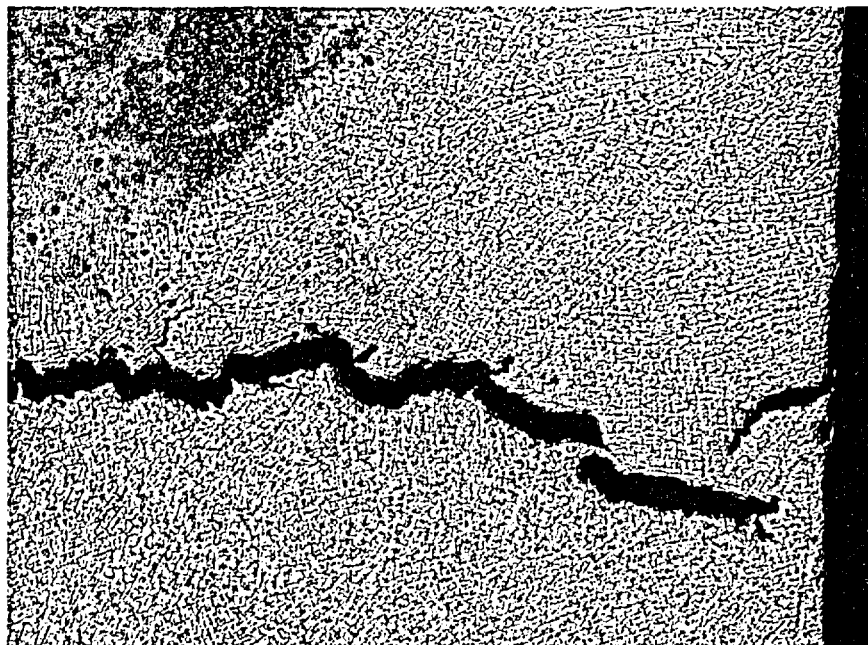
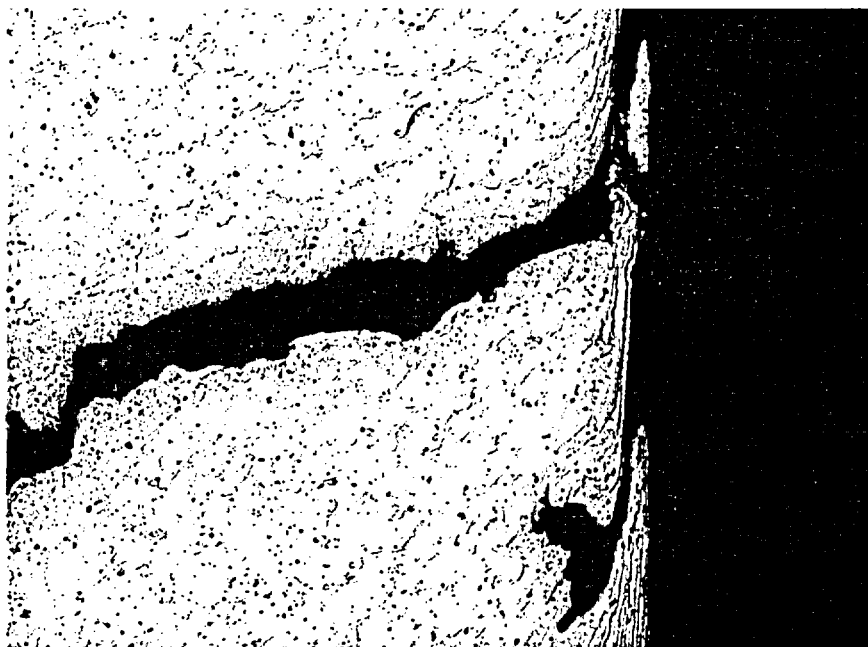
**Figure 7.1.1.5: Higher magnification micrographs of the cracking at  $\sim 180^\circ$  near the bored surface. The bored surface shows evidence of surface cold work. The surface cold work is due to the nozzle removal from the RV head and is not related to the J-groove weld fabrication process.**

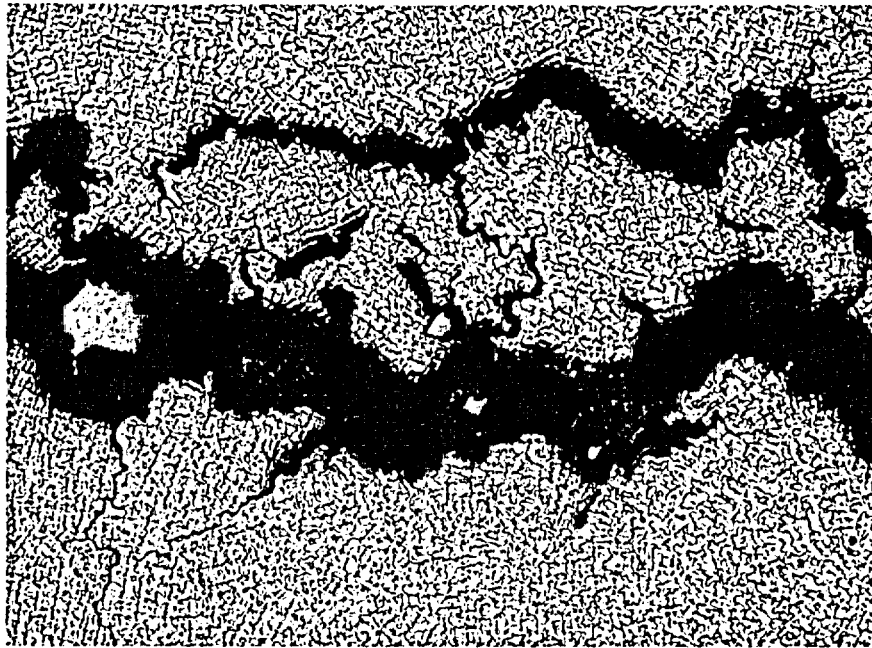
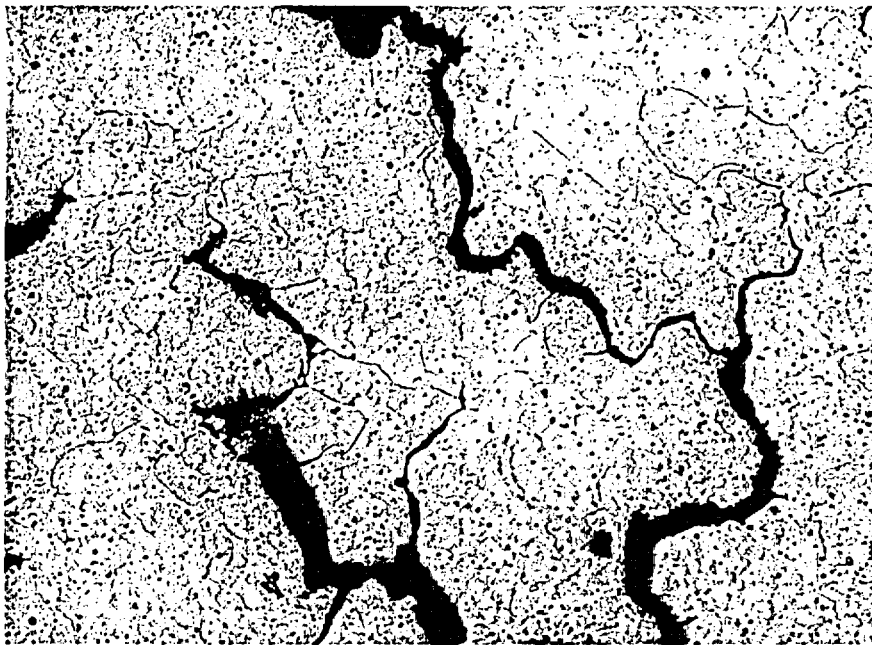
Figure 7.2.1.2: Higher magnification micrographs of the J-groove weld cracking. Cracking is intergranular or interdendritic, similar to the cracking at  $\sim 180^\circ$  in Figure 7.1.1.4.

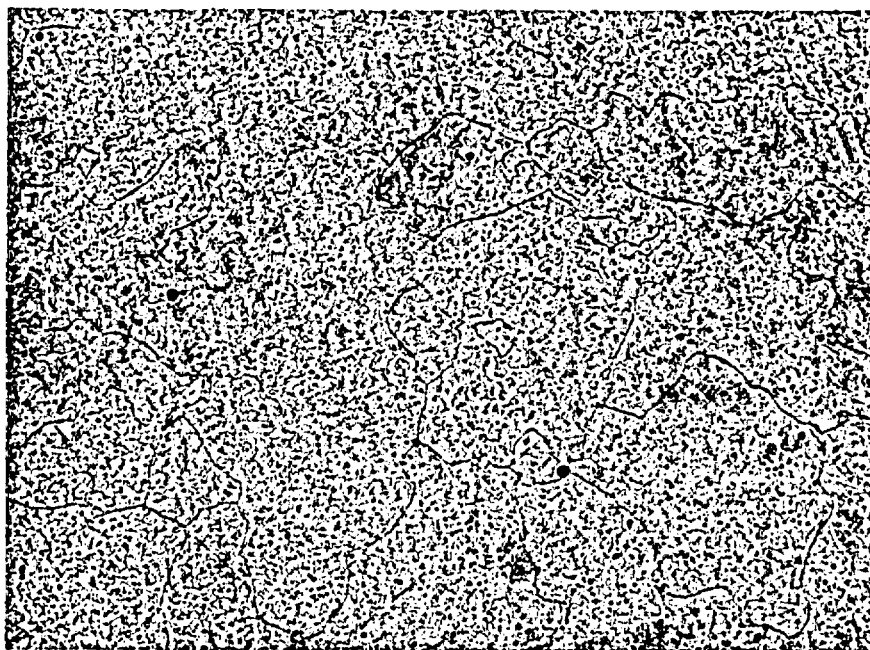
**Figure 7.2.1.3: Typical microstructure of sample A2A6B2, which was similar to Figure 7.1.1.3 (at  $\sim 180^\circ$ ).**

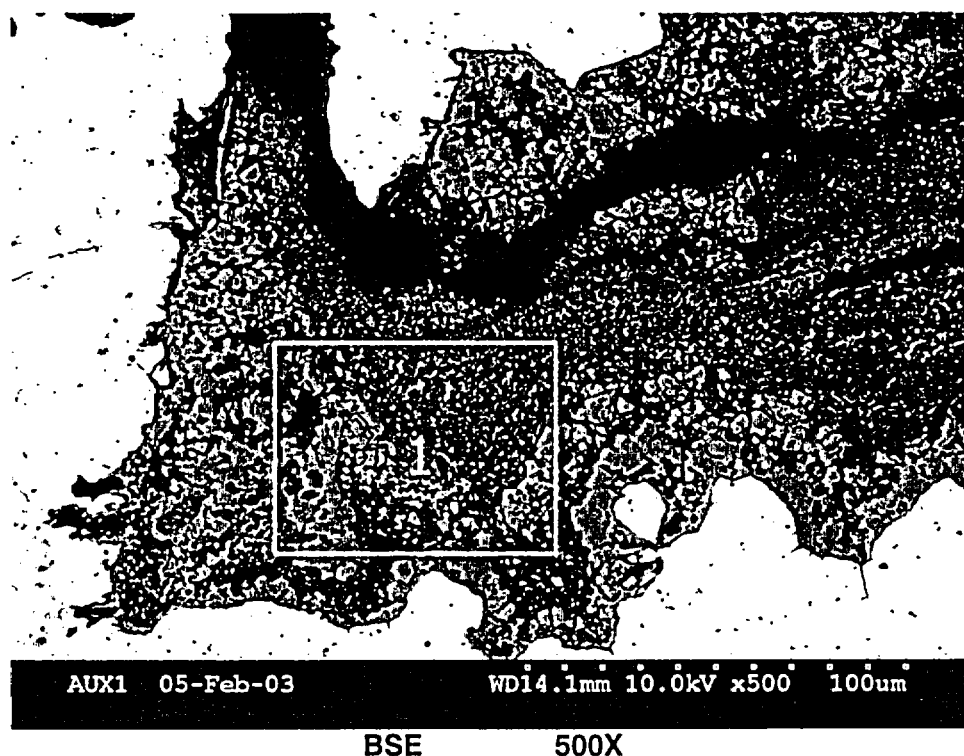
Figure 7.2.2.1: BSE micrograph showing portion of crack filled with corrosion products. The EDS results indicated high concentrations of carbon, oxygen, iron, and nickel.

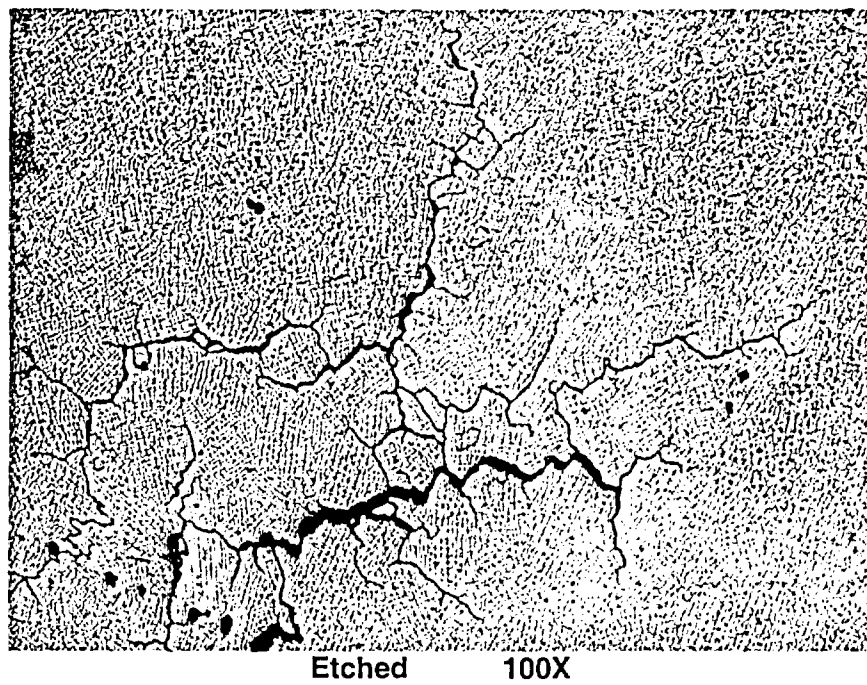
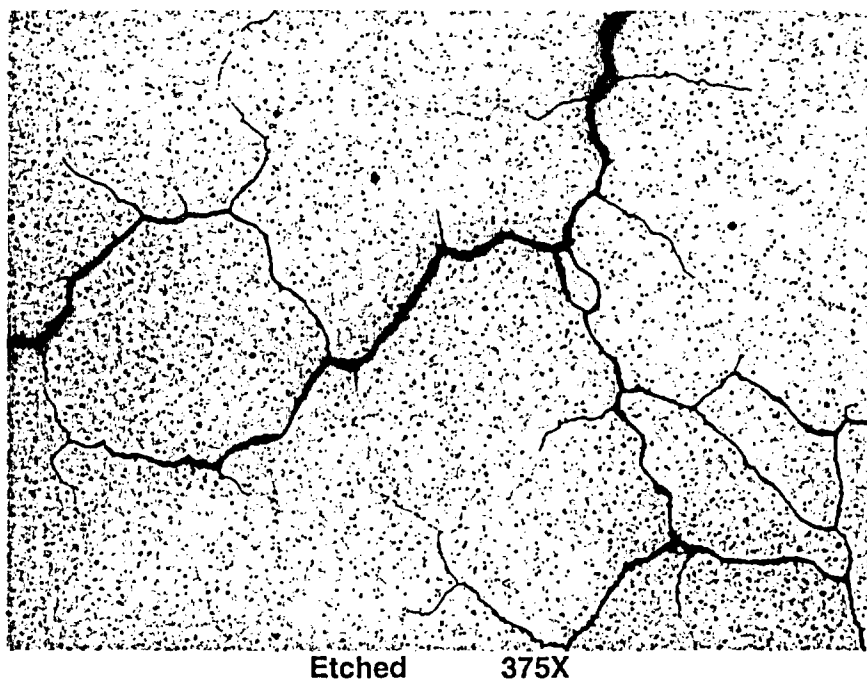
**Figure 7.2.3.4: Interdendritic or intergranular cracking in the J-groove weld away from the bore I.D. surface.**

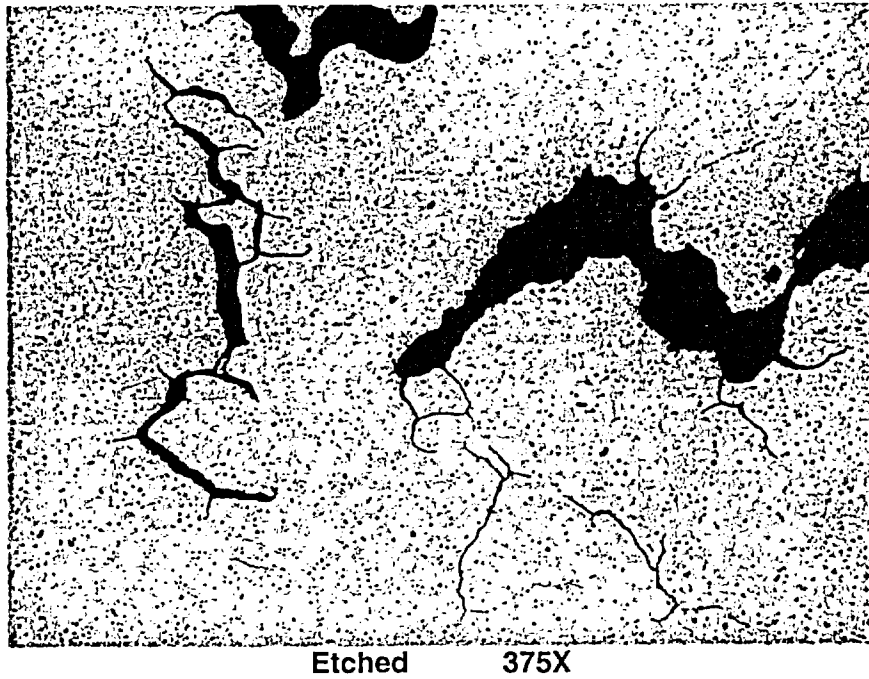
Figure 7.2.3.6: Crack detail from Figure 7.2.3.5.
