Table 5.1: Sample identification listing for Piece A2A.

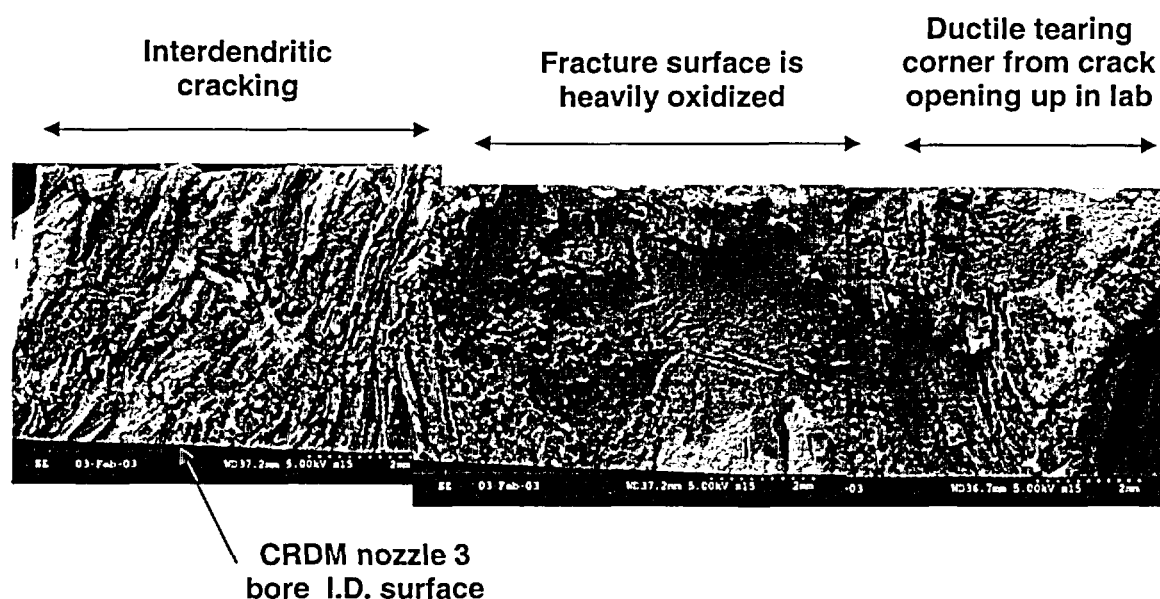
Figure 7.2.4.2: Low magnification SEM mosaic of the fracture surface after opening-up the axial crack. BSE 6.7X

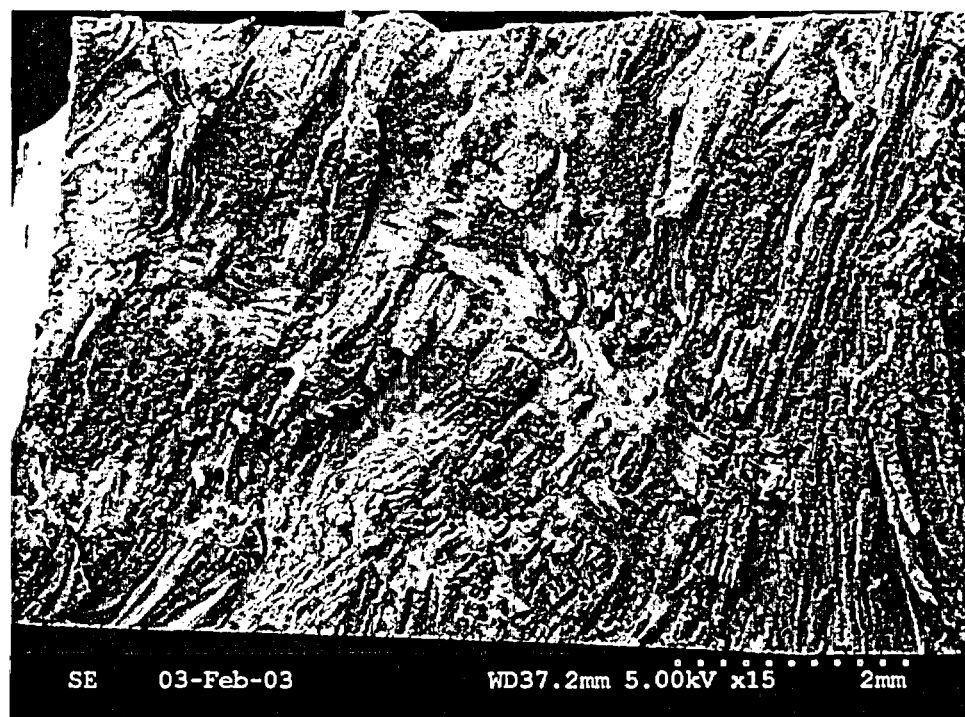
Figure 7.2.4.3: Higher magnification of the left section in Figure 7.2.4.2. Cracking is interdendritic exposing a well-defined columnar solidification structure.

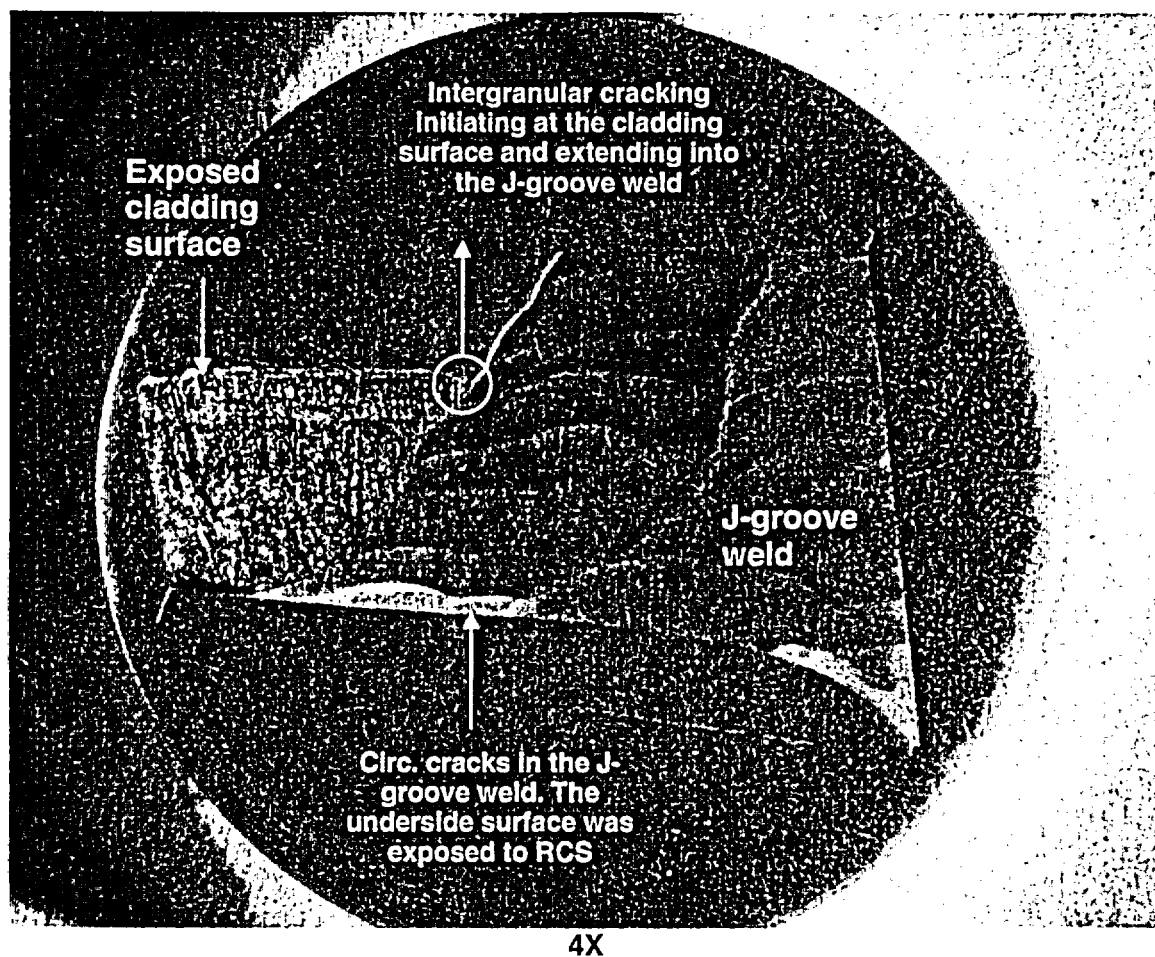
Figure 7.3.1.1: Macro photograph of metallographic sample A2A6A2B2. The mounted surface is through the J-groove weld at  $\sim 45^\circ$ . Refer to Figures 5.6 and 5.7 for the sample orientation.

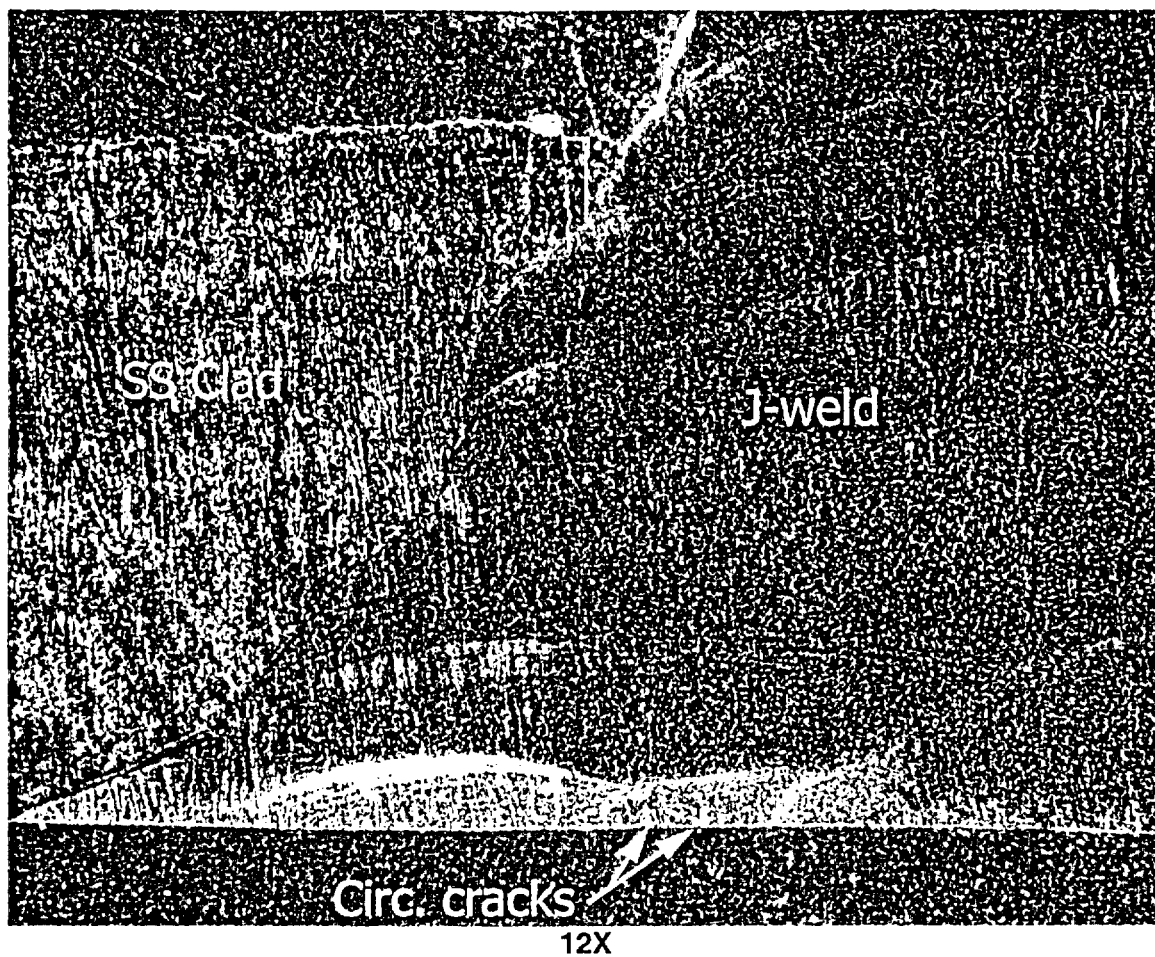
Figure 7.3.1.2: Slightly higher magnification photograph of metallographic mount A2A6A2B2.

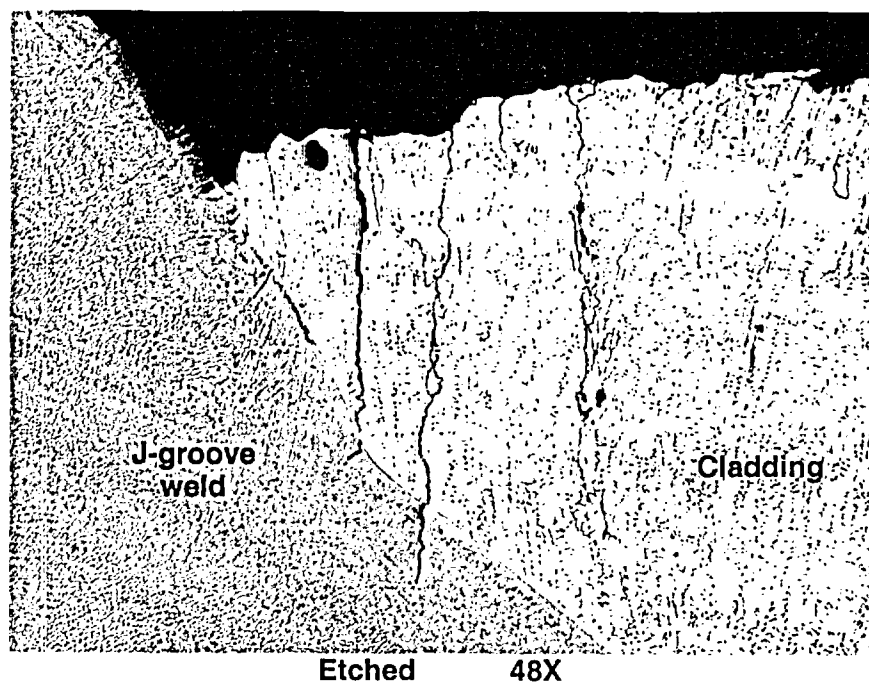
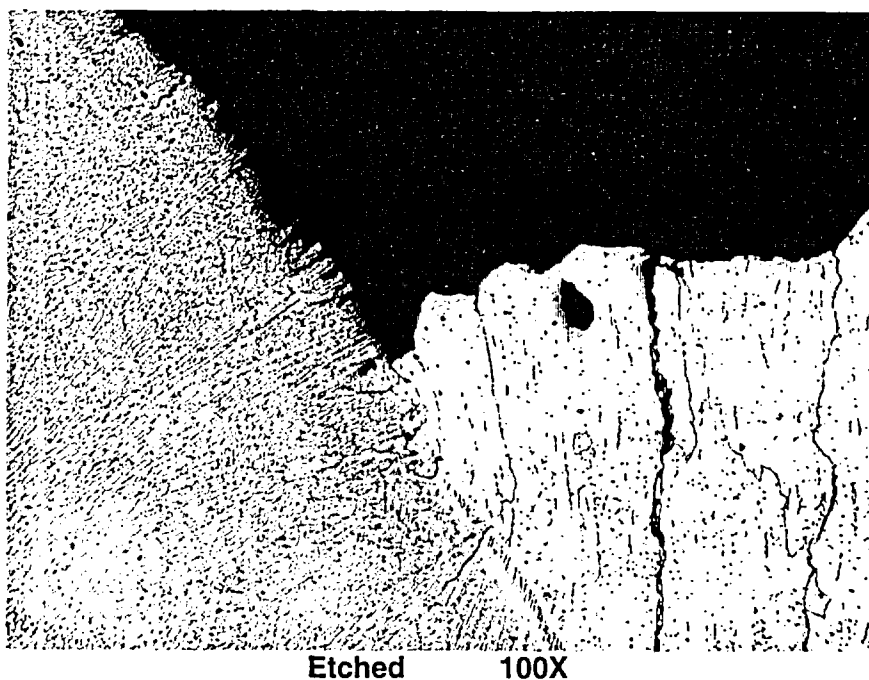
**Figure 7.3.1.3: Intergranular or interdendritic cracking initiating at the cladding surface and extending into the J-groove weld. Note that the micrographs shown are mirror image of the photo in Figure 7.3.1.2. Intergranular attack (IGA) is also evident on the exposed surface of J-groove weld and cladding (surface exposed to oxygenated boric acid). This cracking is likely initiated by IGA.**

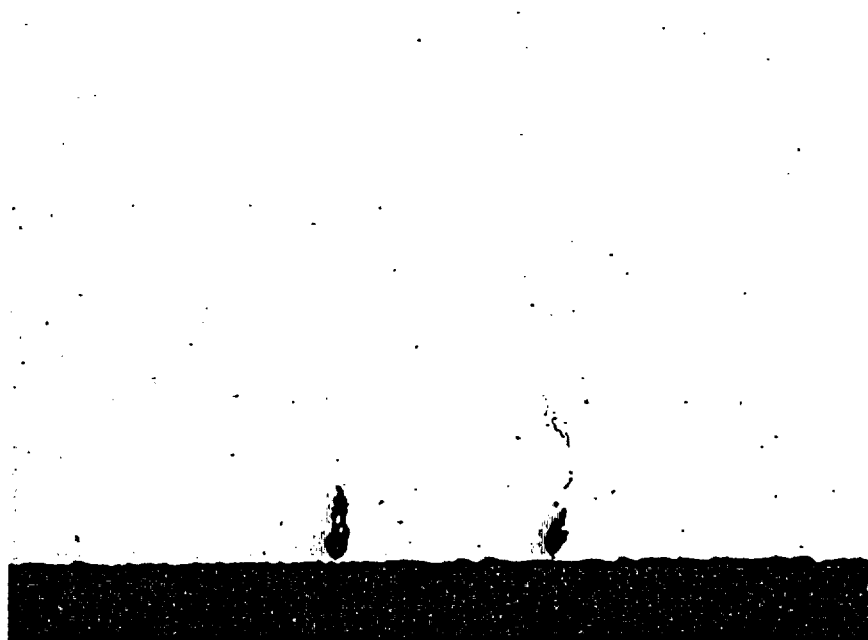
**Figure 7.3.1.5: Low magnification micrographs showing shallow circumferential cracking in the J-groove weld.**

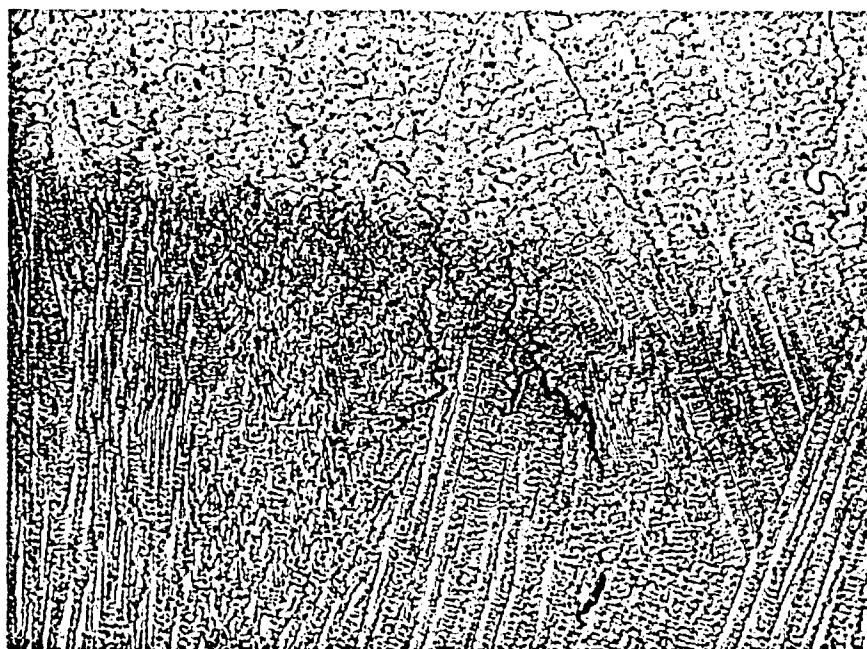
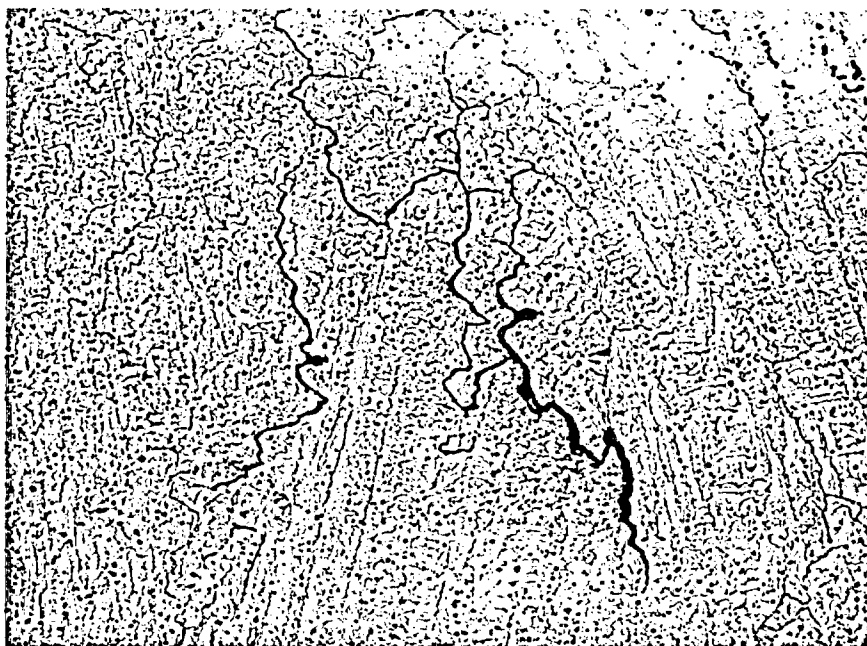
Figure 7.3.1.7: Micrographs showing crack tips of the circumferential cracking in the J-groove weld.

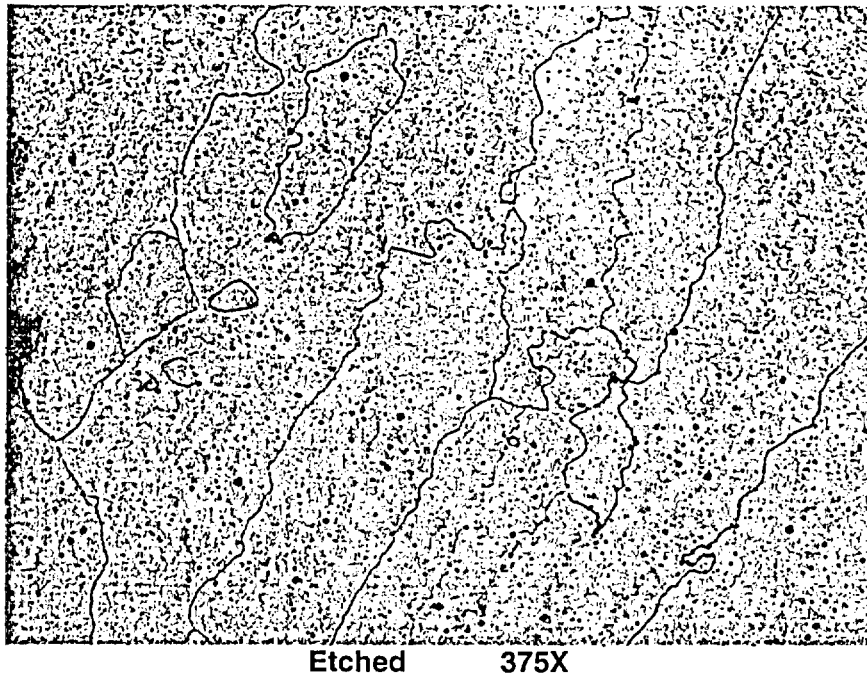
Figure 7.3.1.8: Typical J-groove weld microstructure.

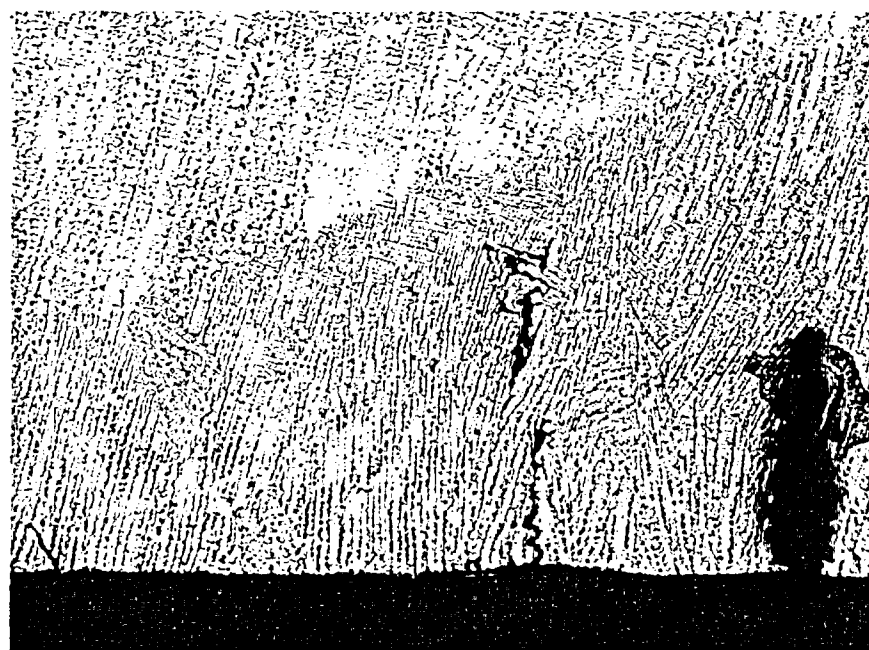
Figure 7.3.2.2: Micrograph showing the circumferential intergranular/interdendritic cracks in the J-groove weld. The maximum cracking depth is approximately 0.018" below the surface. The cavity just below the surface may be due to dendrites or grains encircled by the cracks that dropped out during sample grinding and polishing.

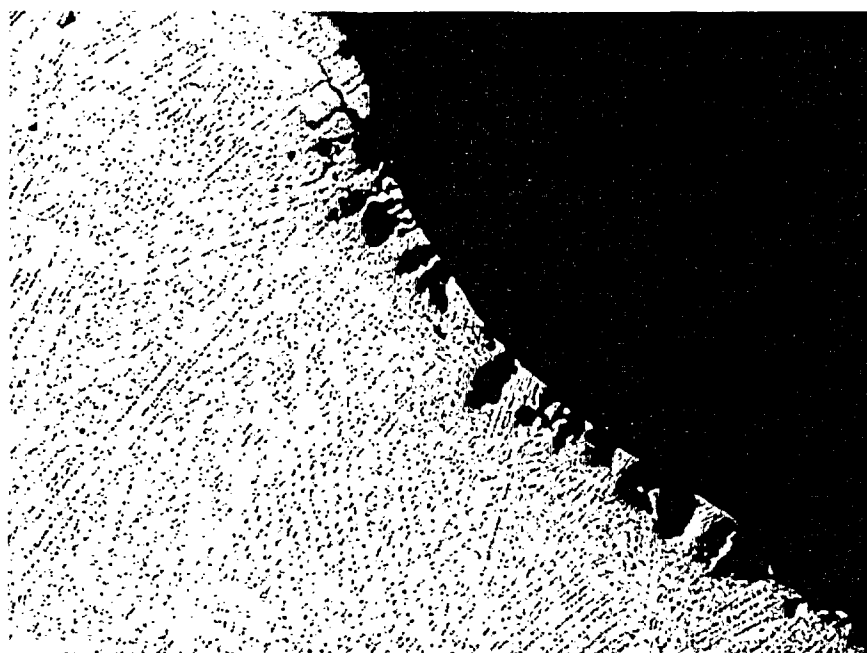
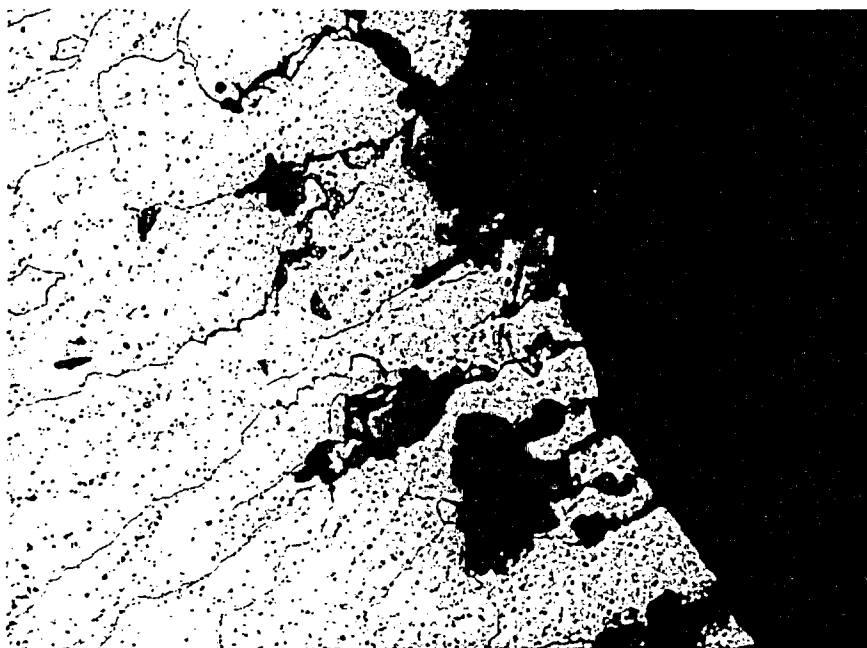
**Figure 7.3.2.4: Intergranular attack (IGA) on the J-groove weld surface exposed to oxygenated boric acid.**

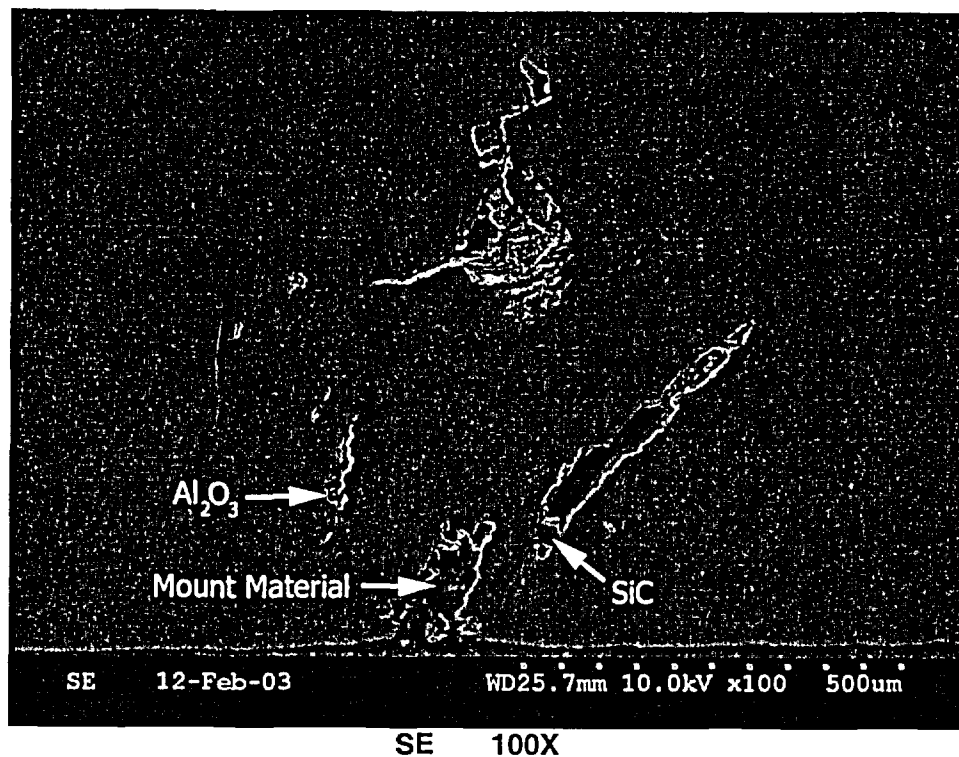
Figure 7.3.3.4: SE micrographs of the circumferential cracking in the J-groove weld. The maximum circumferential cracking depth is approximately 0.032" below the surface. Cracking was interdendritic in nature.

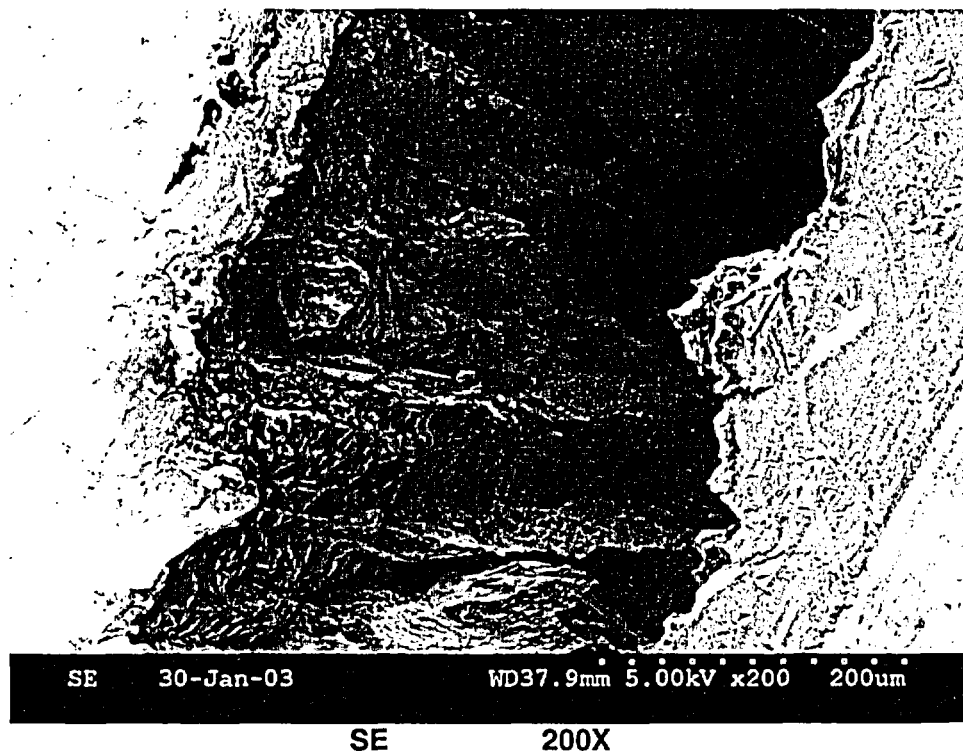
Figure 7.3.4.2: SE micrographs showing the shallow circumferential cracking in the J-groove weld. Cracking was interdentritic.

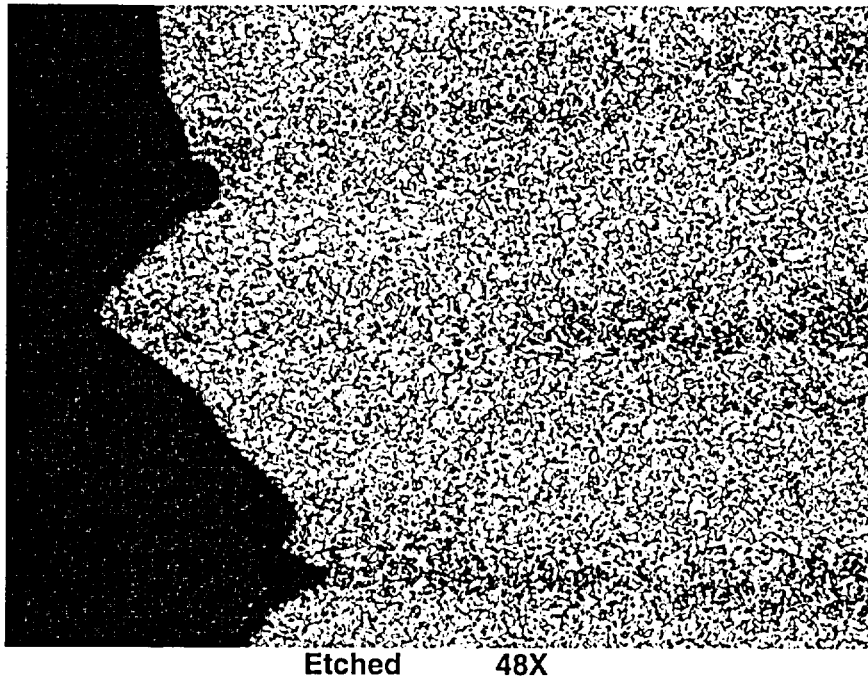
Figure 8.1.1.3: Higher magnification micrograph, which indicates a slightly faster local corrosion rate along the striations.

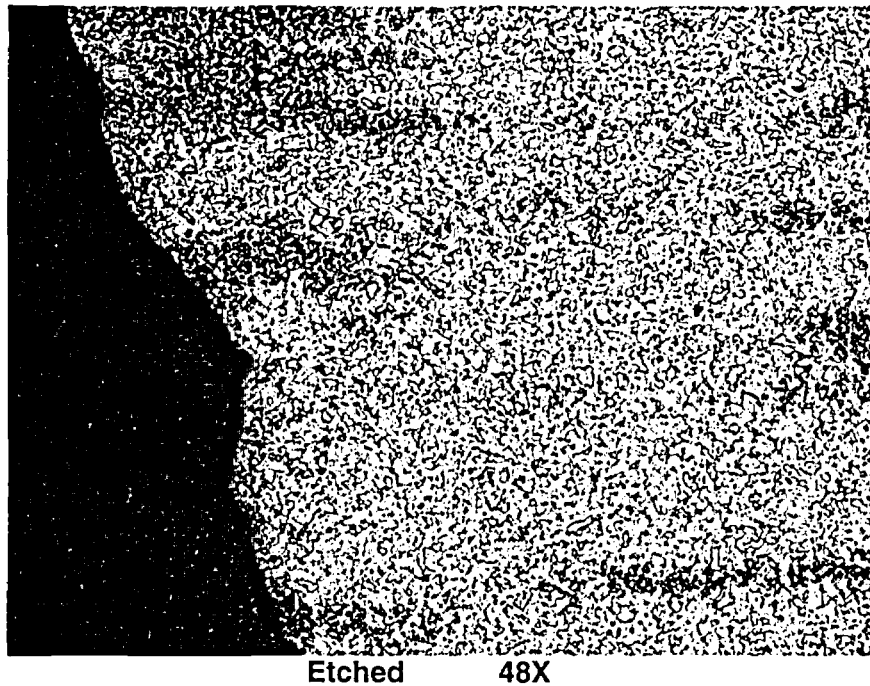
Figure 8.1.2.3: At higher magnification, the local corrosion rate along the striations is increased only very slightly.

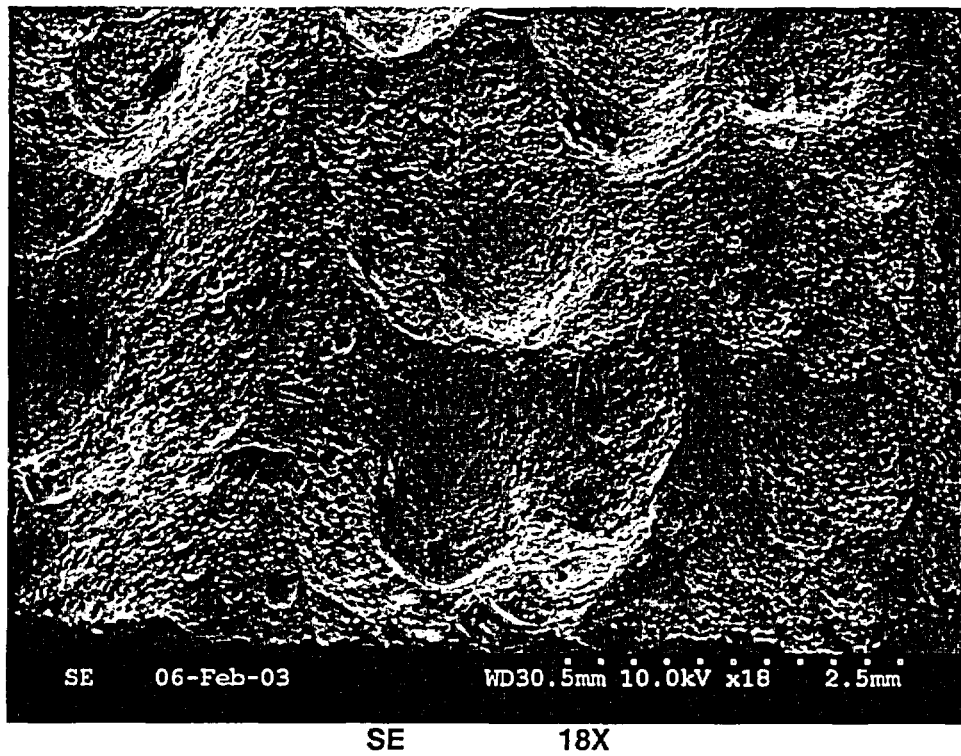
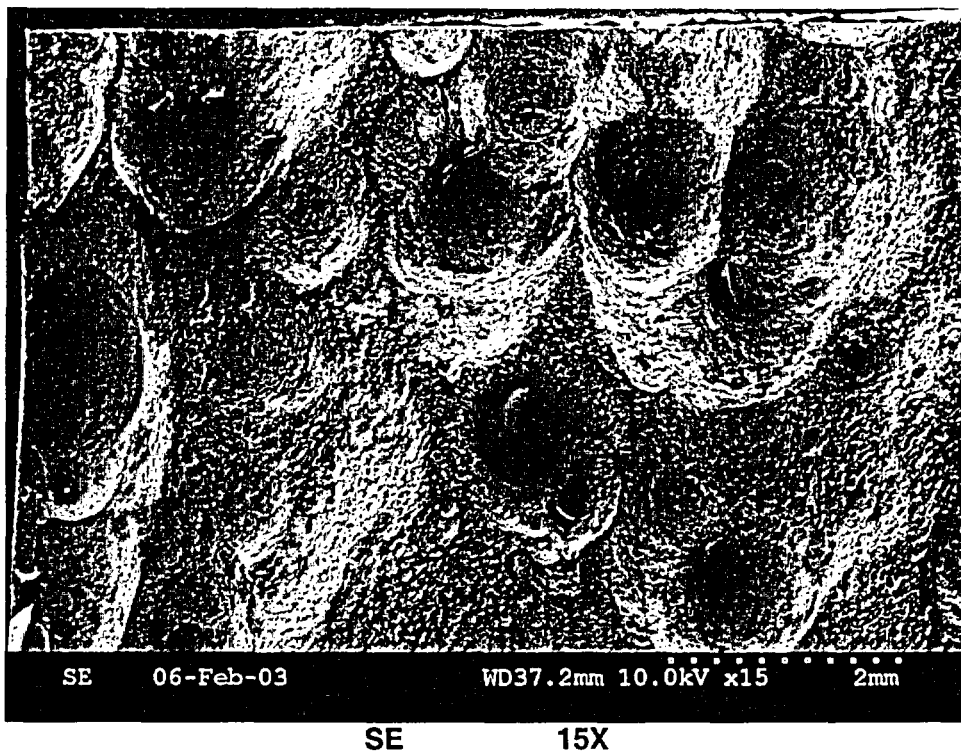
Figure 8.1.3.1: Low magnification SE micrographs of cavity wall surface near 90°. The surface contains generally round depressions measuring ~0.039" or less in diameter.

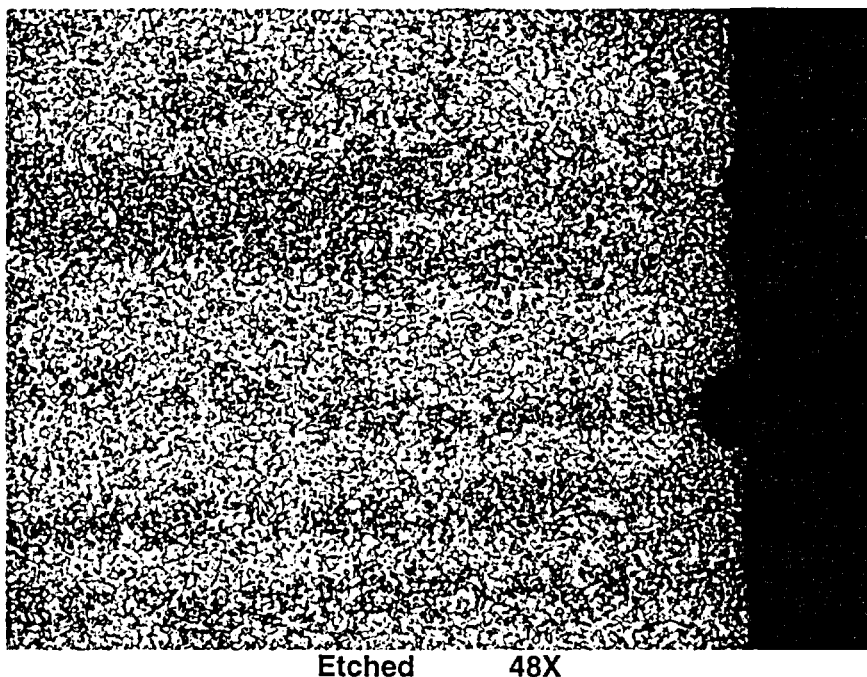
Figure 8.2.2.3: Higher magnification detail of Figure 8.2.2.2, which suggests a slightly faster local corrosion rate along the striations.

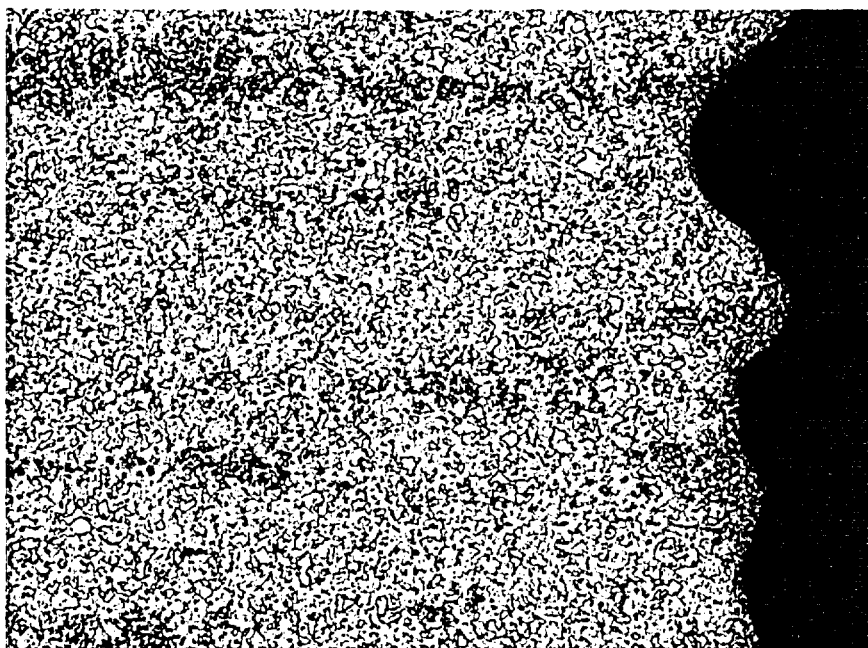
Etched 48X

Figure 8.2.3.3: Higher magnification detail of Figure 8.2.3.2, which suggests a slightly faster local corrosion rate along the striations.

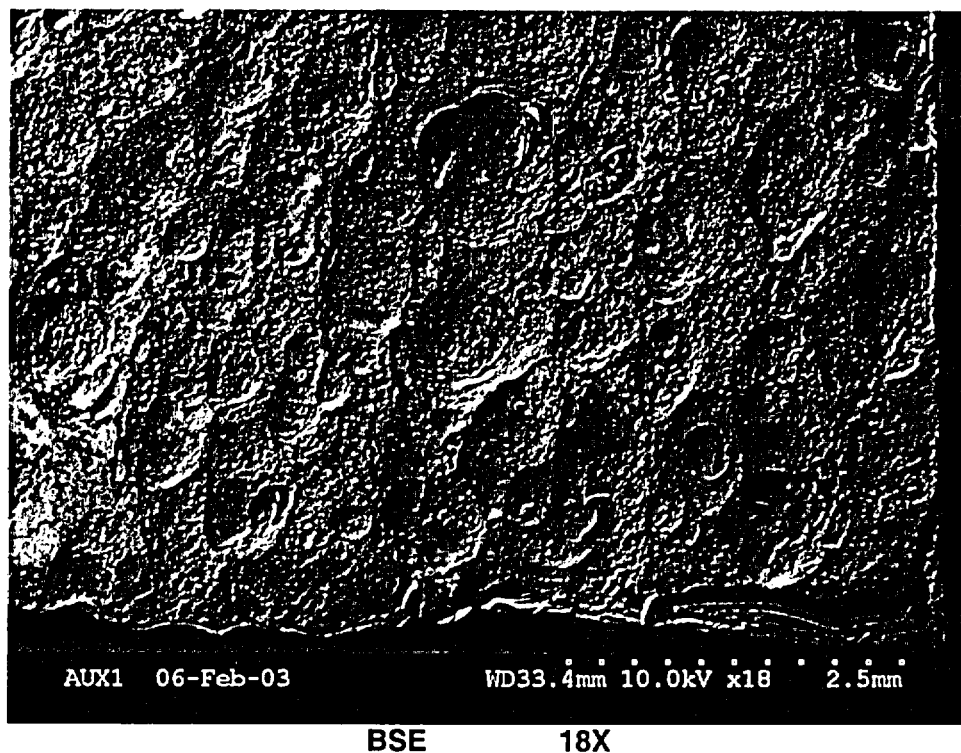
Figure 8.2.4.1: SE (top) and BSE (bottom) micrographs of the cavity wall surface near 270°. The surface contained rounded depressions measuring 0.020" in diameter or less. Orientation of micrographs: lower portion of cavity to the right and upper portion to the right. Nozzle #3 is closer to lower edge of micrograph.

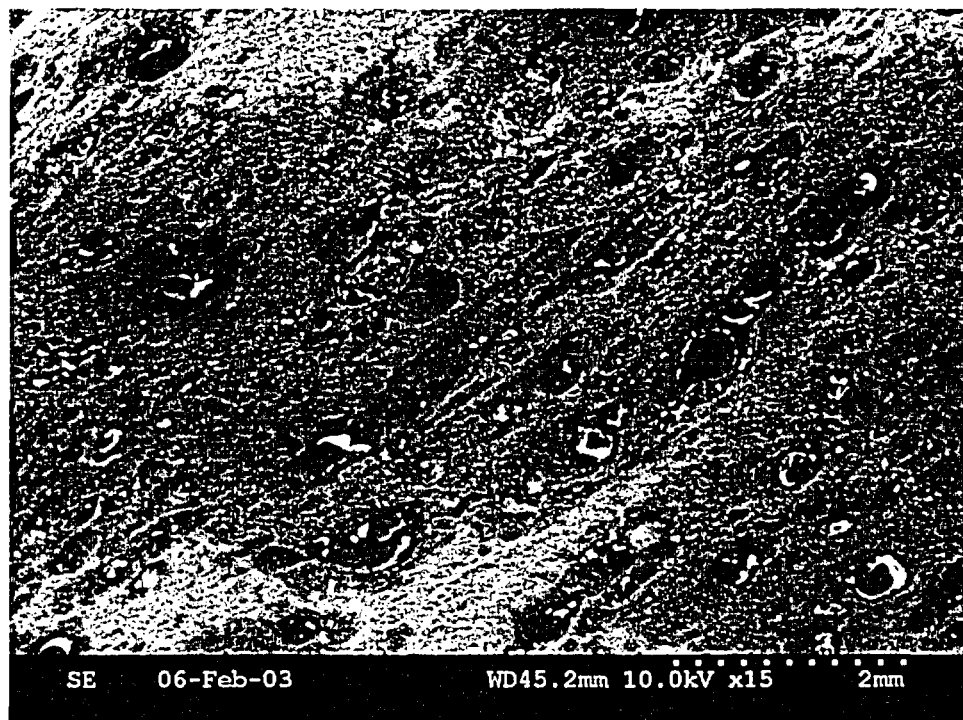
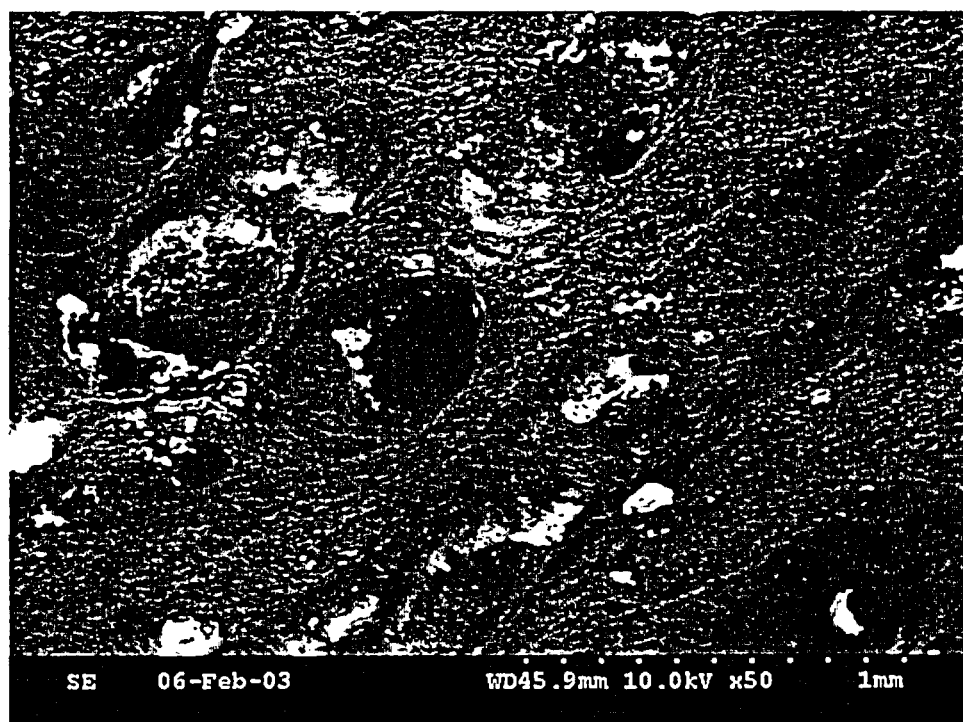
Figure 8.2.4.2: SE micrographs of cavity side wall near 270°. These micrographs suggest that larger (~1 mm dia.) shallower depressions are caused by acid boiling and smaller (~0.3 mm dia.) deeper depressions are caused by inclusions.

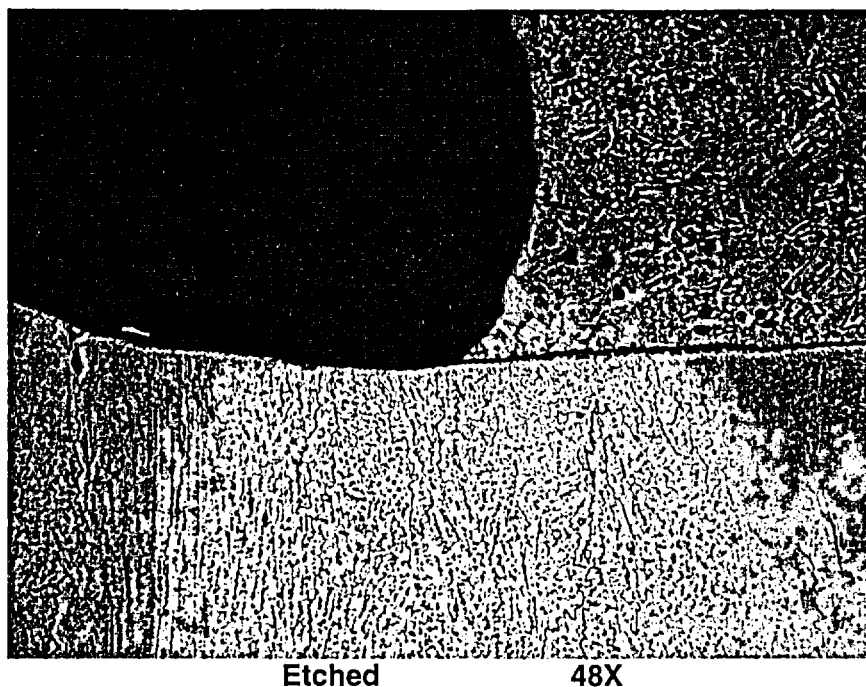
Figure 8.3.1.2: Micrograph showing the edge of the exposed cladding in the undercut region. Note: the micrograph is a mirror image of the macrograph in Figure 8.3.1.1.

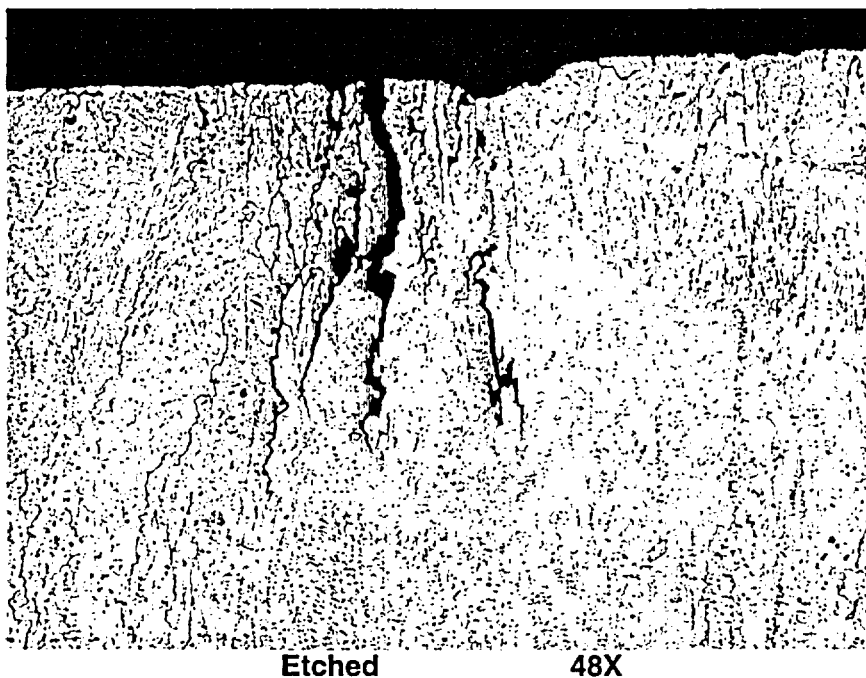
Figure 8.3.1.3: Micrograph showing intergranular attack (IGA) and intergranular or interdendritic cracking in the cladding. The maximum depth of the crack tip is approximately 0.047" below the exposed cladding surface.

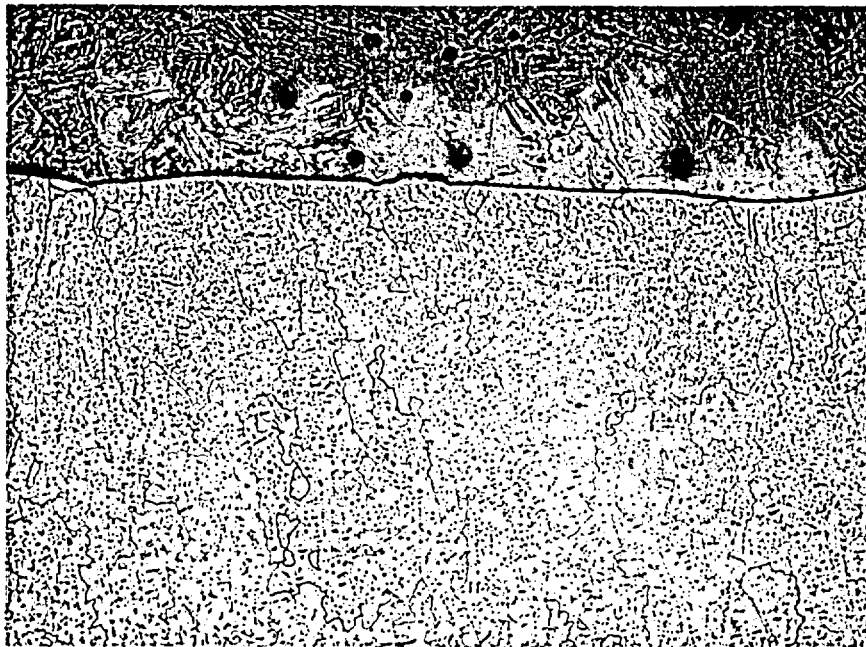
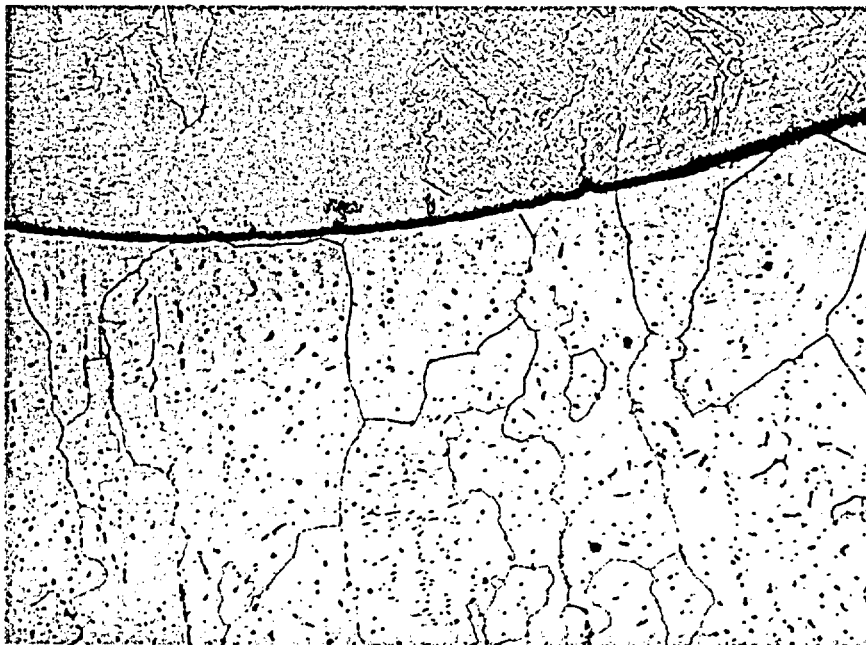
**Figure 8.3.1.5: Micrographs showing the interface between the low alloy steel (above the fusion line) and the stainless steel cladding (below the fusion line).**

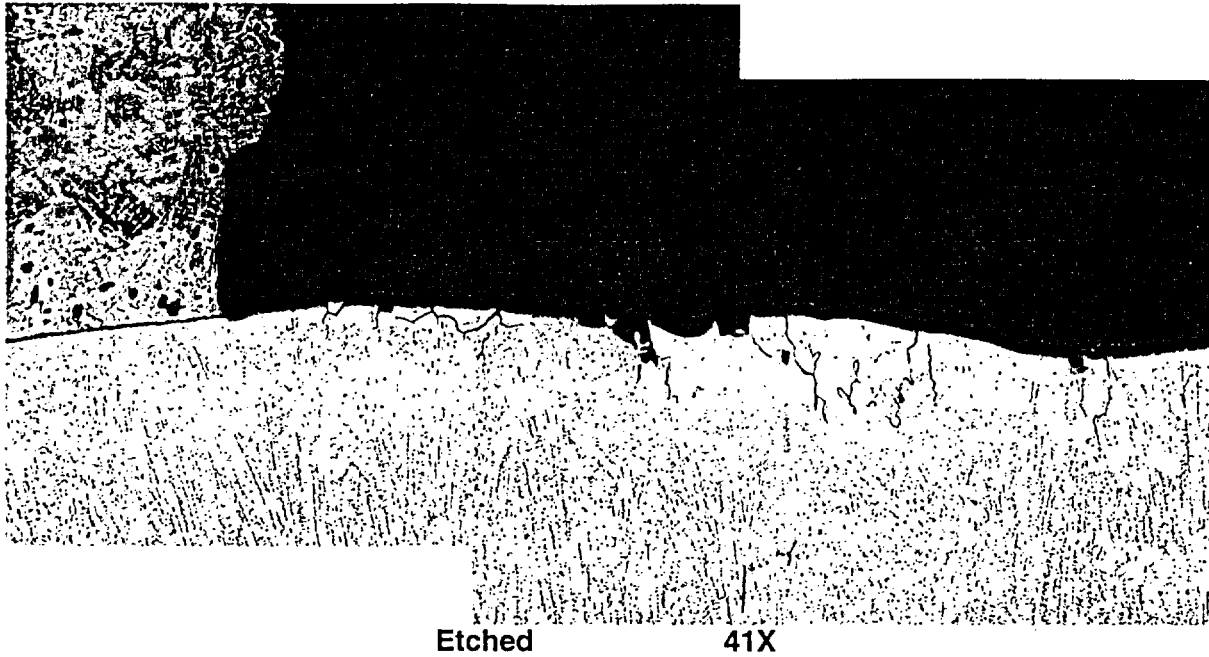
**Figure 8.3.2.2: Micrograph showing the exposed cladding surface. A slight undercut is evident in the low alloy steel. Note: the micrograph is a mirror image of the macrograph in Figure 8.3.2.1.**

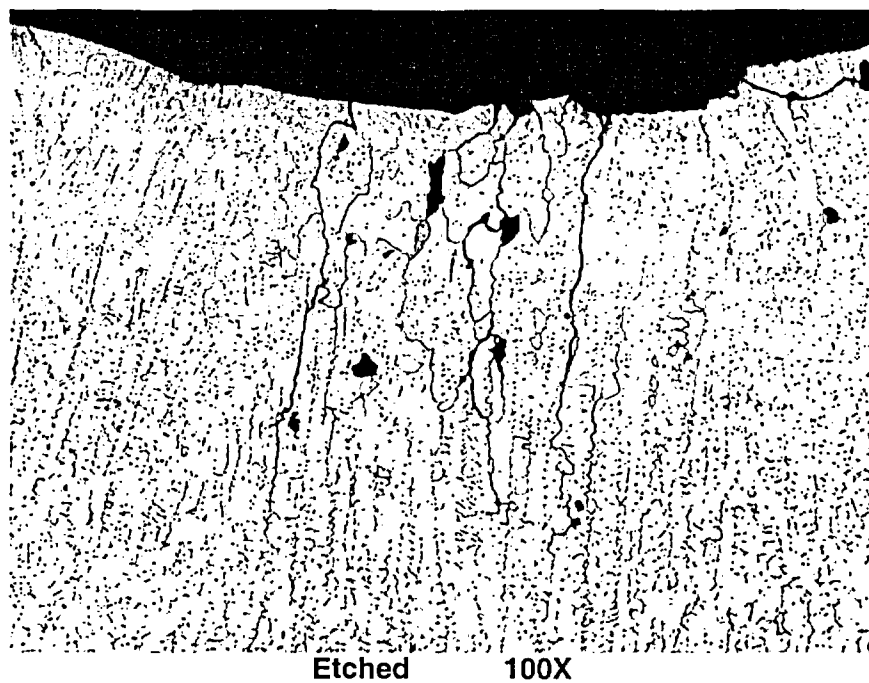
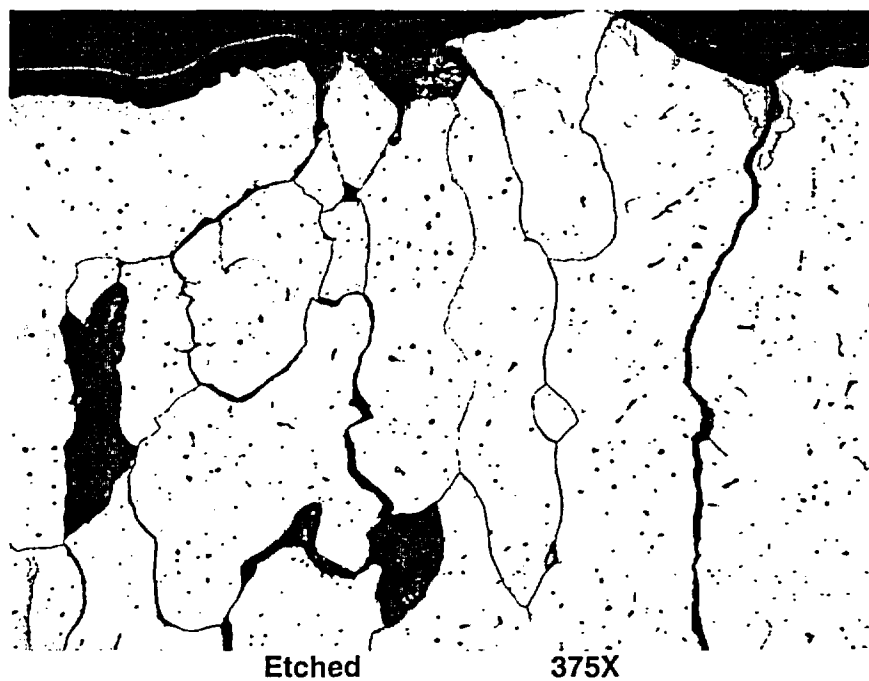
**Figure 8.3.2.3: Micrographs showing intergranular attack (IGA) and intergranular or interdendritic cracking. The maximum depth of the crack tip is approximately 0.024" below the exposed cladding surface.**

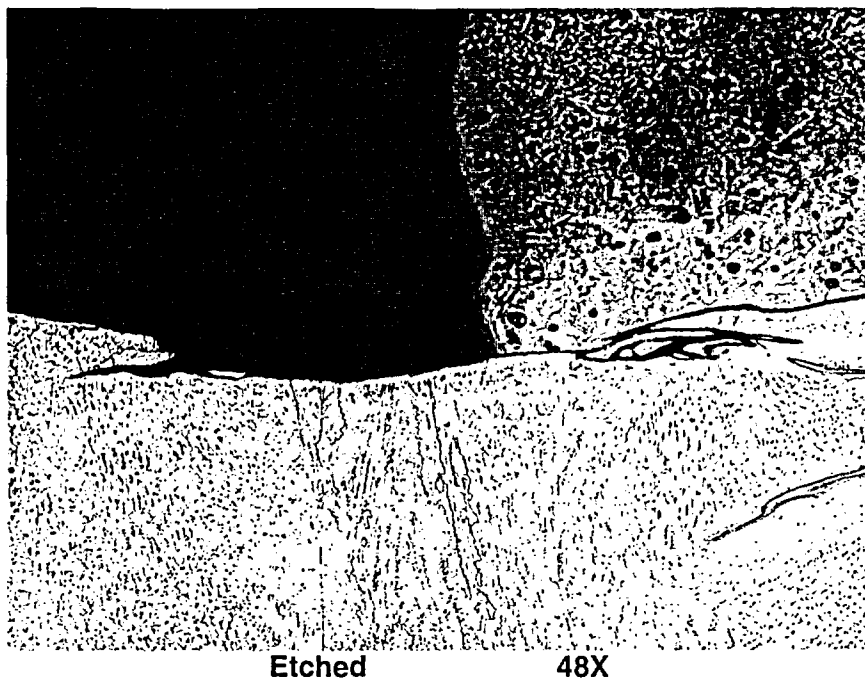
Figure 8.3.3.2: Micrograph showing the edge of the exposed cladding in the undercut region. Note: the micrograph is a mirror image of the macrograph in Figure 8.3.3.1.

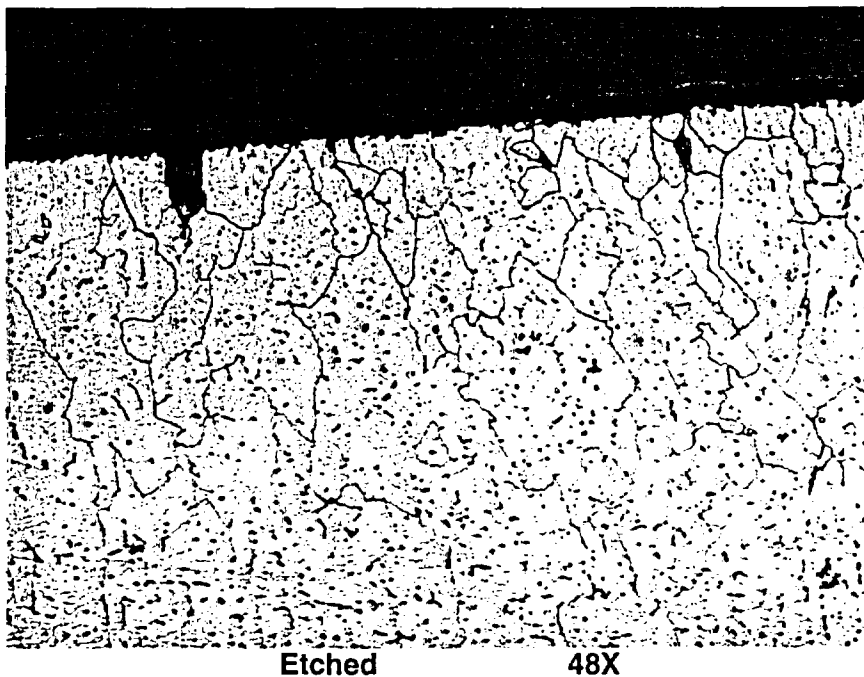
Figure 8.3.3.3: Micrograph showing minor intergranular attack (IGA) in the exposed cladding surface.
