**GENE-0000-0018-3359-NP, "Technical Assessment, Quad Cities Unit 2  
Steam Dryer Failure – Determination of Root Cause  
and Extent of Condition," Revision 0, dated August 2003  
[NON-PROPRIETARY VERSION]**

GENE-0000-0018-3359-NP

# **Quad Cities Unit 2**

### **Steam Dryer Failure – Determination of Root Cause and Extent of Condition**

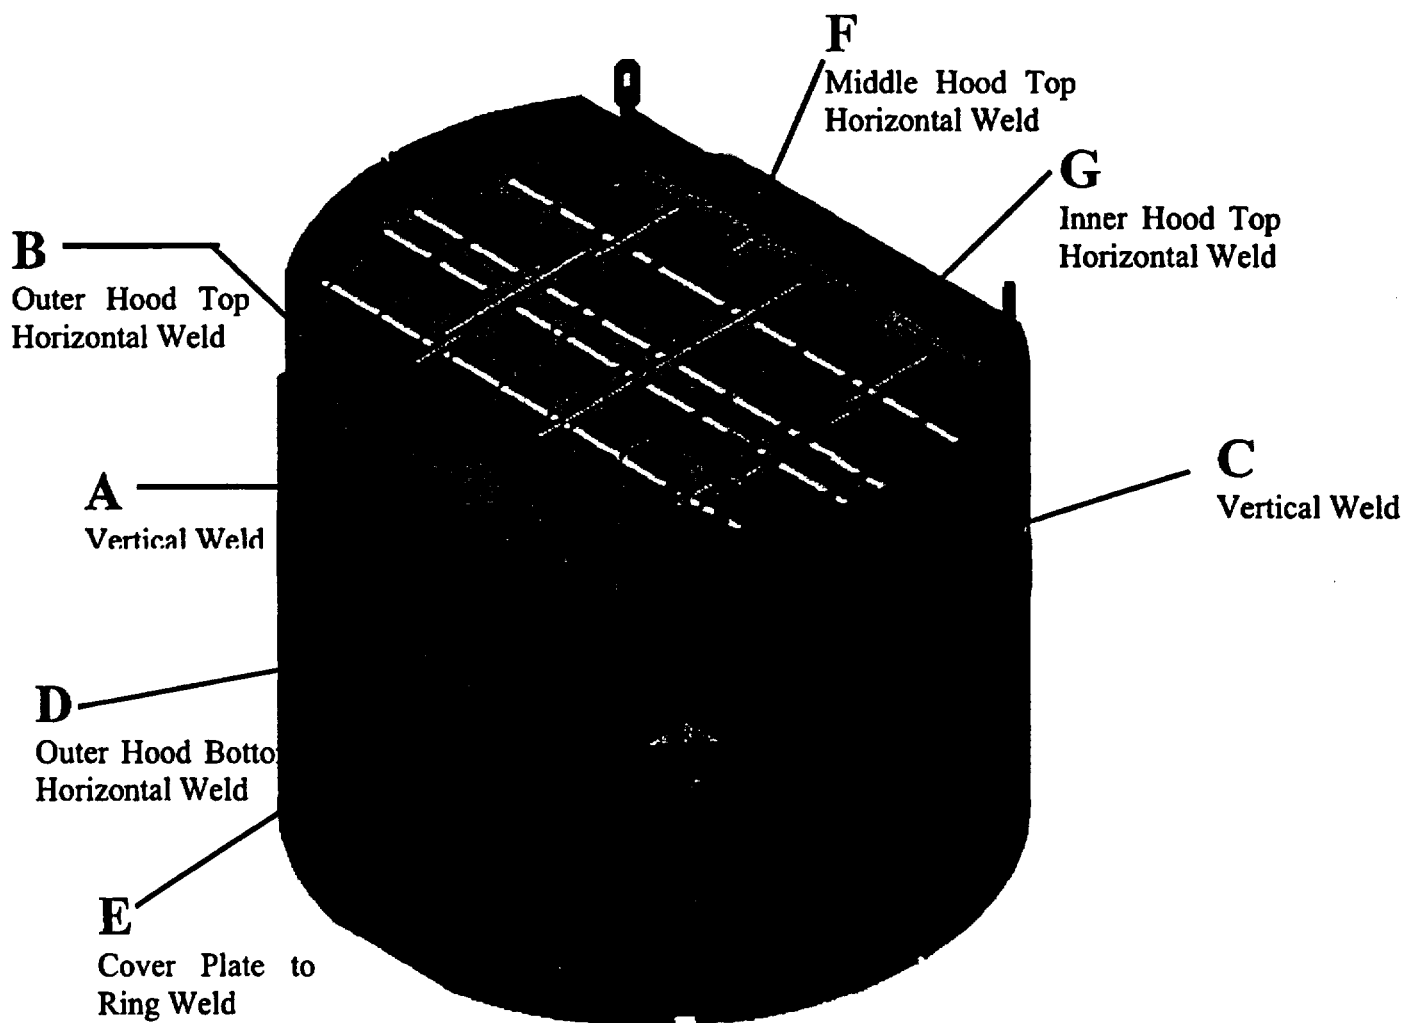
Figure 2.7-1: Possible Crack Locations

Step 1. Identify locations where failure would occur for various postulated root causes.

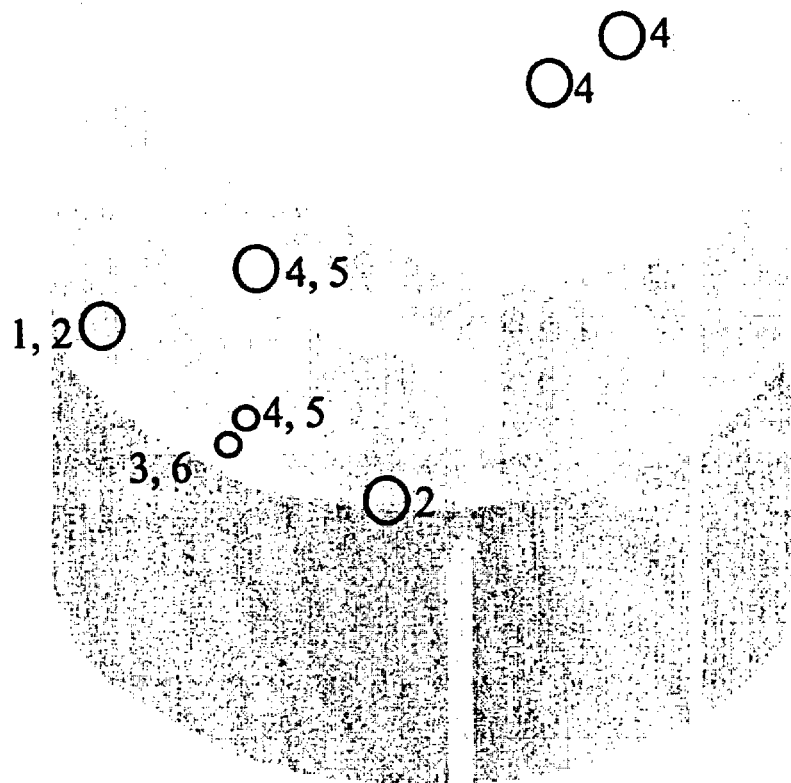
**Figure 2.7-2: High Stress Locations For Various Root Causes**

Root Cause Number	High Stress Location (See Figure 2.7-2)	High Displacement Location	Failure Mode Appearance	Additional Features	Crack Length	Carryover Symptoms
1	Corner of A and D	Yes (denting)	Ductile + Fatigue (vertical seam)	Pizza Size in-line with MSL (pushed in or out)	Long	Jump
2	Corner of A and D; Corner of C and D	NA	Fatigue	Need to confirm Initiation location was bottom	Long	Slow or Jump
3	E at center	NA	Fatigue	Unexpected	Moderate	Slow or Jump
4	D at center	NA	Fatigue		Moderate	Slow or Jump
5	B at Center	NA	Fatigue	Static, unexpected	Short	Slow increase
6	E at Center

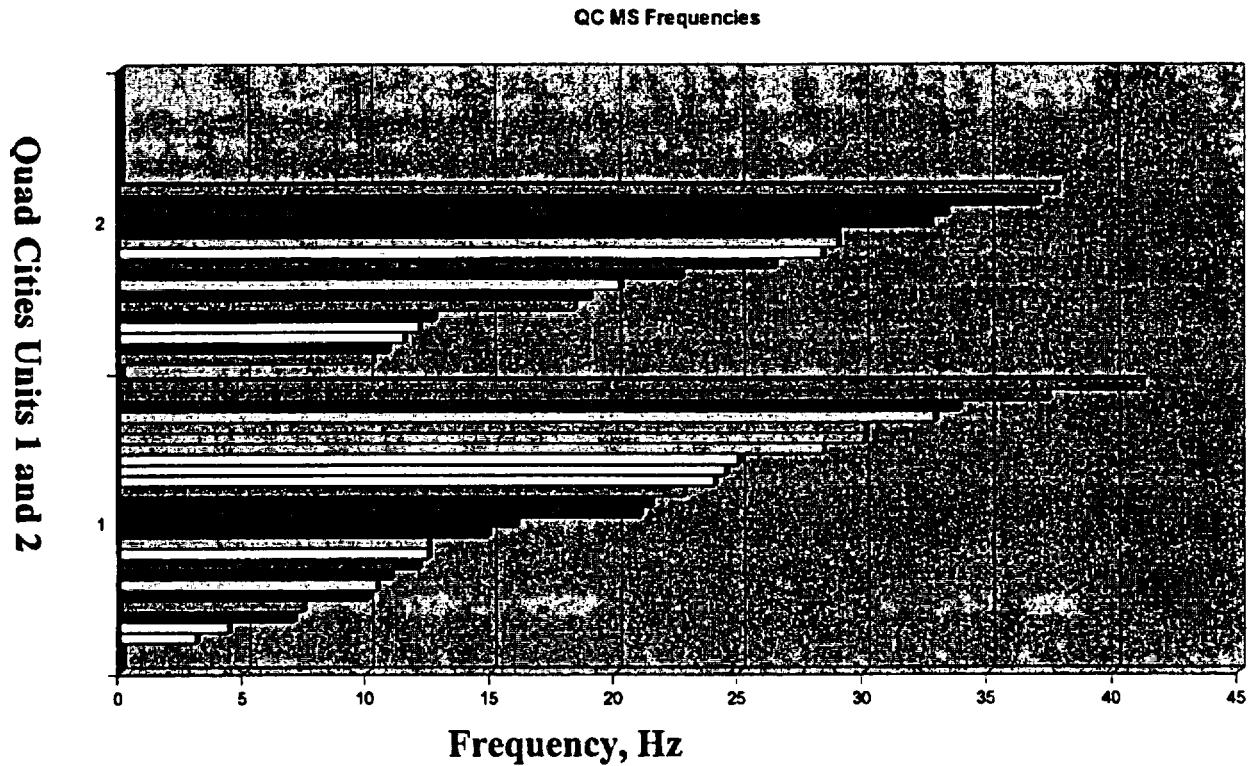
**Figure 2.7-6: MSL Vibration Frequency Content**

The results for both Quad Cities Units 1 and 2 are shown in Figure 2.7-6. The results are fairly consistent with Acoustic Circuit Analysis evaluations with the addition of [[  
]] as a possible frequency to be considered.
