Donald C. Cook Nuclear Plant Units 1 and 2
STEAM GENERATOR INSPECTION – REQUEST FOR ADDITIONAL
INFORMATION (TAC NOS. MB8121 and MB8122)

ATTACHMENT TO AEP:NRC:3691-05

Steam Generator Inspections Request for Additional Information

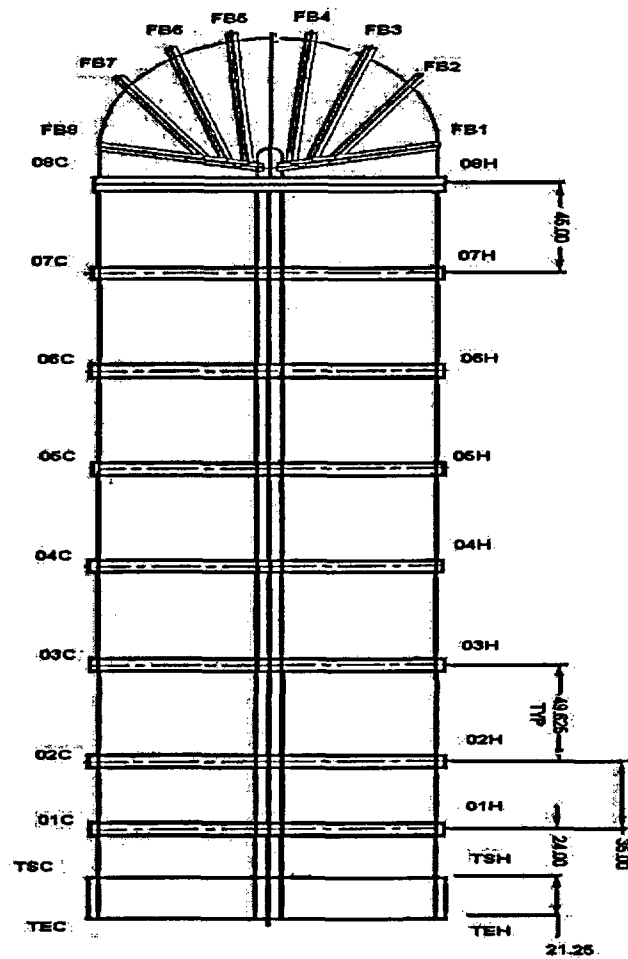
Figure 1
Unit 1 Steam Generator

*See Figure 1. The tube support structure consists of eight stainless steel lattice grid assemblies and four sets of flat bar (also called fan bar) restraints. Each lattice grid consists of interlocking “high” (3.15 inches high and 0.135 inches thick) and “low” (1.0 inches high and 0.135 inches thick) bars that form a lattice pattern to provide lateral support in the straight section of the tube. The flat bar restraints are made of the same material and provide support in the U-bend area.

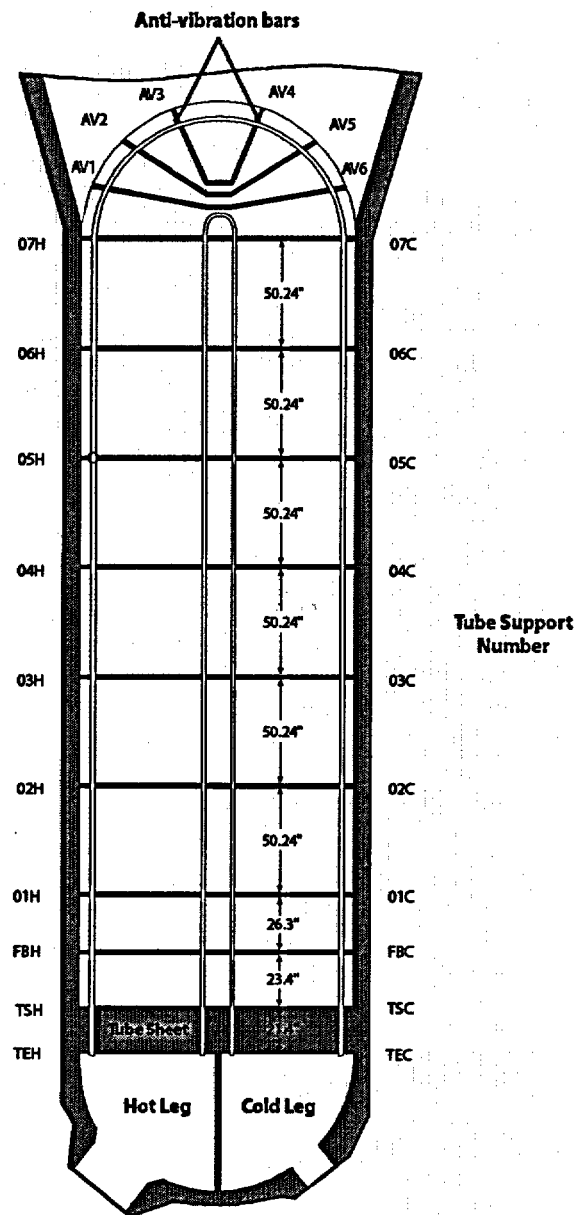
Figure 3
Unit 2 Steam Generator

*See Figure 3. The tube support structures consist of seven 1.12 inch thick support plates with quatrefoil holes and six anti-vibration bars that are located in the U-bend region of the tubes. There is also a flow distribution baffle located between the tubesheet and the first support plate. The flow distribution baffle is 0.75 inches thick with octofoil holes. The support plates, anti-vibration bars, and the flow distribution baffle are all constructed of type 405 stainless steel.
