Subject: 2003 Annual Site Inspection and Monitoring Compliance Report for UMTRCA Title II
Disposal Sites

2003 Annual Site Inspection and Monitoring Compliance Report for Uranium Mill Tailings Radiation Control Act Title II Disposal Sites

**Bluewater, New Mexico
Edgemont, South Dakota
Sherwood, Washington**

November 2003

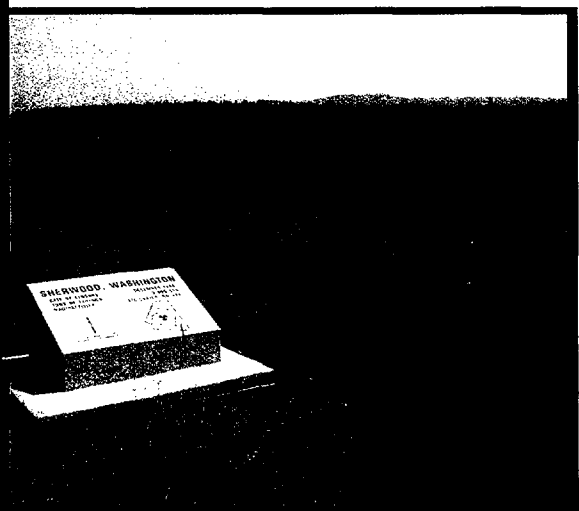
Sherwood, Washington, Disposal Cell Site, 2003

The Sherwood, Washington, UMTRCA Title II disposal site located on the Spokane Tribe of Indians reservation was inspected on August 21, 2003. The site is in good condition overall. Two items of special interest exist: (1) the classification of the reclaimed tailings impoundment as a dam and (2) the periodic ponding of water in a small area on the top of the tailings impoundment. The classification of the impoundment as a dam necessitates a dam safety inspection to assure continued compliance with the Federal Dam Safety Act. Occurrence of ponded water on top of the main tailings pile indicates slight settling of the tailings materials.

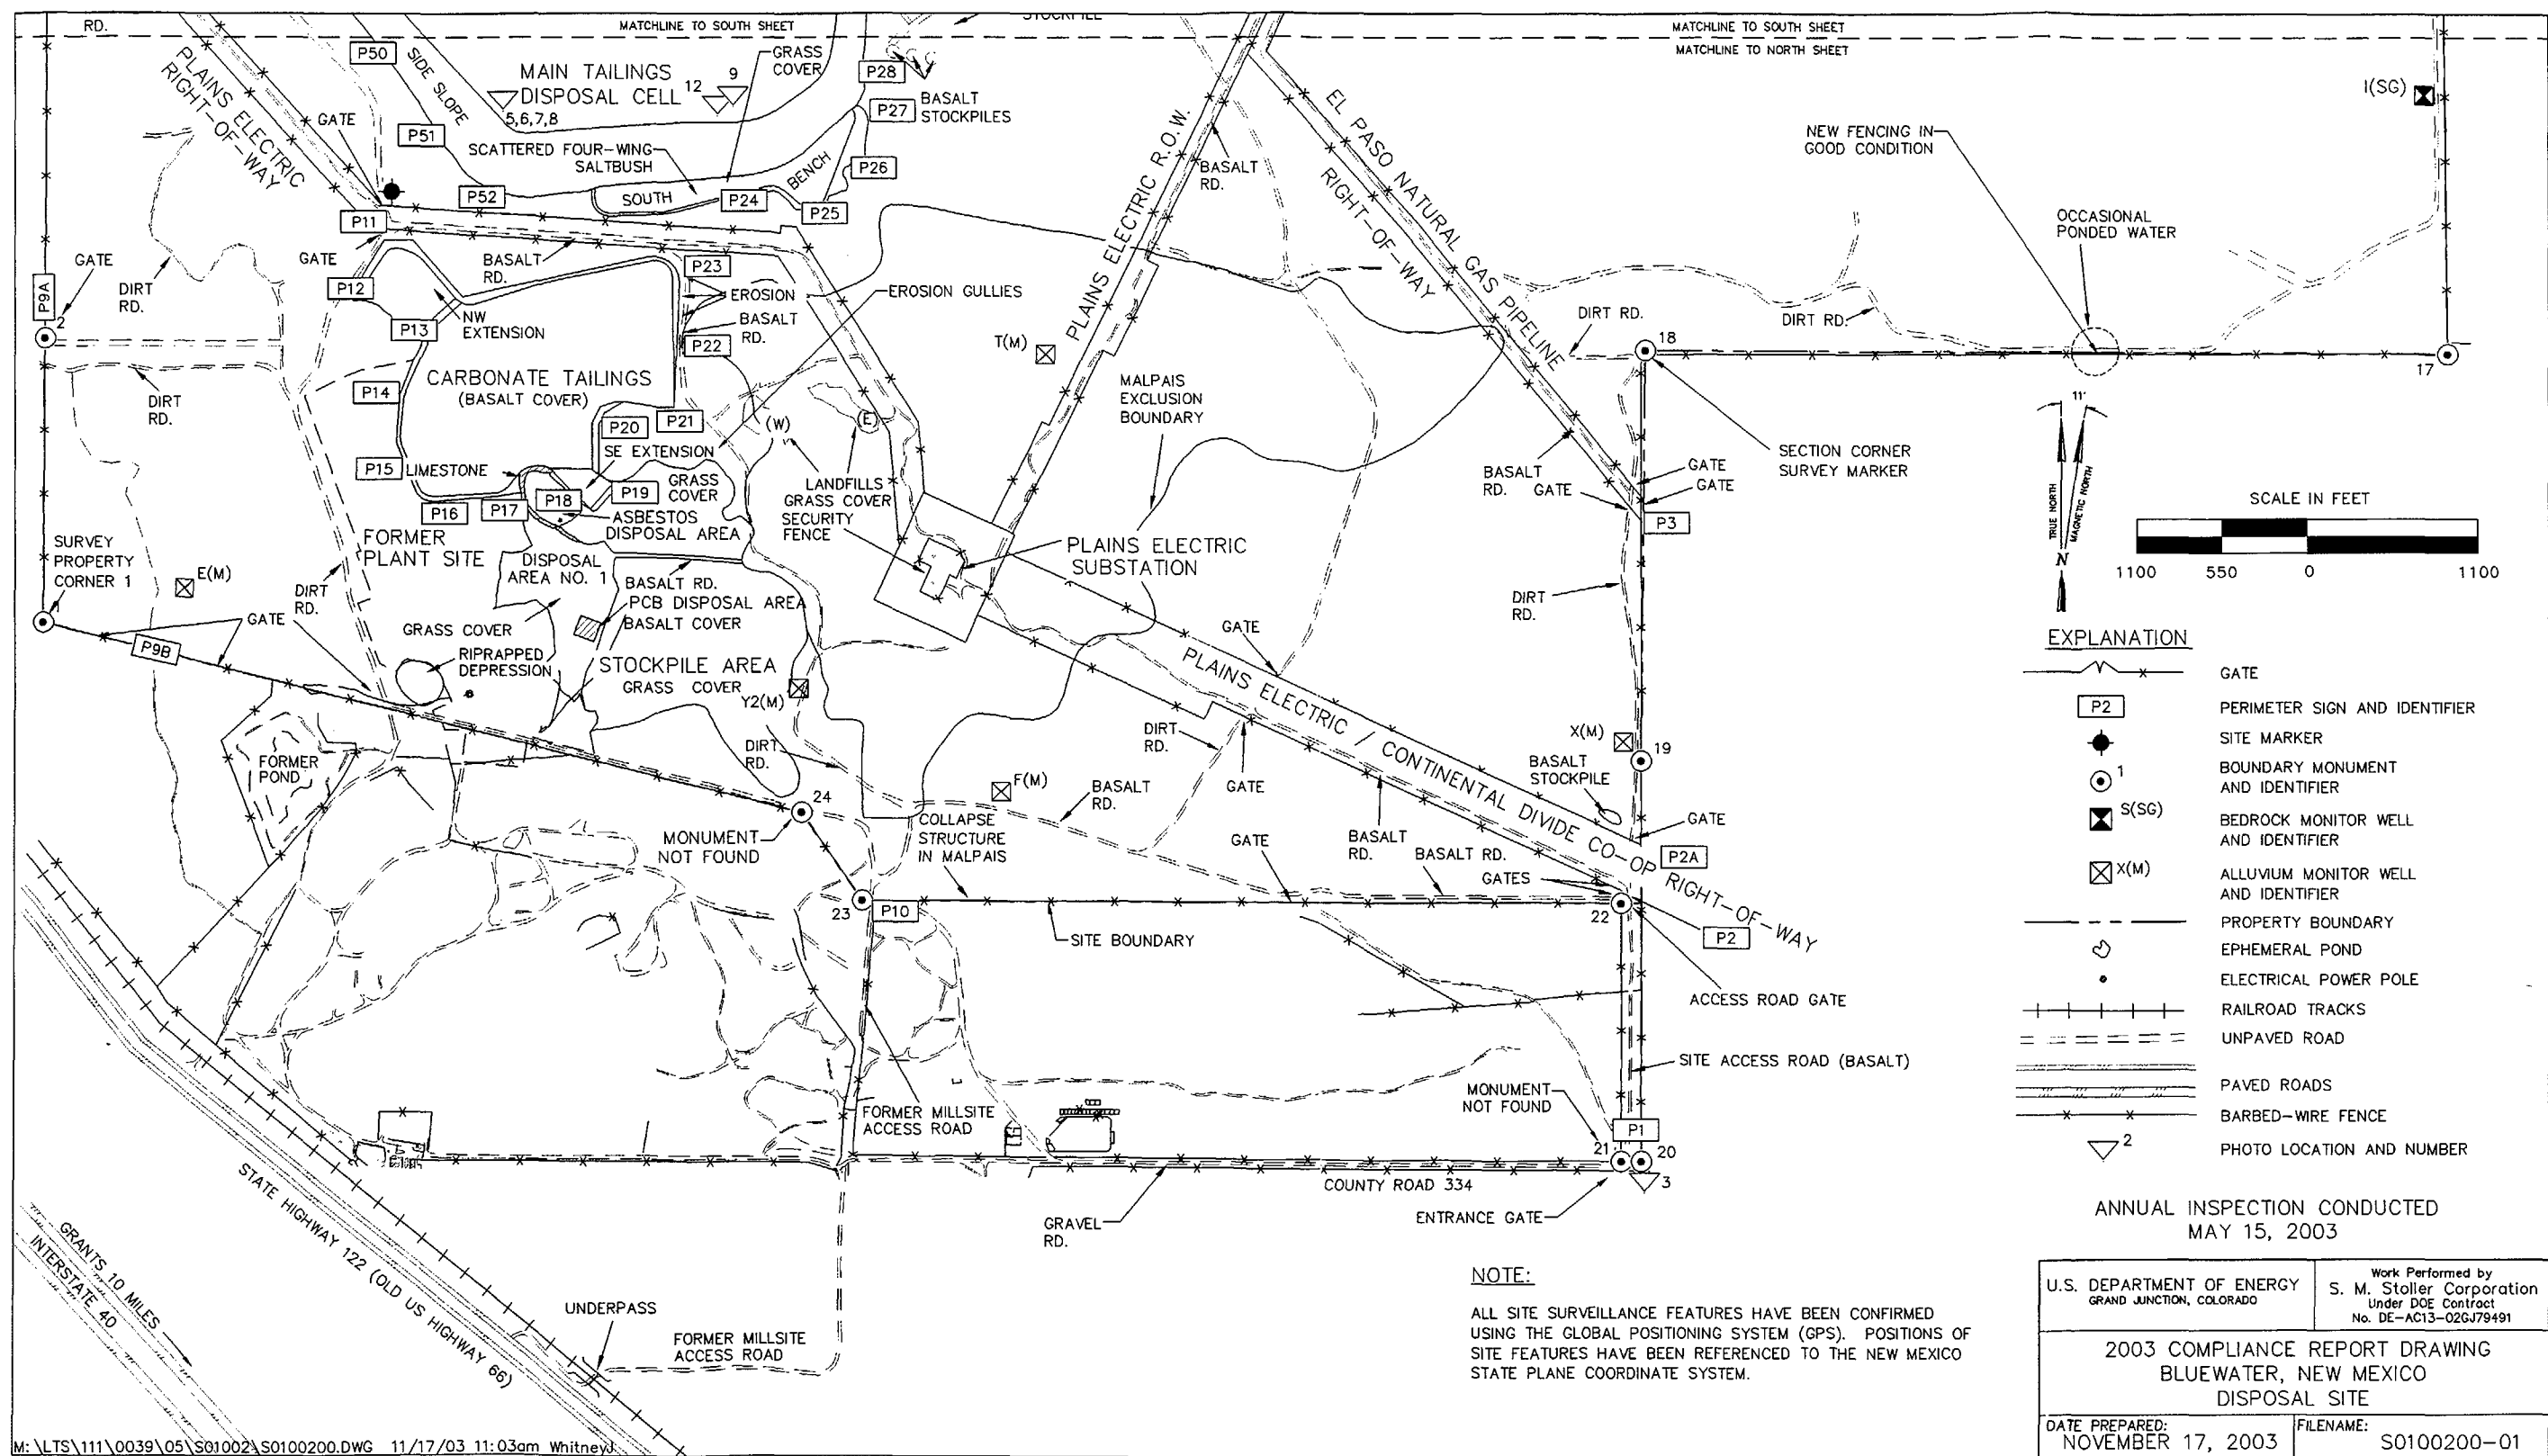
Figure 1-1. Bluewater, New Mexico, South Area, 2003

Fifty-five perimeter or warning signs, designated P1 through P52 on Figures 1-1 and 1-2 (including perimeter signs P2A, P9A, and P9B), are posted at access points along right-of-way intersections with the site boundary and around the main and carbonate tailings disposal cells. At the Bluewater site, all signs are identical and convey the information typically conveyed on entrance signs at other Long-Term Surveillance and Maintenance (LTS&M) Program sites.

An electric power substation is enclosed by a security fence near the center of the site along the Plains Electric Company right-of-way (Figure 1-1). Fencing around this station generally is in good condition.

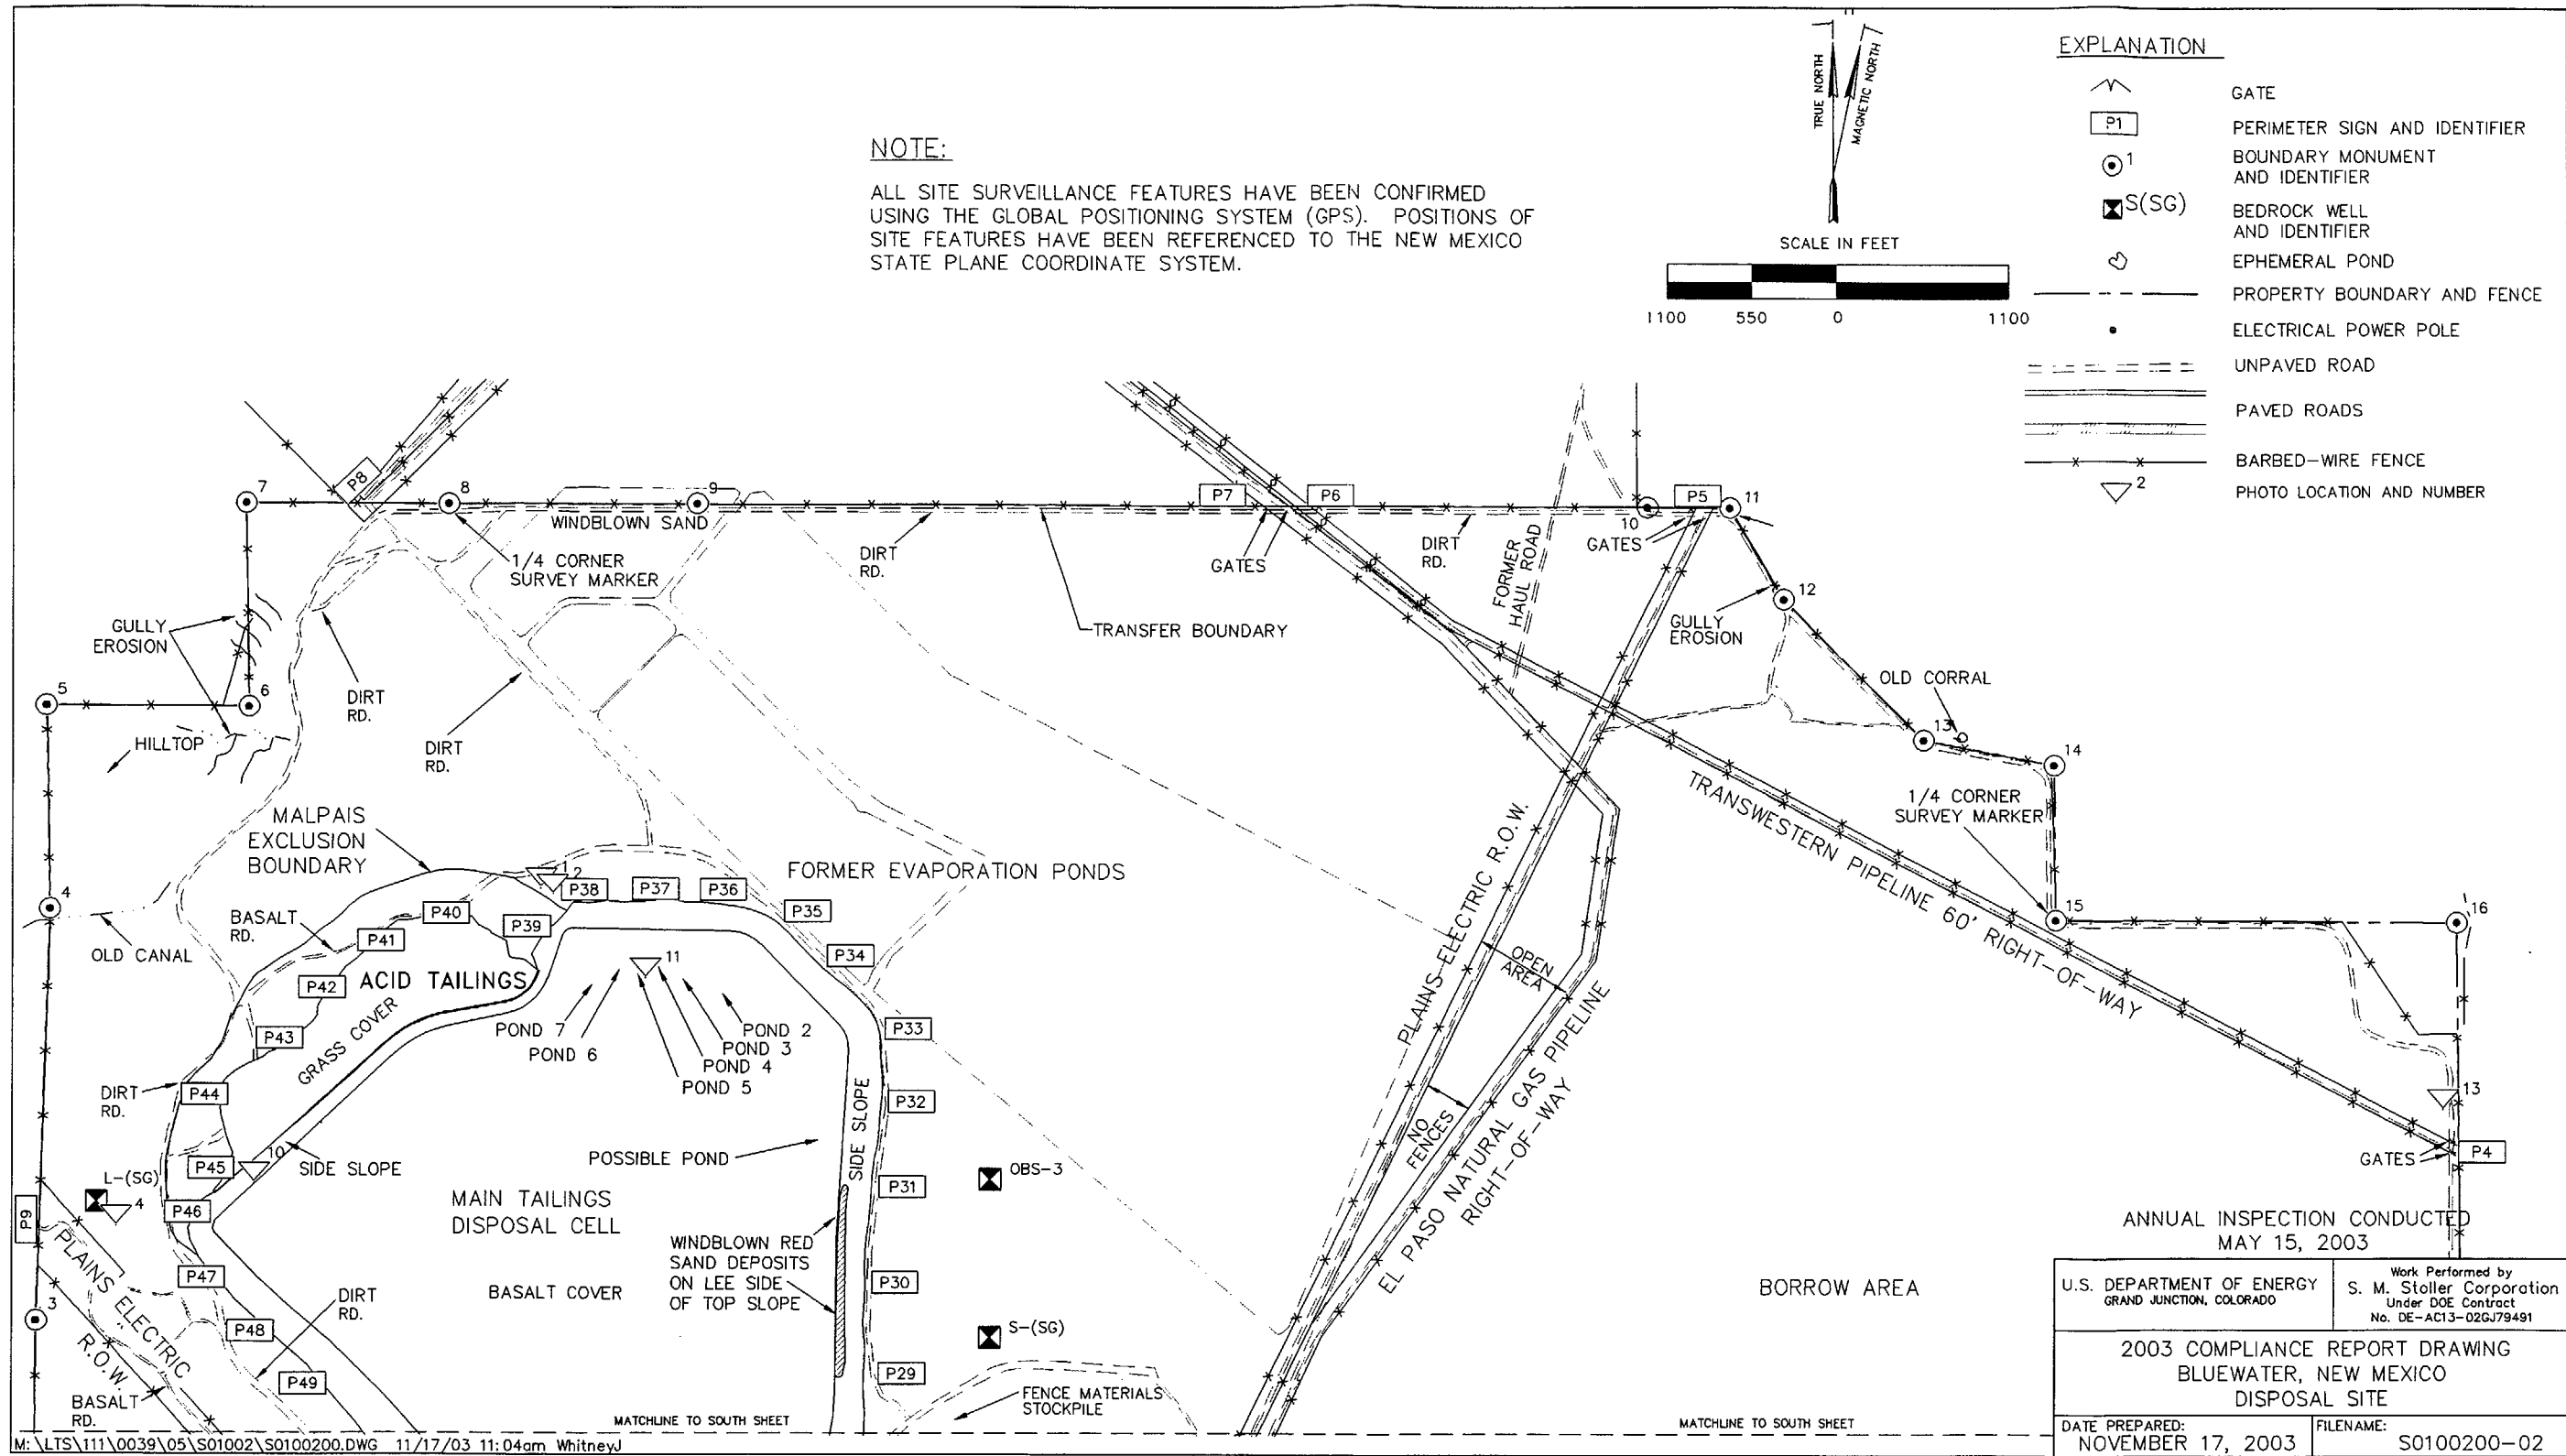
Figure 1-2. Bluewater, New Mexico, North Area, 2003

At the north end of the main tailings disposal cell, the top slope flattens to less than 0.5 percent. In previous years, inspectors found water ponded in depressions in this area. This year the depressions did not contain standing water.

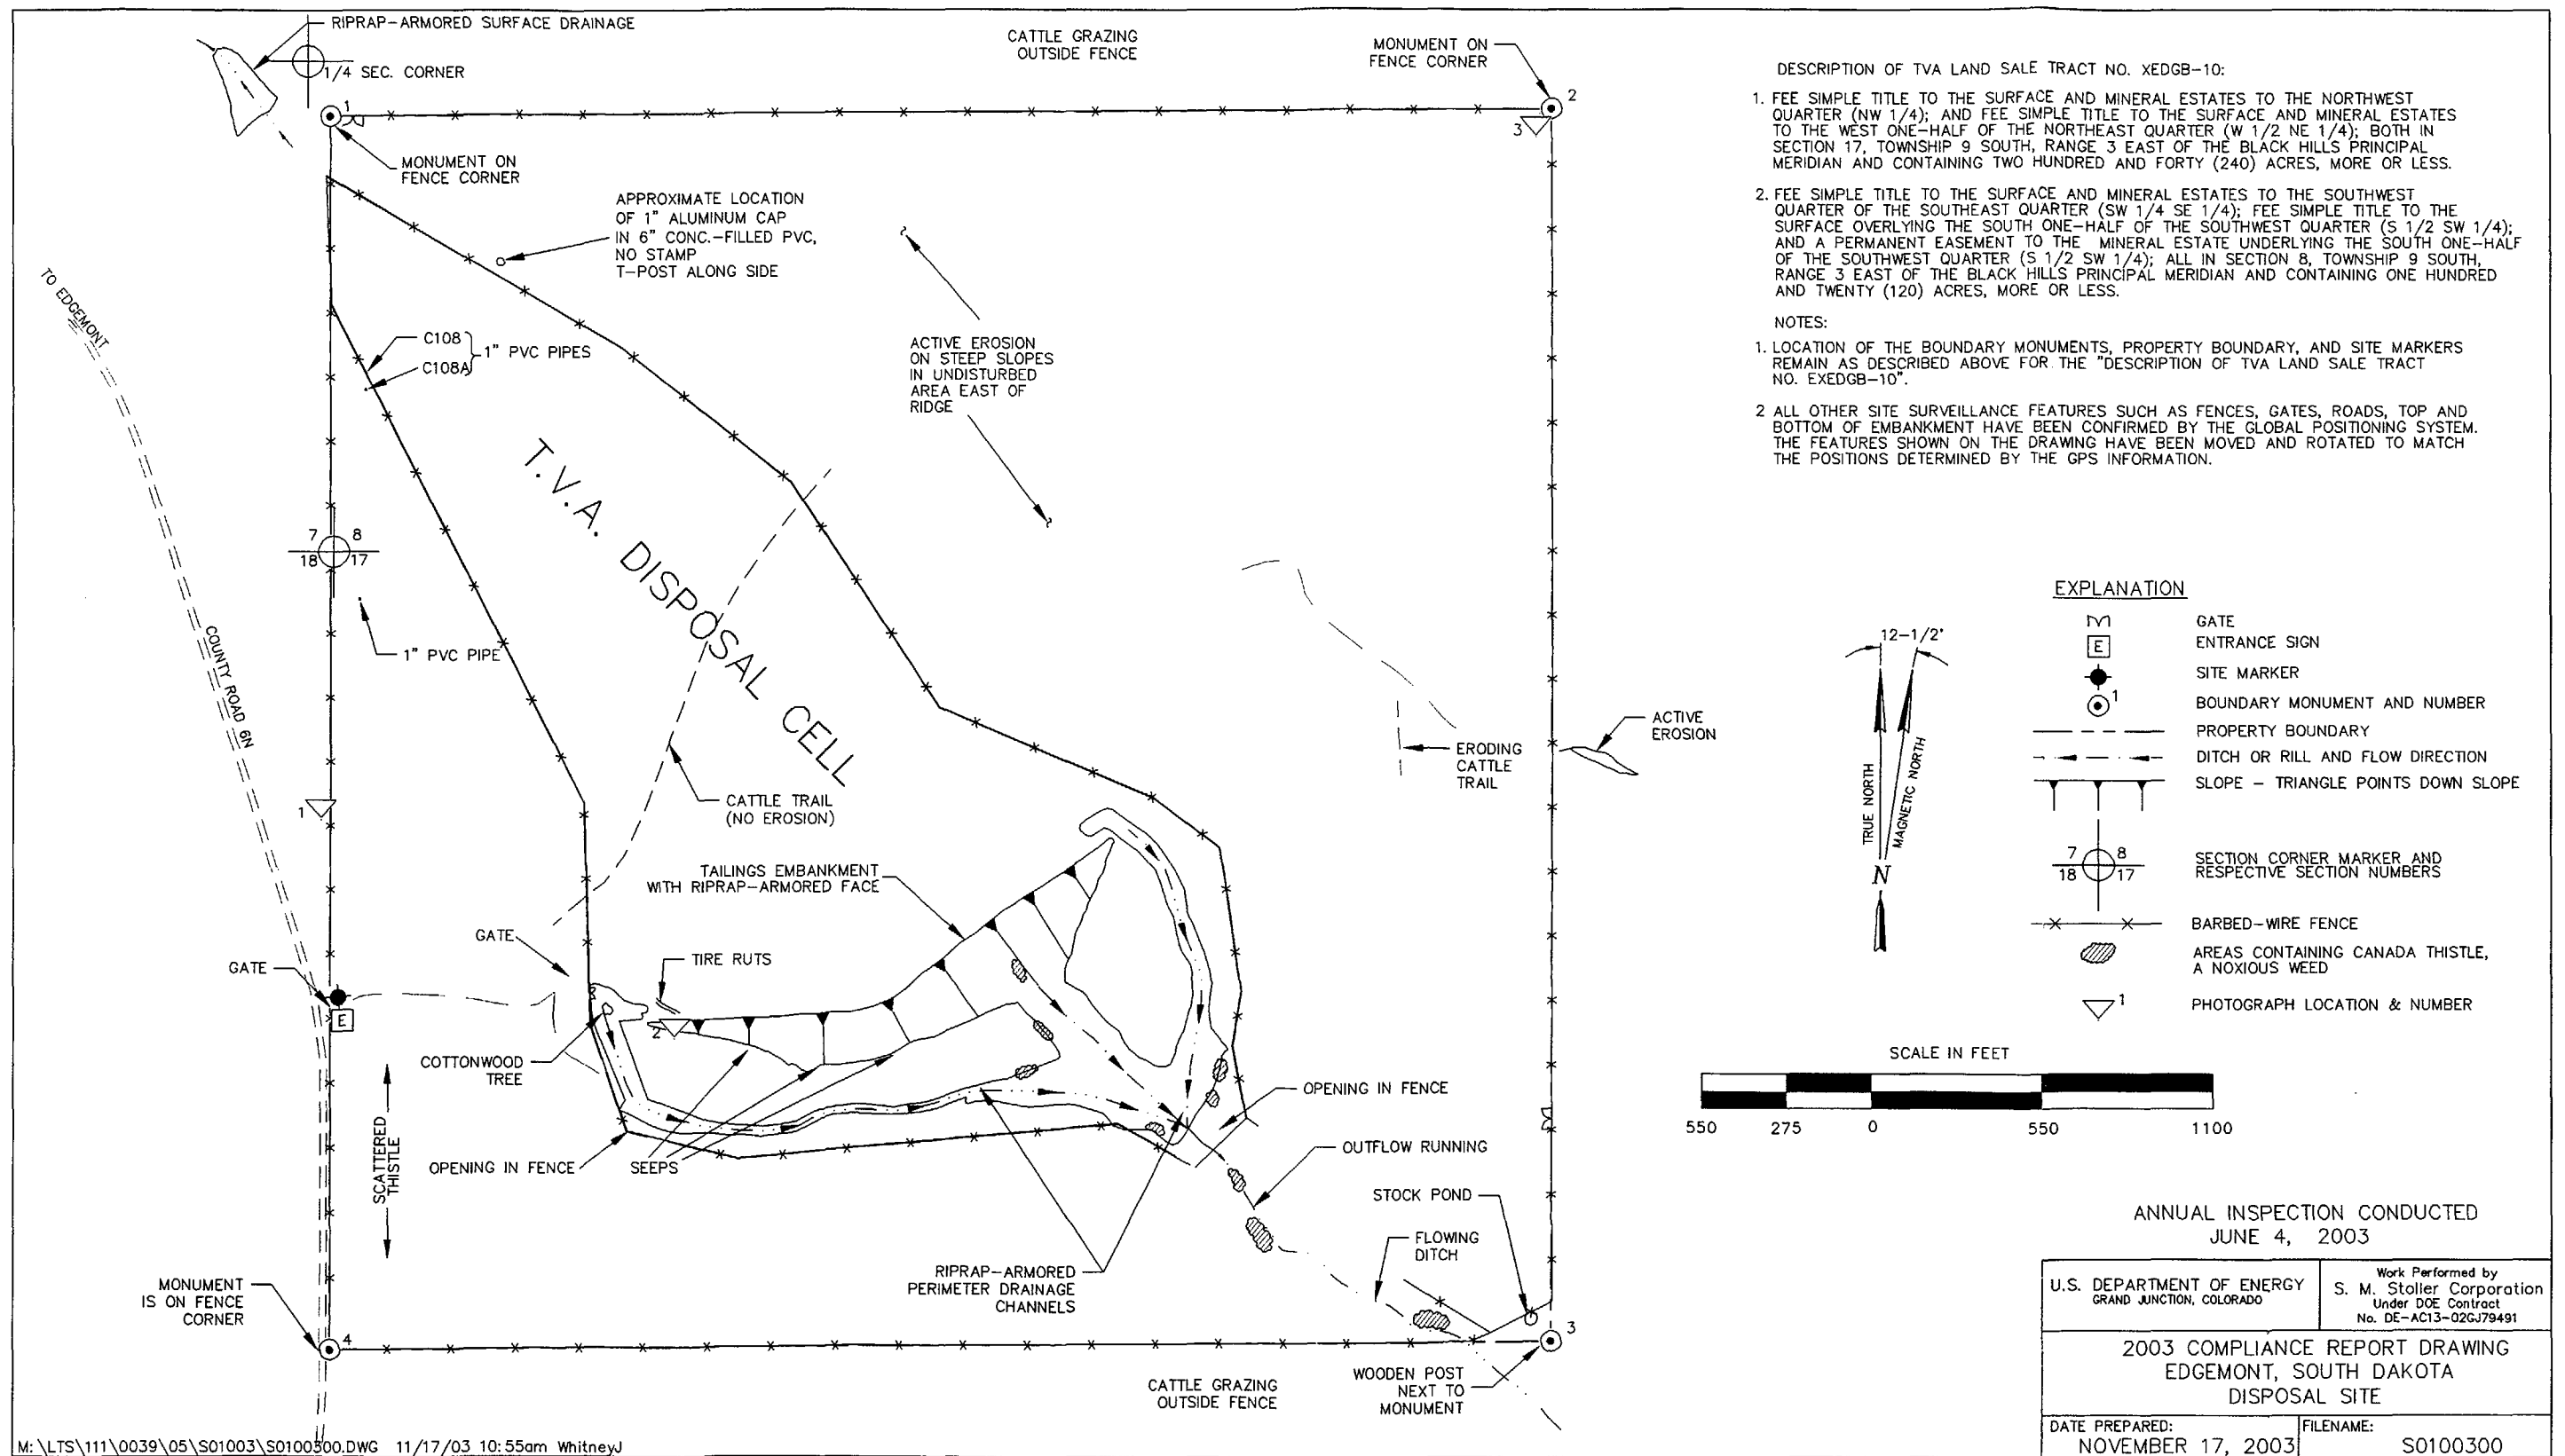
Figure 2-1. Edgemont, South Dakota, 2003

The tailings dam face, the steepest slope on site, is covered with riprap. The slope is stable and the riprap shows no signs of degradation. Scattered plants, mostly grass, grow in the riprap (PL-2). These plants do not pose an immediate threat to stability or function of this structure. The plant density has not increased over the last few years. Plant density in the riprap dam face will continue to be evaluated during future inspections.

Water was present in the drainage outlet below the tailings embankment during the 2003 inspection. The drainage outlet is the lowest point on site and most of the precipitation that falls on the site exits there. There was more water present in the drainage during this inspection than during the 2002 inspection, a result of greater amounts of precipitation falling on the site during the spring and early summer of 2003. Wetland vegetation has established in the drainage outlet below the dam.

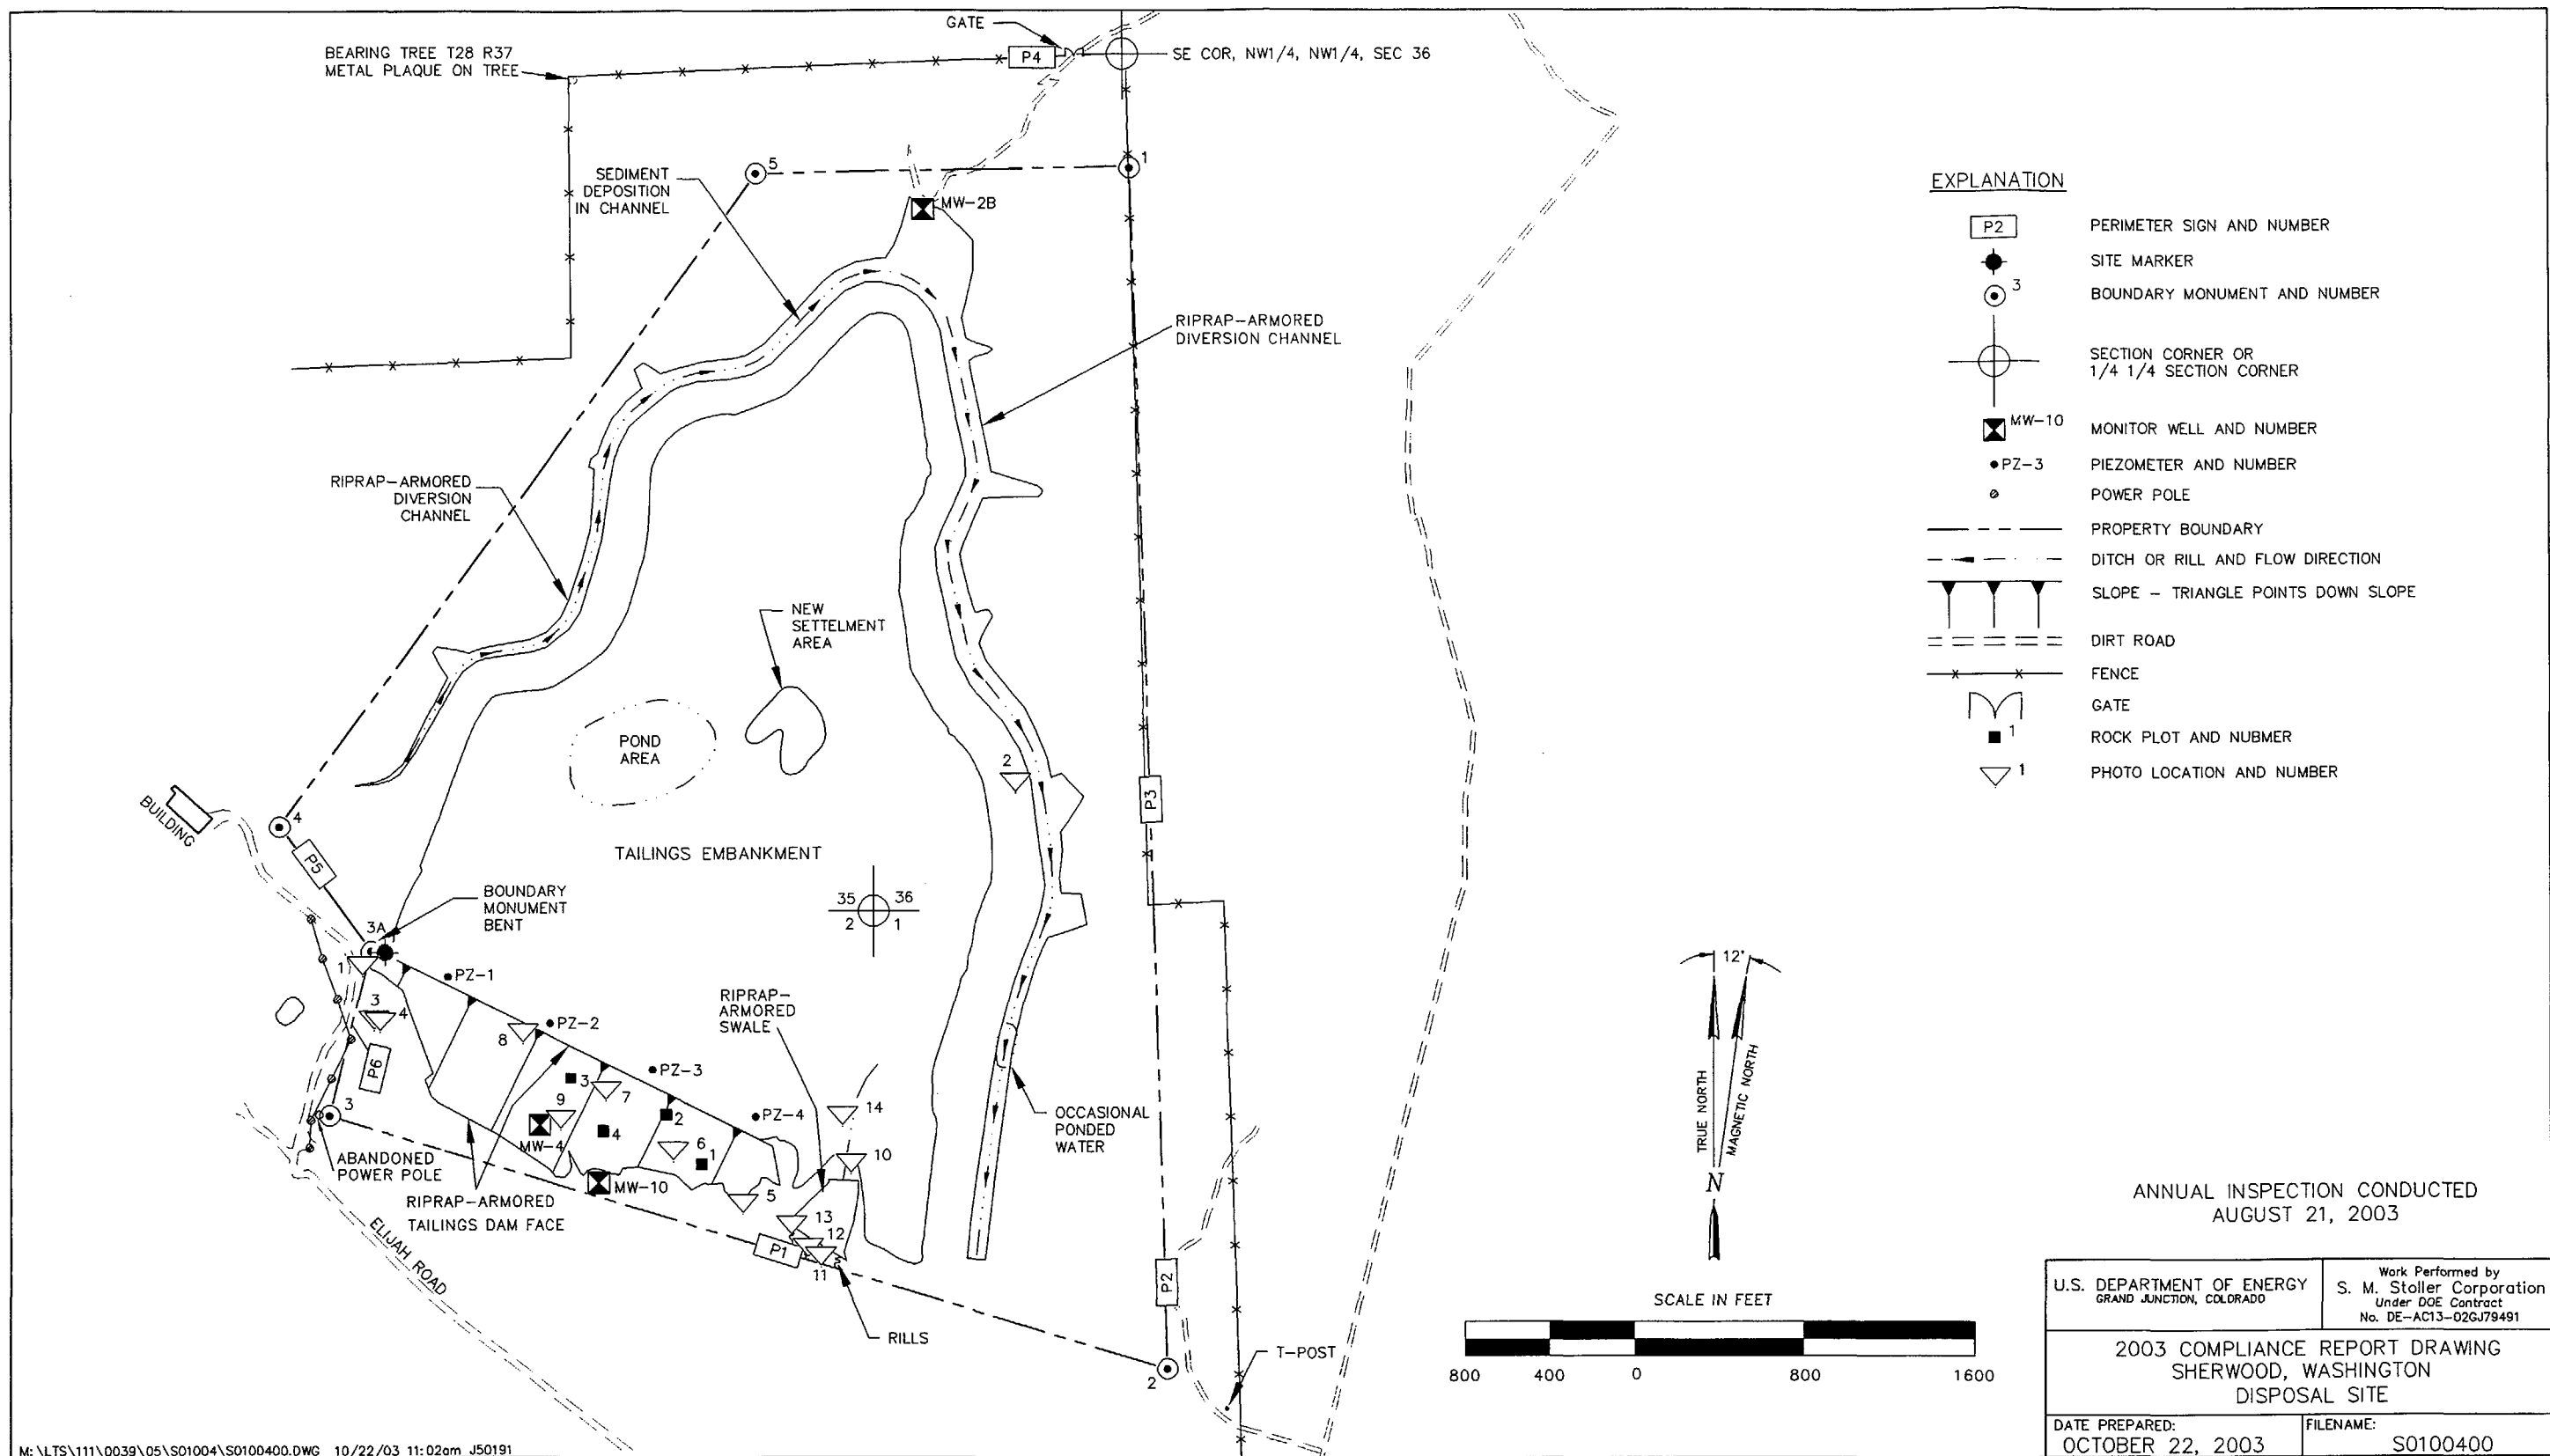
Figure 3-1. Sherwood, Washington, 2003

Designers of the cell predicted that up to 10 feet of settlement could occur on the cover. Settlement has occurred over an approximate 7-acre area that has been referred to as the "pond area" and is shown on Figure 3-1. The pond area contained about 0.5 acre of standing water at the time of the inspection. The pond area was dry during the 2002 inspection. The plant species present indicate that there is year-round moisture below the surface. Vegetation in the pond area is composed primarily of native wetland species such as hardstem bulrush (*Scirpus acutus*), Olney threesquare (*Scirpus americanus*), common spikerush (*Eliocharis palustris*), sandbar willow (*Salix exigua*), and plantain (*Plantago eriopoda*). The pond provides habitat for small mammals, birds, and reptiles and appears to be a water source for larger mammals such as deer and elk, whose sign was abundant in this area.

Inspectors walked the length of the diversion channel. Volunteer plant intrusion within the diversion channel is evident in most areas of the channel; however, because the channel is oversized, this intrusion is not expected to interfere with the channel's design function. Rock condition is good and is the same as observed during earlier inspections. Sediment deposition is evident in places on the west side of the diversion channel, but currently does not interfere with the channel's design function. The degree of sediment deposition should be noted during future inspections although it is not expected to increase to the degree that it could become a maintenance issue. At times, standing water has been observed in the channel along the east side of the impoundment (see Figure 3-1); this area was dry during the 2003 inspection.
