**EXAMINATION OF THE REACTOR VESSEL (RV) HEAD DEGRADATION
AT DAVIS-BESSE**

**FRAMATOME ANP, INC.
DOCUMENT 31-5029337-02**

**PREPARED FOR
FRAMATOME ANP, INC.**

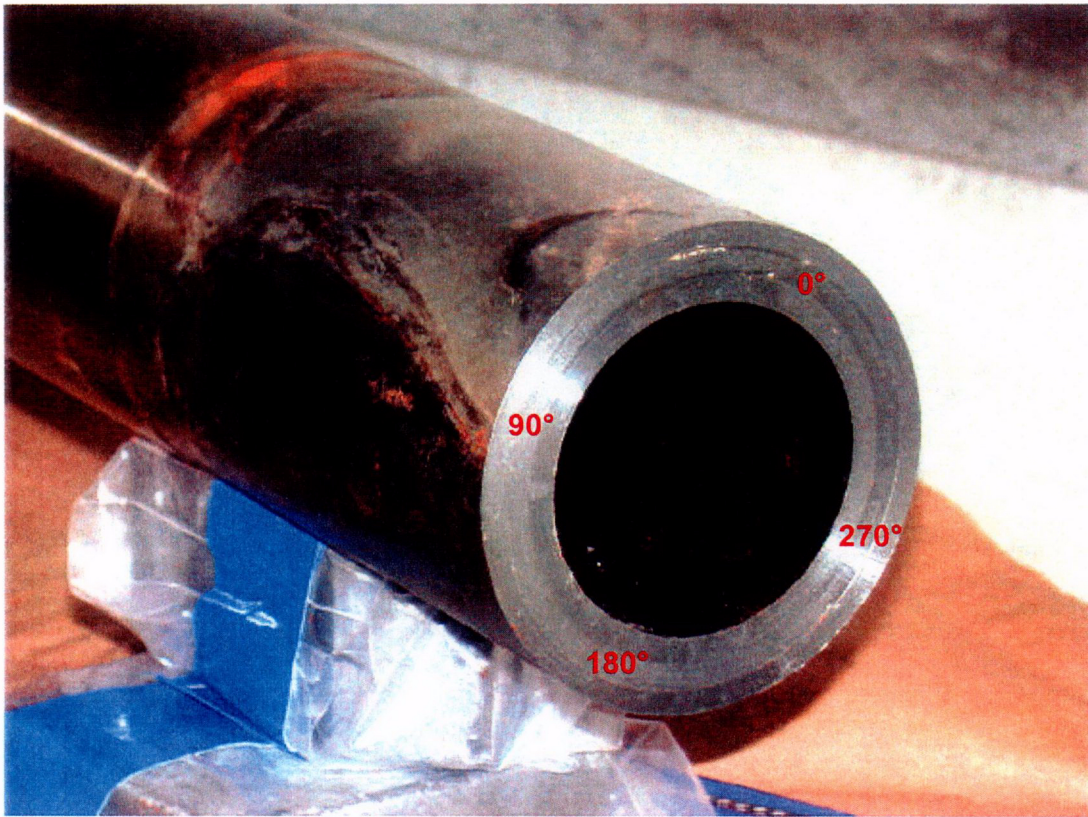
Figure 2.2.3: Photograph showing end view of nozzle #3.

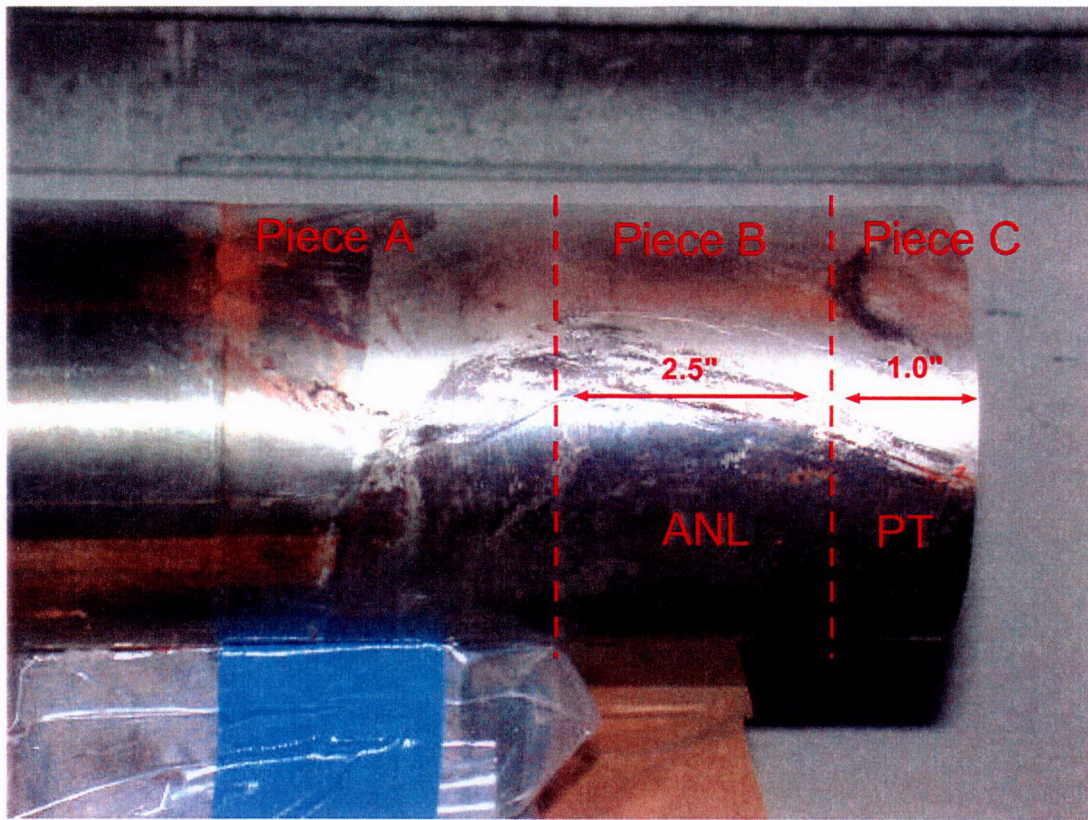
Figure 2.3.1: Sectioning photo for nozzle #3. Piece B was shipped to Argonne National Laboratory and piece C was further tested at BWXT.

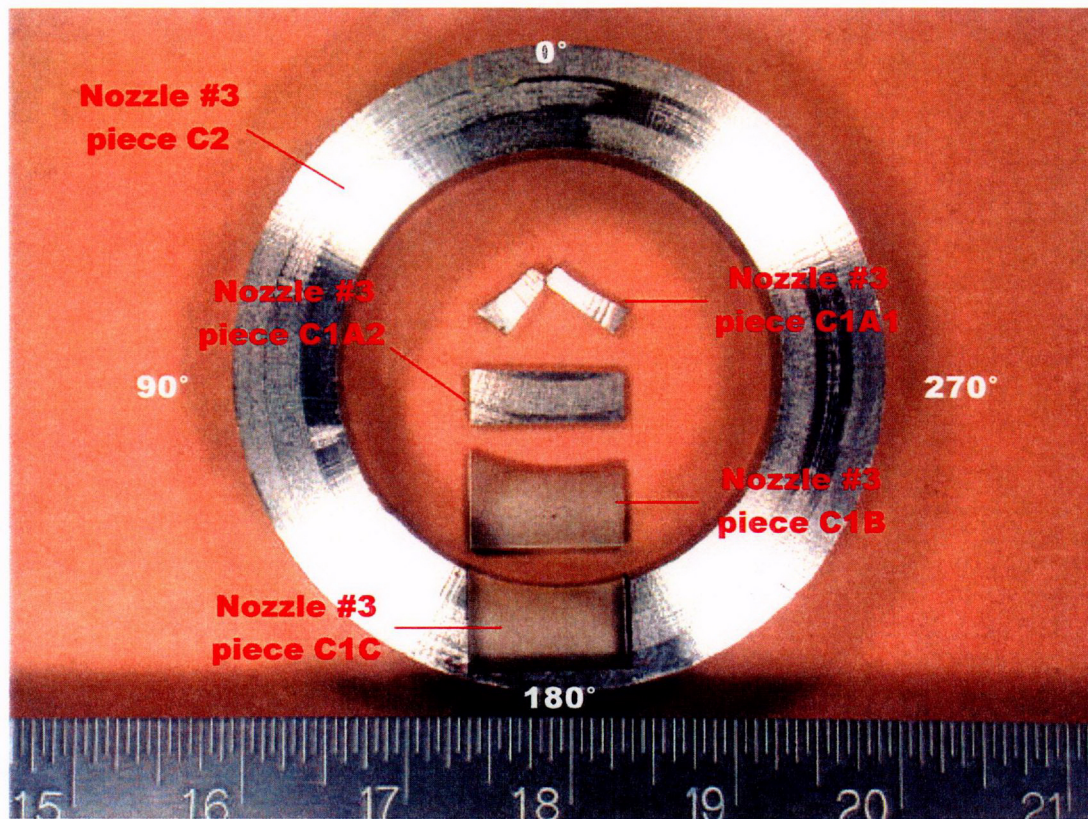
Sectioning for nozzle #3 piece C - looking at lower surface

Figure 2.5.1: Section locations and new sample identifications for nozzle #3 piece C.

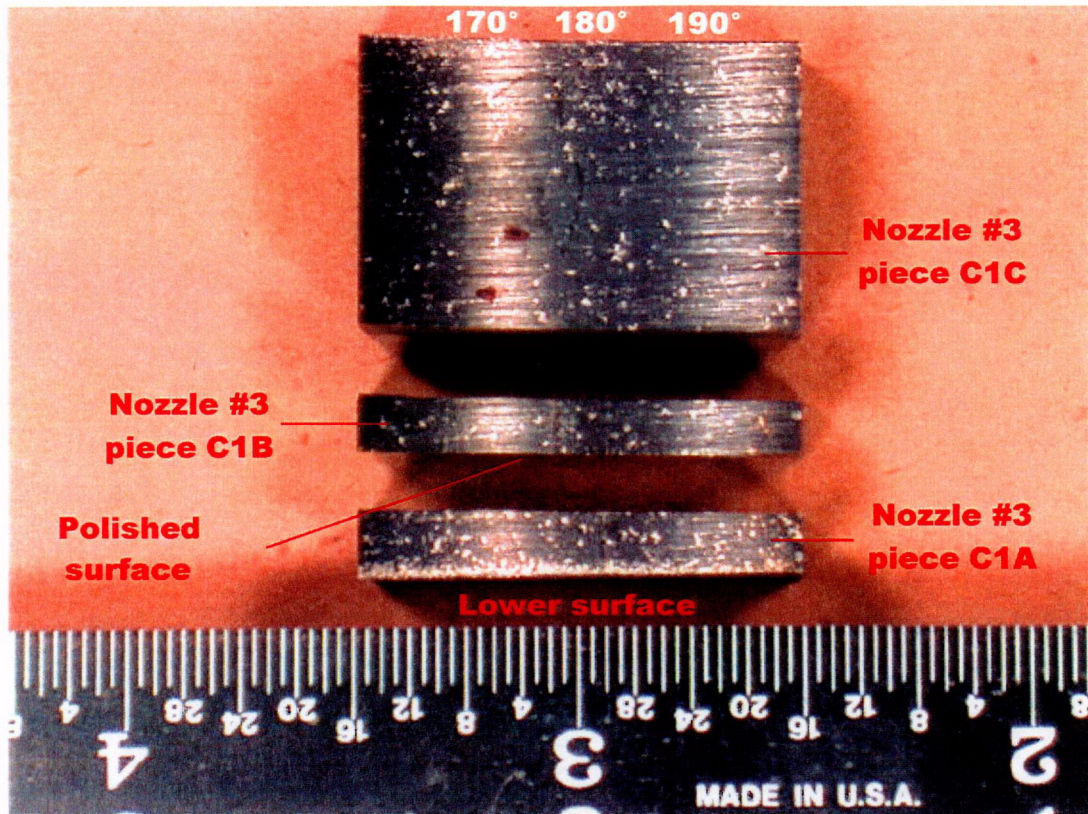
Sectioning for nozzle #3 piece C1 prior to opening lower portion of crack.
Looking at nozzle ID surface; the largest crack is located near 180°.

Figure 2.5.2: Photograph of nozzle #3 samples C1A, C1B, and C1C.

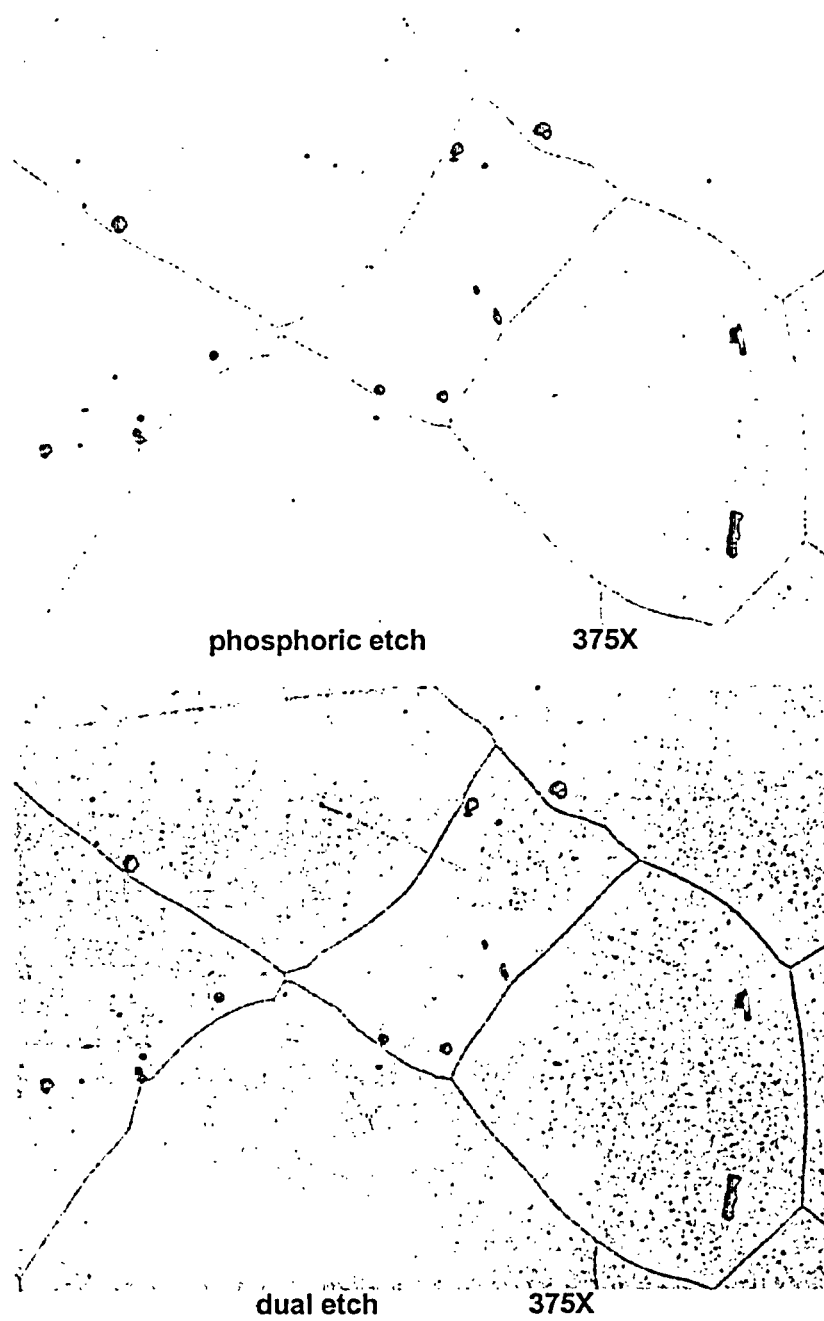
Figure 2.6.5: Typical micrographs taken of the nozzle base material.

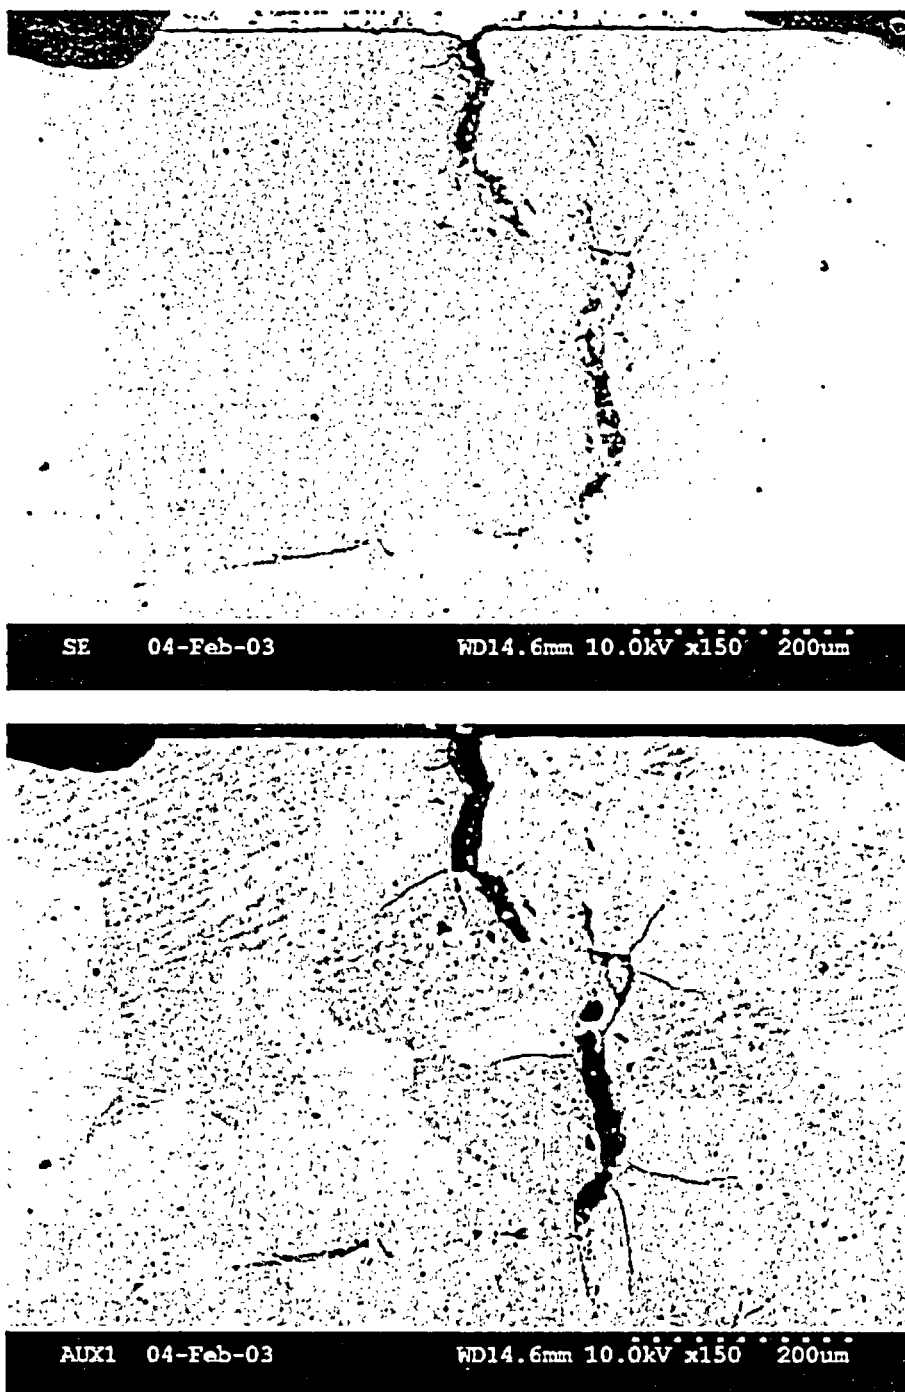
The mounted sample discussed in Section 2.6 above was also examined by SEM/EDS. The sample was examined in the as-polished condition (i.e., no chemical etching). Low magnification micrographs of the largest crack are presented in both the SE and BSE imaging modes in Figure 2.7.1. The full crack length is shown in Figure 2.7.2. In this area, the crack extended approximately 0.08" below the nozzle ID surface. Cracking was also intergranular in nature. A higher magnification micrograph showing the typical grain boundary appearance is provided along with the EDS results in Figure 2.7.3. These results indicated the primary grain boundary constituents were carbon, oxygen, aluminum, nickel, chromium and iron. A very high magnification micrograph and corresponding EDS results are provided in Figure 2.7.4. For this area, the grain boundary composition (solid fill spectrum) is compared to the bulk grain composition (line spectrum). These results clearly show increased oxygen, chromium, and iron as well as diminished nickel at the grain boundary compared to the bulk grain chemical composition. Semi-quantitative EDS analysis was used to determine the nozzle base material chemical composition. These results, which are presented in Figure 2.7.5, were consistent with those expected for Alloy 600.

Figure 2.7.1: Low magnification SE (top) and BSE (bottom) taken near the nozzle ID surface (upper edge of micrographs). 150X

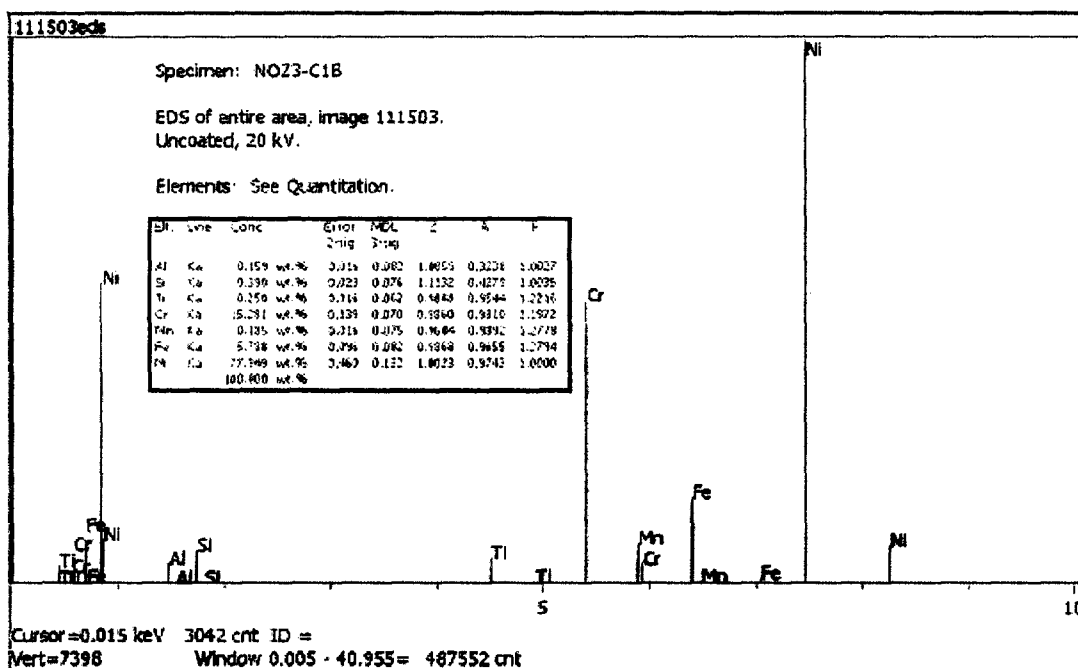
Reference micrograph for EDS semi-quantitative analysis

Figure 2.7.5: Reference micrograph and semi-quantitative EDS results for nozzle material. The results appeared consistent with those expected for Alloy 600.
