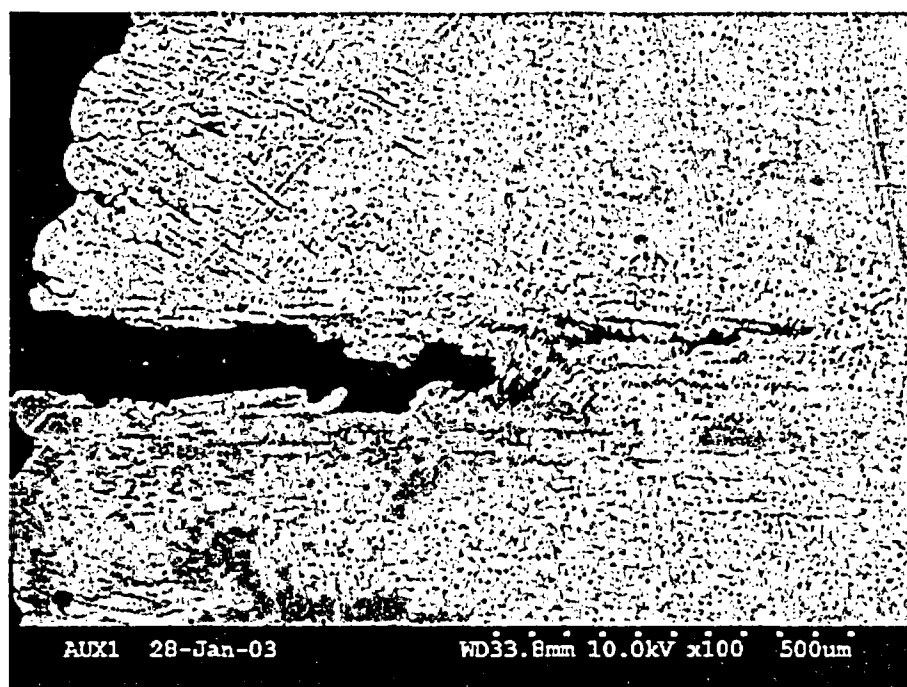
100X

Figure 6.1.2.2: SEM micrographs showing interdendritic crack path along the elongated ferrite pools.

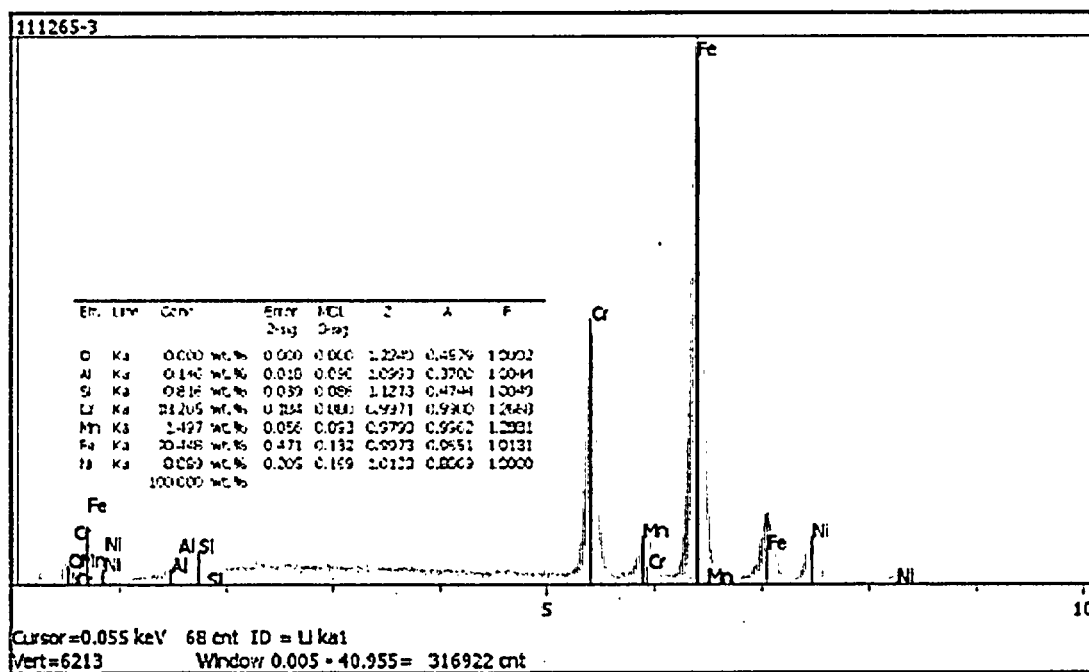
EDS results for Area 3.

Figure 6.2.2.1 (cont.): EDS results for Areas 2 and 3.

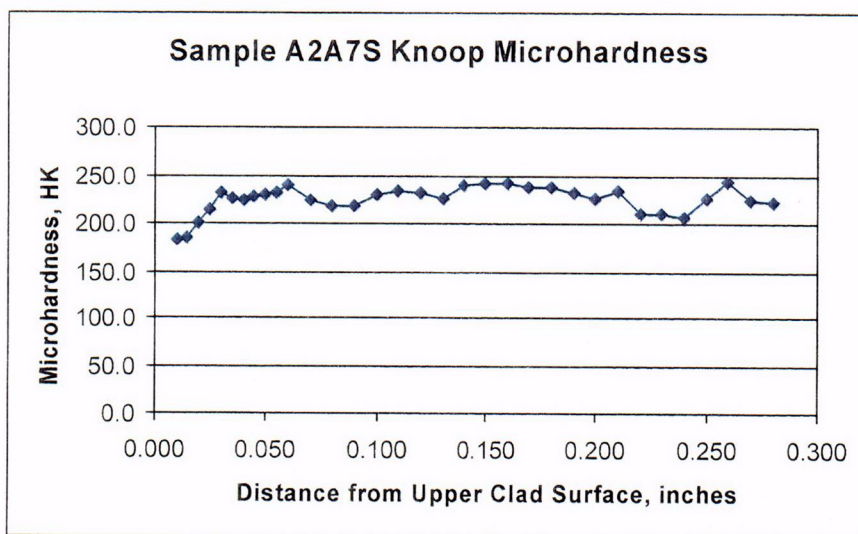
Figure 6.3.1.1: 4X macro photograph of metallurgical mount A2A7S. Refer to Figure 5.11 for the sample orientation. Knoop microhardness values exhibited lower hardness readings toward the exposed clad side (left side of graph), which was in contrast to A2A7M.

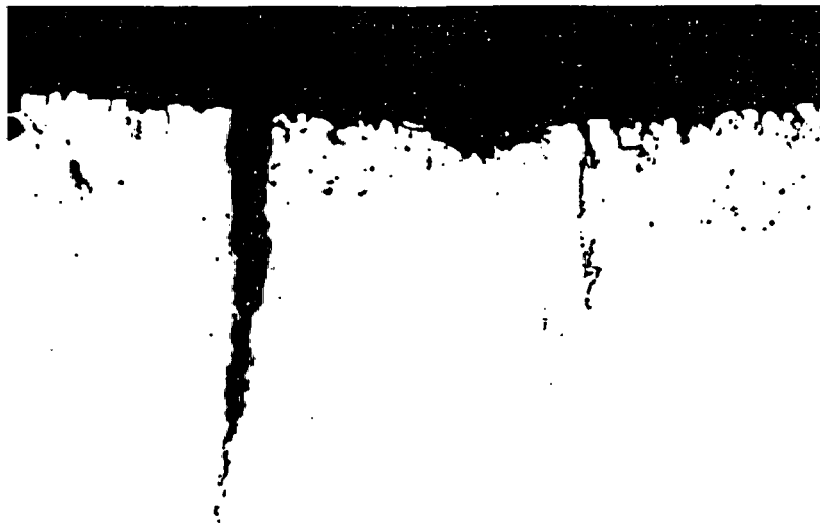
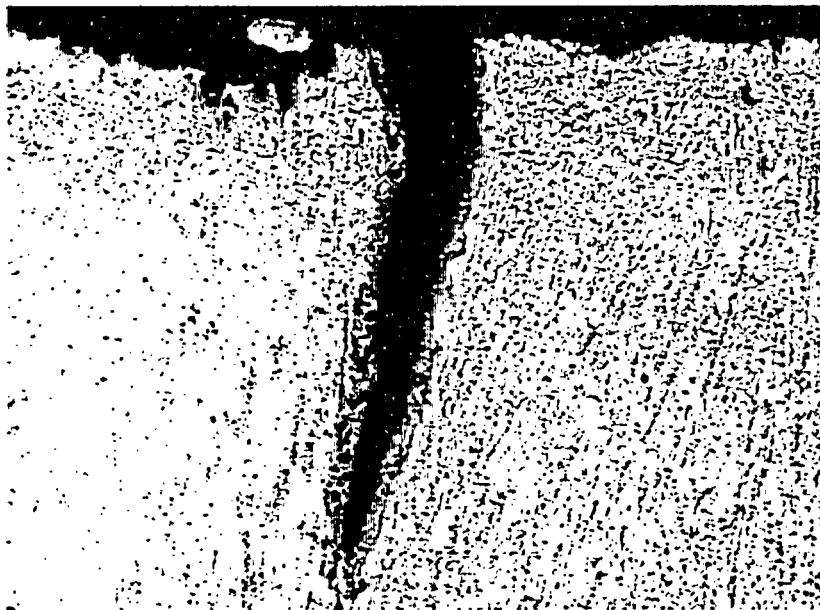
Figure 6.3.1.3: Micrographs of cracking observed on sample A2A7S. Different cracks are shown.

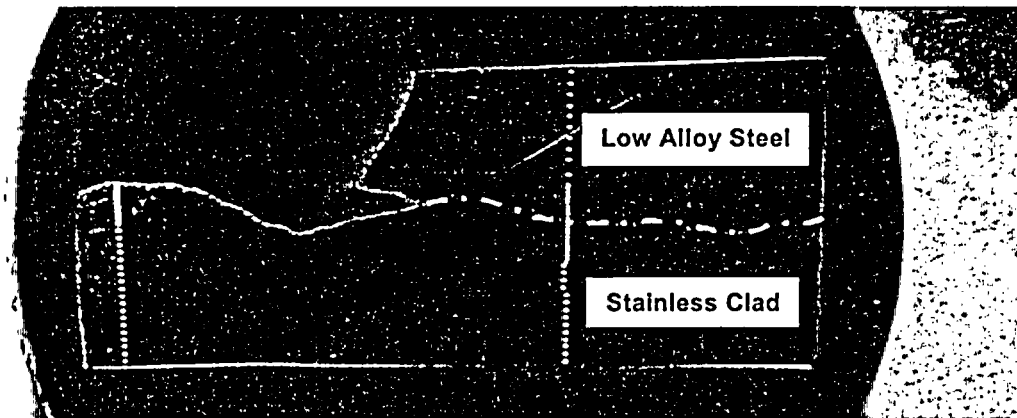
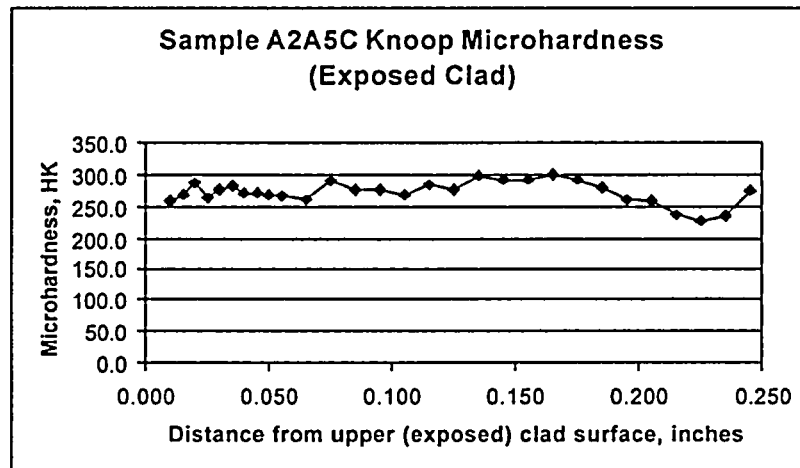
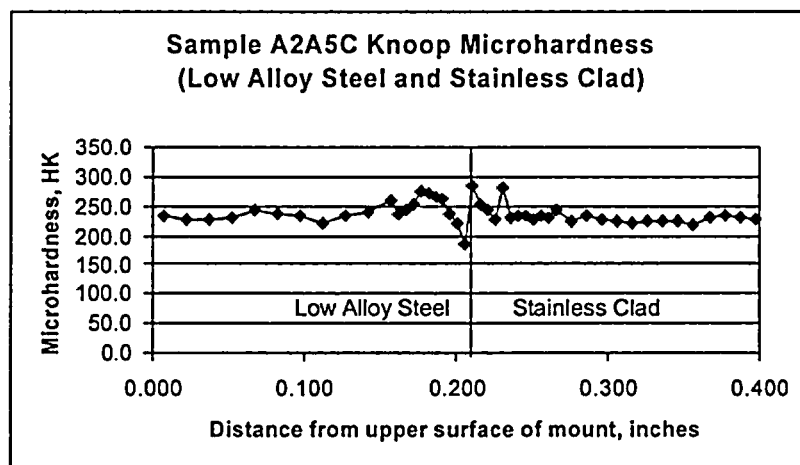
Figure 6.5.1.1: 4X macro photograph of metallographic mount A2A5C, along with Knoop microhardness data. Refer to Figure 5.13 for the sample orientation. The two Knoop microhardness traverse lines are visible in the macro photo. The significant microhardness variations occur in the heat affected zone of the low alloy steel and the cladding adjacent to the fusion line.

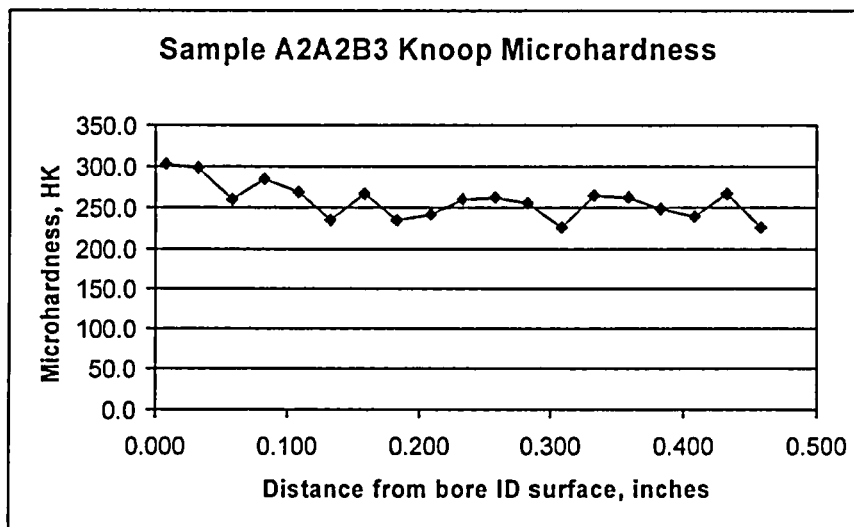
Figure 7.1.1.1: Macro photograph and Knoop microhardness results for metallographic sample A2A2B3 (see Figure 5.2 for the sample orientation). The lower concave surface is the I.D. of the nozzle 3 bore from the nozzle removal process. The crack tips of the two cracks are estimated to be approximately 0.24" and 0.20" below the surface, respectively. The indentations from the microhardness traverse are visible. The elevated microhardness level near the surface is due to the surface cold work layer from the boring of nozzle 3 removal process (see Figures 5.2 and 7.1.1.5).
