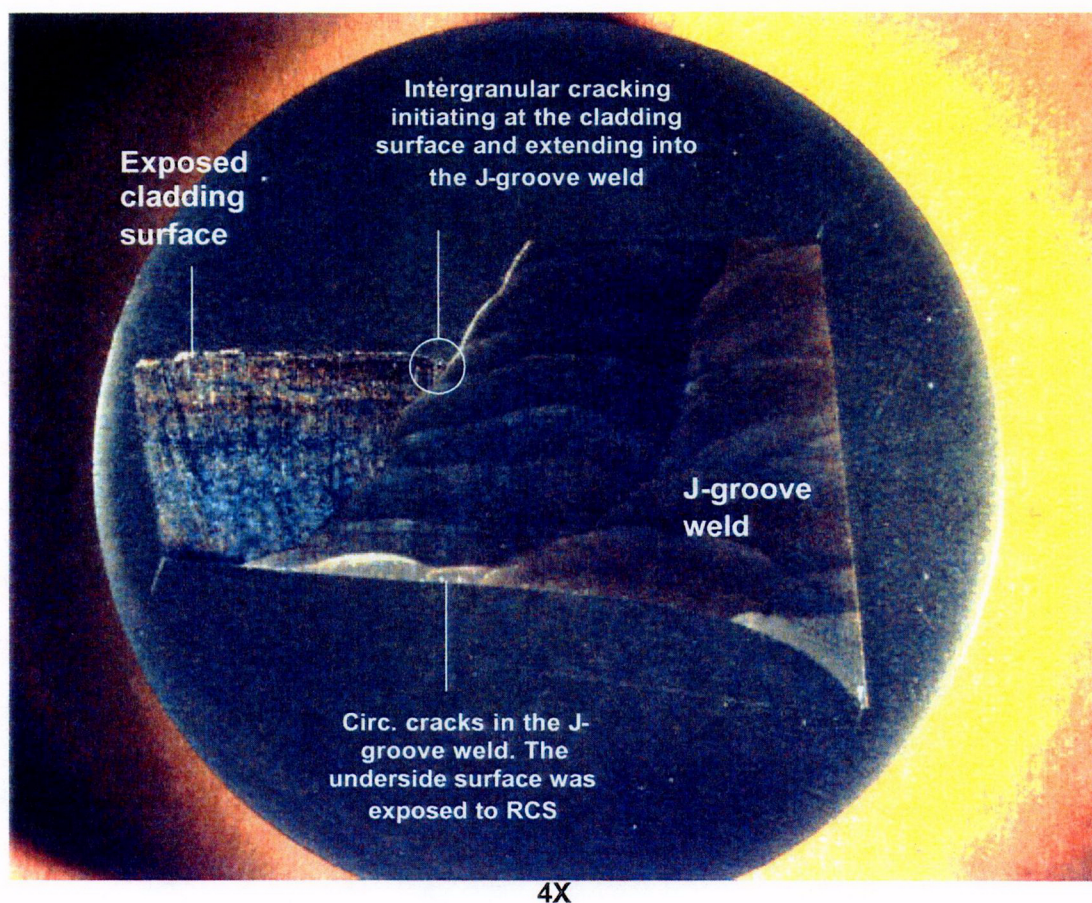
Figure 7.3.1.1: Macro photograph of metallographic sample A2A6A2B2. The mounted surface is through the J-groove weld at  $\sim 45^\circ$ . Refer to Figures 5.6 and 5.7 for the sample orientation.

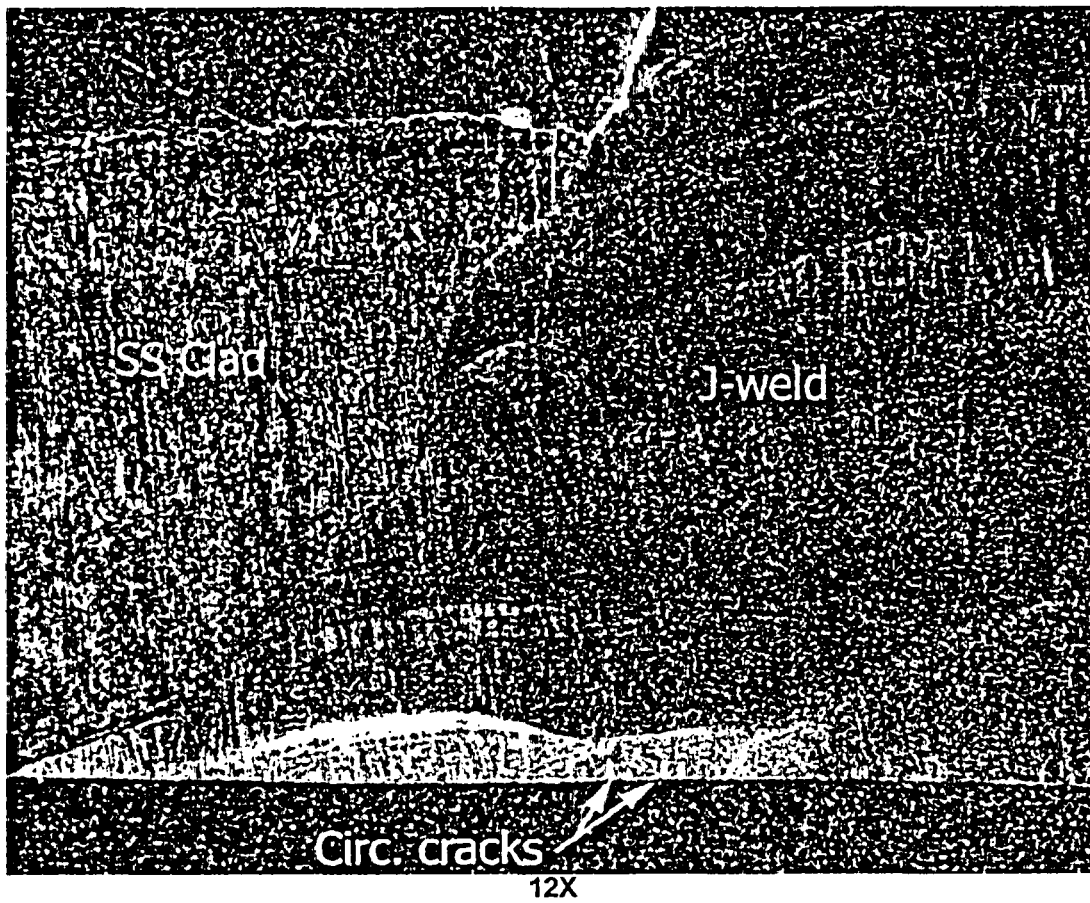
Figure 7.3.1.2: Slightly higher magnification photograph of metallographic mount A2A6A2B2.

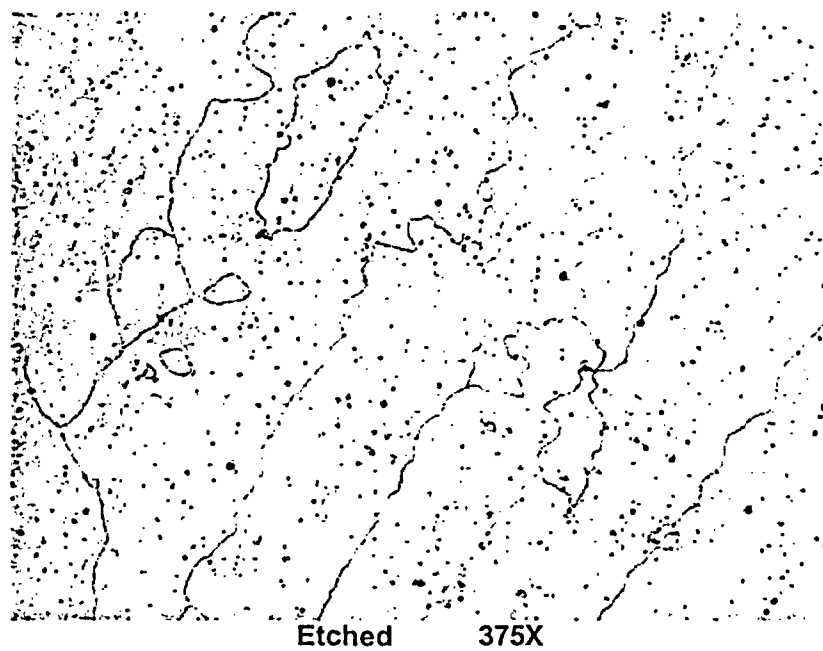
Figure 7.3.1.8: Typical J-groove weld microstructure.

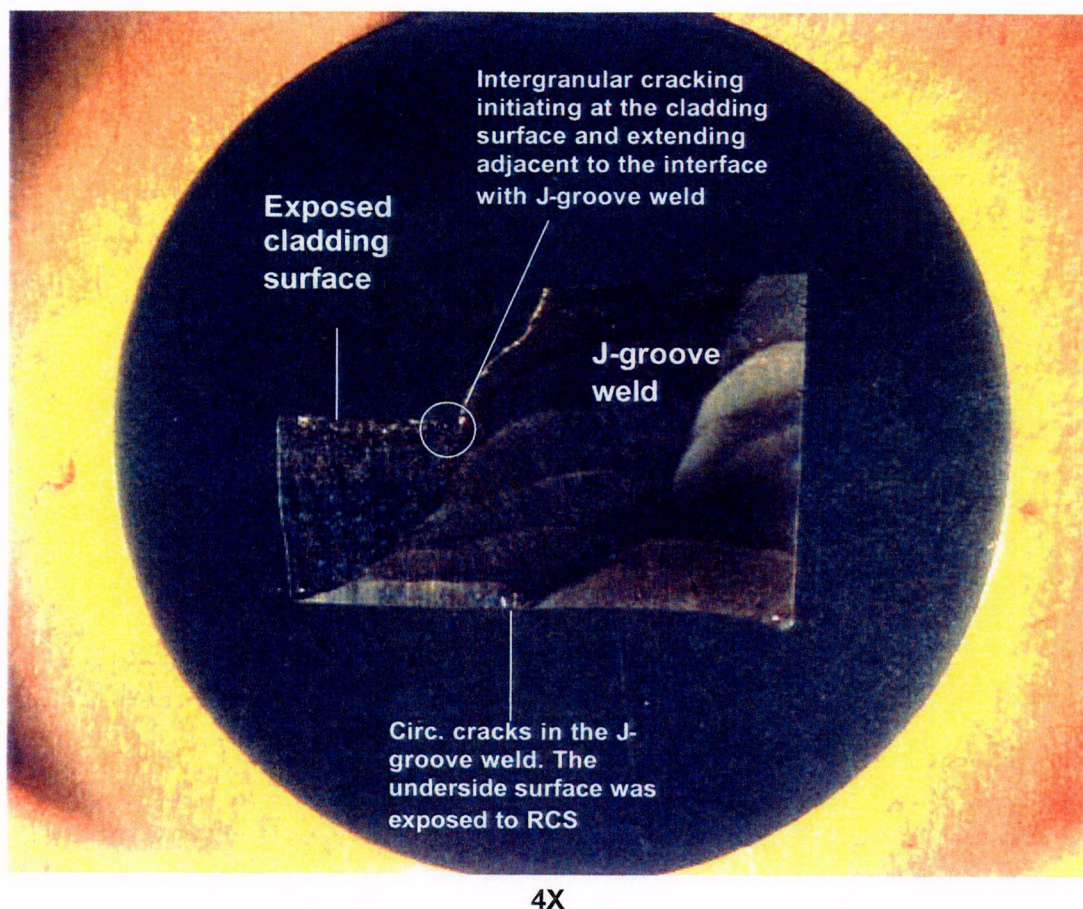
Figure 7.3.2.1: Macro photograph of metallographic mount A2A6A2D2. The mounted surface is through the J-groove weld at  $\sim 30^\circ$ . Refer to Figures 5.6 and 5.9 for the sample location.

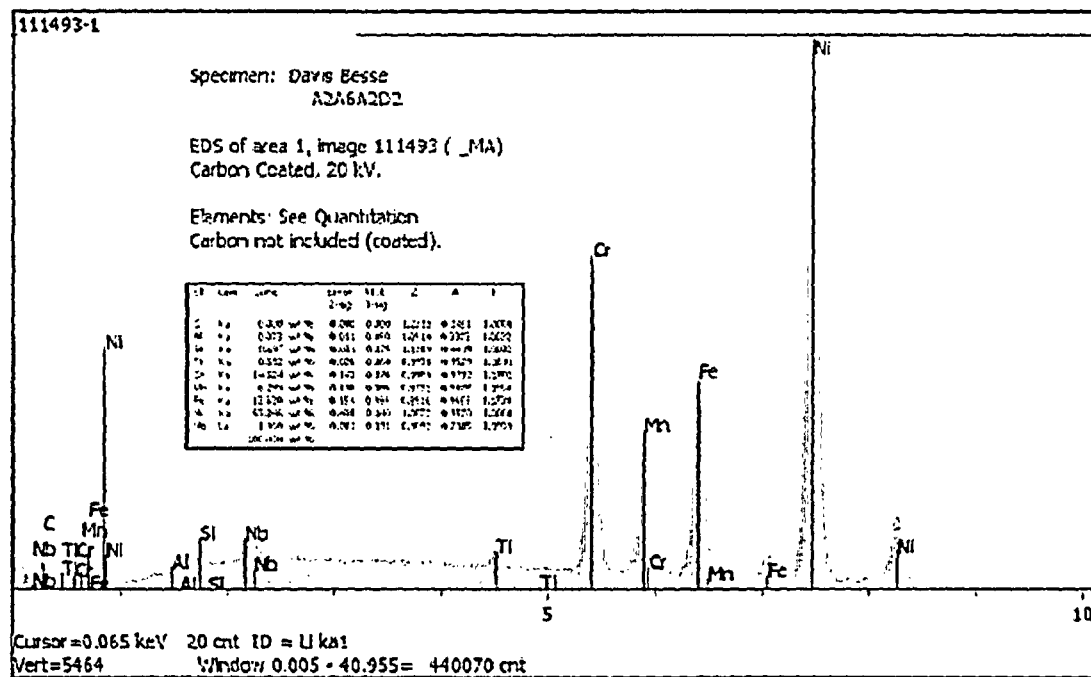
Figure 7.3.3.2: The EDS spectrum for area 1 in Figure 7.3.3.1. The semi-quantitative results from this area, which was located within the J-groove weld, were consistent with Alloy 182 weld metal.

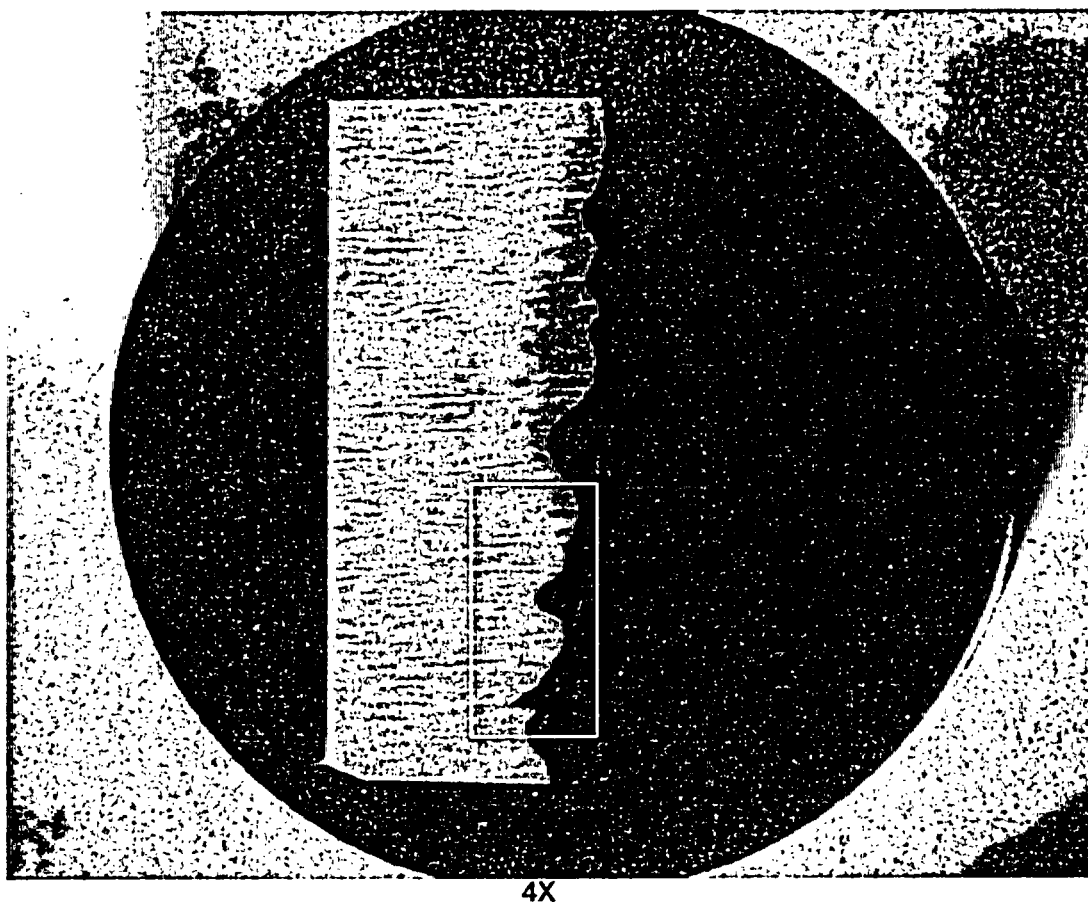
Figure 8.1.2.1: Macro photograph of metallurgical mount A1B4. Refer to Figures 5.13 and 5.14 for the sample location. The white box indicates the area shown at higher magnification in Figure 8.1.2.2.

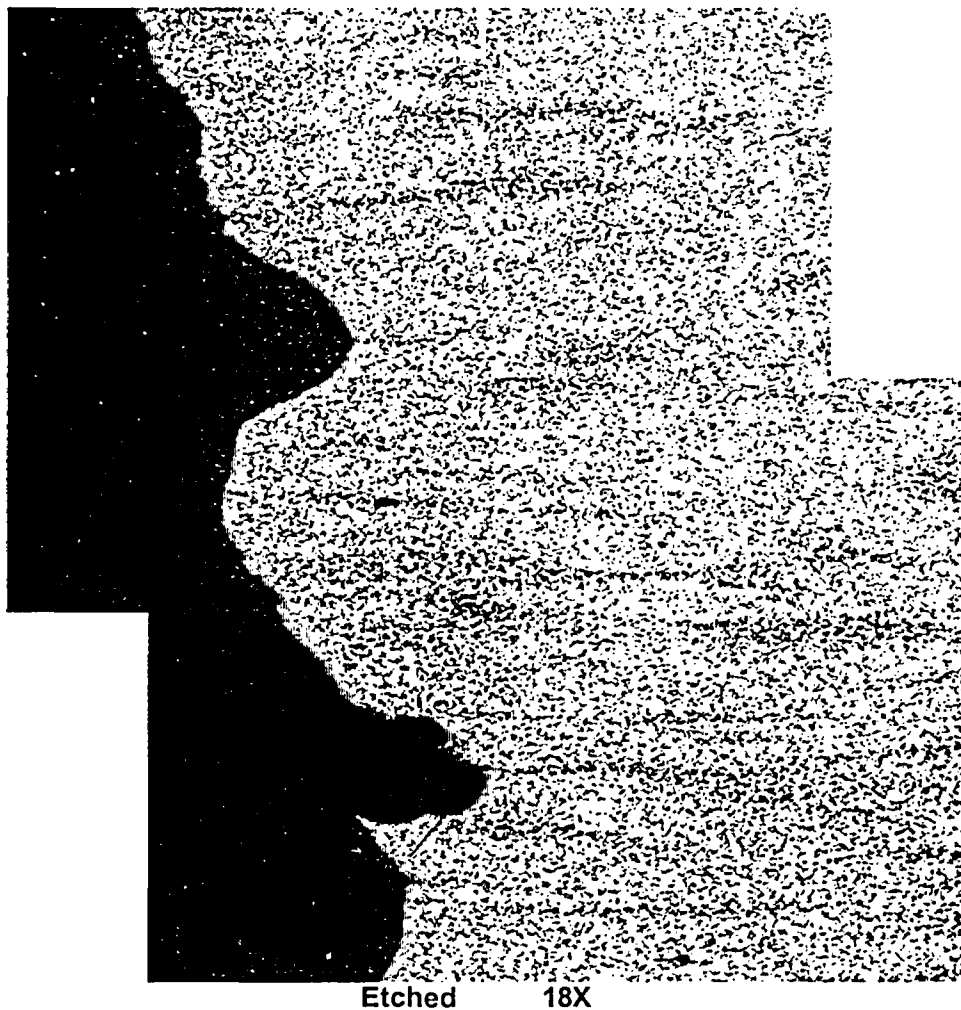
Figure 8.1.2.2: Higher magnification micrograph showing the horizontal striations aligned with the major axis of the RV head low alloy steel plate (SA-533, Gr. B (mod), Cl. 1). However, unlike Figure 8.1.1.3, the striations do not appear to promote a faster corrosion rate locally.

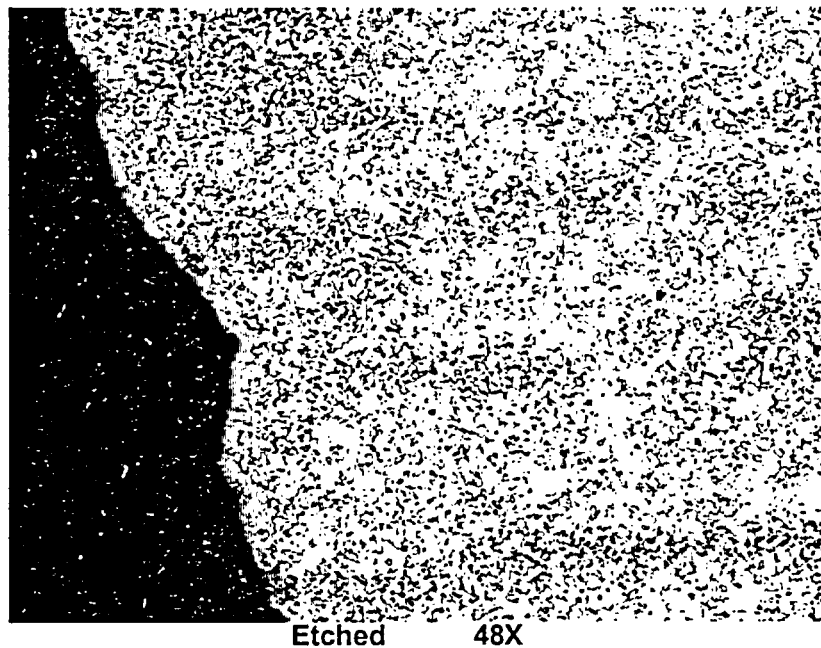
Figure 8.1.2.3: At higher magnification, the local corrosion rate along the striations is increased only very slightly.

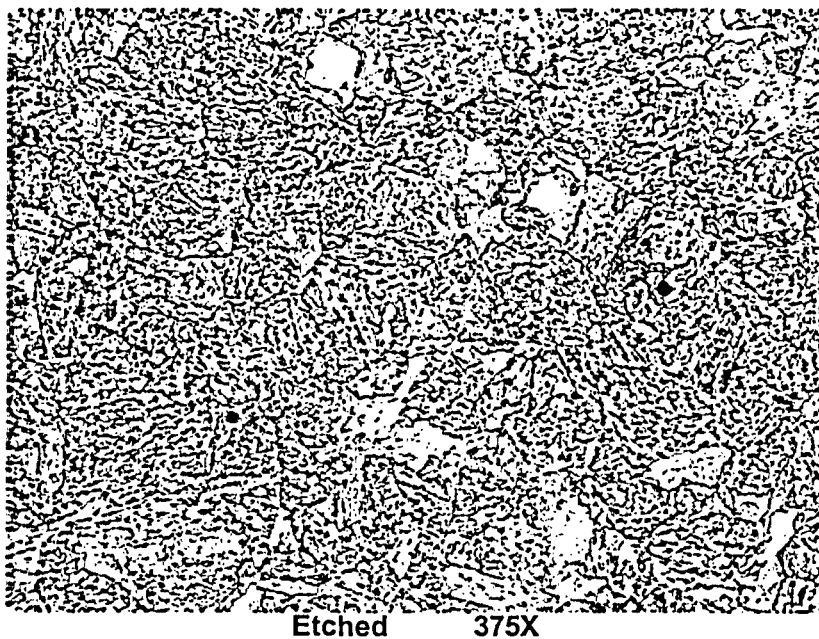
Figure 8.2.2.4: Micrograph showing the typical tempered martensitic microstructure of SA-533, Gr. B (mod), Cl. 1 low alloy steel plate.

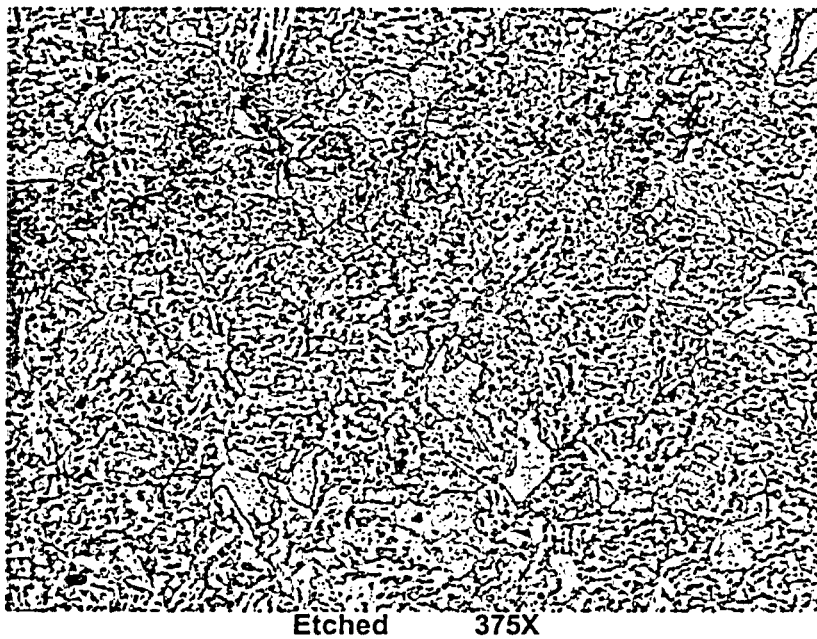
Figure 8.2.3.4: Micrograph showing typical tempered martensitic microstructure of SA-533, Gr. B (mod), Cl. 1 low alloy steel plate.

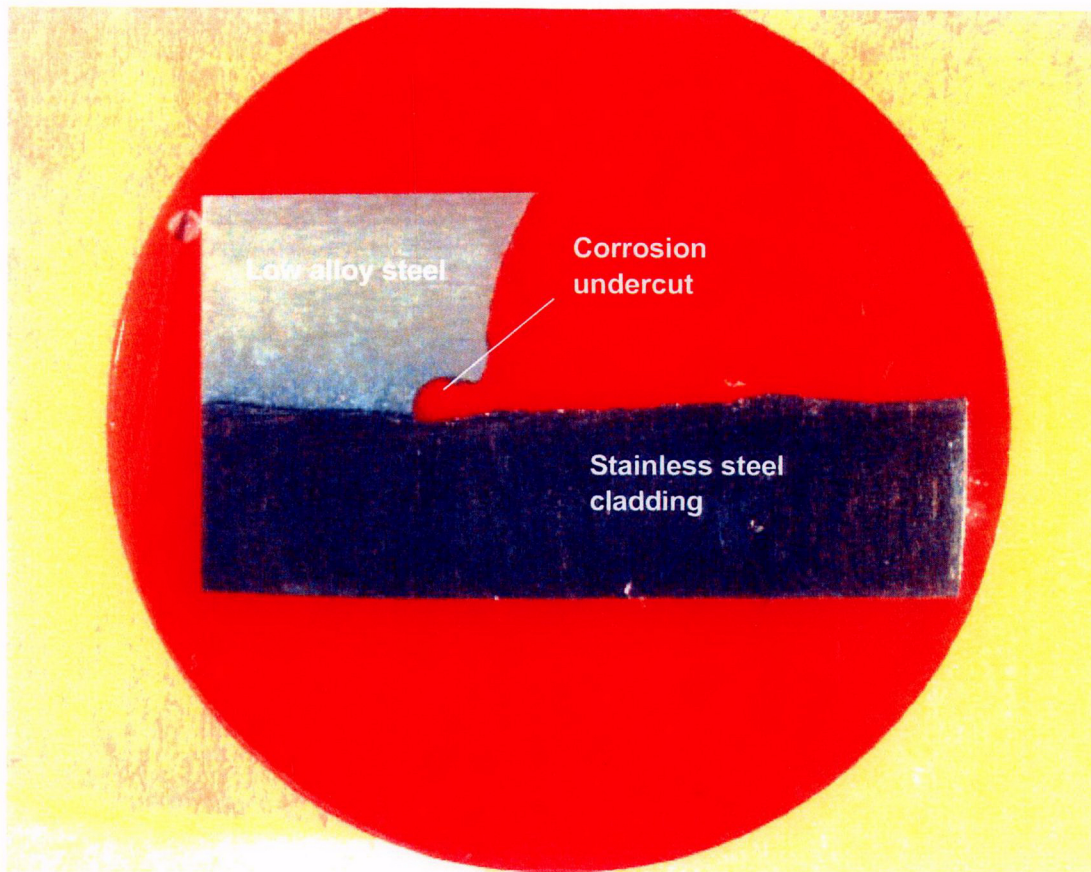
Figure 8.3.1.1: Macro photograph of metallographic mount A2A7D. Refer to Figures 5.1 and 5.11 for the sample location.

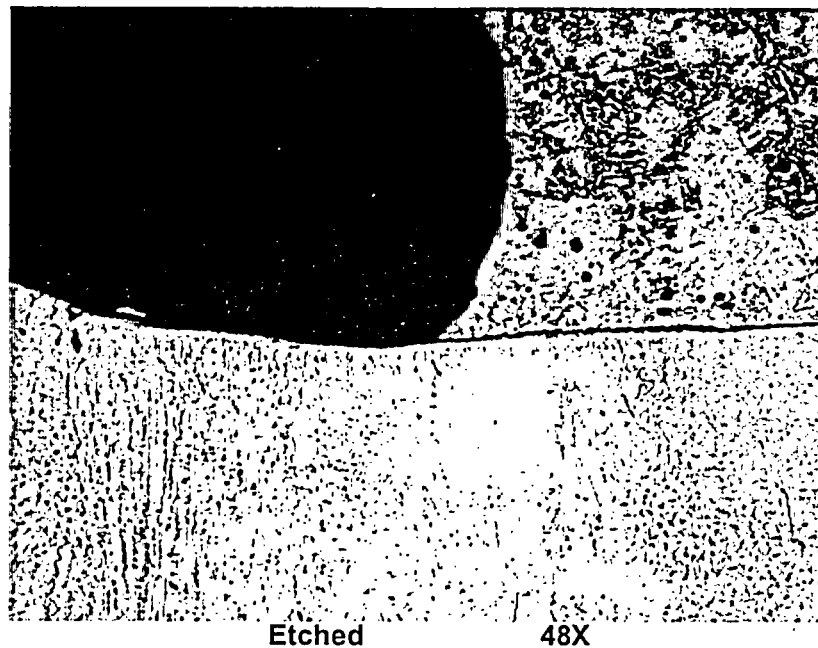
**Figure 8.3.1.2:** Micrograph showing the edge of the exposed cladding in the undercut region. Note: the micrograph is a mirror image of the macrograph in Figure 8.3.1.1.

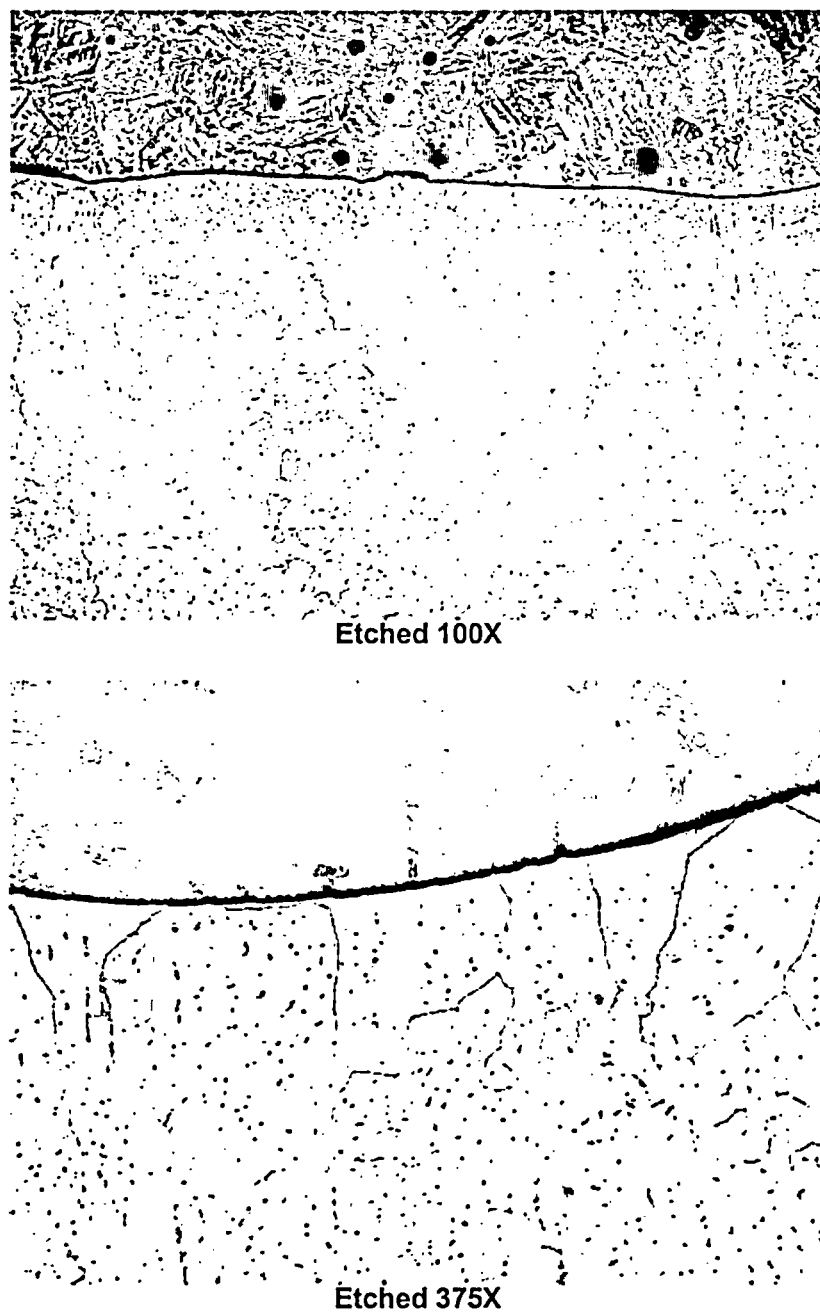
**Figure 8.3.1.5: Micrographs showing the interface between the low alloy steel (above the fusion line) and the stainless steel cladding (below the fusion line).**

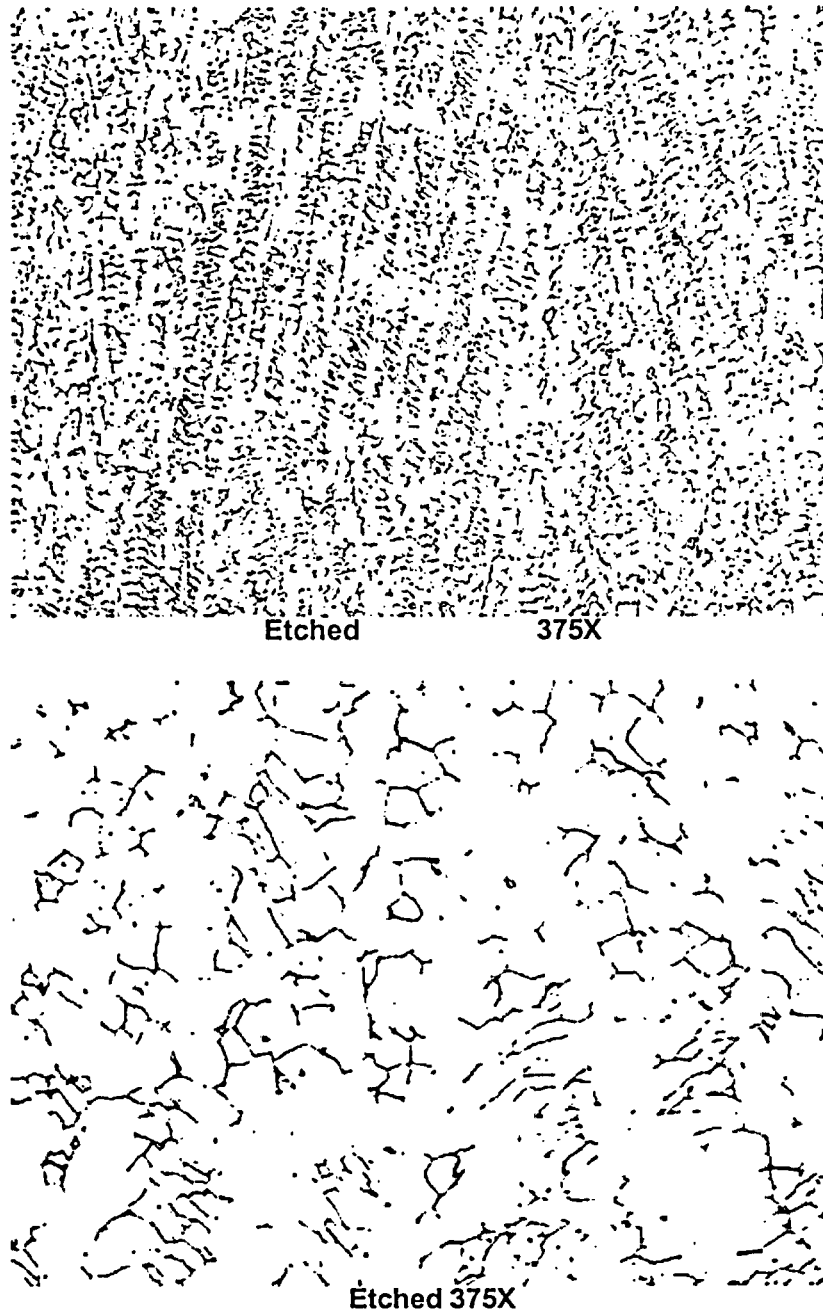
**Figure 8.3.1.6: Micrographs showing typical stainless steel cladding microstructure. The interdendritic solidification structure is delineated by small pools (or islands) of ferrite in an austenitic matrix.**

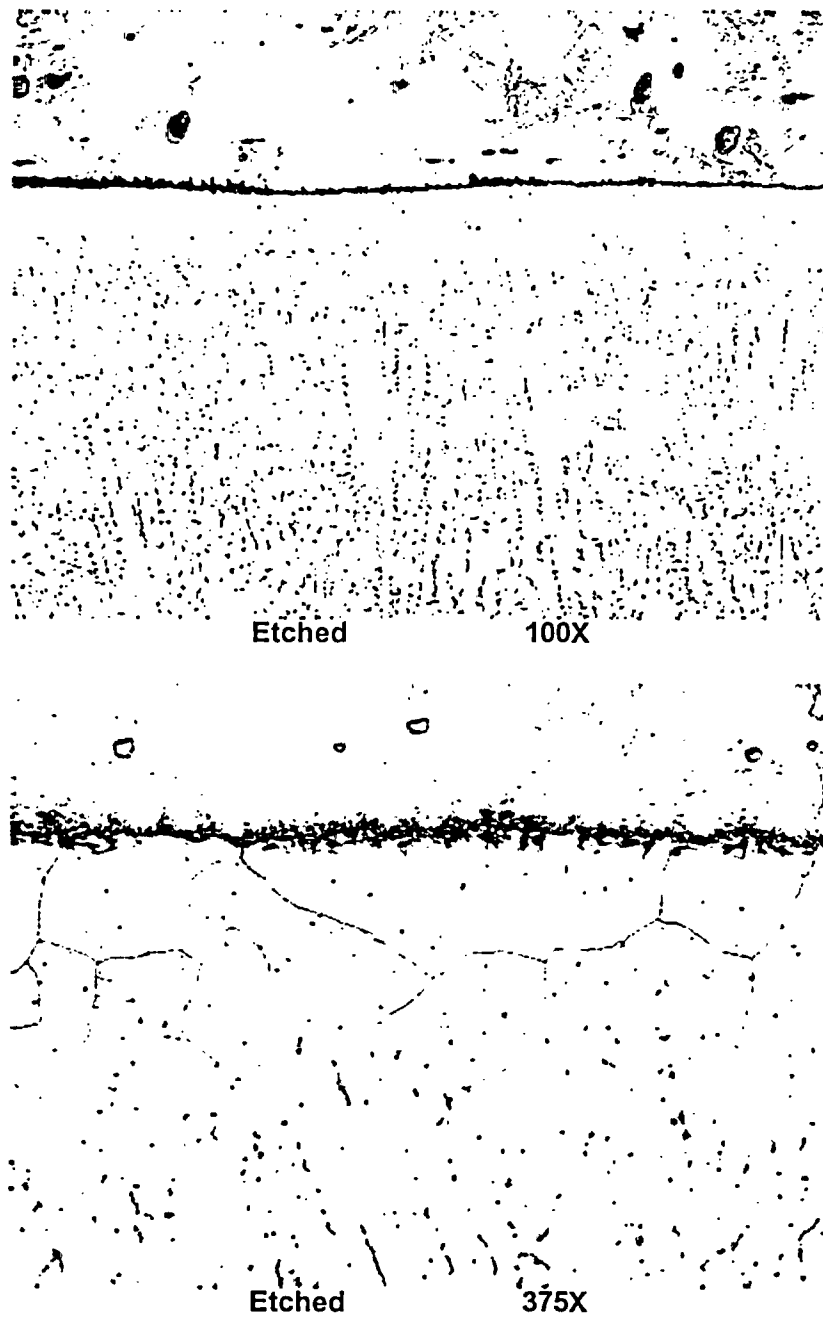
**Figure 8.3.2.4: Micrographs showing the interface between the low alloy steel (above the fusion line) and the stainless steel cladding (below the fusion line).**

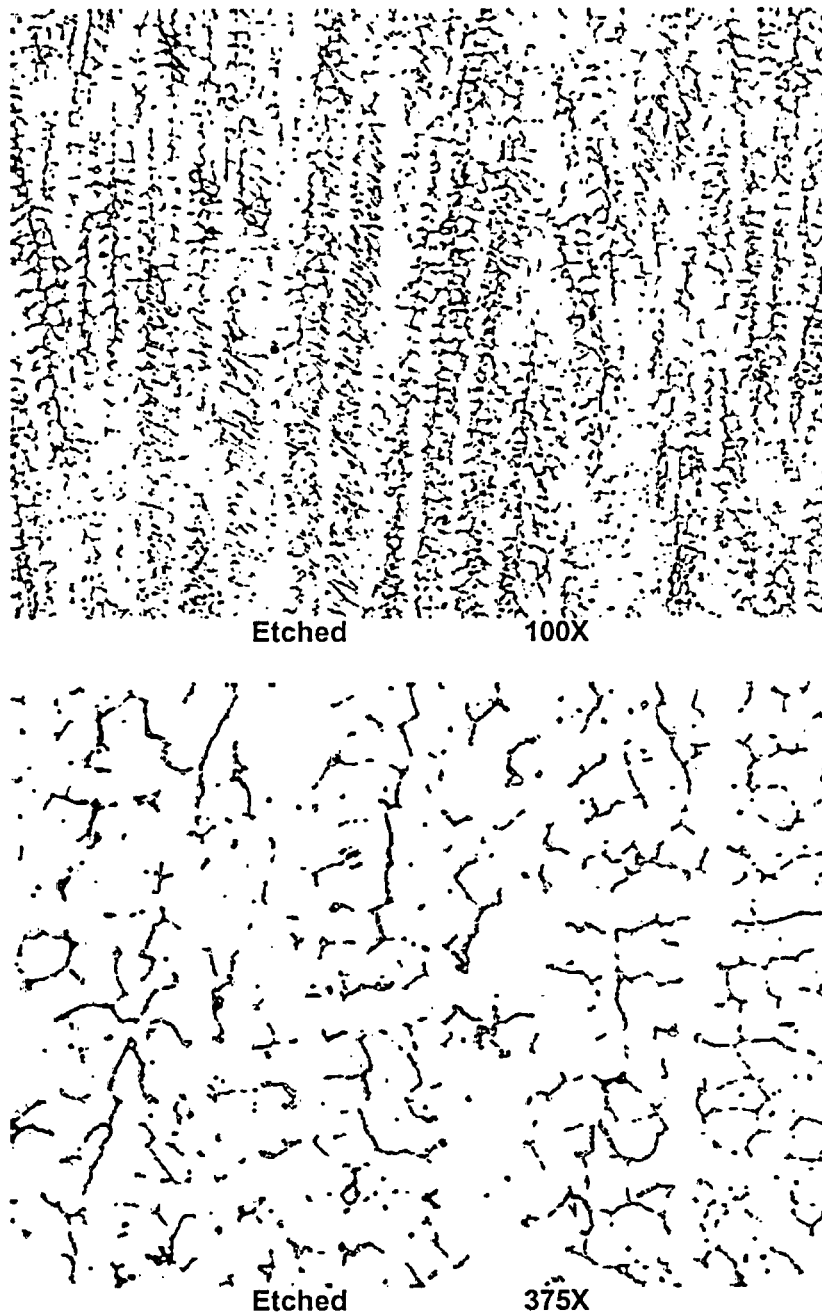
**Figure 8.3.2.5: Micrographs showing the typical stainless steel cladding microstructure. The interdendritic solidification structure is delineated by small pools (or islands) of ferrite in an austenitic matrix.**

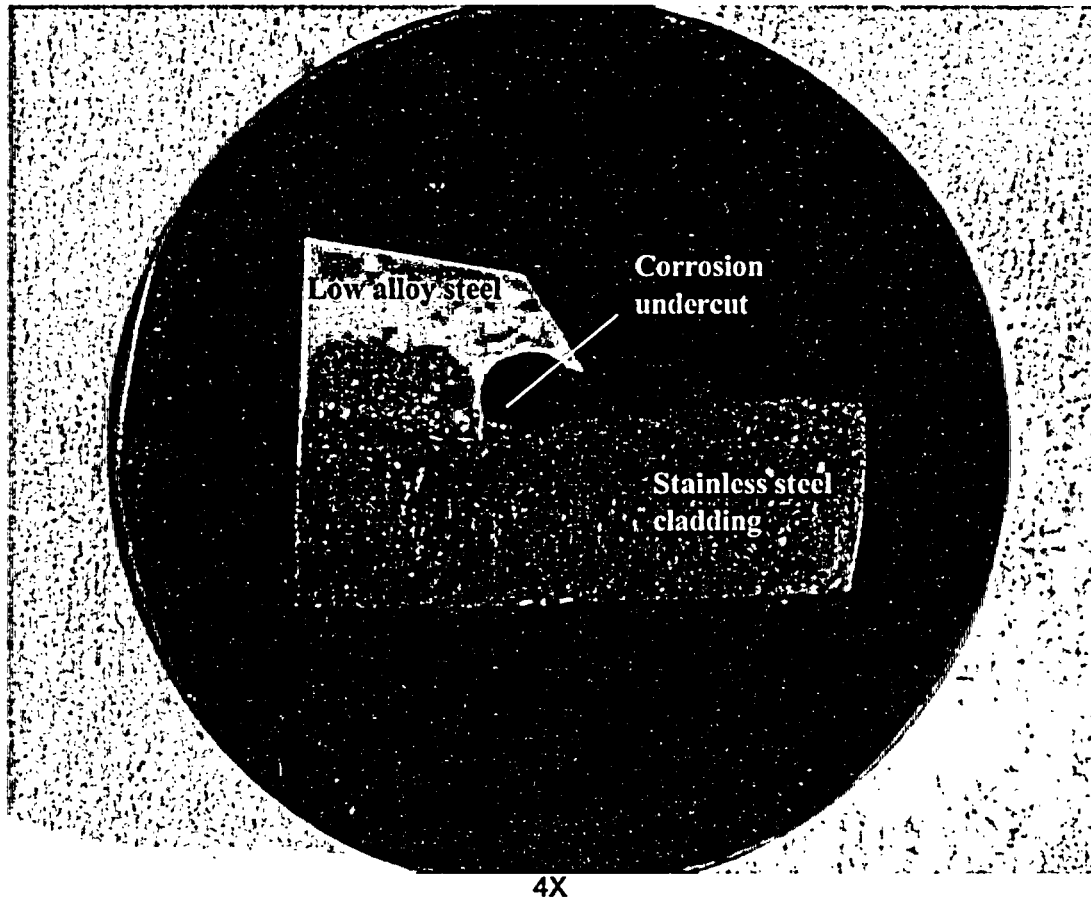
Figure 8.3.3.1: Macro photograph of metallographic mount A2A7K. Refer to Figures 5.1 and 5.11 for the sample location.

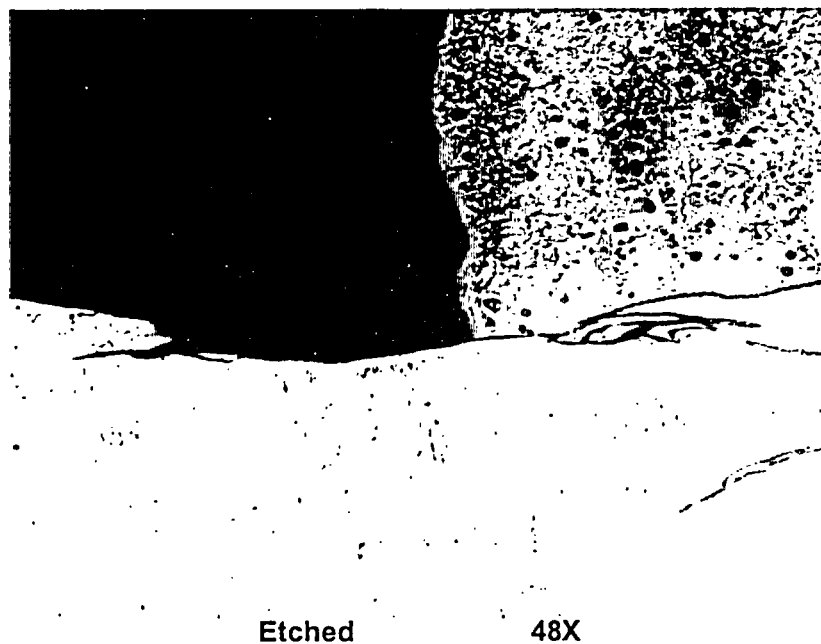
Figure 8.3.3.2: Micrograph showing the edge of the exposed cladding in the undercut region. Note: the micrograph is a mirror image of the macrograph in Figure 8.3.3.1.

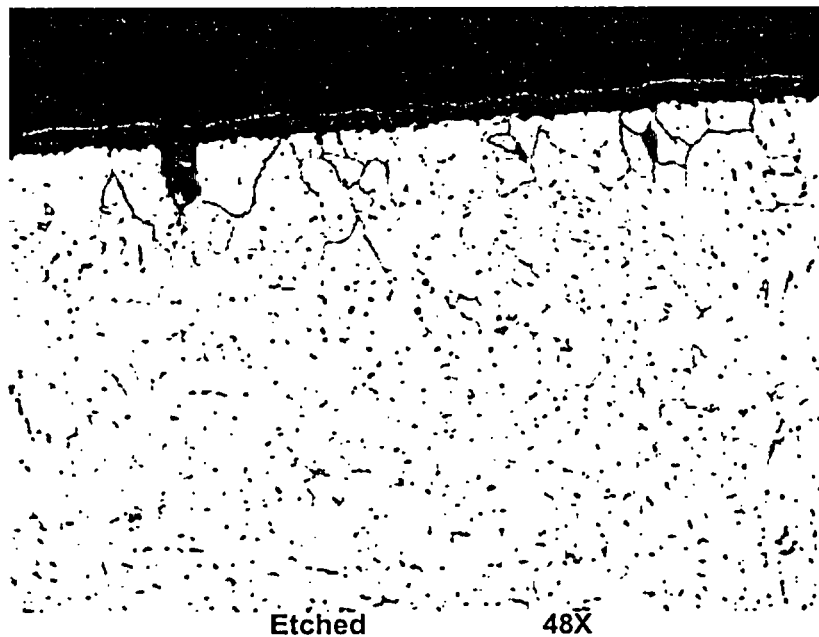
Figure 8.3.3.3: Micrograph showing minor intergranular attack (IGA) in the exposed cladding surface.

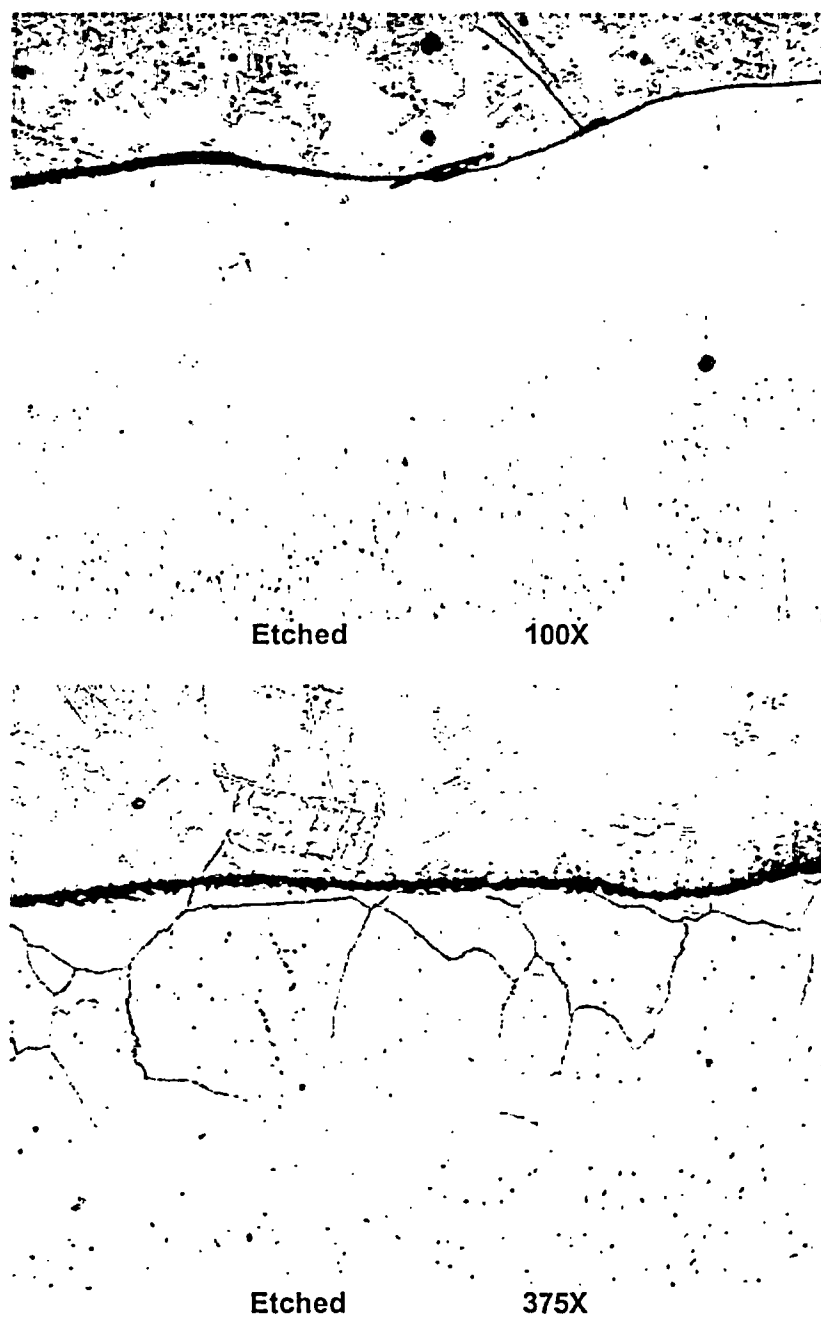
**Figure 8.3.3.4: Micrographs showing the interface between the low alloy steel (above the fusion line) and the stainless steel cladding (below the fusion line).**

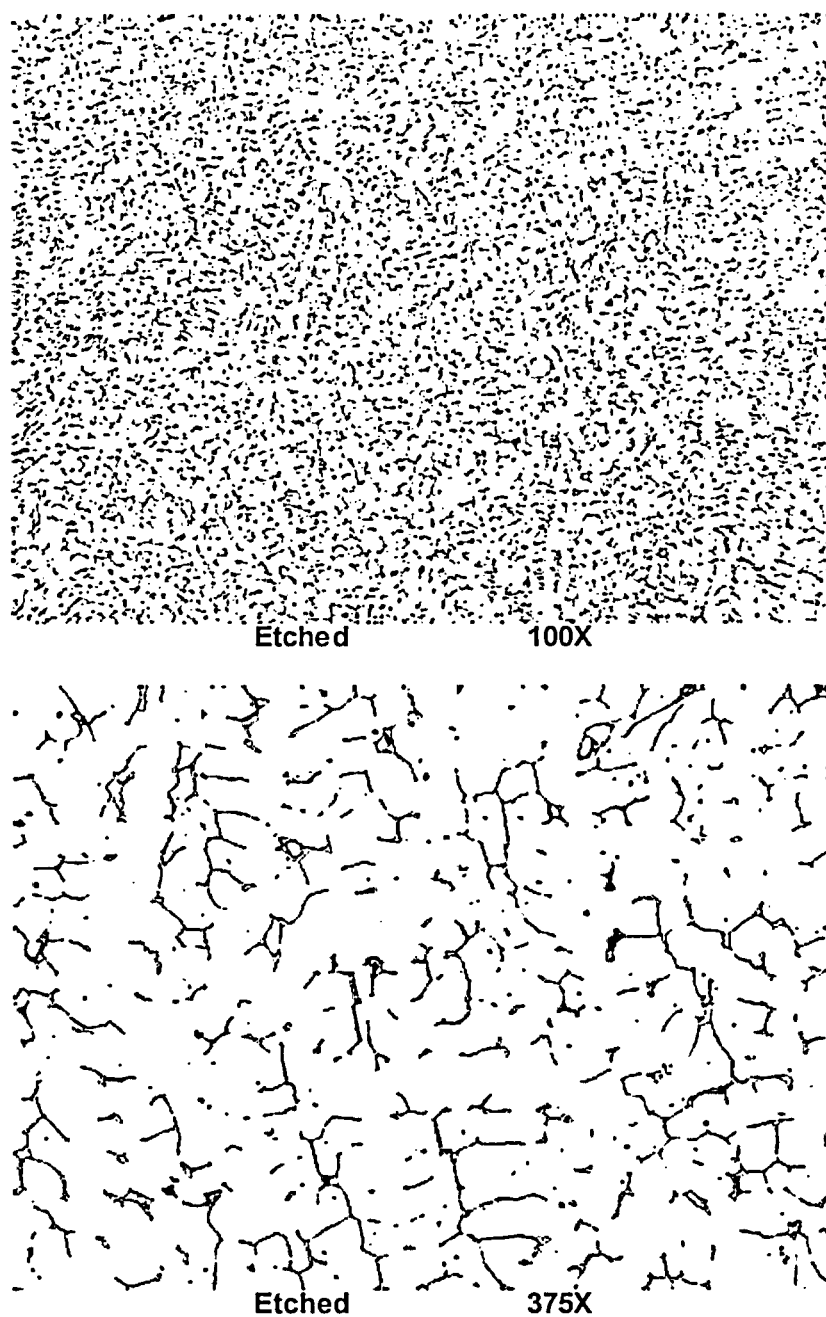
**Figure 8.3.3.5: Micrographs showing the typical stainless steel cladding microstructure. The interdendritic solidification structure is delineated by small pools (or islands) of ferrite in an austenitic matrix.**
