## POST-IRRADIATION EXAMINATION RESULTS FROM THE BTF-105A LOCA/LOECC TEST

VALLIANT, P.J., IRISH, J.D. and CRAIG, S.T.

Fuel Safety Branch  
Reactor Safety Division  
AECL, Chalk River Laboratories  
Chalk River, Ontario, CANADA K0J 1J0

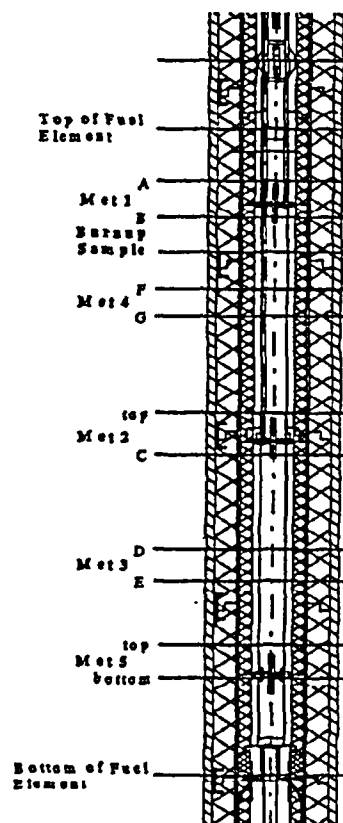
The fuel element and the NILCRA liner and Zircaloy tube of the thermal shroud were cast in epoxy. Transverse sections were taken at 5 elevations over the length of the fuel element, and the sections were examined metallographically (Figure 7). At each cross-section elevation, fuel-sheath-oxide thicknesses were measured along with  $\text{UO}_2$  grain size at the centre, mid radius and periphery of the fuel (Table 1). The  $\text{UO}_2$  grain size has remained relatively unchanged from as fabricated due to the low temperature (fuel-centreline temperature  $\sim 1400^\circ\text{C}$ ) during the 10-day irradiation in pressurized water and due to the short time that the fuel element was at high temperature during the transient. Sheath oxidation ranged from minimal at the top of the fuel element (Figure 8) to through-wall oxidation over the whole bottom half of the fuel element (Figure 9). The  $\text{UO}_2$  fuel was heavily cracked throughout the fuel element with fuel relocation in the lower elevations. Figure 10 illustrates the totally oxidized sheath at the lower element elevation. The lower bearing pad (Figure 11) shows the extent of oxidation and sheath transformation. Near the end of the transient, liquid water passed through the test section. At this time the temperature indicated by TFS03 dropped  $1200^\circ\text{C}$  in 10 seconds. The thermal shock from this quench resulted in a shattered appearance of the fuel, sheathing and NILCRA insulation at the lower elevations (Figure 9). It has been hypothesized [2] that this quench contributed to fuel sheath failure. Metallography at various elevations showed the rhenium clad thermocouples remained intact, confirming that they survived the transient in reasonable mechanical condition. Figure 8 shows the fuel-centreline thermocouple, TFC01, and external sheath thermocouples, TFS01 and TFS02, from the upper bearing pad location. They appear to be mechanically sound with no apparent sign of damage. TFS03, seen in Figure 9, remains intact and is surrounded by relocated fuel sheathing and  $\text{UO}_2$  fuel. The good performance of thermocouples TFS02 and TFS03 [1] attached with Zircaloy clamps, together with the good mechanical condition of the thermocouples as indicated by PIE, showed that thermocouples of this type and the method of attachment should be used for future BTF tests.

Figure 7: BTF-105A Post-Irradiation Examination Sections
