Augmented Inspection Team Inspection of Honeywell Uranium Hexafluoride (UF₆) Release

December 22, 2003

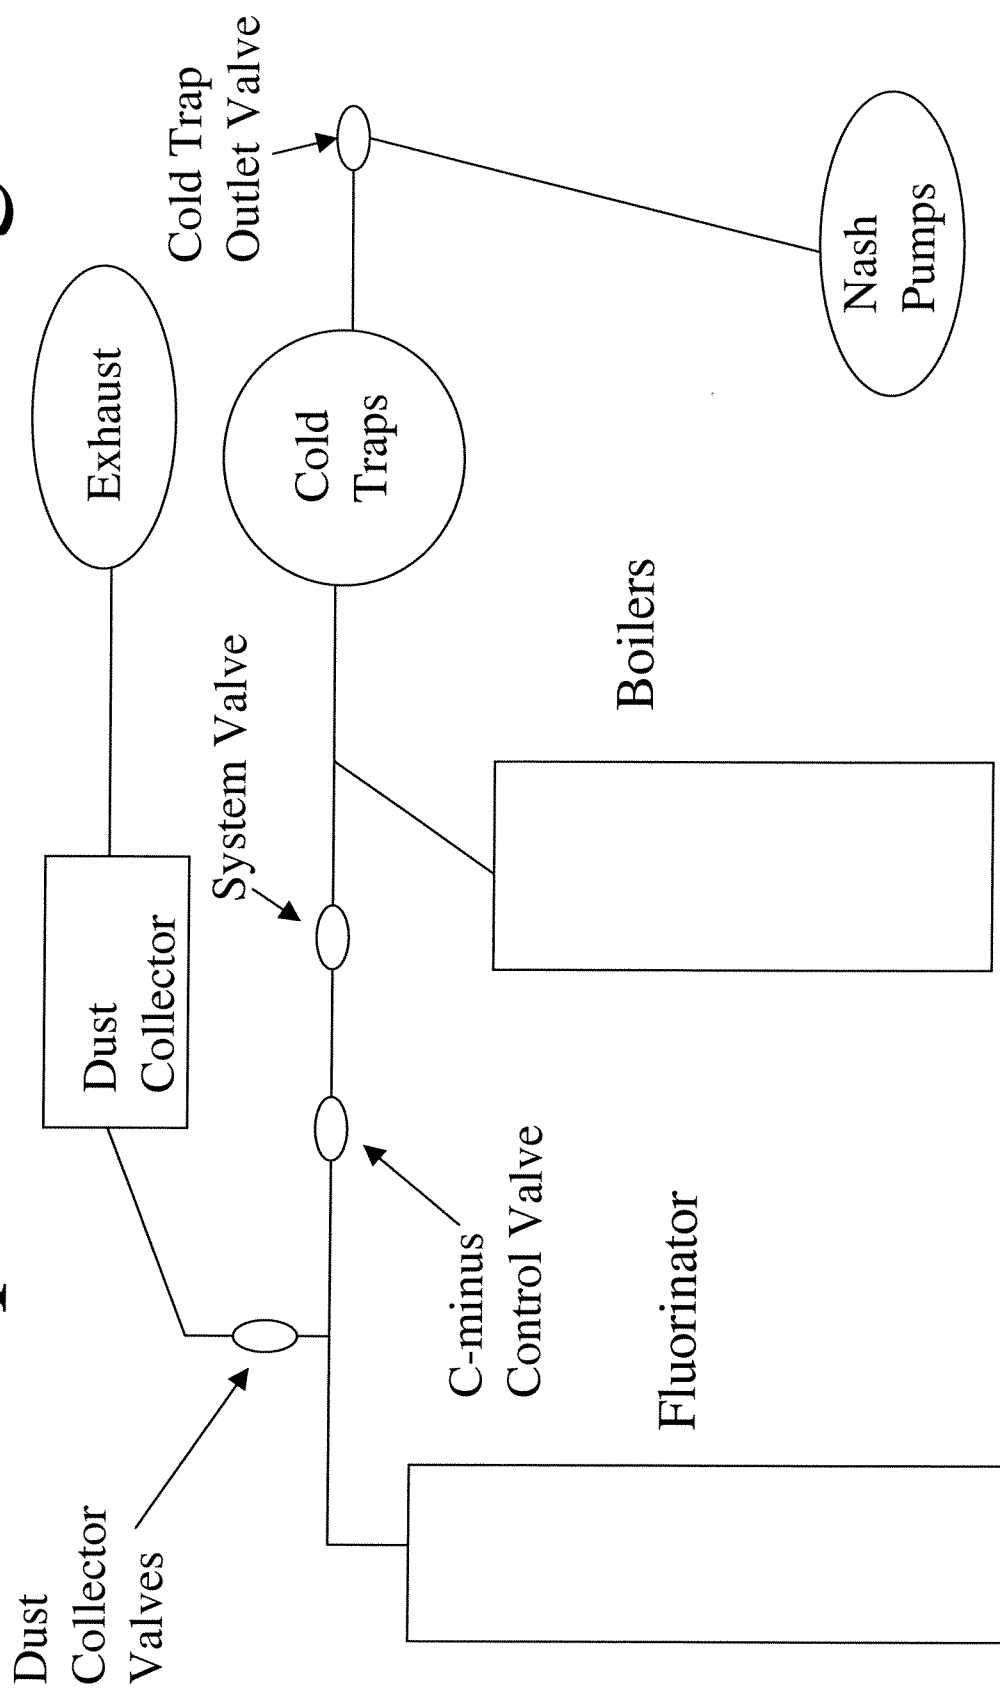
Simplified Process Drawing

- The AFO proceeded with the reconfiguration of the downstream pipes which isolated a section of process equipment and piping from the fluorinators to UF₆ storage tanks called cold traps
- This isolated section began to pressurize from the 90 psi nitrogen gas and from 70 psi of UF₆ entering from the recycling boilers

- The initial UF6 leak was from the C-minus control valve
- The release to the environment occurred when the dust collector valves were opened and the UF6 under pressure in the system exited through the dust collectors and out a horizontal exhaust stack on the southwest side of the Feed Materials Building (86 ft above ground level)
