Generator Rotor and Steam Dryer Meeting

Dresden Nuclear Power Station
December 2, 2004

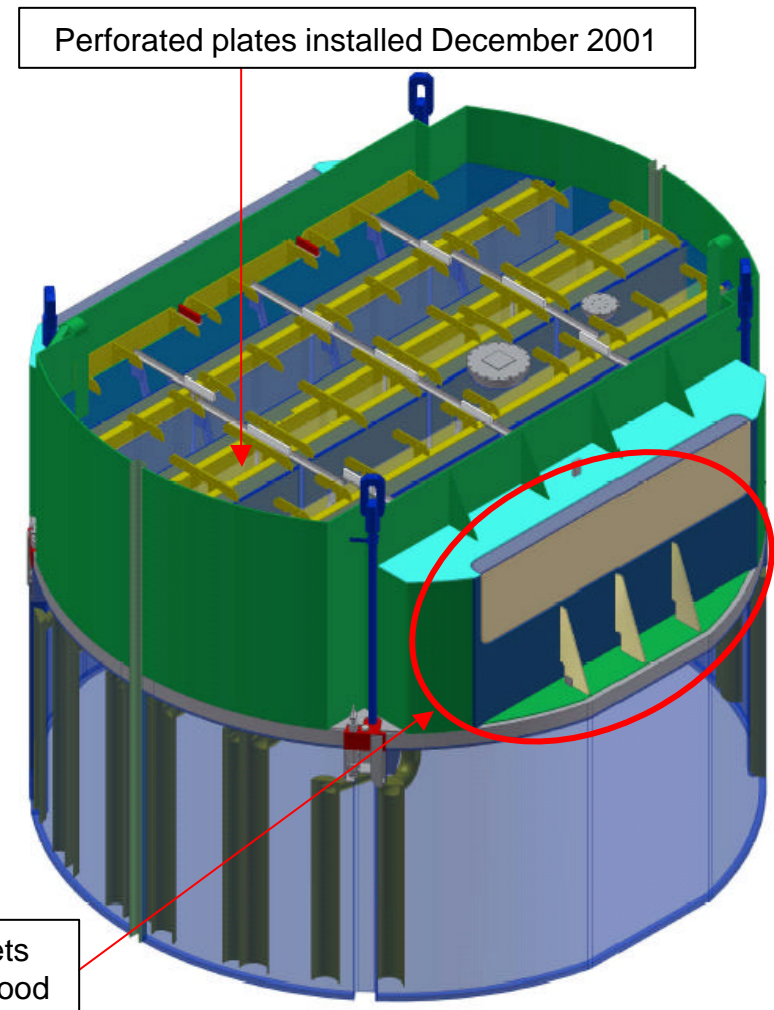
D2 Timeline

- Began EPU operation on December 26, 2001
 - During the Fall 2001 refueling outage, perforated plates were added to reduce moisture carryover
- Fall 2003 refueling outage (post 690 days continuous run at EPU power)
 - Added 1/2" cover plate
 - Added 1" partial height front hood face plate
 - Added 3 gussets on both 90° and 270° sides that did not extend to the 1" plate
 - Interior and exterior examinations performed in accordance with GE SIL 644

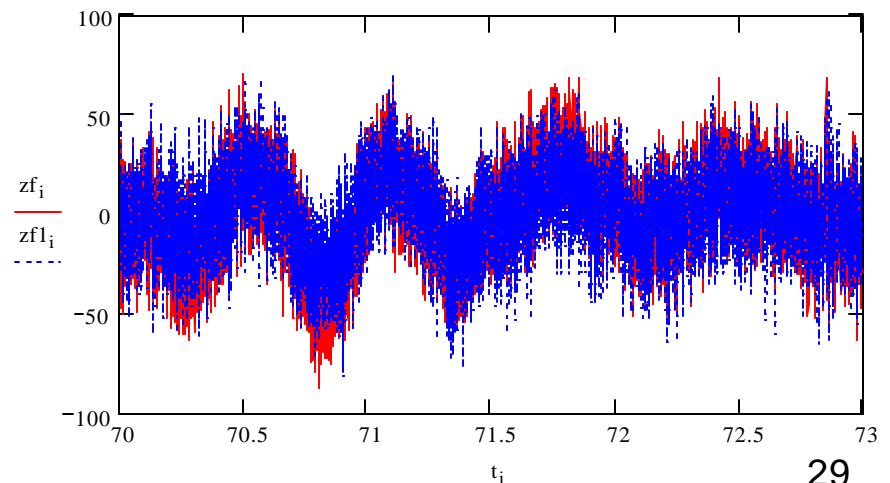
Plot of Filter SMT data (Red) compared to CDI predicted data (Blue) -
First Benchmark Data Point M21
