BWR steam dryer integrity

SIL No. 644
Revision 1

November 9, 2004

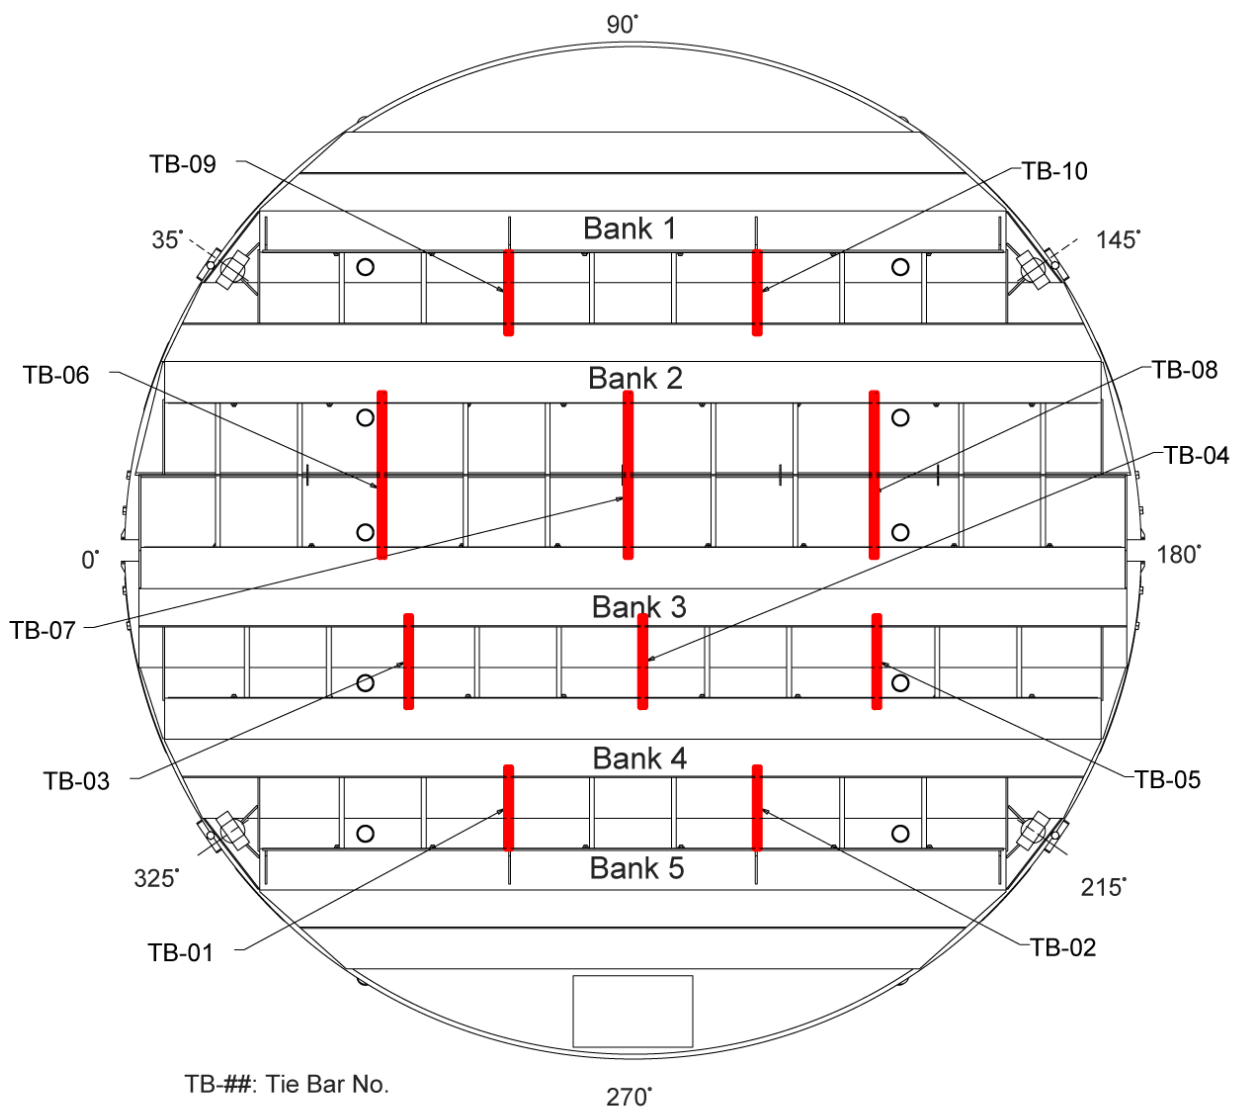
Figure C-10: Tie Bar Locations (Slanted Hood Dryers)

In addition to the outer bank and interior bracket locations, tie bars also require inspection. Figure C-10 provides a schematic of the tie bar locations joining the tops of each set of banks. The primary concern is the presence of fatigue cracking through the bar base material cross-section at axial location where the tie bar is attached to the bank.

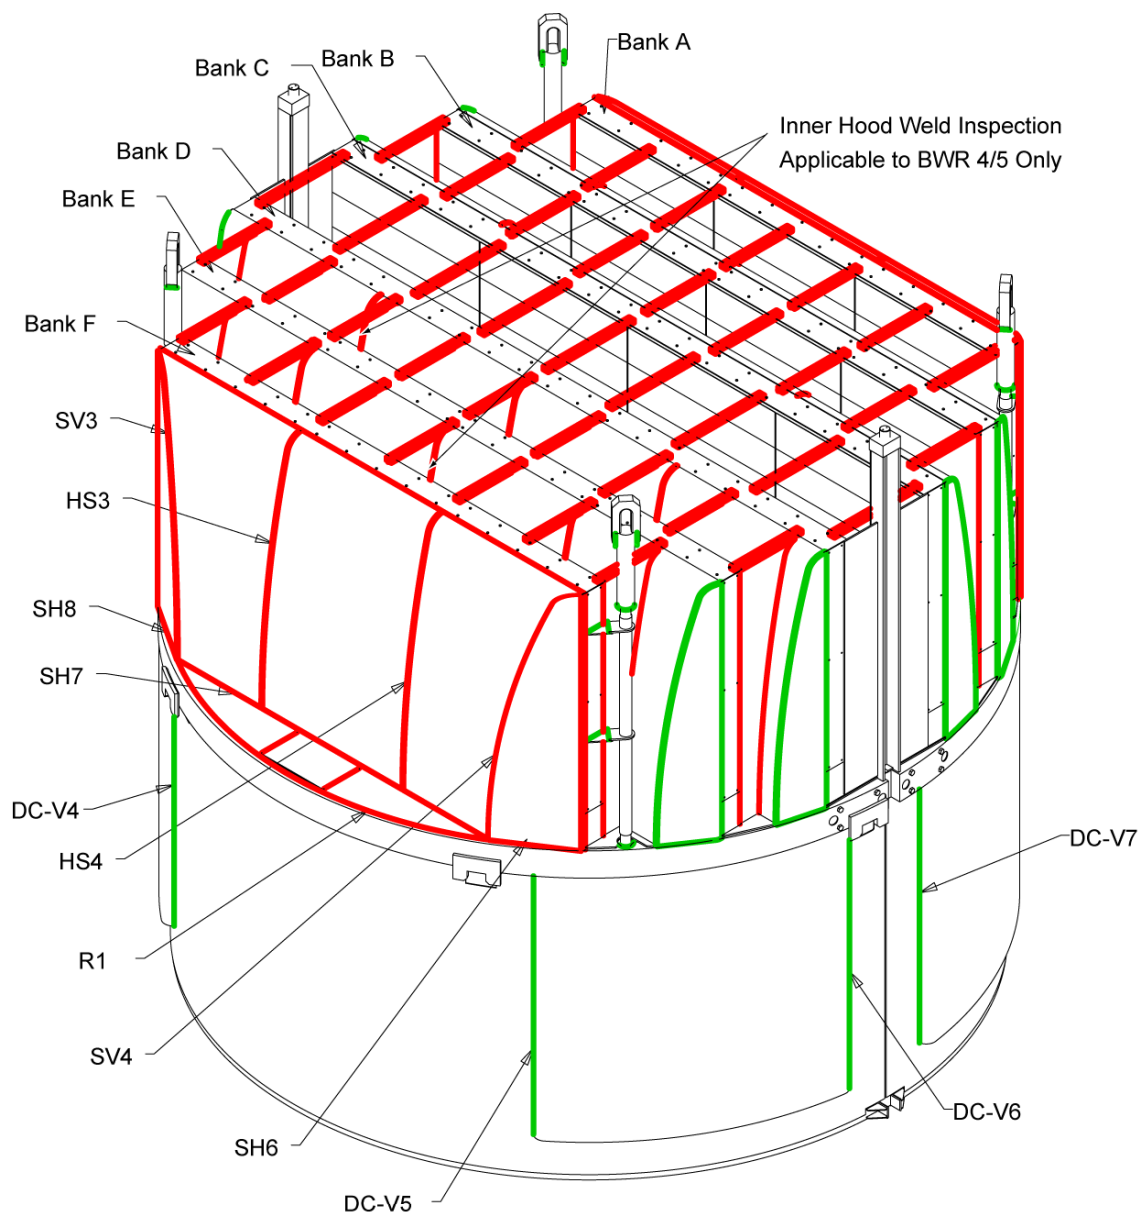
Figure C-11: Inspection Locations (Curved Hood Dryer)

Cracking has been detected in the end panels in later design dryers. Therefore, these additional weld seams associated with the outer side of the inner banks should also be inspected in that this represents a steam path through the dryer. These areas are shown in green in Figure C-11. Cracking has been observed in these locations in dryers of this design. The other locations of interest are primarily associated with IGSCC in drain channels (refer to SIL No. 474 “Steam Dryer Drain Channel Cracking” issued October 26, 1988) and lifting rod attachments.
