Hairline Crack in IPEC Unit 2 Spent Fuel Pool South Wall

9/8/05

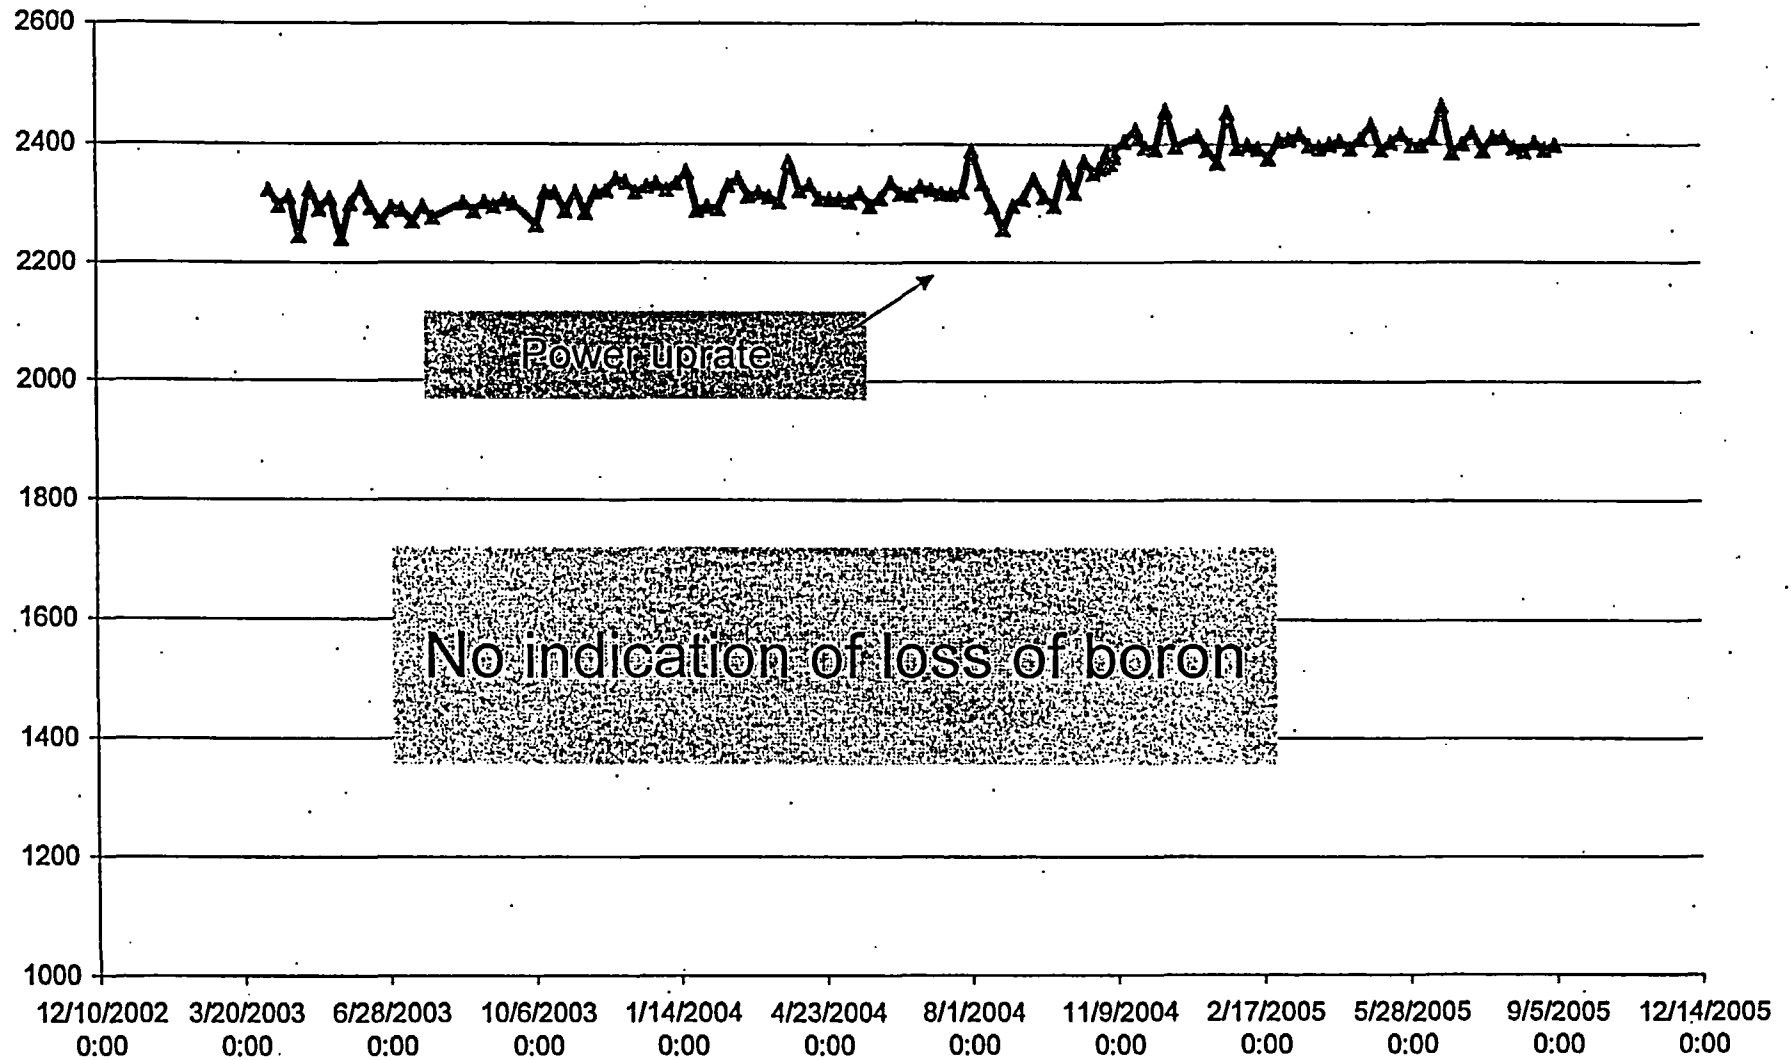
U2 SFP

*) The cracks have been visually inspected by an IPEC civil/structural engineer, and the IPEC Supervisor of Civil/Mechanical Engineering. The condition is typical of cracking due to shrinkage during post-construction concrete curing. The moisture in and around one of the cracks is very slight, essentially a film which is not dripping or beading. The moisture has been analyzed and found to contain trace amounts of Cesium 134 and 137, Cobalt-60, and Boron. The Boron concentration is about six times less than the concentration in the SFP, and the ratios of Cesium-134 and 137 indicate the activity is about six years old. The crack has calcium stains emanating from it, as is expected when moisture leaches through concrete, and no visual evidence of steel corrosion products (rust). Due to the thickness of the SFP wall, amount of steel reinforcement, and lack of evidence that the small amounts of moisture and boron have caused corrosion of the reinforcing rods, there is reasonable assurance that the SFP wall is structurally sound and capable of performing it's intended function.

Dry Cracks ~ 1/64" Width

Crack Map of South Wall Spent Fuel Pit
Looking North
